Slaithwaite Reservoir

Slaithwaite

Desk-based Assessment

Report no. 3950
April 2023

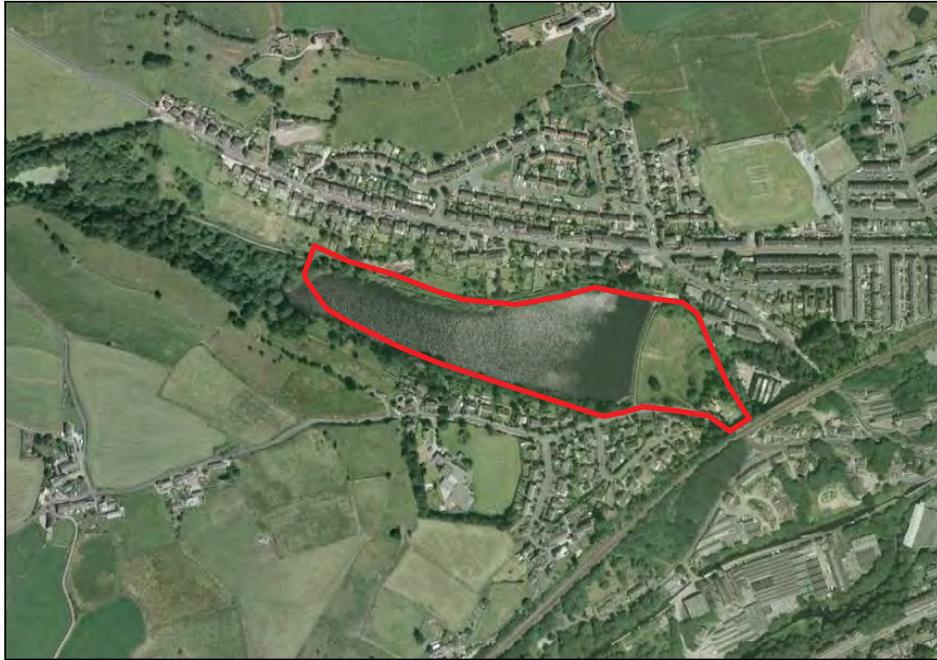
Fig. 12. An aerial photograph of the site taken during 2003

Aerial photography of the site (Fig. 11) shows reservoir largely unchanged from earlier mapping. The woodland on the western side of the reservoir has been extended, particularly around the former site of Clough House Mills and there is increased planting to the south. New residential developments to the south and north of the reservoir are also visible. LiDAR imagery (Fig. 12) shows some possible features in the area of woodland at the western end of the reservoir, but nothing on the banked slope to indicate historical cuttings or the former tunnel.

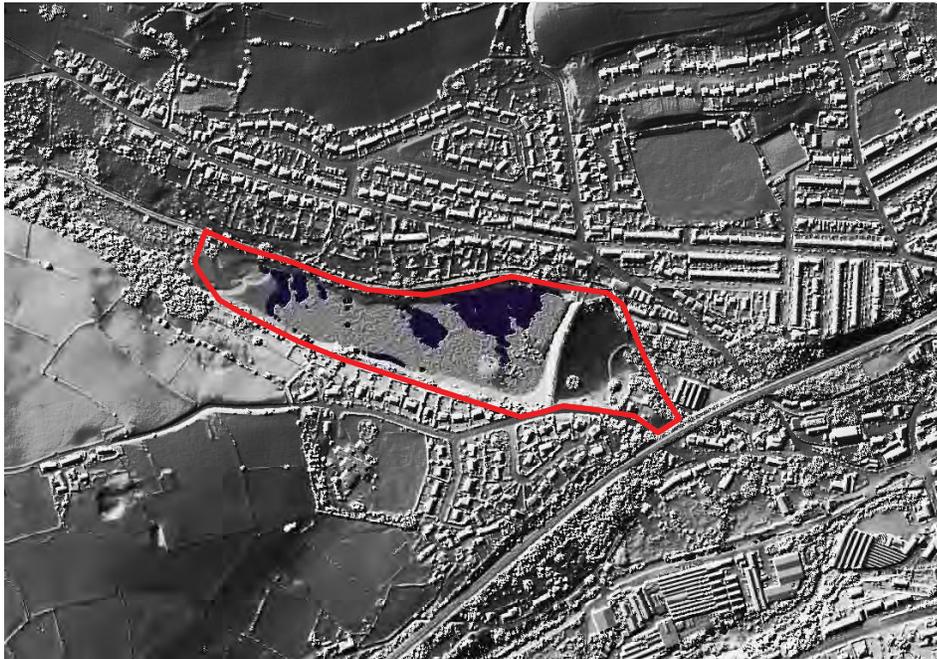
Fig. 13. LiDAR imagery of the site

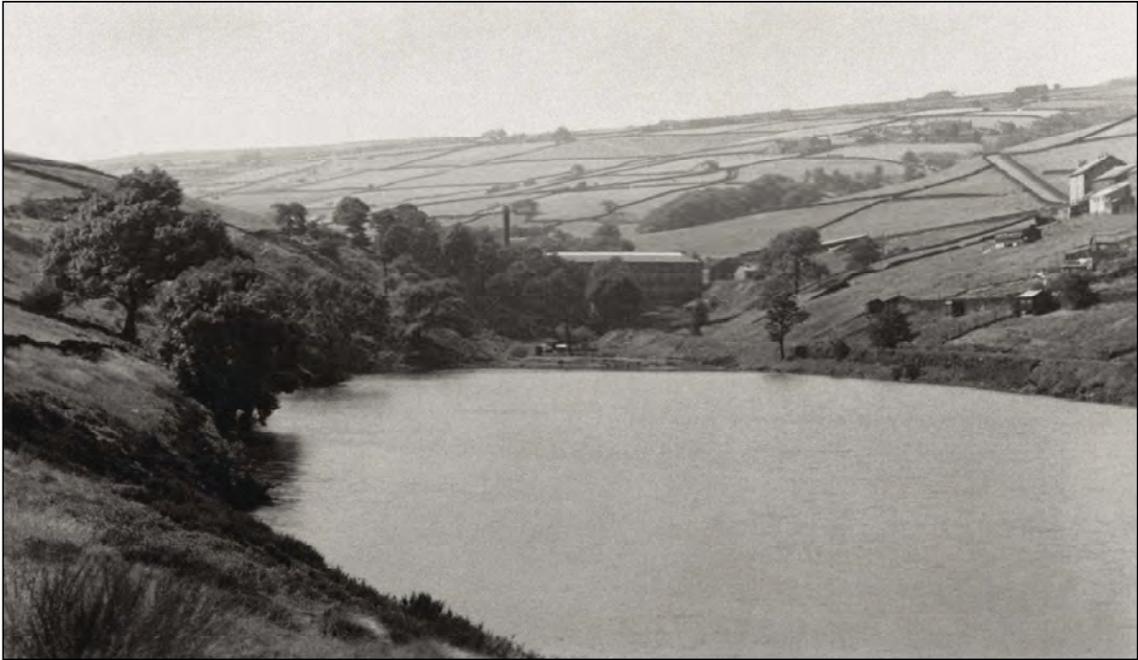
*Plate 1. View of reservoir with Clough Mills in background, unknown date
(Source: Huddersfield Exposed)*

A 20th-century photograph from the Huddersfield Exposed website (Plate 1), shows the reservoir with limited vegetation surrounding it and Clough Mills visible in the background.

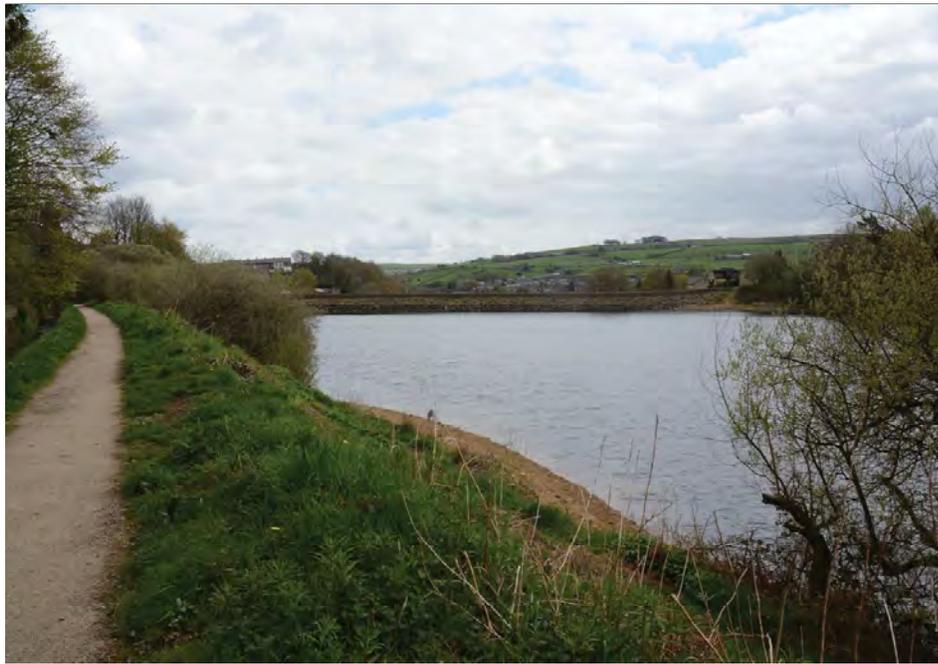
Plate 2. General view of reservoir, looking west

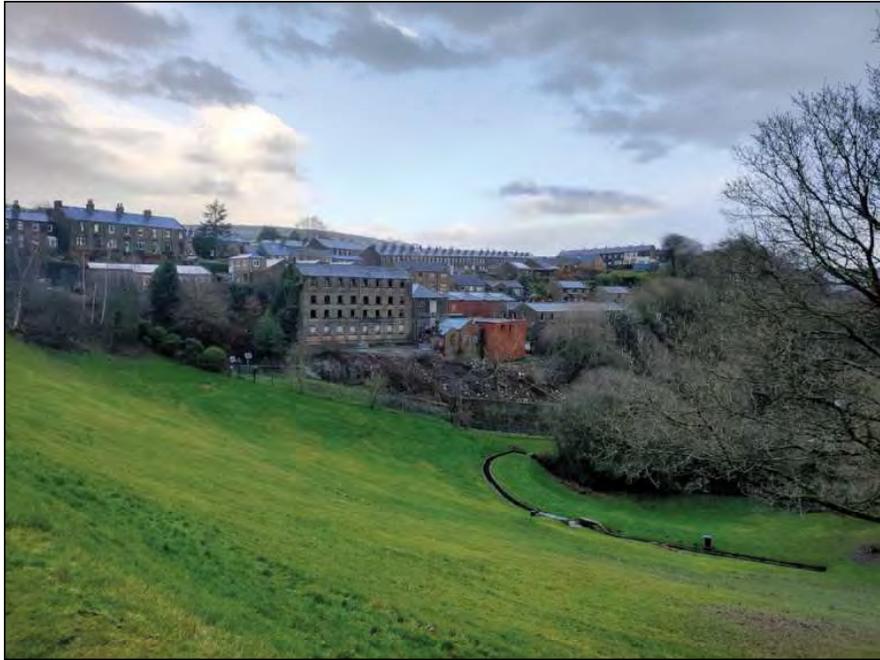
Plate 3. View of banked slope, looking northeast

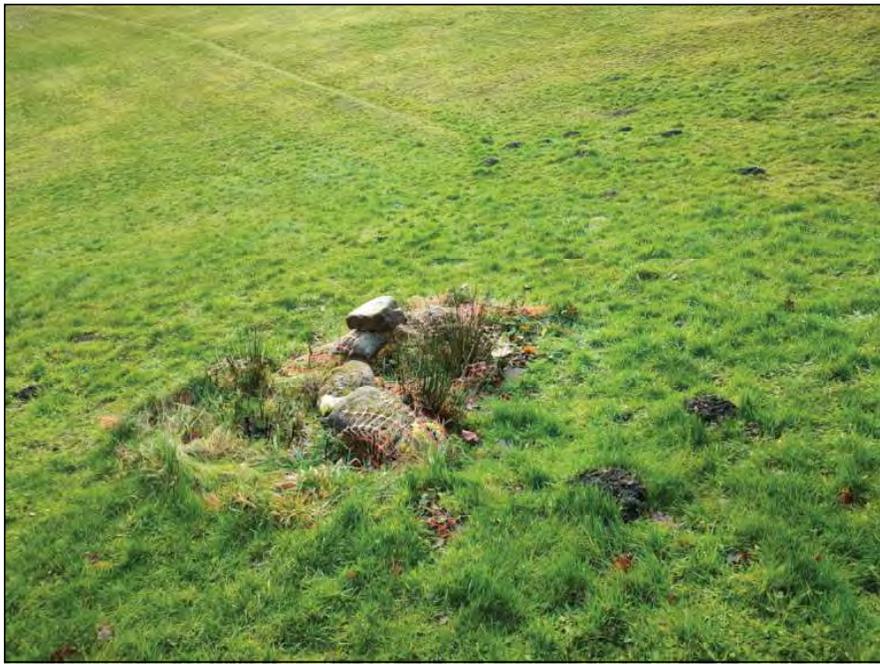
Plate 4. View of exposed stonework on the banked slope, looking south

Walkover surveys of the site were undertaken in January 2023 and again in April 2023 (Plates 2-14). Views across the grassed, banked slope to the east of the dam (Plate 4) show the current incline from the dam, and there is a terrace to allow foot traffic along the bank which was not shown on the earlier OS maps. Some exposed stonework was observed on the northern part of the bank's slope (Plate 4) which does not obviously correspond to features on historic mapping and may belong to the original construction of the reservoir.

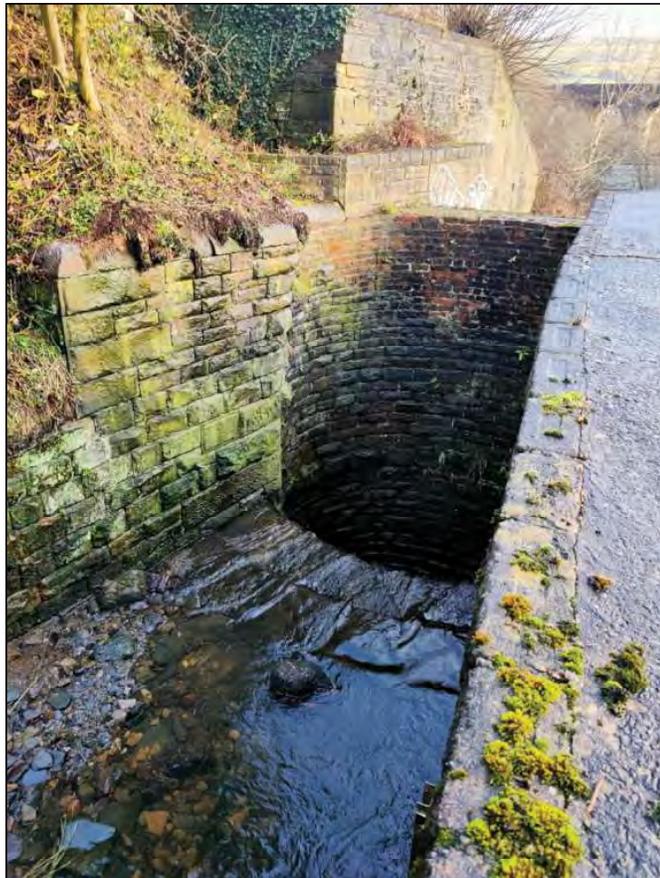
Plate 6. View of top of drop shaft into arched tunnel, looking east

of the drop shaft into the arched tunnel (Plate 6) is in better condition. The exterior of the arched tunnel appears to be in reasonable condition (Plate 7), but a brief examination of the interior (Plates 8 and 9) showed clear deterioration in the stonework.

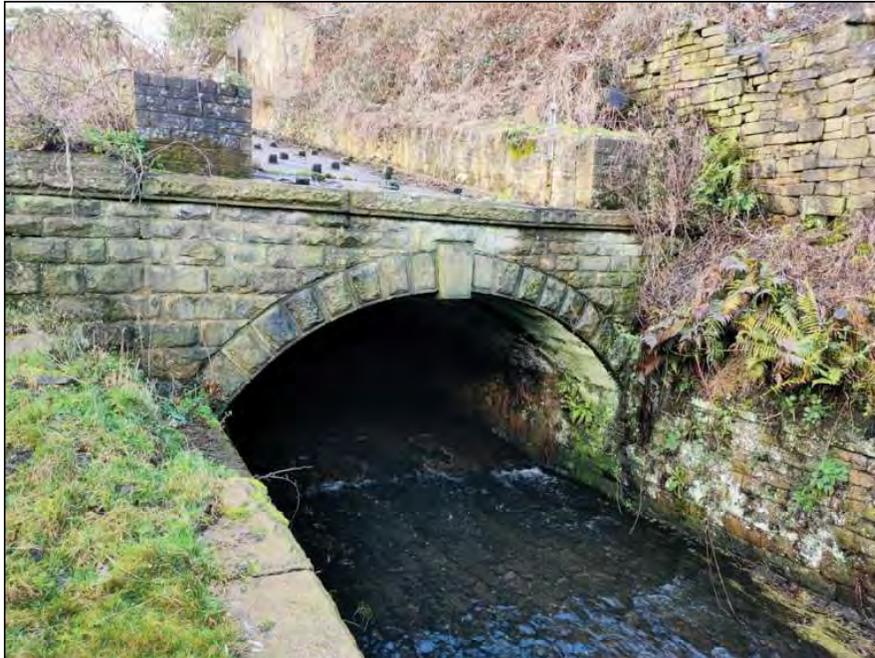
Plate 7. View of arched tunnel exterior with reinforced concrete channel above, looking northwest

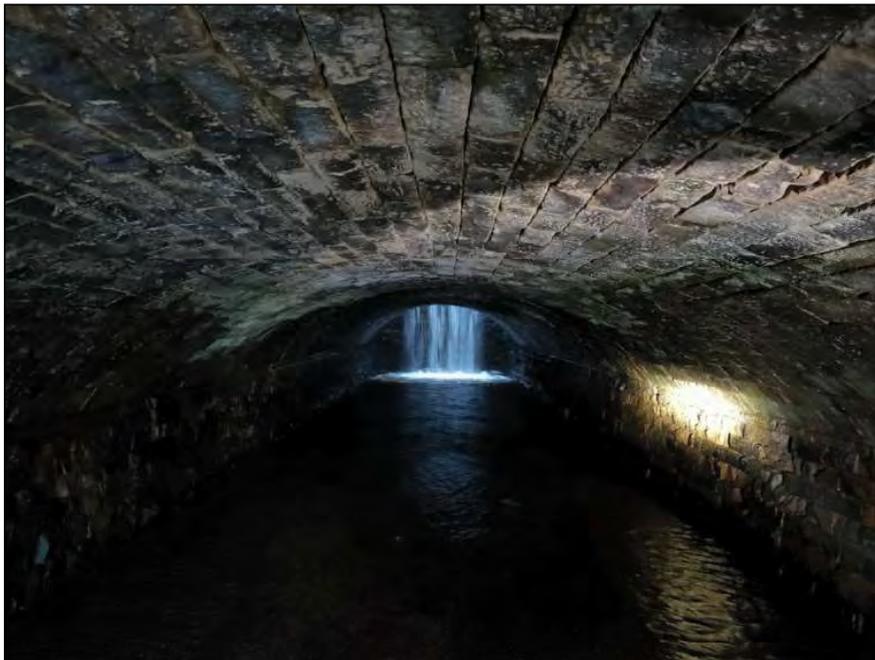
Plate 8. View of arched tunnel interior, looking west

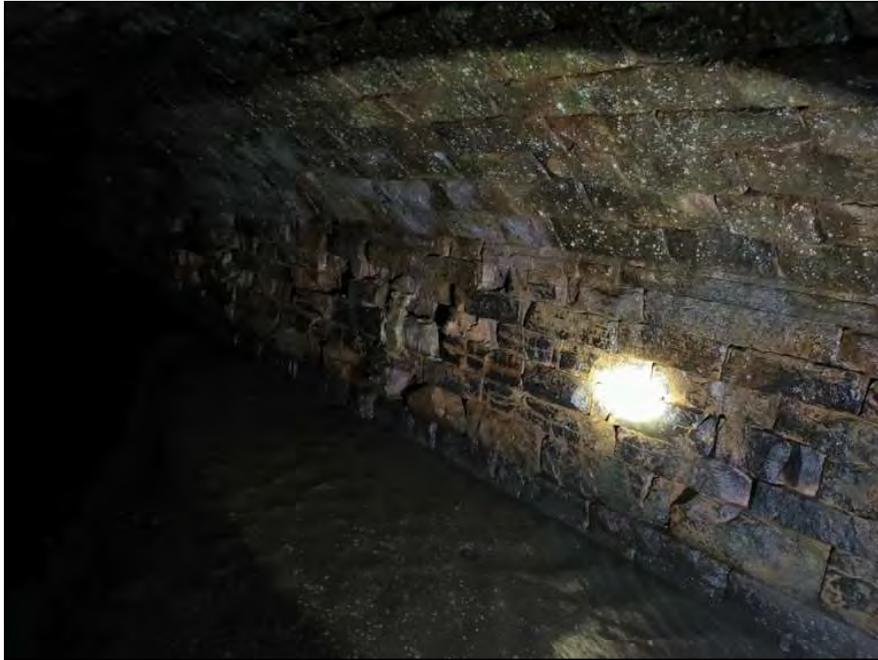
Plate 9. View of arched tunnel interior showing deterioration of stonework

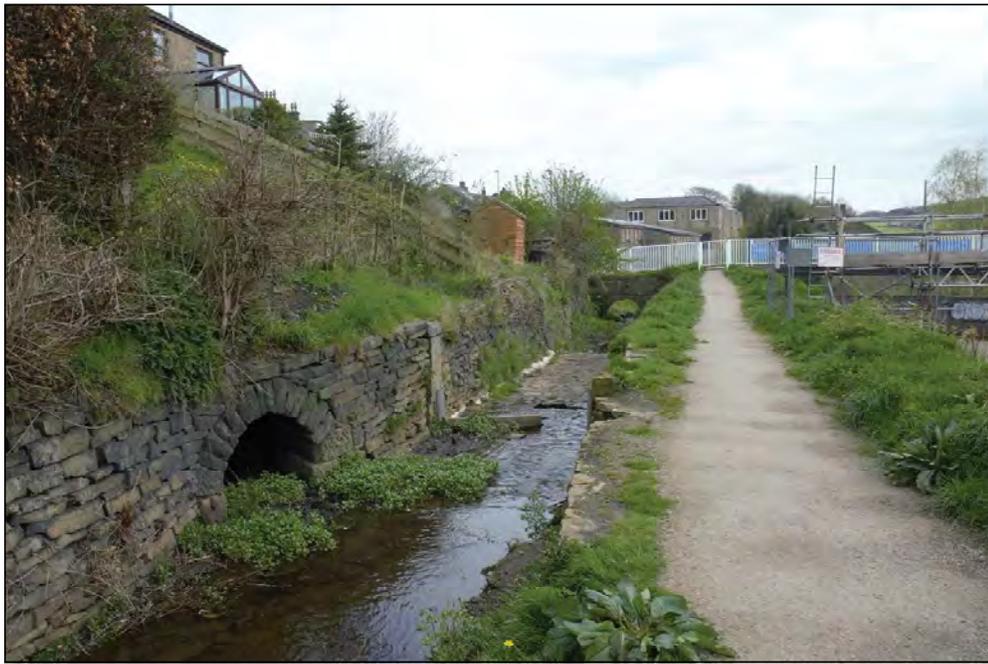
Plate 10. View of mill race, looking east

The stone-built mill race (Plates 10, 11 and 12) is still serviceable and runs along the northern edge of the reservoir into the outlet system. Recent repairs (visible in Plate 10) have been completed in materials unsympathetic to its historical fabric and are detrimental to the aesthetic of the feature. Parts of the stonework are in some disrepair (see upper courses of Plate 11).

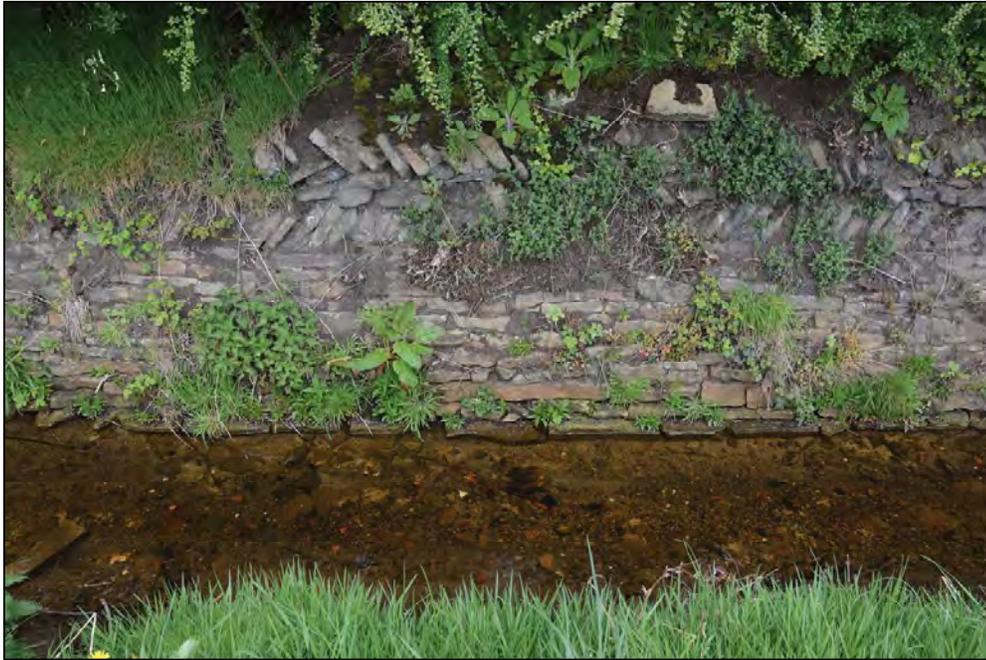
Plate 11. View of mill race northern wall, looking north

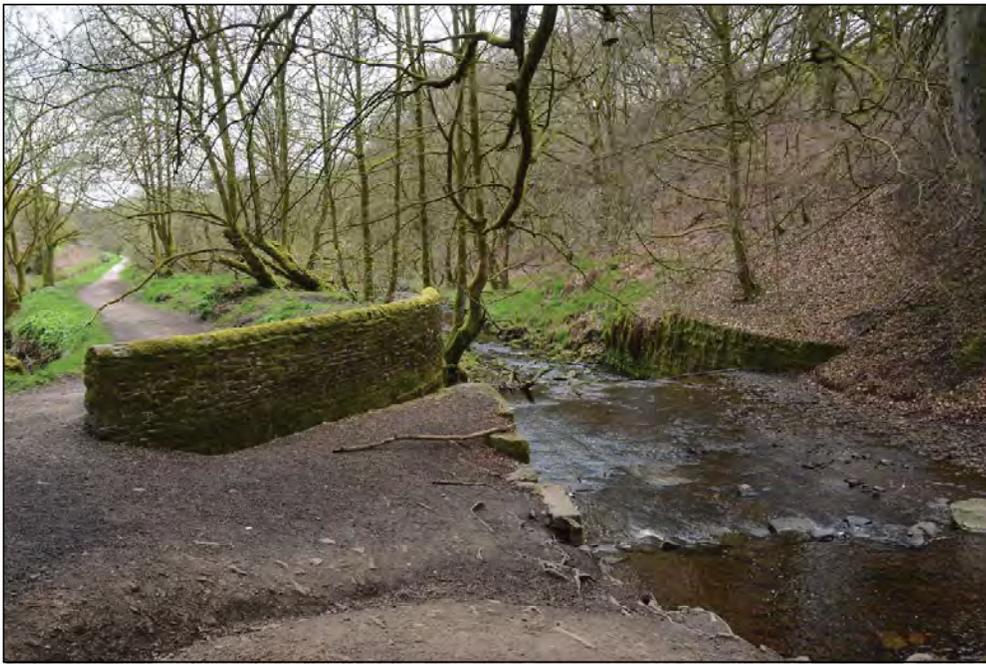
Plate 12. View of mill race, looking southeast

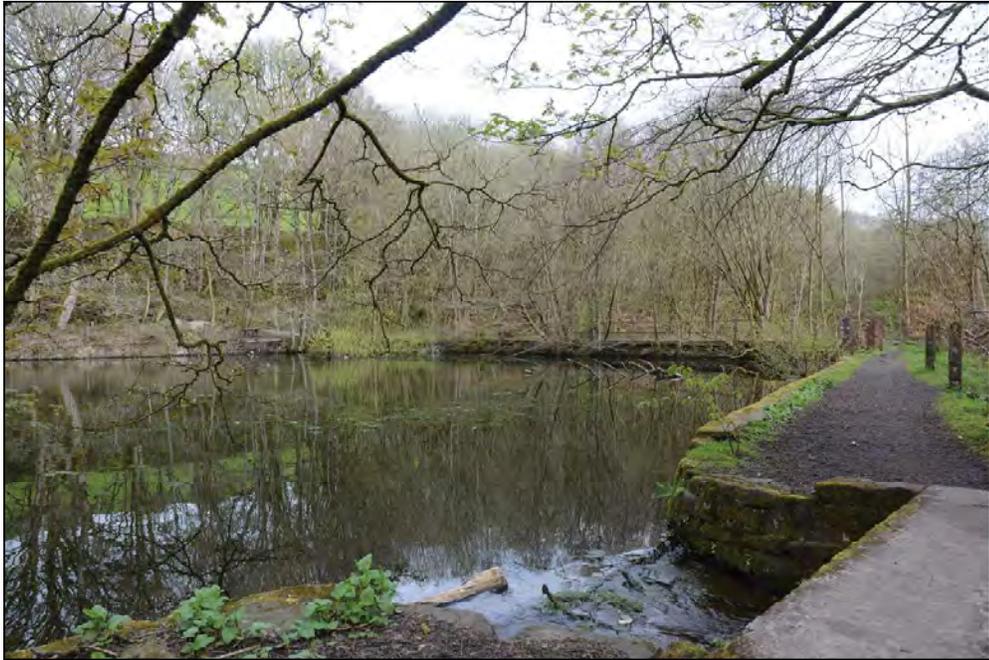
Plate 13. View of mill pond at western end of site, looking southwest

In the wooded area to the west of the reservoir, the former mill pond is still present (Plate 11) and the remains of former structures associated with Clough House Mills can still be seen.
