## Preliminary Ecological Appraisal and Roost Assessment

Oxford Grange Nursing Home, 30 Oxford Road, Dewsbury, WF13 4LL

This report is prepared to inform a planning application with the Kirklees Council. The proposal is described as:

“The conversion of the existing vacant nursing home into flats with associated landscaping and parking areas.”

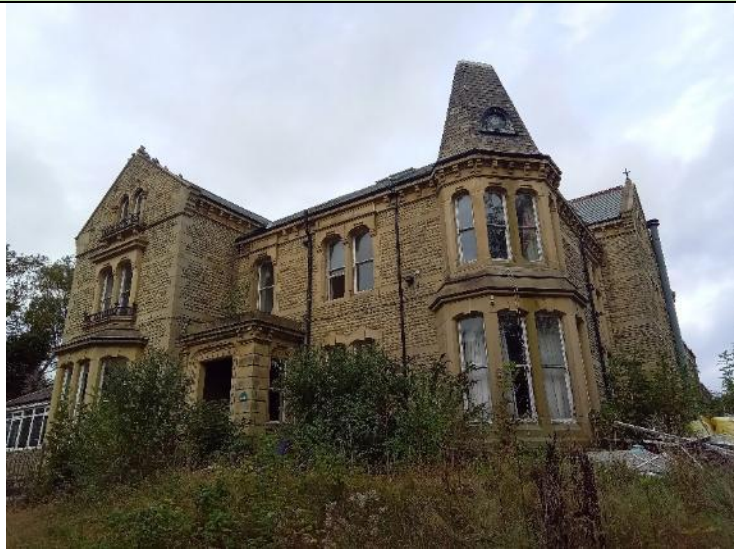
| <p><i>Summary</i></p> <p>B1 is a large vacant stone-built nursing home with a pitched and gabled roof clad in slate roof tiles. The building will be converted into apartments as part of the proposed works. Multiple features were recorded along the exterior of the building suitable for bat ingress, by void or crevice-dwelling species. The building could support moderate numbers. The building is unlikely to support a hibernation roost but could support a maternity roost. As a result, the building has <b>high roost value</b>.</p> | | | |

| <i>Recommendations</i> | <p><b><u>Roosting habitat:</u></b></p> <p><b>B1: Three bat emergence surveys are required during the active bat season (optimal May to August, suboptimal September) to confirm presence or likely absence of a bat roost in the building.</b> At least two of the surveys should be completed during the optimal survey period mid-May to August inclusive and surveys should be spread at least three weeks apart. Infra-red cameras should be used as an aid. Eight surveyors are required to provide full coverage of the building.</p> |

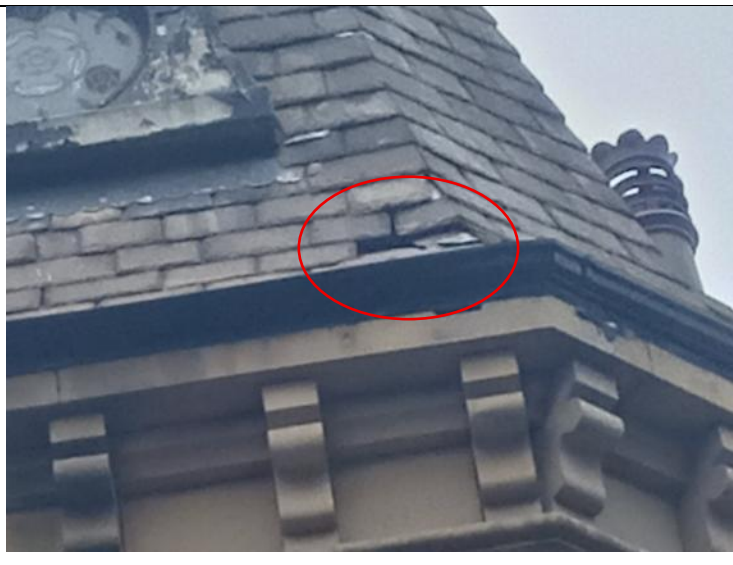
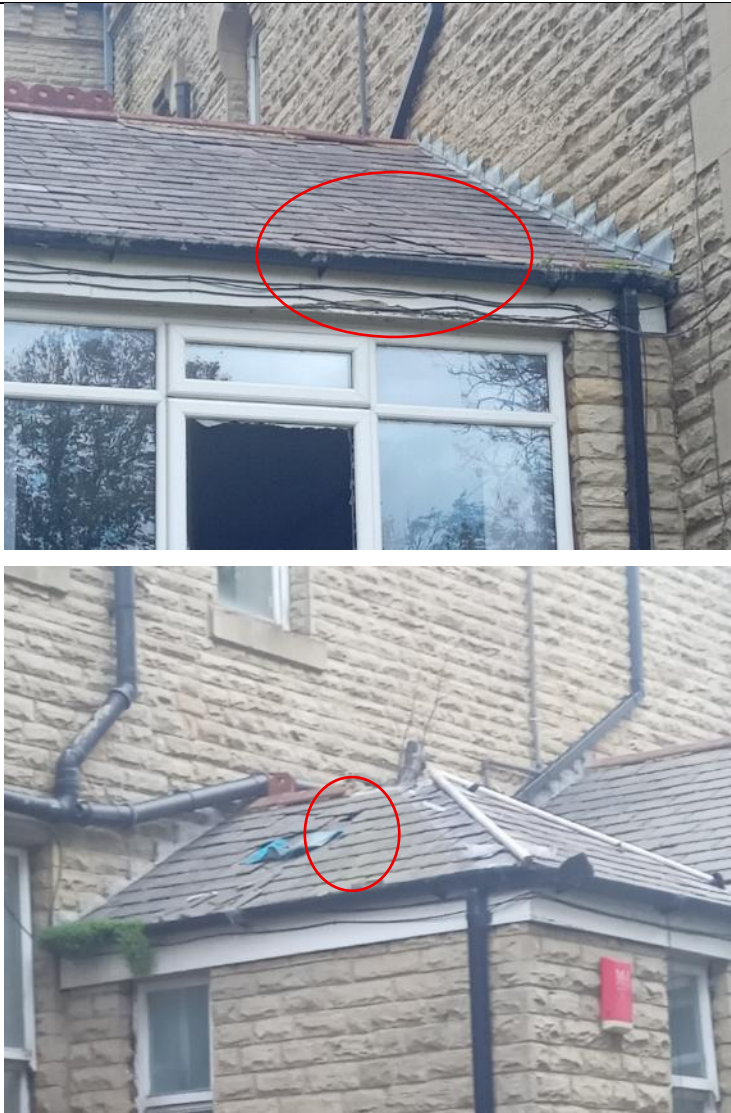
| Roof | Slate | <p><b>Condition/description:</b></p> <p>Missing and slipped roof tiles were recorded along the south and west elevations which could support bat ingress into cavities and crevices present behind.</p> <p><b>Suitability/access/evidence of bats:</b></p> <p>Space under tiles could support low to moderate numbers of crevice-dwelling species.</p> | |

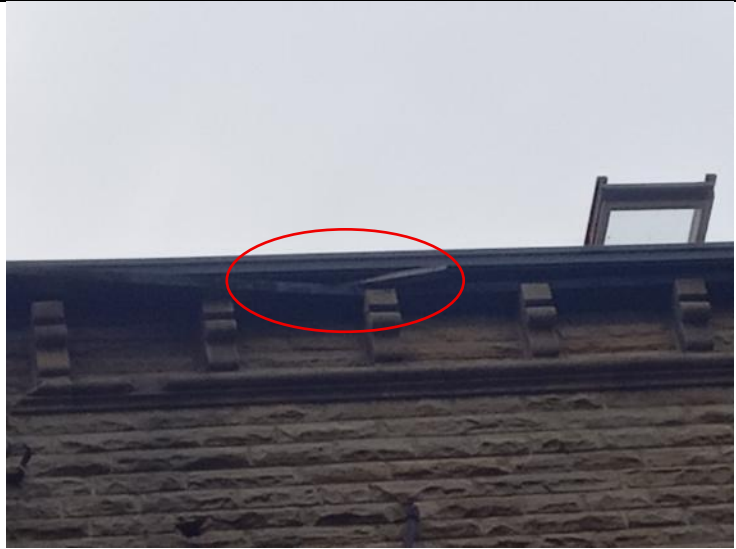
| Soffits | Wooden | <p><b>Condition/description:</b></p> <p>An area of broken soffit was recorded along the west elevation which could support bat ingress.</p> <p><b>Suitability/access/evidence of bats:</b></p> <p>Provides possible bat access into internal void and crevices within the soffit.</p> | |

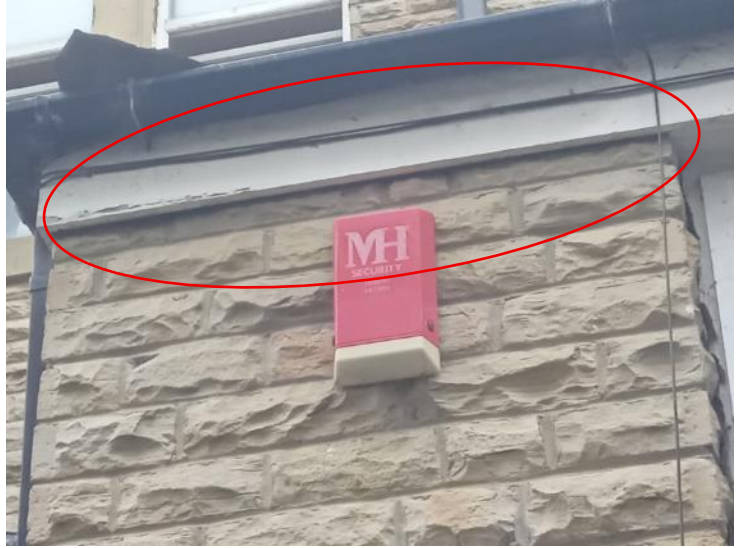
| Barge boards/fascia boards | Wooden | <p><b>Condition/description:</b></p> <p>Gapping was recorded along an area of west elevation fascia which could support crevice-dwelling species.</p> <p><b>Suitability/access/evidence of bats:</b></p> <p>Provides possible bat access into internal void and crevices along the wall tops.</p> | |

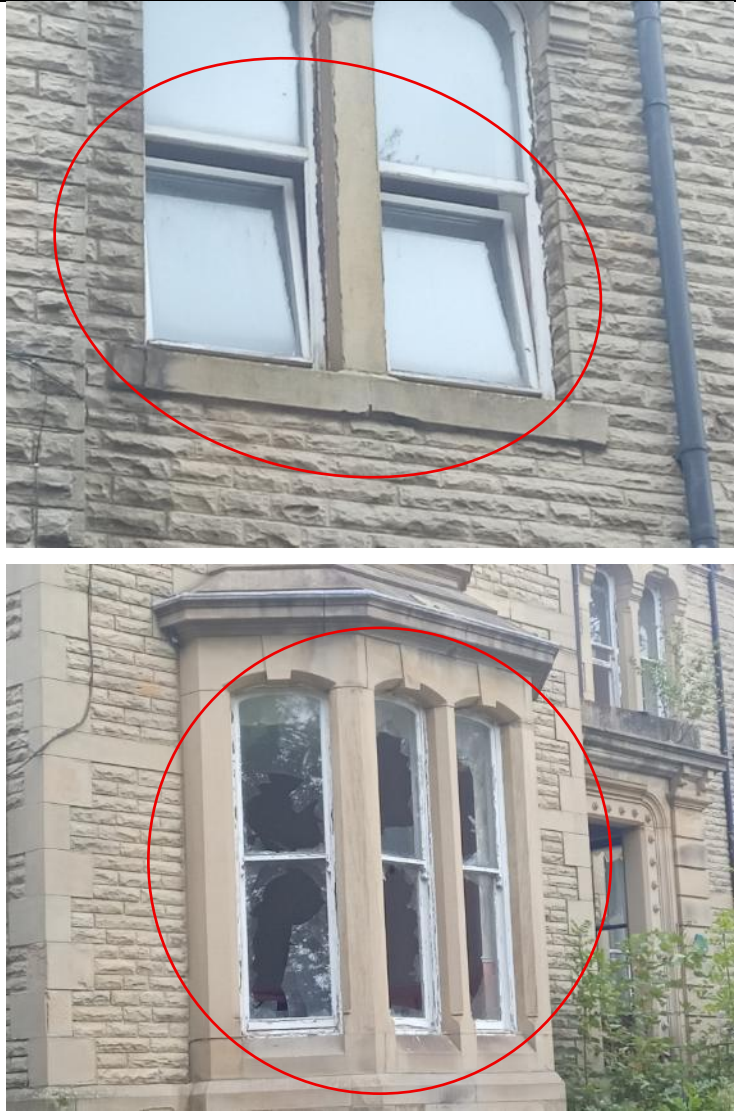
| Windows/<br>doors frames<br>and lintels | uPVC and<br>wooden | <p><b>Condition/description:</b></p> <p>Multiple open and smashed windows were recorded along the west, south, and east elevations which could support bat ingress.</p> <p><b>Suitability/access/evidence of bats:</b></p> <p>Provides possible bat access into internal voids.</p> | |

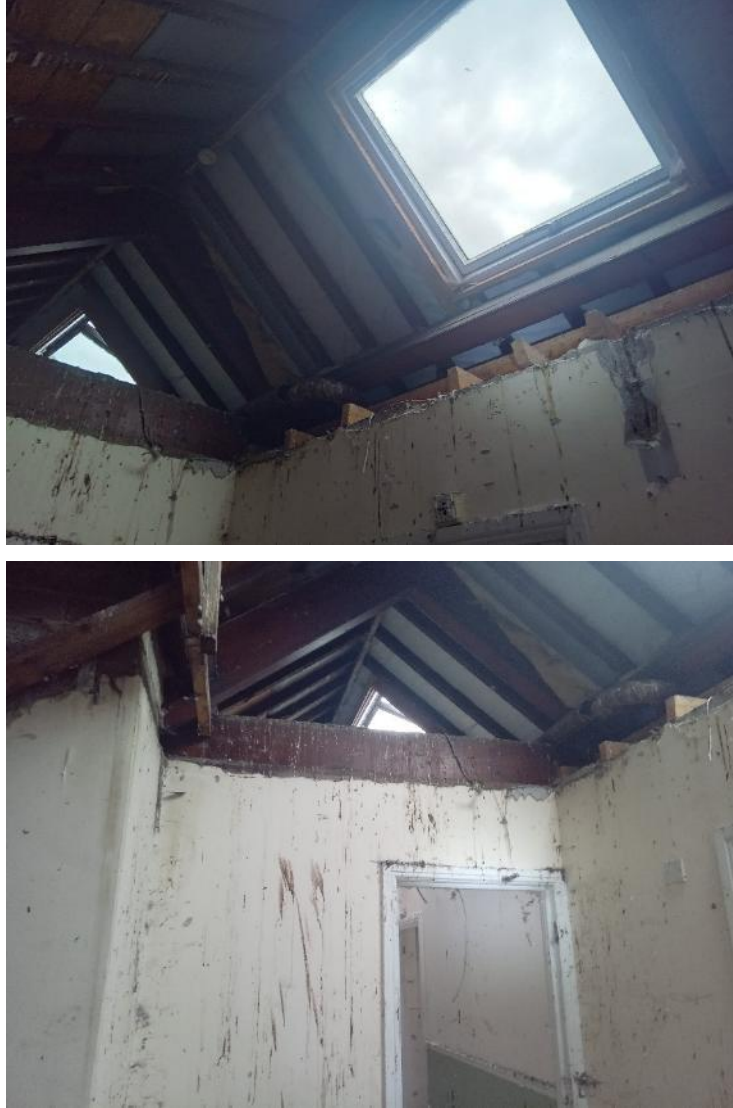
| Internal voids | <p>Timber rafters and ridge beam.</p> <p>Open floor to ridge.</p> <p>Breathable membrane roof lining.</p> <p>Fibre wool membrane insulation.</p> | <p><b>Condition/description:</b></p> <p><b>Top floor:</b> There are no loft voids within B1, the top floor has been subject to break ins leading to areas of the roof and roof lining exposed within. No evidence of bats was recorded internally, though evidence could be concealed between the roof lining and roof tiles. Evidence of bird activity was recorded within with large areas of pigeon droppings, and physical pigeon presence.</p> <ul style="list-style-type: none"> <li>❖ Temperature reading: 14.2°C</li> <li>❖ Humidity reading: 61.8%</li> </ul> <p><b>Cellar:</b> The cellar is tightly sealed with no opportunities for bat ingress or evidence recorded.</p> <ul style="list-style-type: none"> <li>❖ Temperature reading: 12.5°C</li> <li>❖ Humidity reading: 63.0%</li> </ul> <p><b>Suitability/access/evidence of bats:</b></p> <p>No evidence was recorded.</p> | |

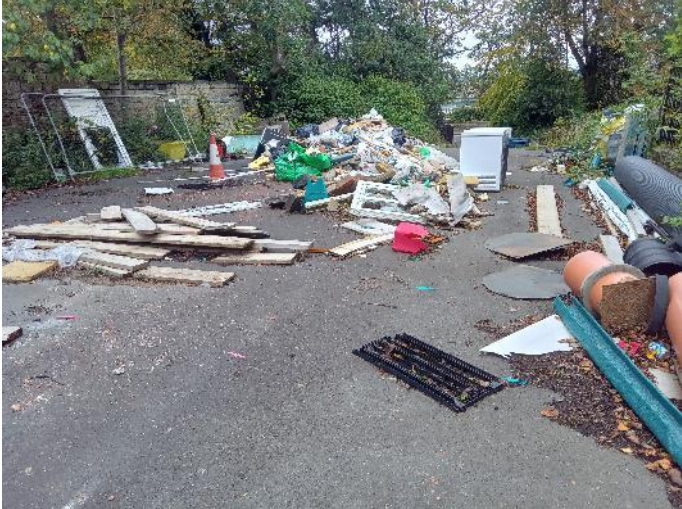
| Other developed land | |
|---|---|
| | <b>Figure 1:</b> On-site hardstanding – facing south. |

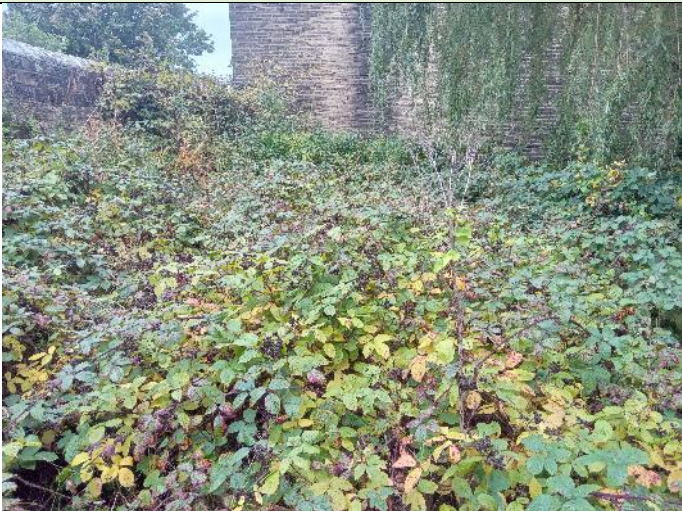
| Other developed land | |
|---|---|
| | <b>Figure 2:</b> On-site bramble scrub – north of site. |

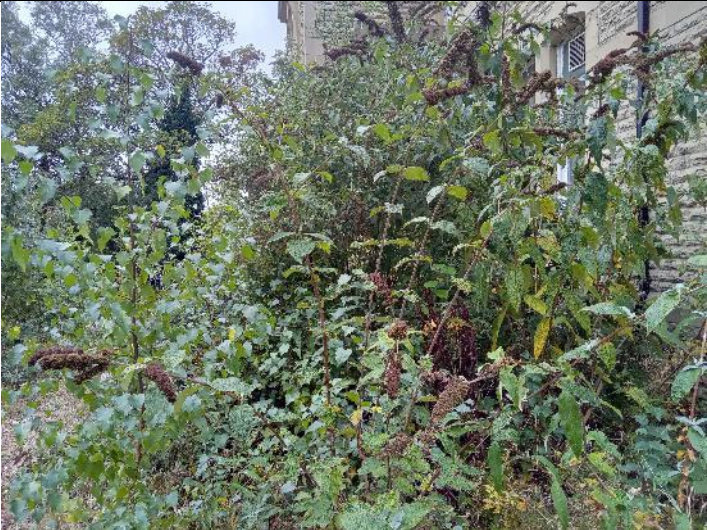
| Introduced shrubs | |
|---|---|
| | <p><b>Figure 3:</b> On-site introduced shrubs – centrally of site.</p> |

- Rhododendron should be dug up, including roots, and disposed of in line with appropriate controlled waste measures, or controlled during construction works to prevent the spread off-site.

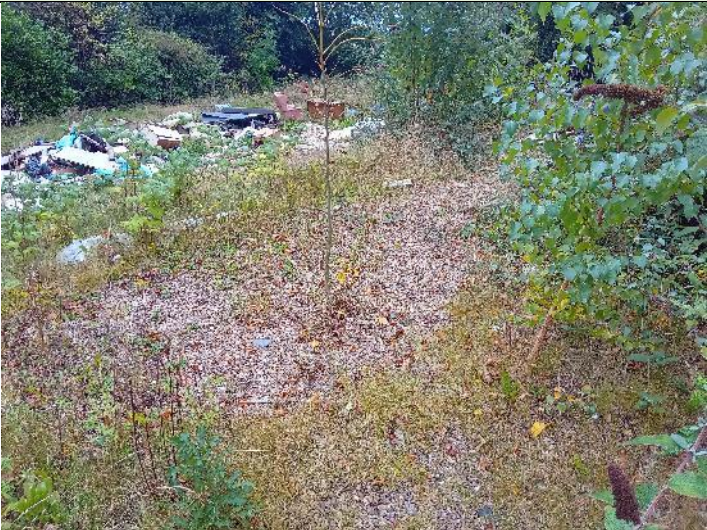
| Introduced shrubs | |
|---|---|
| | <p><b>Figure 4:</b> On-site gravel bed – centrally of site.</p> |

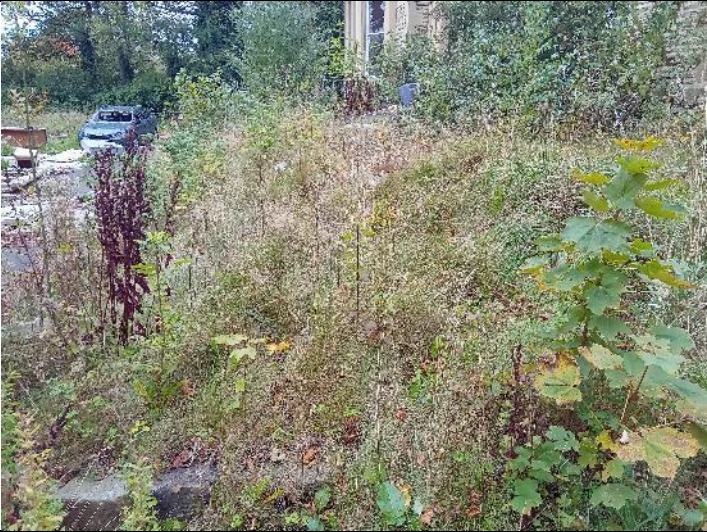
| Other neutral grassland | |
|---|---|
| | <p><b>Figure 5:</b> On-site grassland – south of site.</p> |

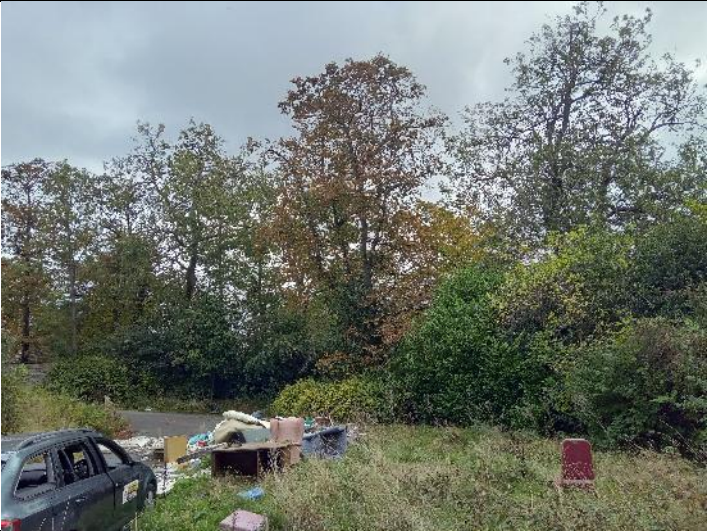
| Other neutral grassland | |
|---|---|
| | <p><b>Figure 6:</b> On-site woodland along the east site boundary.</p> |

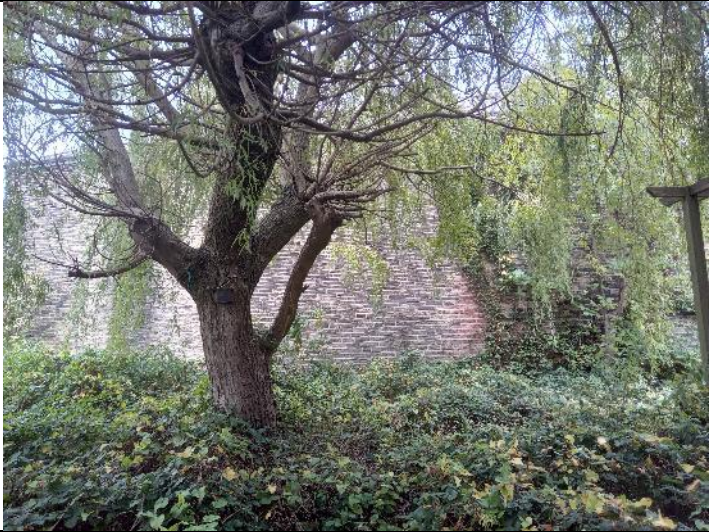
| Scattered trees | |
|---|---|
| | <p><b>Figure 7:</b> On-site scattered trees – north of site.</p> |

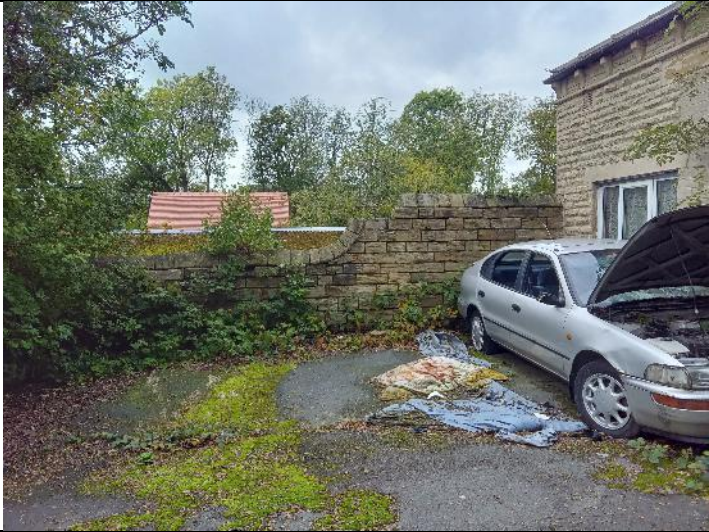
| Scattered trees | |
|---|---|
| | <p><b>Figure 8:</b> On-site mortared wall along the west site boundary.</p> |
