316/318 Middle Road

Intrusive Coal Mining Assessment

September 2024

Project: 316/318 Middle Road Intrusive Coal Mining Assessment

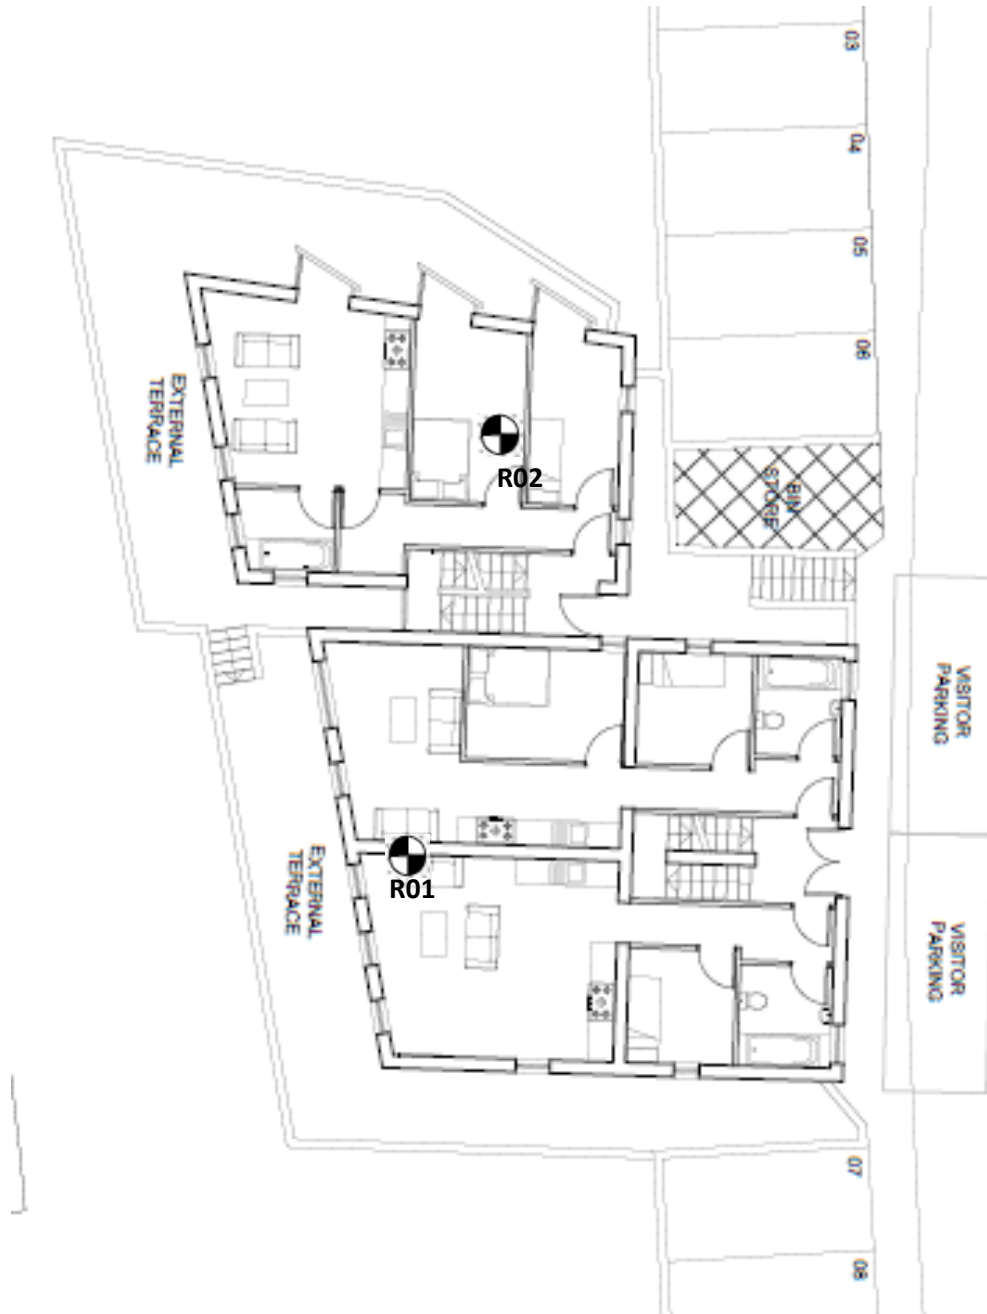
**Rotary Open Hole
Boreholes**

An Intrusive Investigation was carried out on the site on 2nd August 2024, comprising two Rotary Open Hole Boreholes, labelled RO1, and RO2 (undertaken by Cape Site Services Ltd). The exploratory hole location plan is shown in Appendix A and full Rotary Open Hole Borehole Logs are included as Appendix B.

Two Rotary Open Hole boreholes were carried out across the proposed development site. Upon using this drilling method, whereby a water flush is utilised, it ensures that there is no danger should mine gas be encountered. This drilling method is used to identify a void or mine working, whereby a sudden loss of water flush is encountered during drilling. Where voids or mine workings are not encountered, the water flush would continue to flow into the borehole at a generally consistent rate. Table 4.1 shows a summary of the findings of the Rotary Open Hole Drilling.
