Applicant: Kirklees Council
Building: George Hotel
L054-AHR-XX-XX-RP-A-08804
Assessment of Significance (With addendum)
Revision P1 (Planning and LBC)

Kirklees Council
George Hotel

**Assessment of
Significance**
(With Addendum)

HERITAGE STATEMENT
DECEMBER 2022

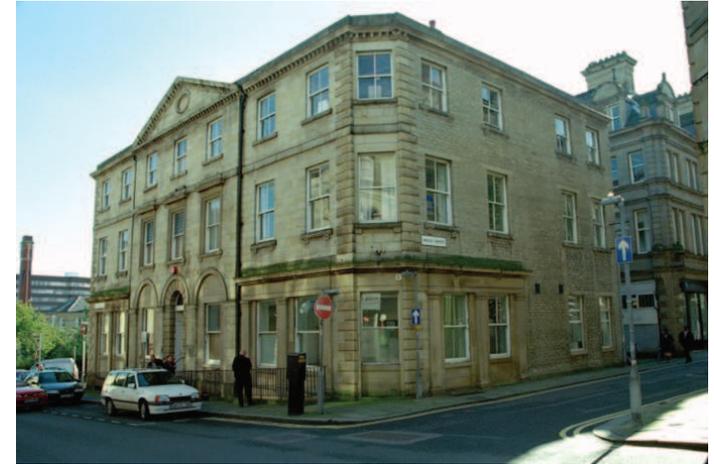
Photograph of the reconstructed George Hotel on St Peter's Street

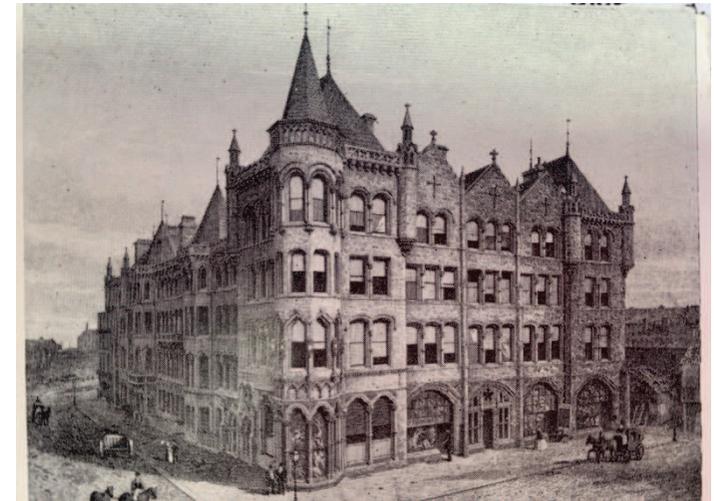
Early drawing of the Estate Offices

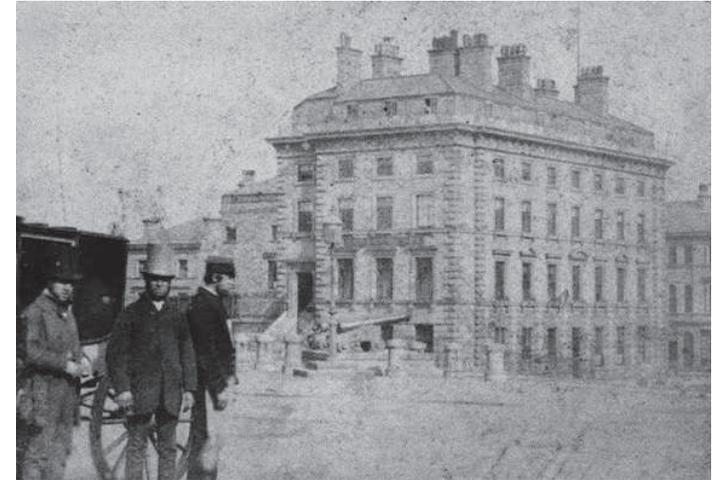
Photograph taken from the Station towards The George Hotel dating from between 1850 and 1874

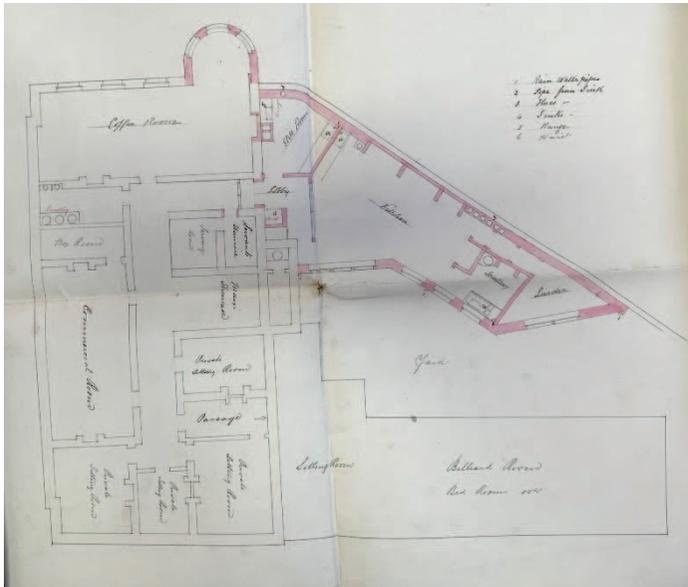
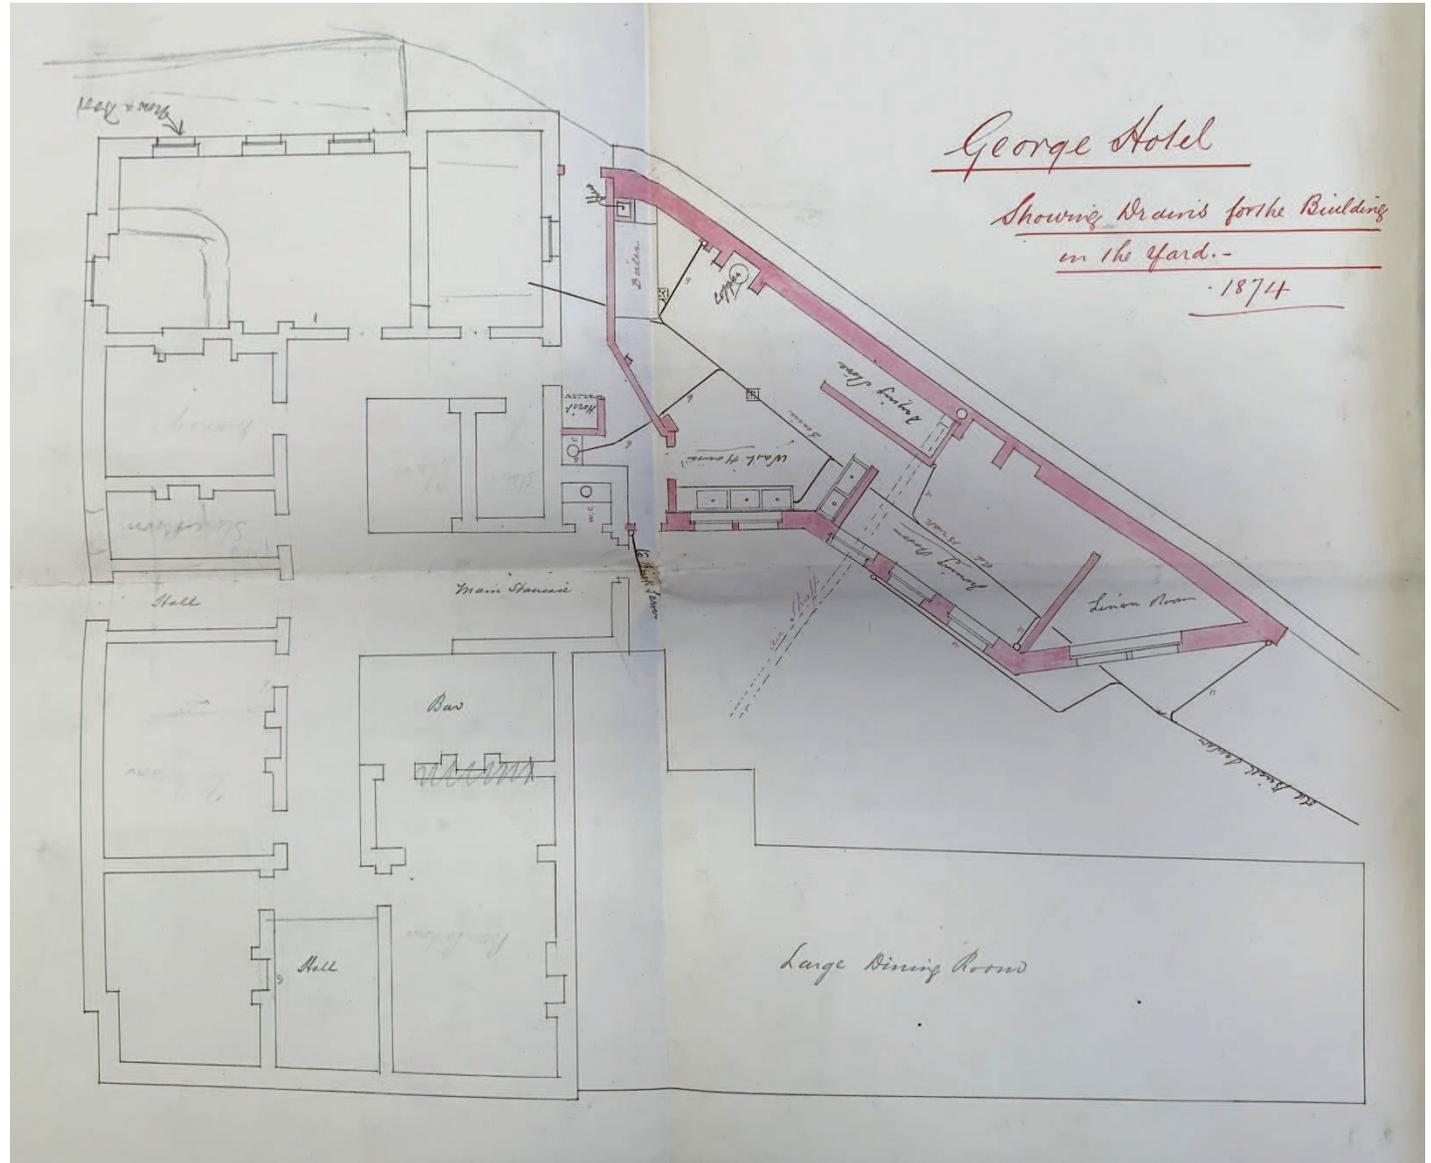
Drawings from 1874 show a proposal for a West Wing (Block B), and these suggest that the East Wing was extant, with a dining room to the ground floor, sitting rooms and a billiard room to the first floor, and bedrooms above. The proposed West Wing was to contain a wash house and linen stores to the ground floor, and kitchens at first floor. A photo (Figure 1) taken around this time, looking from the railway station towards the main range (Block A) shows the hotel in context; East Wing (Block C) was present but Block B was not. There is also no bow window on the west elevation of Block A but there is a staircase which was probably a key or main entrance into the hotel from the train station.

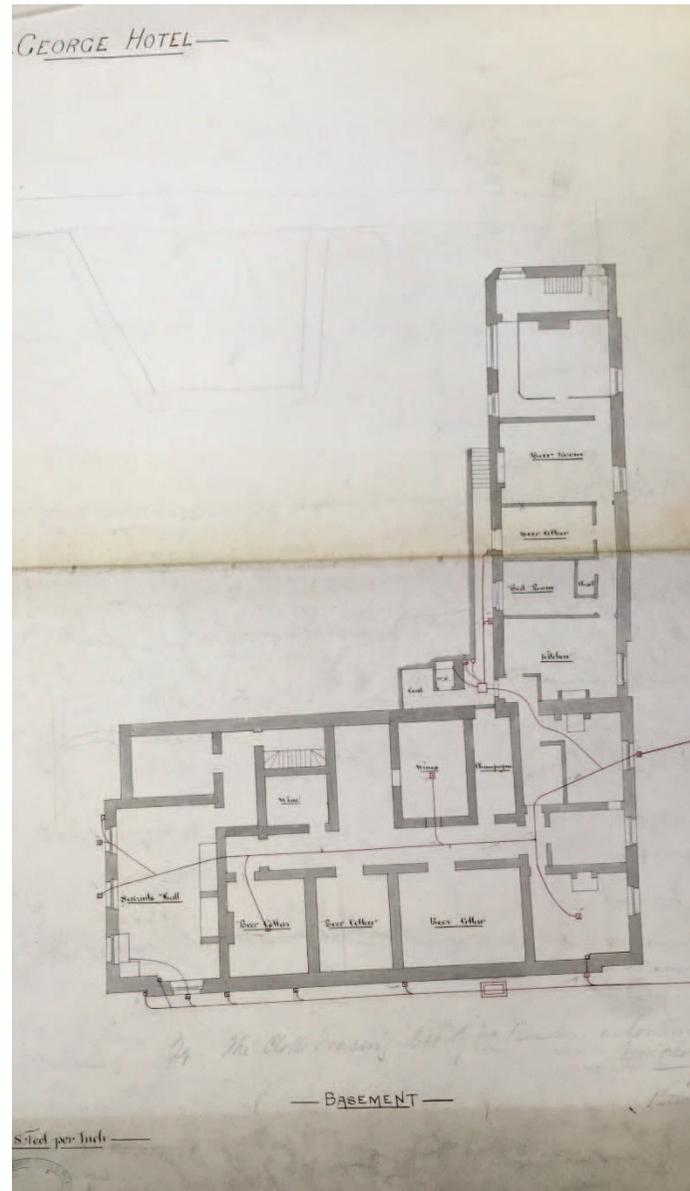
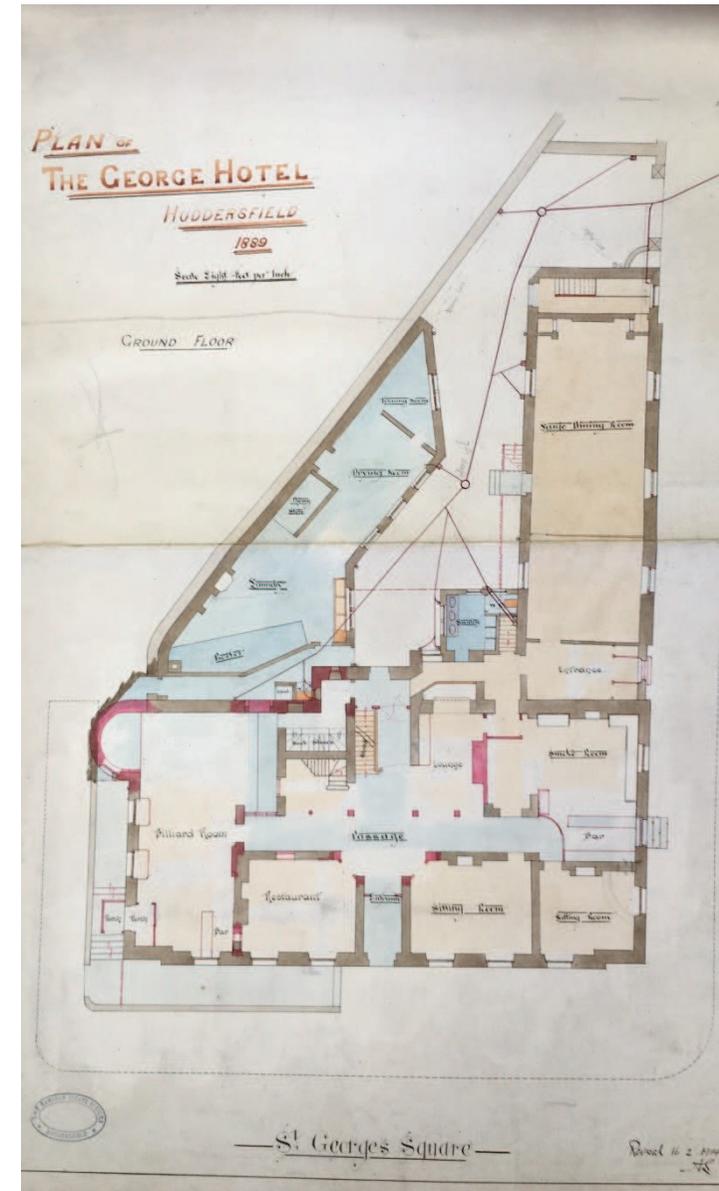
Drawings from 1886 provide further information, notably, that the East Wing had a basement containing ancillary accommodation, however there is no basement accommodation indicated for the West Wing. The ground and first floors of this wing show the same type of spaces, but not the same layout as shown on the 1874 plan. In addition, changes are shown to the original building (e.g. the inclusion of the bow window and making the ground floor circulation space more open), and a glazed walkway is shown to the courtyard side of the East Wing at first floor. The footprint of these drawings matches the OS plan of 1887 and the town plan of 1889. At this time, the East Wing did not extend Northwards to the full extent of the site, and a Cabman's shelter is shown at the Northern tip of the site, with the cab stand indicated next to it on John William Street.

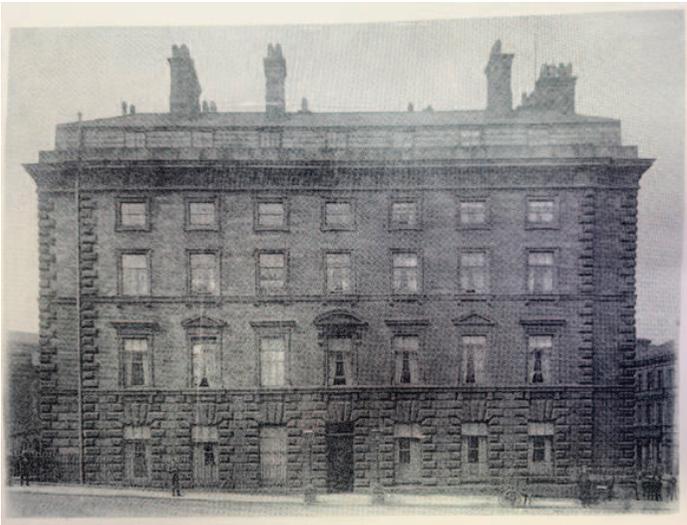
A photo from the late 19th century shows the main range (Block A) facing St. George's square and provides some indication of how the space was occupied. It also confirms that there was no canopy above what is understood as the main entrance .

Photograph of the front façade from the late 19th century

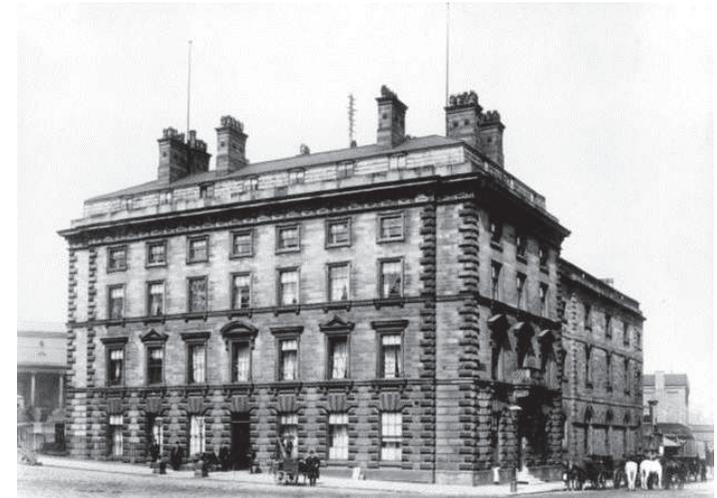
Photograph of The George Hotel in 1912 showing the former entrance from John William Street

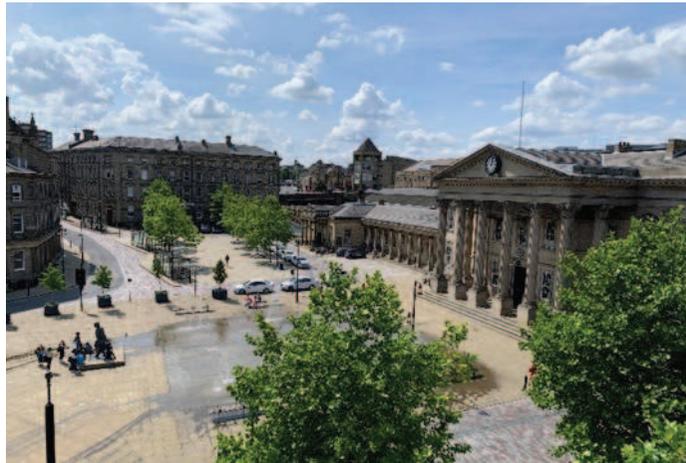
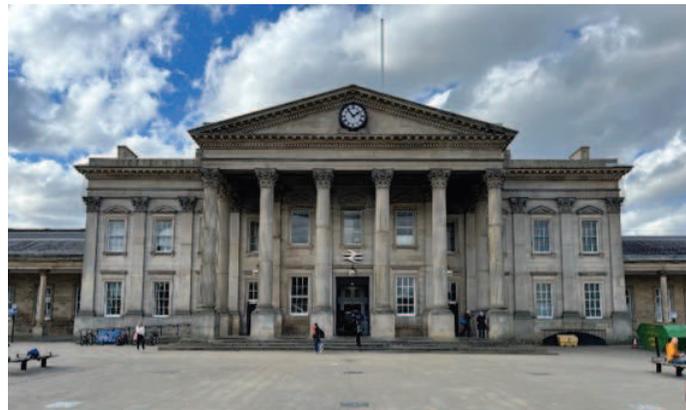
The Grade I Huddersfield Train Station faces onto St George's Square. It has a classical, symmetrical form, with a two-storey central section, and single storey platform wings either side. The large columns and pediment indicate its importance.

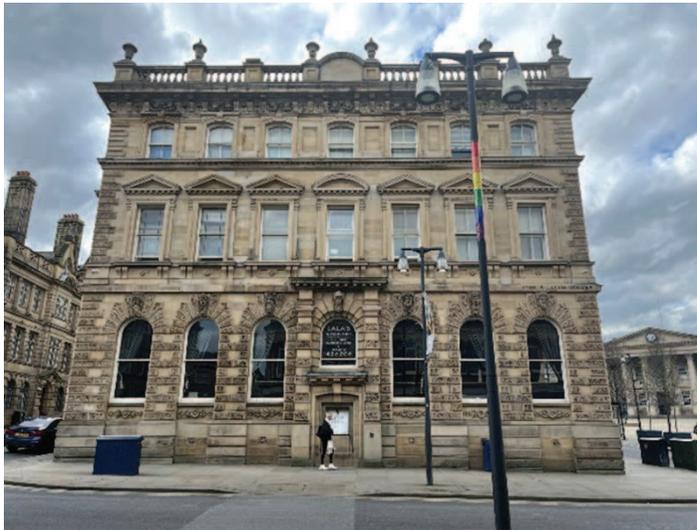
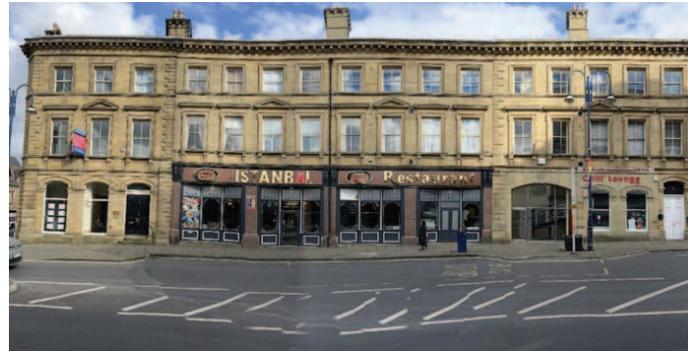
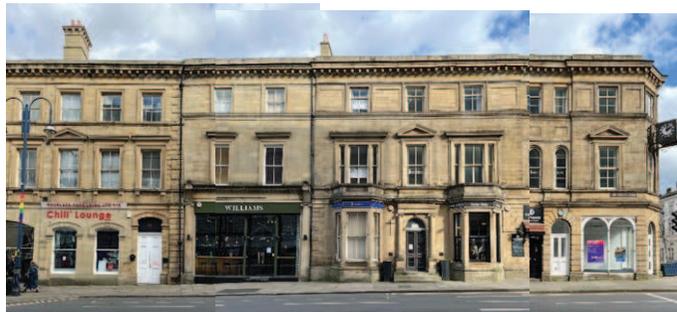
This Grade II* listed building is on the opposite side of St. George's Square to the George Hotel. As with the Lion Buildings, it has a strong symmetry, and demonstrates a hierarchy of space through its reducing floor heights. Here however, the style of fenestration suggests it had a more formal historical use than retail. The tall ground floor windows with sills above head height, have voussoirs, while the upper floor windows are square-headed with pediments to the first floor and low arches at second floor. At the top, there is a decorative frieze, cornice and balustrade.

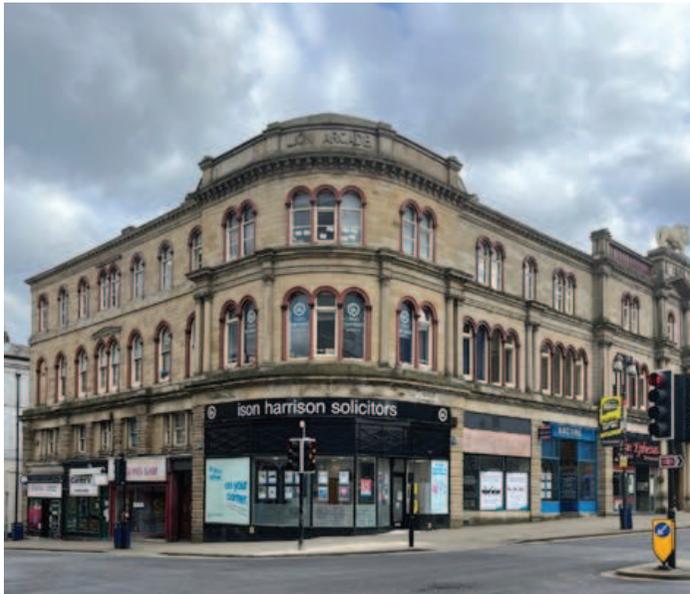
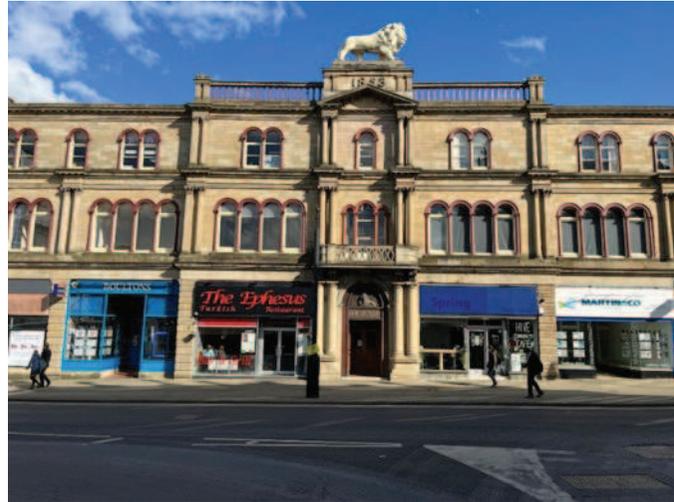
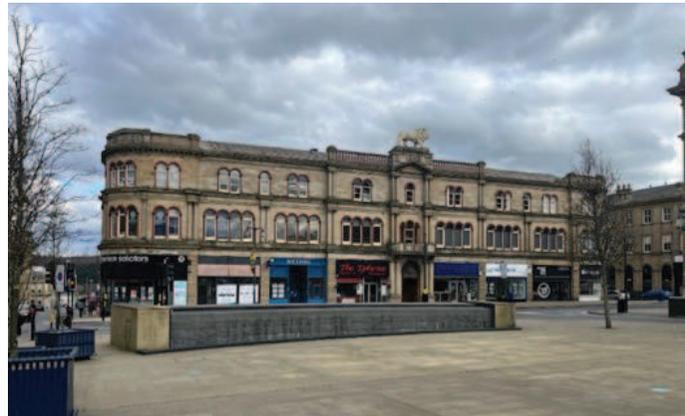
This Grade II* building faces St. George's Square, The George Hotel and Huddersfield Train Station. This building is designed in a near symmetrical way, with a large curved façade to the primary road network. Its central entrance bay projects forward and features a large lion statue at the top. There is a hierarchy in the architecture, with a taller ground floor retail offering, and two further floors with reducing heights and window proportions. The double, triple and quadruple mullioned windows with projecting arches are a distinctive feature.

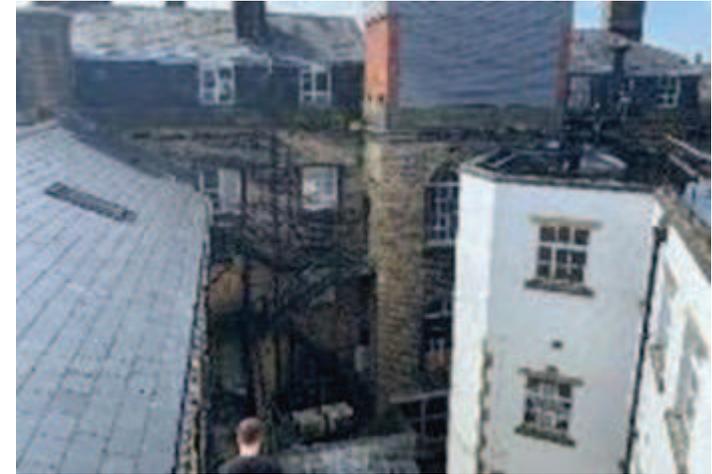
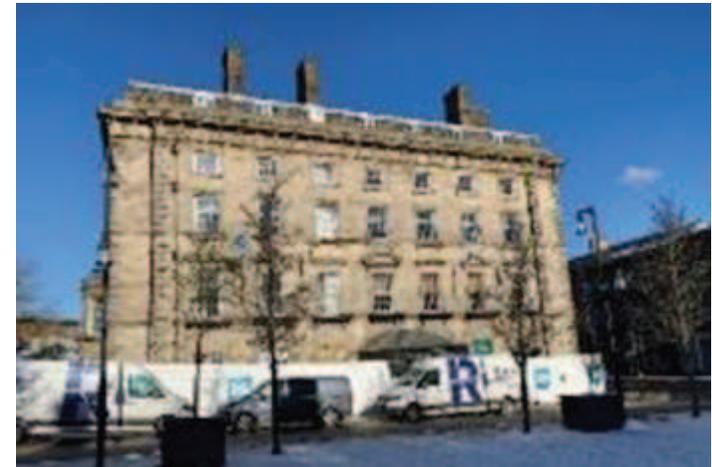
The internal triangular courtyard is formed by the Main Range, East Wing, and the West Wing. The elevations overlooking this area are comprised of painted brickwork with stone sill and head details to the rear of the West Wing. The rear of the Main Range is coursed split faced sandstone as is the rear of the East Wing. The external corridor which was constructed in the 1930s along the rear elevation to the East Wing at first floor level is also constructed of painted brickwork similar to the West Wing.

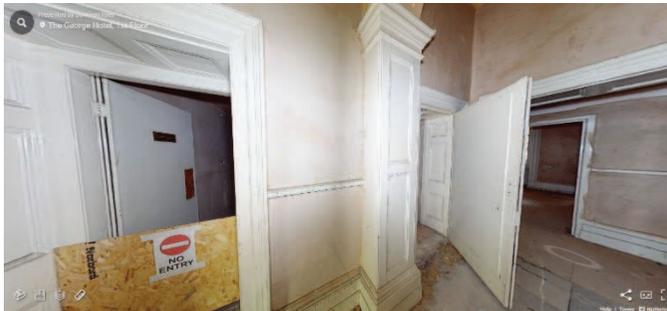
The later Victorian doorset to the right has the same design as the original to the left.

The second and some of the third phase of work, generally uses the same Victorian detailing, so for example, in room x (next to the Commercial Room), a new door from the corridor has the same panelled lining as the earlier doors .

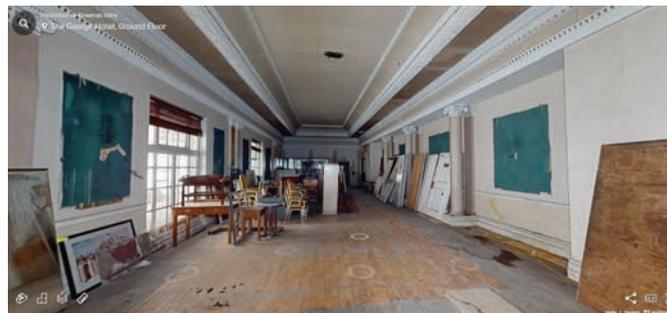
The open plan ground floor area
The dining room and ballroom are two other key 1930s spaces.
The dining room features pilasters and columns with capitals, a coffered ceiling and decorative joinery.

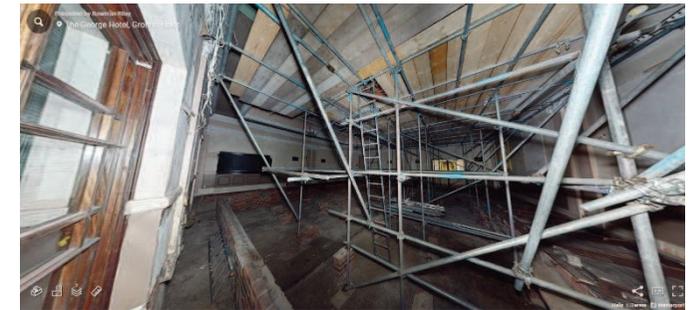
The ballroom is architecturally similar, although it has no floor (Figure x). The two rooms are currently divided by a partition with pilasters on it and columns offset by a short distance into the dining room. It is thought that the line of the partition is close to the position of a vertical sliding partition that was shown on the 1930s drawings.

The ball room has similar features to the dining room.
The basement ‘pocket’ and hydraulic room appear to have been built, but if so, this means that the vertical sliding partition was either not installed, or that it was removed and the fixed wall was constructed as a later replacement. This raises questions about the intended purpose of features such as the columns, and the phasing of attached features such as joinery.

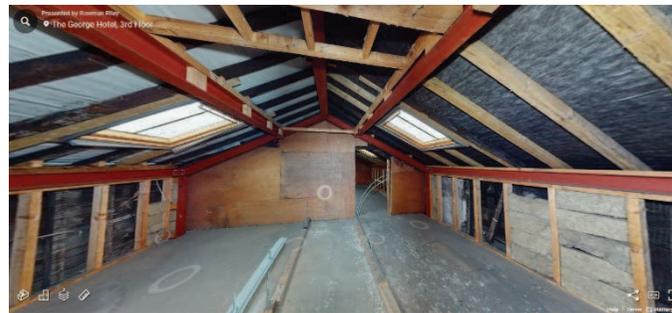
Steel frame to the third floor of Block C.

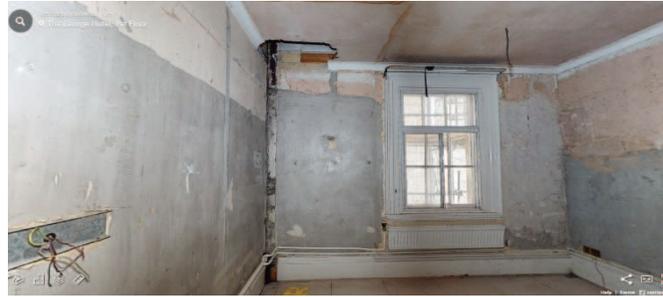
Evidence of former openings (top) and stairs (bottom). Unfortunately, previous adaptations involving new fabric have also tended to use a philosophy that does not align with current thinking in relation to being able to distinguish different phases of the building, so Victorian cornice details have been applied to new walls within existing rooms for example.

While many of the modifications have been particularly unsympathetic to some historic fabric, it has been retained in some areas, such as above or behind new insertions, and the form of some openings previous can still be seen. For example, on the ground and upper floors, there are numerous examples of false ceilings being inserted below the original. In some cases, it has been possible to see the original ceiling and cornice above.

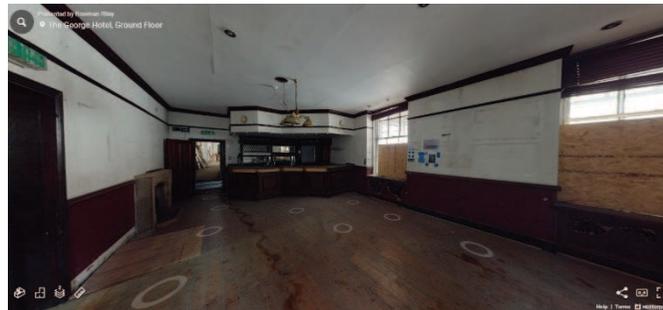
False ceilings below the original. In the basement, where walls are painted brickwork, doors inserted into pointed arch openings (formed by vaulted ceilings) can be clearly identified, as can the edges of steps .

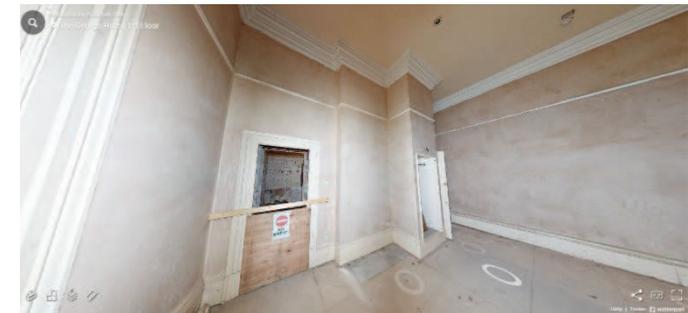
The Victorian cornice design has been recreated on new walls, such as the built-in cupboards.

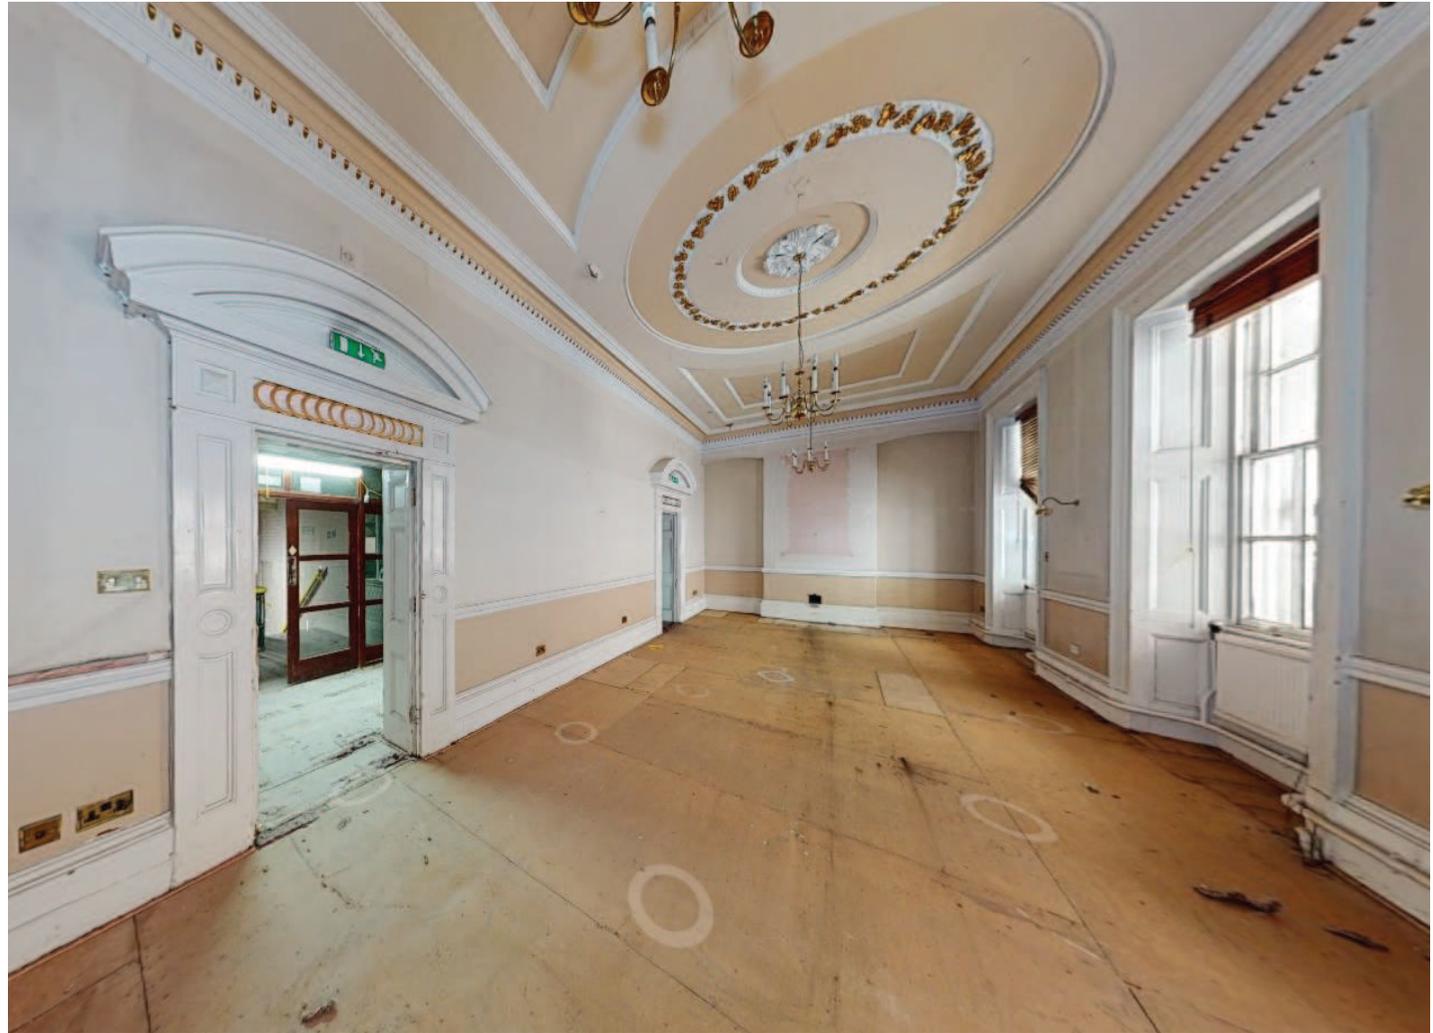
Original floor plan, plastered walls, highly decorative plastered ceiling with cornice and rose, sash windows with panelled linings and architraves, skirting boards, decorative doorcases with pediments and panelling, dado rail (some if not all is a later addition), no fireplaces. A connecting doorway has been blocked up.

This room has a very low capacity for change and every effort should be made to retain the architectural features. The plan of the room should not be changed.

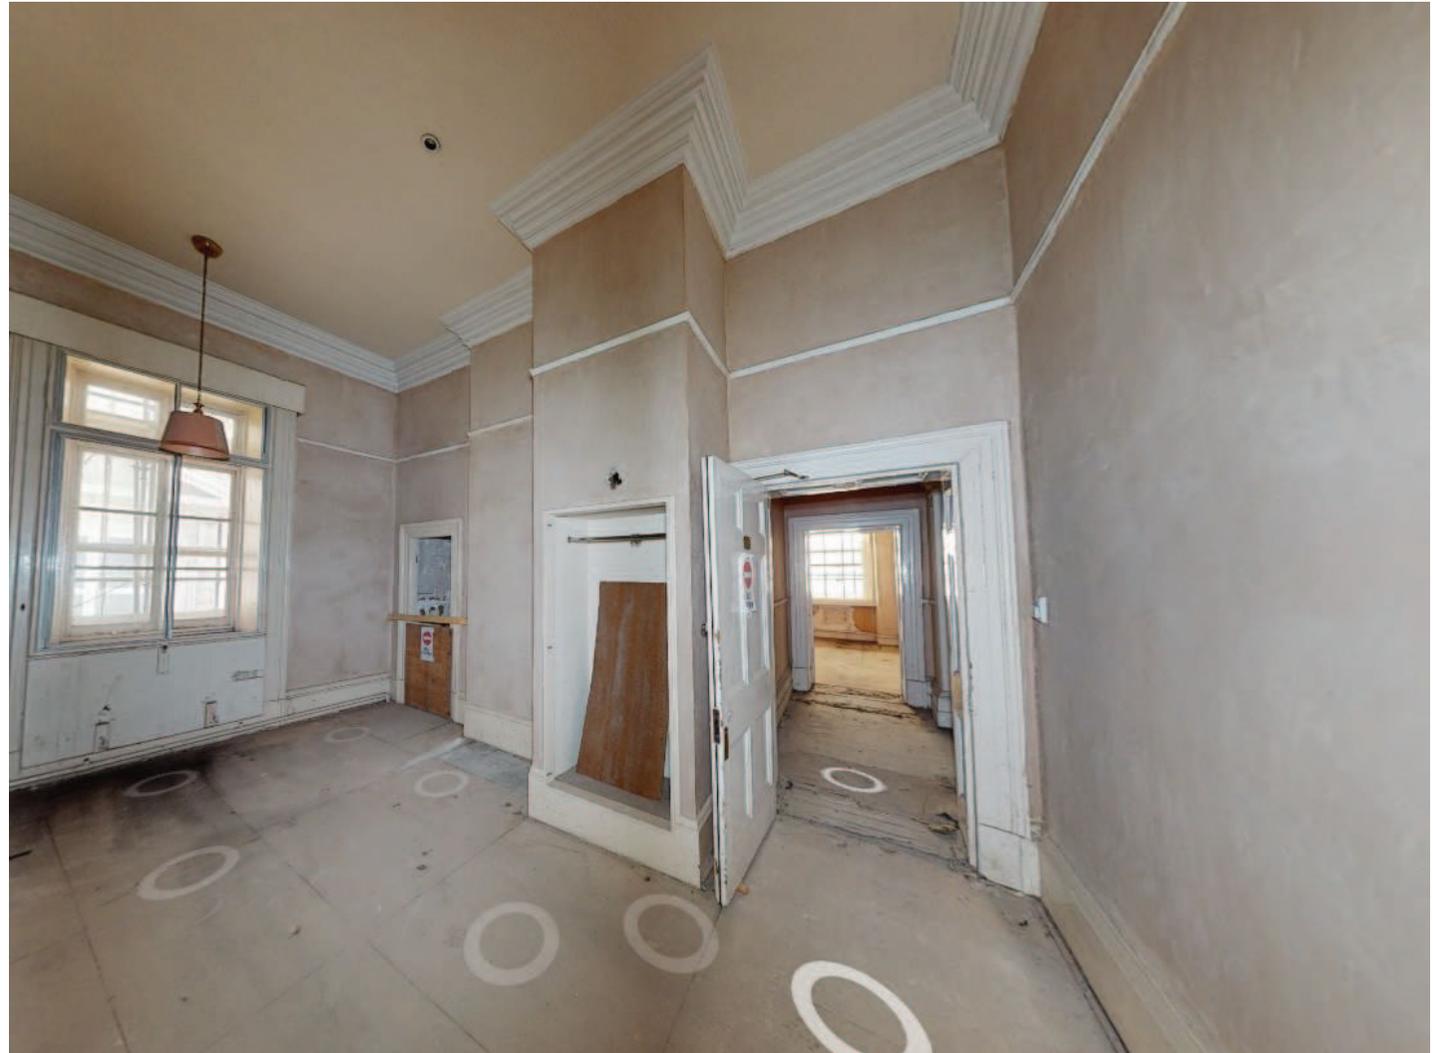
Original floor plan. Retains plastered walls and ceilings, skirting boards, architraves, windows, corbels, staircase and balustrades. Later additions include a handrail, dado rail and replacement doors.

This room has a low capacity for change and every effort should be made to retain the architectural features.

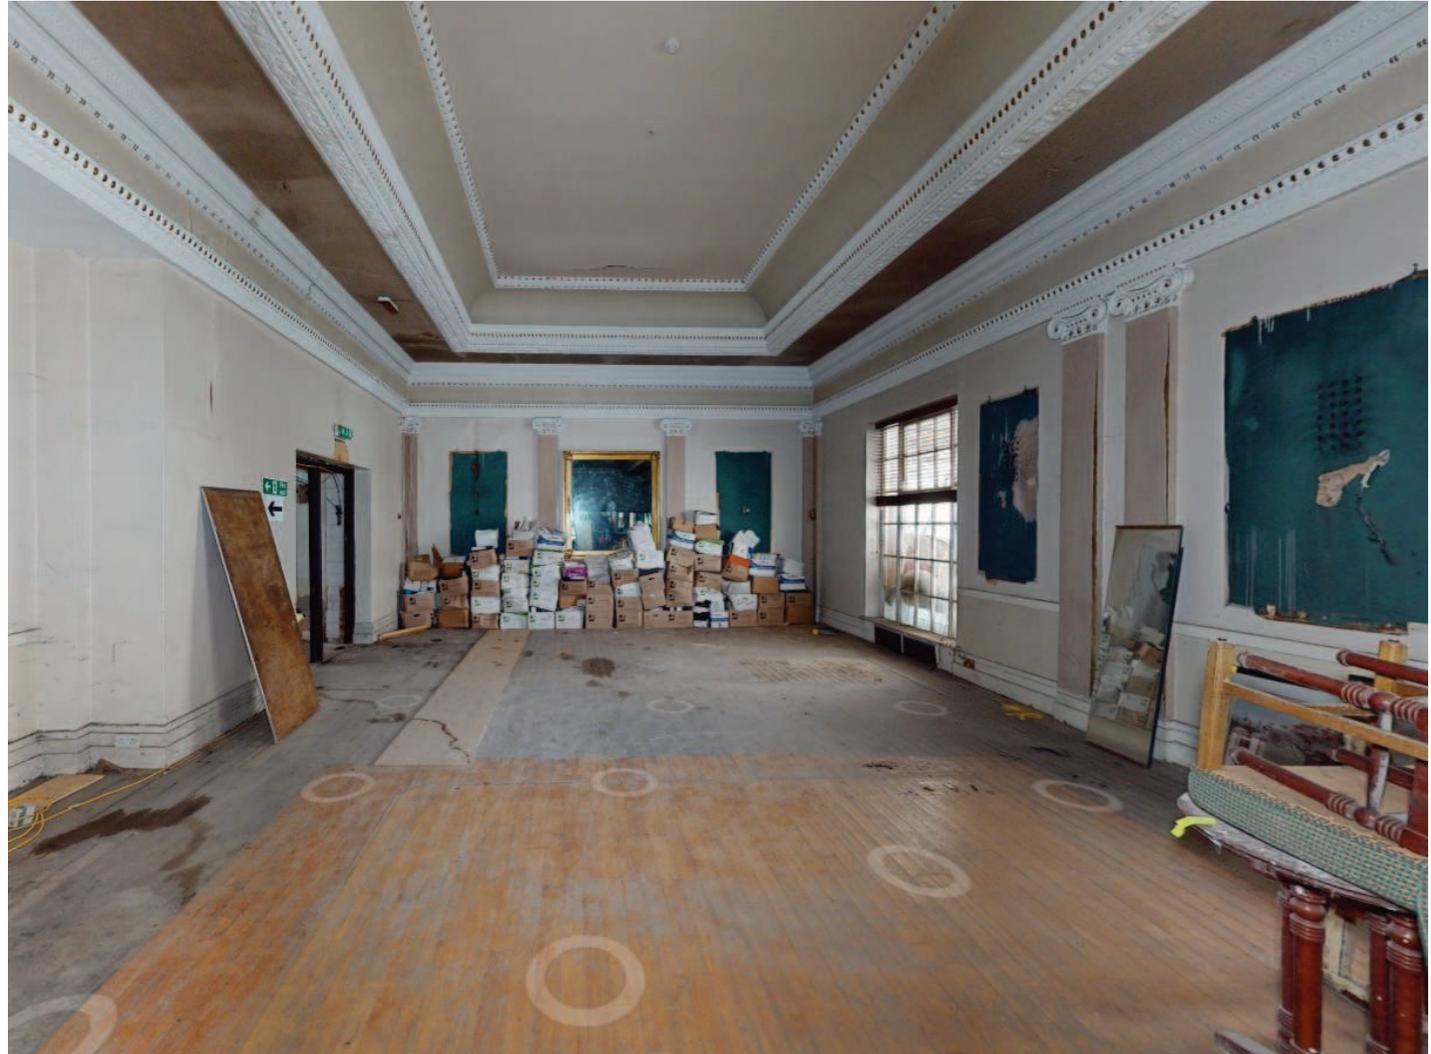
The original finishes and fixtures have been lost and the room was re-designed in the 1930s. The 1930's floor plan is still readable, but there have been changes to the inner wall, which probably includes the removal of a vertical sliding partition, and the fixing of a wall and columns to the rear of the partition area.

The room retains the 1930's decorative ceiling with cornice and columns. The majority of the skirting boards appear to also date to the 1930's, but where later changes have been made to walls, reproduction skirting boards have been installed, making it difficult to distinguish the phasing. Window fittings are also later replacements.

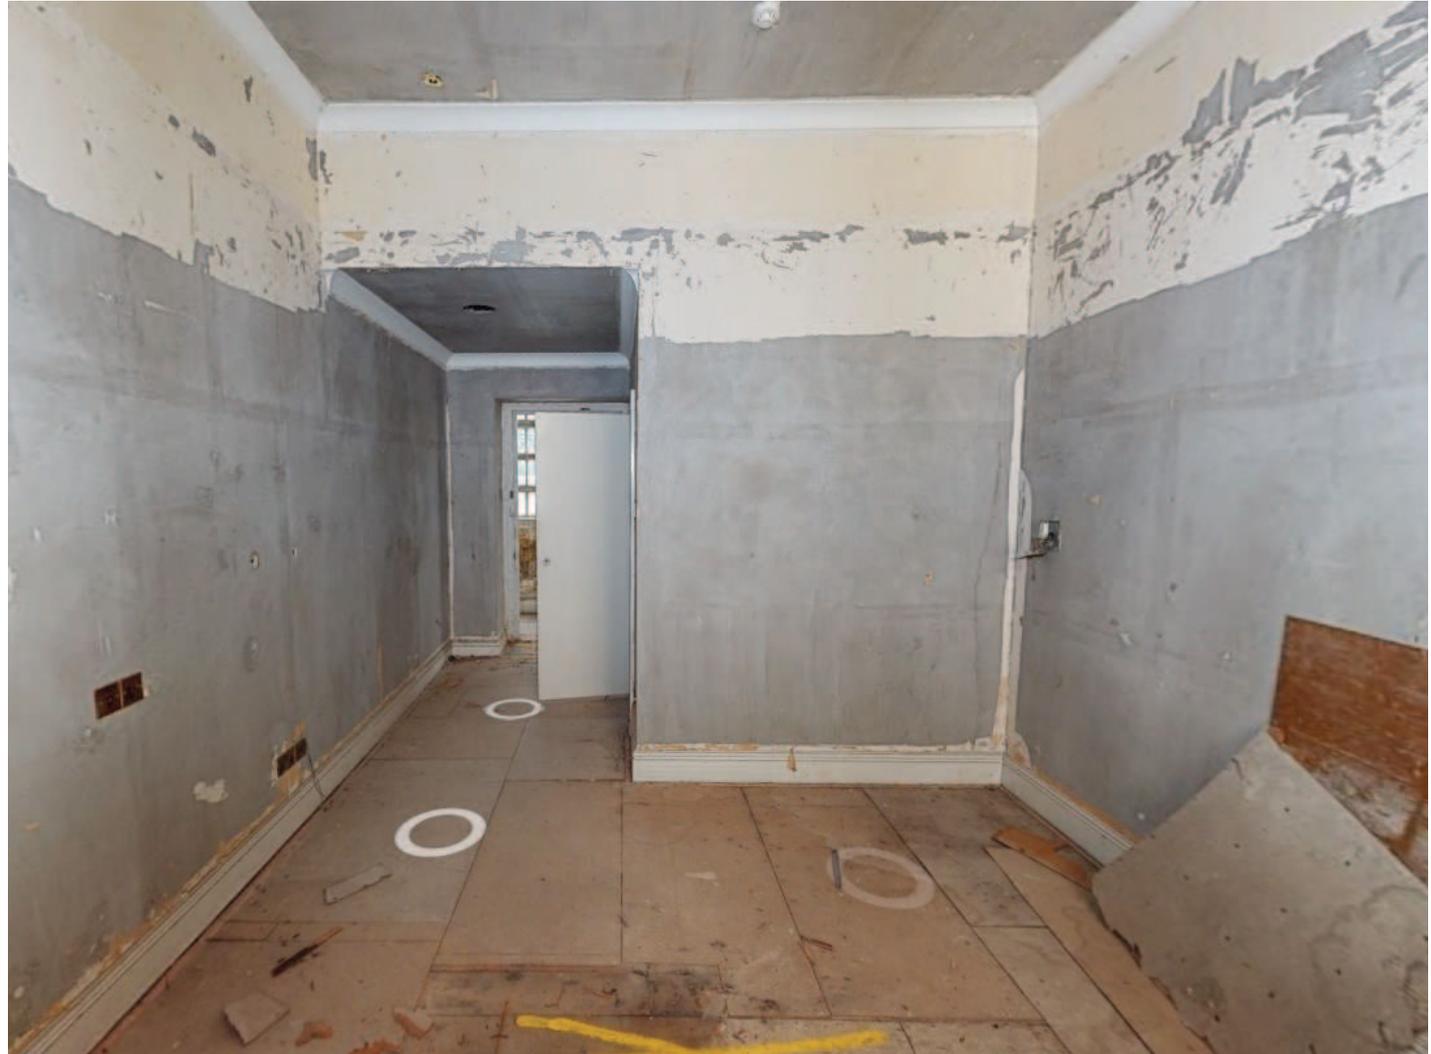
The original floor plan is still readable, but an en-suite room has been inserted into the corner of the room (Room 087). The room retains its original sash window and one section of skirting board but the ceiling has been lowered obscuring any original cornice and there is a service bulkhead over the room entrance and en-suite area.

The room has a high capacity for change.

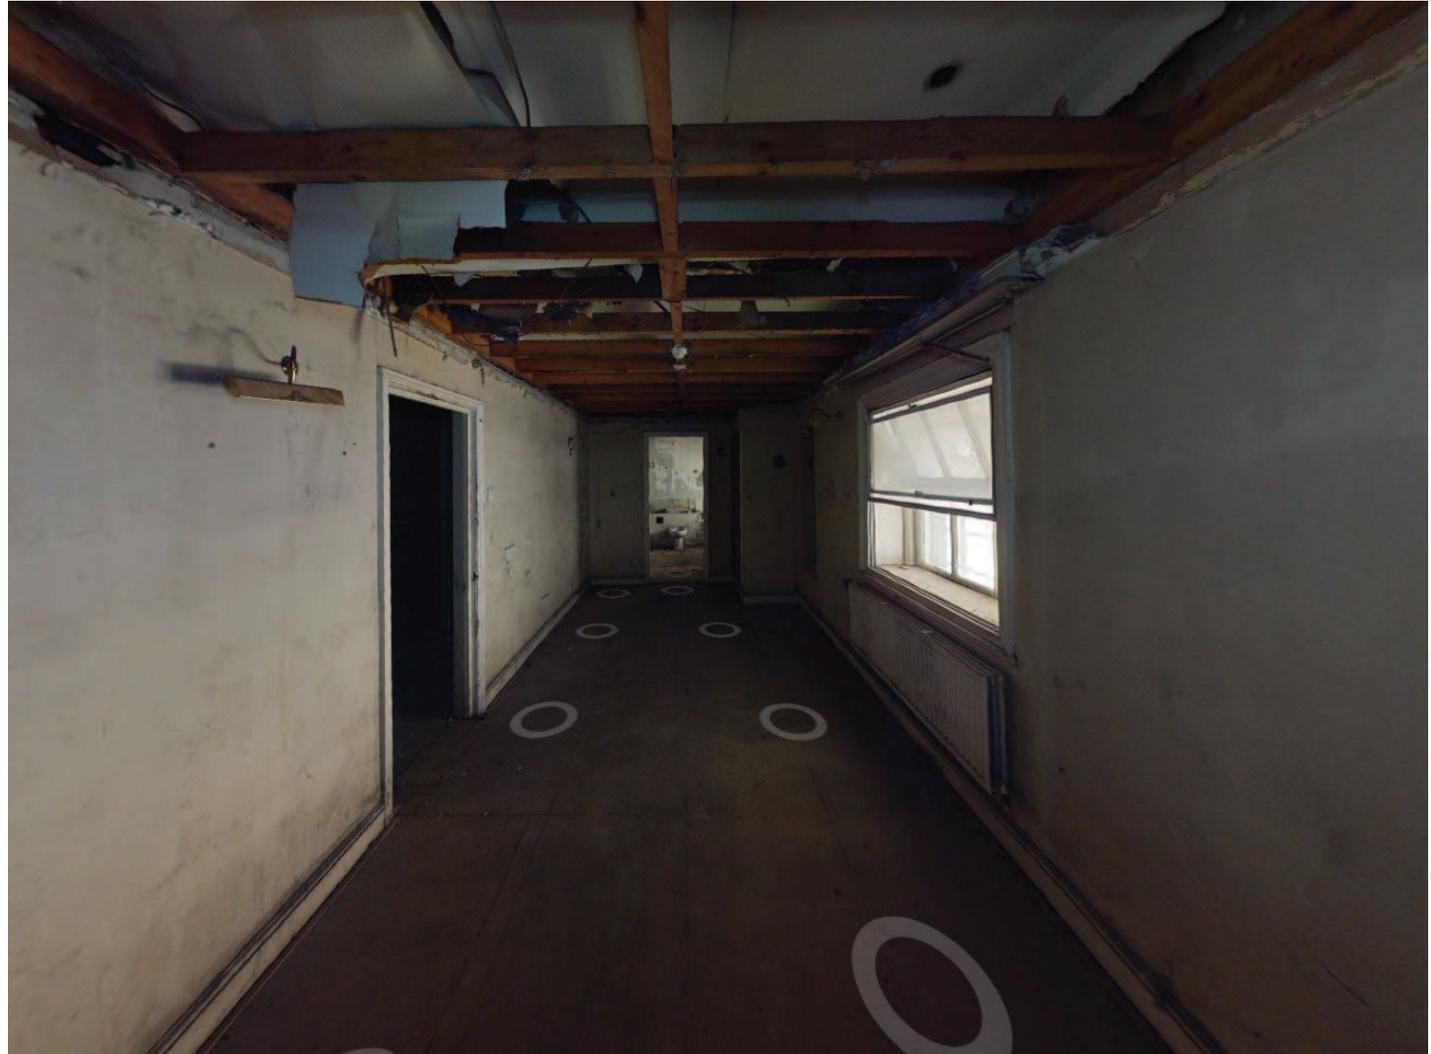
The original floor plan is still readable in part, but the wall dividing the room from the next bedroom has been removed. The room is now open combined with the original adjacent room, which itself has an en-suite inserted (Room 128). The room retains its window and door architraves, and at least some of the skirting appears to be original. There is no ceiling and it is not possible to know if there was a cornice on construction as the evidence of one having been removed almost certainly relates to a later insertion.

The room has a high capacity for change.

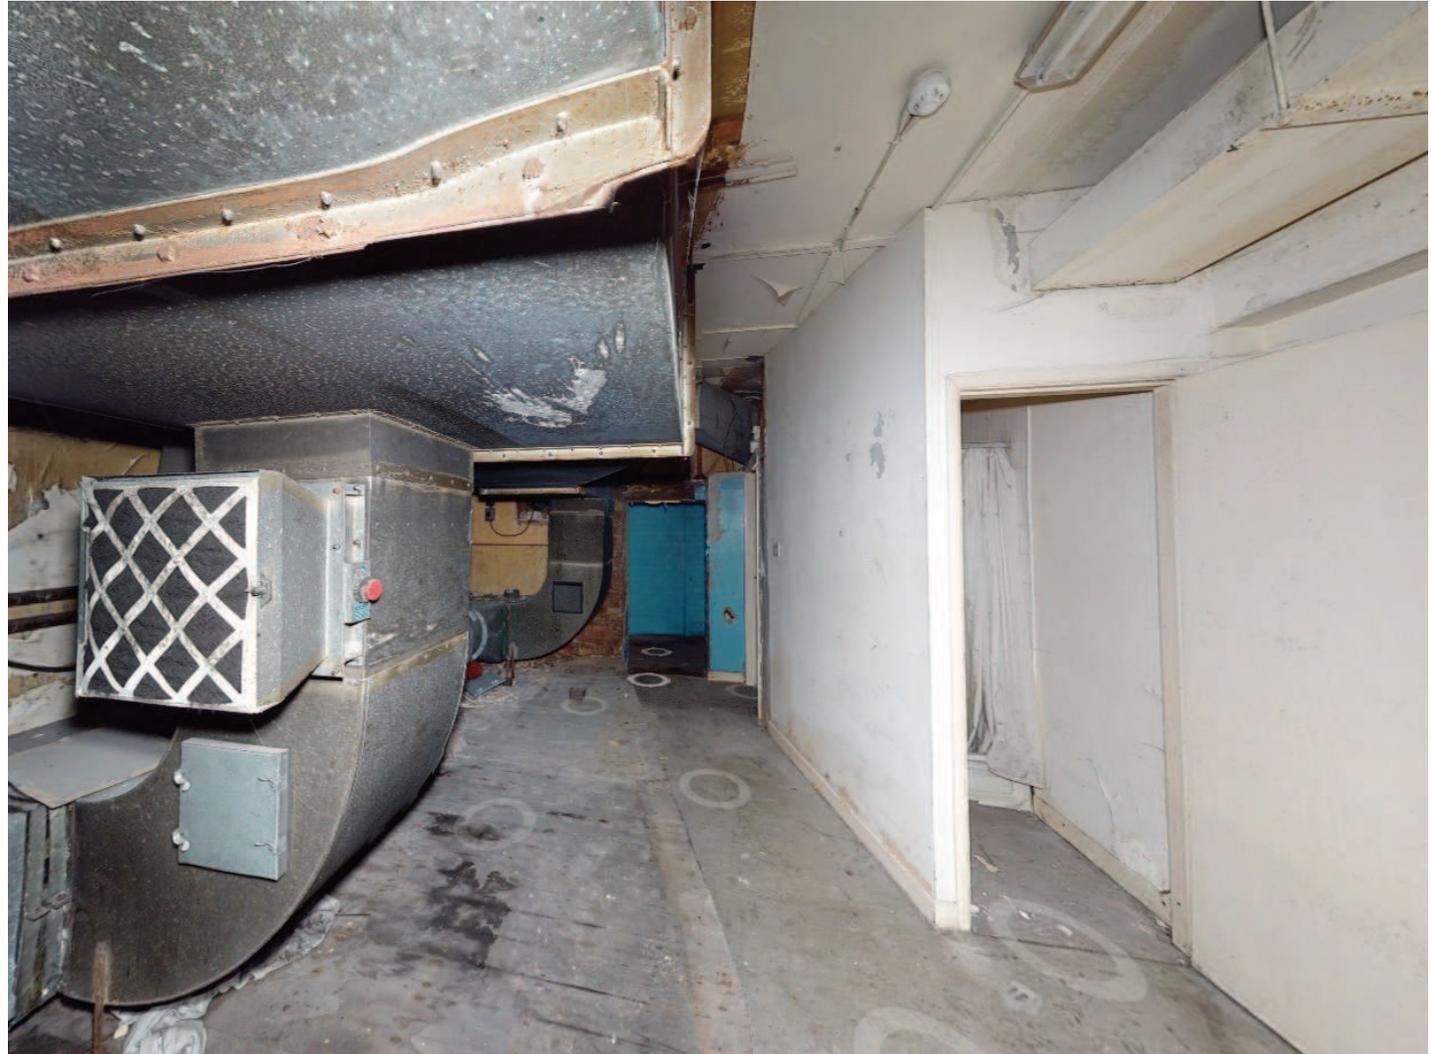
The room retains has been divided to create a small room in the corner. its original plan form, but a doorway has been blocked up and another has been created. No original features are retained.

The room has a high capacity for change.
