Applicant: Kirklees Council
Building: George Hotel
L054-AHR-XX-XX-RP-A-08804
Assessment of Significance (With addendum)
Revision P1 (Planning and LBC)

Kirklees Council
George Hotel

**Assessment of
Significance**
(With Addendum)

HERITAGE STATEMENT
DECEMBER 2022

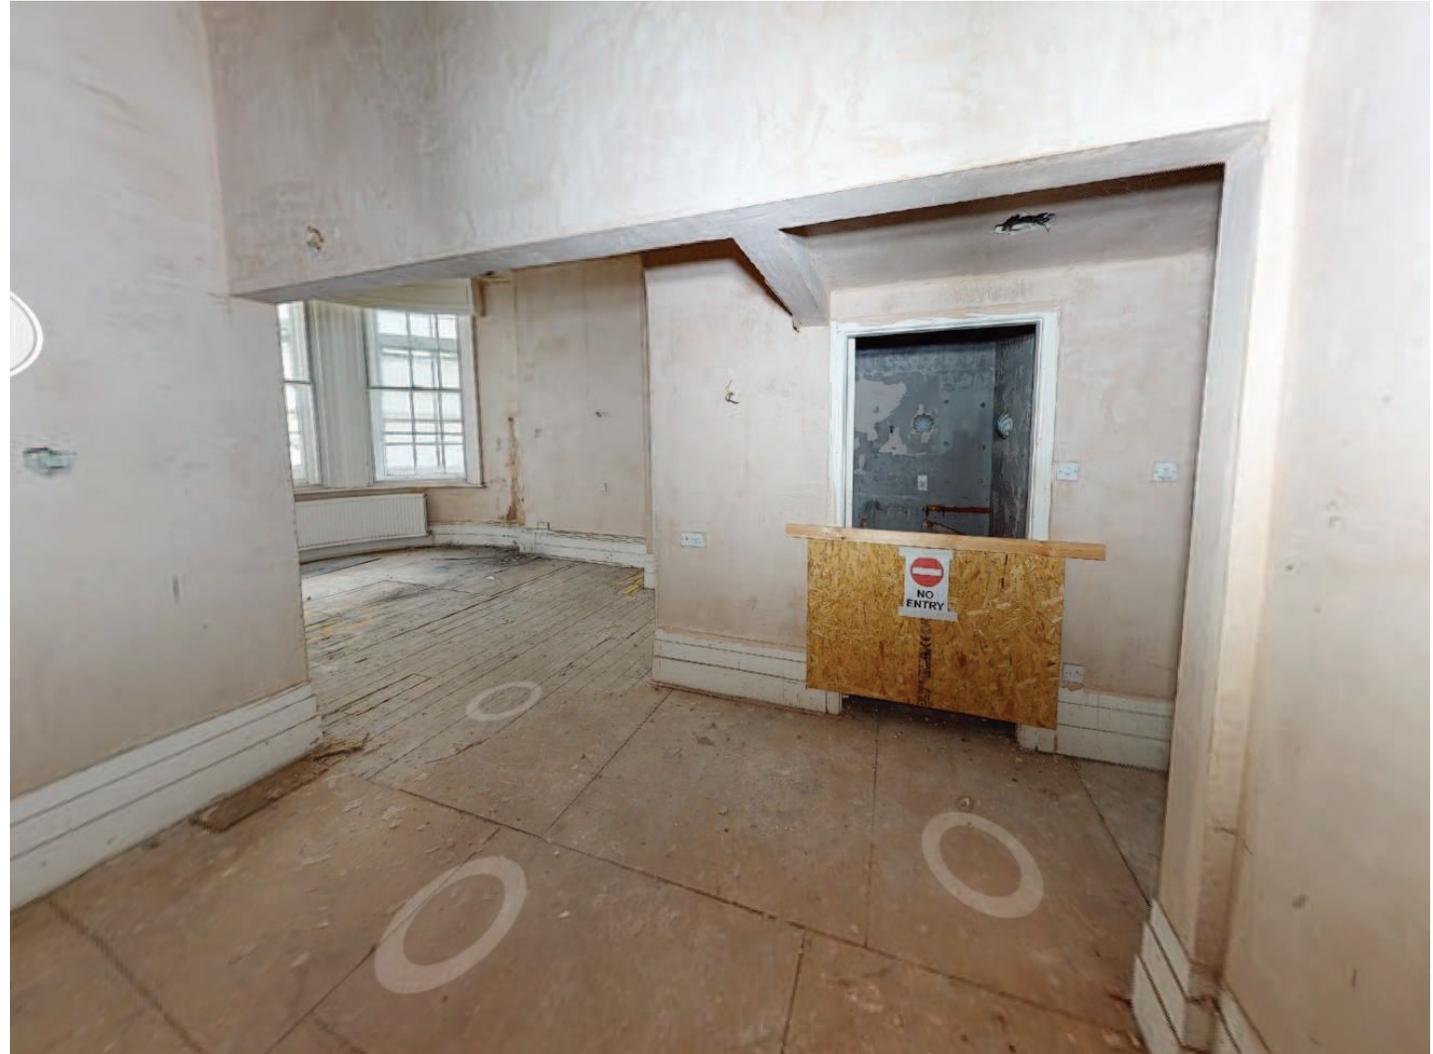
This part of the building was originally a single, large space, and has been subdivided into six smaller spaces. There are lowered ceilings and bulkheads and reproduction skirting boards, all of which make it difficult to understand the original design intent and use. Other than the windows, no original features remain.

The room has a very high capacity for change.

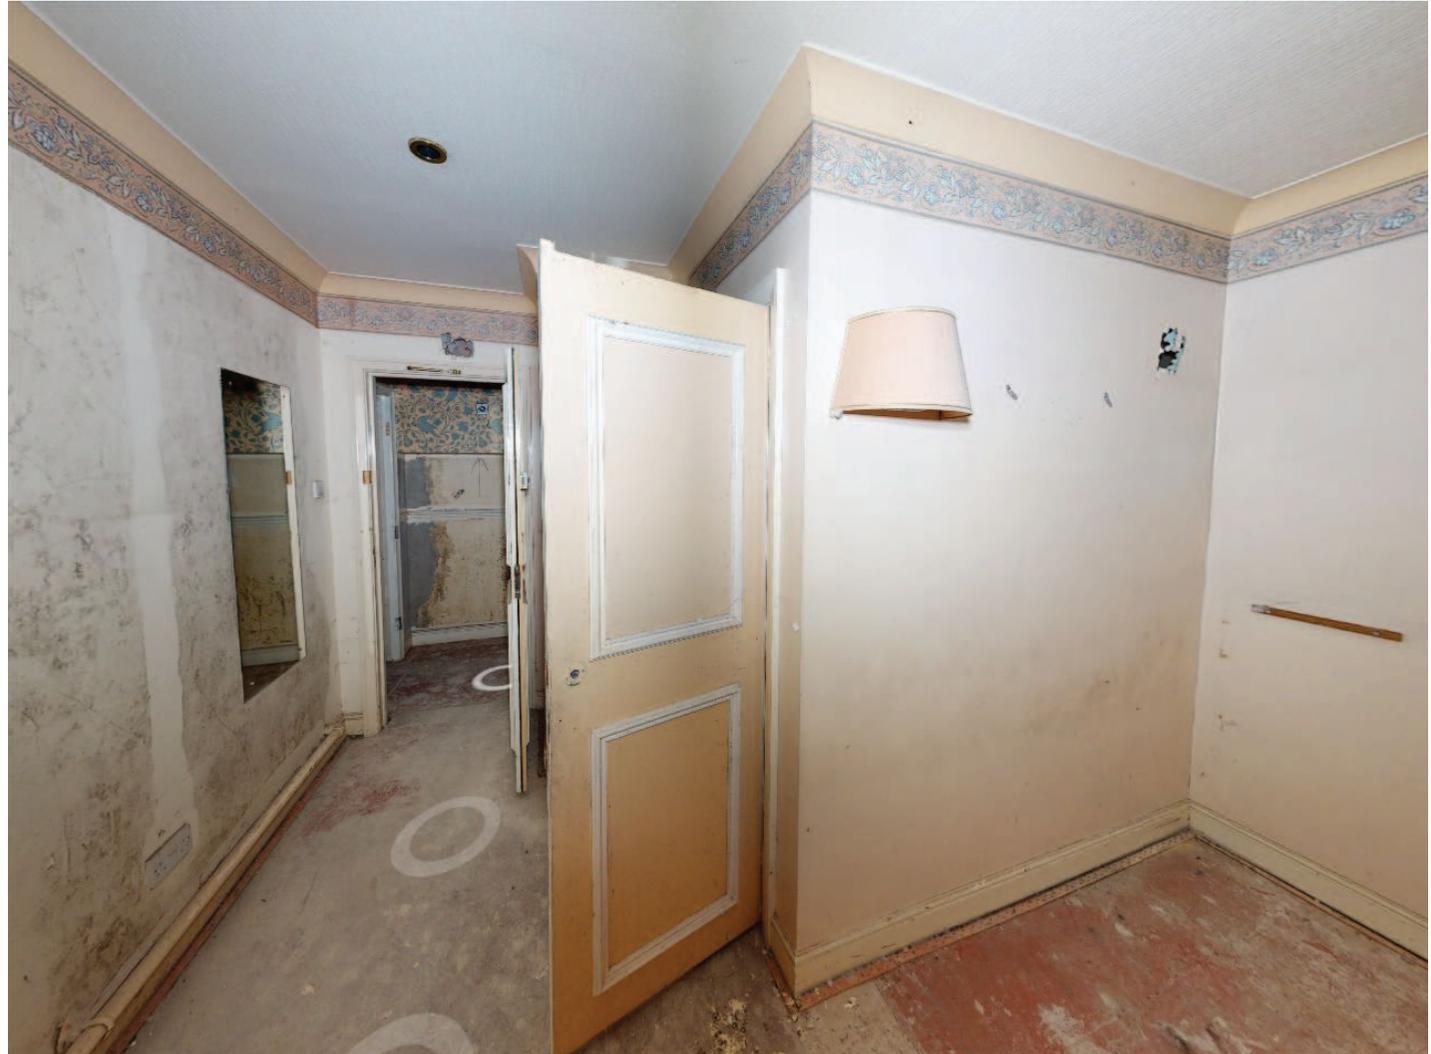
The 1930's floor plan is still readable, but an en-suite room has been inserted into the corner of the room, and there is a built-in wardrobe, both of which have a significantly negative impact on the original space. There are no architectural features worthy of note.

The room has a high capacity for change.
