Yew Tree Lane, Holmbridge

Bat Survey Report

18th June 2025

Document ref: MBE/BAT/2025/009/01				
Purpose and Description	Originated	Checked	Reviewed	Date
For Planning	R Bell MCIEEM	P Middleton MCIEEM	R Bell MCIEEM	18/06/2025

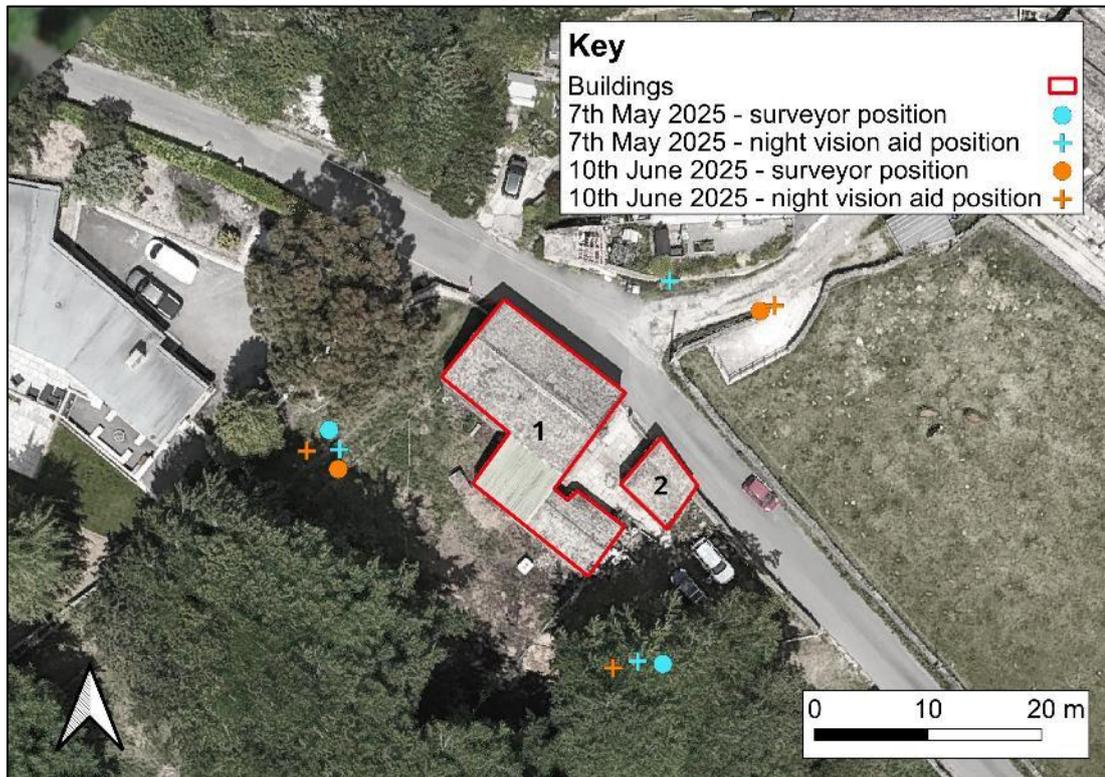
Figure 2. Nocturnal survey plan

4.1.2 Two nocturnal surveys were undertaken in compliance with relevant Bat Survey Guidelines (Collins 2023). Three surveyor positions were covered during each survey visit, with two manned positions and one unmanned position on each night. The dusk emergence surveys continued from 15 minutes prior to sunset until 1.5 hours after this

time. Nocturnal surveyor positions are shown on Figure 2. Both buildings were covered during both survey visits.

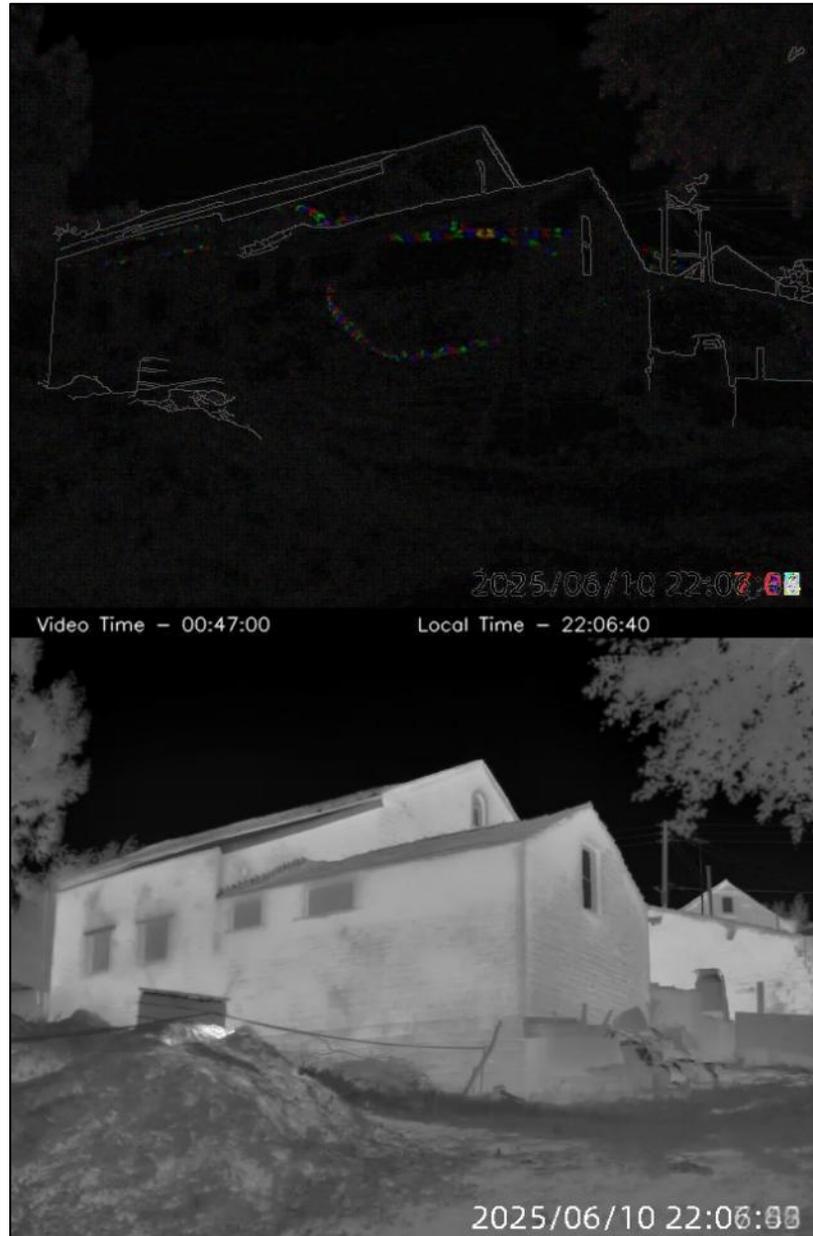
4.1.5 Camera footage from the unmanned survey position on the 7th May 2025 was reviewed in its entirety by Robert Bell. Footage from the unmanned survey position on 10th June 2025 was initially analysed by Wildlife Imaging Systems. Their software identified all movement (frame by frame) within the videos and produced a set of images showing the movement traces for each 30 seconds of video. These images were then reviewed by Robert Bell and where the image identified a trace that could potentially have been a bat flight, the relevant section of footage was also reviewed. An example image produced by the software is shown in Plate 1 overleaf. Only sections of footage relating to confirmed or potential bat roosting activity were reviewed from the manned survey position.

Plate 1. Example 30 second summary image from camera position on 10th June 2025, with the emerging bat indicated by dotted red-green-blue line on upper image

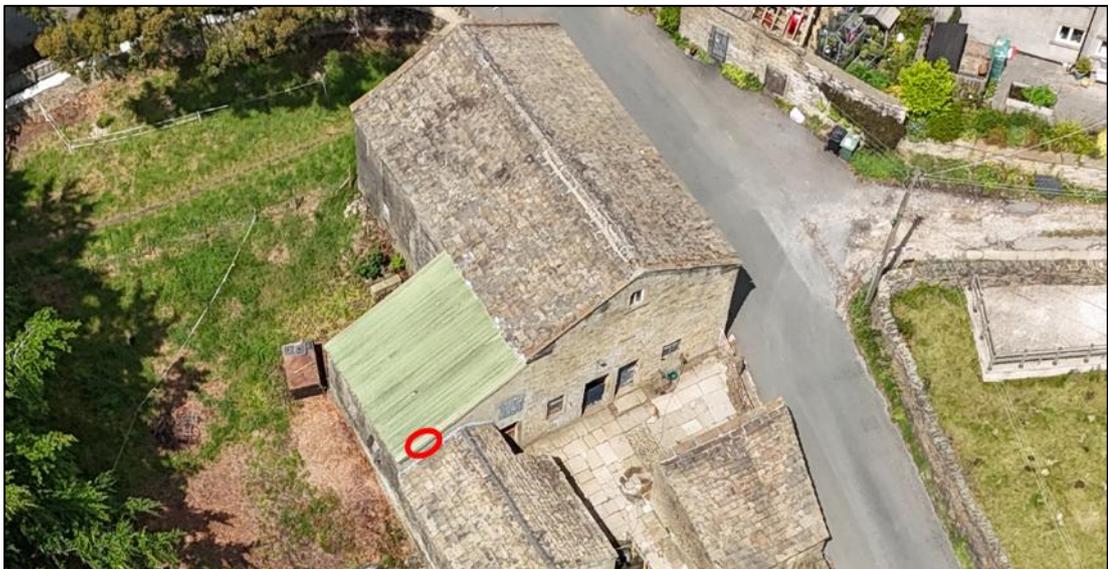
- 5.1.4 At 22:07 a common pipistrelle was recorded emerging from a roost location on a southeast facing section of wall top, located beneath corrugated metal sheeting on the barn (Plate 2). This emerging bat can be seen here: <https://youtu.be/ahwAyaiZFrc?si=xKDFH0xqTH8ekTsA> (the clip is unlisted).

Plate 2. Common pipistrelle roost location recorded on 10th June 2025

- 6.1.1 Nocturnal survey of the barn recorded the presence of a common pipistrelle day roost, used by a peak count of one bat, with the barn (B1). No bats were recorded from the outbuilding (B2) and absence of roosting bats is assumed for this building.
- 6.1.2 Proposals to re-develop the barn will result in the loss of this roost location.

- 6.3.5 Over time bats will often get into renovated buildings. Bats have been shown to regularly become entangled and die in the component filaments of standard modern woven roofing membranes (Appendix 1). There are however now a number of modern roofing membranes which have been shown to be relatively safe for bats. As a result, and given the presence of a bat roost on site, the roof of the new dwelling should be lined with a 'bat safe' membrane.
- 6.3.6 To offset the loss of the identified roost, three new integrated bat boxes (Plates 3-5) should be integrated into, the redeveloped barn. At least two of these boxes should be located on either the southeast or southwest elevations.

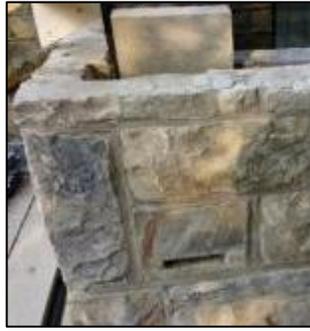
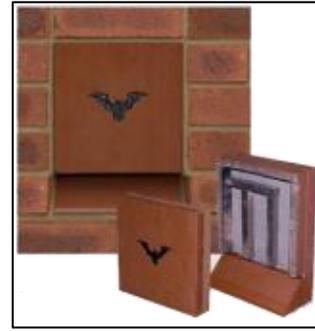
Plates 3-5. Build-in bat roost products

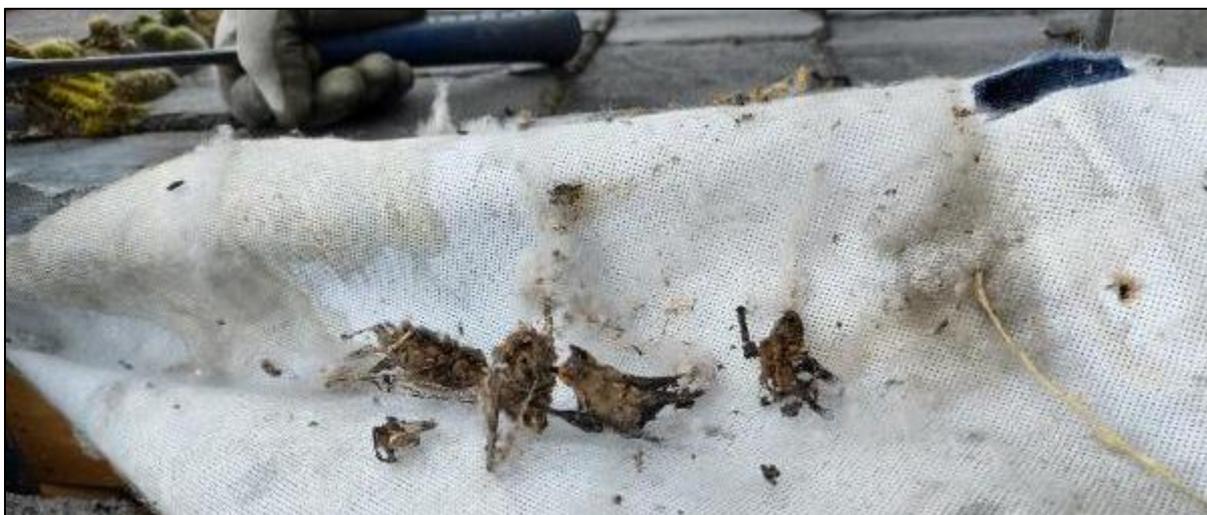
Non-bitumen coated membranes used below roof slates and tiles present a significant problem for bats. Over time, strands are pulled away from the surface of these materials as bats crawl over them. These fuzzy strands are very strong and can tangle and trap bats, sometimes causing the death of bats over multiple years¹.

One example we have encountered comprised a pipistrelle roost which formed in a building extension constructed in 2009. Over the course of just 13 years the roofing felt degraded to the extent that it trapped and killed more than 10 bats. Fortunately, the problem in this roost was identified and remedial work was undertaken to replace the roofing membrane in 2022.

Plate A1.1. Four dead pipistrelles tangled in breathable roofing felt

The best roofing membrane option for areas where bat roosts are expected is traditional Type 1F bitumen coated hessian backed roofing felt. Bitumen coated roofing felts have been widely and safely used as a secondary weather barrier since approximately the 1950s/1960s. Wooden sarking has also been used for many decades and if appropriately treated, is safe for

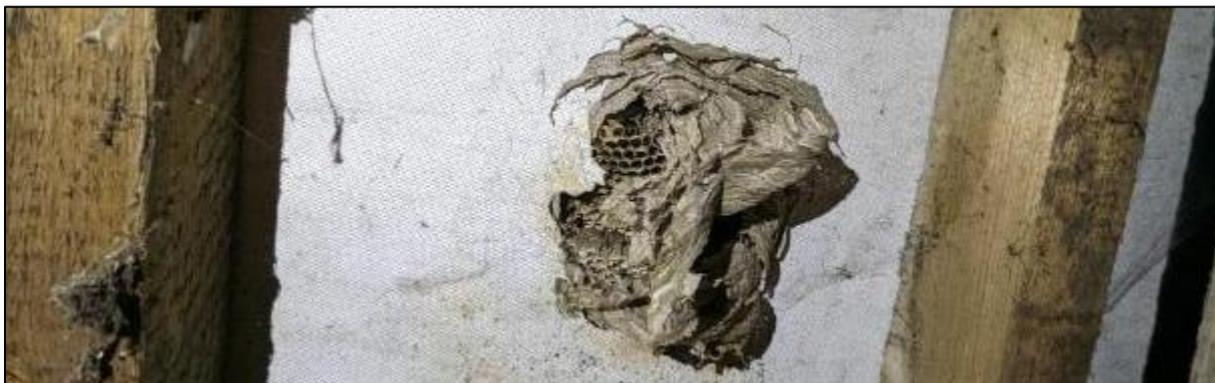
In recent years a fairly substantial proportion of the lofts we have surveyed which had existing breathable felt, were found to have been damaged by wasps (Plate A2.2). In these situations, the wasps appear to have chewed holes in the felt and formed nests in the holes. This doesn't appear to be a problem associated with the traditional bitumen coated roofing felt. Obviously, any holes within roofing felt would be likely to significantly reduce its functionality as a secondary weather barrier. Where bats or birds do come into contact with breathable roofing membranes, they can damage the membrane causing it to leak and they can also significantly reduce the breathability of the felt in that location.

Plate A1.2. Damage to a breathable roofing membrane adjacent to a wasp nest
