Yew Tree Lane, Holmbridge

Construction Environmental Management Plan

30th September 2025

Document ref: MBE/OTH/2025/005/01				
Purpose and Description	Originated	Checked	Reviewed	Date
For Planning	R Bell MCIEEM <i>R Bell</i>	P Middleton MCIEEM <i>P Middleton</i>	R Bell MCIEEM <i>R Bell</i>	30/09/2025

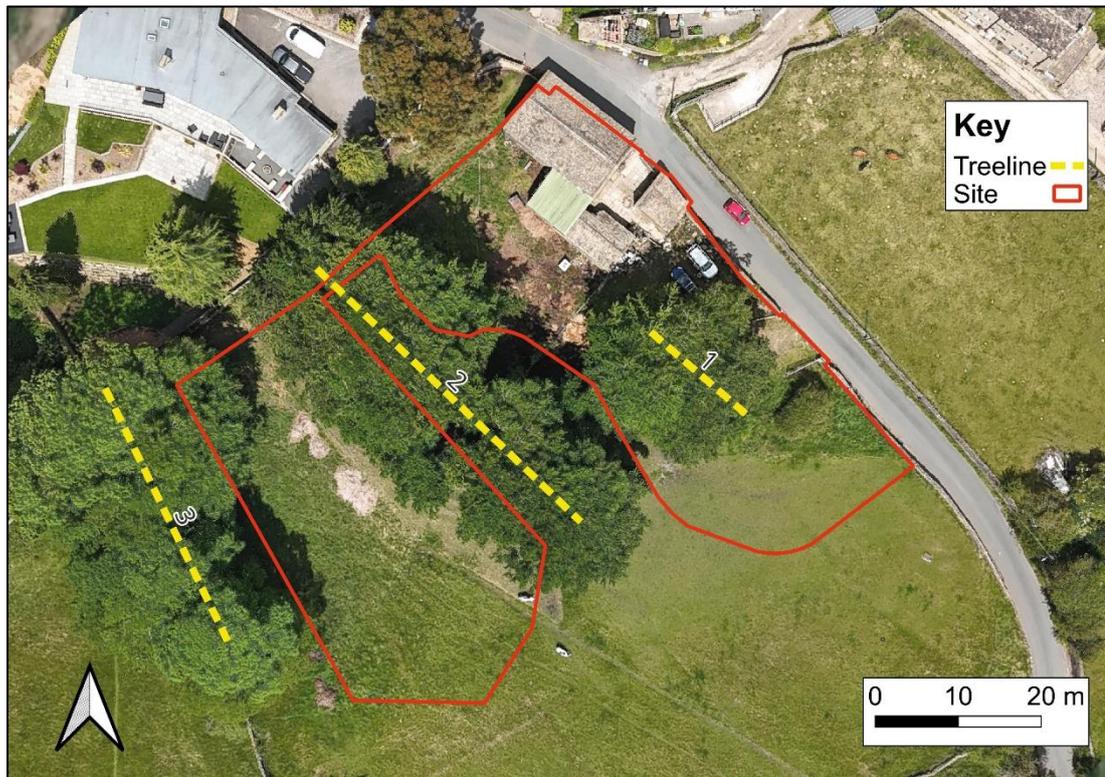
3.1.2 Three treelines are present either within, partially within, or adjacent to the site. The locations of these treelines are shown in Figure 3. These treelines comprise features of ecological interest.

Figure 3. Treelines and their identification numbers

- 4.1.2 Of the treelines shown on Figure 3, Treeline 1 is to be retained. However, groundworks will need to take place within the normal root protection area of these trees, as they are located within a turning area to the southeast of the new house (Appendix 1). The edge of this turning area should be clearly marked, and prior to the commencement of other development works on site, a ring of tree protection fencing must be installed to prevent damage to the trees from activities such as the storage of materials at their base.

- 4.1.3 Treeline 2 is partly within the red-line boundary but predominantly outside it. Construction activities are planned immediately northeast of this treeline. Consequently, tree protection fencing is to be installed along the northeast edge of the treeline, in accordance with British Standard 5837 (2012): Trees in relation to design, demolition and construction, to ensure the full root protection zones are included. No tree protection fencing is required along the southwest edge, as no potentially damaging activities will take place in this area.

- 4.1.4 Treeline 3 is located wholly outside the proposed development zone, with the only works to take place in the southwest section of the red-line boundary to comprise ecological enhancement of the adjacent grassland and some tree planting. It is not considered that tree protection fencing is required in relation to this treeline.

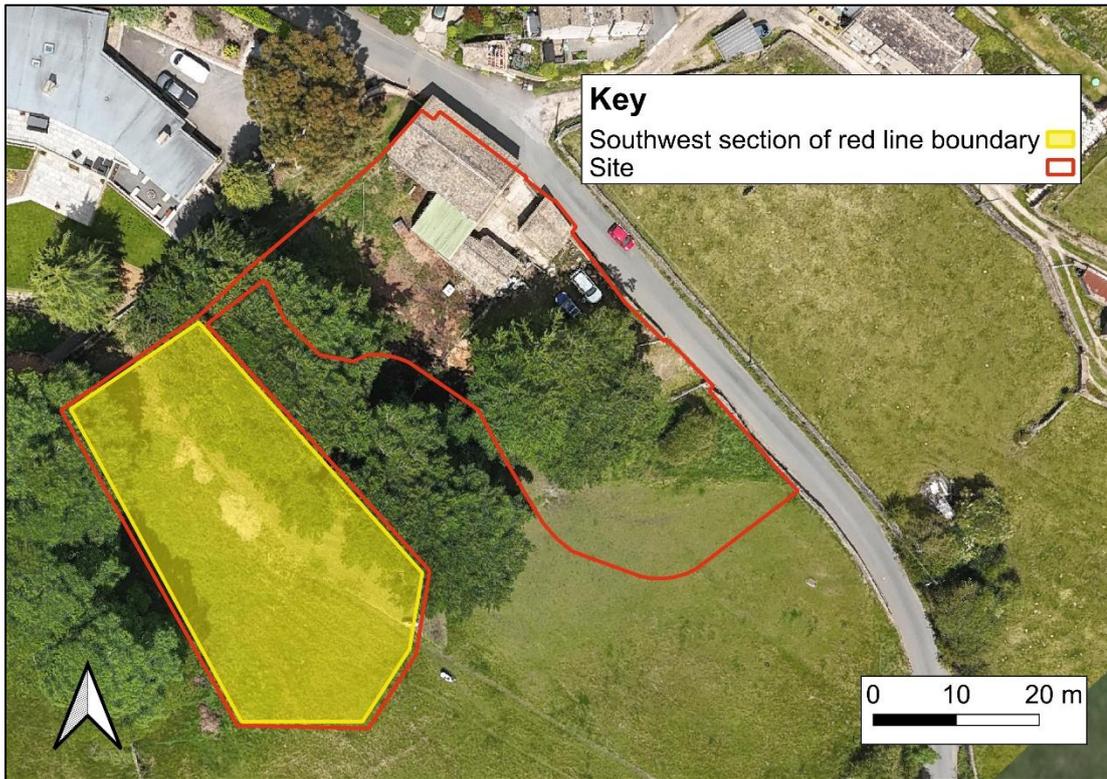
3.1.3 The red-line boundary includes the northwest polygon, within which development is to take place (Appendix 1), and the southwest polygon which is to be subject to ecological enhancement works, with a thin connecting section between (Figure 4). No construction works are proposed to take place in the southwest section of the site and thus no land-take is required. Pasture in this area is considered to comprise a feature of ecological interest.

Figure 4. Southwest section of site

- 4.1.6 The connecting link along the northwest edge of the site, within the red-line boundary, is publicly accessible. Consequently, it is not possible to install a fence in this location to prevent access to the southwest area of the site during construction. Construction staff will, however, be instructed not to enter the southwest section of the site (Figure 4) for any reason, including the storage or tipping of materials or the movement of vehicles

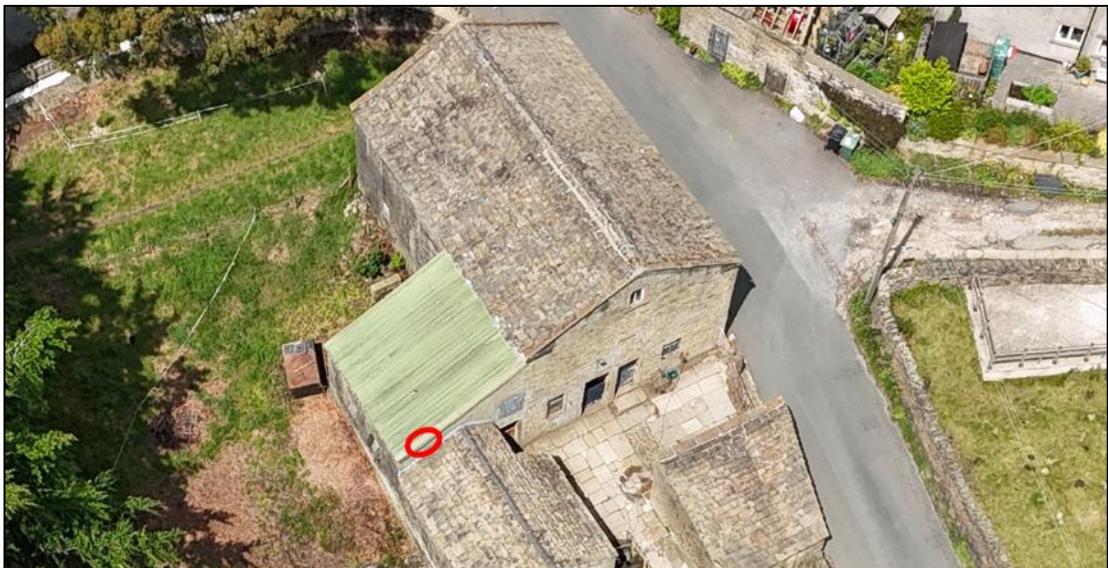
- 3.1.4 A common pipistrelle day roost, used by a maximum count of one bat, was recorded from the southeast elevation of the barn (MBE, 2025b). In addition, land within the site to the southwest of the barn was used quite extensively by foraging common pipistrelle, with a *Myotis* bat species also recorded active on the site. Roosting, foraging and commuting bats are of considerable ecological interest.

Plate 1. Bat roost location on barn

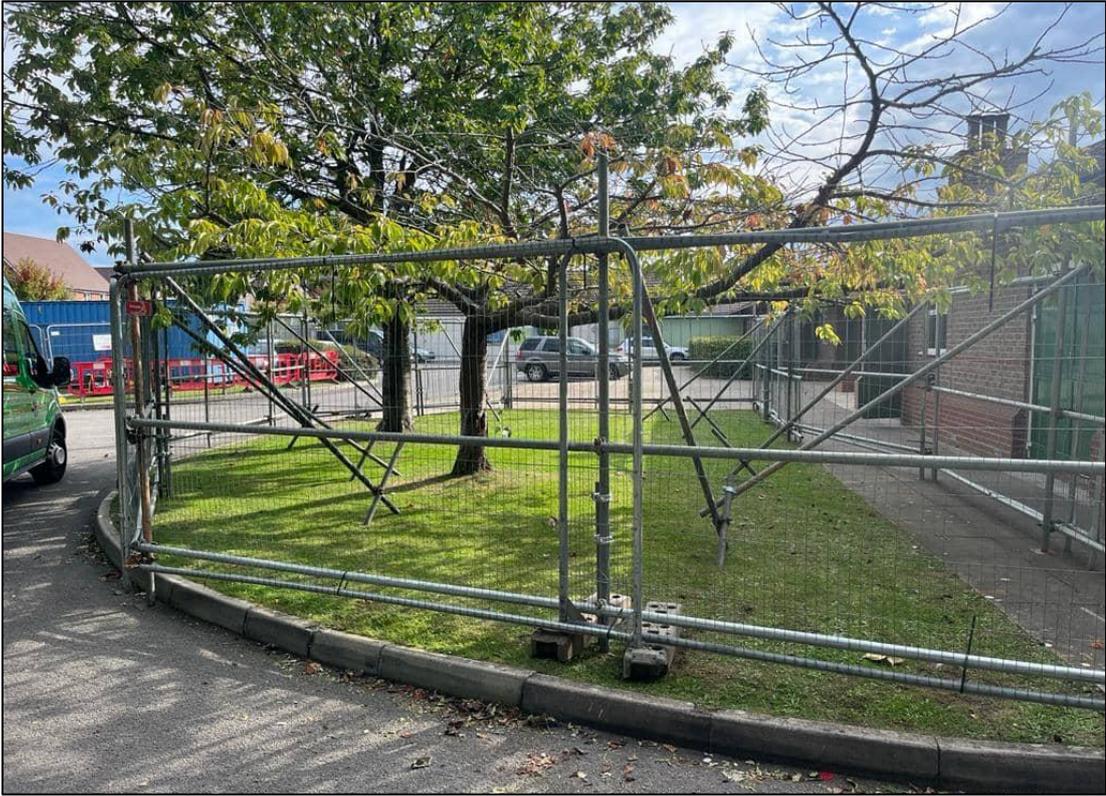
- 4.1.5 Tree protection fencing should comprise either permanent post and rail fencing, or Heras fencing (Plate 2). This fencing should remain in place for the duration of the construction scheme. Construction staff are to be instructed not to enter the fenced sections of the site without prior agreement from the site foreman. Any works, other than foot access or non-intrusive survey works, are to be undertaken only following agreement with the project ecologists (Middleton Bell Ecology). Signs should be fitted to fencing stating that no access is permitted to these fenced biodiversity protection zones without prior agreement from the project ecologists.

Plate 2. Tree Protection Fencing

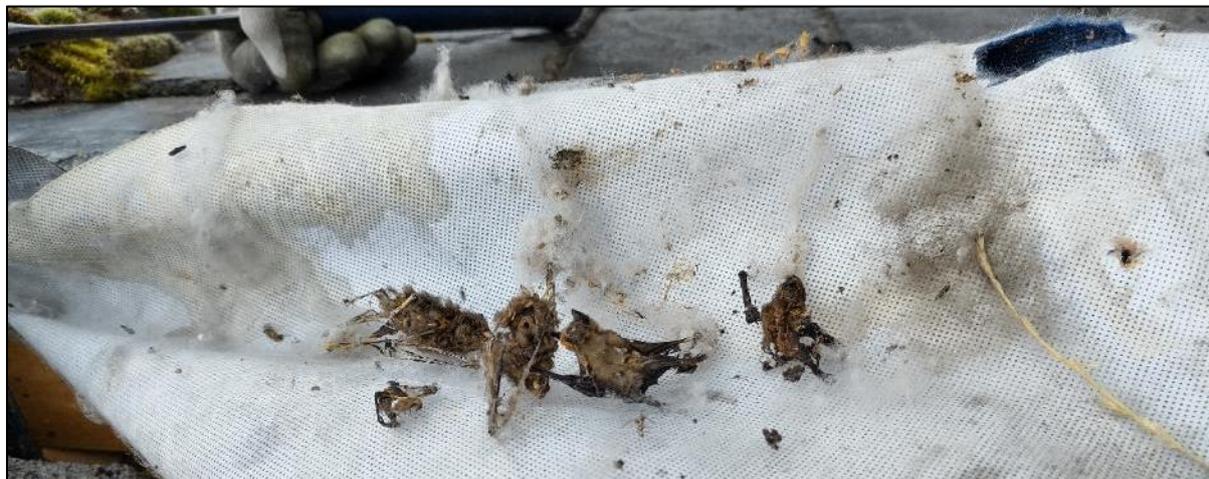
Standard non-bitumen coated membranes (including almost all breathable membranes) used below roof slates and tiles present a significant problem for bats. Over time, strands are pulled away from the surface of these materials as bats crawl over them. These fuzzy strands are very strong and can tangle and trap bats, sometimes causing the death of bats over multiple years¹.

One example we have encountered comprised a pipistrelle roost which formed in a building extension constructed in 2009. Over the course of just 13 years the roofing felt degraded to the extent that it trapped and killed more than 10 bats. Fortunately, the problem in this roost was identified and remedial work was undertaken to replace the roofing membrane in 2022.

Plate A2.1. Four dead pipistrelles tangled in breathable roofing membrane

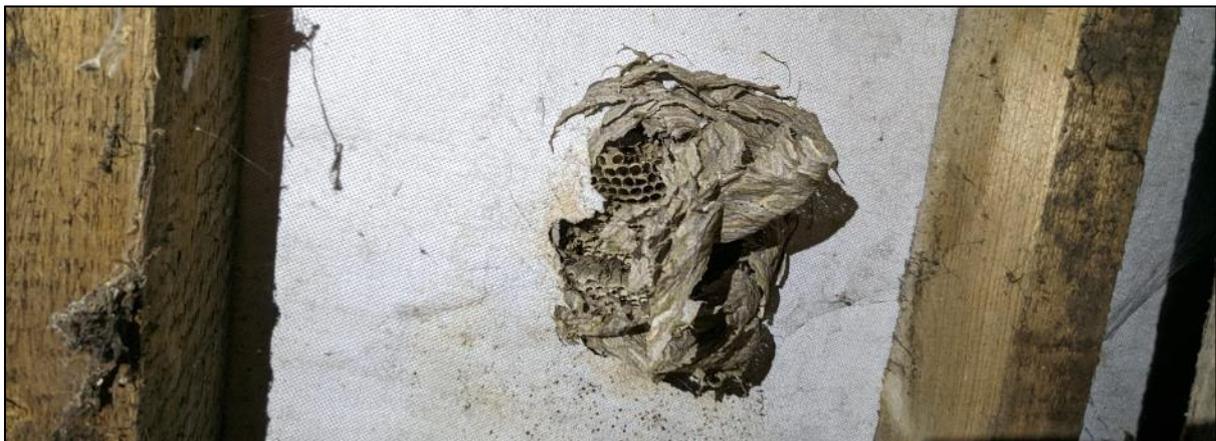
In recent years a fairly substantial proportion of the lofts we have surveyed which had existing breathable felt, were found to have been damaged by wasps (Plate A3.2). The wasps appear to have chewed holes in the felt and formed nests. This doesn't appear to be a problem associated with traditional bitumen coated roofing felt. Any holes within roofing felt are likely to significantly reduce its functionality as a secondary weather barrier. Where bats or birds come into contact with breathable roofing membranes, they can also damage it causing it to leak, they can also significantly reduce the breathability of the felt in that location.

Plate A2.2. Damage to a breathable roofing membrane adjacent to a wasp nest
