Bat Survey to
12 Chapel Lane
Moldgreen
Huddersfield
HD5 9BG

31st July 2025

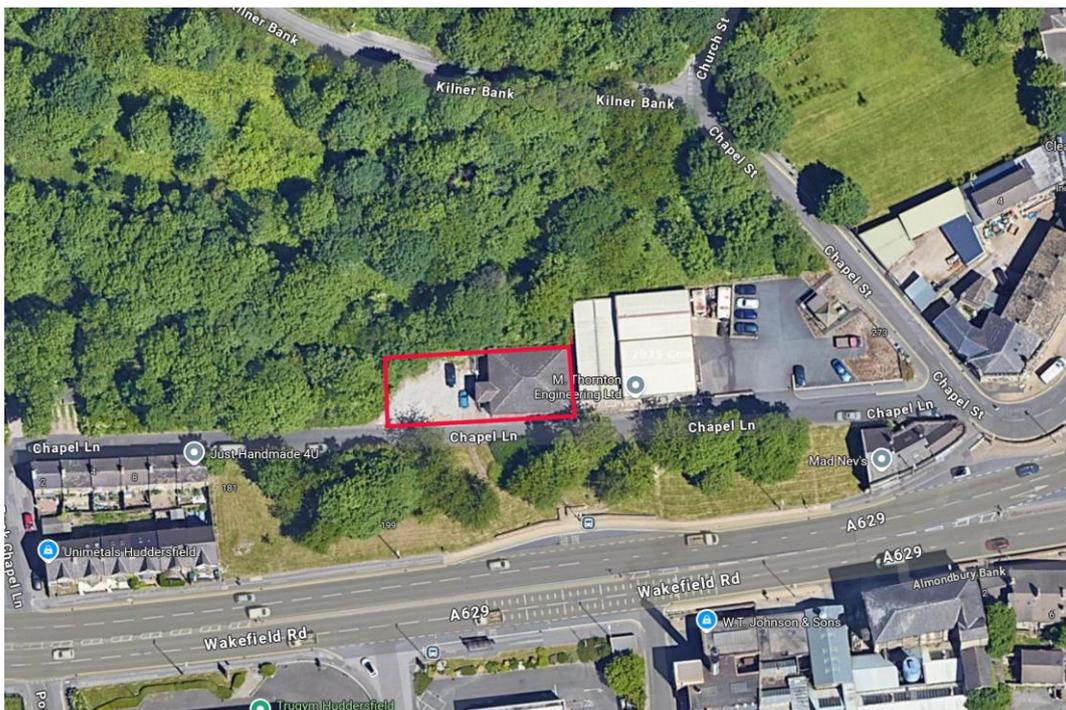
The site consists of a former office and storeroom building which is now disused and is located in an urban area close to both traffic and light pollution but there is good foraging habitat to the rear. Bats using Chapel Lane have easy access to the areas north of the site but are less likely to cross to areas south of the site.

Figure 2 Aerial view of the site, surroundings and buildings surveyed

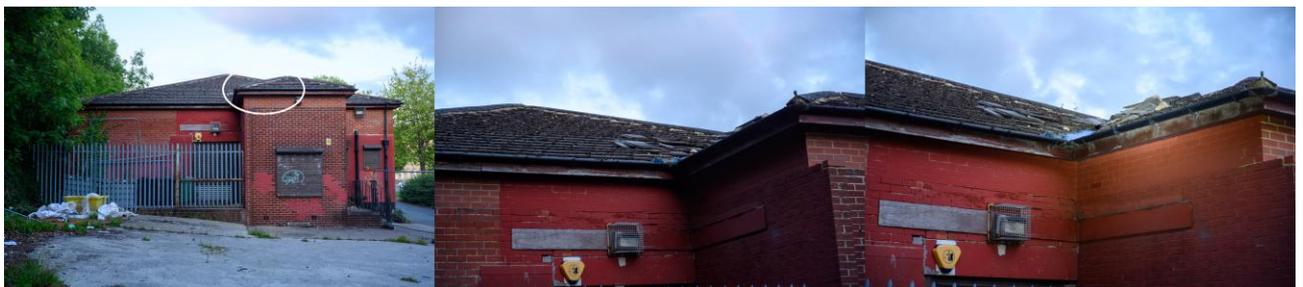
The building is a medium sized former office and stores and is now unused. The roof is hipped and is covered with Marley modern tiles which interlock and sit flat and do not present gaps. The ridge tiles are present and generally, all ridge pointing is present. There is a section of roofing which has been stripped by vandals along a valley, presumably for lead, but this is unlikely to be used by bats as it is too big and open to predators. Internally, the roof is lined with traditional felt and has no light ingress apart from where the roof has been damaged. There is a very complex system of timbers internally which makes the roof unsuitable for brown long-eared bats and generally, hipped roofs are less often used by ridge dwelling species.

Photo 1: Showing the roof's general condition and area of damage

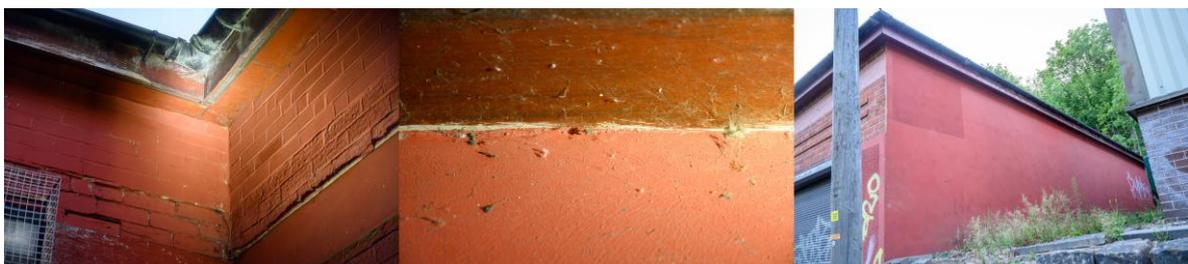
The walls are brick and in good condition and do not have any structural gaps or cavities and the east elevation is entirely rendered and therefore of no interest to bats. There are wooden boxed eaves, but these fit snugly to the wall and offer no roost potential. All windows and doors are covered by roller shutters.

Photo 2: detailing rendered wall and snug fitting box eaves.

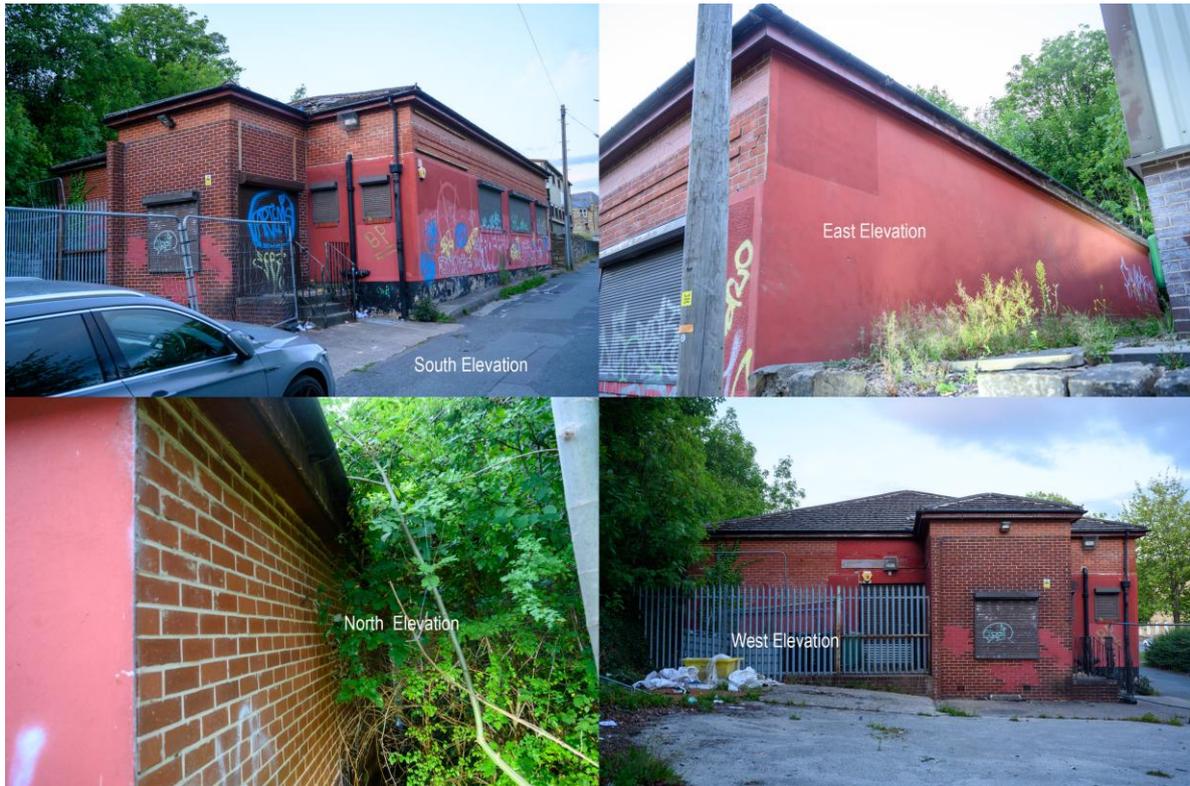
Photo 3: General views of the building.

The photographs illustrate the limited number of potential roosting features present. The east wall is totally rendered, and the soffits lack any potential access, while the back wall is heavily obscured by vegetation in addition to tightly fitted box eaves. The roof may offer some potential if there are areas of failed ridge mortar, but the building is not considered essential to species survival and is assessed as being of extremely low importance to bats.

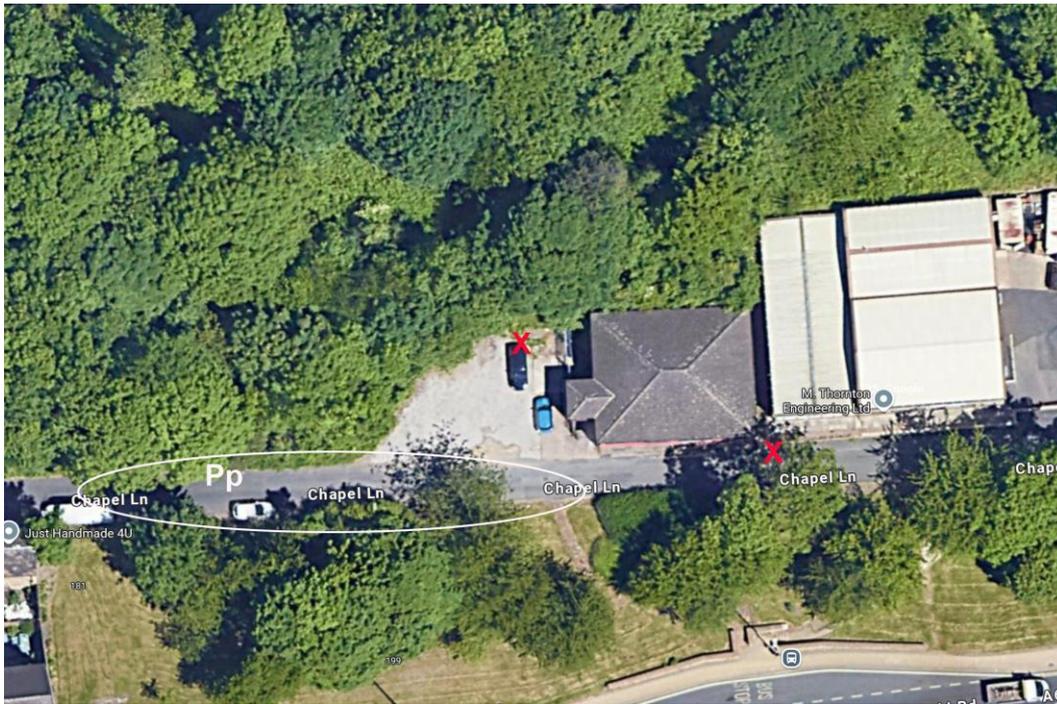
An evening emergence survey was carried out on the same evening as the daytime survey by two very experienced surveyors. The first bat was recorded just 10 mins after sunset indicating a local emergence, but it was detected flying along Chapel Lane from the west and was seen returning a few minutes later. A second bat was detected 30minutes after sunset and came from the same westerly direction and looped round and back the same way. Only 5 bat passes were recorded and all single bats which could potentially all relate to the same individual. No bats were recorded emerging from the building, and no bats were recorded later than 50 minutes after sunset. The number of bats was unremarkable and very much as expected for the locale.

Figure 4. Observer location and main areas of bat activity
