**Whitcher Wildlife Ltd.
Wildlife Consultants.**

OXFORD ROAD, GOMMERSAL.

BAT SURVEY.

Ref No:- 140735.

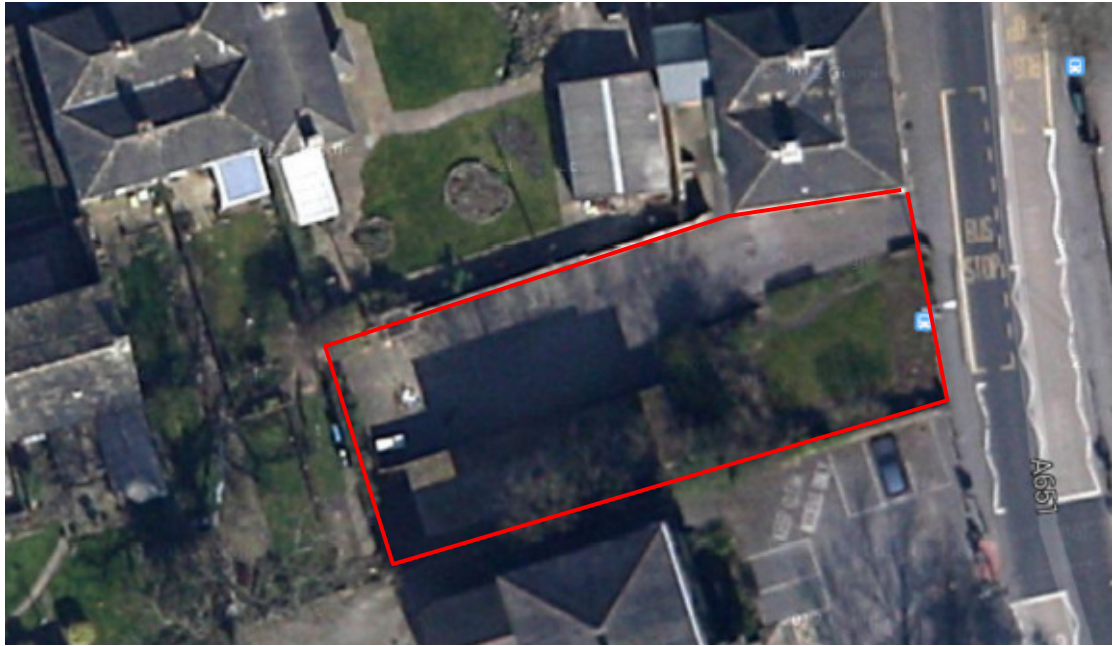
3.1.6. The site comprises the old Police Station car park with a small lawn and flower garden that has become neglected and overgrown, shown below.

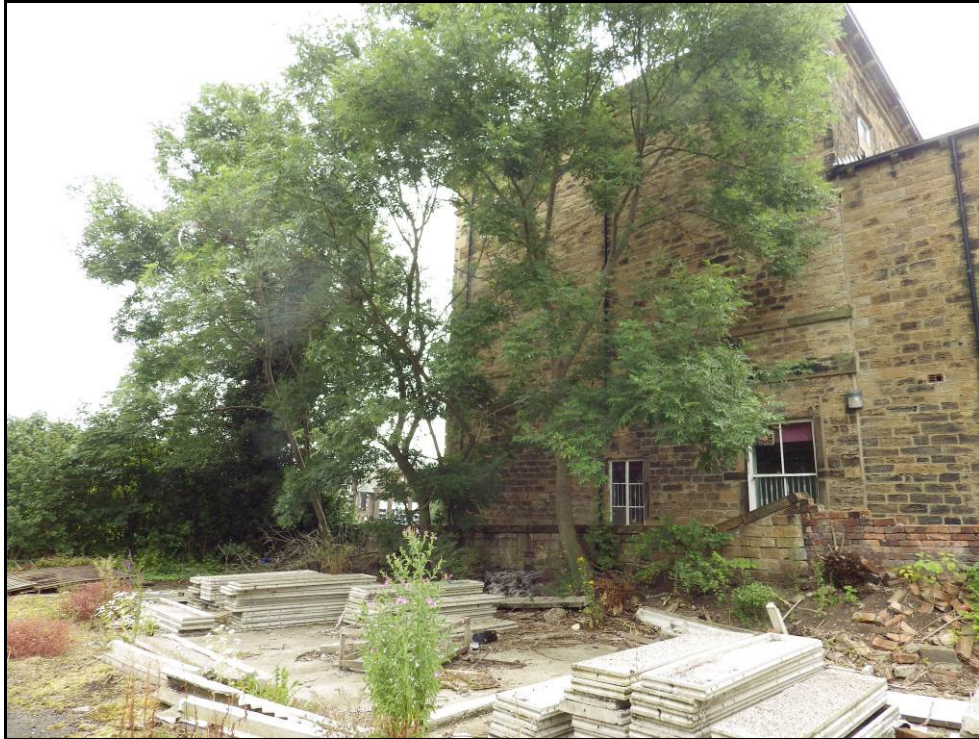
3.1.10. The photograph below looks across the back of the site towards Gomersal Hall and shows a line of four immature ash trees along the southern site boundary. The maximum girth of the trees is 200mm and one has a trunk with ivy cover.

3.2.1. The only trees on the site are four immature ash trees and one holly bush. None of these contains any opportunities for roosting bats.

4.2. Four immature ash trees on the site boundary adjacent to Gomersal Hall will be removed. These trees are too immature to provide bat roosting opportunities and they form no connective flight line for foraging bats.

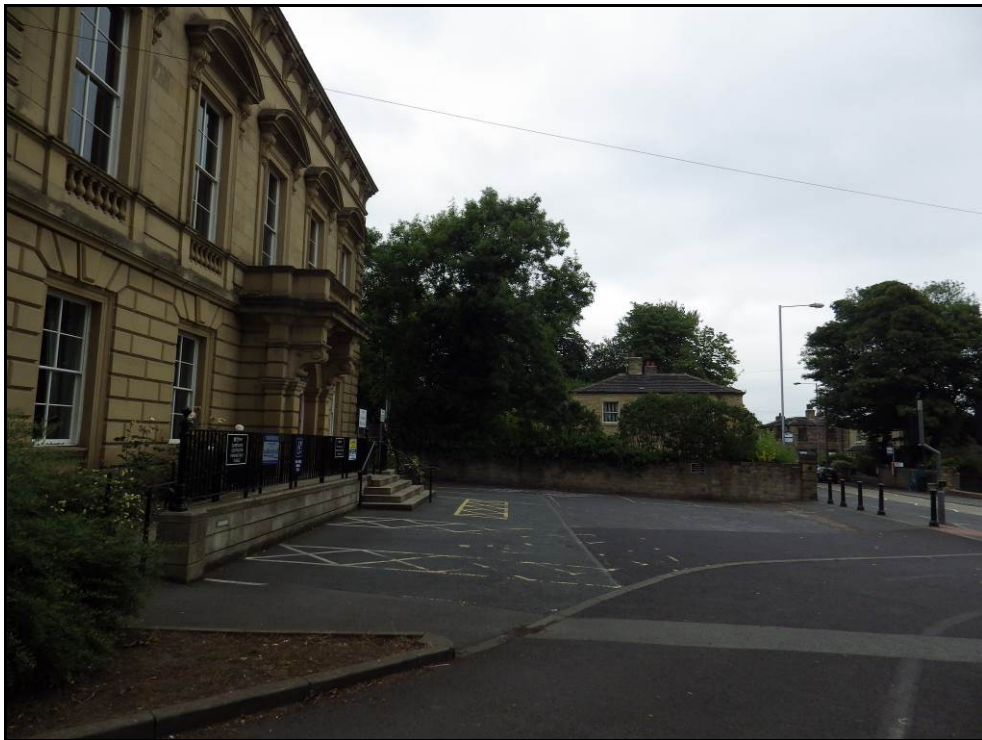
3.2.5. Gomersal Hall is located adjacent to the southern boundary of the site. This is also constructed from cut and coursed stone with walls in good condition and stone cornices. The roof is covered with stone slates and the roof is in good condition. This building is also assessed to have no bat roosting potential.

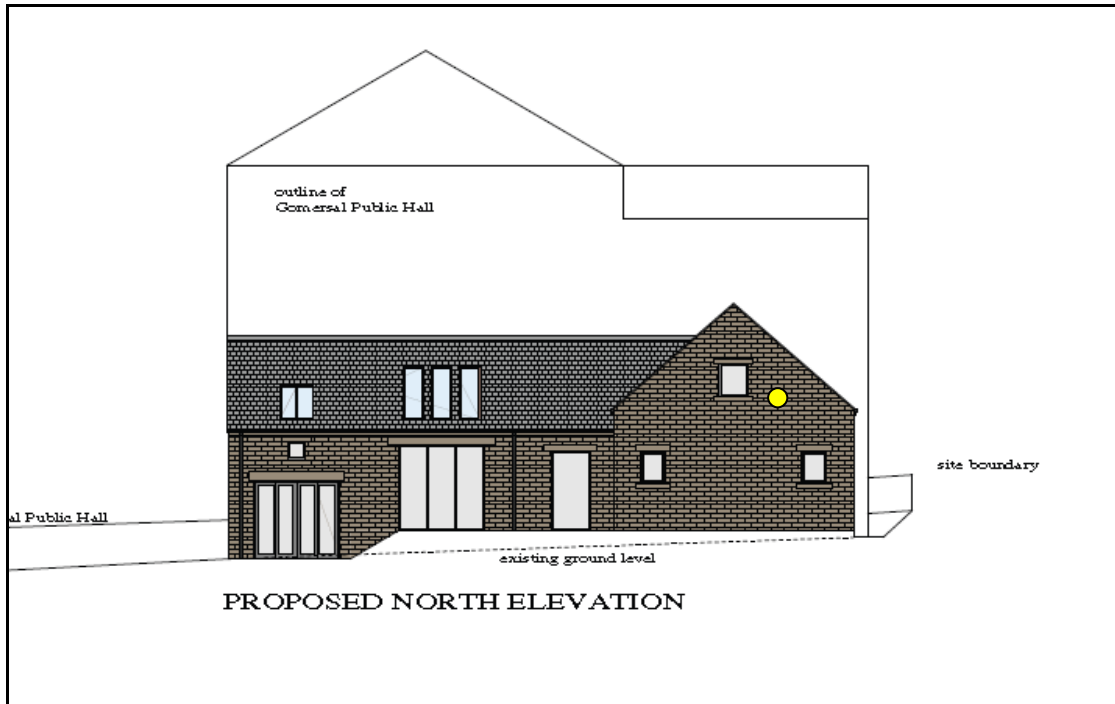
5.3. As the new dwelling will be position low down within the site in relation to the surrounding buildings, the optimum position for the bat box is in the northern gable end of the building, as shown by the yellow dot in the elevation drawing below.

5.2. While no mitigation is necessary, the developer is prepared to install a bat box into the cavity of the new dwelling. An example is shown below.
