**ARBORICULTURAL IMPACT ASSESSMENT
to BS 5837:2012
at
Bradley Hall
Lower Quarry Road
Bradley
Huddersfield
West Yorkshire
HD2 1FN**

JCA Ref:
21655-A/AJB

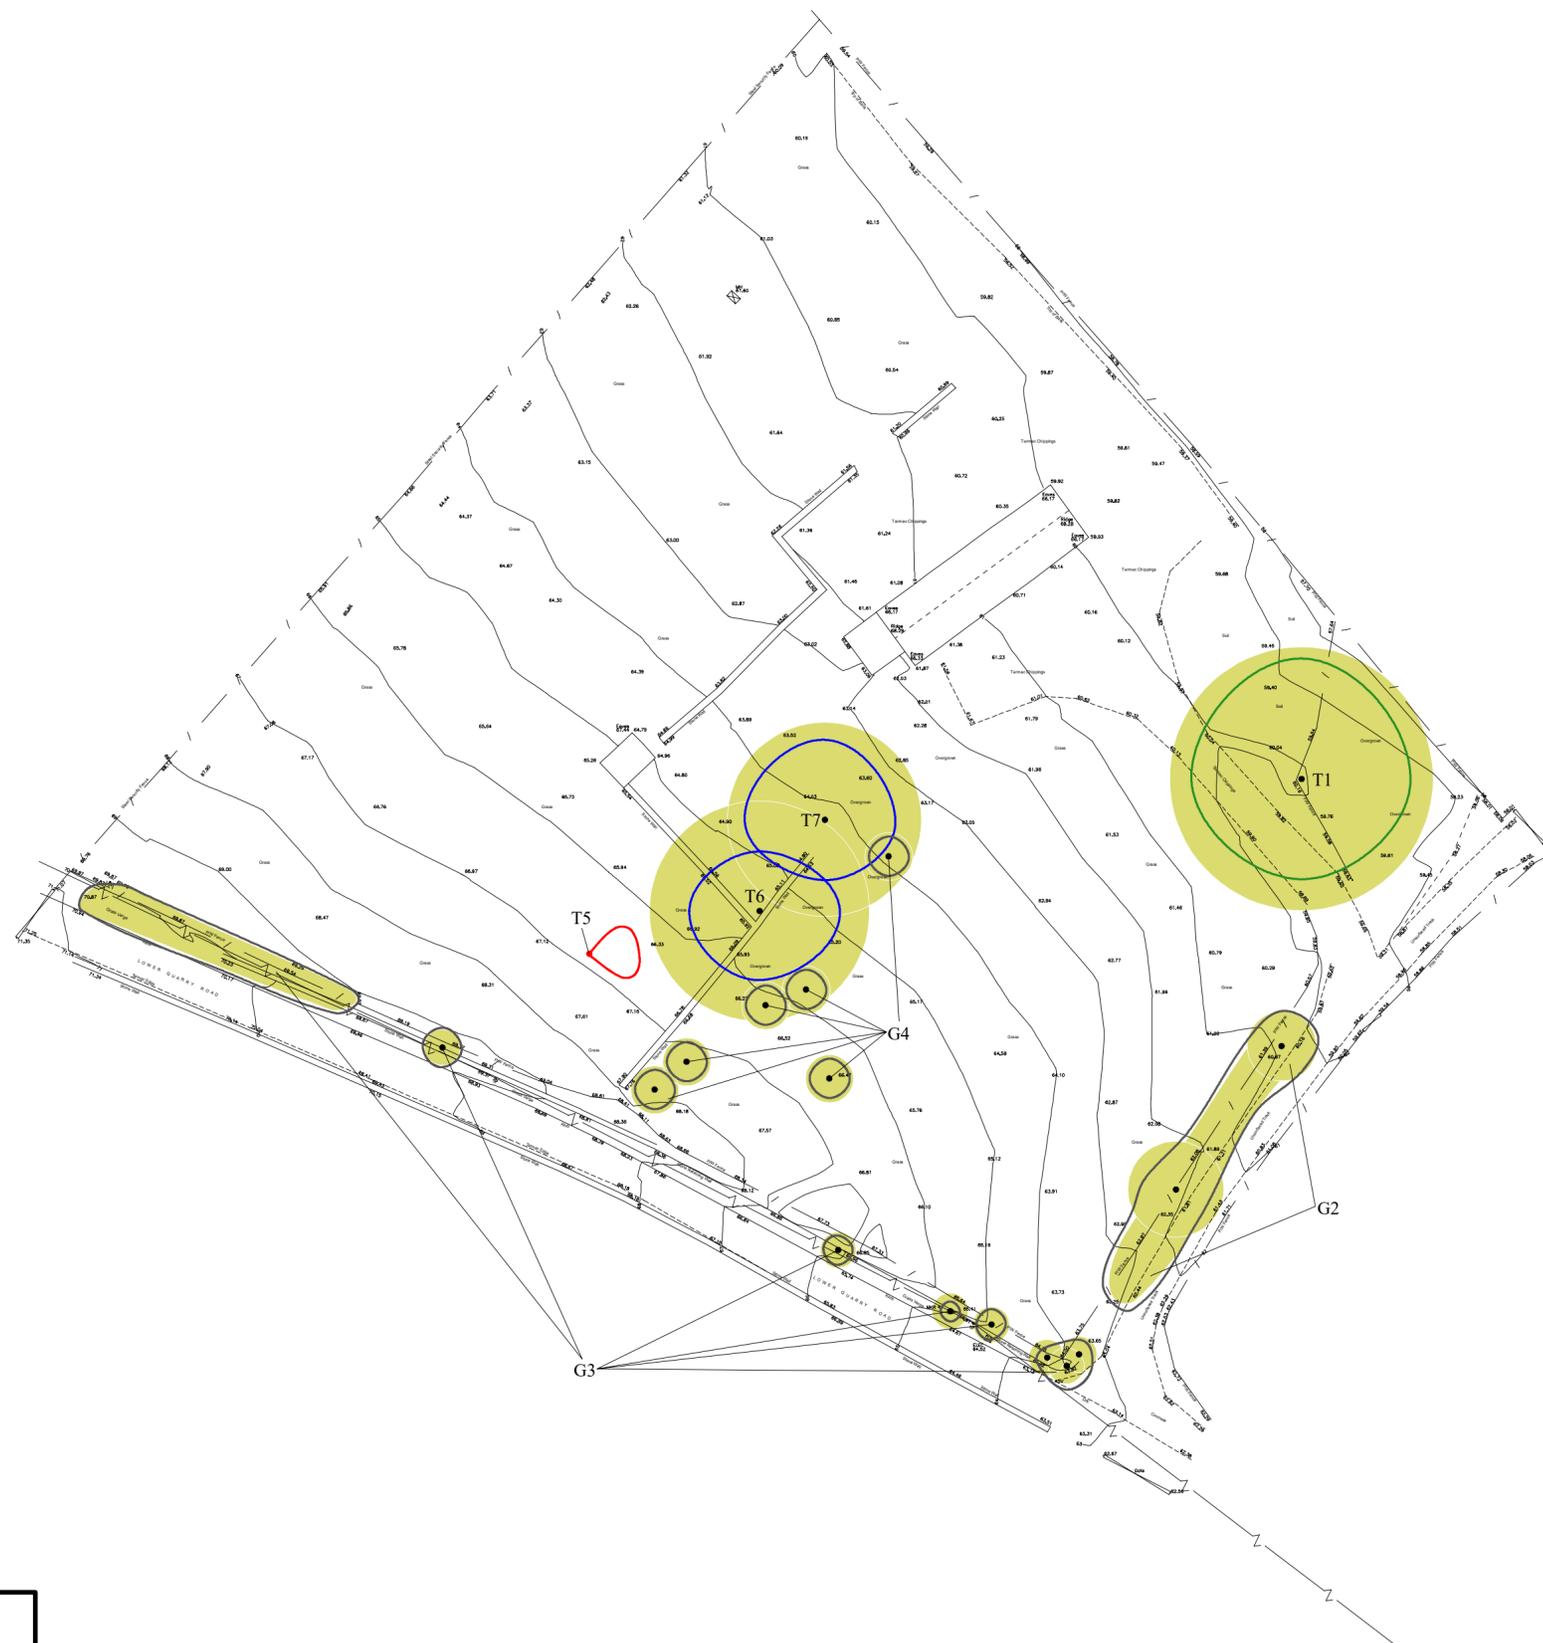
**Appendix 5:
Tree Constraints Plan**

Root Protection Area: RPA

THE ROOT PROTECTION AREA SHOULD IDEALLY REMAIN UNDISTURBED IF THE TREE IS TO BE RETAINED.

THE DEVELOPMENT PROPOSALS SHOULD THEREFORE BE DESIGNED TO AVOID THE RPA OF ANY TREE WHICH IS TO BE RETAINED.

IF IT IS NECESSARY FOR THE DEVELOPMENT TO ENCR OACH INTO THE RPA OF A TREE WHICH IS TO BE RETAINED THEN SPECIALIST CONSTRUCTION TECHNIQUES AND MATERIALS MUST BE CONSIDERED.

- 2.1 The tree information recorded during the original survey is detailed in the tables at **Appendix 1**. A full explanation of the tables can be found at **Appendix 2**. Please refer also to the Tree Constraints Plan at **Appendix 5** for tree locations.

- 4.7 The protection of retained trees can be achieved by the creation of a Construction Exclusion Zone based on the Root Protection Area of a tree. The Root Protection Area of each tree or group is marked on the Tree Constraints Plan at **Appendix 5**.

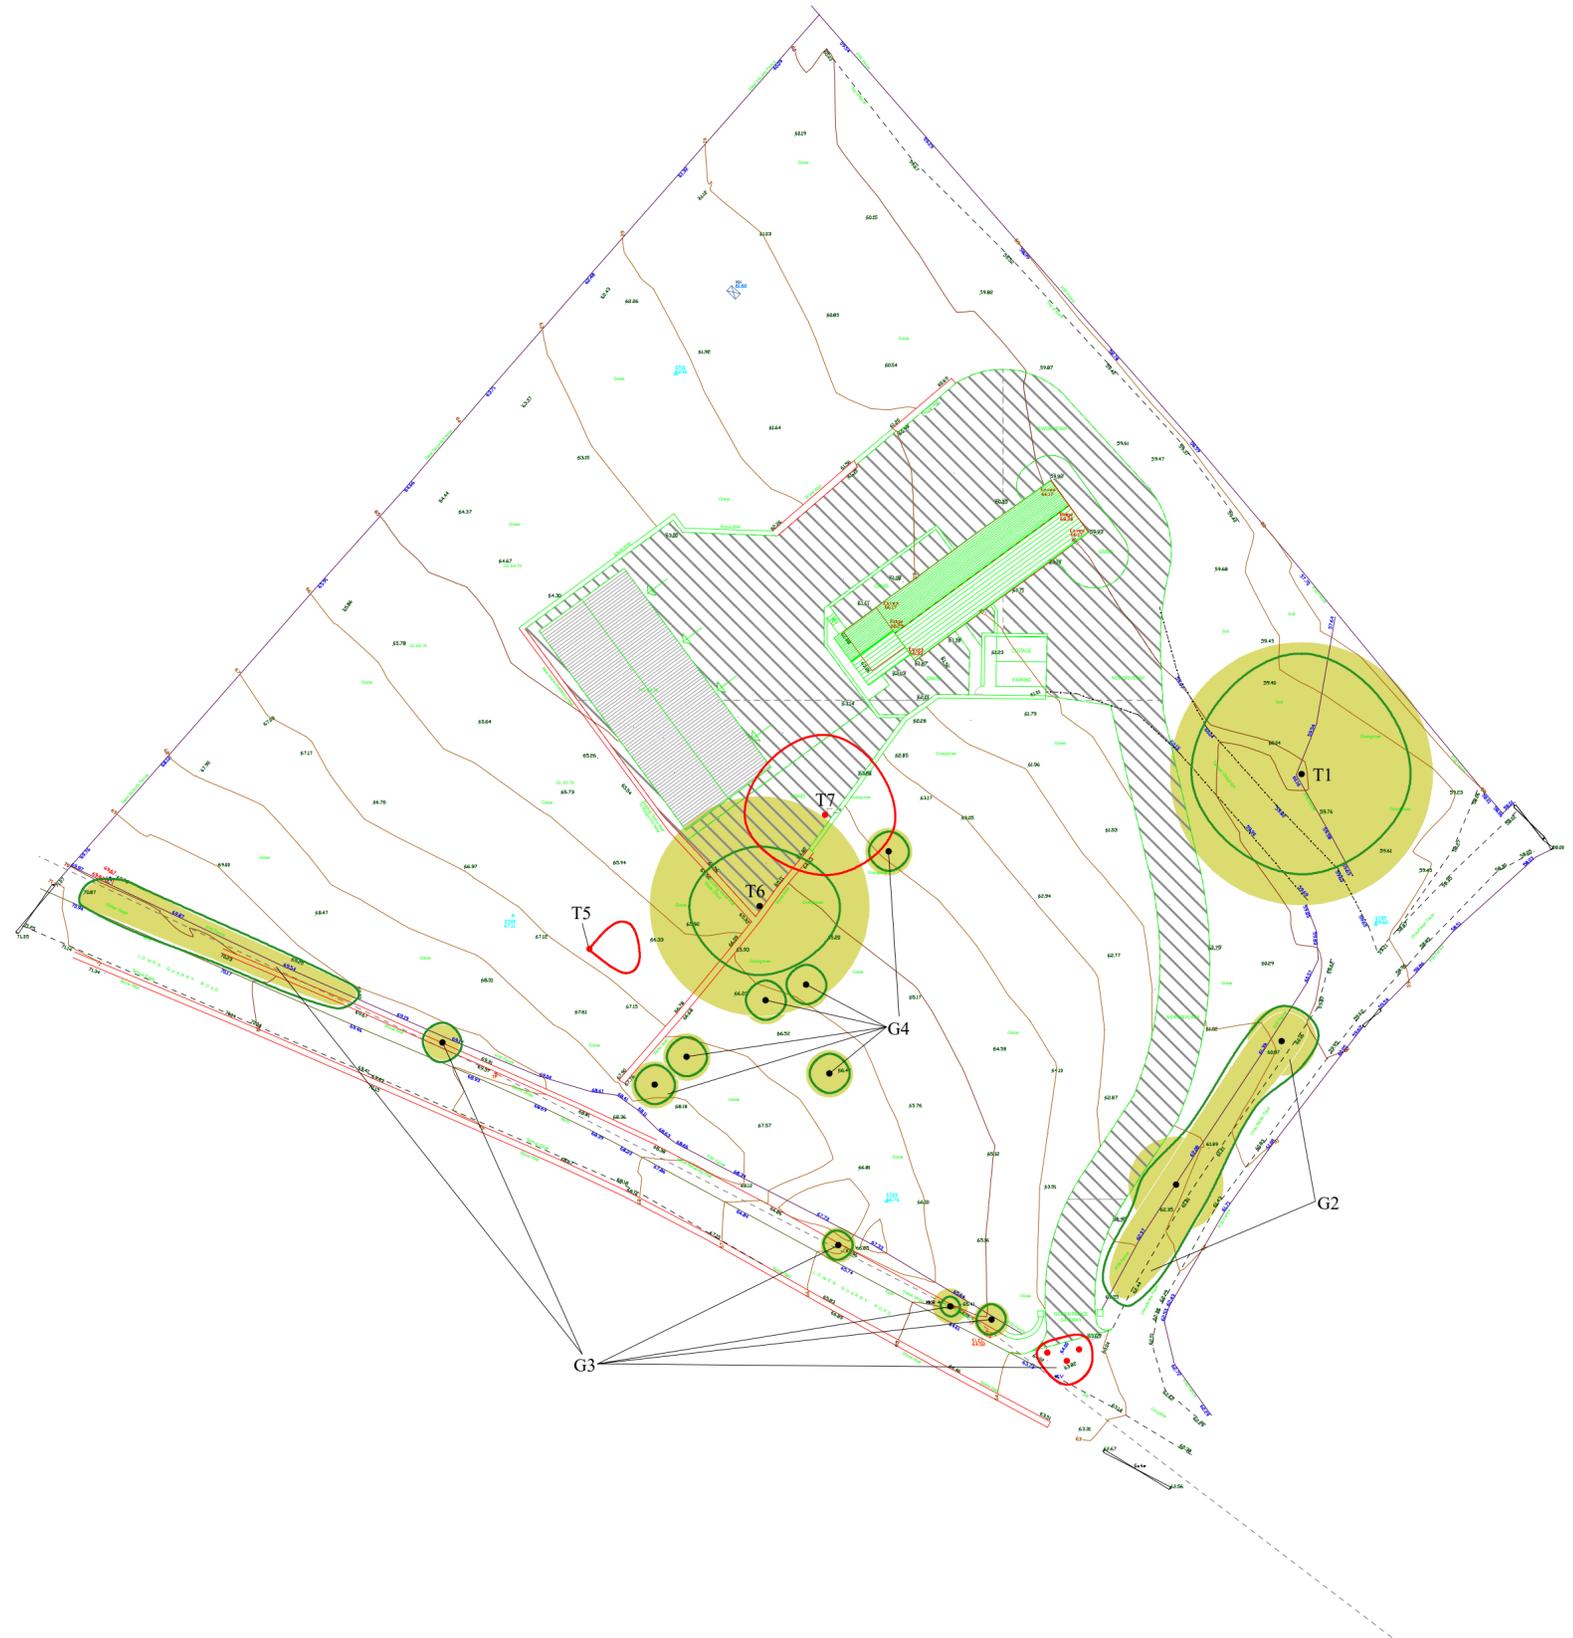
Appendix 6: Arboricultural Implications Plan

TREE TO BE RETAINED
	TREE TO BE REMOVED
	STEM OF TREE TO BE RETAINED
	STEM OF TREE TO BE REMOVED
	ROOT PROTECTION AREA

- 3.2.1 In order to facilitate the proposed development, it will be necessary to remove three small trees within **G3** (as shown in red on the plan at **Appendix 6**) and **T7**. Of these, the tree trees within **G3** fall into retention category 'C' and **T7** falls into retention category 'B'.

- 4.4 The arboricultural implications of the development have been considered and are discussed in **Section 3**.
- 4.5 Three small trees within **G3** and **T7** require removal in order to facilitate the proposed development. Tree works required to accommodate the proposals are detailed in *italics* in the tables at **Appendix 1**. Those trees requiring removal are shown in red on the Arboricultural Implications Plan at **Appendix 6**, where the proposals can also be viewed.
