**PROPOSED CADET HUT
2 HUDDERSFIELD ROAD
MIRFIELD
WF14 9DQ**

**REMEDICATION AND ENABLING WORKS
STRATEGY**

**CWT BUILDING CONSULTANTS LTD
MEDLOCK FARM
MEDLOCK LANE
LITTLE NELSON
WORRAL
CHESHIRE
CH64 4BW**

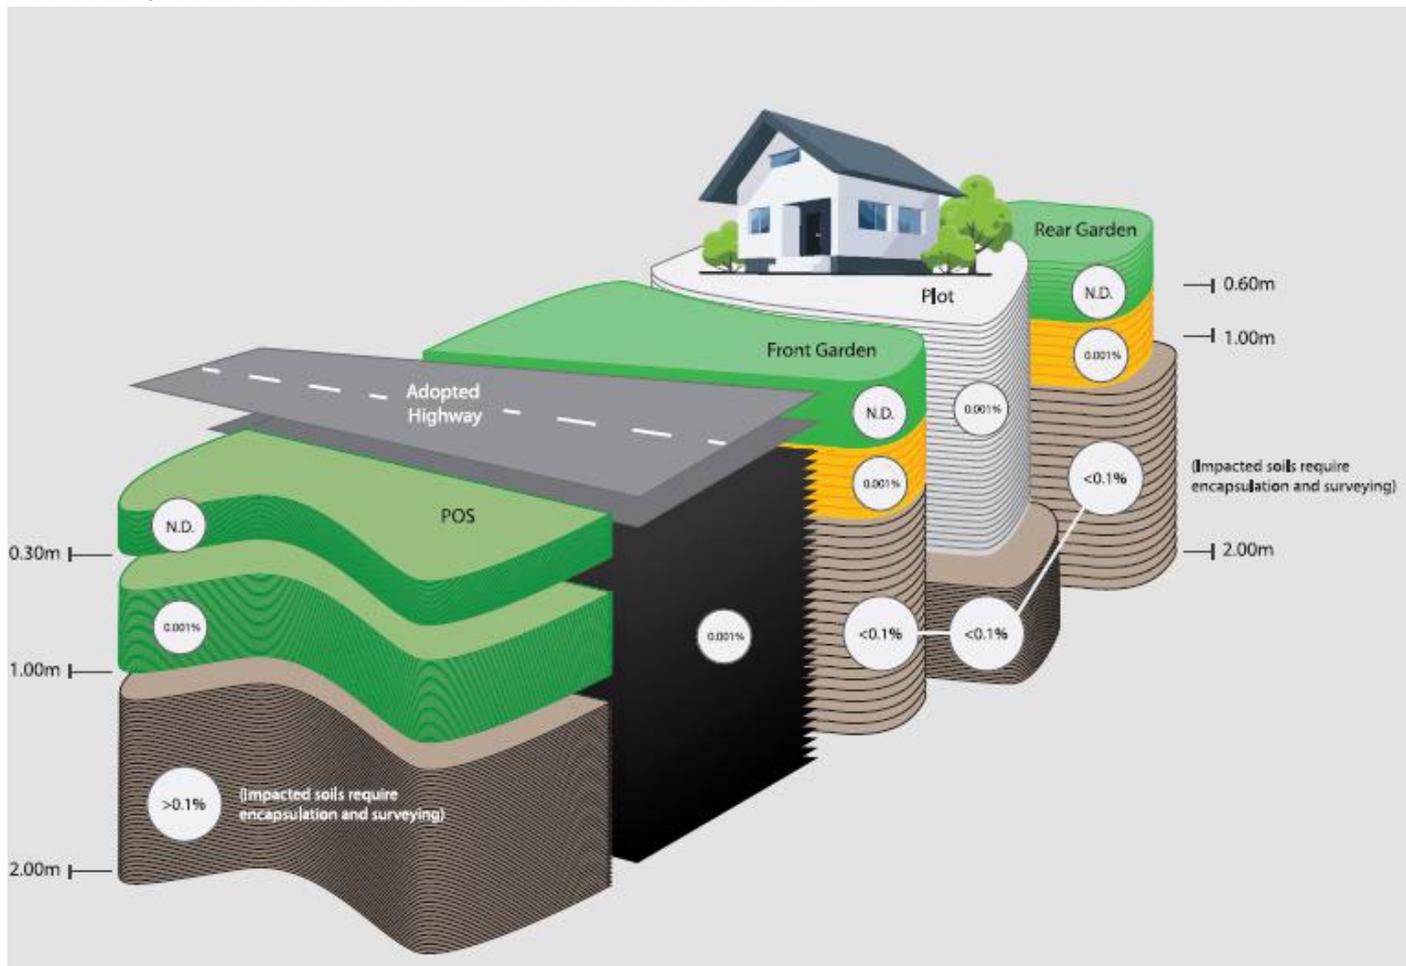
FIGURE 6.1 ASBESTOS CONCEPTUAL SITE MODEL

ND None Detected

No asbestos was identified in any of the shallow PWAG samples. G&M (November 2022) reported 2 out of 6 samples tested had positive asbestos identification. Loose fibrous debris of amosite was identified in TP2 at 3.00 m bgl, and loose fibrous debris of chrysotile, amosite, and crocidolite was identified in TP2 at 1.00 m bgl.

The previous site investigation (G&M November 2022) identified the presence of asbestos on the site, but the asbestos content was not quantified. To ensure appropriate remediation, further testing by a UKAS-accredited laboratory is recommended to quantify the asbestos content as a percentage

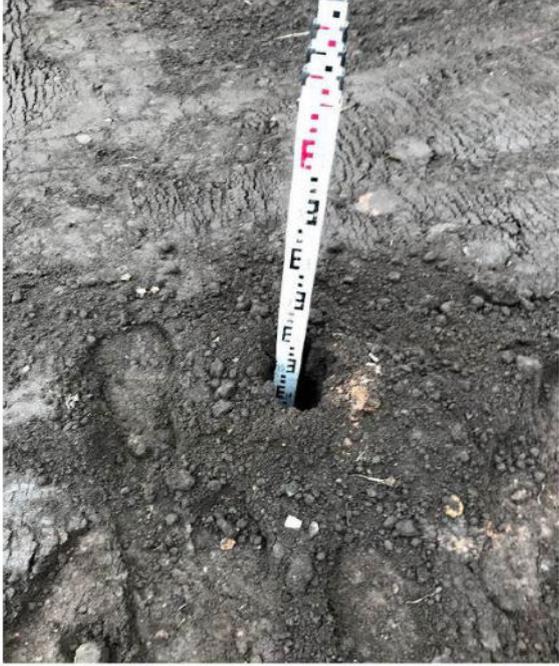
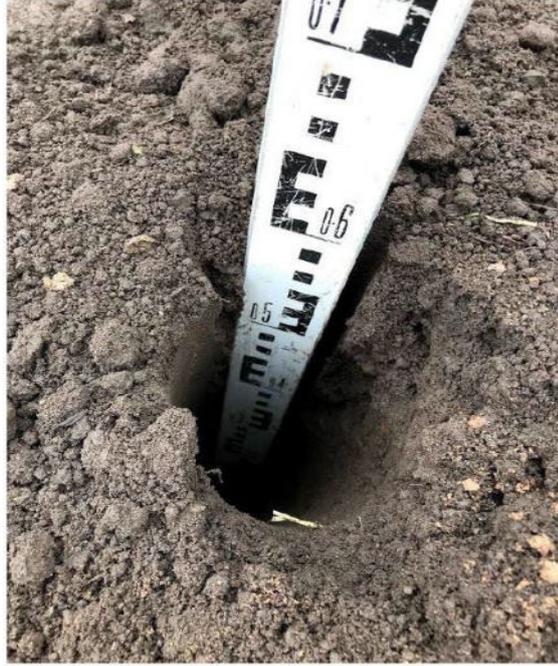
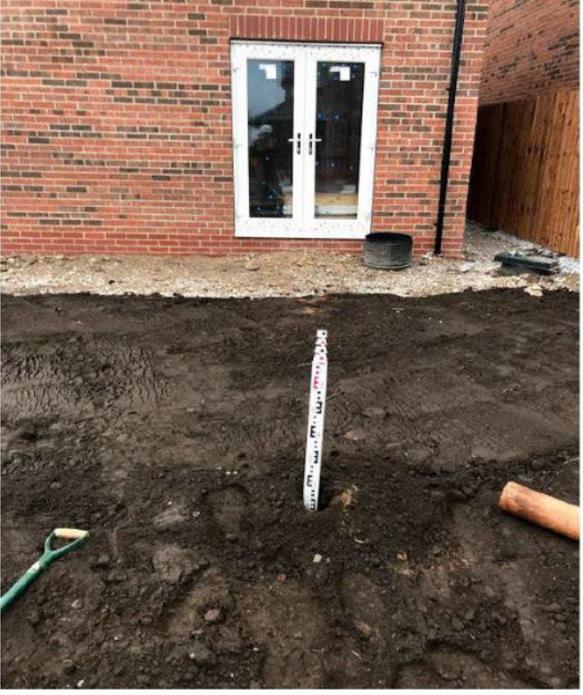
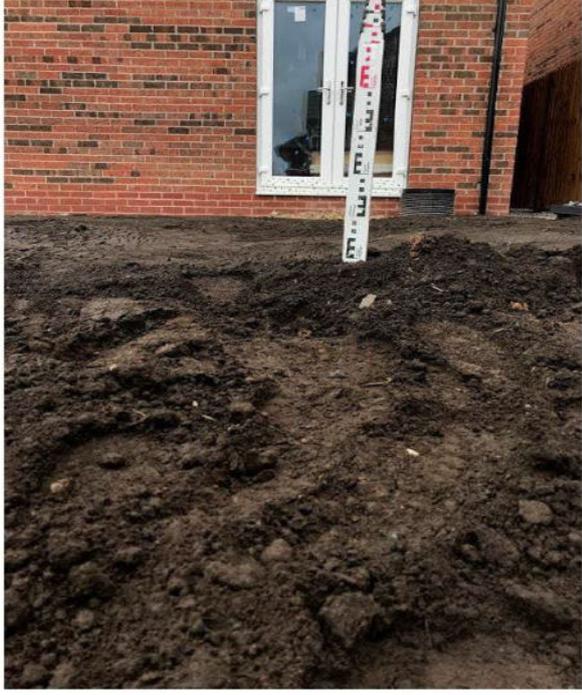
PLATE 1 EXAMPLE PLOT COVER SYSTEM VALIDATION

Plate 1 provides an example of a garden validation photographs that will be required for each plot.

Plot No: 70		
Depth of Strata (m bgl)	0.00-0.15	Validated TOPSOIL
	0.15-0.60	Validated SUBSOIL
Depth of Cover System Materials		Depth of Cover System Materials

Depth of Cover System at Ground Level		Depth of Cover System in Relation to Plot

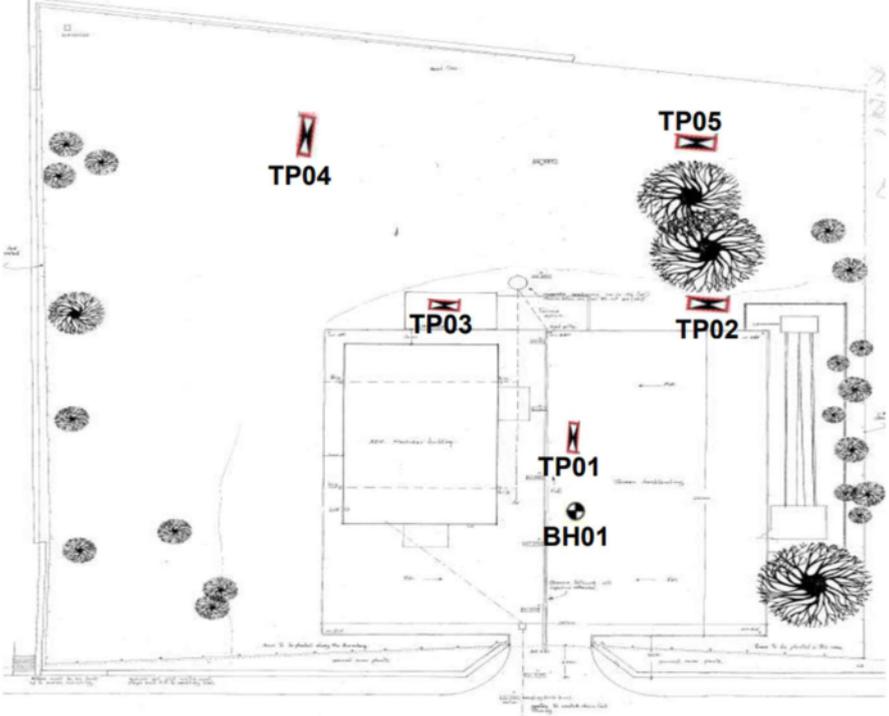
Table 2. Summary of Previous Findings	
Exploration Location Plan

Visual and Olfactory Evidence of Contamination	Probable ACMs were encountered in TP02. No other visual or olfactory evidence of contamination was noted.
Ground Gases	BH1 Installed with gas monitoring equipment, six rounds of monitoring were conducted. The has been characterized as CS1.
Chemical Testing	When compared to LQM/CIEH and DEFRA C4SL's Generic Assessment Criteria for Human Health Risk Assessment, elevated levels of arsenic, lead and PAH speciates were recorded in samples of the made ground along with asbestos (Chrysotile, amosite, and crocidolite), that was identified in two samples. Ground conditions regarding concrete classification have been calculated at DS-3 in the made ground and DS-1 in the underlying natural soils.
Geotechnical Findings	Made ground was deemed unsuitable for constructing foundations in and was too deep to extend shallow footings through. As such, a piled solution was recommended. An alternate solution of ground improvement was also suggested, utilising a raft foundation on top of the treated made ground.

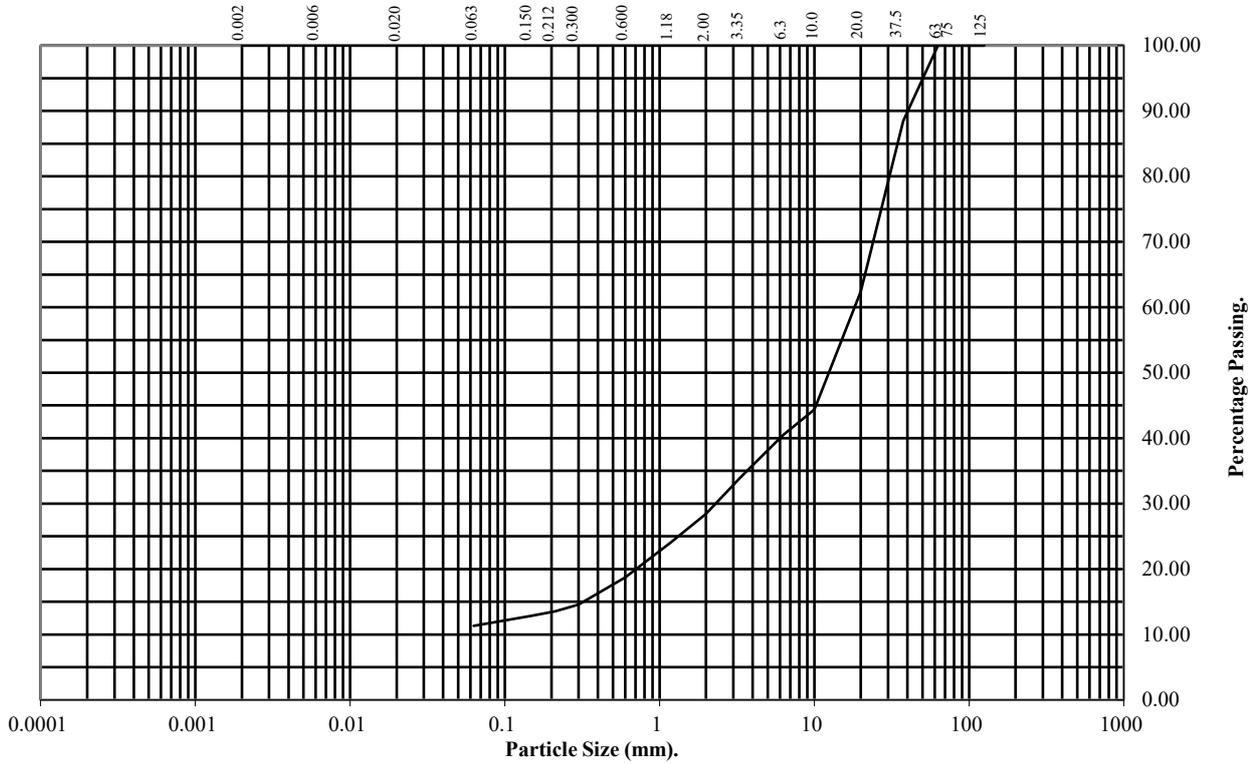
Sample Type: **B**

BS Test Sieve (mm)	Percentage Passing
125	100
75	100
63	100
37.5	88
20	62
10	44
6.3	40
3.35	34
2	28
1.18	24
0.6	19
0.3	15
0.212	14
0.15	13
0.063	11

Soil Fraction	Total Percentage
Cobbles	0
Gravel	72
Sand	17
Silt/Clay	11

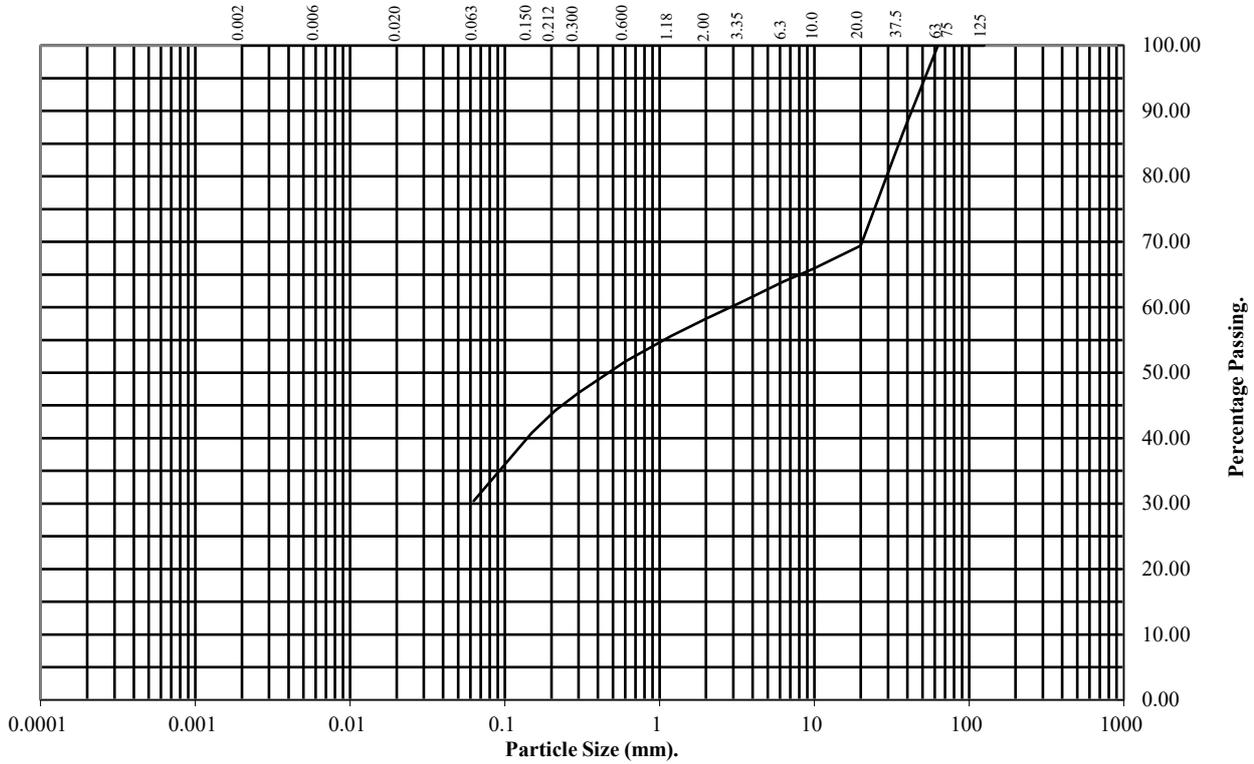
Sample Type: B

BS Test Sieve (mm)	Percentage Passing
125	100
75	100
63	100
37.5	87
20	69
10	66
6.3	64
3.35	61
2	58
1.18	56
0.6	52
0.3	47
0.212	44
0.15	41
0.063	30

Soil Fraction	Total Percentage
Cobbles	0
Gravel	42
Sand	28
Silt/Clay	30

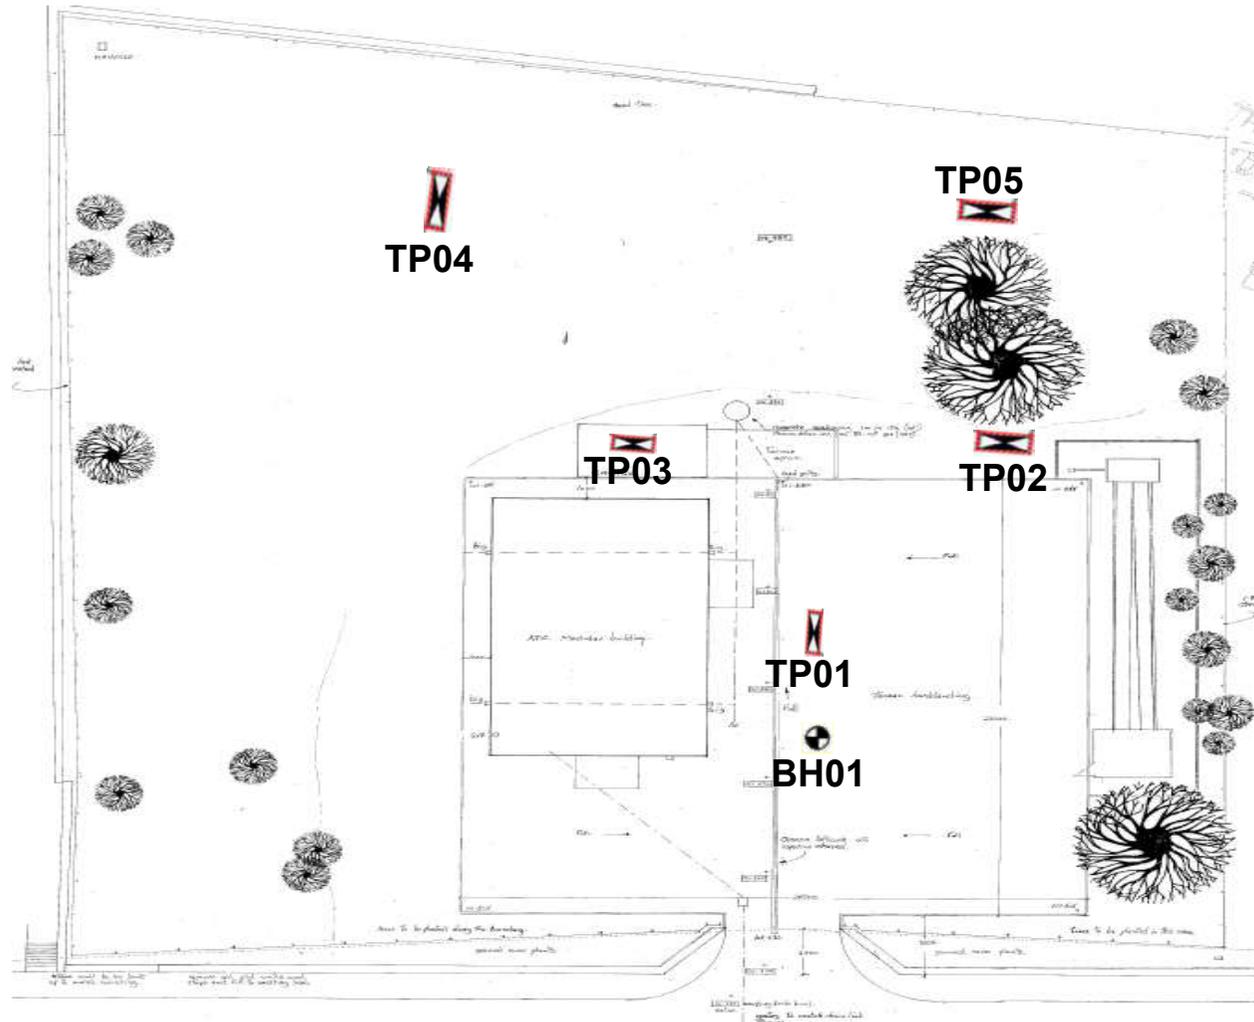
Drawings:	C541/1/2	Scale NTS	
Contract	C541 – Mirfield ATC	Drawn AS	Approved GS
		Drawing Name – Exploratory Hole Location Plan	
Client: John Hill Associates

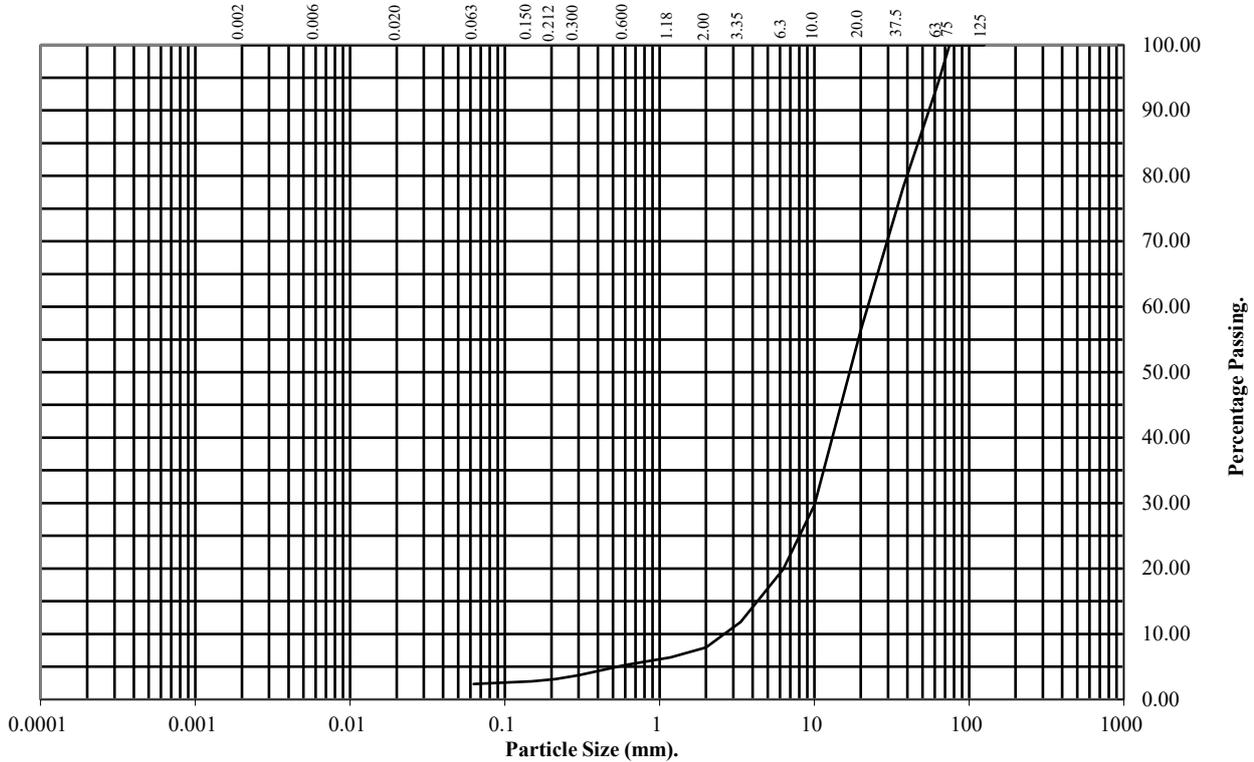
Sample Type: **D**

BS Test Sieve (mm)	Percentage Passing
125	100
75	100
63	94
37.5	78
20	56
10	30
6.3	20
3.35	12
2	8
1.18	6
0.6	5
0.3	4
0.212	3
0.15	3
0.063	2

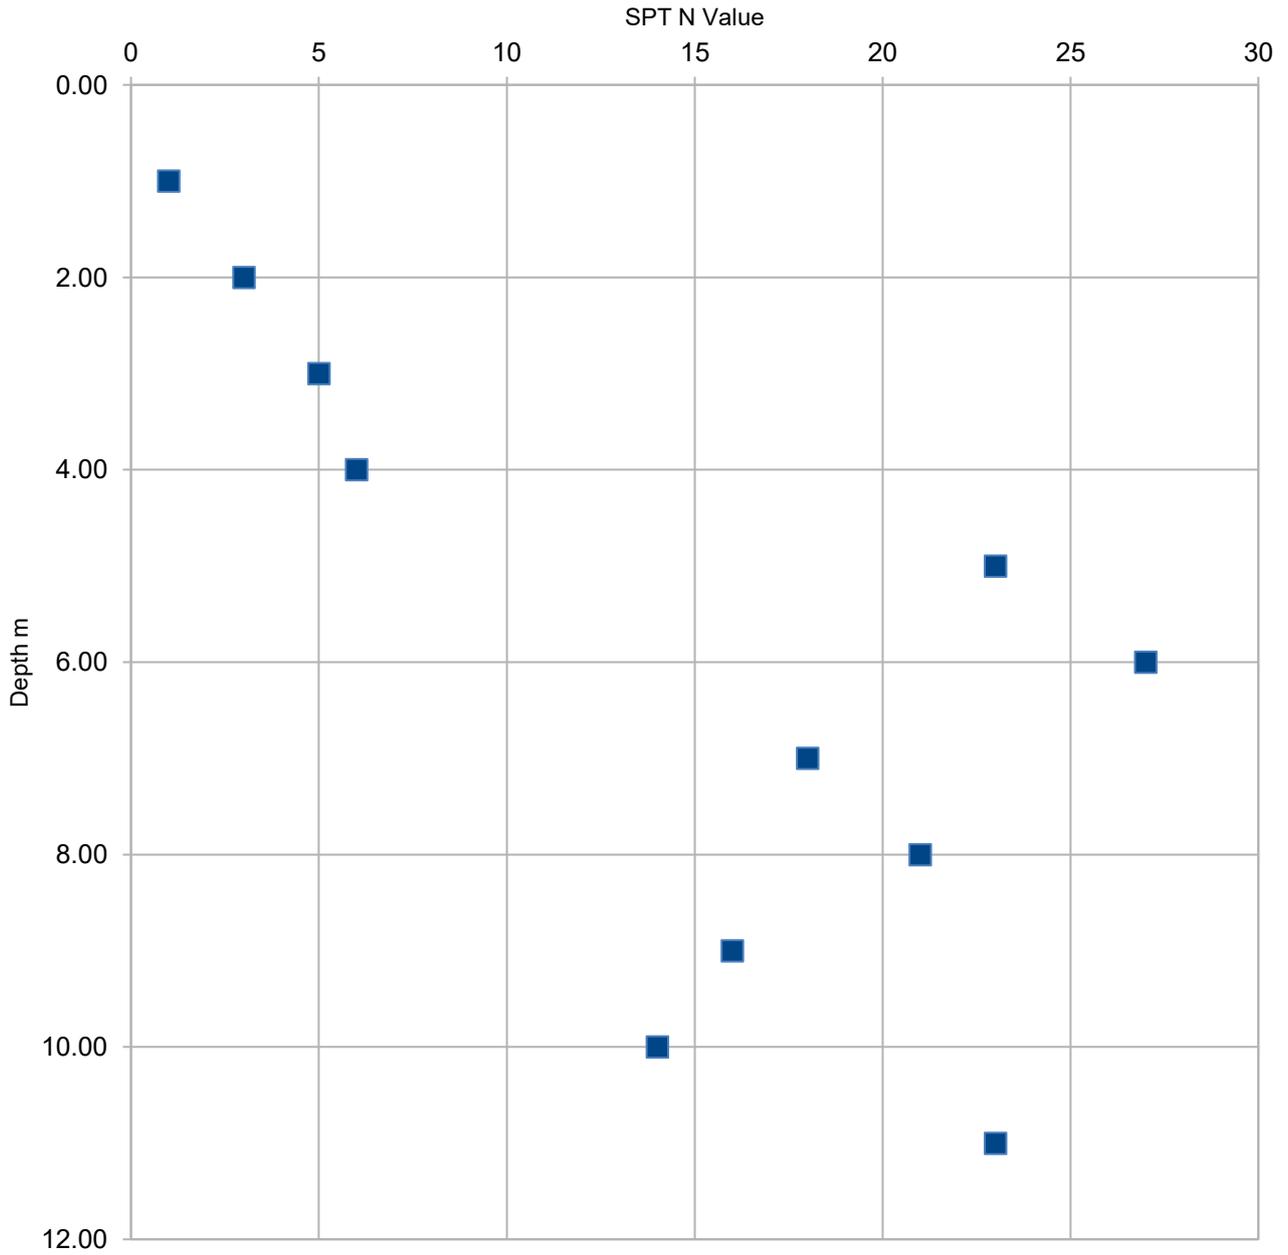
SPT N Value V Depth

Contract Number: C541			
Contract	Mirfield ATC	Plotted by ATS	Approved GS
		Drawing Name: SPT N Value Vs Depth	
Client	John Hill Associates

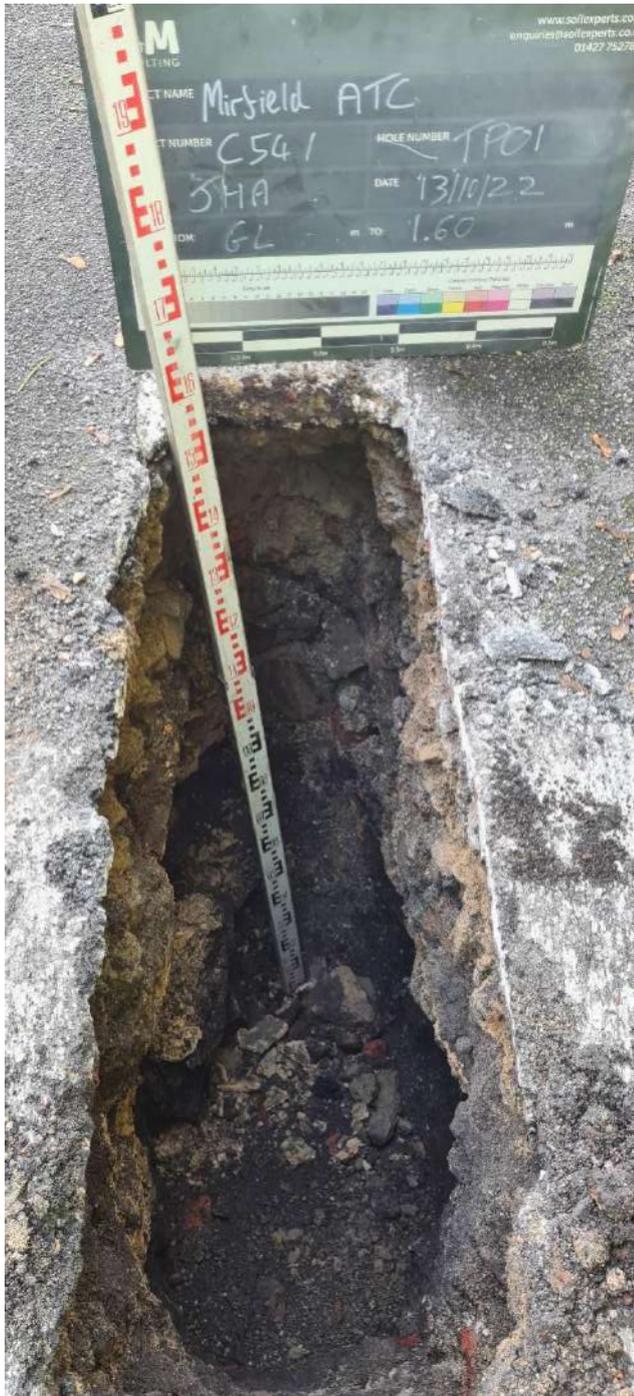
Project Number: C541	Project Name: Mirfield ATC
Client: John Hill Associates	Document Name: Trial Pit Photographs: Photo 1 – TP01 (1.60m), Photo 2 – TP02 (3.20m)

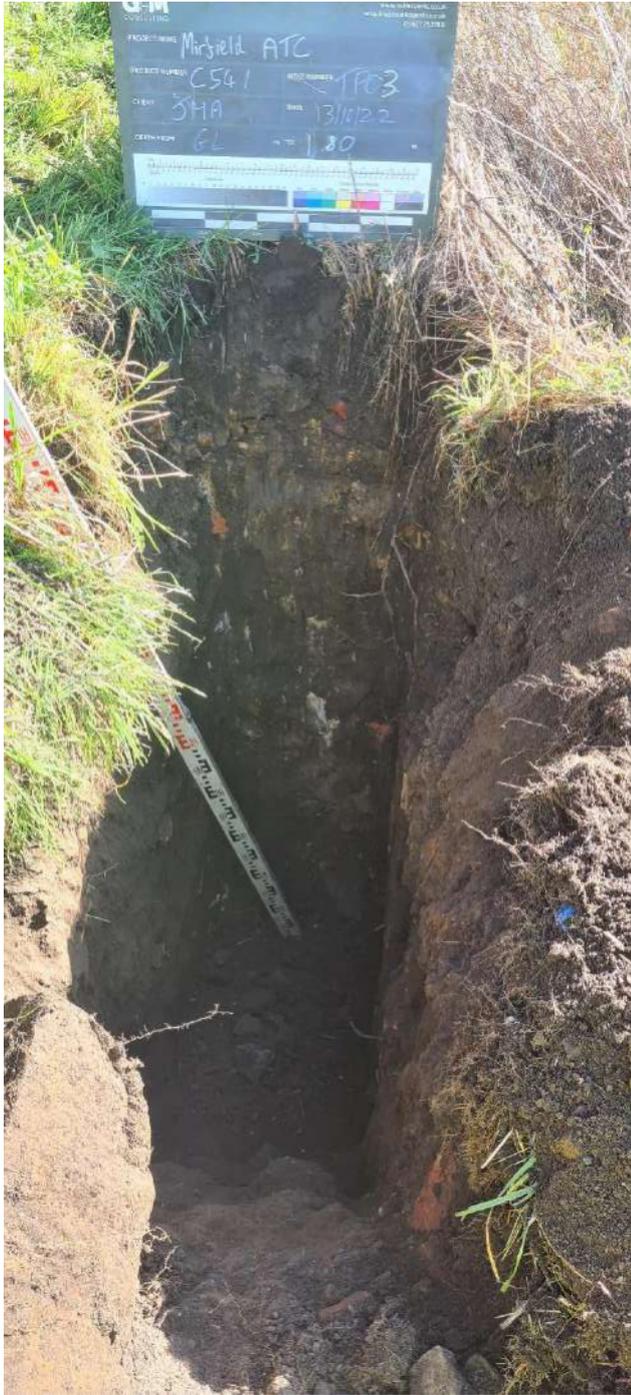
Project Number: C541	Project Name: Mirfield ATC
Client: John Hill Associates	Document Name: Trial Pit Photographs: Photo 3 – TP03 (1.80m), Photo 4 – TP04 (3.90m)
