Land at Gynn Lane, Honley For Vivly Living

Report no: 4749/2

Date: September 2024

SUMMARY OF GEOENVIRONMENTAL ISSUES

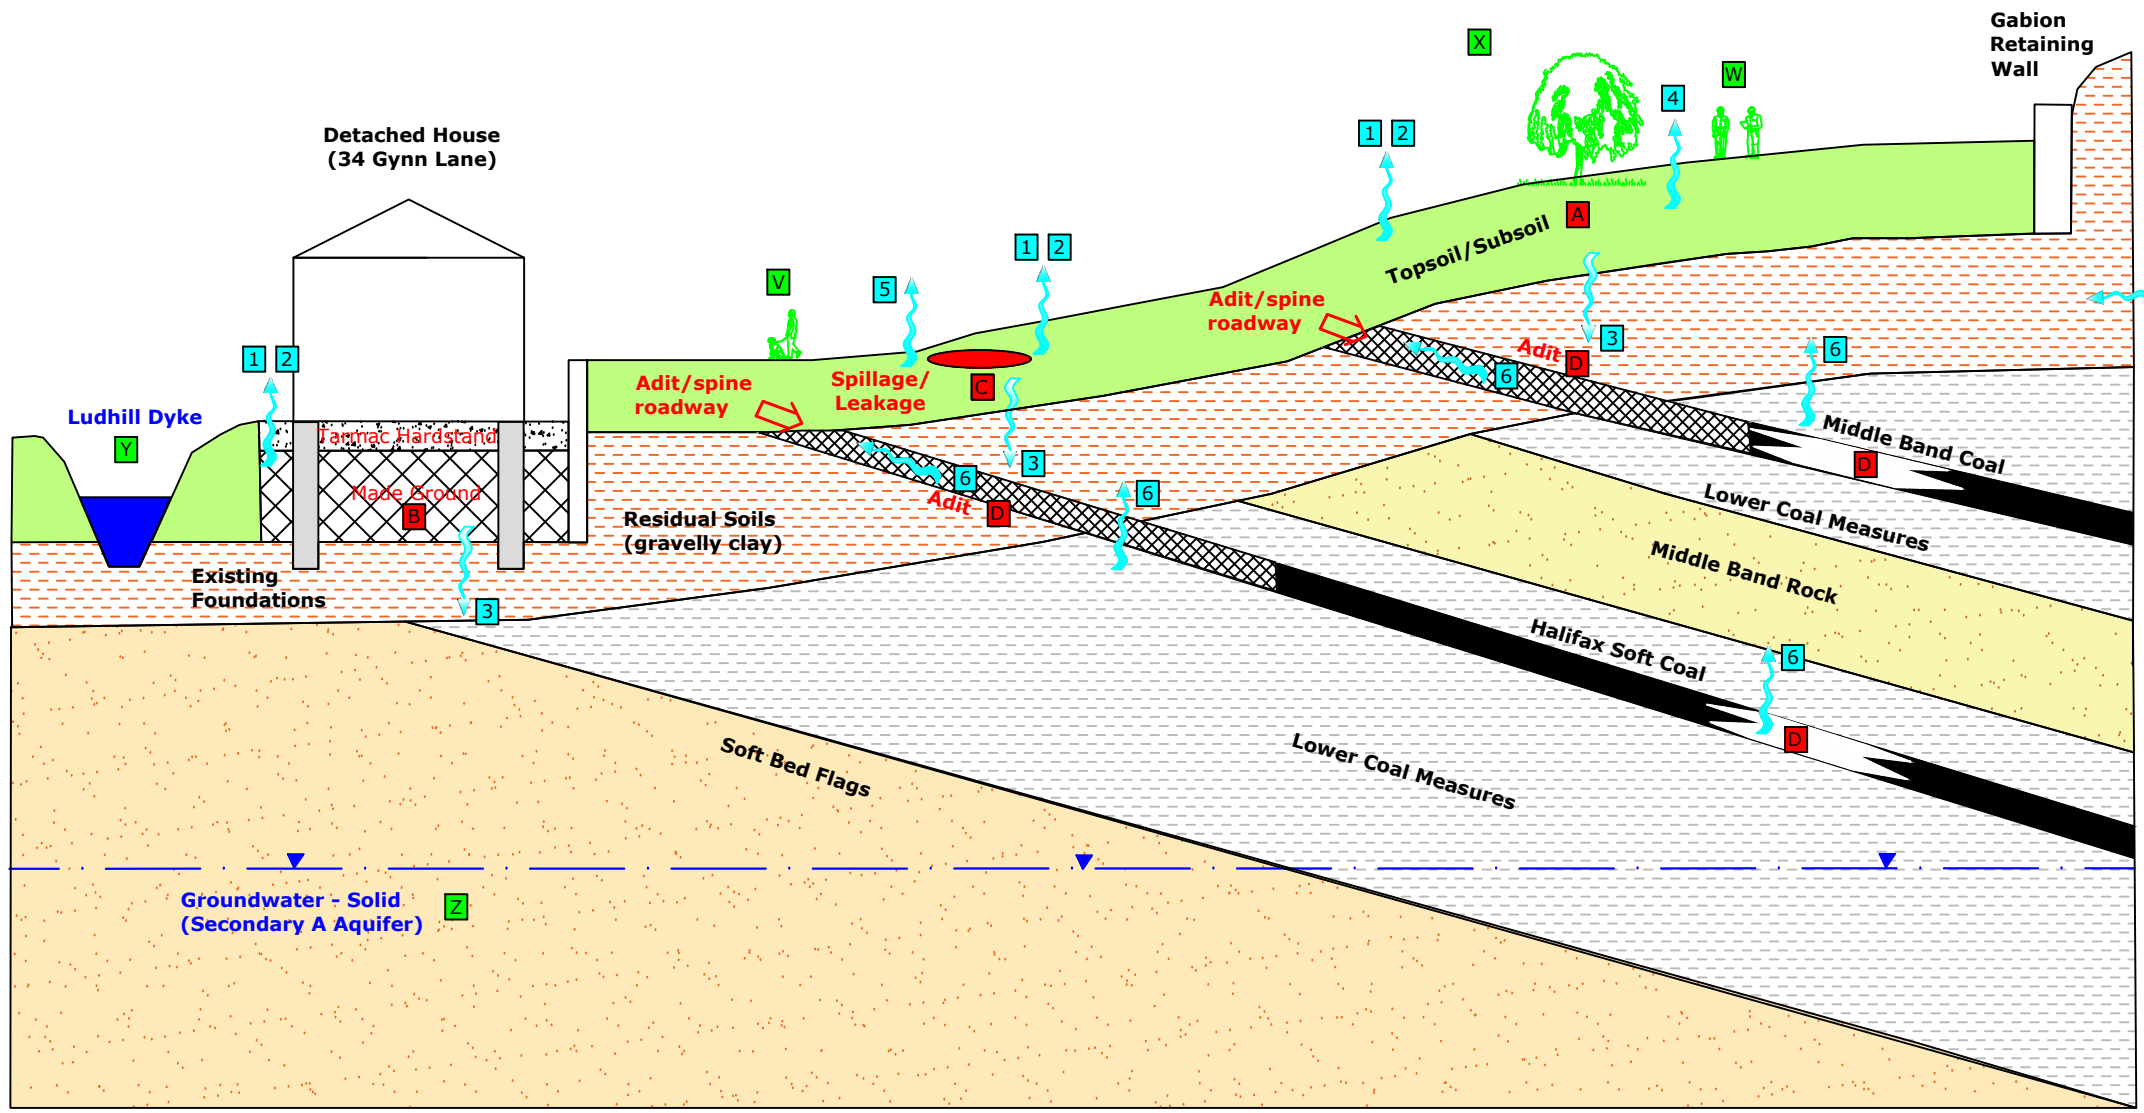
DRAWN	CC	DATE	29 05 2024	STATUS	FOR COMMENT <input type="checkbox"/>
CHECKED	AG	DATE	29 05 2024	FOR APPROVAL	DRAFT <input type="checkbox"/>
					FINAL <input checked="" type="checkbox"/>
SCALE	Not to scale	SHEET	A3	DRAWING NO.	4749/5
				REVISION

SOURCES	
A	REWORKED TOPSOIL (INORGANICS)
B	MADE GROUND (INORGANICS)
C	LEAKAGE/SPILLAGE (ORGANICS)
D	MINEWORKINGS/ADITS (HAZARDOUS GAS)

PATHWAYS	
1	DERMAL CONTACT
2	INGESTION/INHALATION
3	LEACHING OF CONTAMINANTS
4	UPTAKE BY PLANTS
5	VOLATILISATION
6	MIGRATION OF GAS

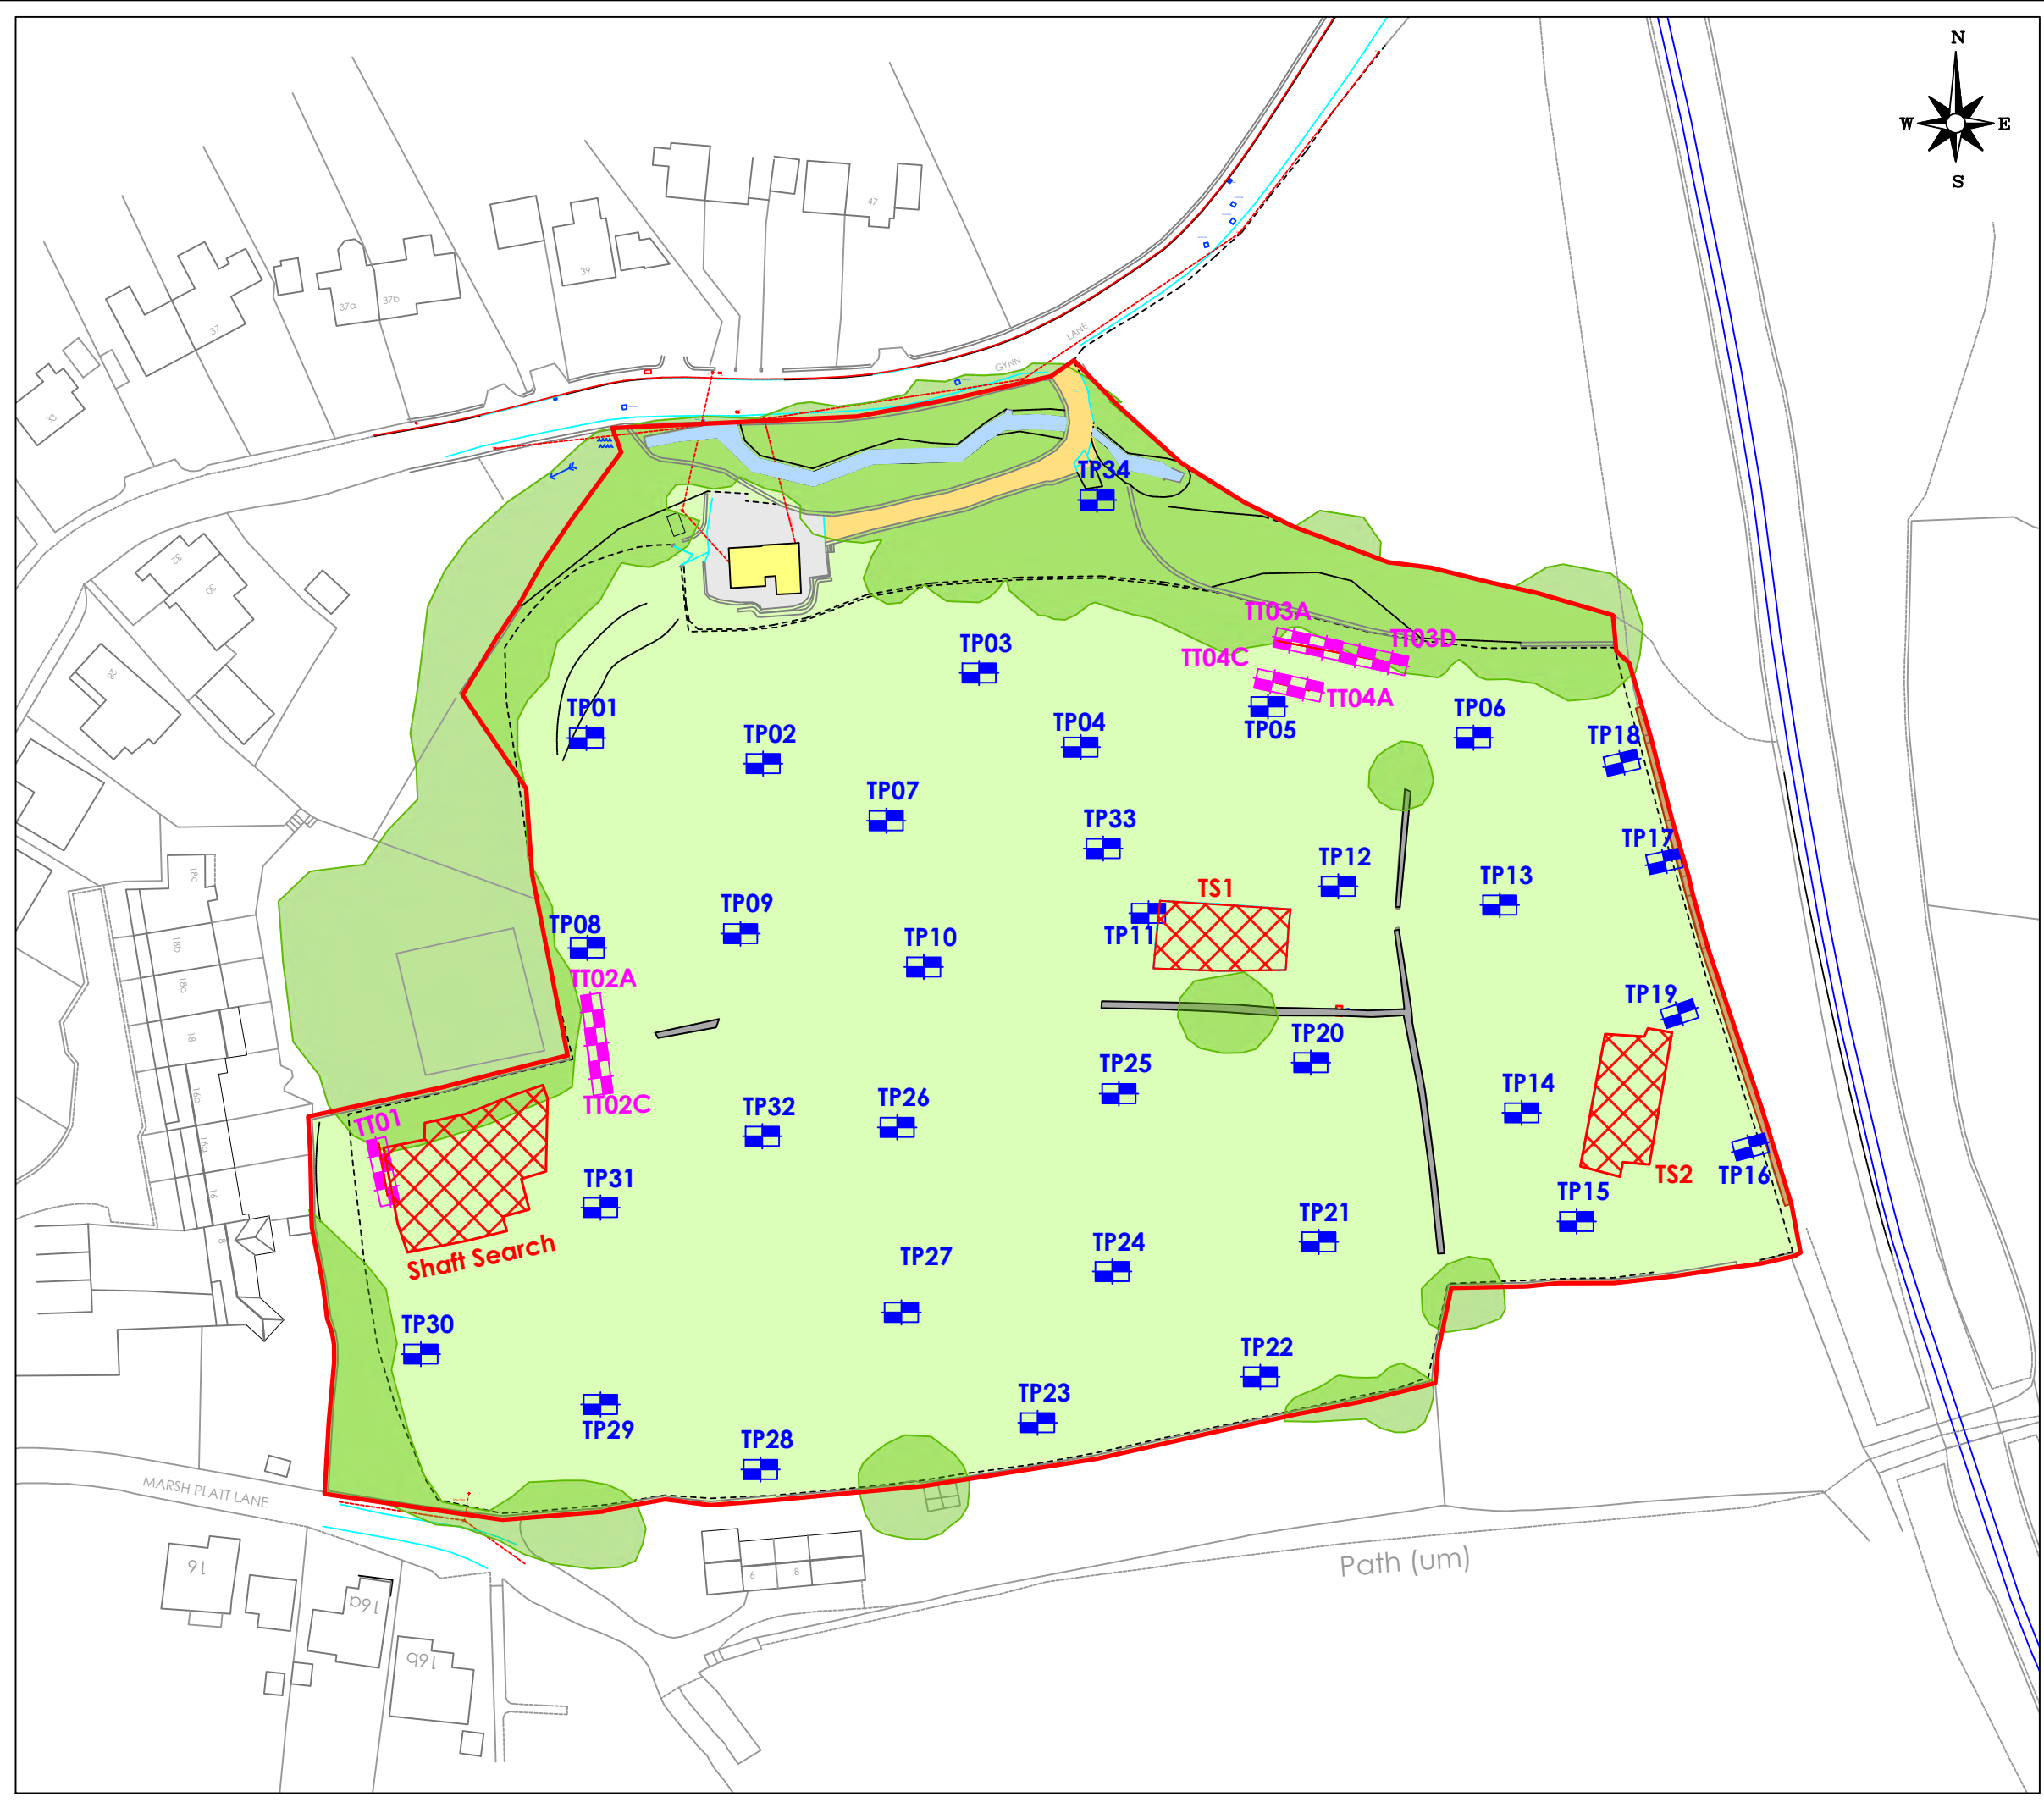
PRELIMINARY CONCEPTUAL SITE MODEL

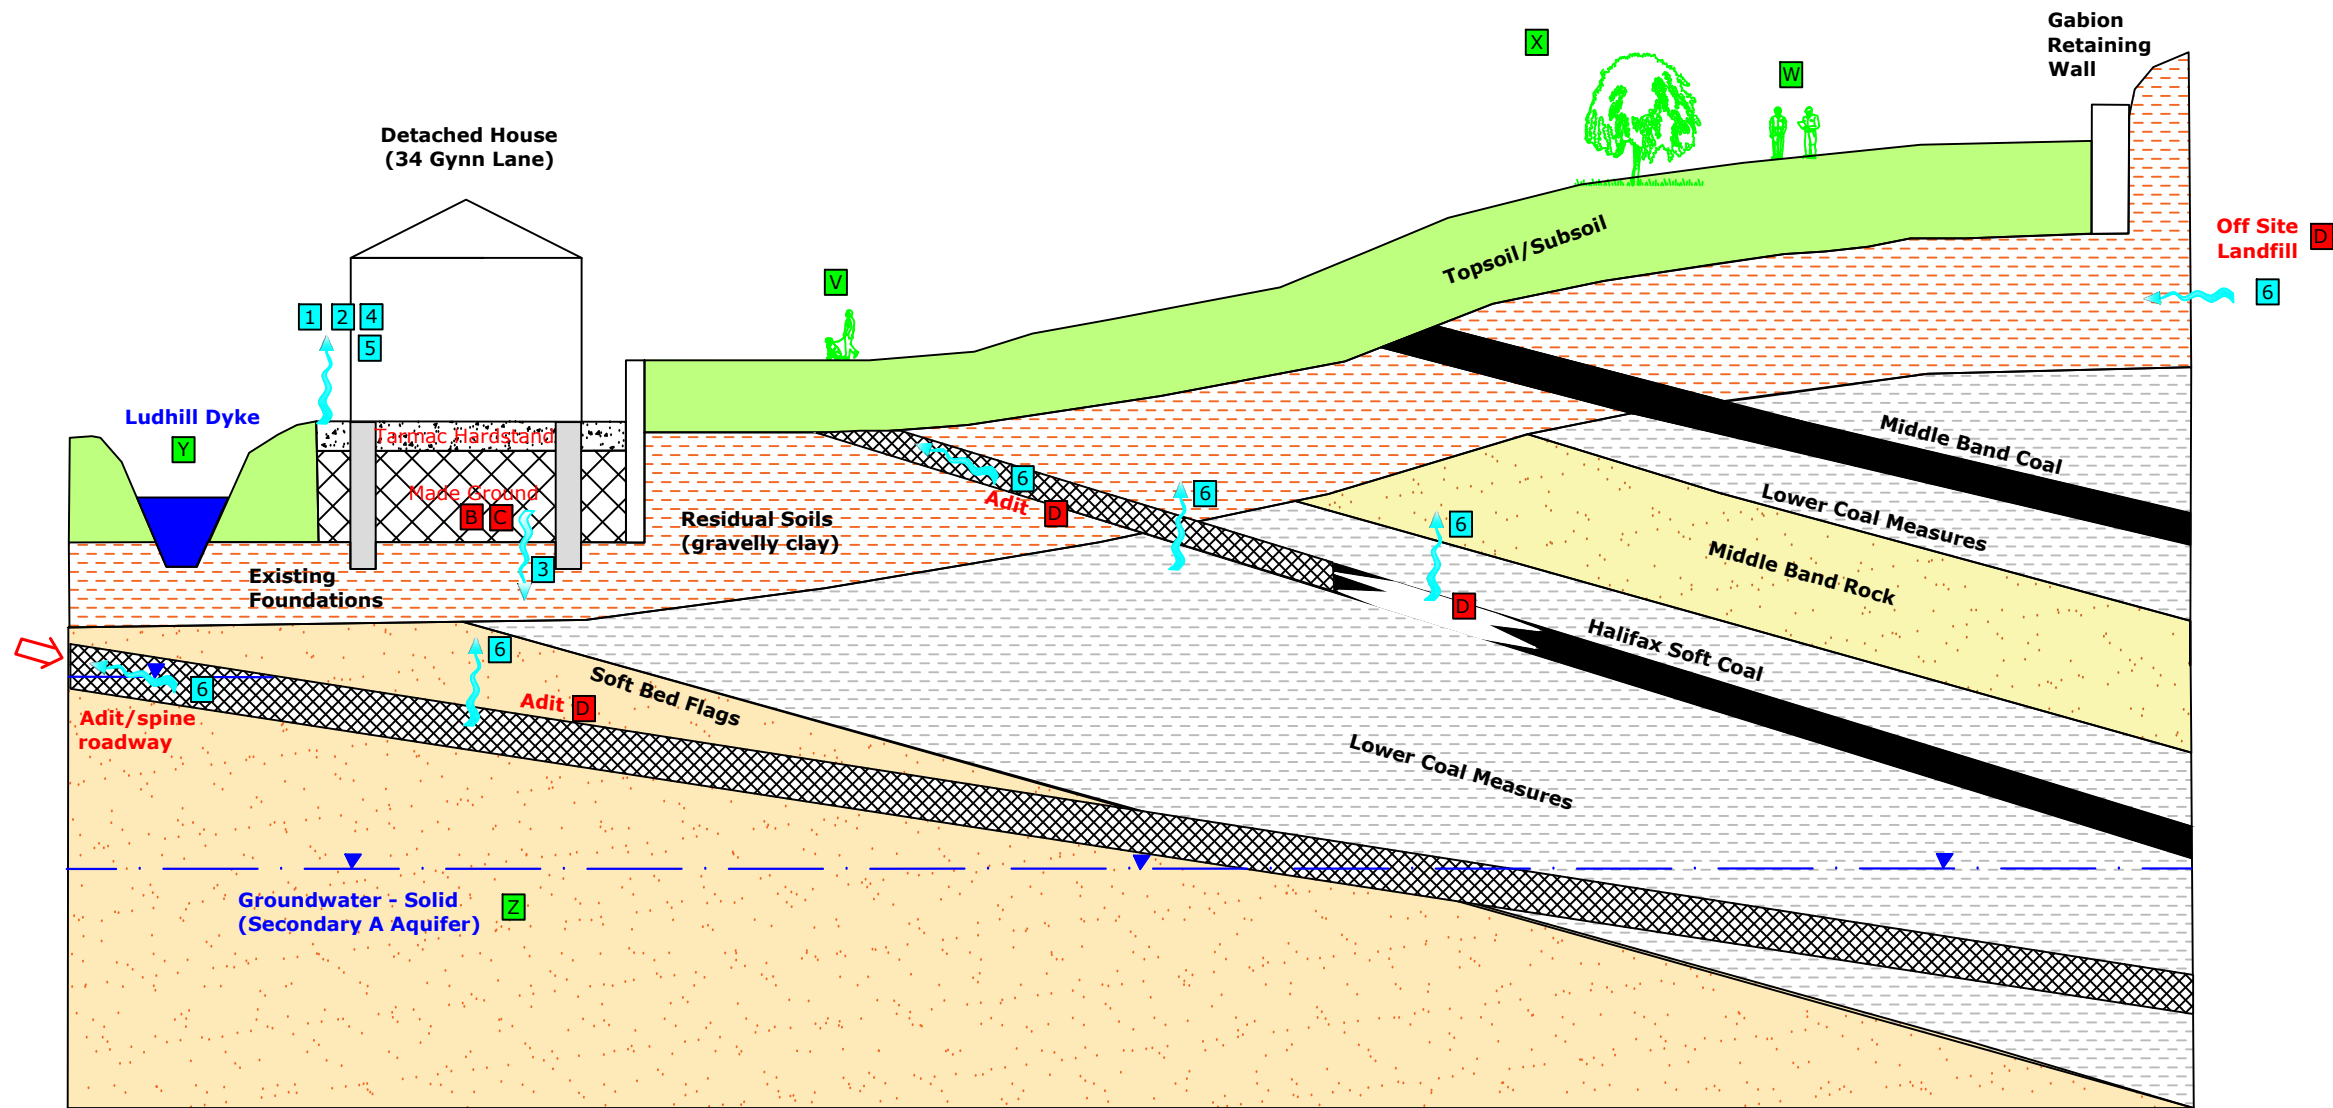
SCALE Not to scale	SHEET A3	DRAWING NO. 4749/7	REVISION
-----------------------	-------------	-----------------------	----------

SOURCES	
B	MADE GROUND (INORGANICS)
C	LEAKAGE/SPILLAGE (ORGANICS)
D	MINERWORKINGS/ADITS (HAZARDOUS GAS)

PATHWAYS	
1	DERMAL CONTACT
2	INGESTION/INHALATION
3	LEACHING OF CONTAMINANTS
4	UPTAKE BY PLANTS
5	VOLATILISATION
6	MIGRATION OF GAS

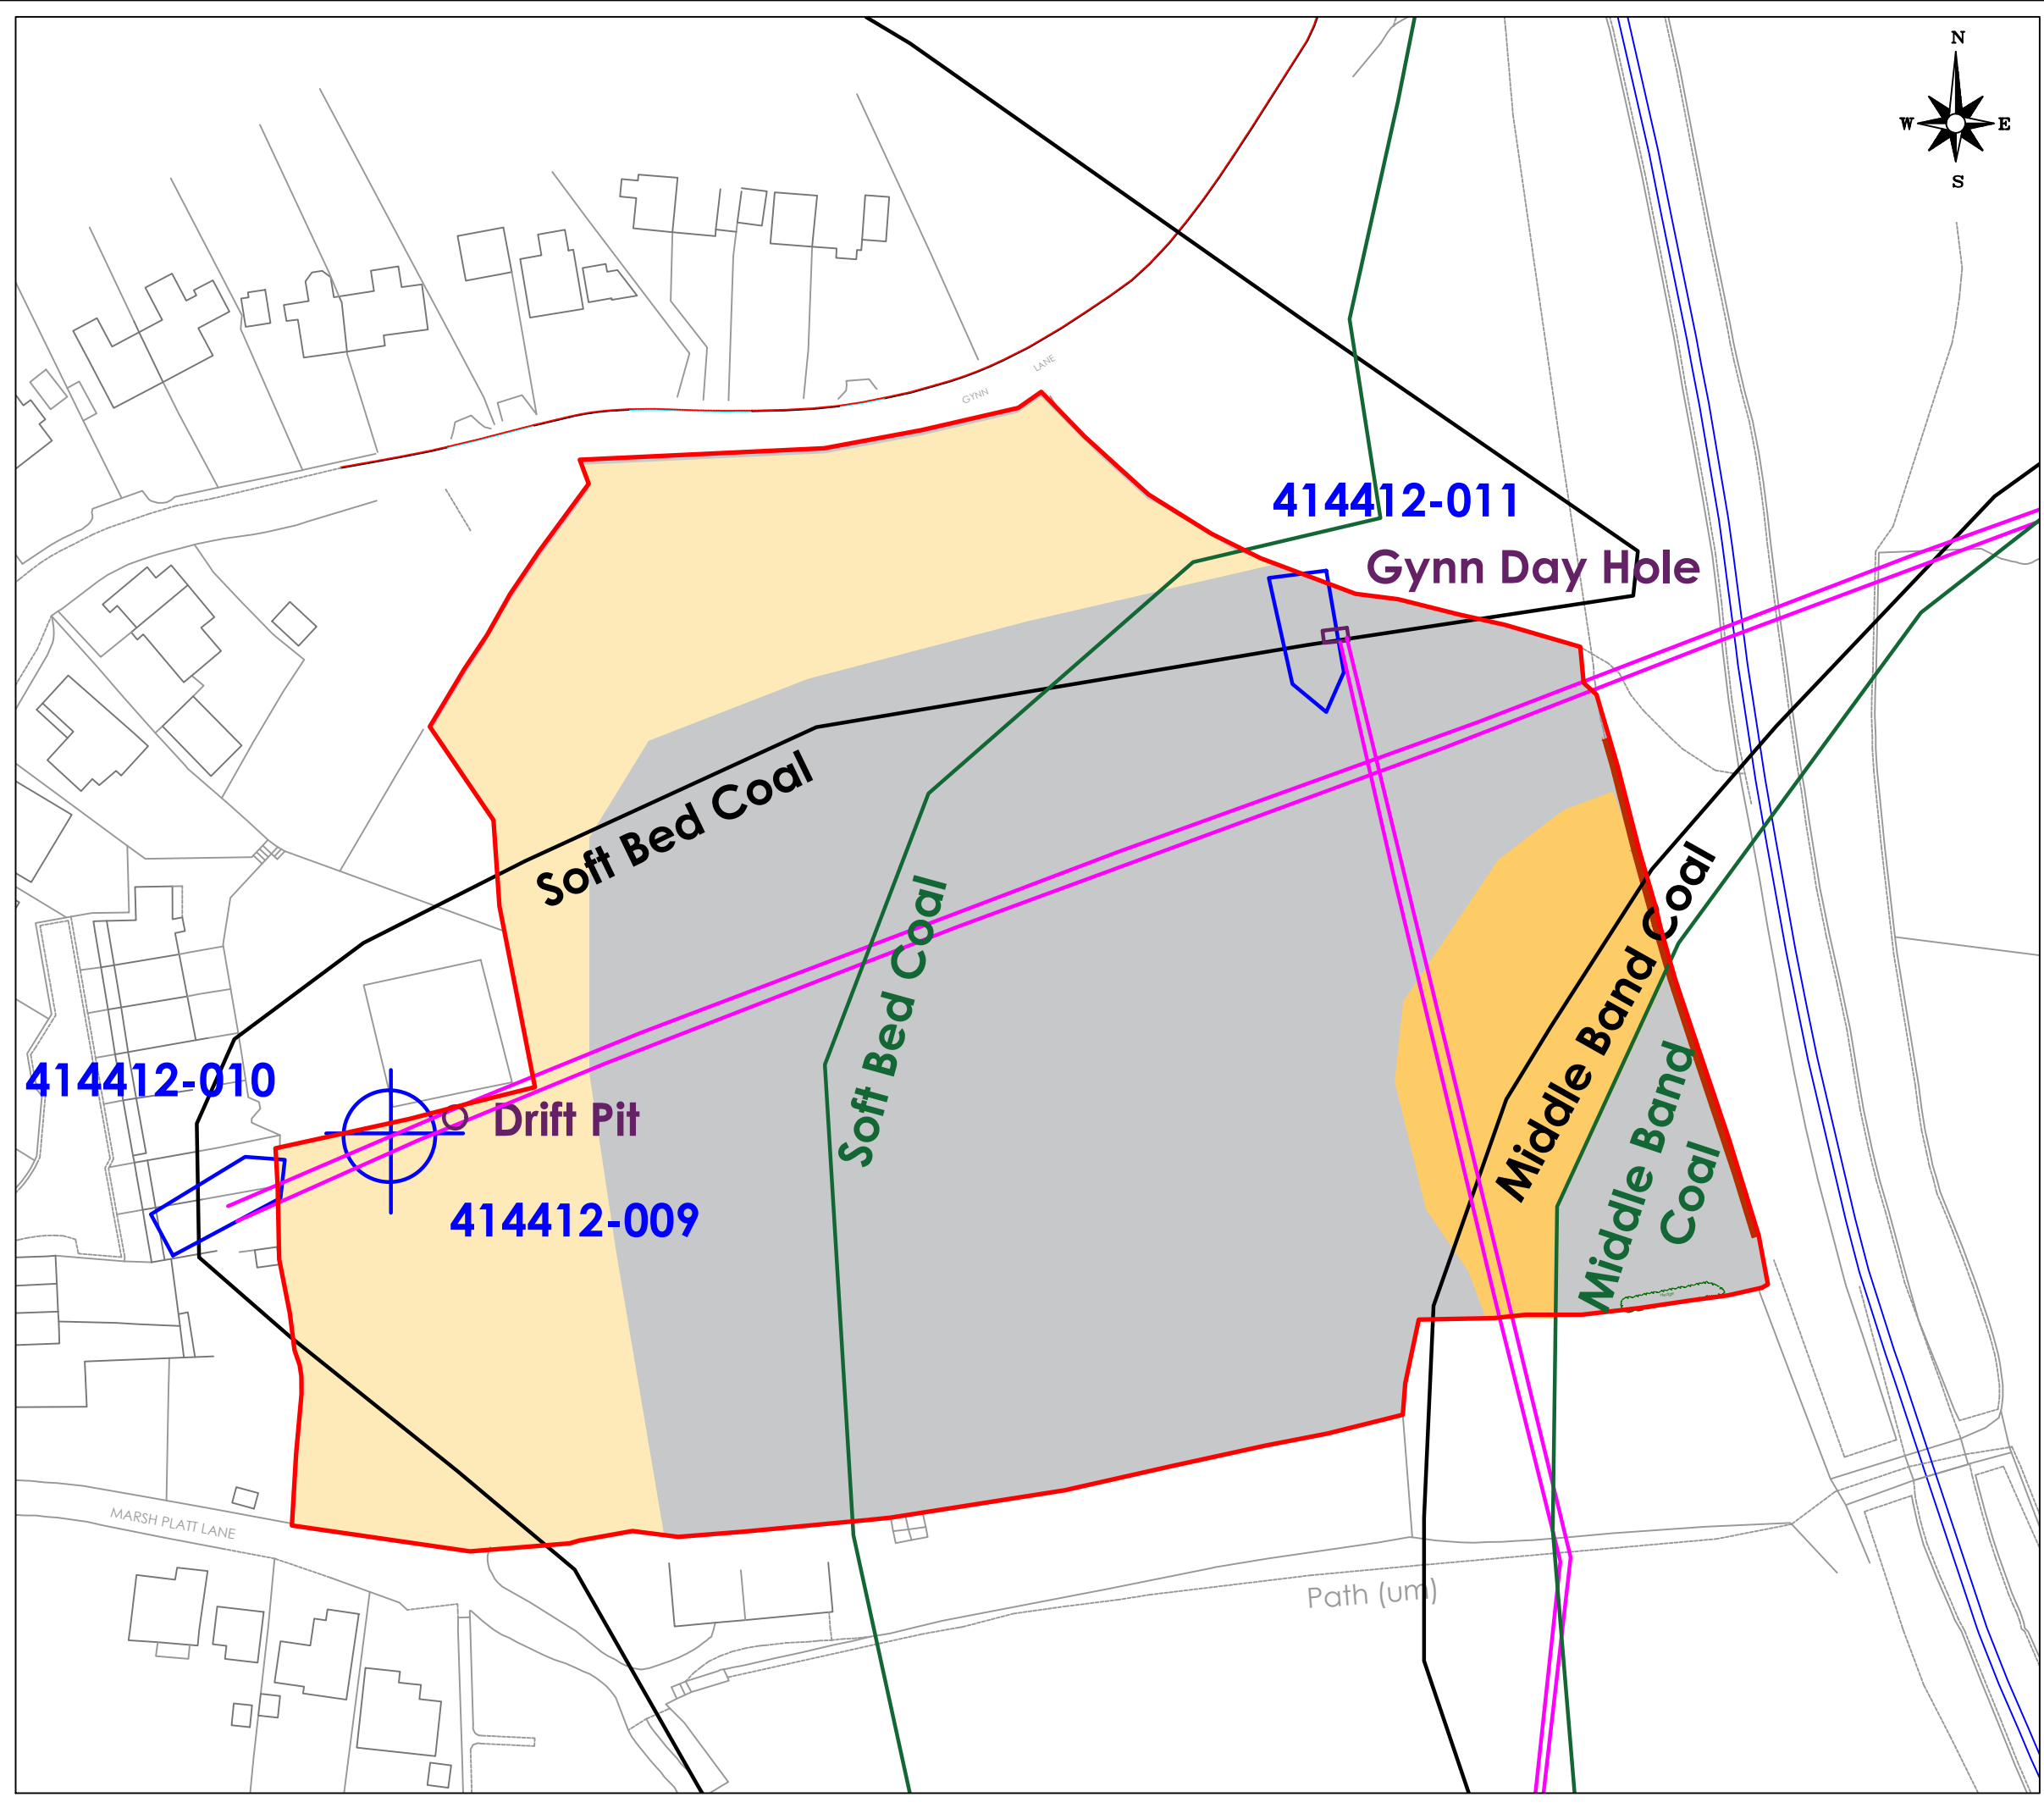
SCALE 1:1500	SHEET A3	DRAWING NO. 4749/9	REVISION
-----------------	-------------	-----------------------	----------

- NOTES
- LOWER COAL MEASURES
 - SOFT BED FLAGS (SANDSTONE)
 - MIDDLE BAND ROCK (SANDSTONE)
 - ADIT (TAKEN FROM ABANDONMENT PLAN)
 - ADIT (TAKEN FROM CA MINING REPORT)
 - ROADWAY (TAKEN FROM ABANDONMENT PLAN)
 - COAL OUTCROP (TAKEN FROM CA REPORT)
 - COAL OUTCROP (TAKEN FROM BGS MAP)
 - APPROXIMATE SITE BOUNDARY

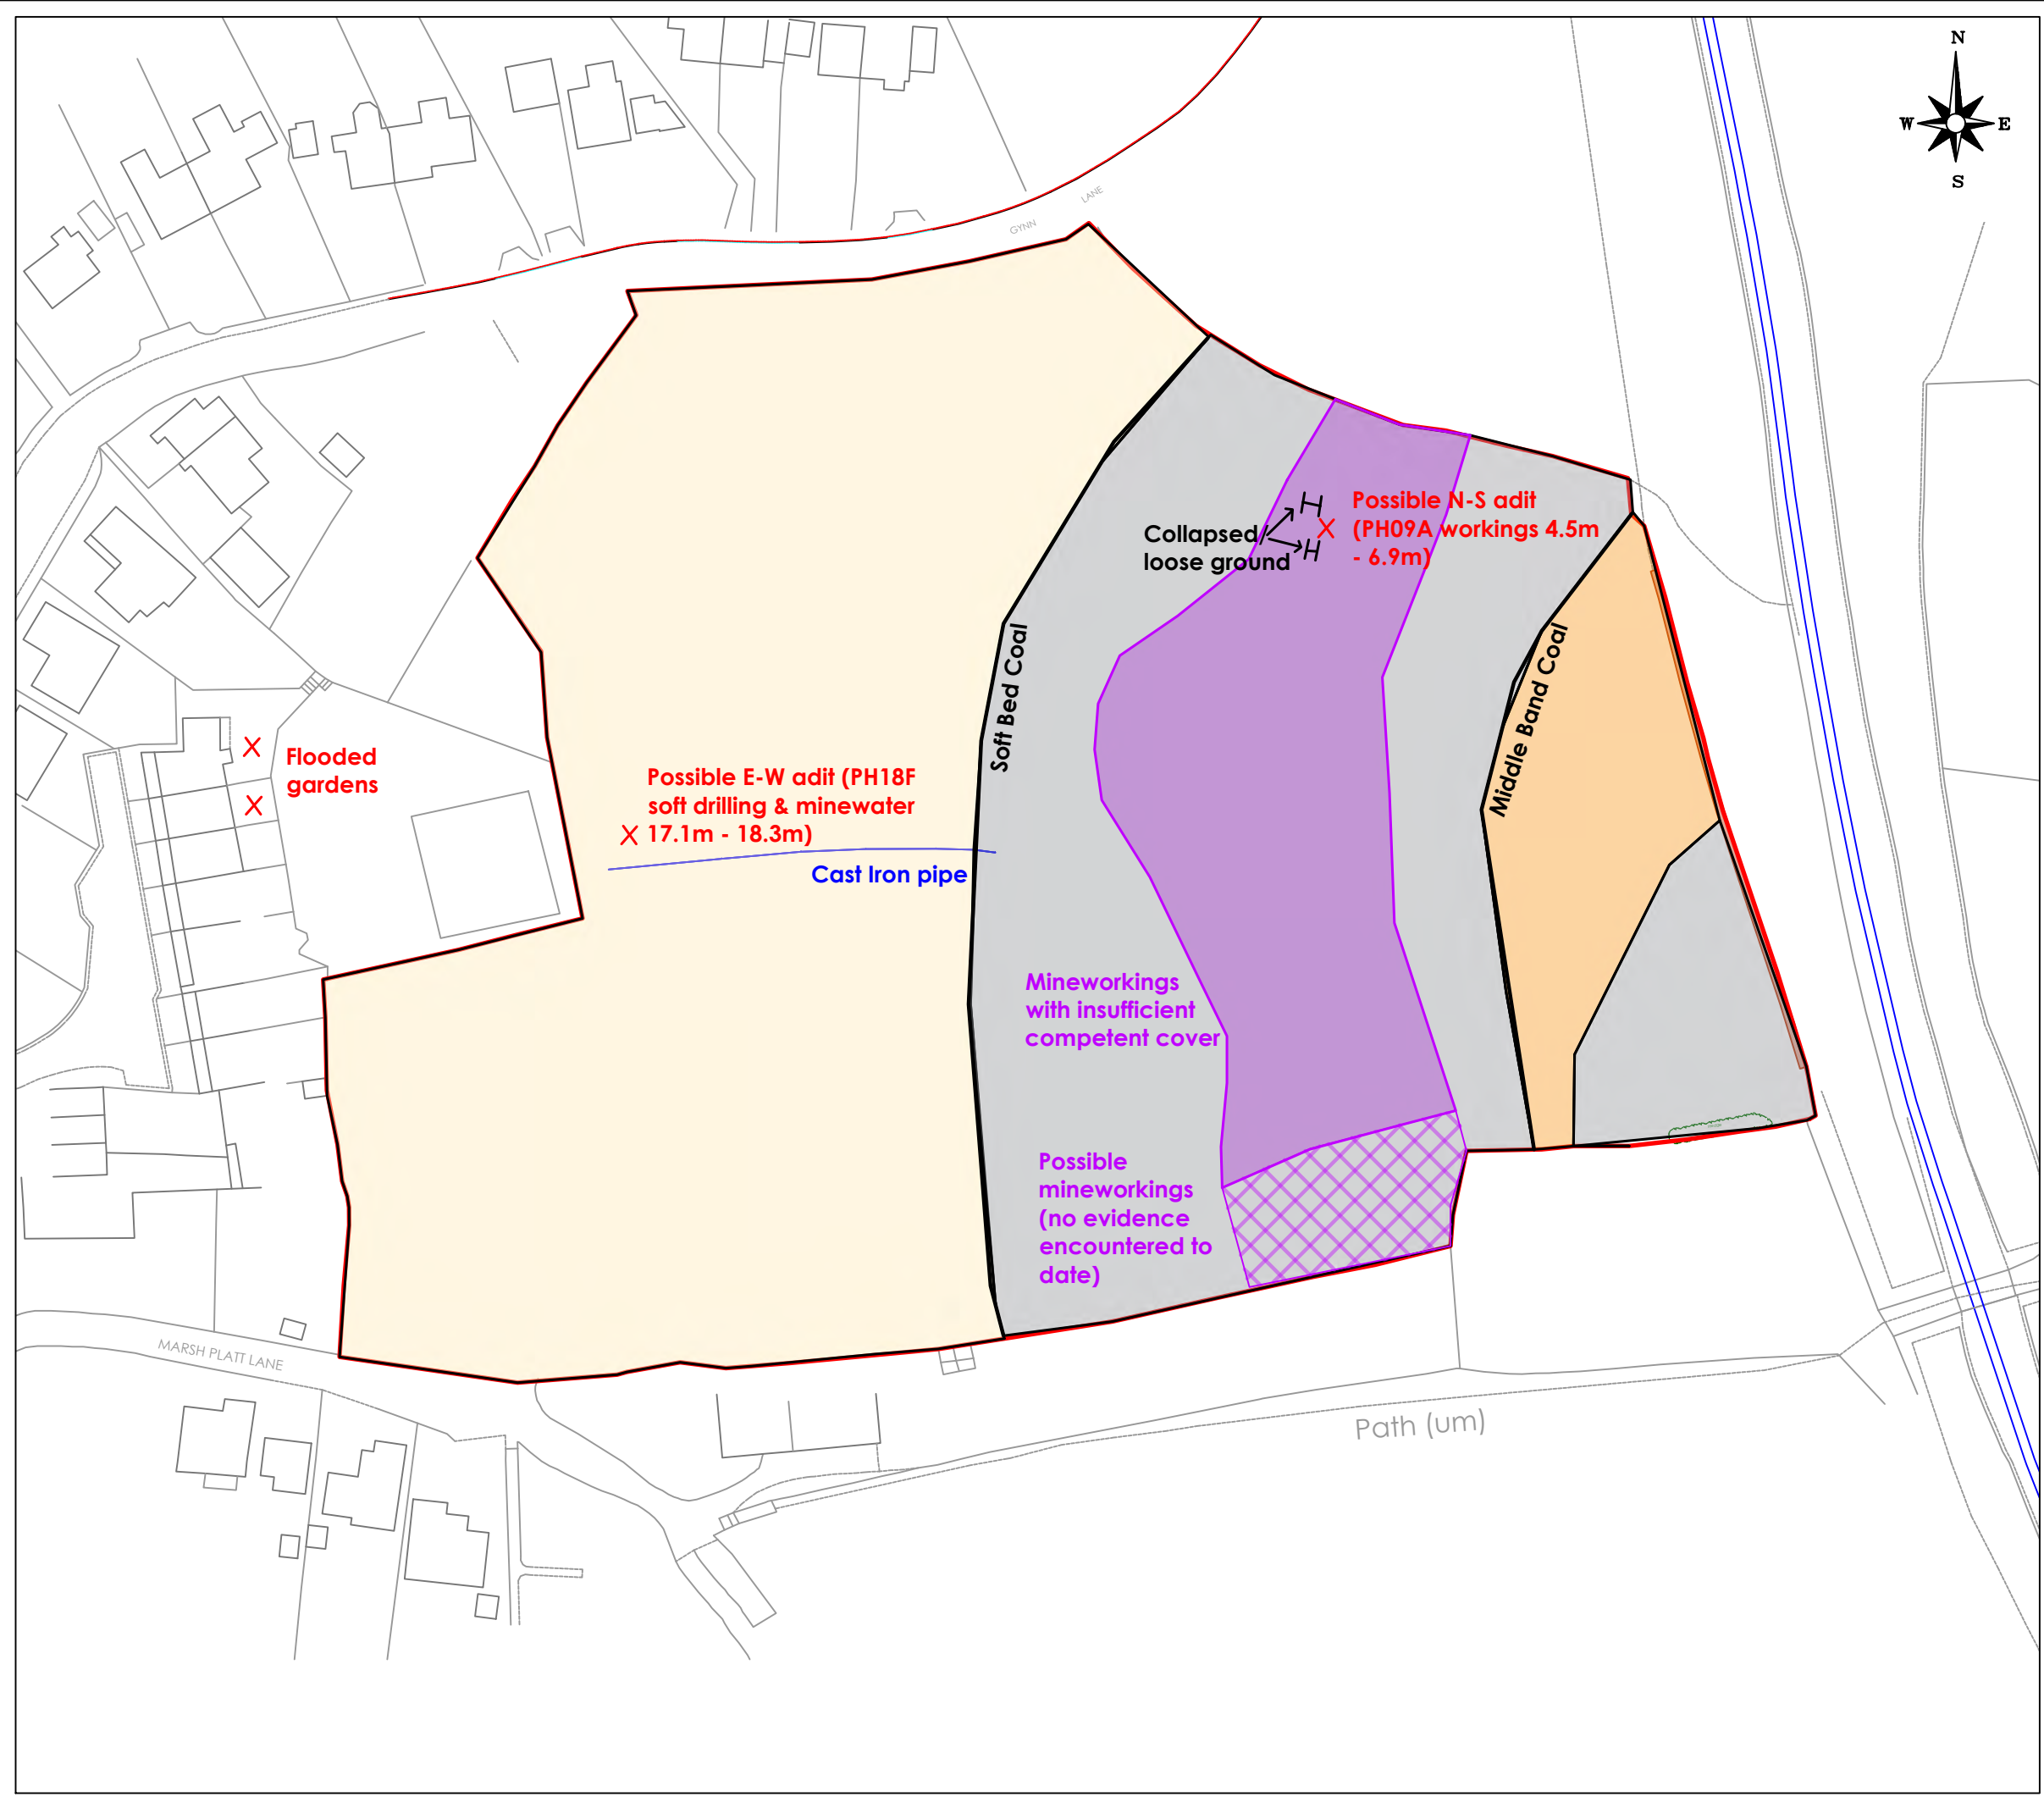
- NOTES
- LOWER COAL MEASURES
 - SOFT BED FLAGS (SANDSTONE)
 - MIDDLE BAND ROCK (SANDSTONE)
 - WORKINGS REQUIRING GROUTING
 - AREA OF POSSIBLE WORKINGS
 - COAL OUTCROP
 - APPROXIMATE SITE BOUNDARY

- Shallow mineworkings associated with the Soft Bed coal have been encountered beneath an area of approximately 4,000m² in the centre of site, which will require consolidation via drilling and grouting. Alternatively, where workings are shallow enough (<5m depth), Vivly may consider excavating the workings and replacement with engineered fill.

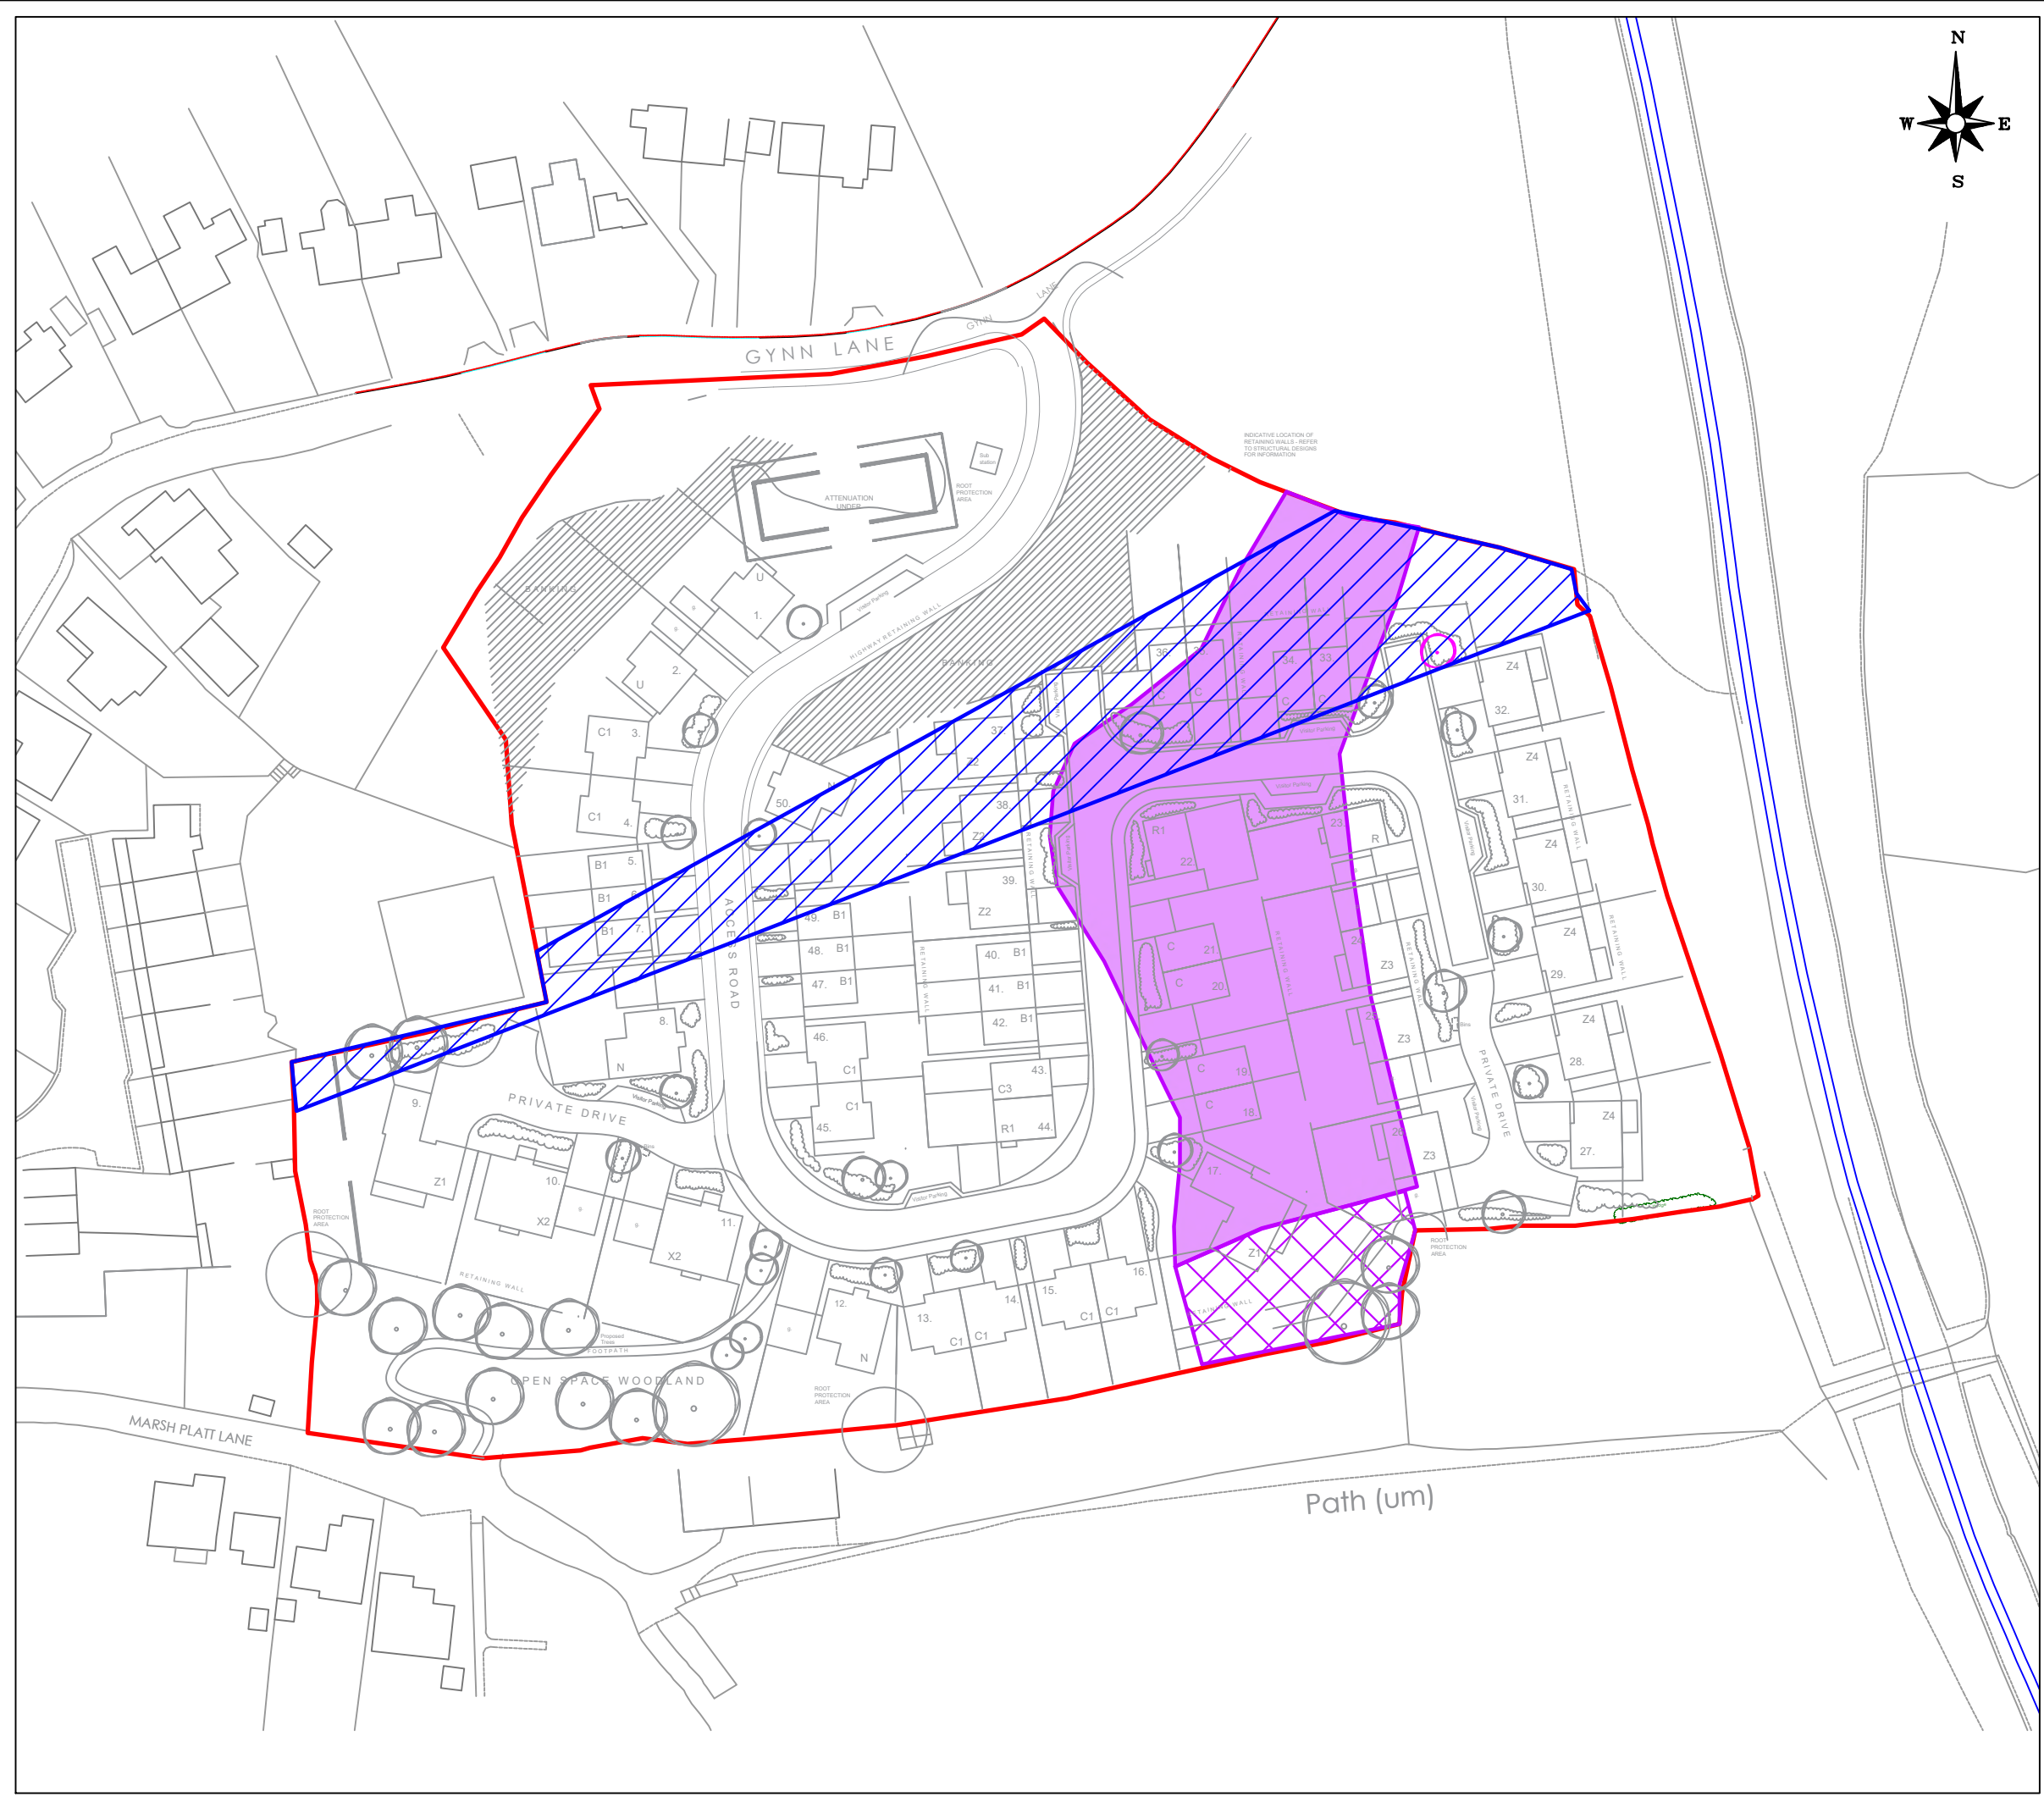
- NOTES
- POSSIBLE AREA UNDERLAIN BY E-W ADIT
 - WORKINGS REQUIRING GROUTING
 - AREA OF POSSIBLE WORKINGS
 - APPROXIMATE SITE BOUNDARY

- The orientation the E-W adit across the site is uncertain, and further investigation will prove difficult/costly. Therefore, it is recommended that plot foundations which may be underlain by the E-W adit are reinforced as a precaution.

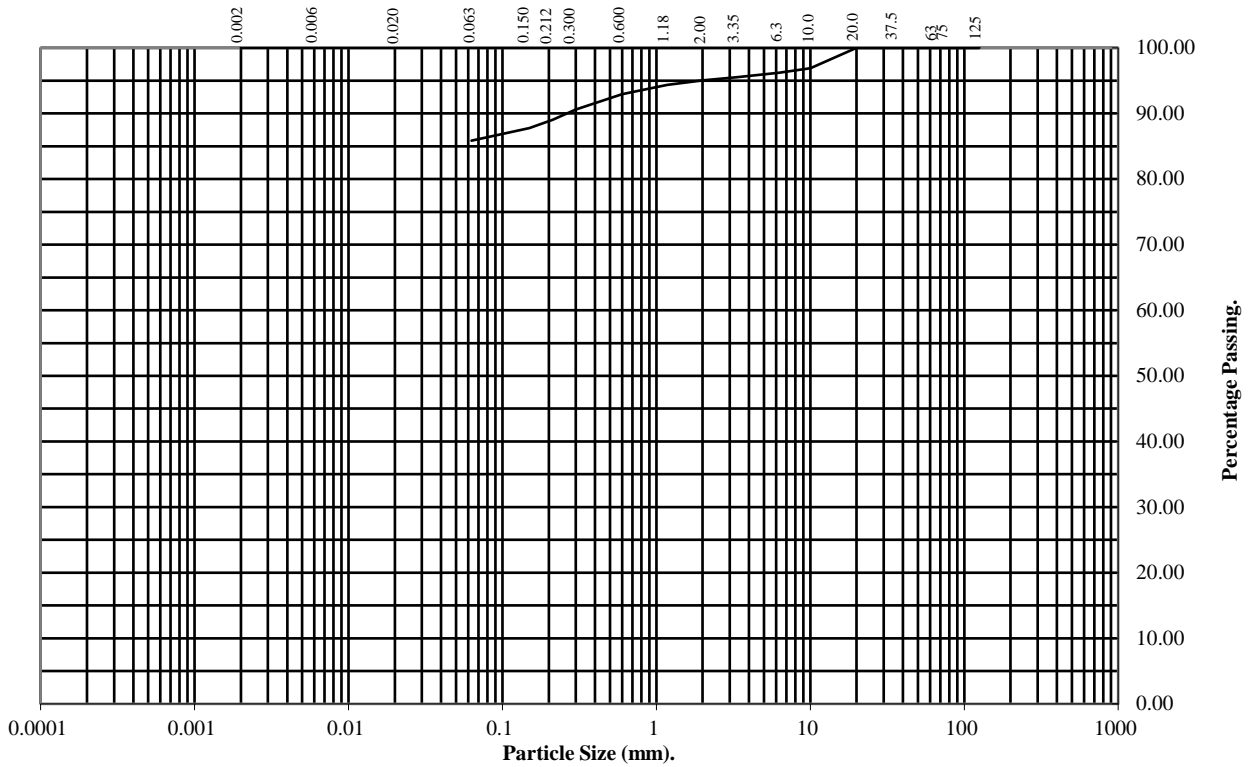
Sample Type: D&B

BS Test Sieve (mm)	Percentage Passing
125	100
75	100
63	100
37.5	100
20	100
10	97
6.3	96
3.35	96
2	95
1.18	94
0.6	93
0.3	91
0.212	89
0.15	88
0.063	86

Soil Fraction	Total Percentage
Cobbles	0
Gravel	5
Sand	9
Silt/Clay	86

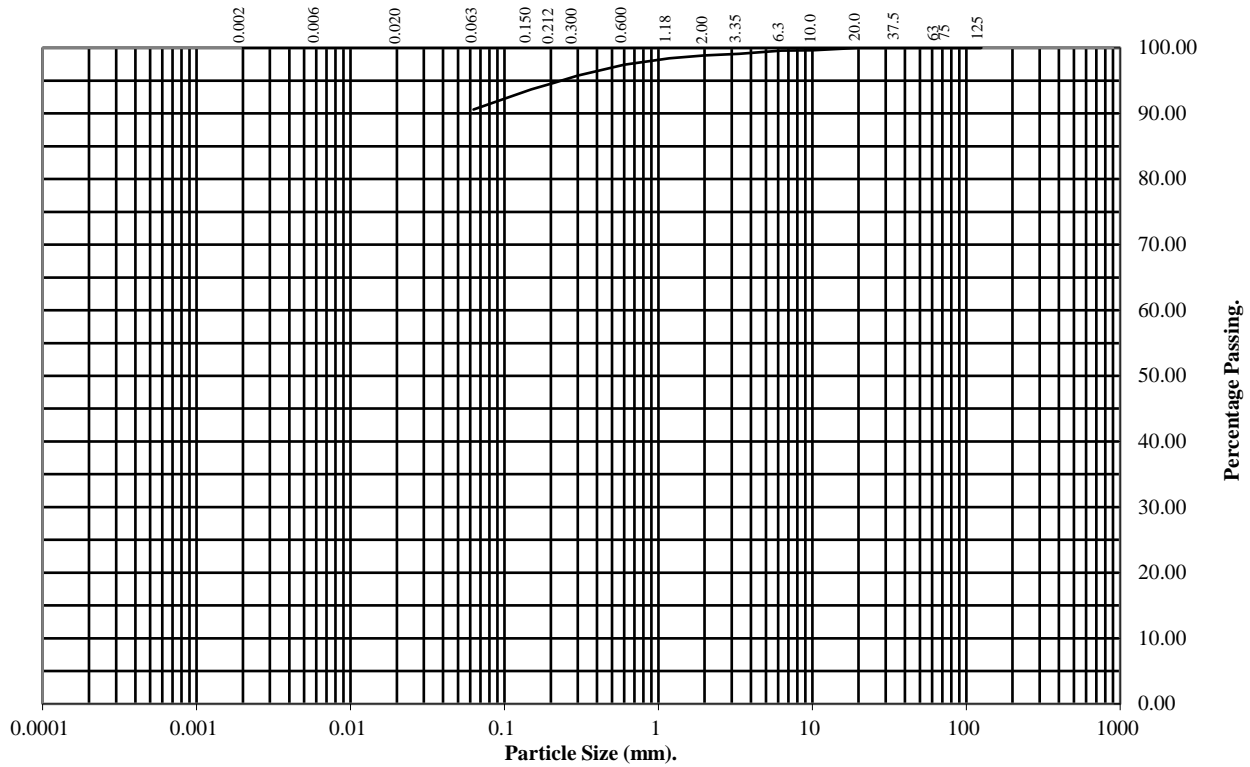
Sample Type: **D&B**

BS Test Sieve (mm)	Percentage Passing
125	100
75	100
63	100
37.5	100
20	100
10	100
6.3	100
3.35	99
2	99
1.18	98
0.6	97
0.3	96
0.212	95
0.15	94
0.063	91

Soil Fraction	Total Percentage
Cobbles	0
Gravel	1
Sand	8
Silt/Clay	91
