Land at Gynn Lane, Honley For Vivly Living

Report no: 4749/2

Date: September 2024

SUMMARY OF GEOENVIRONMENTAL ISSUES

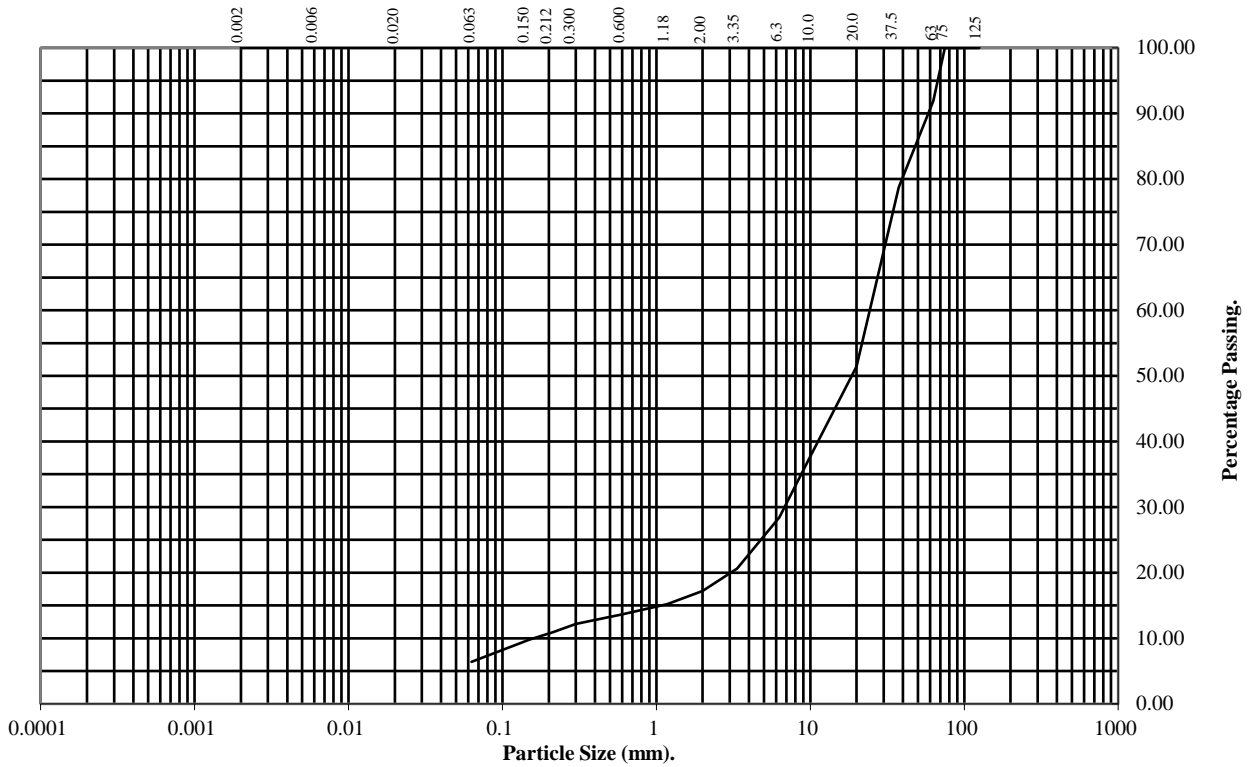
Sample Type: **D&B**

BS Test Sieve (mm)	Percentage Passing
125	100
75	100
63	92
37.5	79
20	51
10	38
6.3	28
3.35	21
2	17
1.18	15
0.6	14
0.3	12
0.212	11
0.15	10
0.063	6

Soil Fraction	Total Percentage
Cobbles	8
Gravel	75
Sand	11
Silt/Clay	6

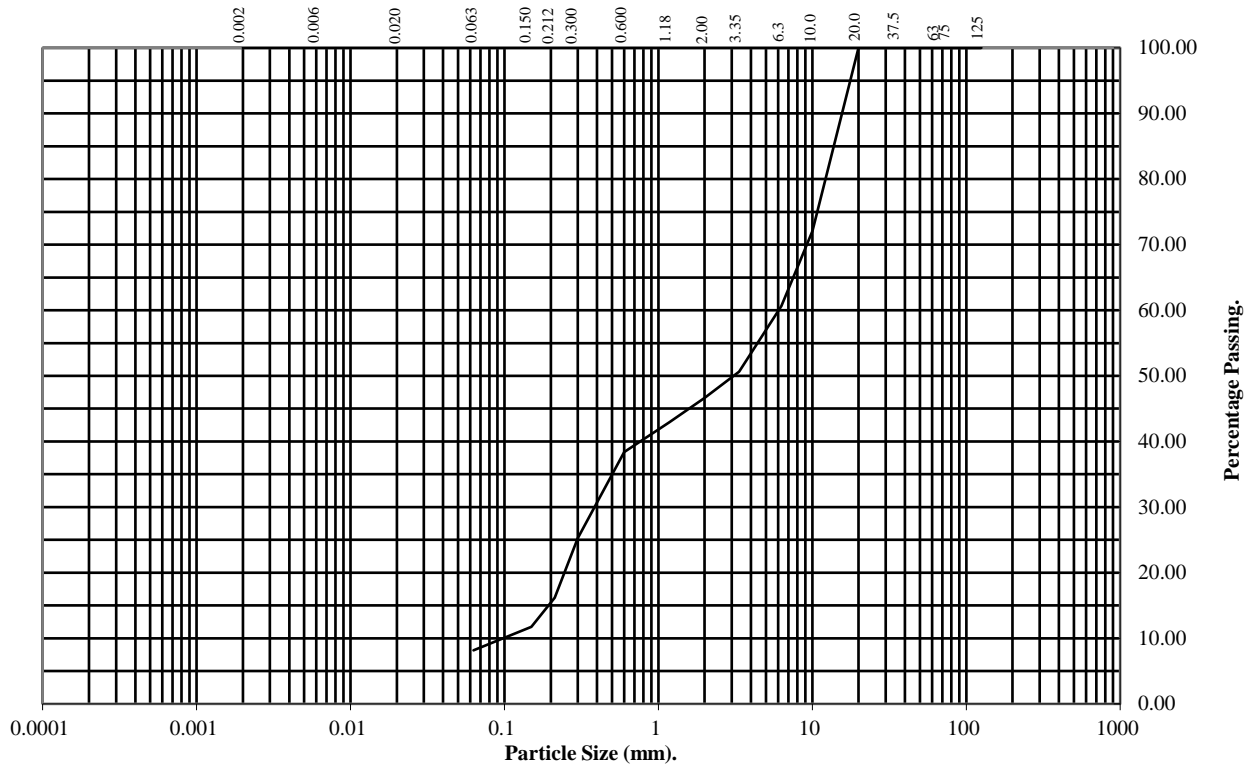
Sample Type: **D&B**

BS Test Sieve (mm)	Percentage Passing
125	100
75	100
63	100
37.5	100
20	100
10	72
6.3	61
3.35	51
2	47
1.18	43
0.6	38
0.3	25
0.212	16
0.15	12
0.063	8

Soil Fraction	Total Percentage
Cobbles	0
Gravel	53
Sand	39
Silt/Clay	8

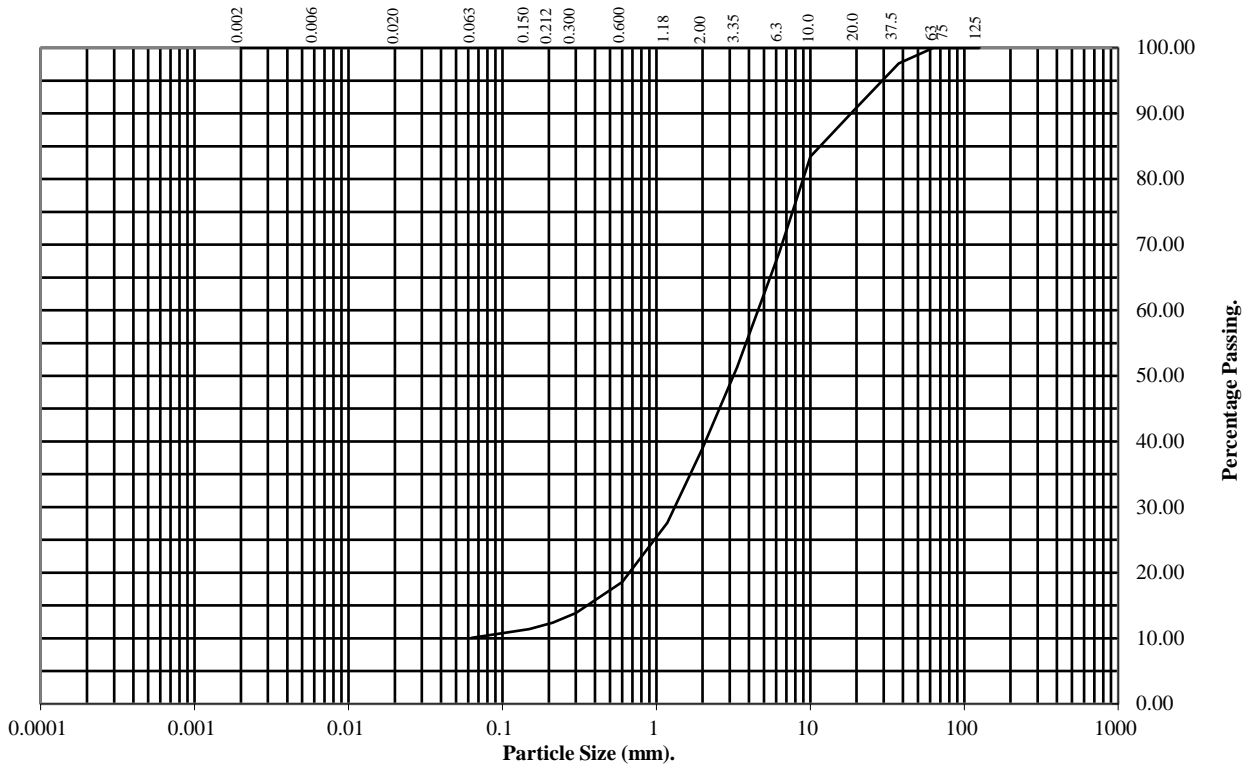
Sample Type: **D&B**

BS Test Sieve (mm)	Percentage Passing
125	100
75	100
63	100
37.5	98
20	91
10	83
6.3	69
3.35	51
2	39
1.18	28
0.6	19
0.3	14
0.212	12
0.15	11
0.063	10

Soil Fraction	Total Percentage
Cobbles	0
Gravel	61
Sand	29
Silt/Clay	10

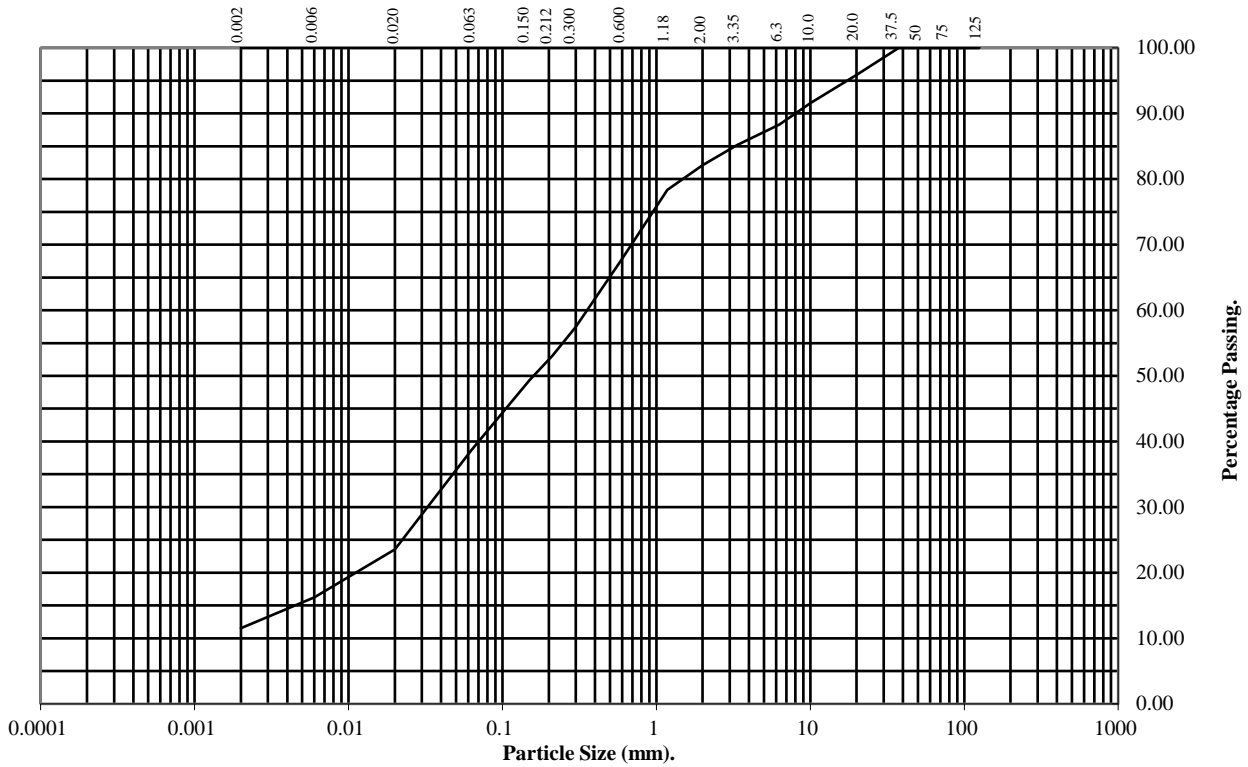
Sample Type: **B**

BS Test Sieve (mm)	Percentage Passing
125	100
75	100
50	100
37.5	100
20	96
10	92
6.3	88
3.35	85
2	82
1.18	78
0.6	68
0.3	57
0.212	53
0.15	49
0.063	39

Particle Diameter	Percentage Passing
0.02	24
0.006	16
0.002	12

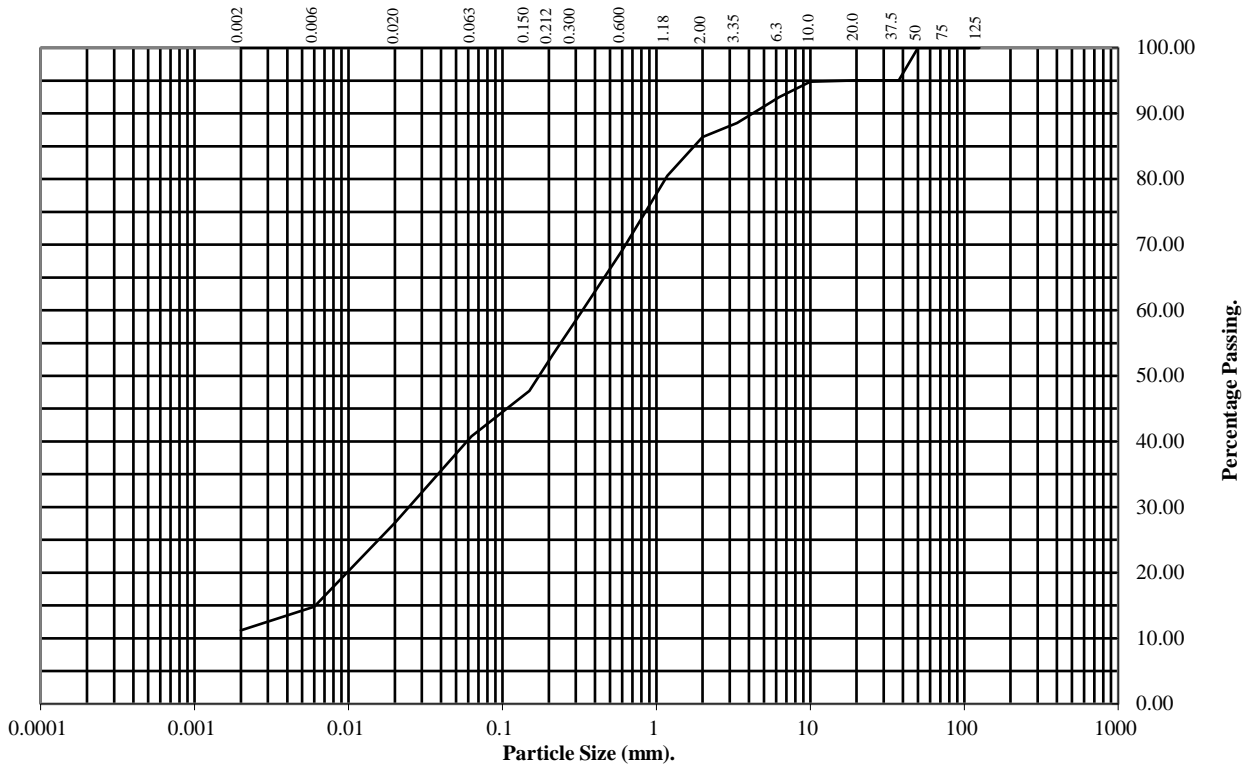
Sample Type: **B**

BS Test Sieve (mm)	Percentage Passing
125	100
75	100
50	100
37.5	95
20	95
10	95
6.3	93
3.35	89
2	86
1.18	80
0.6	69
0.3	58
0.212	53
0.15	48
0.063	41

Particle Diameter	Percentage Passing
0.02	28
0.006	15
0.002	11

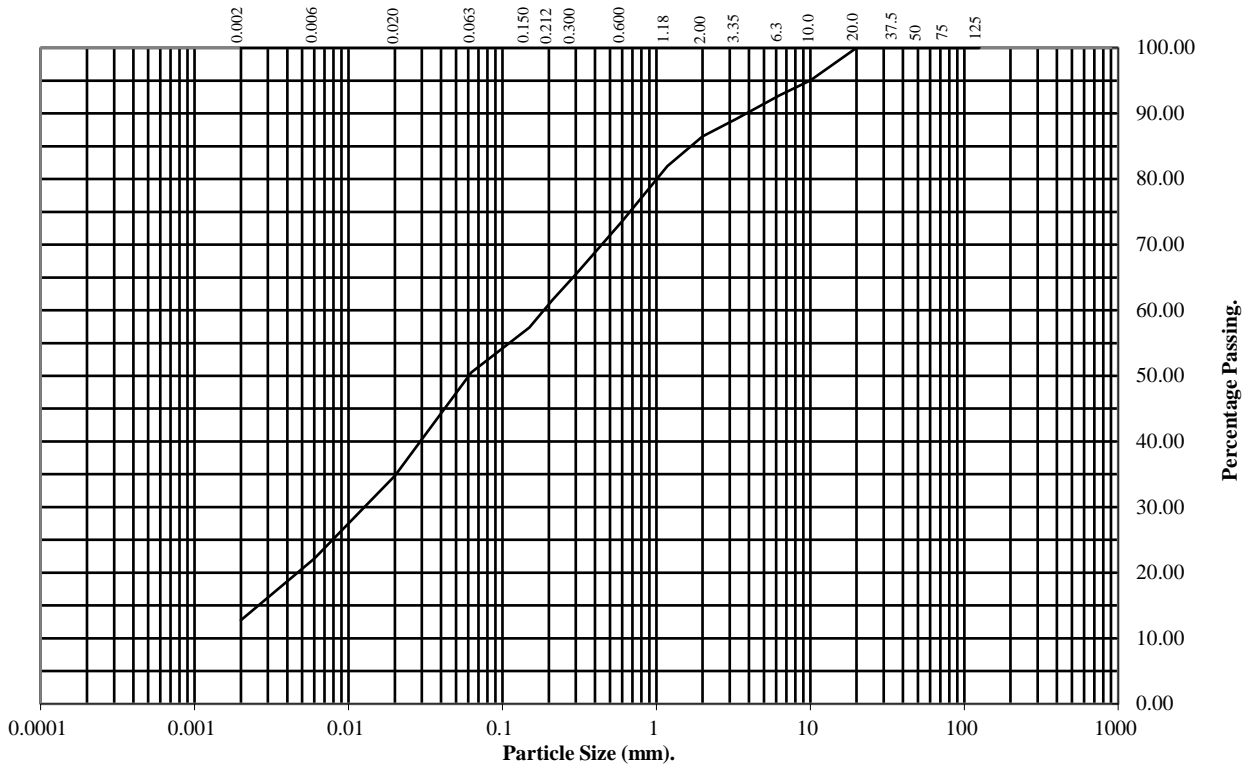
Sample Type: B

BS Test Sieve (mm)	Percentage Passing
125	100
75	100
50	100
37.5	100
20	100
10	95
6.3	93
3.35	89
2	86
1.18	82
0.6	74
0.3	65
0.212	62
0.15	57
0.063	51

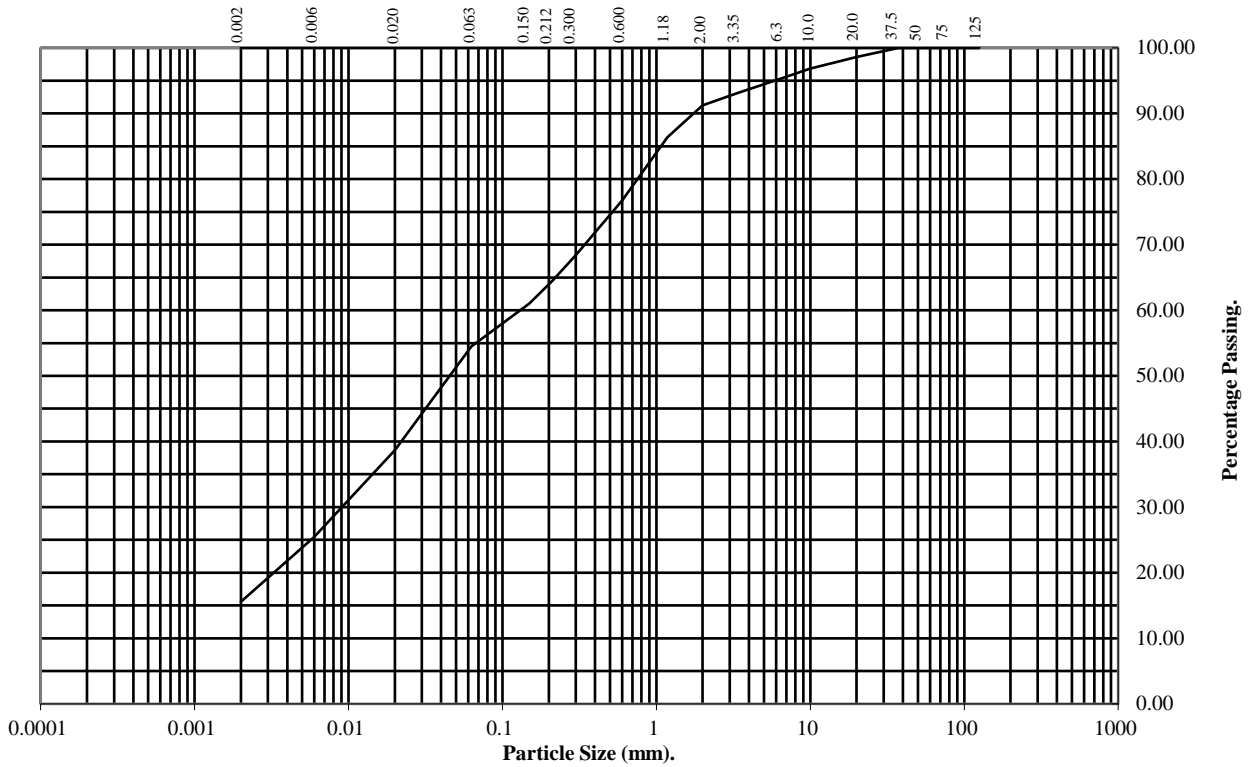
Sample Type: **B**

BS Test Sieve (mm)	Percentage Passing
125	100
75	100
50	100
37.5	100
20	99
10	97
6.3	95
3.35	93
2	91
1.18	86
0.6	77
0.3	68
0.212	65
0.15	61
0.063	55

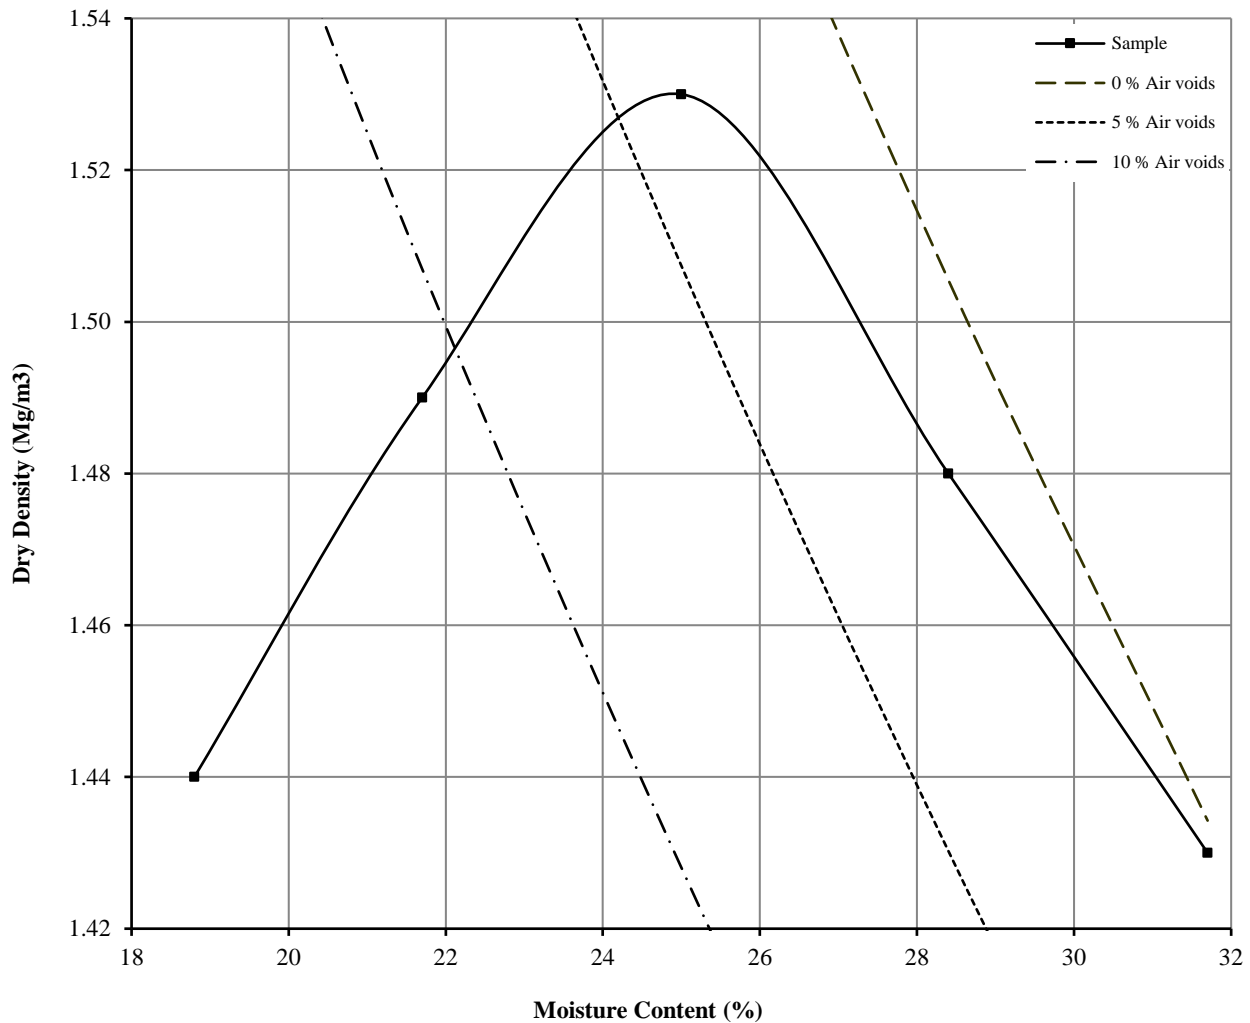
Sample Type: D&B

Initial Moisture Content:	25	Method of Compaction:	4.5kg	Separate Samples
Particle Density (Mg/m ³):	2.63	Measured	Material Retained on 37.5 mm Test Sieve (%):	0
Maximum Dry Density (Mg/m ³):	1.53		Material Retained on 20.0 mm Test Sieve (%):	0
Optimum Moisture Content (%):	25			
Remarks See summary of soil descriptions

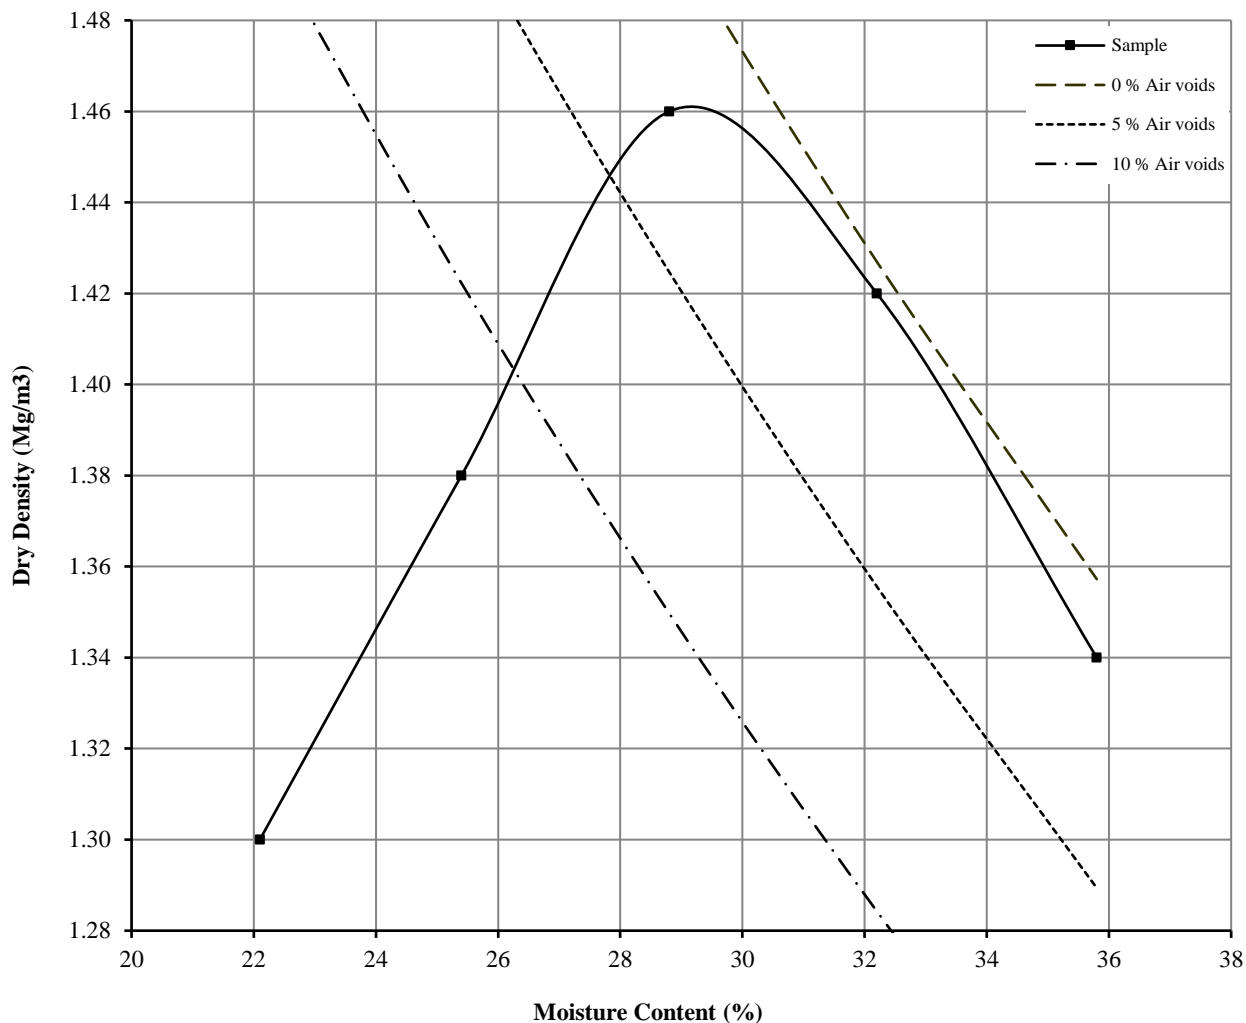
Sample Type: D&B

Initial Moisture Content:	36	Method of Compaction:	4.5kg	Separate Samples
Particle Density (Mg/m ³):	2.64	Measured	Material Retained on 37.5 mm Test Sieve (%):	0
Maximum Dry Density (Mg/m ³):	1.46		Material Retained on 20.0 mm Test Sieve (%):	0
Optimum Moisture Content (%):	29			
Remarks See summary of soil descriptions

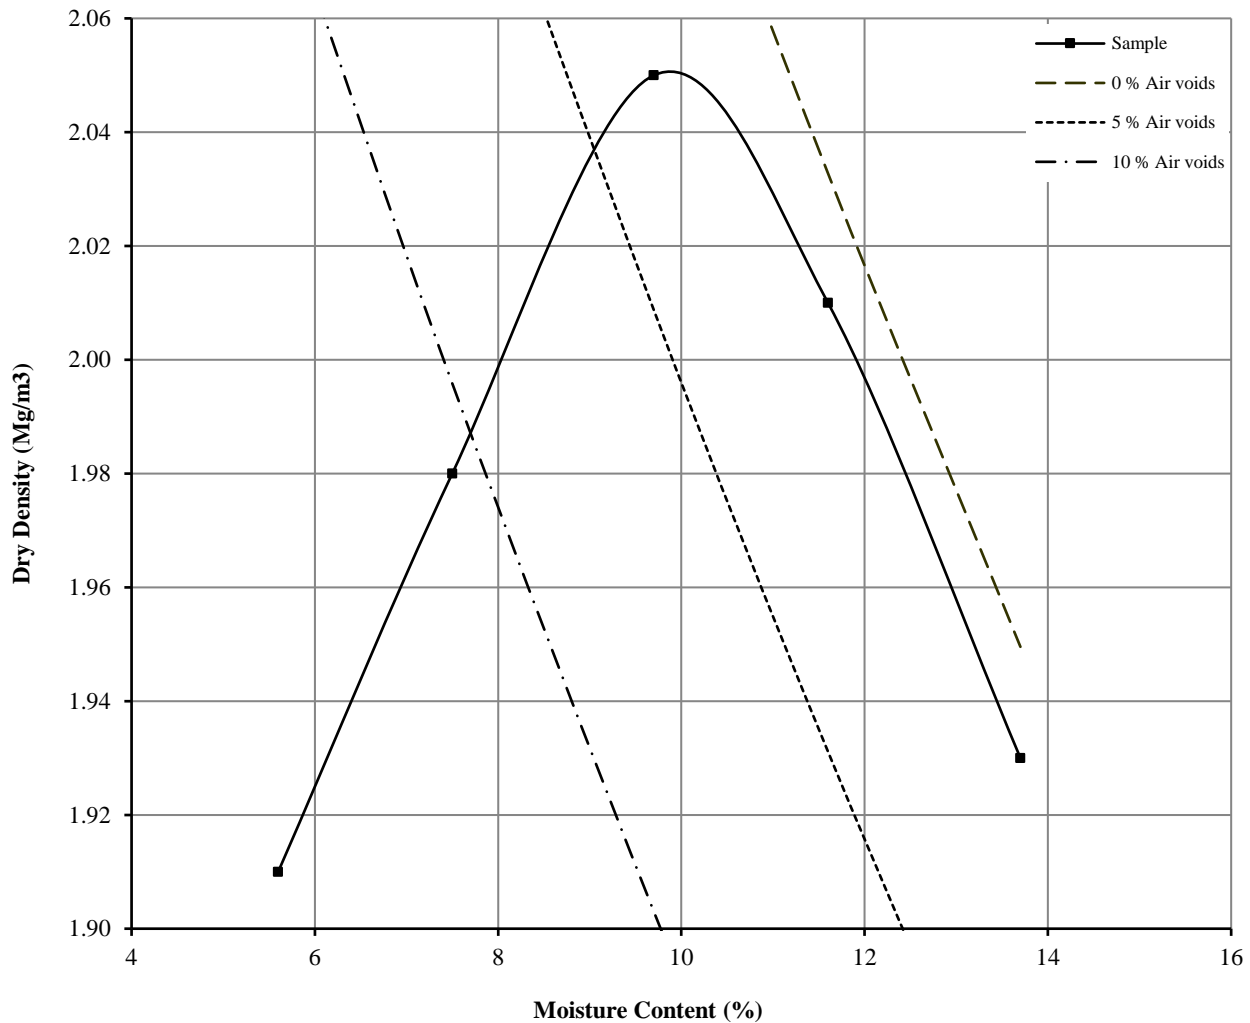
Sample Type: D&B

Initial Moisture Content:	12	Method of Compaction:	4.5kg	Separate Samples
Particle Density (Mg/m ³):	2.66	Measured	Material Retained on 37.5 mm Test Sieve (%):	21
Maximum Dry Density (Mg/m ³):	2.05	Material Retained on 20.0 mm Test Sieve (%):	28	
Optimum Moisture Content (%):	10			
Remarks See summary of soil descriptions

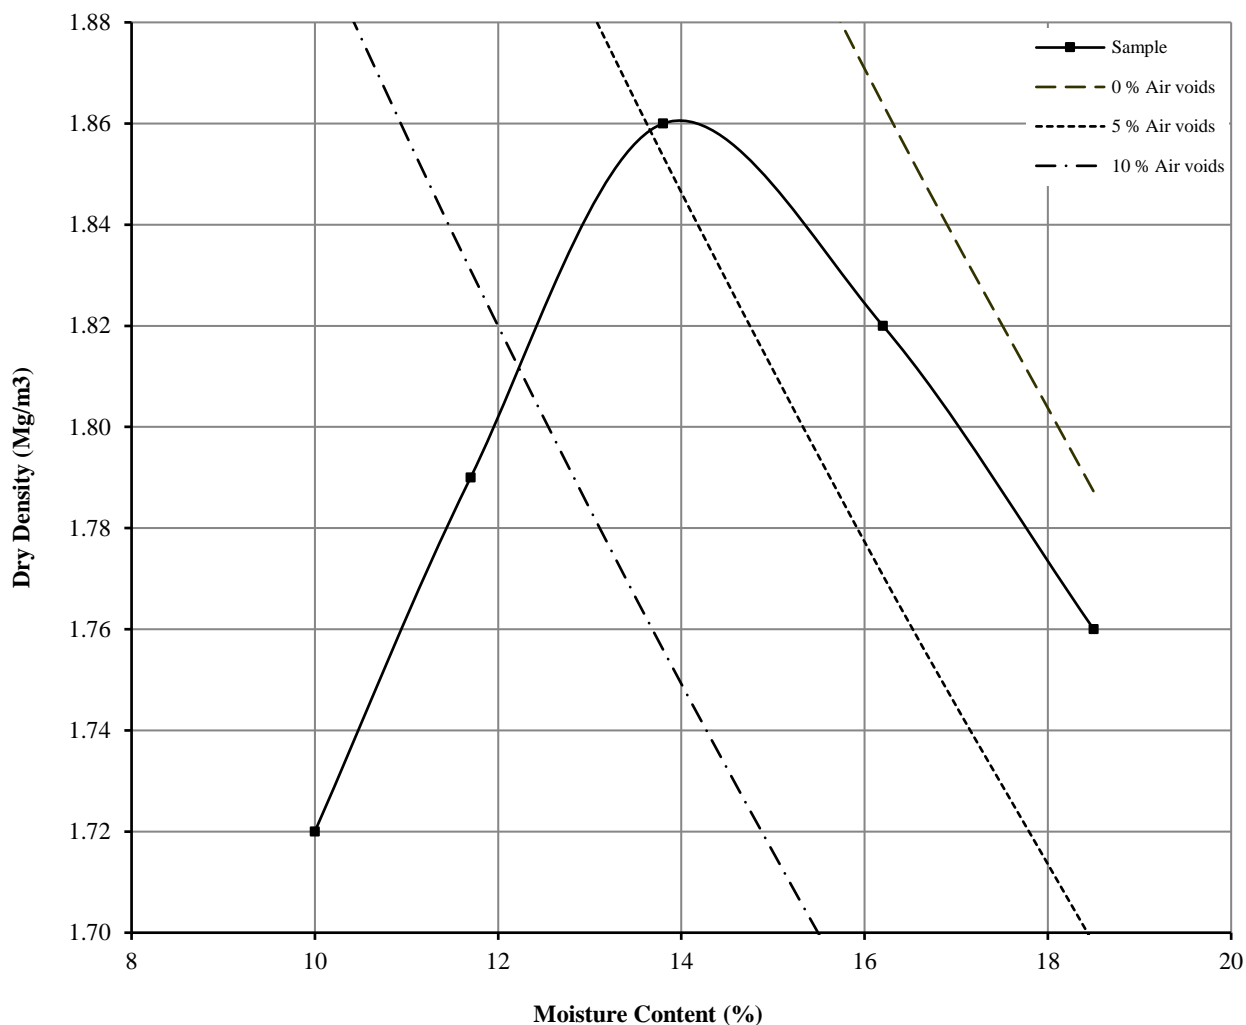
Sample Type: D&B

Initial Moisture Content:	16	Method of Compaction:	4.5kg	Separate Samples
Particle Density (Mg/m ³):	2.67	Measured	Material Retained on 37.5 mm Test Sieve (%):	0
Maximum Dry Density (Mg/m ³):	1.86		Material Retained on 20.0 mm Test Sieve (%):	0
Optimum Moisture Content (%):	14			
Remarks See summary of soil descriptions

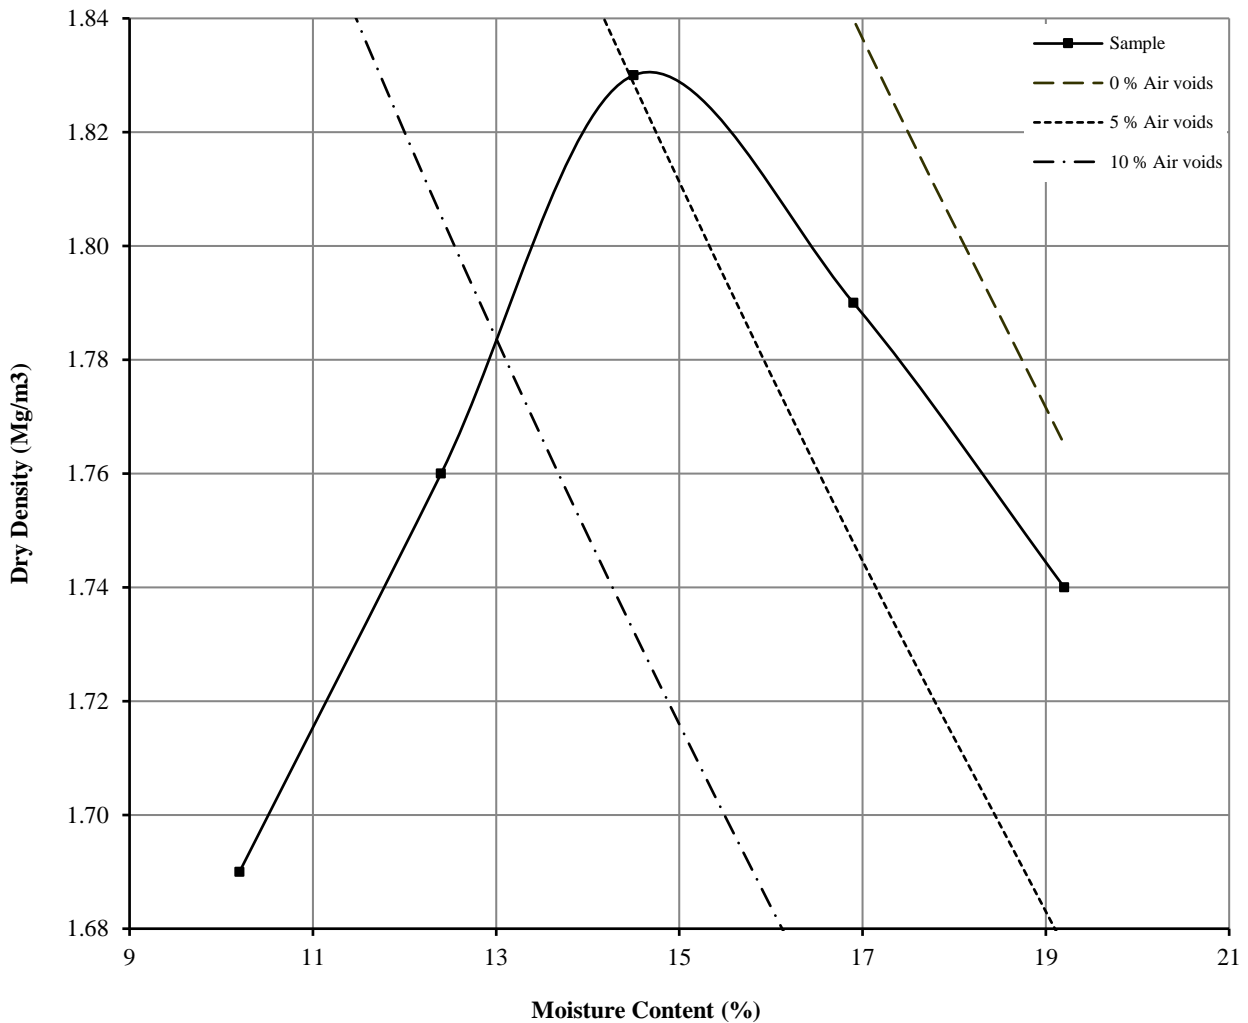
Hole Number: TP19 Top Depth (m) : 1.50
 Sample Number: 1 Base Depth (m) :
 Sample Type: D&B

Initial Moisture Content:	17	Method of Compaction:	4.5kg	Separate Samples
Particle Density (Mg/m ³):	2.67	Measured	Material Retained on 37.5 mm Test Sieve (%):	2
Maximum Dry Density (Mg/m ³):	1.83		Material Retained on 20.0 mm Test Sieve (%):	7
Optimum Moisture Content (%):	15			
Remarks See summary of soil descriptions
