Structural Appraisal Report for Proposed Conversion of an
Agricultural Building to a Dwelling (Class Q) - Barn 2

Meltham Grange Farm, Deer Hill End Road, off Slaithwaite
Road, Meltham, HD9 5PT

Survey Report

Dated: 13th May 2025

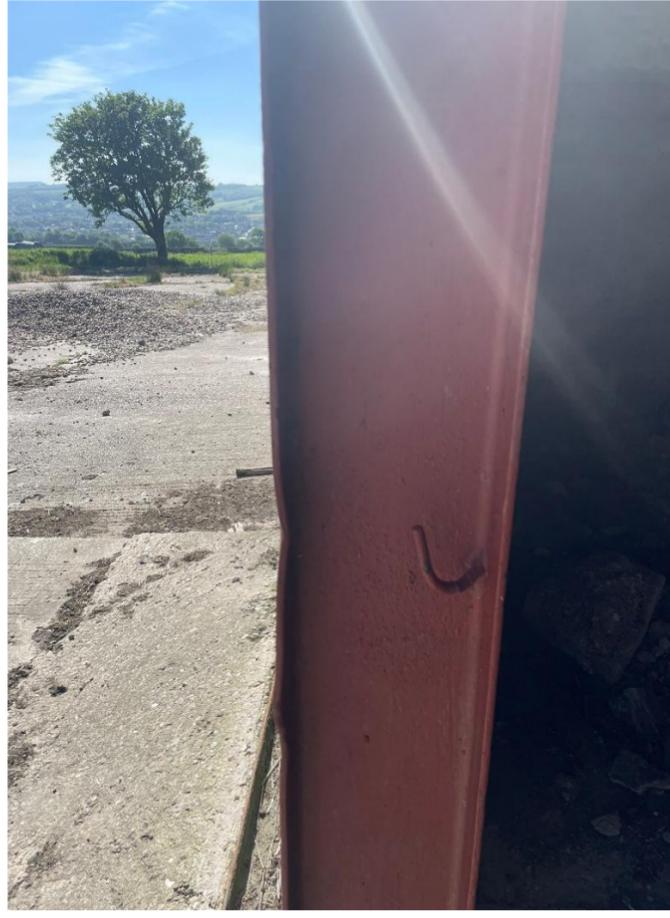
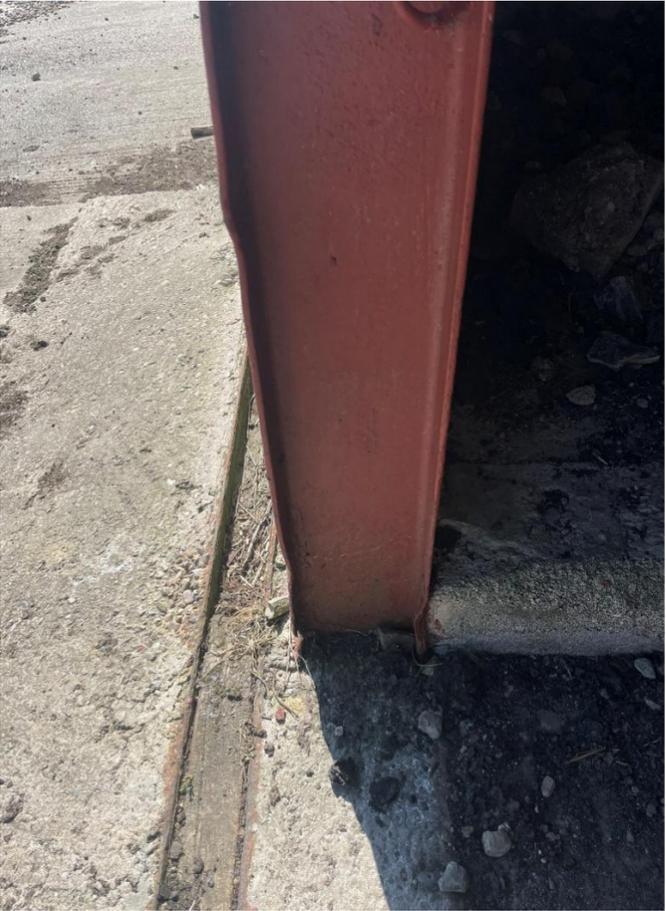
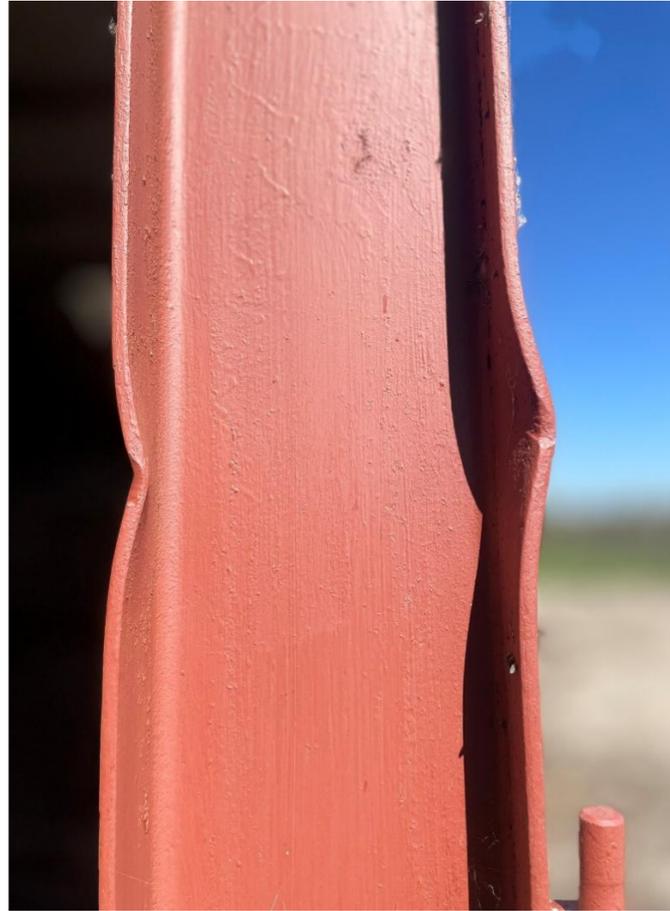
Slight impact damaged noted at low level to steel stanchions to the main entrance. Simple remedial fabricating required to enhance the structural integrity of the column. Seek further advice from structural engineer. **Pic Ref: 22-24 Internal Areas**

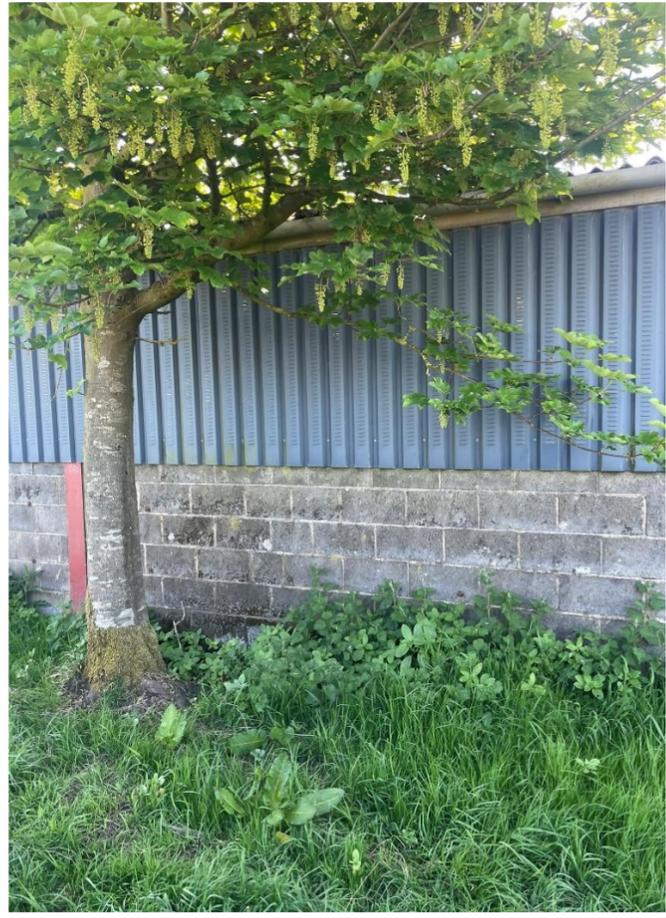
Tree situated to the North elevation approximately 500mm away from the building. There is no evidence of recent and on-going movement to the ground and foundations to localised areas due to the locations and size of the tree. However due to its proximity to the building we recommend that it is removed to prevent potential future structural defects. **Pic Ref: 14 External Areas**
