# Leeds Road, Heckmondwike

Project	
LAND AT 195 LEEDS ROAD HECKMONDWIKE	
Client	
ORION HOMES LTD	
Title	
SITE INVESTIGATION PLAN	
Date	
NOVEMBER 2024	
Drawn	Scale
JP	AS SHOWN
Job No.	
ORH/25

### **METHOD STATEMENT FOR ASSESSMENT OF IMPORTED SOILS**

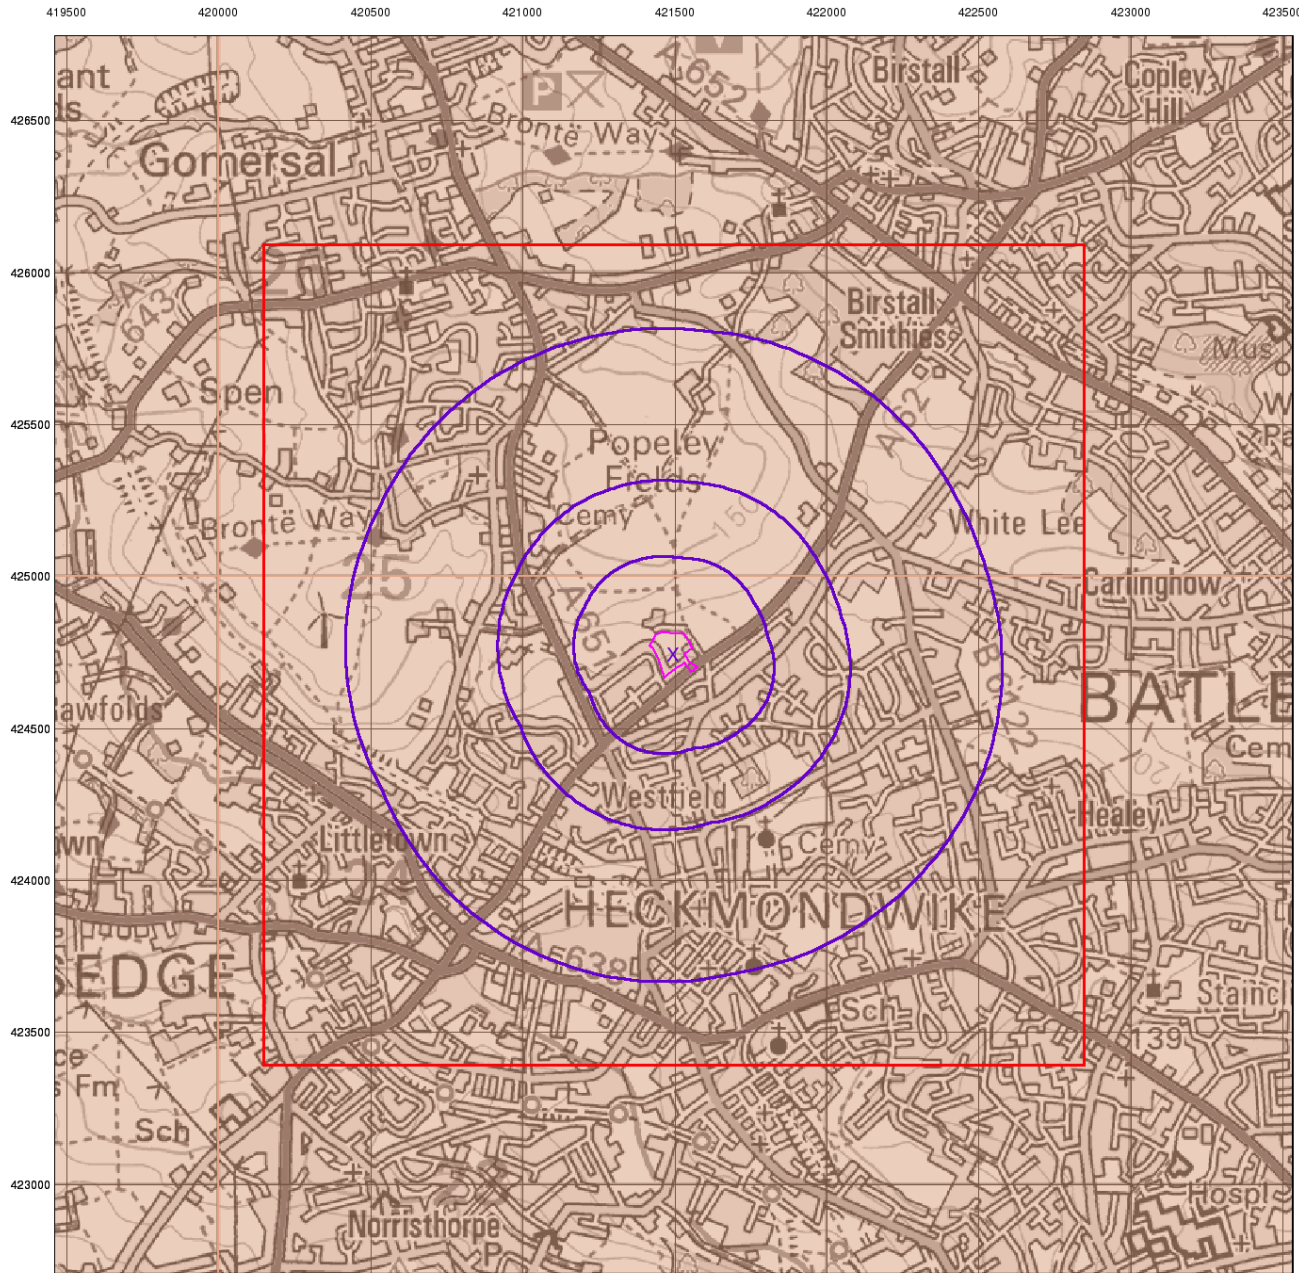
## Bedrock Aquifer Designation

- Geological Classes**
- Principal Aquifer
  - Secondary A Aquifer
  - Secondary B Aquifer
  - Secondary Undifferentiated
  - Unproductive Strata
  - Unknown
  - Unknown (Lakes and Landslip)

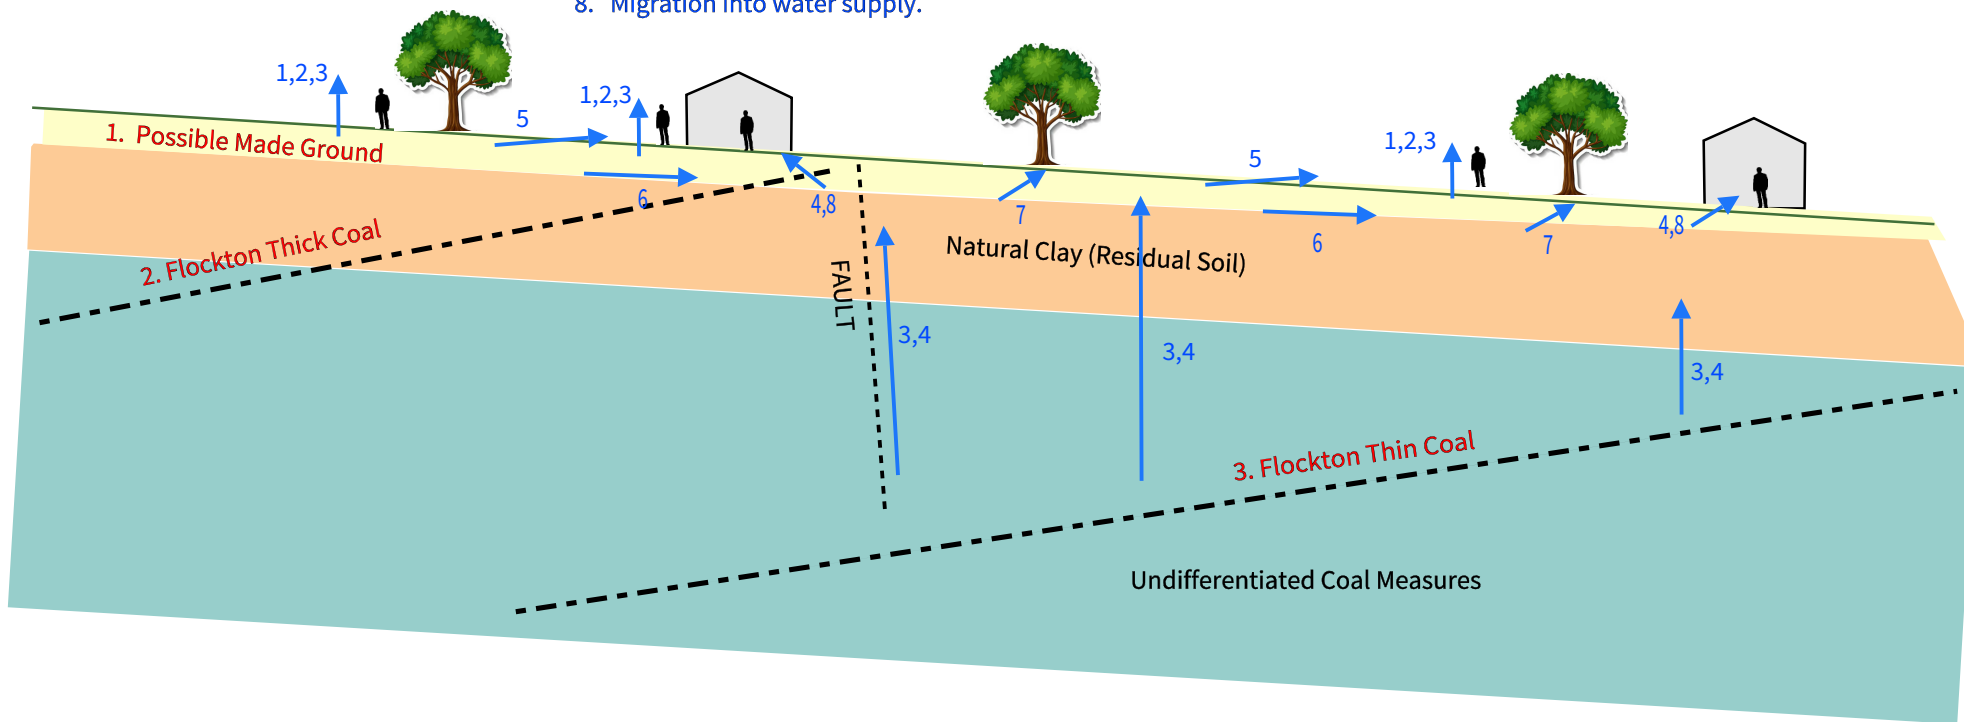
<p>Title</p> <p style="text-align: center;">CONCEPTUAL SITE MODEL - FINISHED DEVELOPMENT</p>	<p>Client</p> <p style="text-align: center;">ORION HOMES</p>

- 1. Possible localised Made Ground: Metals, Inorganics, TPH, PAH, Asbestos.
- 2. Probable workings within Flockton Thick Coal beneath northern end of site: CO<sub>2</sub>, CH<sub>4</sub>.
- 3. Recorded shallow workings within Flockton Thin Coal underlying southern end of site

- 1. Inhalation, ingestion & dermal contact with soil and dust.
- 2. Fruit & vegetable intake, with soil.
- 3. Vapour inhalation outdoor.
- 4. Vapour inhalation indoor.
- 5. Migration in surface water.
- 6. Migration in groundwater
- 7. Root uptake.
- 8. Migration into water supply.

- o Future occupants, maintenance workers and adjacent residents/public.
- o Surface Water.
- o Groundwater.
- o Vegetation.

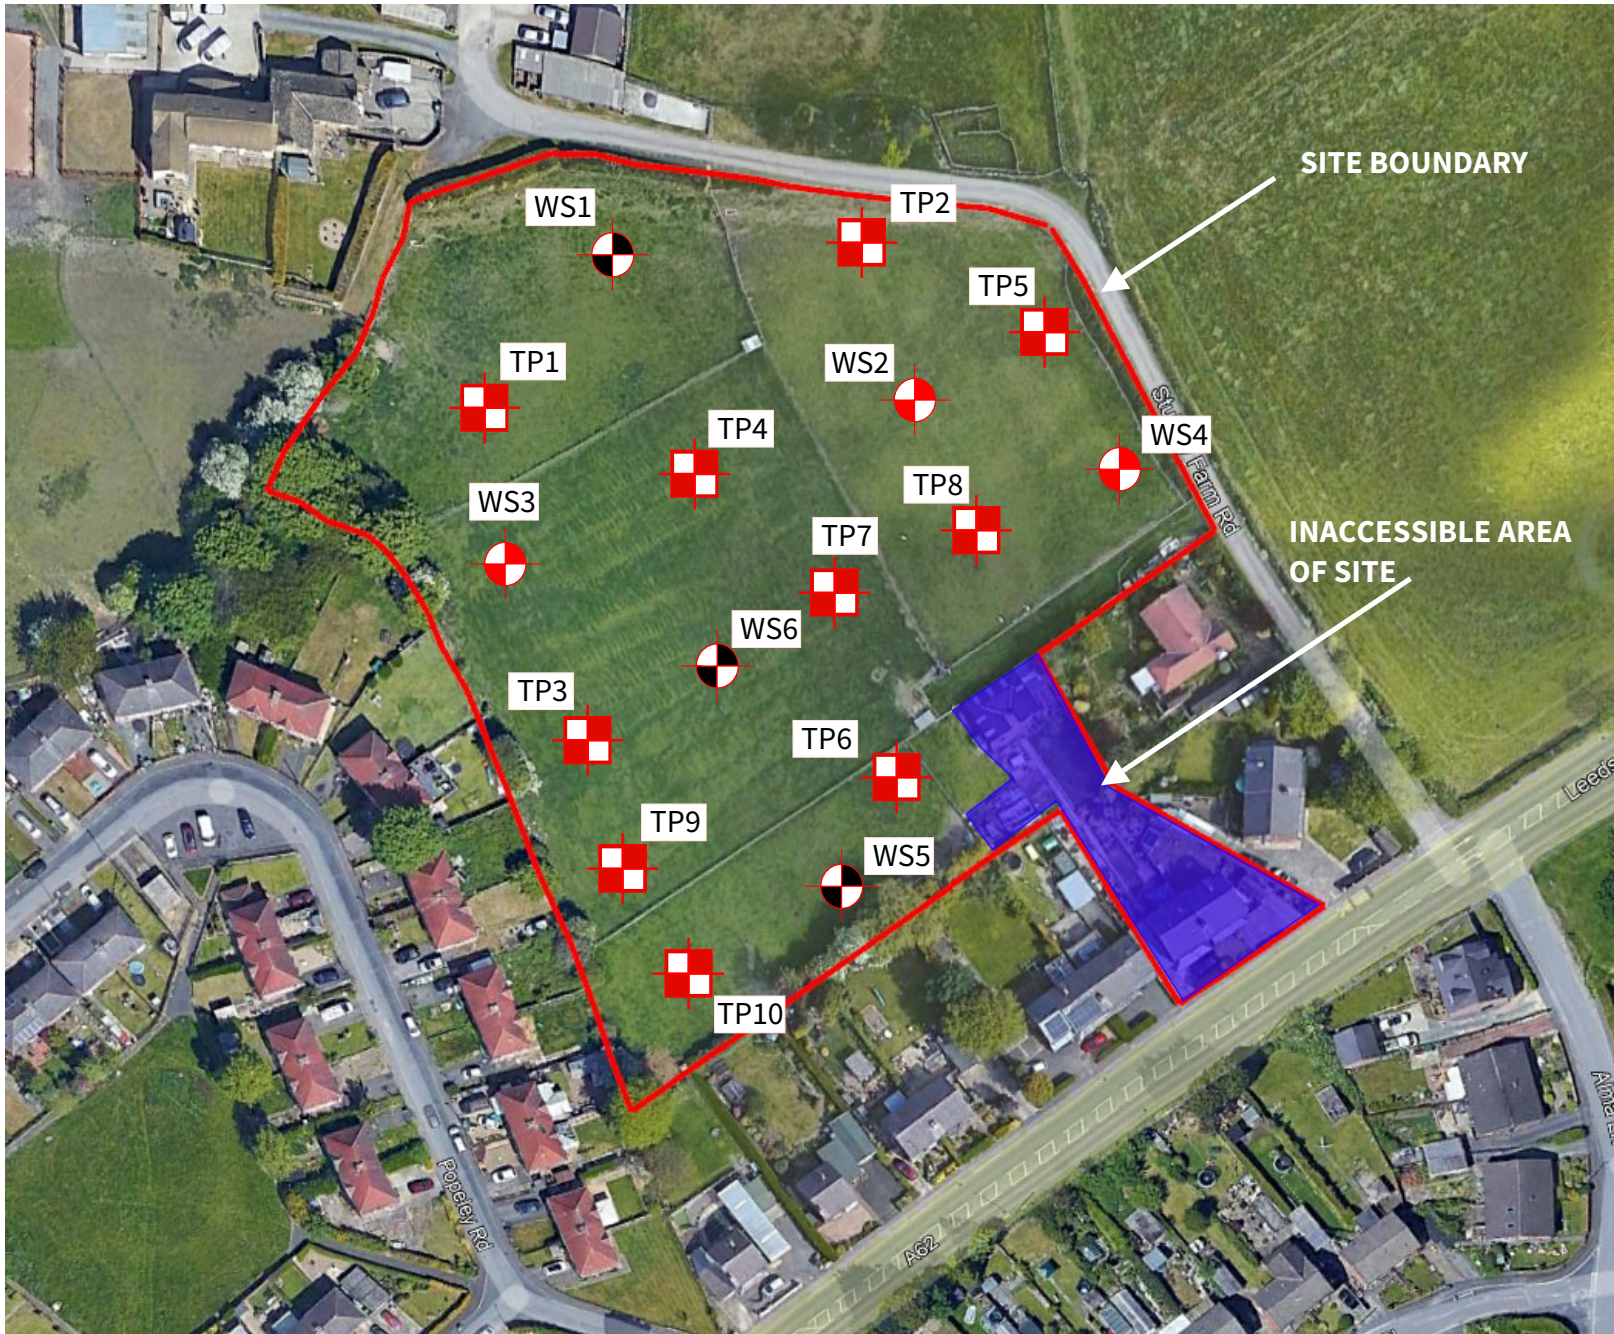
- Trial Pit
- Window Sample Borehole
- Window Sample Borehole and Gas Well Installation

- 2.9 The ground investigation only encountered made ground at one location (WS1), 0.4m thick. Below this, and below topsoil on the rest of the site, a sequence of gravelly clays onto clayey gravels onto mudstone, was encountered, consistent with in situ weathering of Coal Measures mudstone. A 0.7m thick weathered coal seam was found in one borehole on the north of the site, which is consistent with the published geological map.
