**Dewsbury & District Hospital  
Remediation Verification Report  
(February 2026)**

**Prepared for Darwin Group Ltd**

<b>Project name</b>	Dewsbury & District Hospital
<b>Project number</b>	9202-011
<b>Report title</b>	Remediation Verification Report
<b>Document number</b>	9202-011-R-01
<b>Revision</b>	0

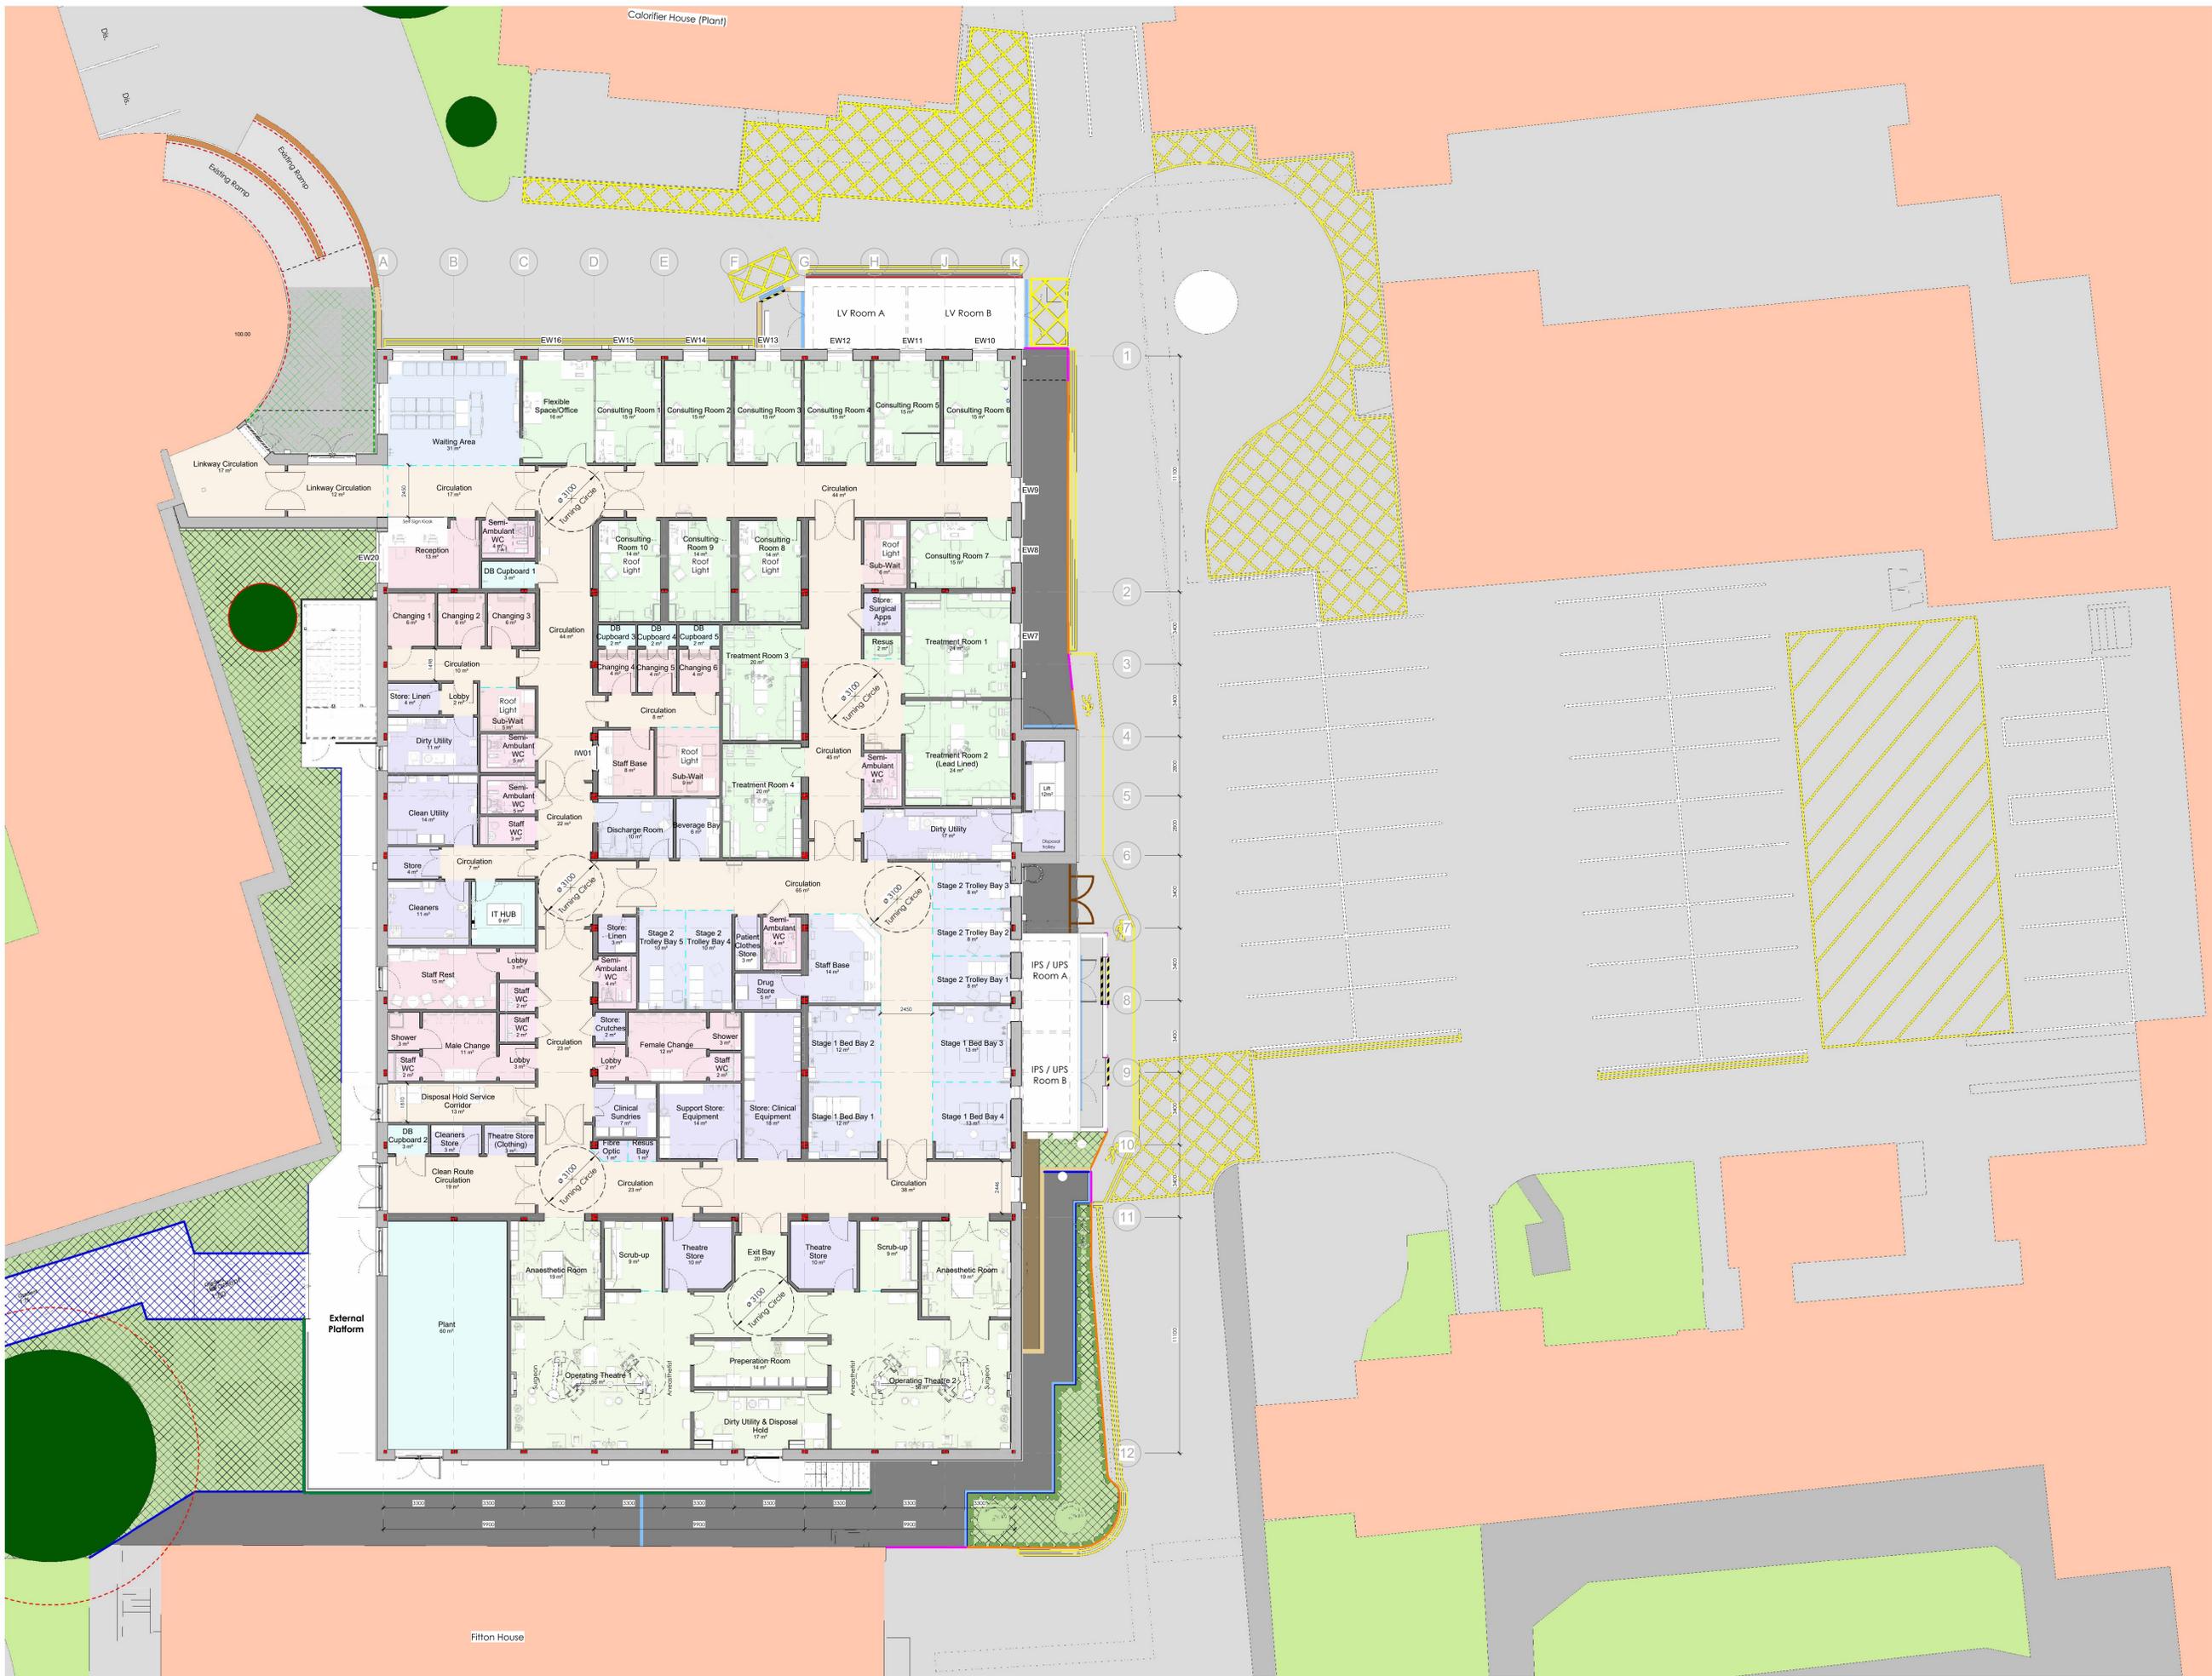
DRAWING TITLE: Proposed Site Plan

Prior to the site visit, KGS were informed by Darwin that an area of proposed soft landscaping, located in the southwestern corner of the site, was outside the scope of the development and had not been disturbed during the works (see Drawing Ref. 180598-DGL-01-XX-DR-A-1402, Appendix 1).

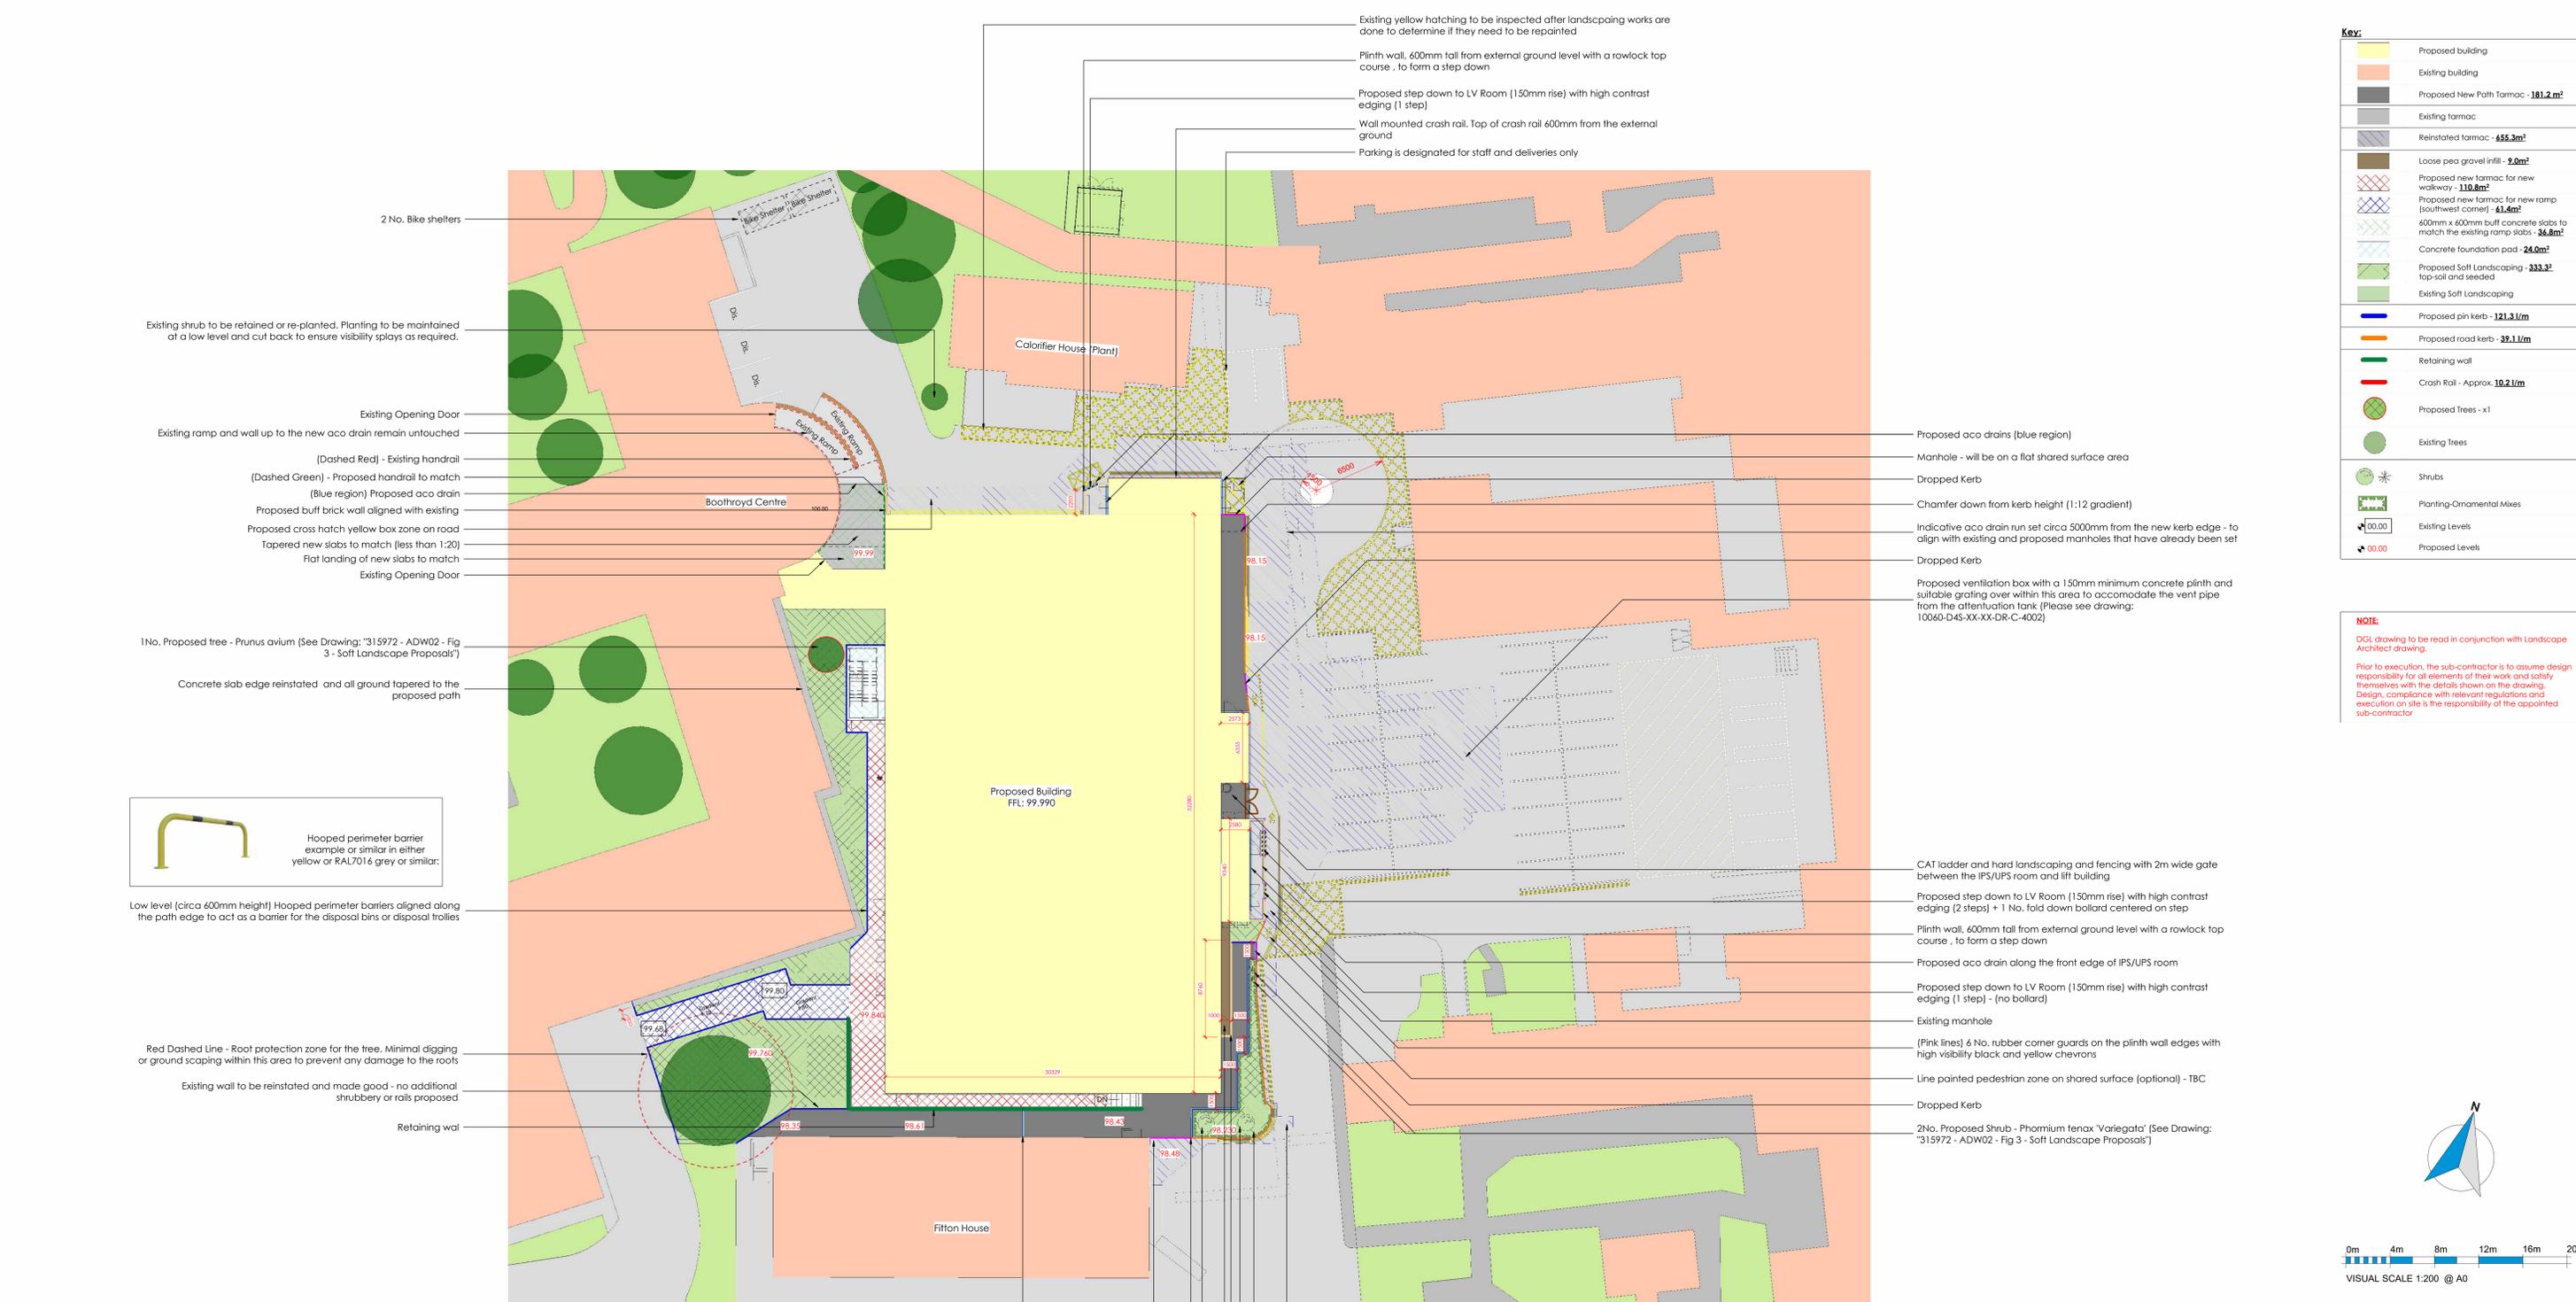
**Proposed Landscaping Plan 01**  
1 : 200

The site visit undertaken by KGS on 17<sup>th</sup> December 2025 and 20<sup>th</sup> January 2026 confirmed that imported topsoil had been placed in areas of soft landscaping, in general accordance with Darwins Landscaping Plan (Appendix 1).

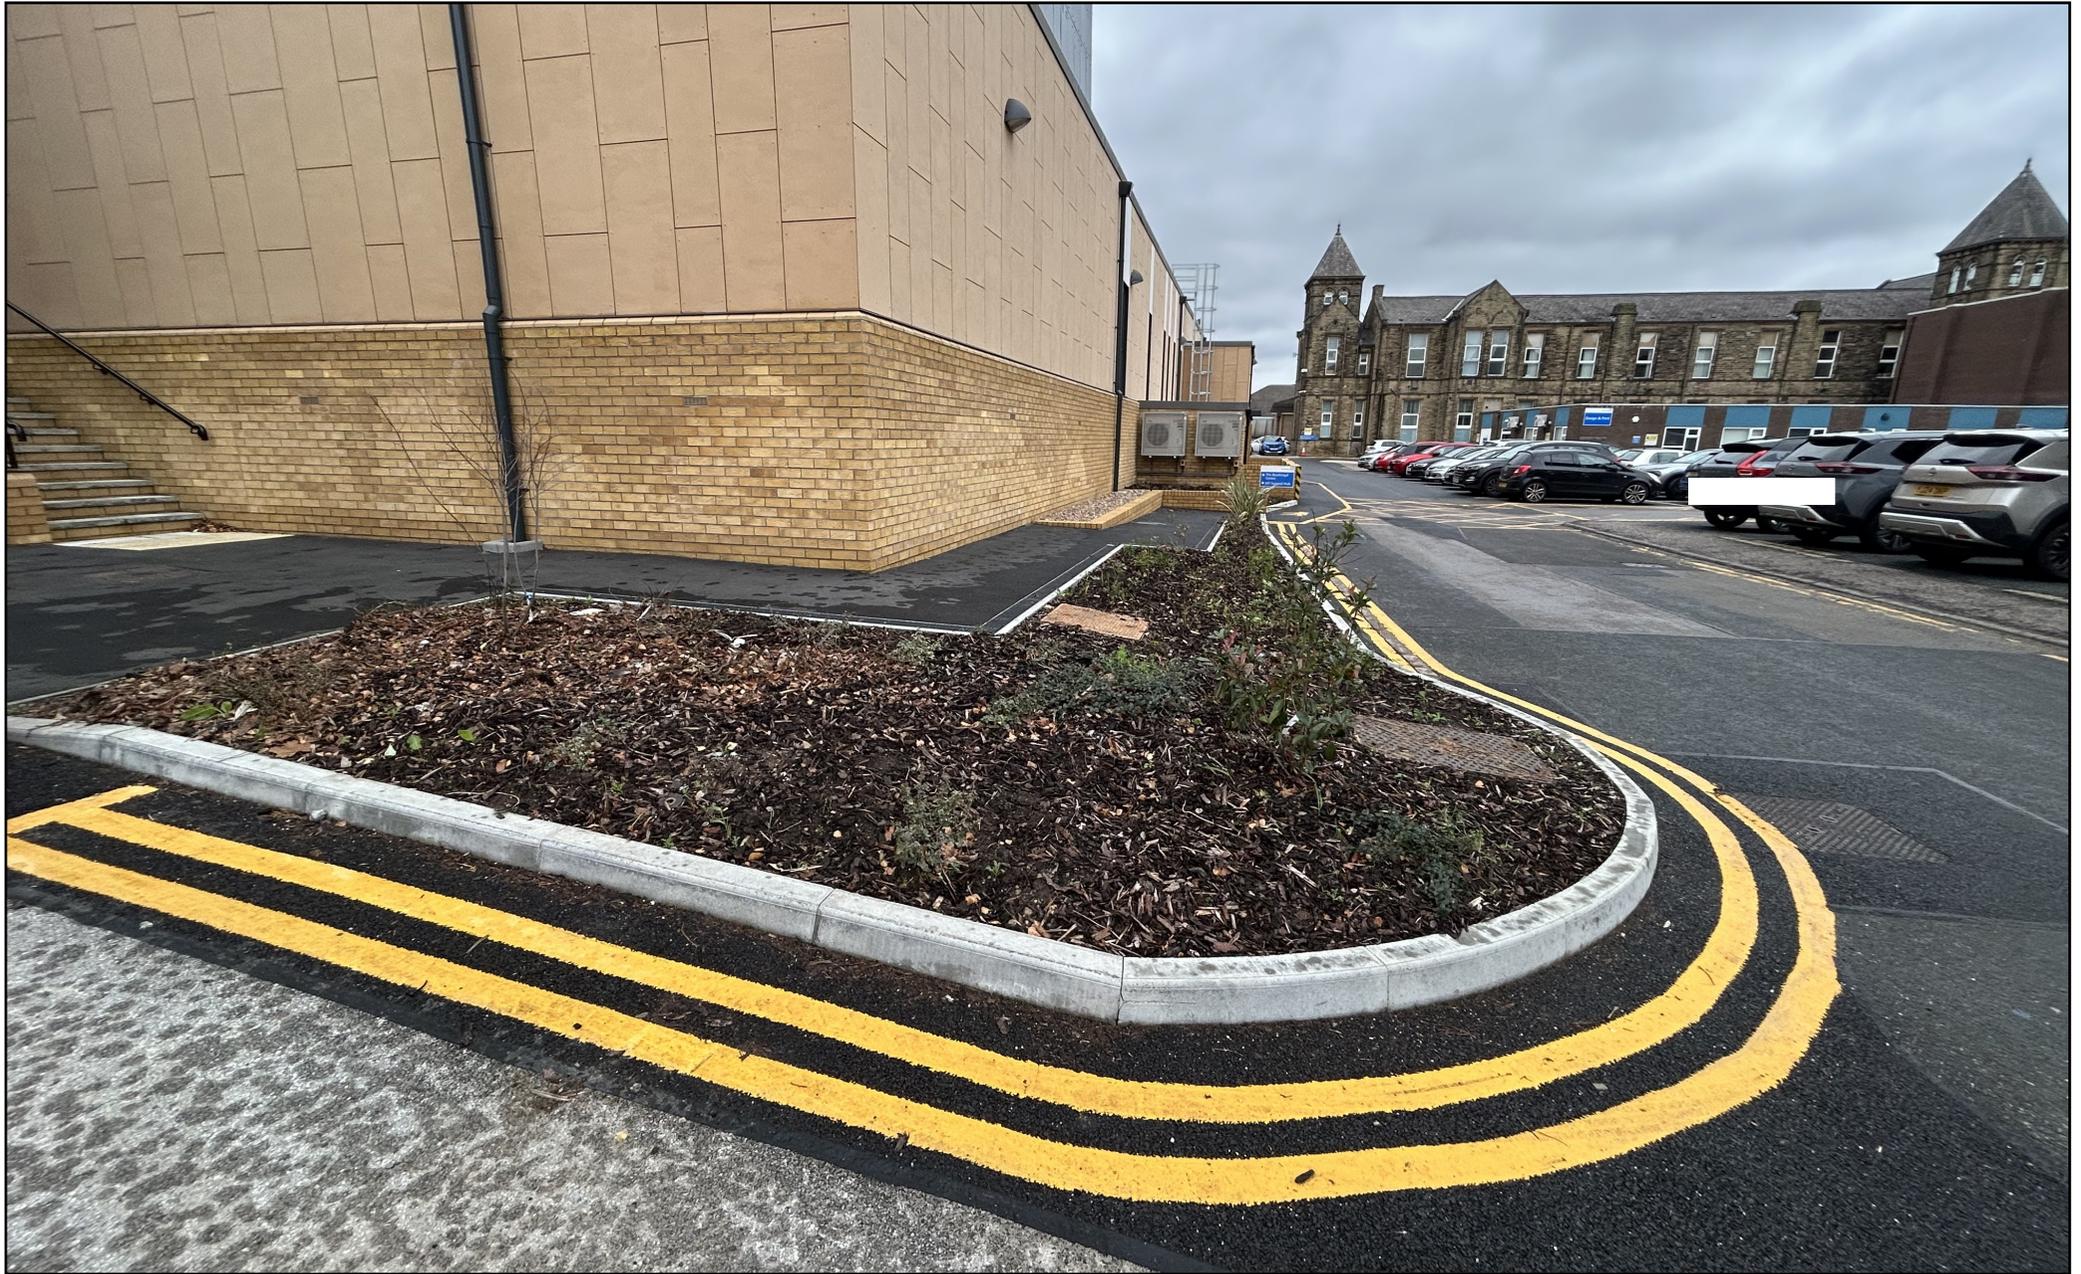
Trial pitting along the southeastern corner of the building confirmed that a cover system had been installed at between 215 to 440mm thickness. The cover system is composed of 200 to 250mm of topsoil underlain by 0 to 220mm of reworked Made Ground, underlying a geotextile separation layer. Two trial pits (DH1 and 2) intercepted concrete associated with Aco drains that appear to underly the soft landscaping area.

Photo 1 - View of soft landscaping area along southeastern corner of the building

The trial pits along the southeastern corner of the building confirmed that a cover system had been installed generally to between 414 to 440mm thickness (locally 215-224mm where concrete associated with the Aco drains was encountered) and underlain by a geotextile separation layer. Although this

thickness is at variance with the Remediation Strategy, given that the soft landscaping area is limited in extent and is unlikely to be used as a communal open space for recreational purposes, a revised minimum cover thickness of 300mm is considered suitable to remove any exposure pathways.

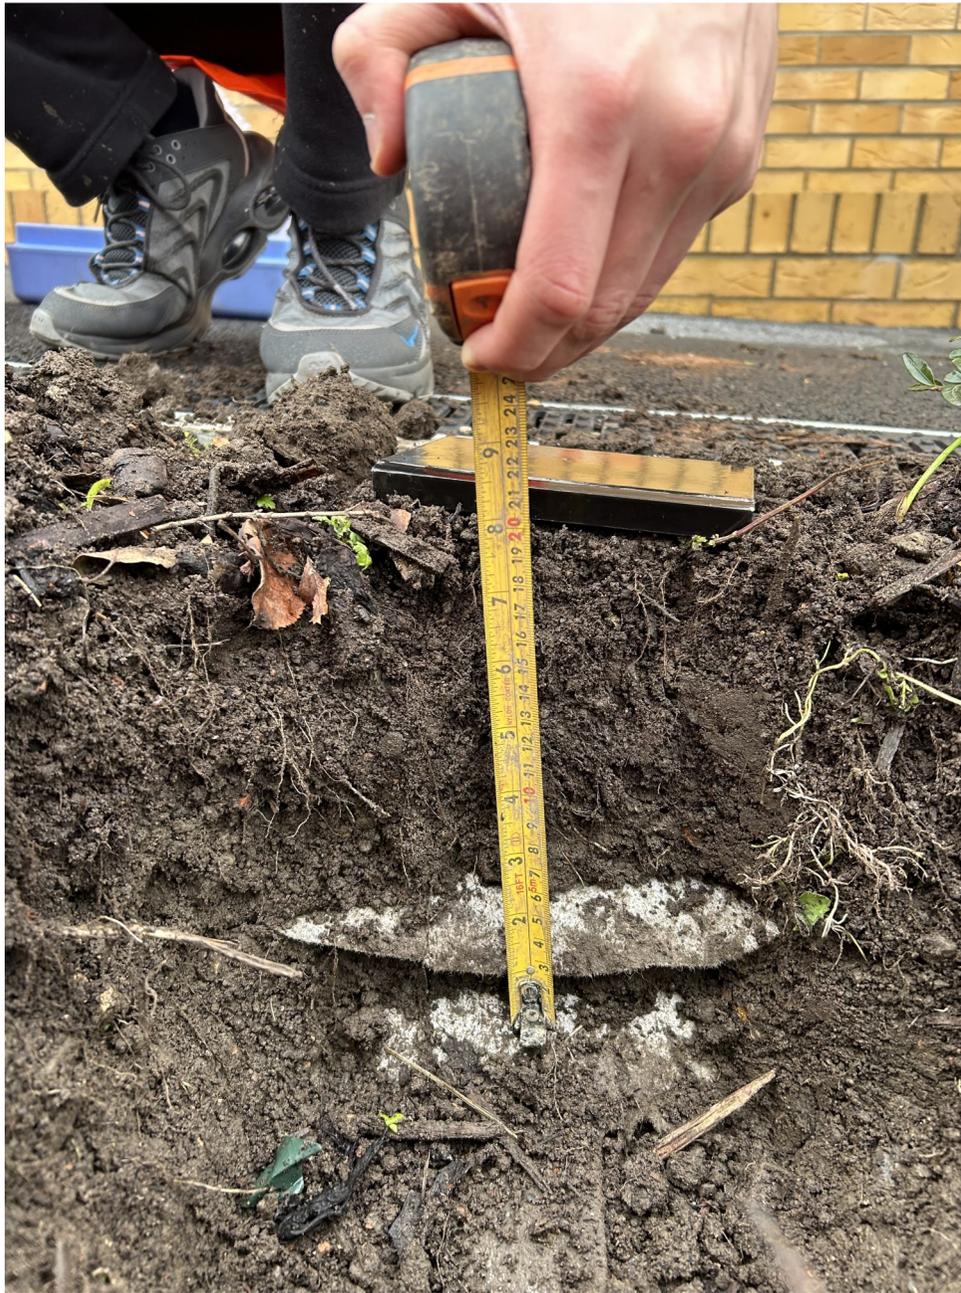
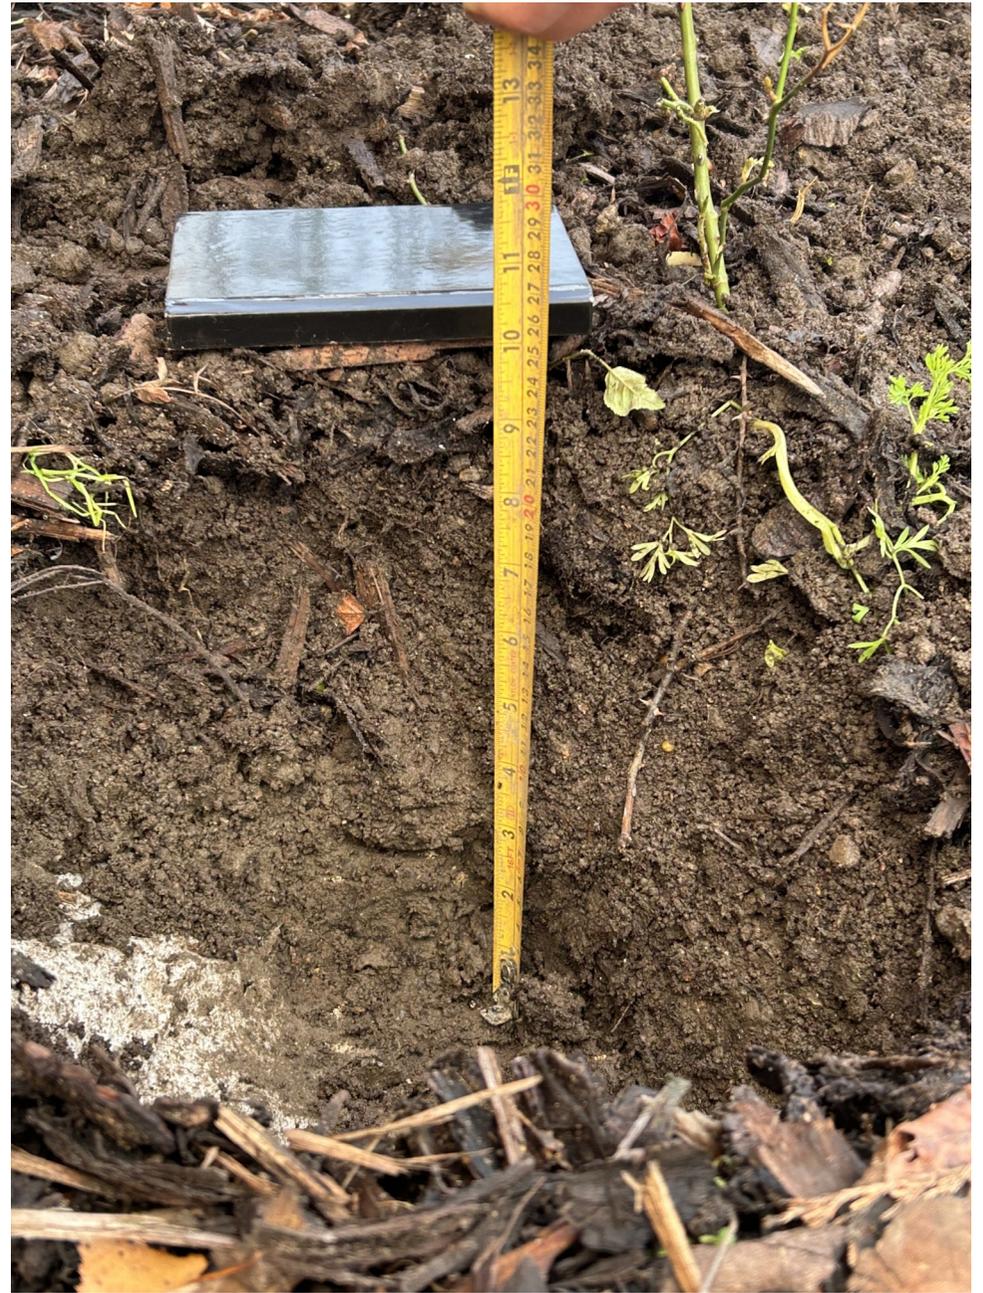
Photo 2a and 2b - View of DH1 (left) and DH4 to the top of the Made Ground (right)

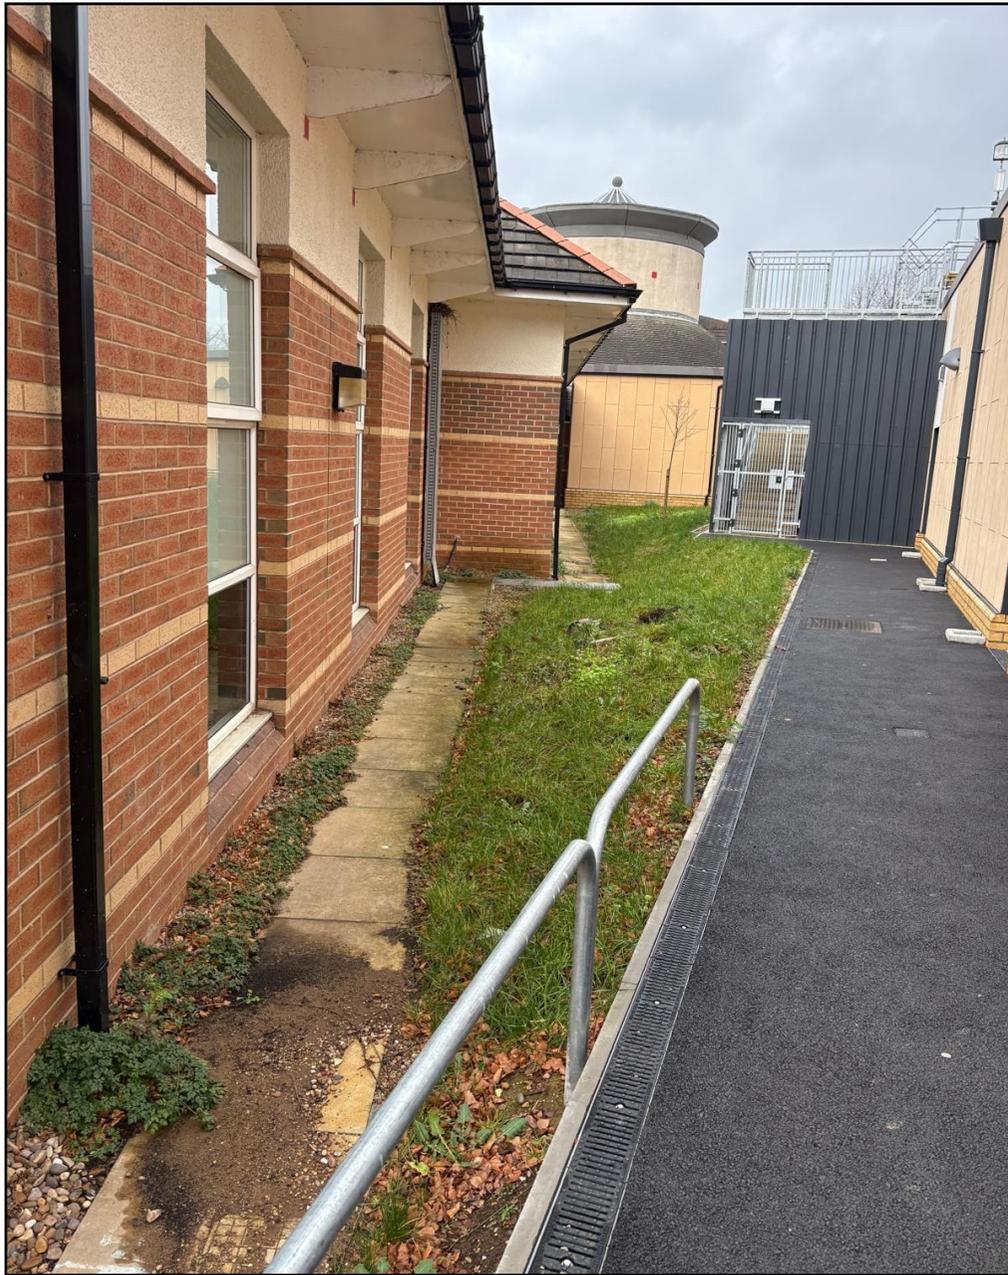
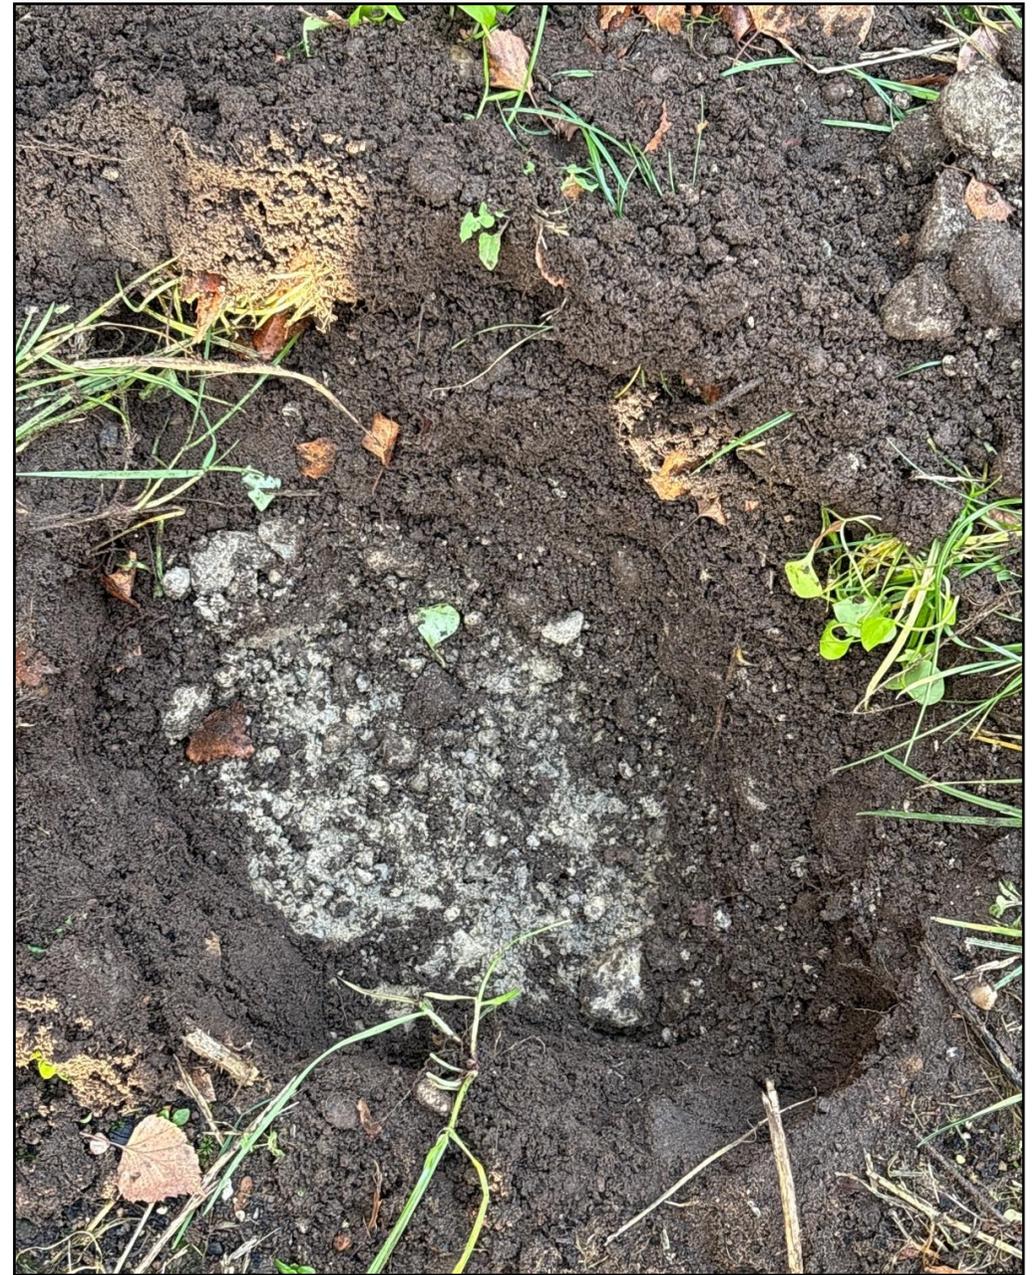
Trial pitting along the western margin of the building confirmed a variable cover system thickness had been installed across the area. In the central and southern sections (DH6 to 8), topsoil had been installed to a thickness of approximately 170 to 230mm and was underlain by a hard-to-dig layer composed of concrete. In the northern section (DH9), topsoil had been installed to a thickness of at least 660mm thick.

Photo 3a and 3b - View of soft landscaping area along western margin of building (left) and hard-to-dig layer below clean topsoil (right)

The trial pits along the western margin of the building confirmed that the cover system was composed of either at least 600mm of clean cover (DH9) or approximately 170 to 230mm of clean cover underlain by a hard-to-dig layer of concrete (DH6-8). Although a hard-to-dig layer is at variance with the Remediation Strategy, it is considered to act as a physical barrier preventing any exposure to the underlying Made Ground and is a suitable alternative.

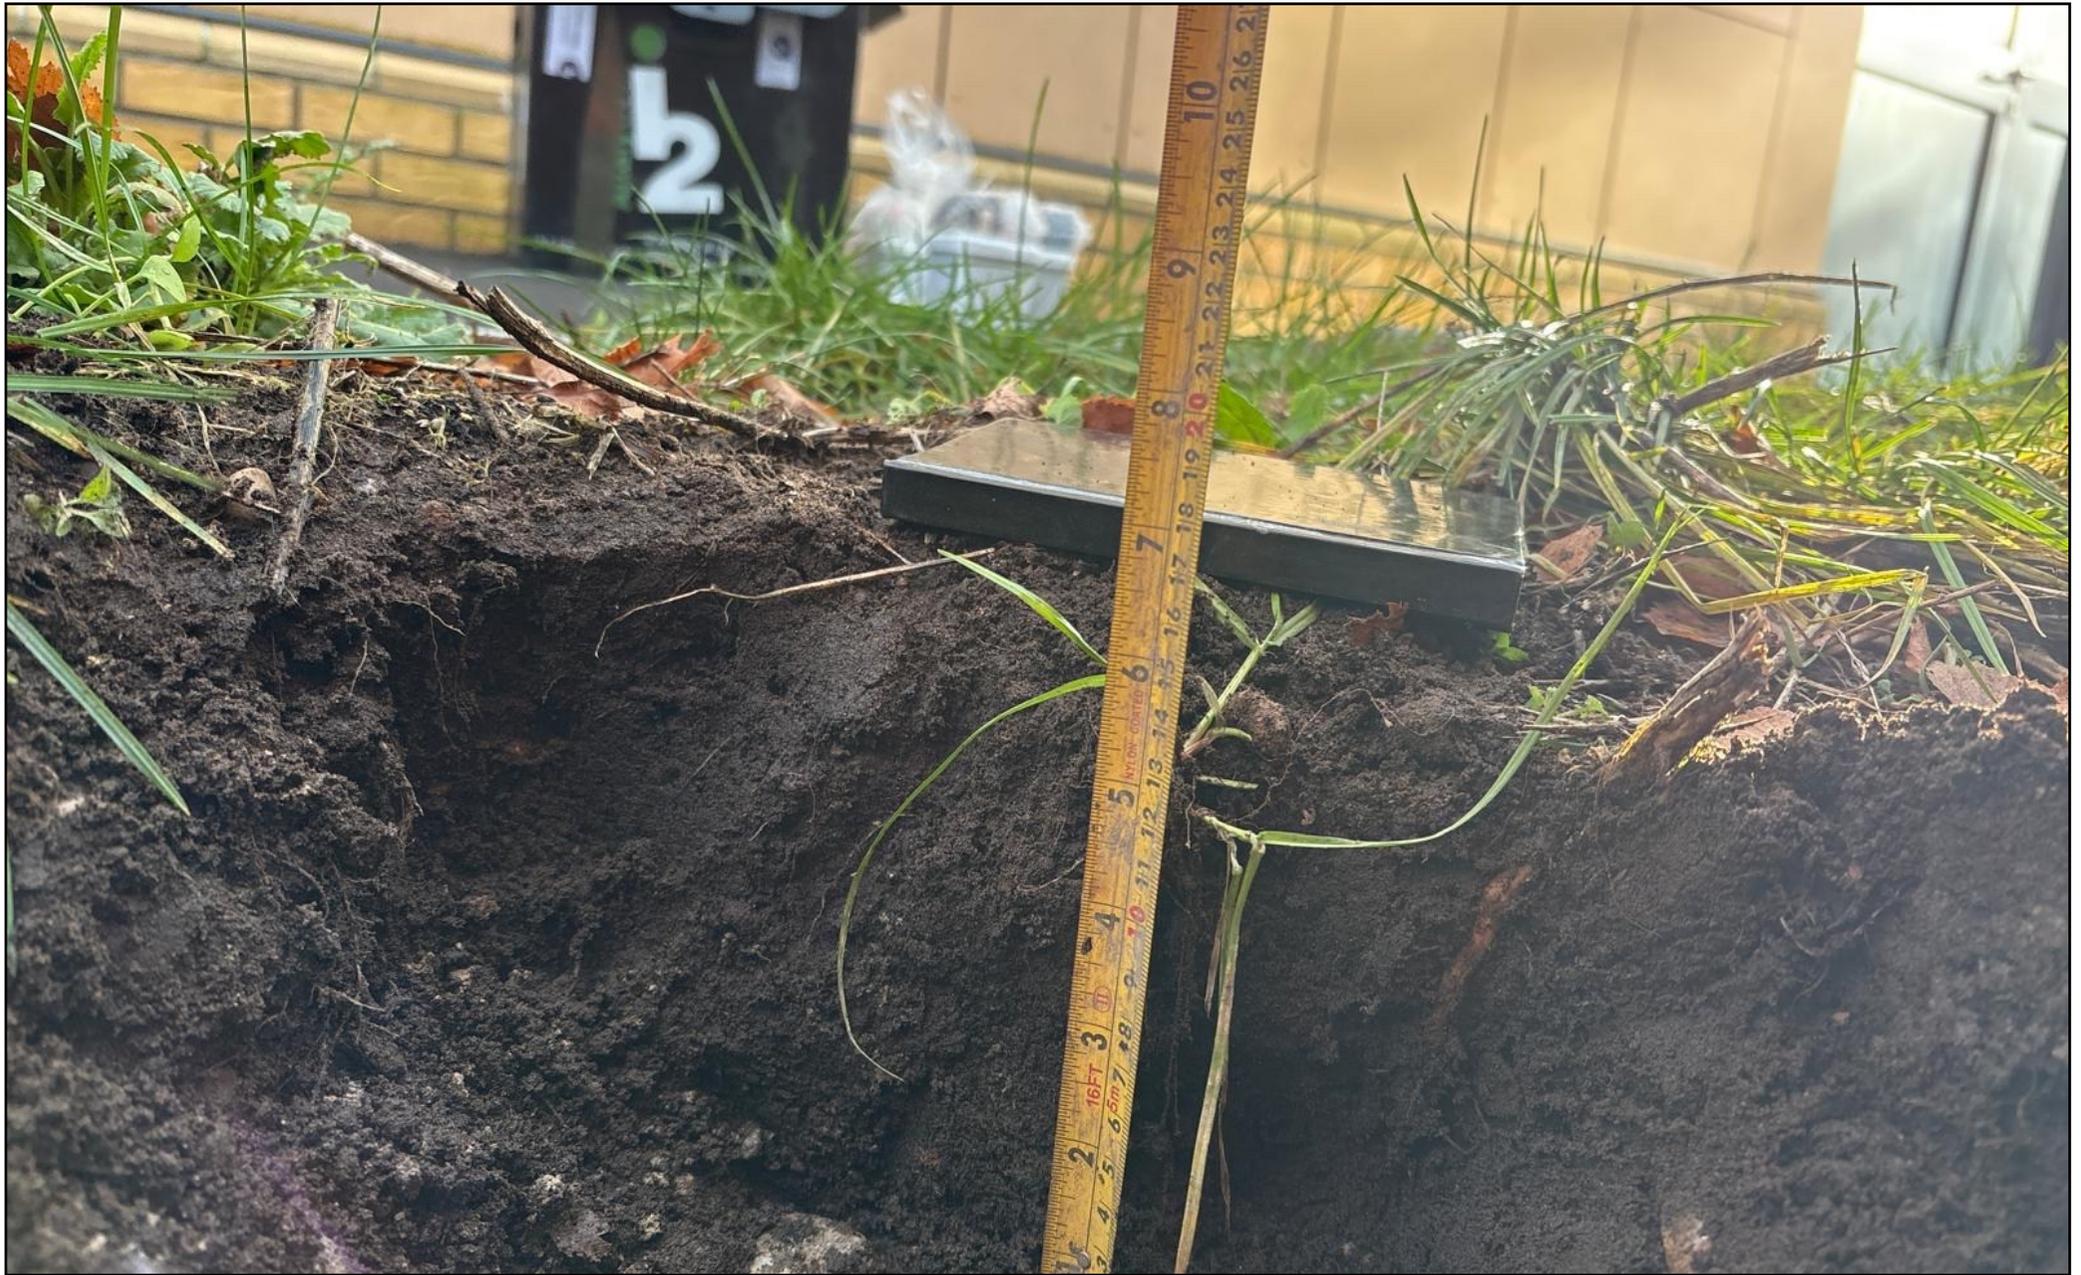
Photo 4 - View of DH7
