67 Hall Ing Lane, Honley

Bat Survey Report

26th June 2025

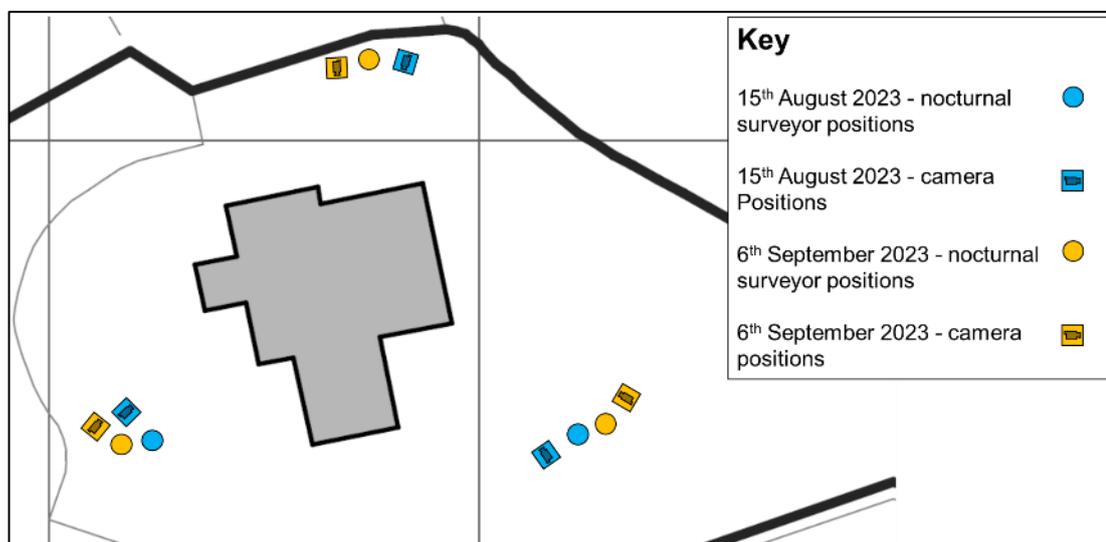
4.2.9 All surveyors were equipped with Wildlife Acoustics EM Touch bat detectors and iPad/iPod recorders. Three Canon XA10 video cameras were used during each survey visit. Surveyor locations and building numbers are shown in Figure 2.

Figure 2. Building numbers and nocturnal survey positions

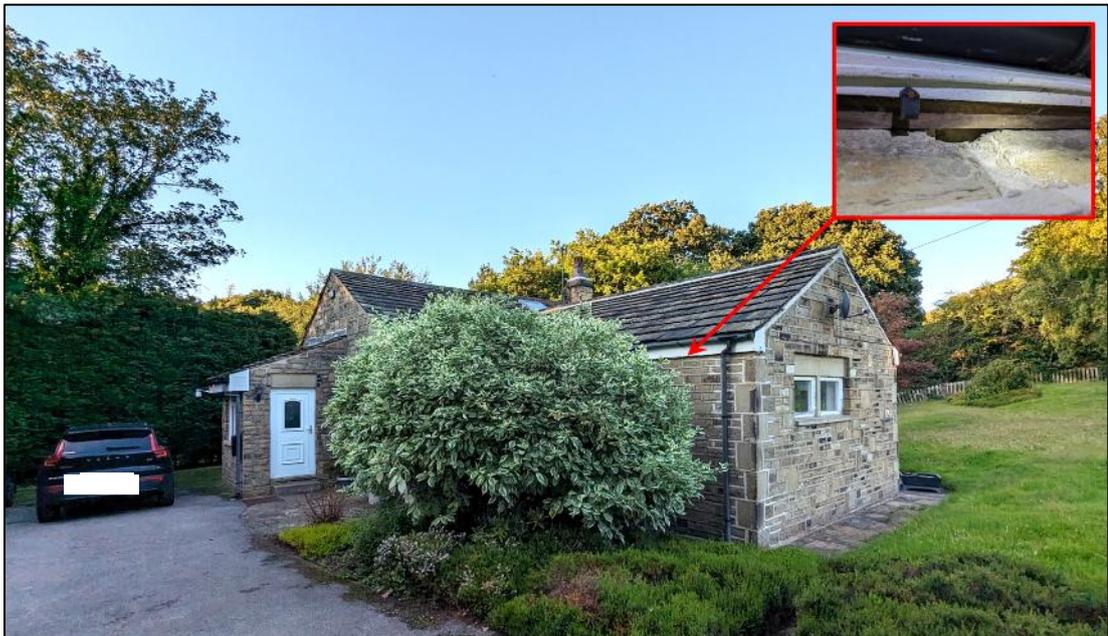
- 5.2.3 Potential roost features on the exterior of the dwelling were limited mainly to crevices present between stone roof slates (Plate 4), with such slates typically uneven in width. These gaps were particularly prominent on gable verges. Gaps were also present in places between wood fascia boards and the underlying masonry, with a cluster of three probable pipistrelle droppings recorded between a wooden fascia board and the wall on the west elevation (Plate 1). This finding of droppings behind a fascia board was considered to be evidence of a confirmed bat roost, likely a day roost.

Plate 1. South corner of dwelling, with roost location behind fascia board shown in subset image

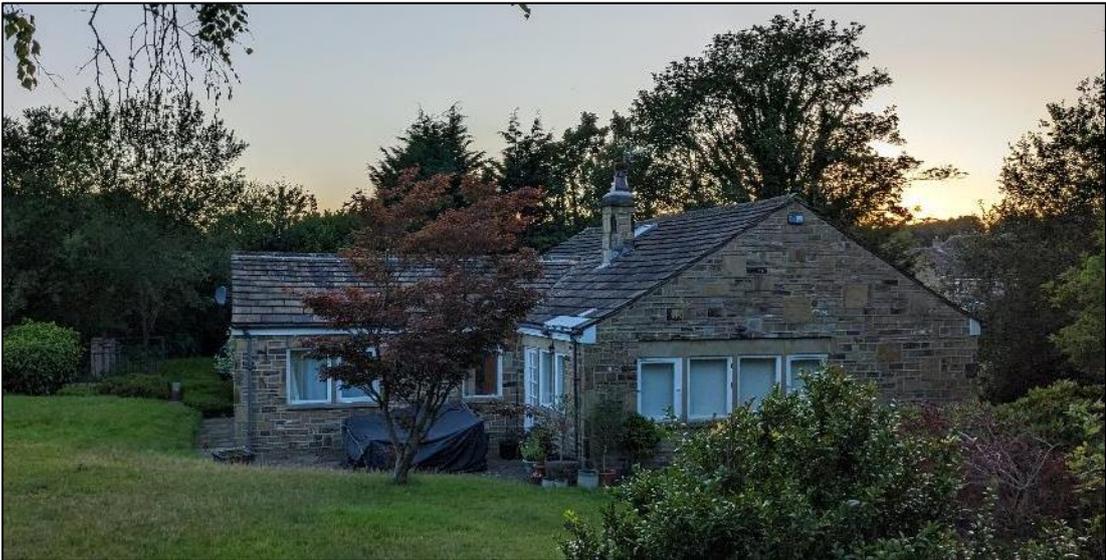
- 5.2.2 The surveyed dwelling comprised a stone-built bungalow with a multi-pitched stone-slate covered roof (Plates 1-3). The walls were expected to be of cavity construction. The building had three gables with mortar filled verges and a single-storey porch on the west elevation. A stone chimney was present. Wooden fascia boards were present with a plastic soffit on the east elevation. Single-paned wood-framed windows were present with a mix of wood and plastic doors present. Guttering was plastic.

Plate 2. East elevation of dwelling

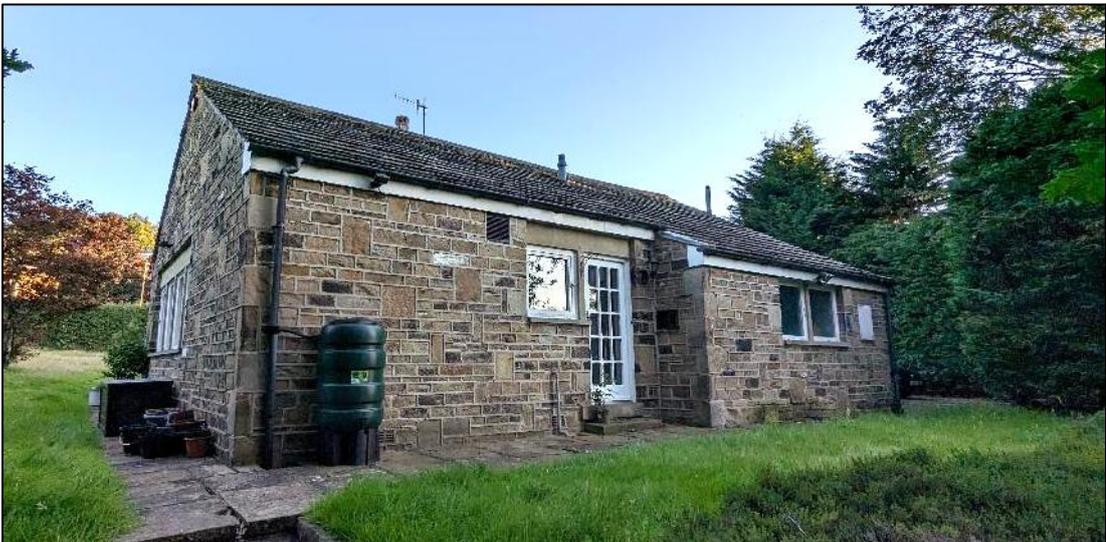
Plate 3. North elevation of dwelling

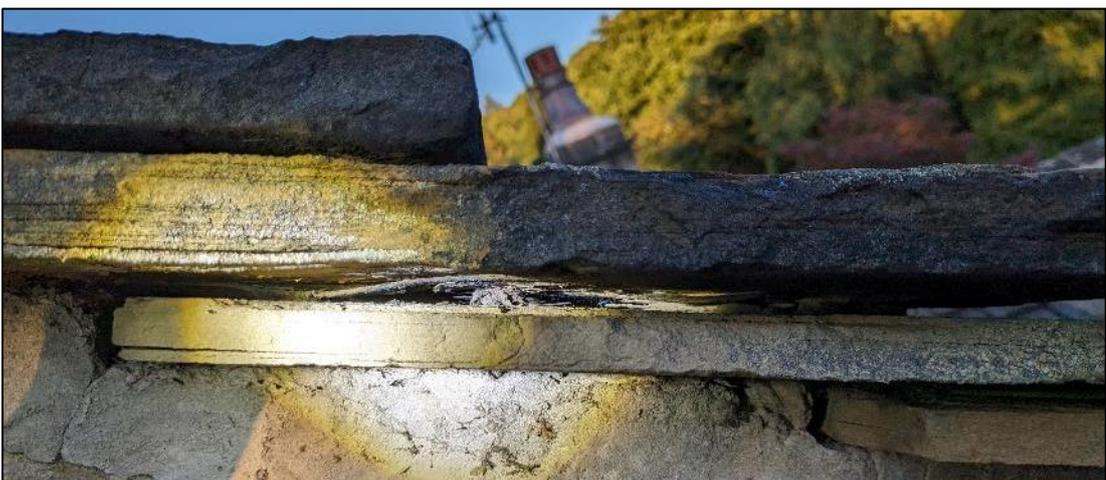
Plate 4. Example of gap between slates on verge

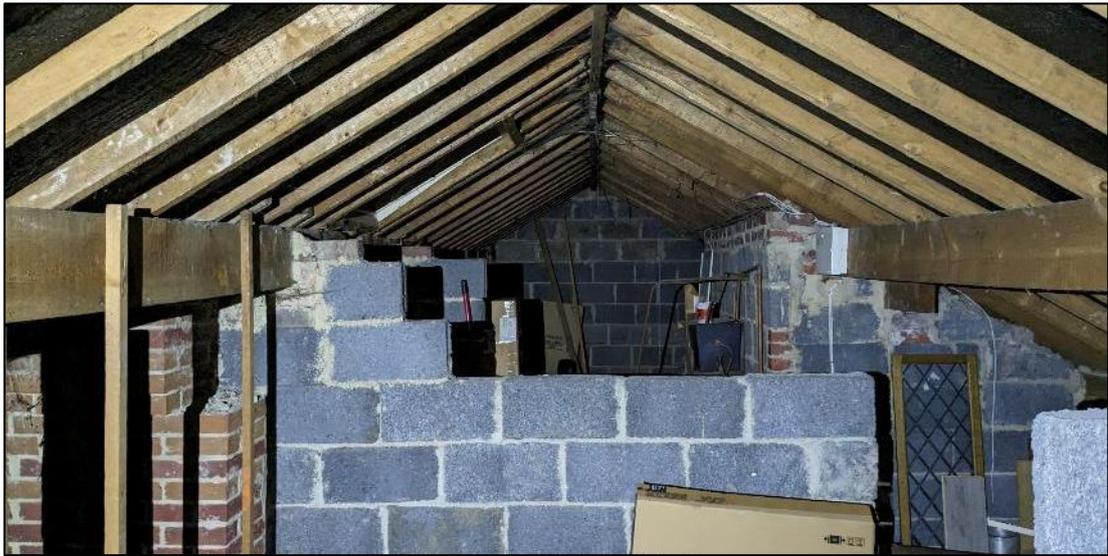
- 5.2.4 A large T-shaped roof void was present, with a maximum height of 2.2 m. The roof was mainly lined with hessian backed Type 1F bituminous felt, although some breathable roof membrane was present on the southern projection of the roof. The roof was suspended on a ridge beam, purlins, rafters and battens, with the ceiling mainly boarded out for storage but with c. 100 mm of glass-fibre insulation present elsewhere. Approximately five small (likely pipistrelle) bat droppings were recorded from within the roof void.
- 5.2.5 The surveyed building was considered to display a moderate level of bat roosting suitability. No evidence of bird nesting was recorded during the survey.

Plate 5. Roof void interior

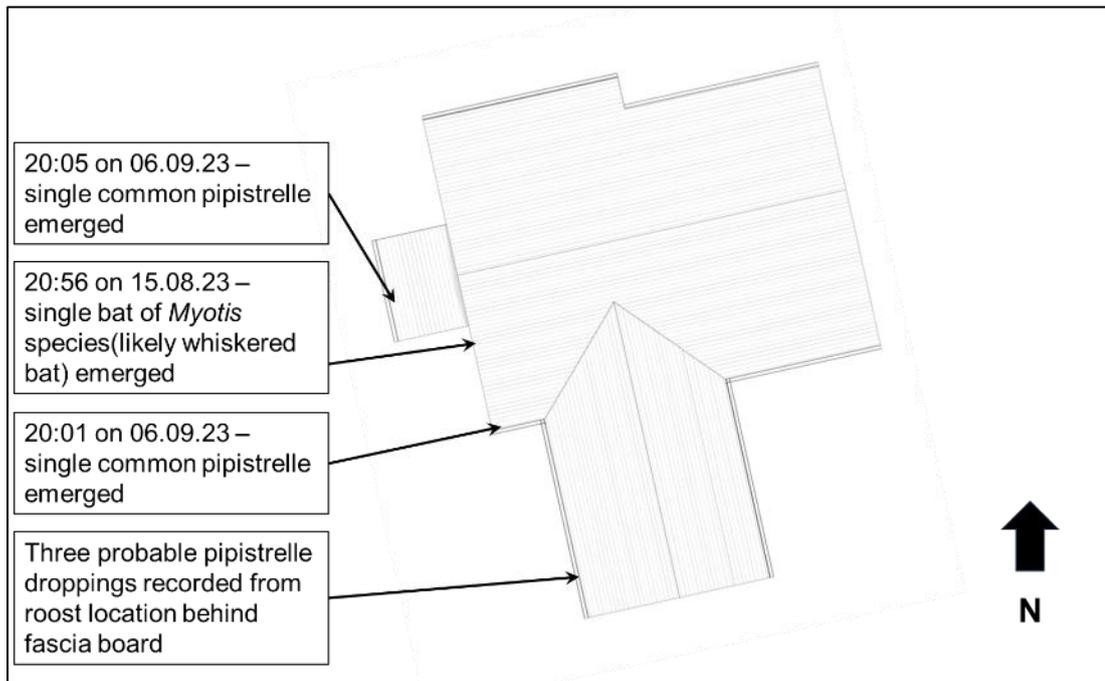
Figure 3. Bat roost evidence recorded

- 5.2.12 One bat roost location was recorded during the visual inspection, with this roost comprising a space behind the fascia board at the south end of the western elevation. The size and shape of droppings indicated pipistrelle bats, with common pipistrelle the only pipistrelle species recorded during nocturnal surveys. It is considered this roost is likely to comprise a common pipistrelle day roost. The low number of bat droppings scattered in the roof void are not considered indicative of roosting within this space.

- 5.2.13 Three roosts were recorded during the nocturnal surveys. These roosts included a roost on the western gable verge used by a single bat of a *Myotis* species, considered likely to be a whiskered bat. This roost was assessed as being a day roost. Two common pipistrelle day roosts were also recorded, one from the fascia board at the south end of the west gable and a second from the lower edge of the porch roof on the west elevation.

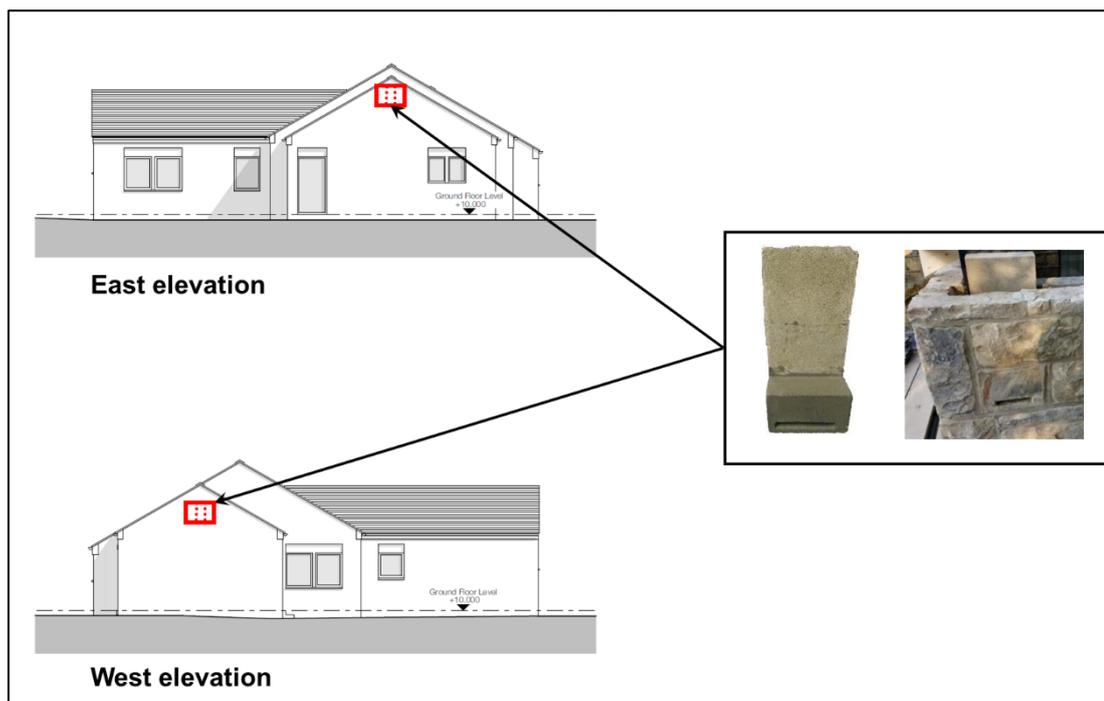
Figure 4. Proposed locations of two new interconnected sets of three PRO UK Build-in WoodStone Bat Boxes

- 6.3.7 In order to provide long-term alternative bat roosting provision in the re-modelled dwelling, it is recommended that two connected sets of three PRO UK Build-in WoodStone Bat Boxes (or equivalent) should be installed in both the east and west elevations of the new dwelling (see Figure 4). This compensatory roost provision would

be suitable to compensate for the slim residual possibility of a crevice roosting bat species (i.e. common pipistrelle or whiskered bat) using the site building

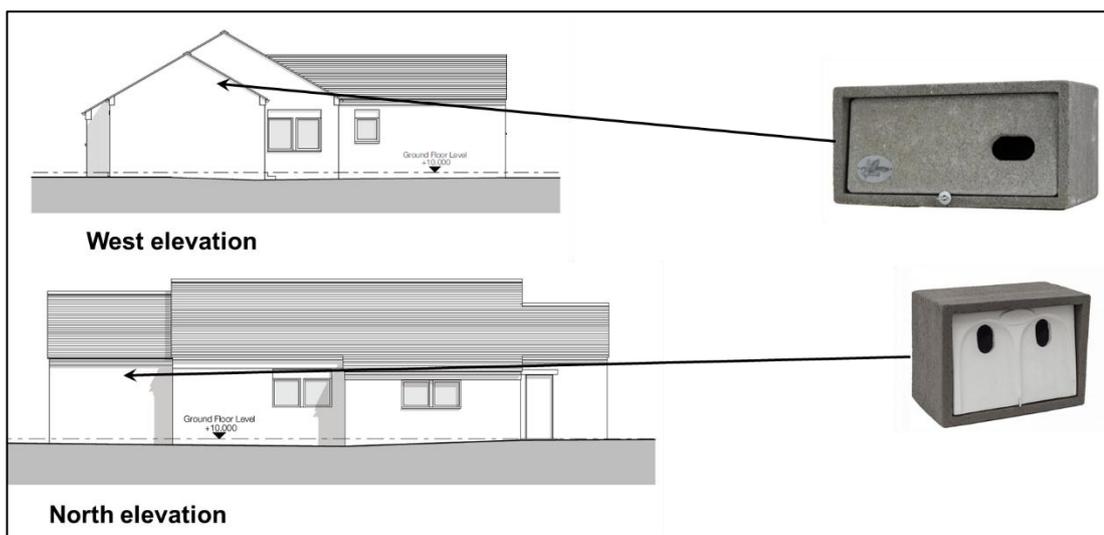
Figure 5. Proposed swift brick and sparrow box locations

- 6.3.11 In accordance with the aims of the National Planning Policy Framework, and to compensate for the loss of bird nesting habitat associated with the outbuilding, it is recommended that one integrated swift *Apus apus* box (i.e. the Orlando Swift Box (Figure 5)) be installed within the dwelling. This box should be fitted in the west gable. Studies have shown that swift boxes are used by other bird species that utilise buildings and consequently this measure will provide potential nesting space for house sparrows and starlings *Sturnus vulgaris*, in addition to potentially providing future nest space for swift. It is also recommended that one Vivara Pro WoodStone® House Sparrow Nest Box be integrated into the proposed north elevation (Figure 5).
