**Flood Risk Assessment and Drainage Strategy Report**  
**Roslyn Avenue, Netherton**  
**Harron Homes (Yorkshire) Ltd**

| <b>Project</b> | Roslyn Avenue, Netherton | | |
| <b>Title</b> | Flood Risk Assessment and Drainage Strategy Report | | |

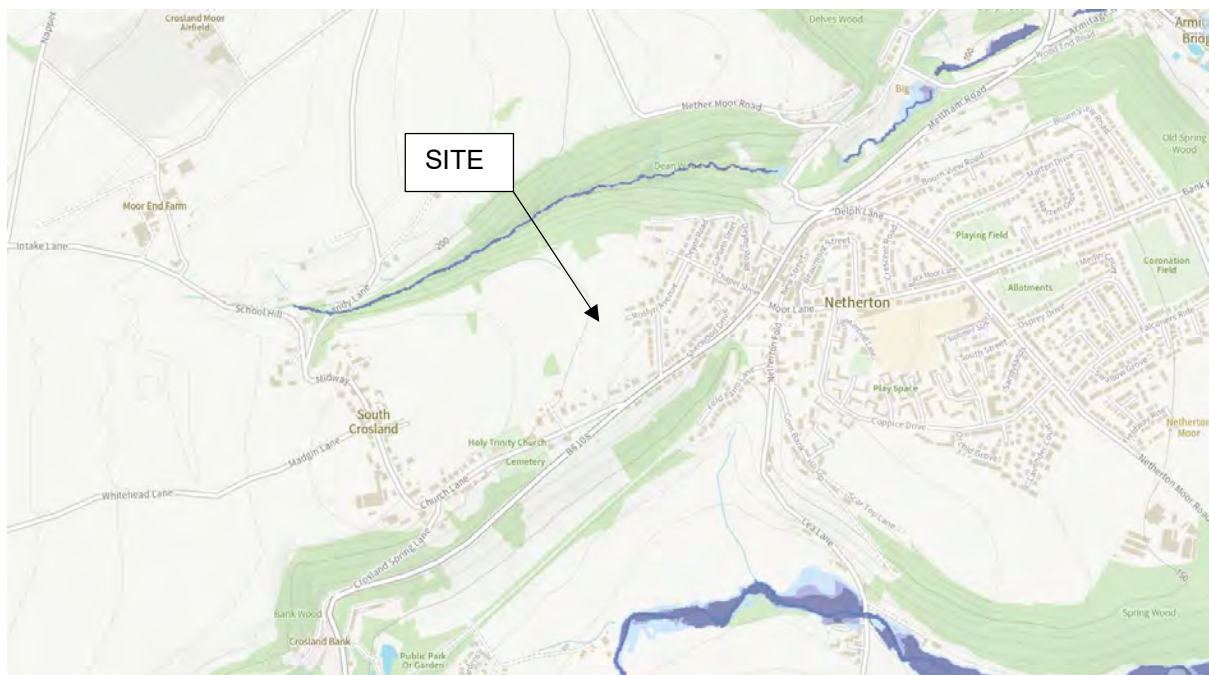
Figure 2 - Environment Agency Risk of Flooding from Rivers and Sea mapping for the site.

The Environment Agency flood mapping shows the site is not affected by flooding from fluvial sources.

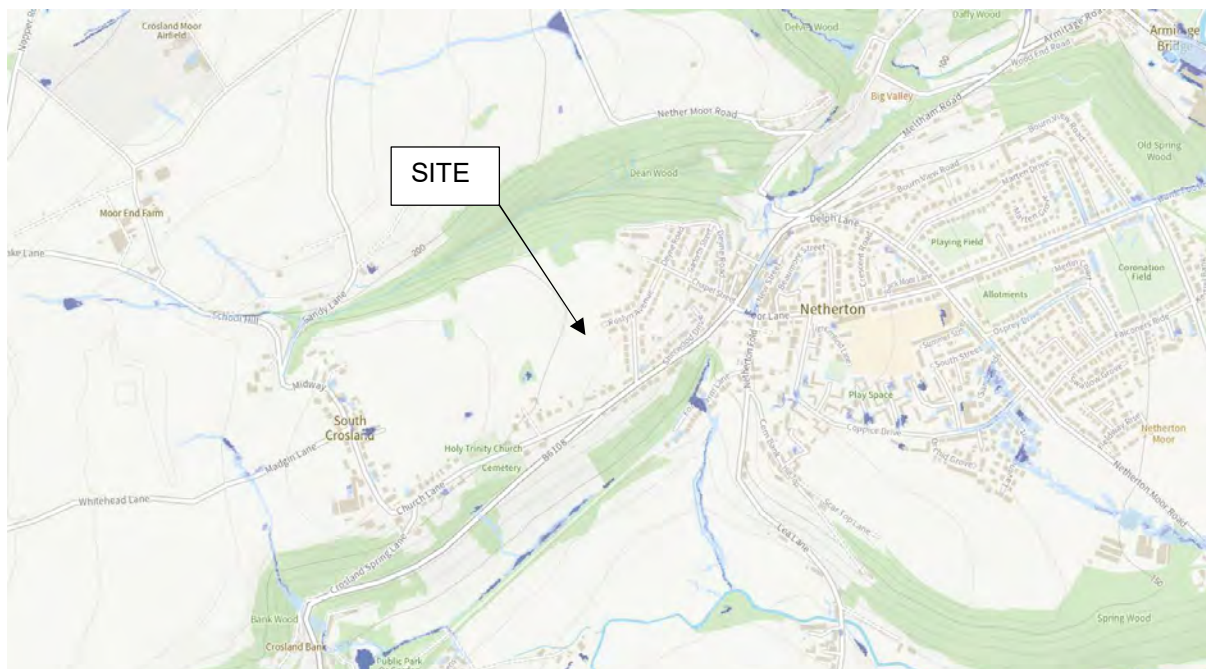
Figure 3 - Environment Agency Flood Mapping - Flood Risk from Surface Flooding – Low Risk

From the Environment Agency mapping the development is therefore not considered to be at risk of flood from Pluvial Sources.

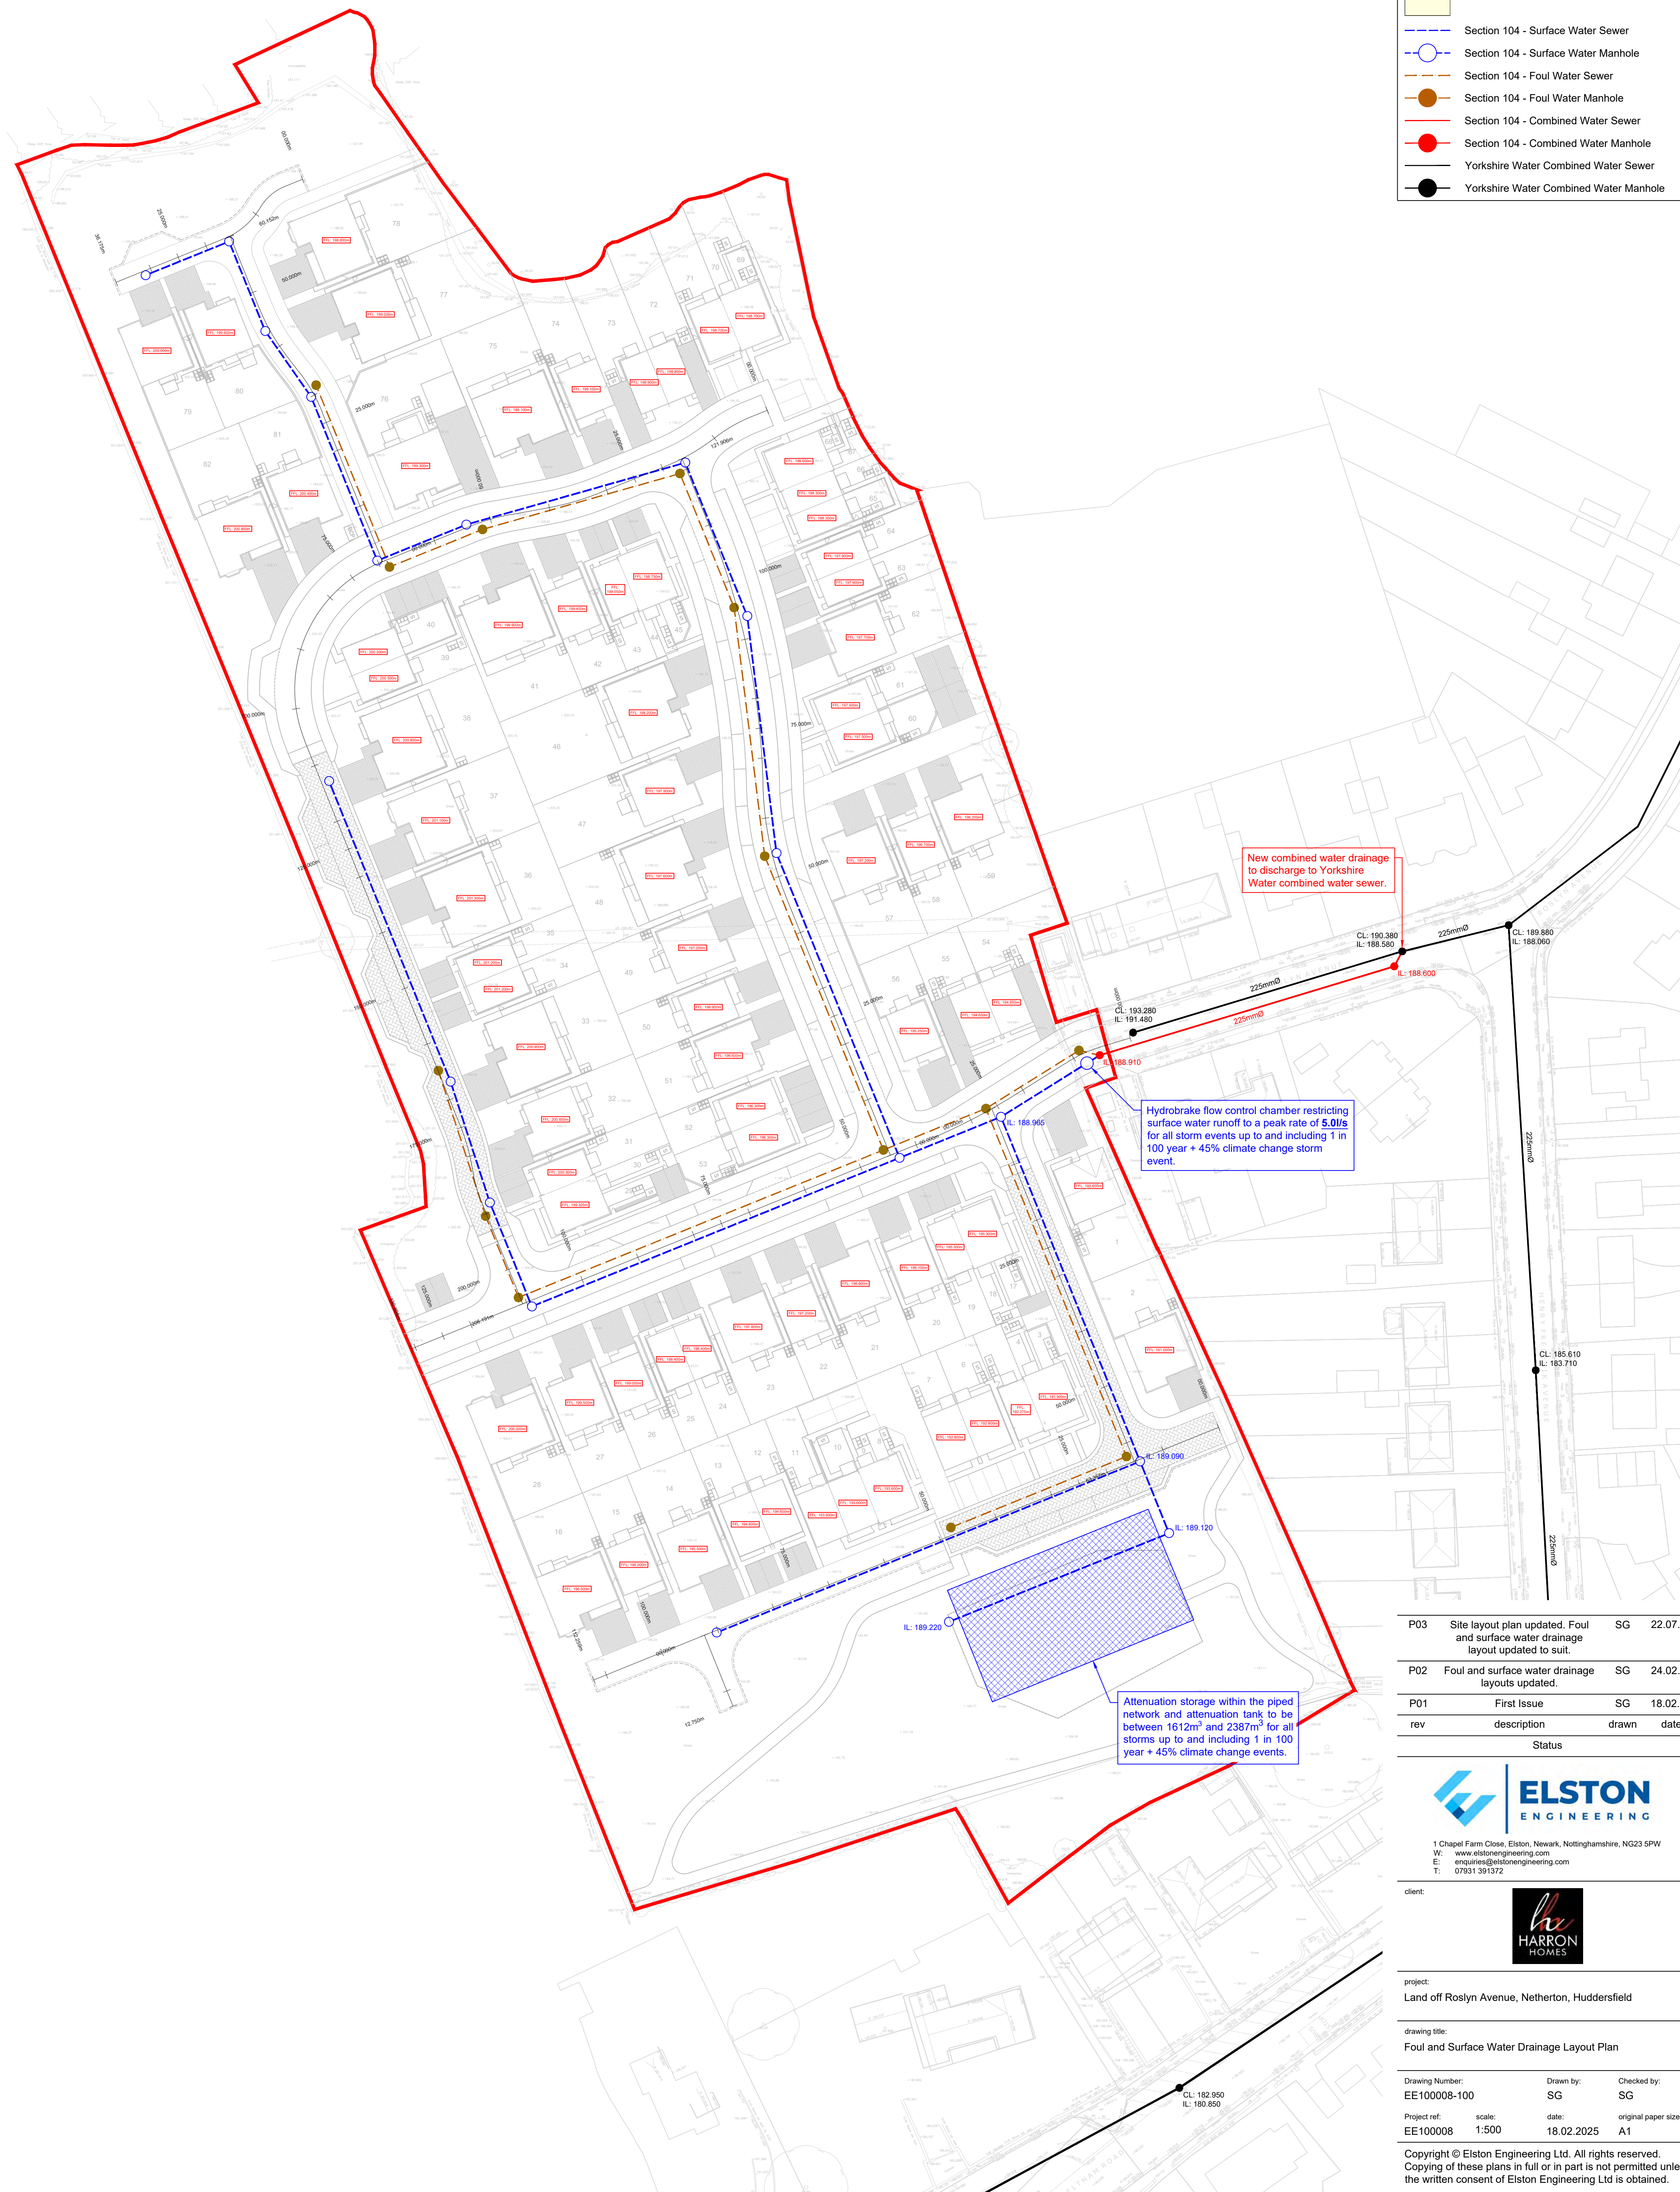
- Site Boundary
- Section 104 - Sewer Easement
- Section 104 - Surface Water Sewer
- Section 104 - Surface Water Manhole
- Section 104 - Foul Water Sewer
- Section 104 - Foul Water Manhole
- Section 104 - Combined Water Sewer
- Section 104 - Combined Water Manhole
- Yorkshire Water Combined Water Sewer
- Yorkshire Water Combined Water Manhole

| P03 | Site layout plan updated. Foul and surface water drainage layout updated to suit. | SG | 22.07.25 |

An indicative foul and surface water drainage layout plan, drawing EE100008-100 can be found in Appendix E.
