ARBORICULTURAL REPORT

to BS 5837:2012 at:

***14 Manor Road,
Farnley Tyas,
Huddersfield,
HD4 6UL***

Reference: *AWA6782*

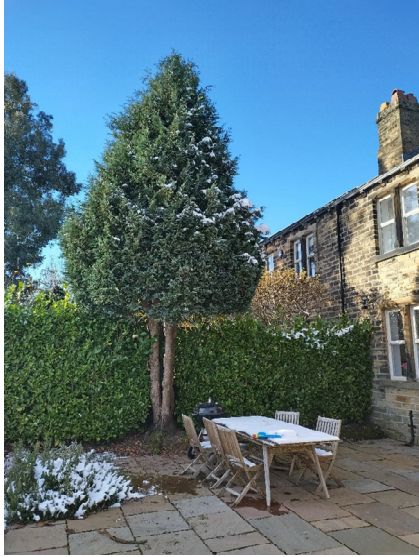
Photo 1: T1, looking west

- 3.2.7 T1 Cypress is located close to the site's western boundary and is similar in stature to T2. This tree currently offers only a low level of amenity value.

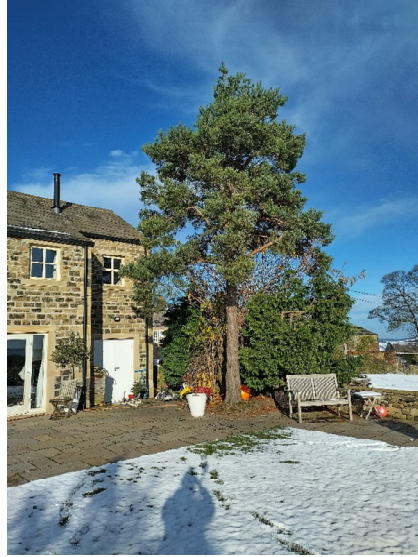
Photo 2: T2, looking northeast

- 3.2.5 All of the trees are semi-mature, with a mix of species and sizes. Species on site includes Pine, Cypress and Cherry.
- 3.2.6 The sites most significant tree is T2, a semi-mature Pine. Situated close to the site's eastern boundary. This tree is the most notable in size and species in the survey area, but currently offers only a low level of amenity value.

4.2.3 The trees to be removed are all lower value, retention category 'C'. T2 is a semi-mature Pine, T3 and T5 are young to semi-mature Cypress and T4 is a semi-mature Cherry. T2 displays signs of historical pruning wounds and snapped branches in the crown. T3, T4 and T5 show signs of historic hard pruning works and have poor forms as a result. Due to the low value of the trees to be removed, the removals will have only a negligible negative arboricultural impact.

4.2.2 The trees that require removal to facilitate the development are T2, T3, T4 and T5.

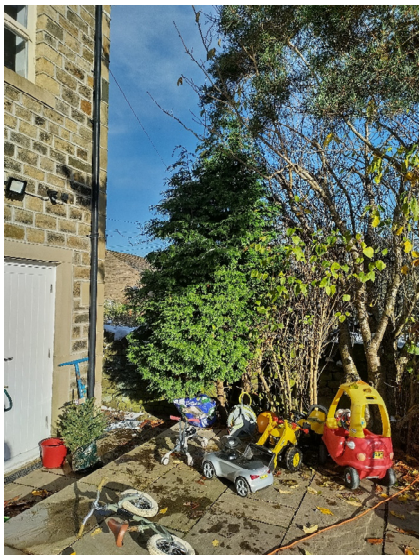
Photo 3: T3, looking east

- 3.2.8 T3 – T5 are multi stemmed specimens of Cypress and Cherry that display signs of historic pruning works consisting of stem and branch removal. These

trees are located along the eastern site boundary wall and offer a low level of amenity value.

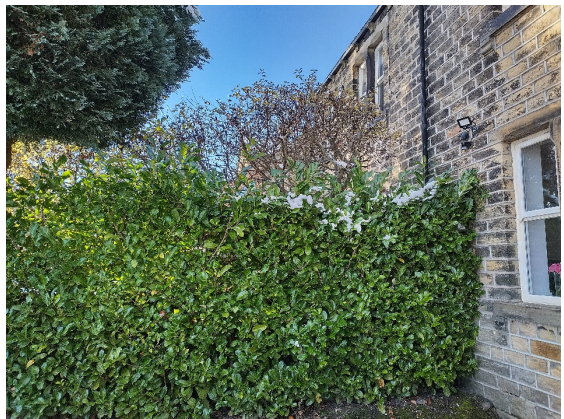
Photo 6: T6 adjacent tree, looking west

Tree Species		Measurements					Crown (m)				Tree Condition					Value		Management				
Tree ID	Common Name	Latin Name	Maturity	Height (m)	Stems	Stem Diameter (mm)	Estimated	Crown height	N	E	S	W	Roots	Stem	Crown	Comments	Physiological	Structural	Life Expectancy	Amenity	Category	Works
T6	Goat Willow	<i>Salix caprea</i>	Semi-mature	4.5	2	100, 100	Yes	1.5	1	1	1	1	Limited access around base	Twin stemmed	Old pruning wounds	Adjacent tree, not inspected in detail. Managed in small form	Fair	Fair	10 to 20 yrs	Low	C	No works required

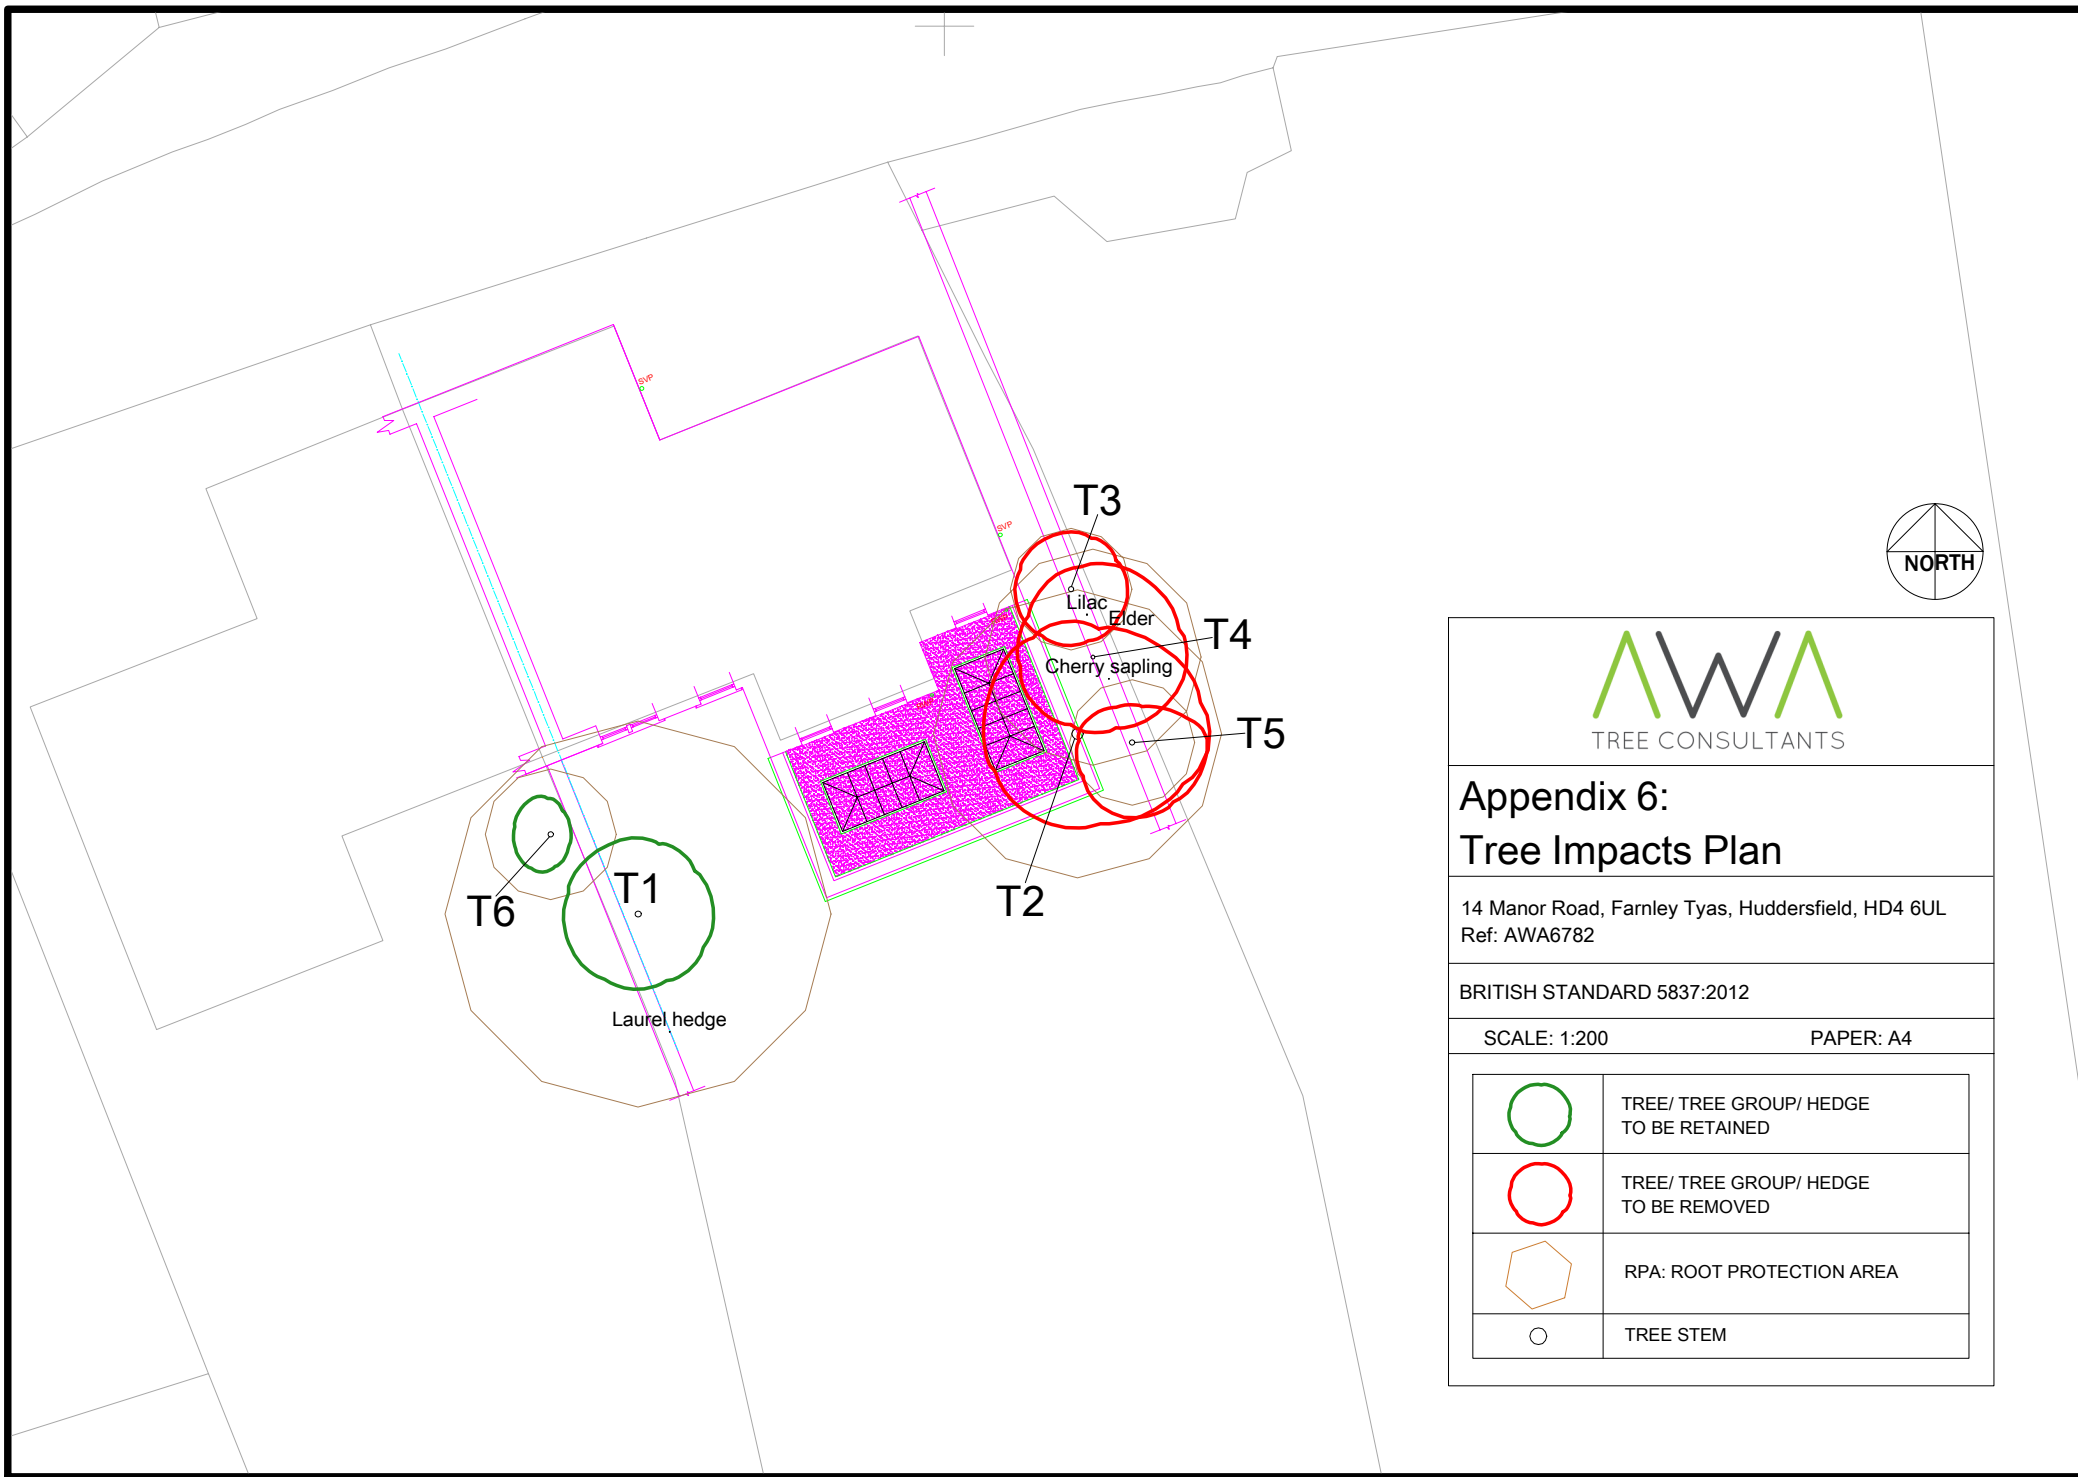
Appendix 6: Tree Impacts Plan

4.2.1 From assessing the new development proposals, 4 trees will require removal to facilitate the development as they are situated in the footprint of the development or their retention and protection throughout the development is not suitable.

4.3.2 Potentially damaging activities are proposed in the vicinity of retained trees. The new development encroaches close to and into the edge of the RPA of T1. Construction within the RPA, can have negative impacts on tree roots. However, the encroachment is very minor, and the detailed RPA for these trees is likely to be a slightly exaggerated representation of the trees actual rooting area. As such, it is unlikely that significant roots will be within these areas and the retained tree should remain largely unaffected by the works, provided care is taken during construction.

4.5.1 An associated Arboricultural Method Statement, detailing protective fencing specifications and construction methods close to the retained trees has been provided.
