## Green belt remains green belt

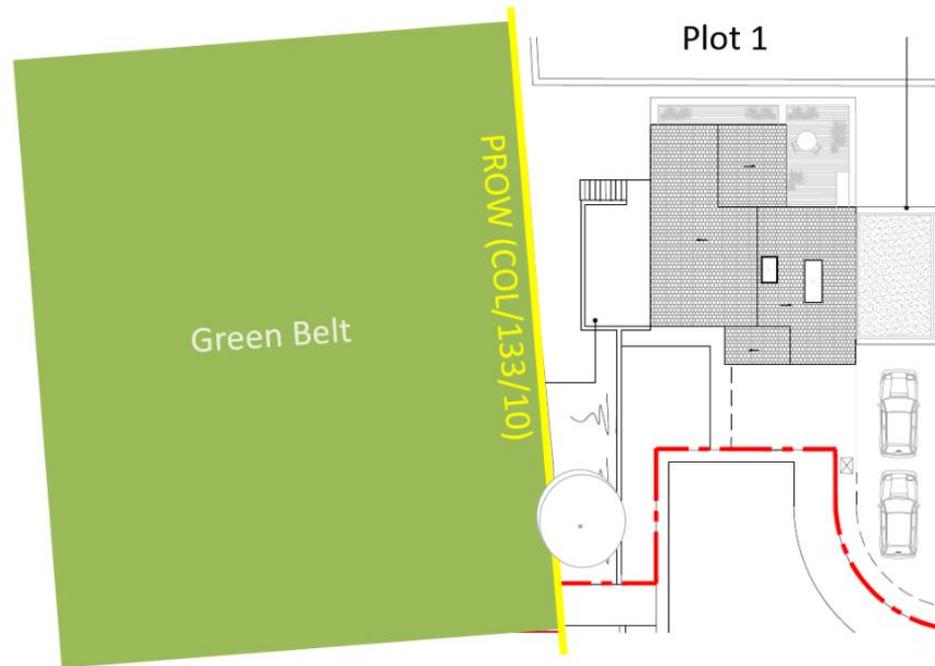
From within the dwelling, the elevated position may offer far-reaching views that are undoubtedly desirable to the occupant. But from the Green Belt or PROW, the experience is markedly different. There is no soft edge, no transitional landscaping, and no visual containment. The

building dominates the scene—its massing, glazing, and architectural assertiveness shows minimal regard for principles of edge-softening and contextual design.

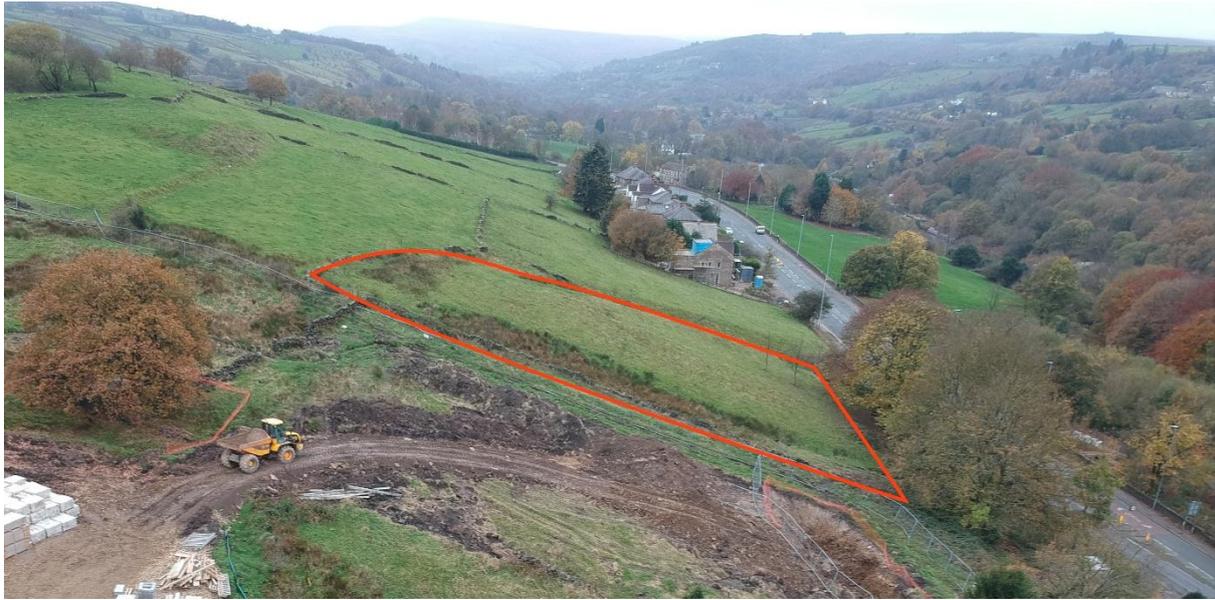
To the northwest of the site lies designated Green Belt land where permission has been granted for the installation of an attenuation tank: *see photograph above*. While the tank is required to be buried underground, the natural slope of the land means that part of the structure will protrude above the original field level. This exposed section is to be covered with soil, resulting in a raised landform that cannot be returned to its original state. Planning documents acknowledge that this specific footprint is permitted to remain altered. However, by implication, the remainder of the field—beyond the tank’s immediate footprint—**must** be reinstated to its original contours and character: *see image below*.

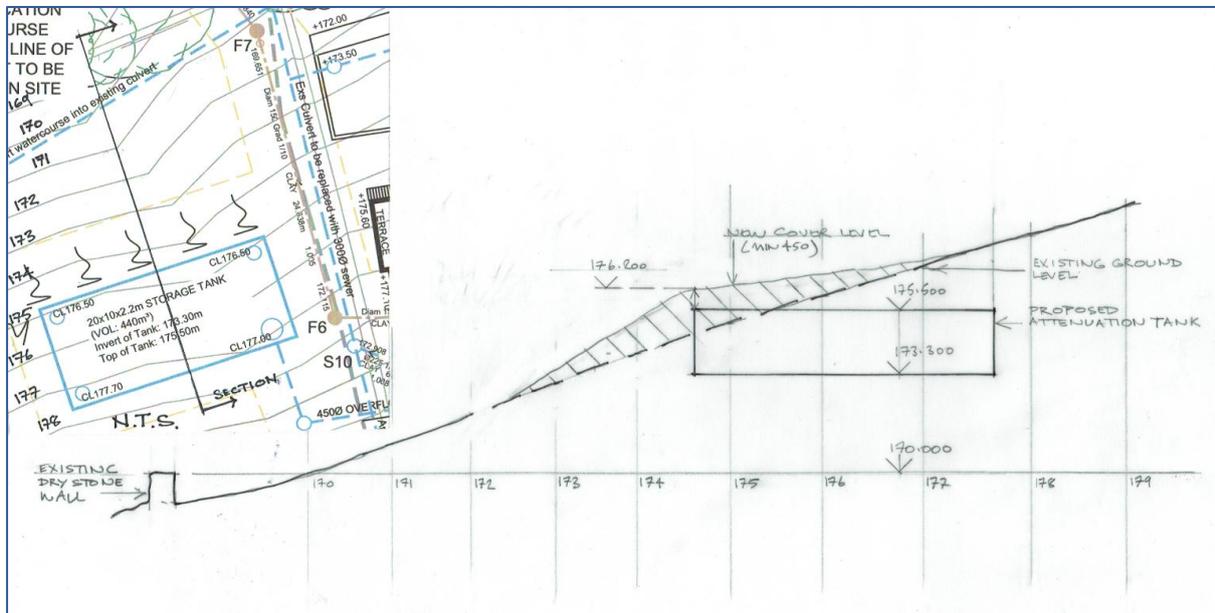
The regraded soil profile is shown above. Existing ground levels to be returned above, below and around the tank.

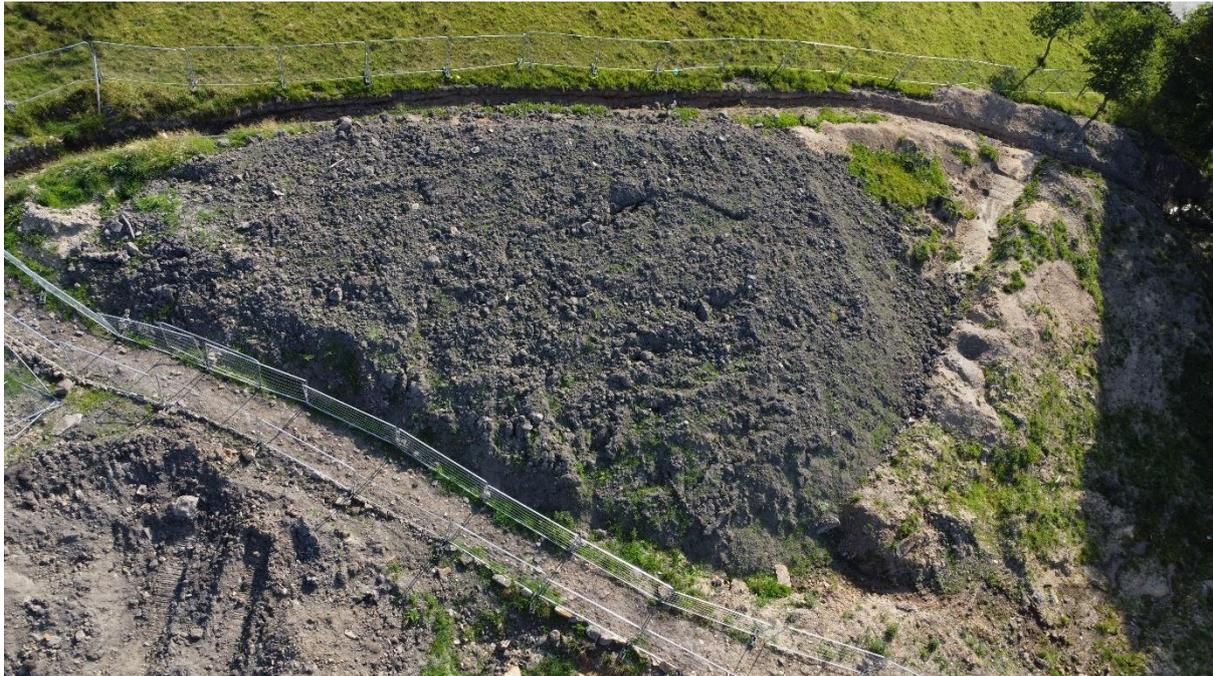
The photograph above shows how much soil was dumped on the green belt before the attenuation tank was even started.

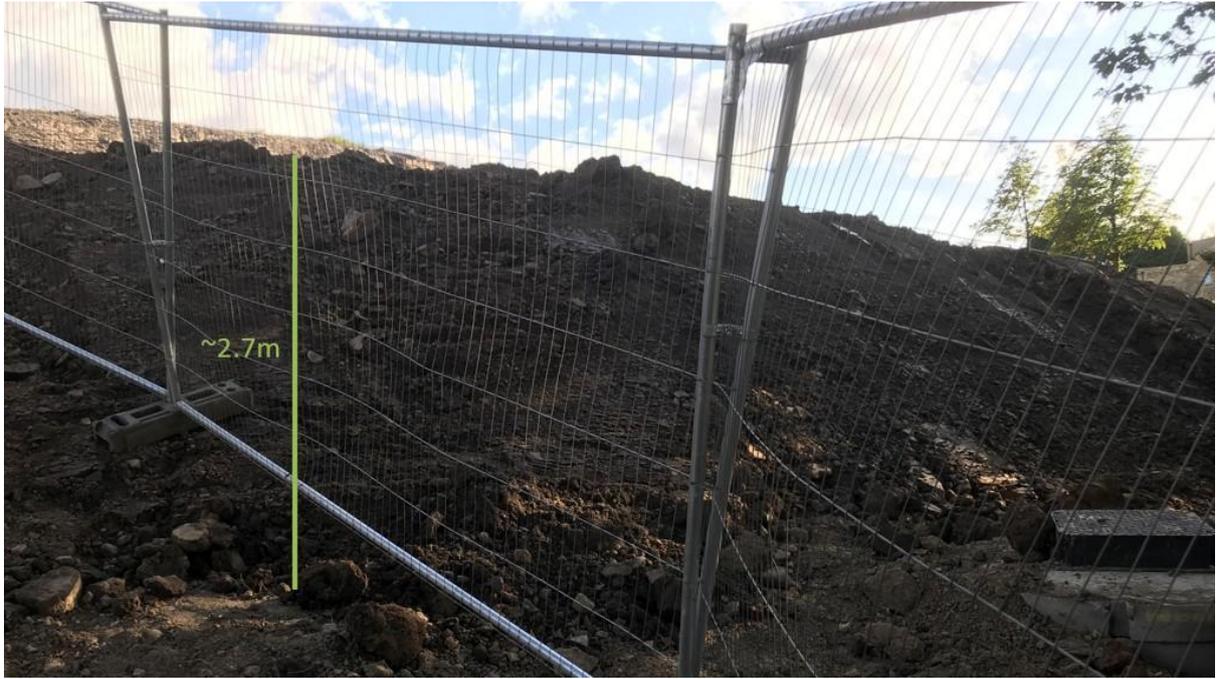
From the entrance to the public right of way off Manchester Road, the depth and volume of soil now visible is striking. Its sheer mass disrupts the natural contours of the landscape and constitutes a clear visual intrusion into the Green Belt. What was once an open, gently sloping field has been replaced by an engineered landform that temporarily undermines the character and openness the Green Belt is intended to protect.
