**ARBORICULTURAL METHOD STATEMENT
to BS 5837:2012
at
Land at Woodhead Road
Honley
Huddersfield
West Yorkshire
HD9 6PW**

18440-F/AJB

1.2.2 The proposed development will consist of the installation of a temporary surgery along with associated external works, as shown within the red line boundary on the plan at **Appendix 4**.

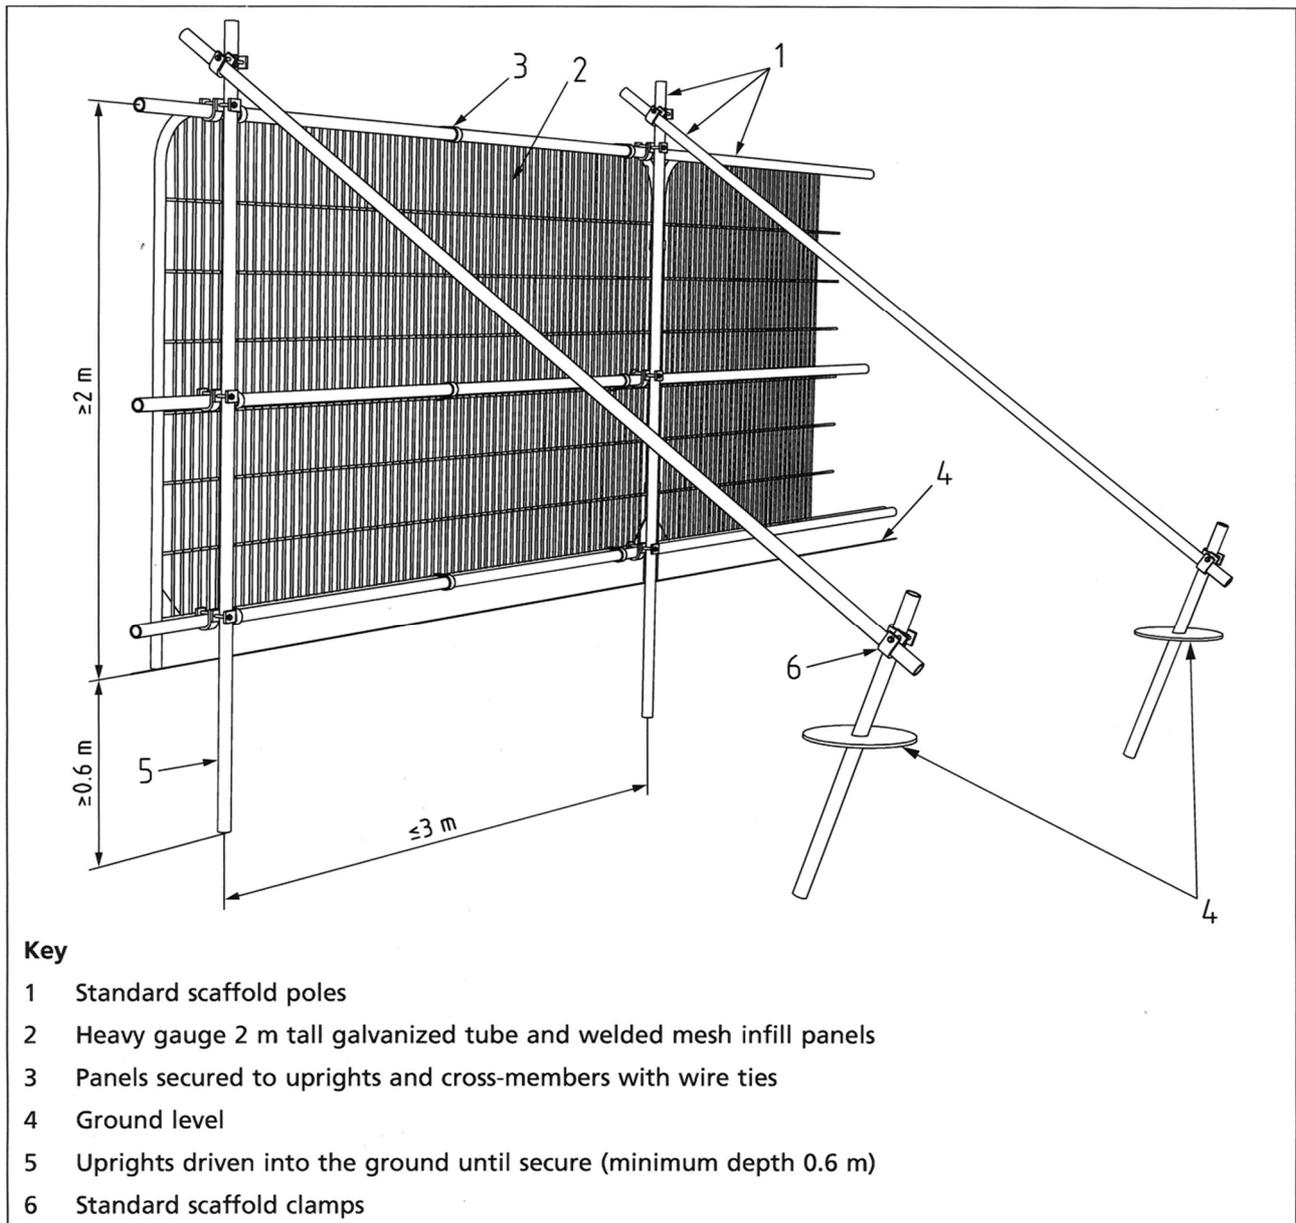
A2.1 The protective barrier will be installed in accordance with BS5837: 2012. The default specification of BS 5837: 2012 (pictured below for reference) recommends a vertical and horizontal, scaffold framework, well braced to resist impacts, with vertical tubes at no more than 3m intervals. These should be driven into the ground. Welded mesh panels should be affixed to this framework with scaffold clamps.

Protective Barrier to BS 5837: 2012.

- 3.1.3 The protective fencing will be installed in accordance with BS 5837: 2012 and will comprise of a vertical and horizontal scaffold framework, well braced to resist impacts. The vertical tubes should be spaced at a maximum interval of 3m and driven securely into the ground, taking care to avoid underground services and structural roots. Finally, weld mesh panels are to be securely fixed on the scaffold framework. Please refer to **Appendix 2** for protective fencing details.

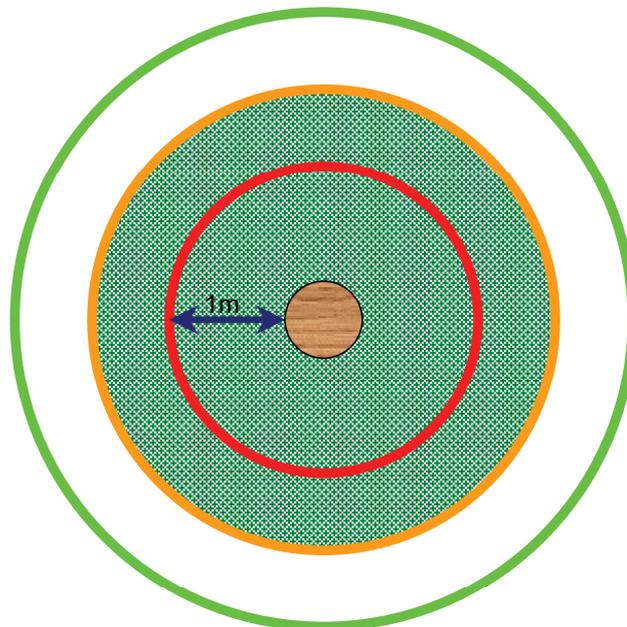
NJUG Guidelines for the Planning, Installation and Maintenance of Utility Apparatus in Proximity to Trees – Issue 2

TREE PROTECTION ZONE

PROHIBITED ZONE – 1m from trunk. Excavations of any kind must not be undertaken within this zone unless full consultation with Local Authority Tree Officer is undertaken. Materials, plant and spoil must not be stored within this zone.

PRECAUTIONARY ZONE – 4 x tree circumference. Where excavations must be undertaken within this zone the use of mechanical excavation plant should be prohibited. Precautions should be undertaken to protect any exposed roots. Materials, plant and spoil should not be stored within this zone. Consult with Local Authority Tree Officer if in any doubt.

PERMITTED ZONE – outside of precautionary zone. Excavation works may be undertaken within this zone however caution must be applied and the use of mechanical plant limited. Any exposed roots should be protected.

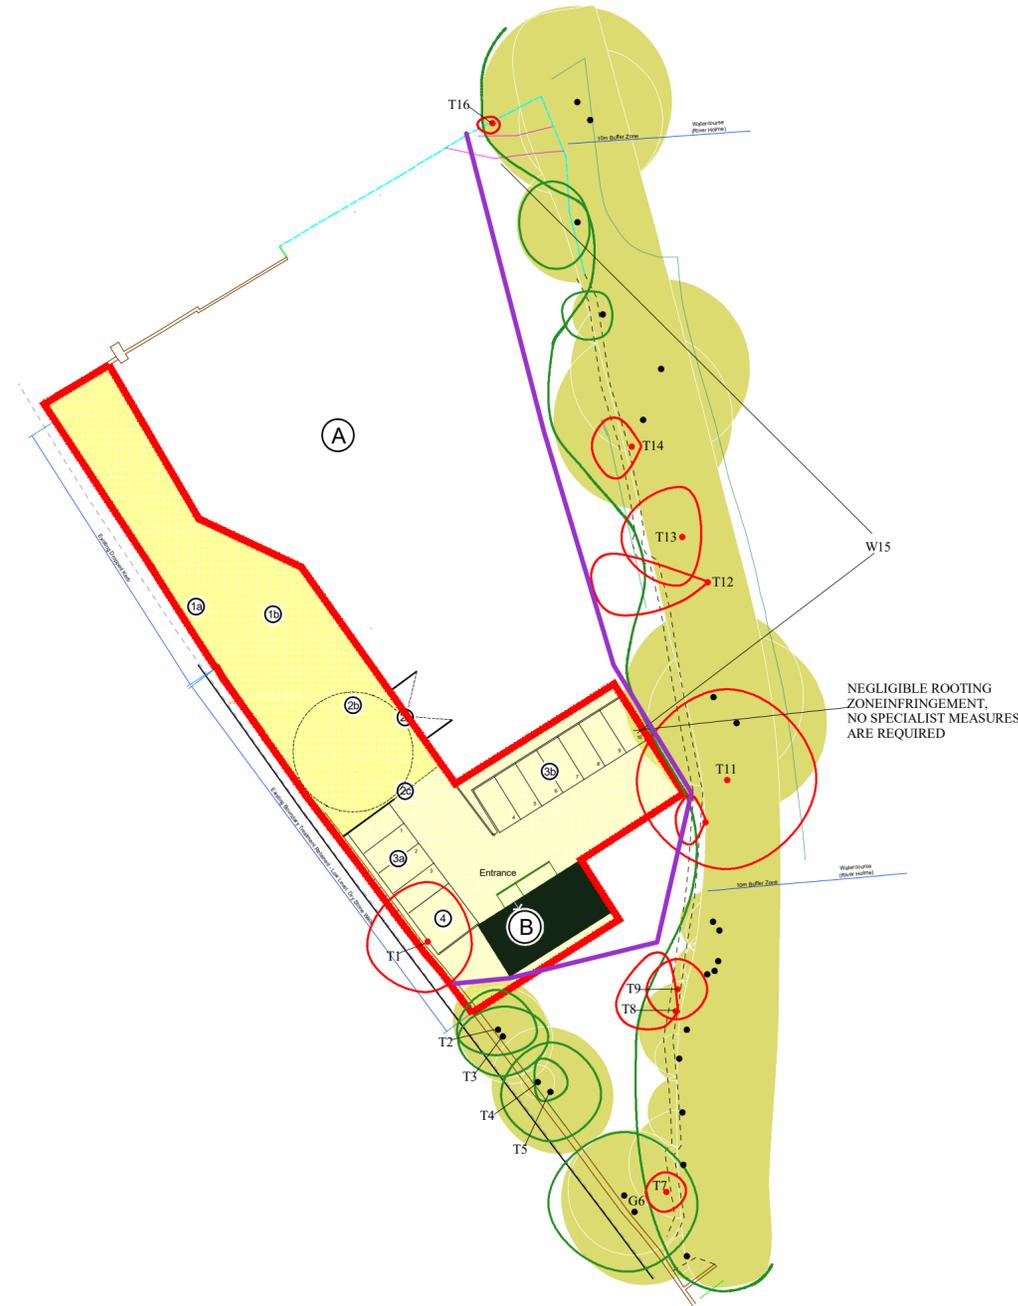
Default specification for a protective barrier
