Barn Buildings at
White Cross Farm
Woodhouse Lane
Emley, HD8 9QU

Built Heritage Statement

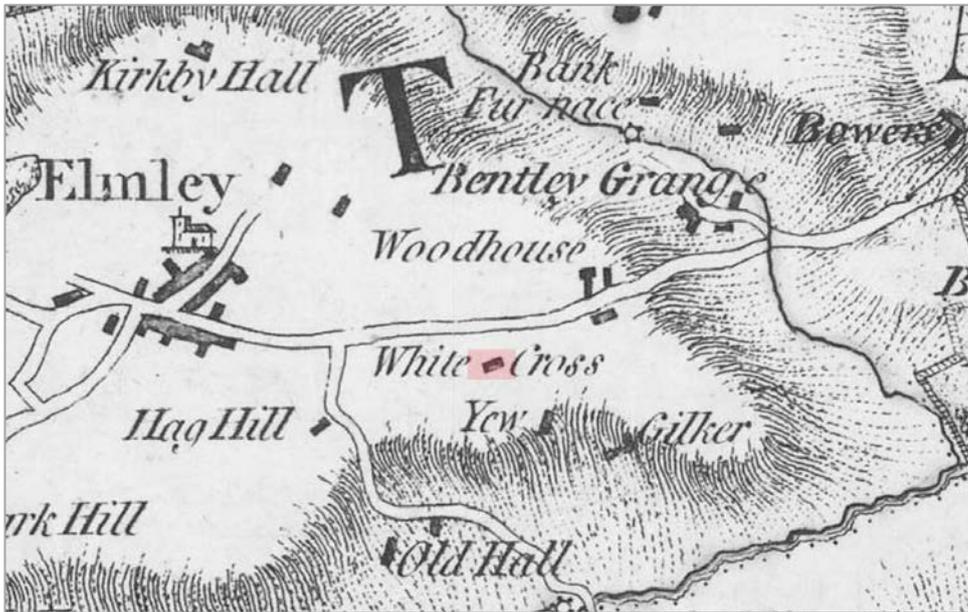
Figure 3.1: Jefferys' Map of Yorkshire 1771

- 3.14 Thomas Jefferys' Map of Yorkshire 1771 (Figure 3.1) shows *White Cross*, depicted as a single building, as one of a number of relatively isolated farmsteads located around the settlement of Emley (Elmley) and to the south of Woodhouse Lane.

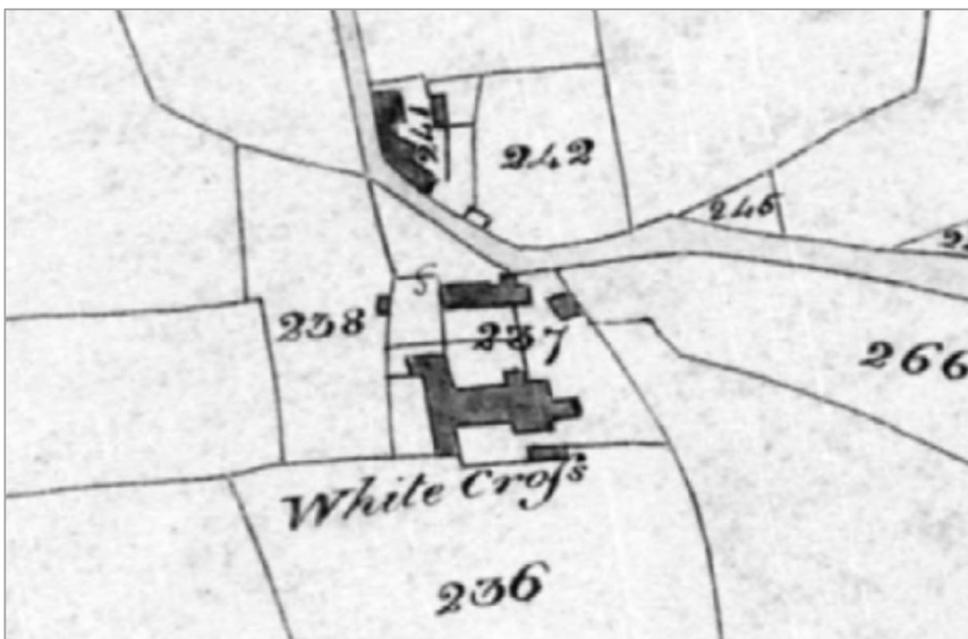
Figure 3.2: 1841 Tithe Map

- 3.16 The main range barn is shown on an east-west axis with cart opening extension to the north and further extensions to the east and south-west corner. A cross-range is shown to the west with the southern section corresponding with the position of the retained single storey outbuilding although shown on a broader footprint.

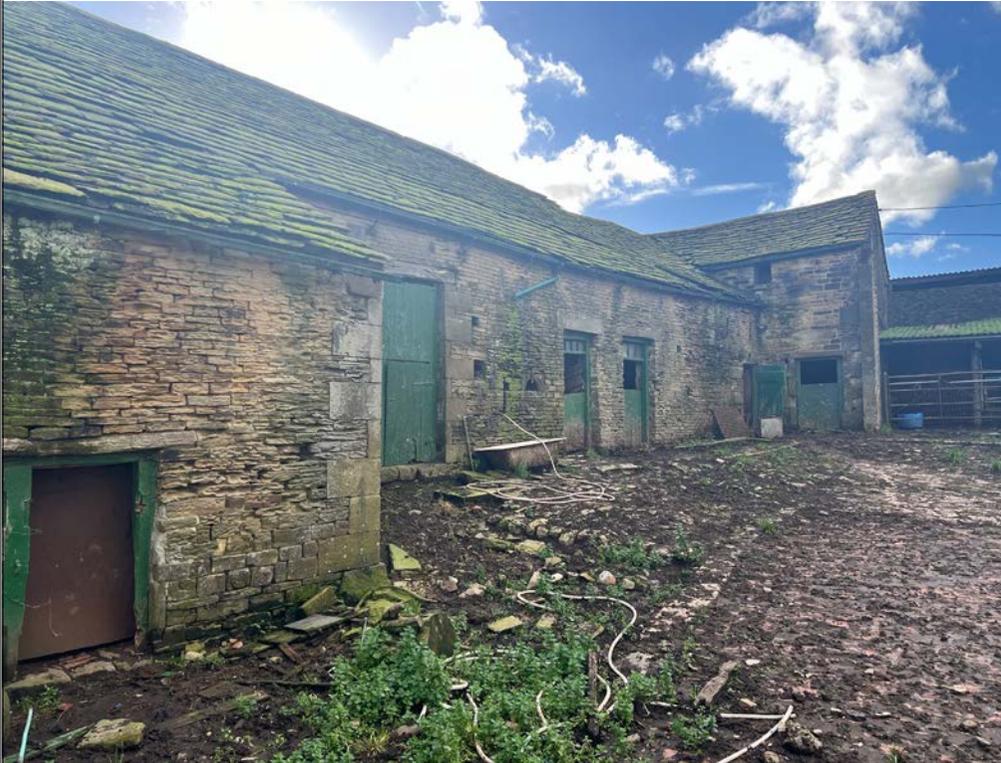
PLATE 1:
Main range of farm buildings (listed building Grade II) north elevation. The northern extent of the truncated west range to rear of image.

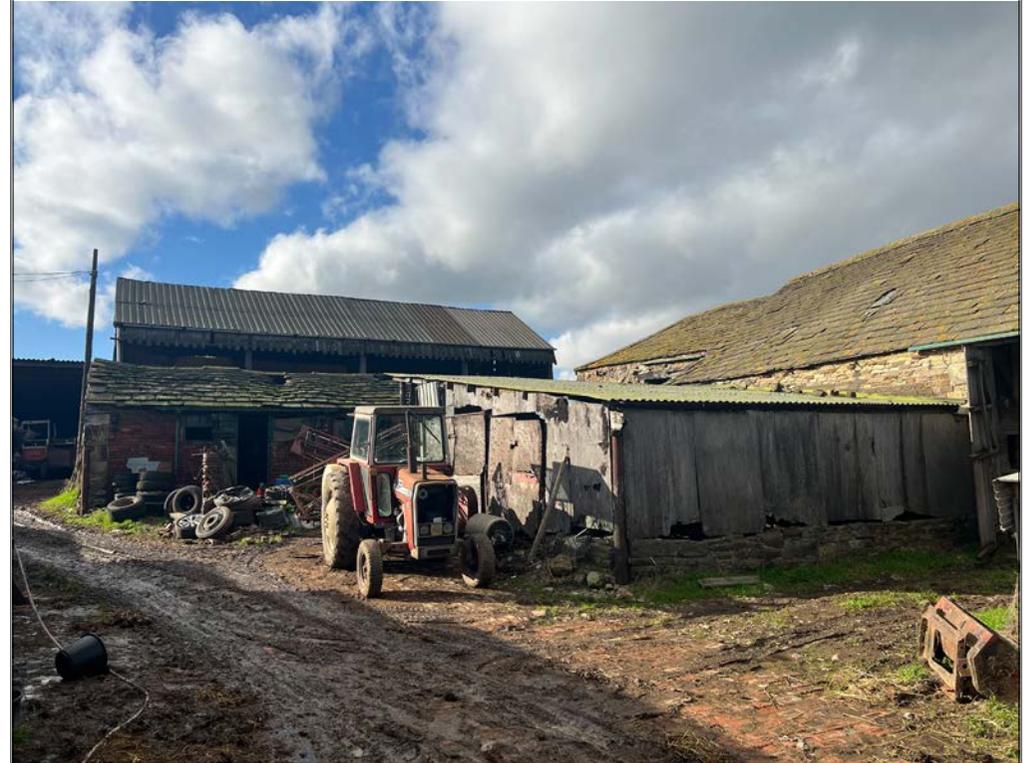
PLATE 2:
Rear, south facing elevation of the main range with later outbuilding and timber clad yard cover.

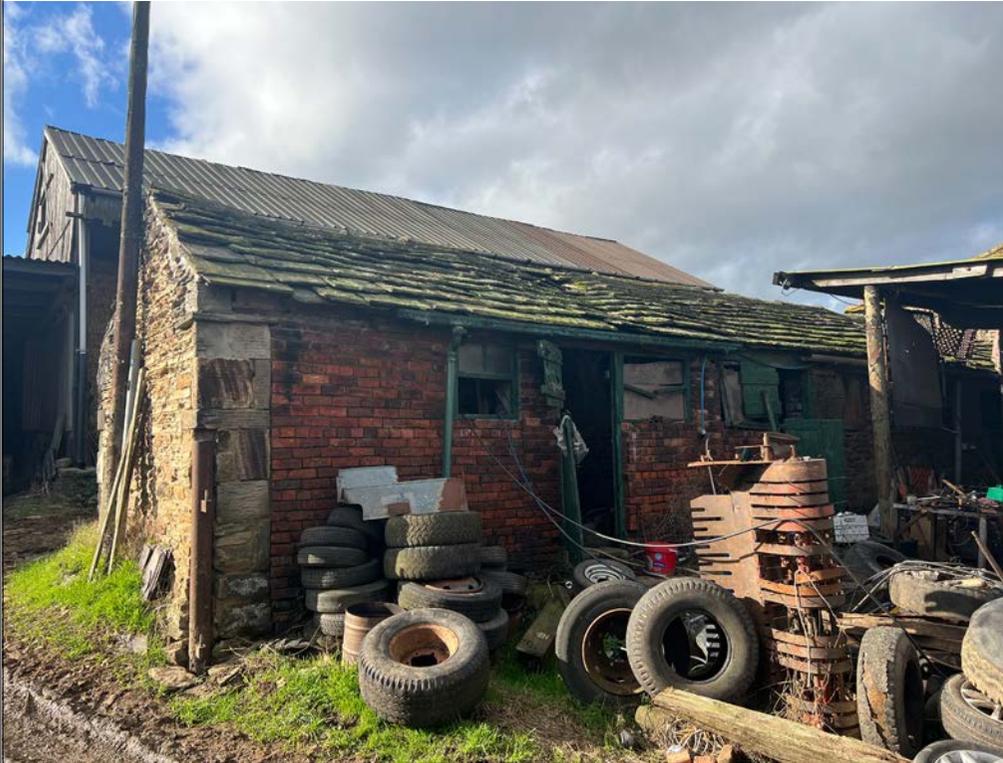
PLATE 3:
East facing elevation of outbuilding.

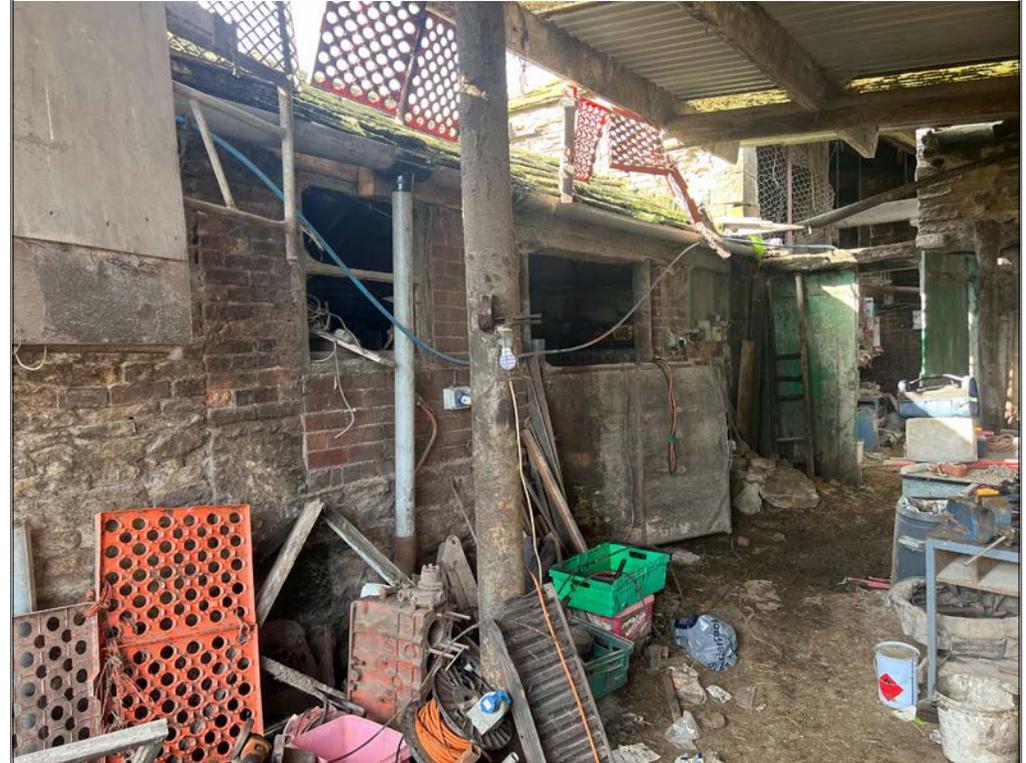
PLATE 4:
East facing elevation at junction with main barn range.

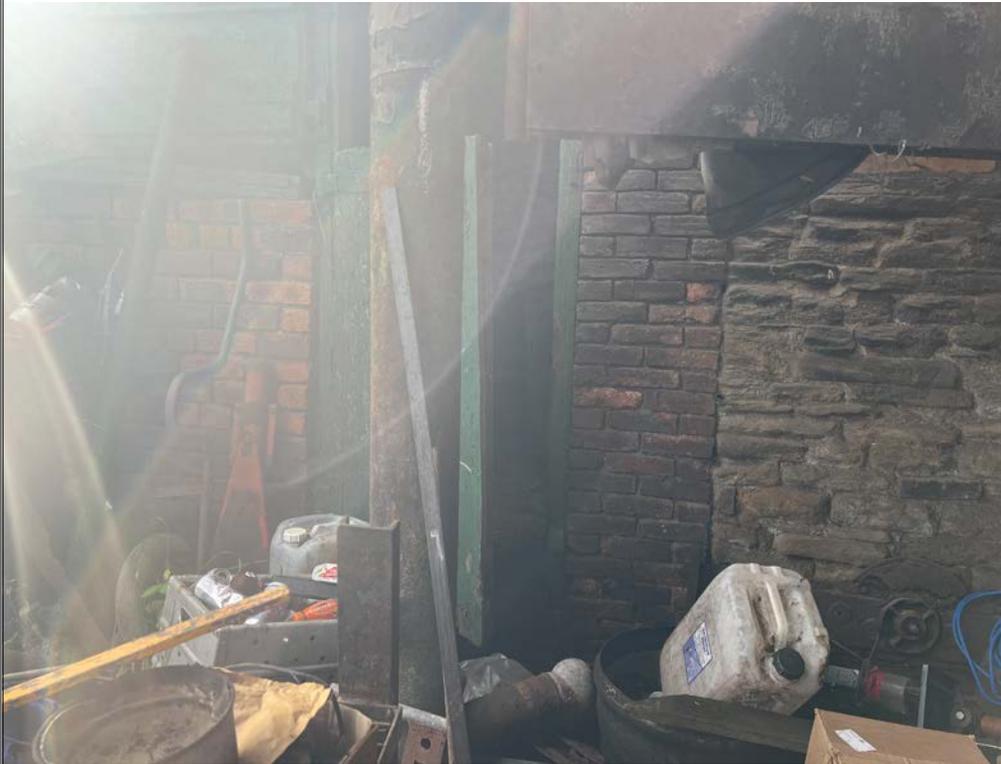
PLATE 5:
East facing elevation of outbuilding with short section of stonework and later brick pier.

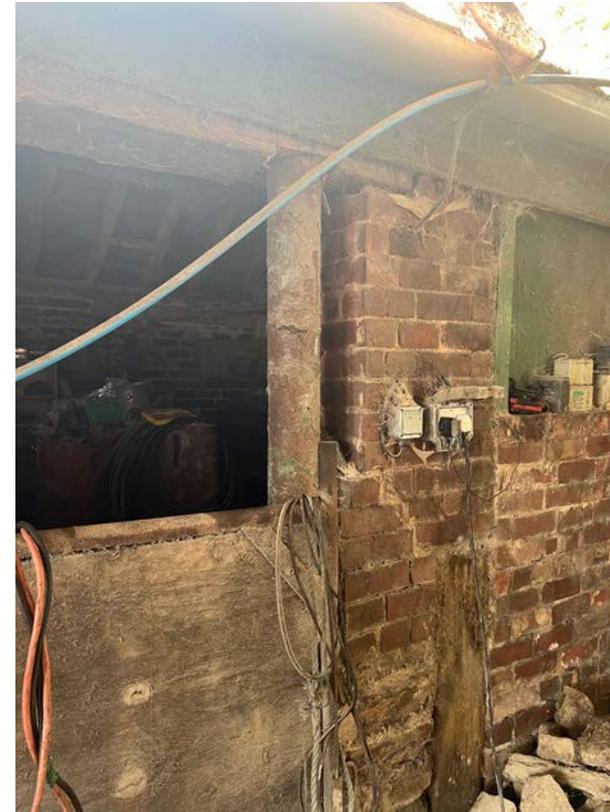
PLATE 6:
East facing elevation of outbuilding showing later brick panels and support posts.

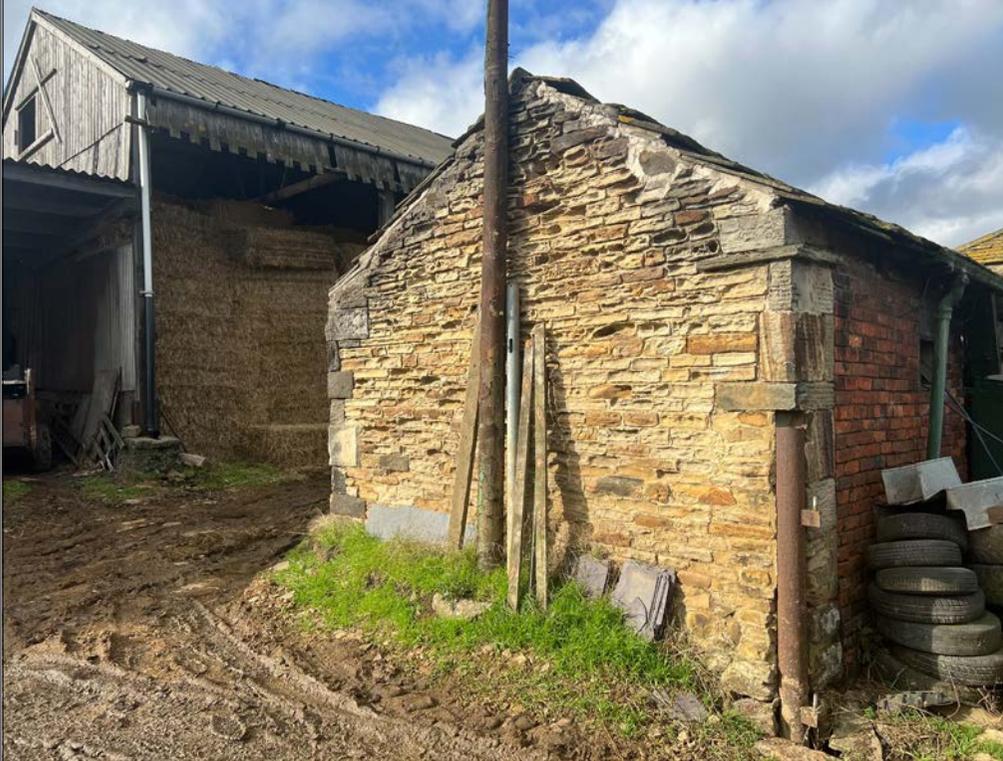
- 3.25 The south facing gable end is blank and of coursed rubble stone construction. Stonework shows significant pitting and erosion to stone elements through weathering action with areas of cement render patch repair. End stone blocks/quoins are retained although have been replaced and rebuilt in stone, along with a steel support post at lower level to the right-side return.

PLATE 7:
South gable end of outbuilding evidencing significant weather erosion. The support post at lower level cuts through end stone blocks. Roof covering is bedding on a cement mortar.

- The existing roof timbers and roof covering are in a poor state or repair and require imminent replacement and repair
- The existing gable wall has experienced severe weathering and as such realistically requires demolition

- Given the above the most practical solution would be to remove 2 bays of the cart shed and utilise the reclaimed materials to rebuild a new relocated gable wall and undertake repair/replacement to the stone roof covering – in the process, stripping away all rotten/perished timbers and replacing them for a softwood alternative with new breather membrane.

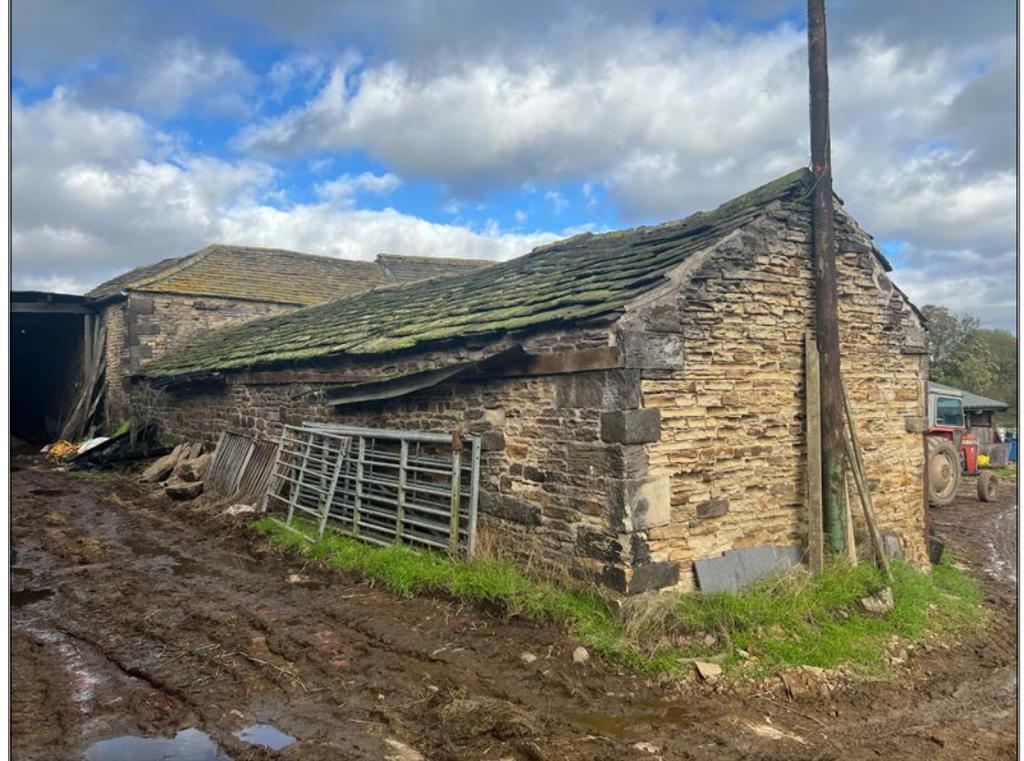
PLATE 8:
West facing elevation of outbuilding.

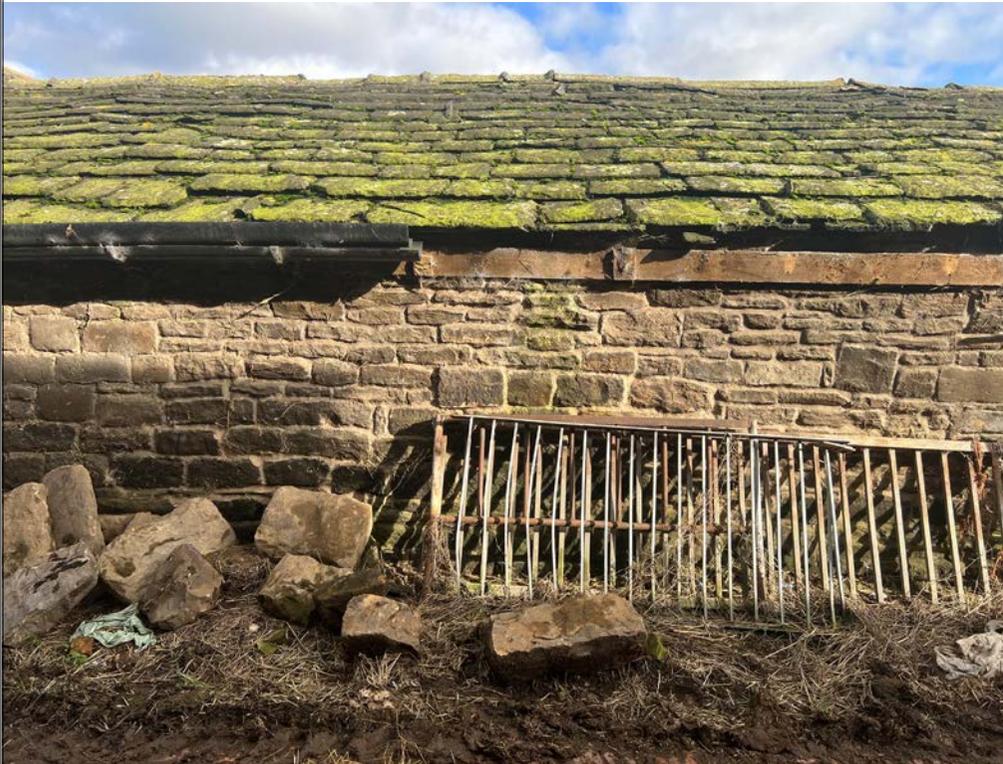
- 4.13 The west elevation shows similar evidence of full or partial reconstruction with random rubble walling, including a number of over-sized stone pieces, comprising the retained walling. The walling is distinct from the coursed stone used in the main barn range. The end gable to the south has also deteriorated through loss of end stone/quoins and serious deterioration and erosion through weathering.

PLATE 9:
West facing elevation of outbuilding. Walling is of irregular/random coursing incorporating a number of out-sized stone pieces suggesting later reconstruction.

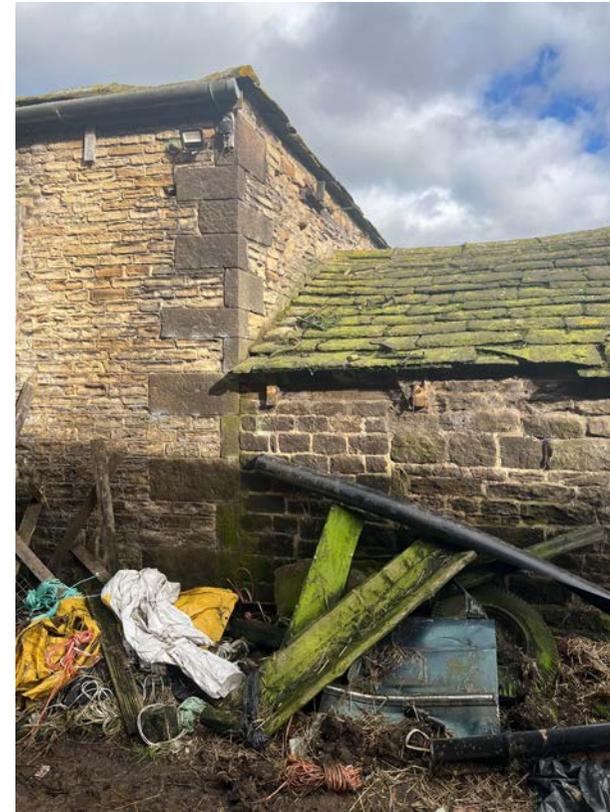
PLATE 10:
West facing elevation of outbuilding at junction with the two storey main range. The outbuilding is not tied in and cut across end stone/quoins and a now blocked off window opening at upper level to the main barn. Evidence of a blocked off door opening.

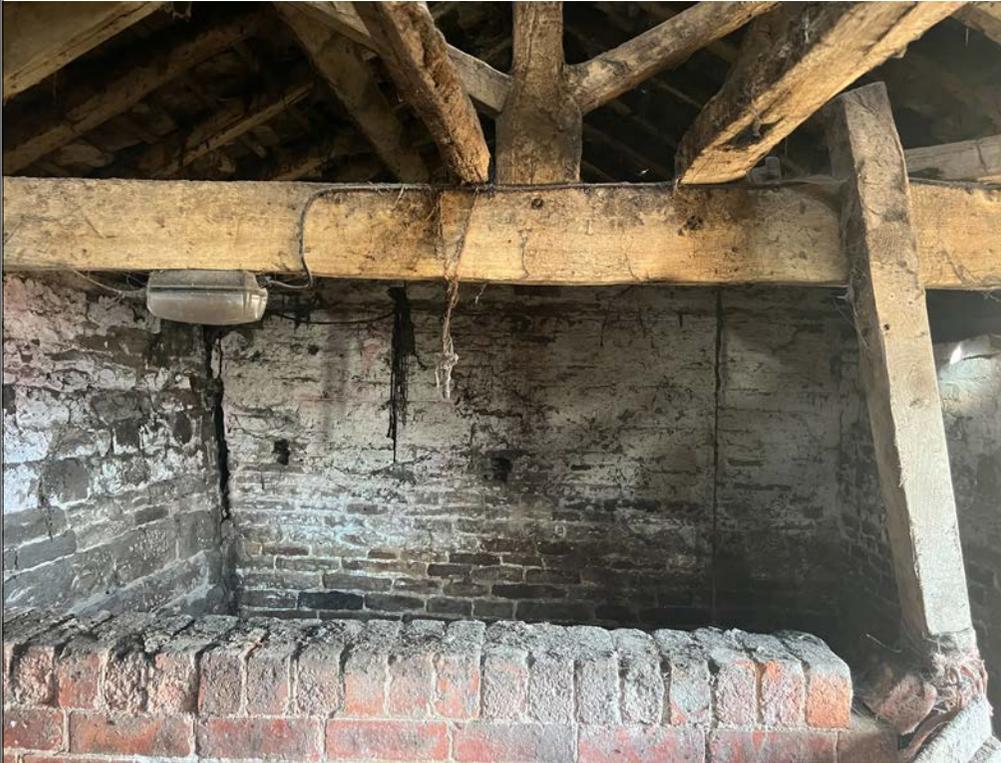
- 3.28 Internal bay divisions are constructed in a random rubble stone and lower level red brick. Floor covering is now predominantly a cement screed. Roof timbers comprise principle King post trusses, machine tooled and of later 19th century dating, along with earlier hand tooled timbers /baulks used, in part, to binders, joists and rafters. The timbers are in generally poor condition, showing evidence of damp penetration and decay and a number of localised sections have had modern timbers introduced to provide support. Unjointed planking and joist holes within a number of timbers indicate that they are not retained in situ.

PLATE 11:
Internal bay divisions comprise a central stone wall and brick half walls. Roof timbers include the use of timber baulks and hand carved binders, joists and rafters along with later machine tooled king post truss and struts.

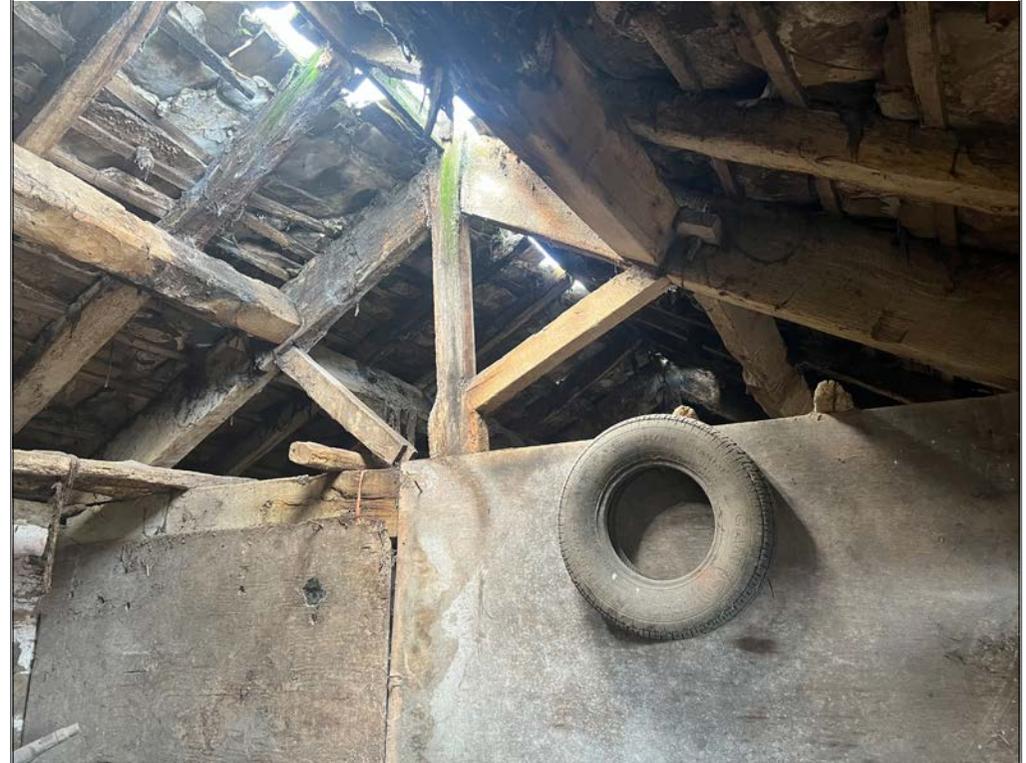
- 4.14 The interior of the building retains no significant fixtures or fittings. The roof framing is of note in the retention of hand tooled timbers and baulks although the principal trusses are machine tooled. The extent to which these timbers are retained in their original position is questionable and a number of timbers are clearly of modern construction and likely added to provide additional support to the roof covering. Timberwork throughout is in poor condition following

ongoing water ingress with areas of insect infestation and fire damage evident. This has led to deflection and sagging of the roof and the structural condition of the interior is extremely poor.

PLATE 12:
Interior roof structure with dislodged strut to King post truss.

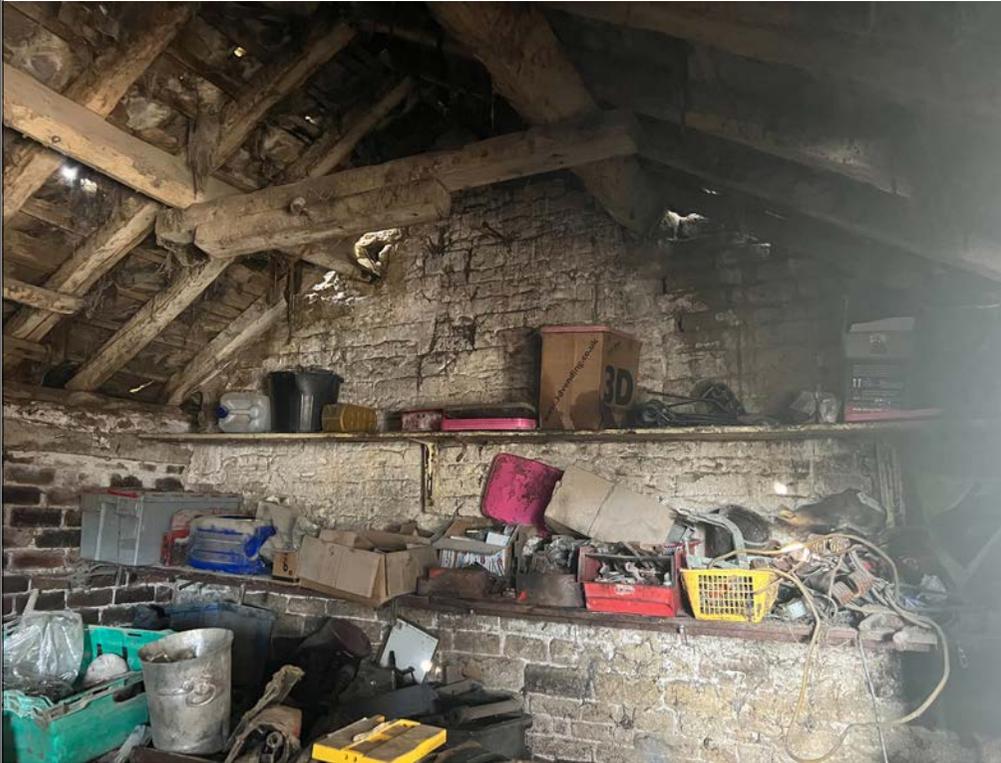
PLATE 13:
Internal junction with the south wall of the main barn range.

- The replacement of a failed oak lintel over the main barn opening adjacent to the cart shed with a reclaimed oak section with masonry over the lintel to be repaired and reinstated.
- Masonry walling to the west side of the main barn opening has areas of severe weathering which will be reconstructed using matching reclaimed stone with lime mortar jointing. Through stones and rubble fill will be reinstated where currently present.
- Displaced stone quoins to the west side of the barn opening will be taken down during reconstruction, numbered and reinstated using lime mortar.
- During the works, the existing oak trusses, timber wall plates and door lintel will be propped to allow for safe working.
