Report No: C723

**GEOENVIRONMENTAL APPRAISAL  
OF LAND ADJACENT TO  
480 HALIFAX ROAD, LIVERSEEDGE, WEST YORKSHIRE**

| <b>REPORT TYPE:</b> | Geoenvironmental Appraisal | | |

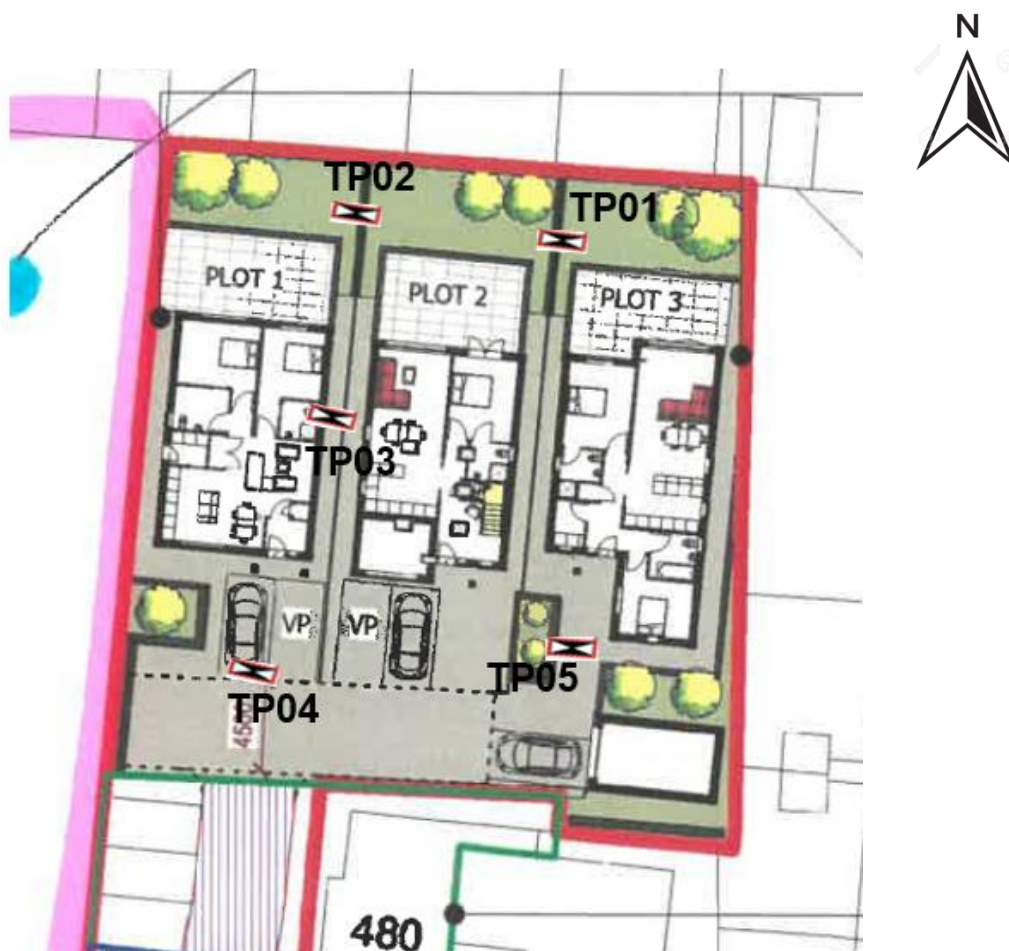
The exploratory hole positions were set out and the fieldwork supervised by a G&M engineering geologist. The locations of the exploratory holes are shown below;

The location and spatial distribution of the trial pits was considered adequate to suitably characterise the shallow soils present on site.

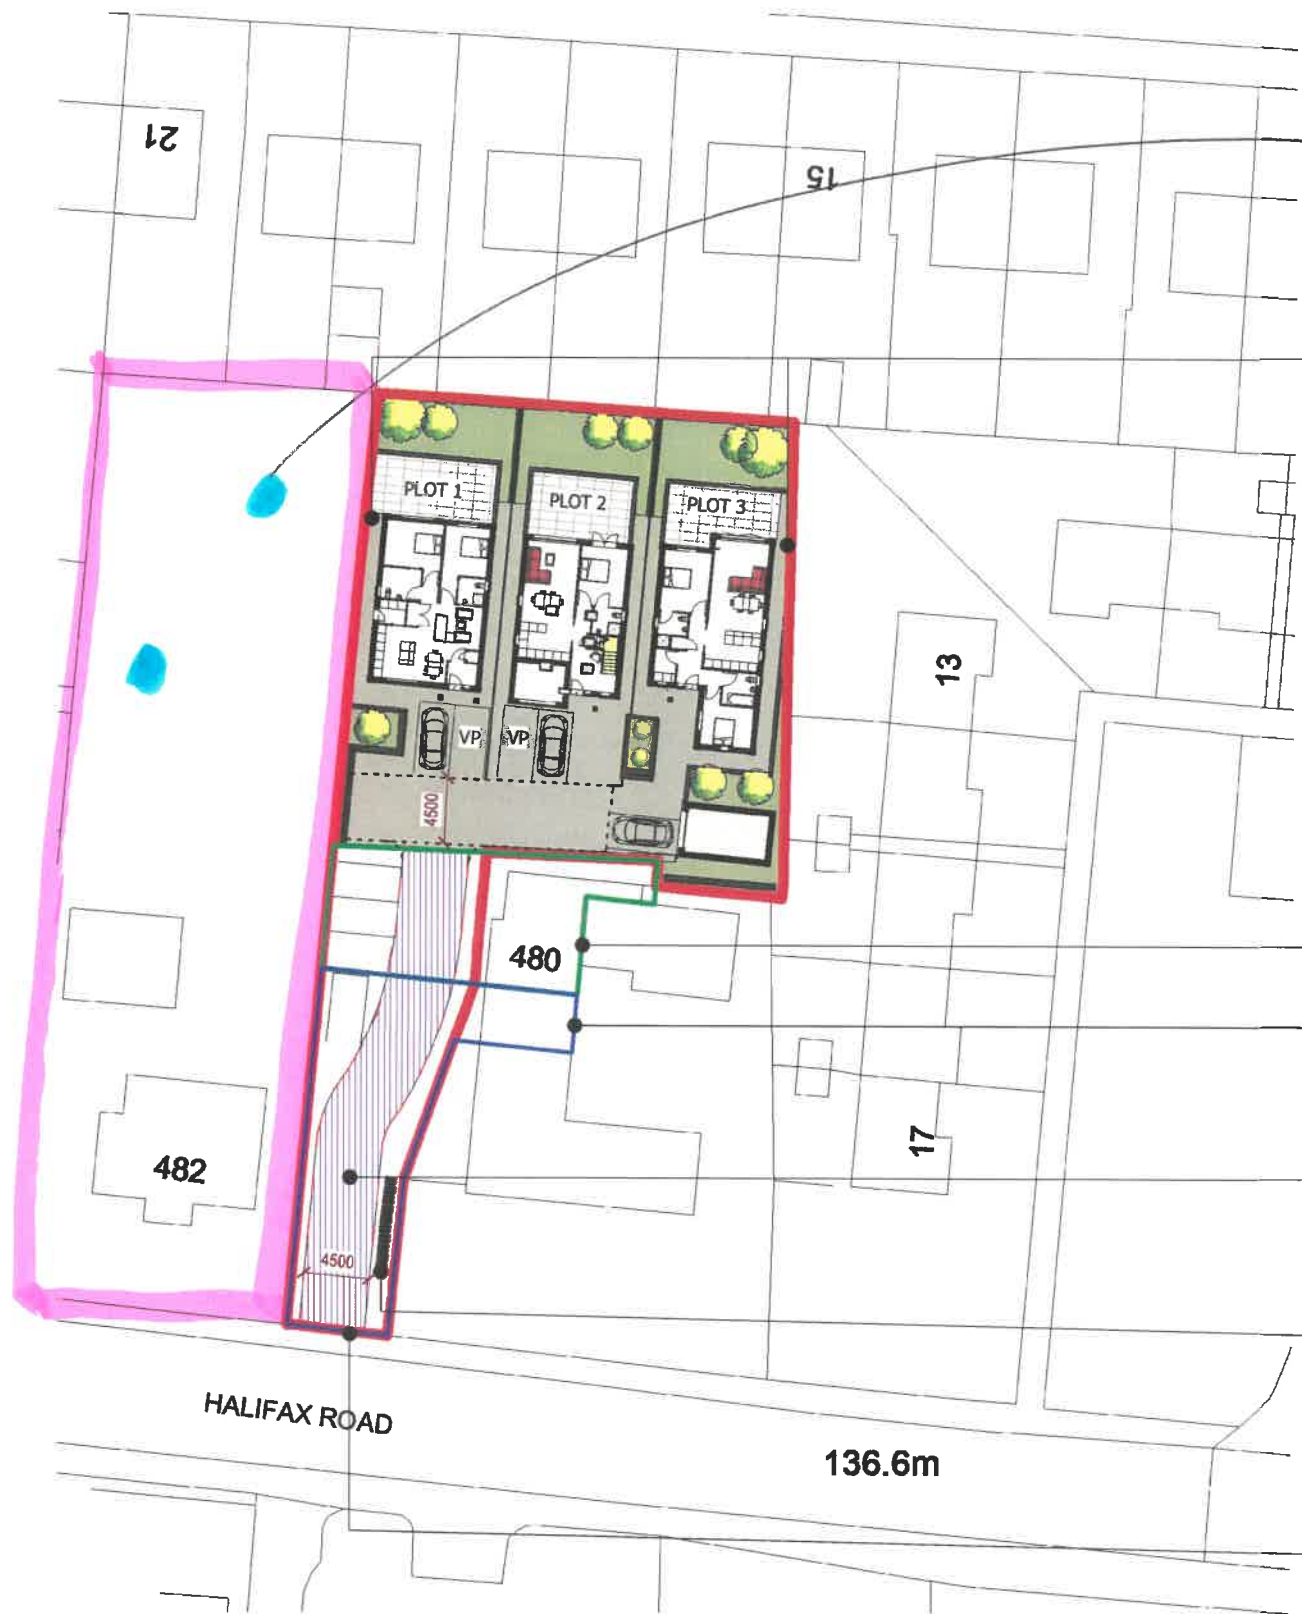
2 x additional dog-hole

MIN. 1m WALKWAY TO SITE PERIMETER

It is understood that approvals have been granted for the development of the site with three residential dwellings. The proposed development is shown on the drawing prepared by Barnes Architectural Services Ltd, a copy of which is presented in Appendix A of this report. This report has been commissioned in support of the discharge of any contaminated land conditions associated with the approval.

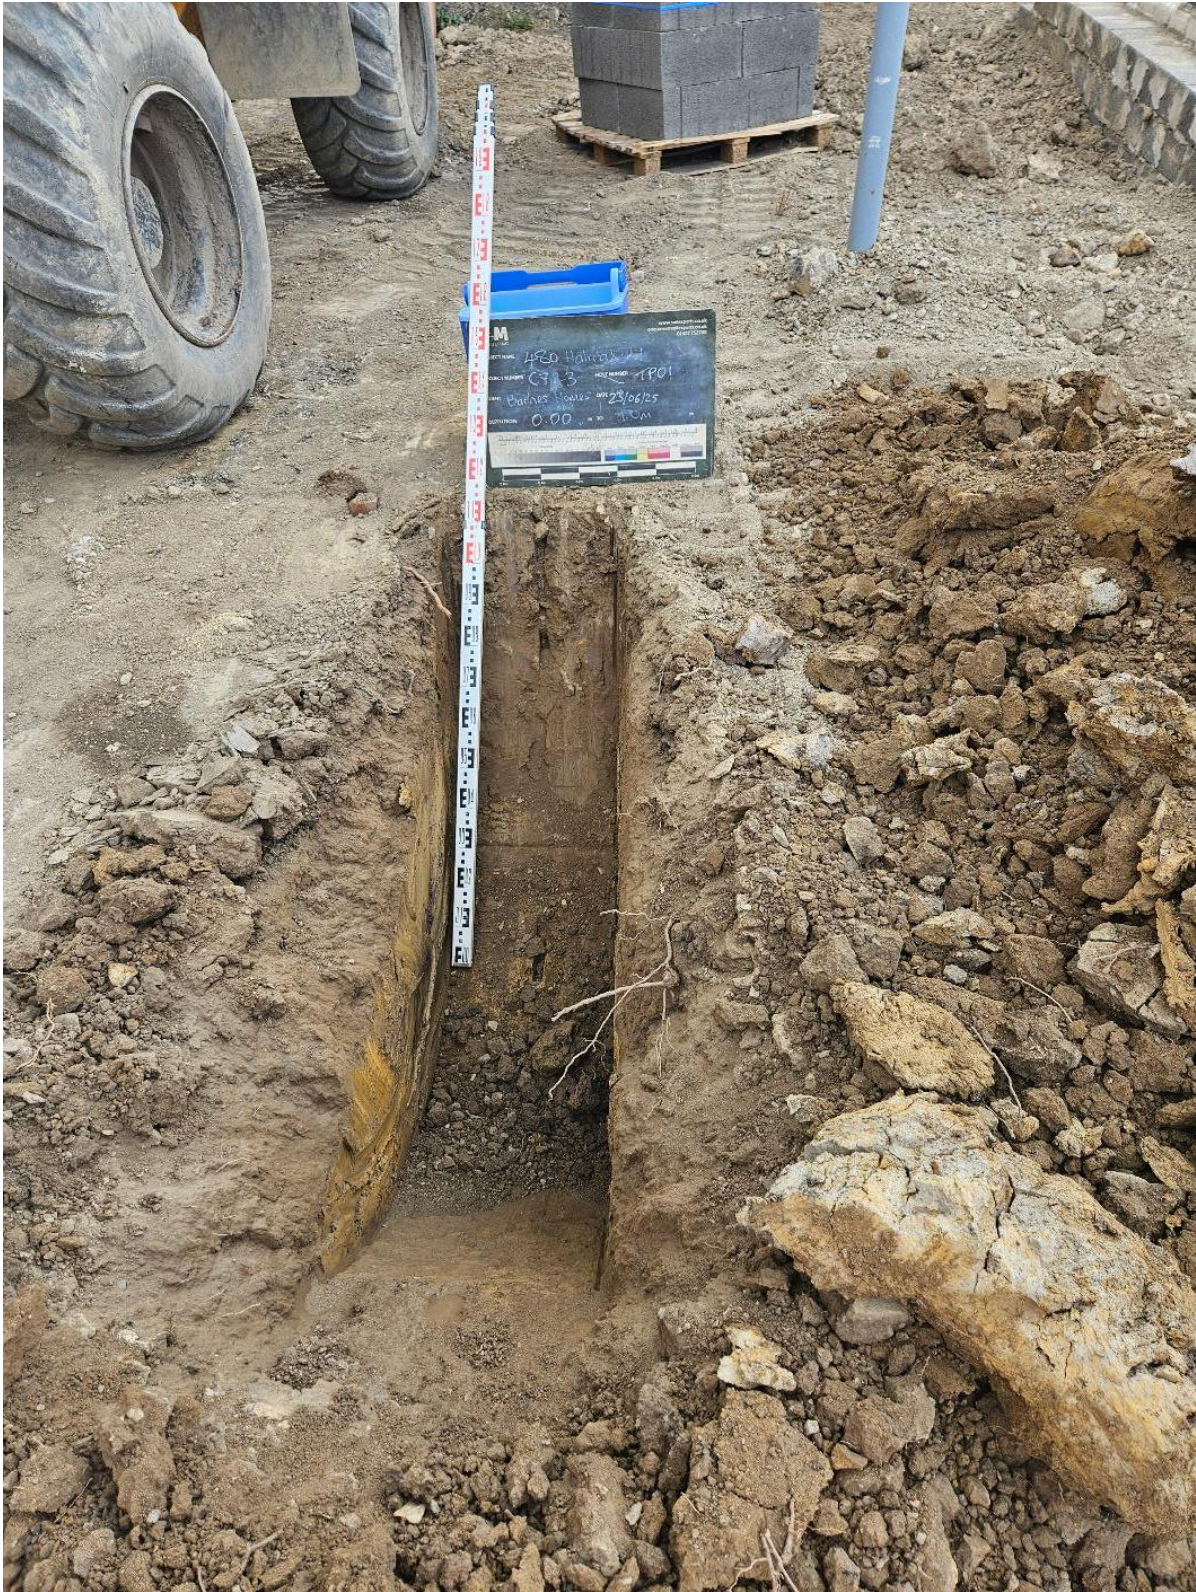
| Project Name<br>480 Halifax Road | Project No.<br>C723 | | Start Date<br>2025-06-23 | End Date<br>2025-06-23 |

| Remarks<br>Trial Pit Complete | Method, Plant, Stability, Dimensions<br>0.00 - 1.00m TP Doosan DX85R-7<br>Stable<br>Inclination: 90°<br>L = 1.60m<br><div><div></div>W = 0.50m</div> | Logger<br>G Swinbourne |

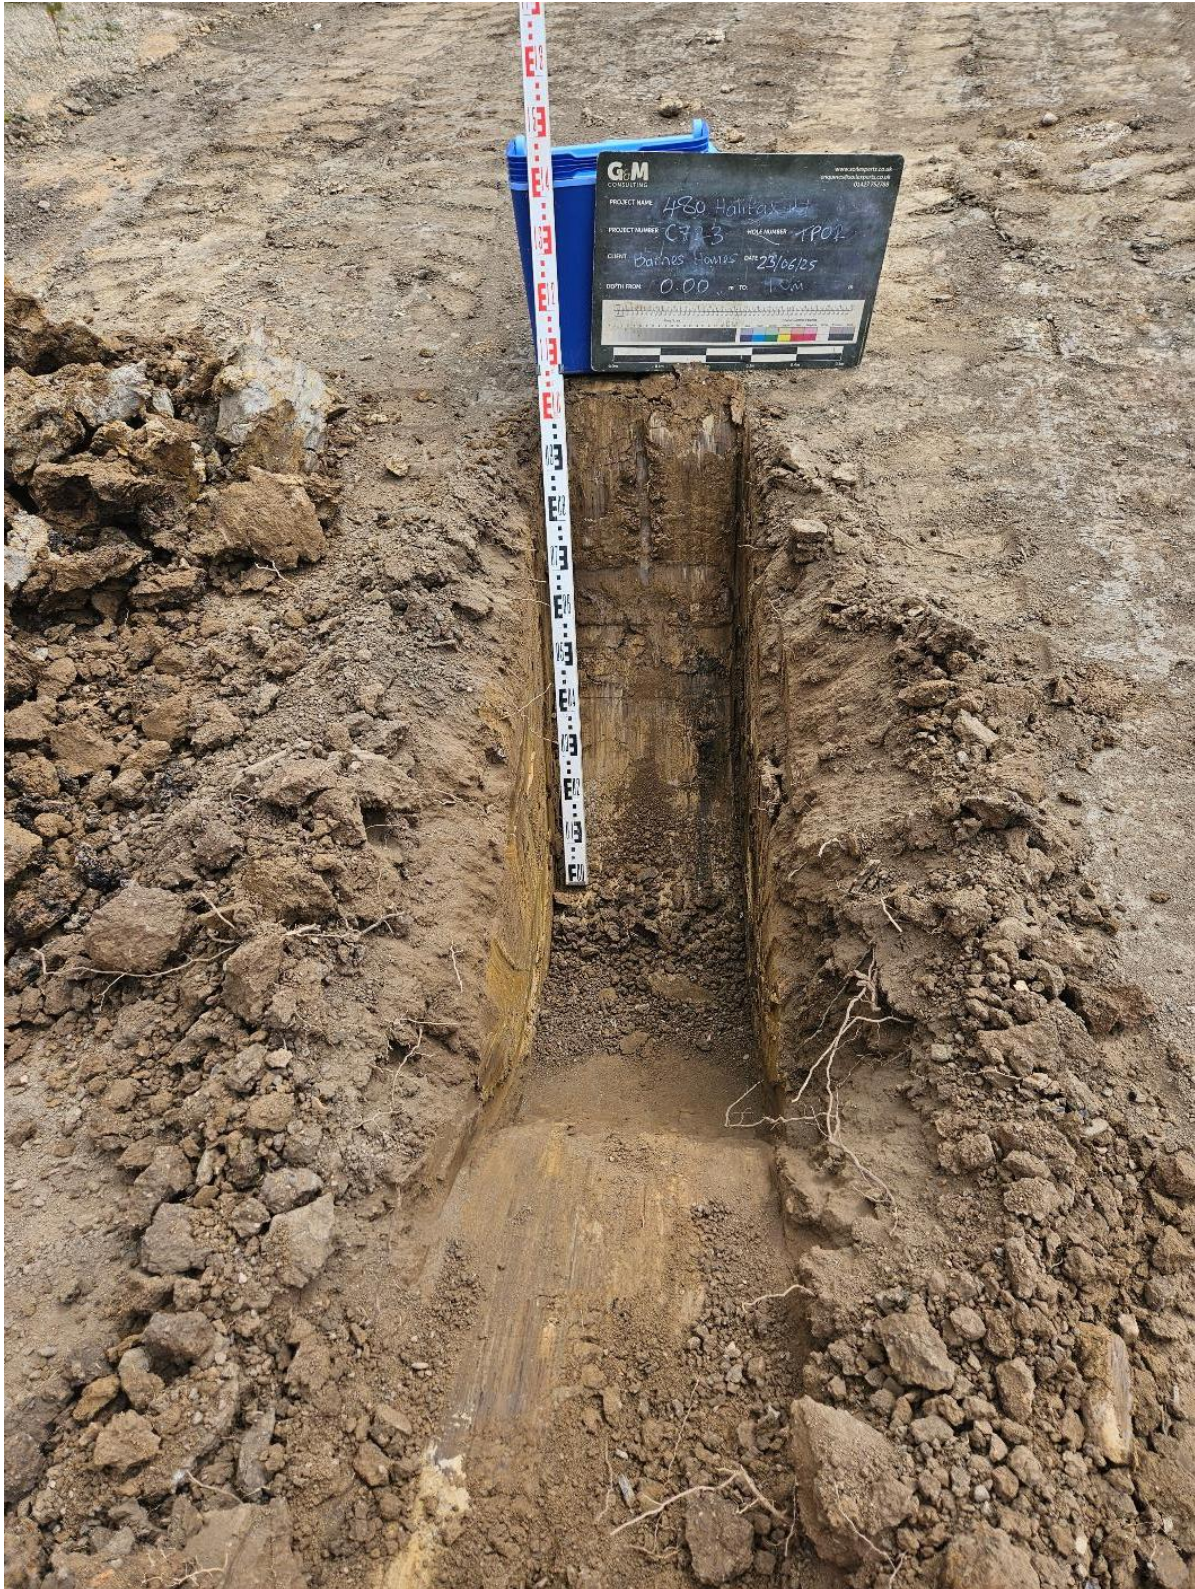
Remarks  
Trial Pit Complete

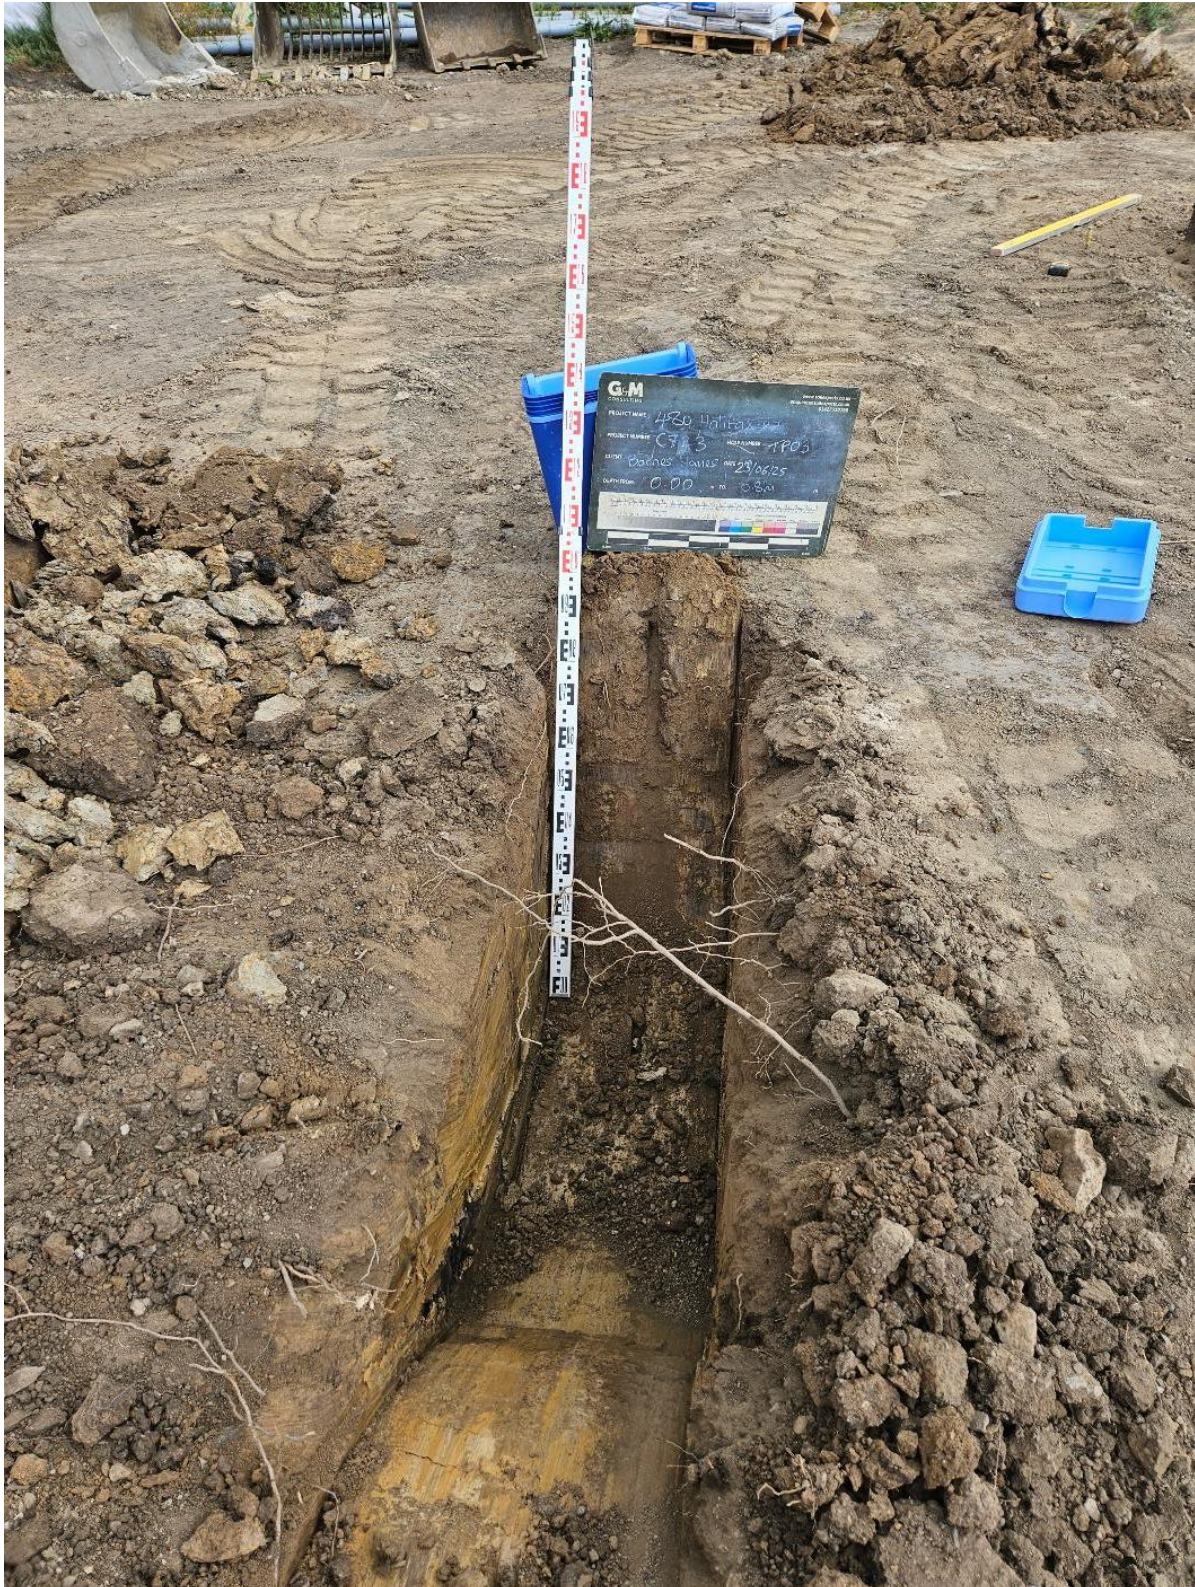
Remarks  
Trial Pit Complete

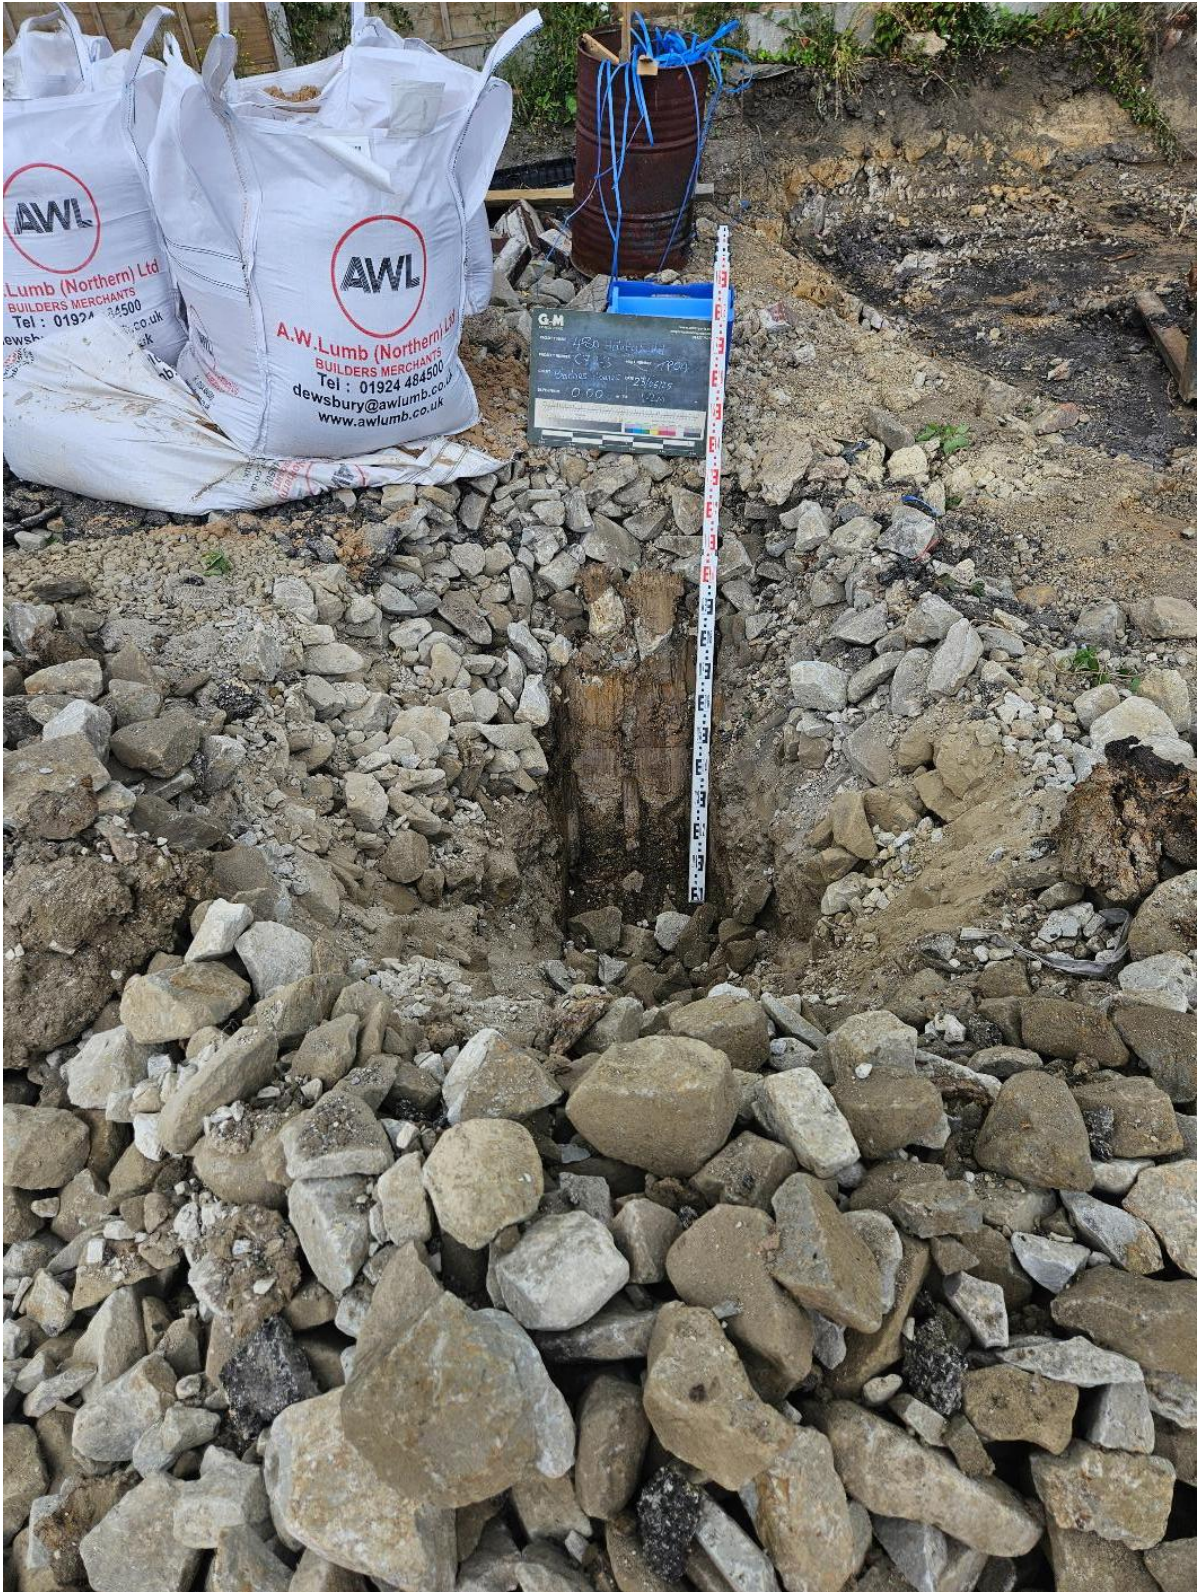
| Project Name<br>480 Halifax Road | Project No.<br>C723 | | Start Date<br>2025-06-23 | End Date<br>2025-06-23 |

| Remarks<br>Trial Pit Complete | Method, Plant, Stability, Dimensions<br>0.00 - 1.20m TP Doosan DX85R-7<br>Stable<br>Inclination: 90°<br>L = 1.50m<br>W = 0.50m | Logger<br>G Swinbourne |

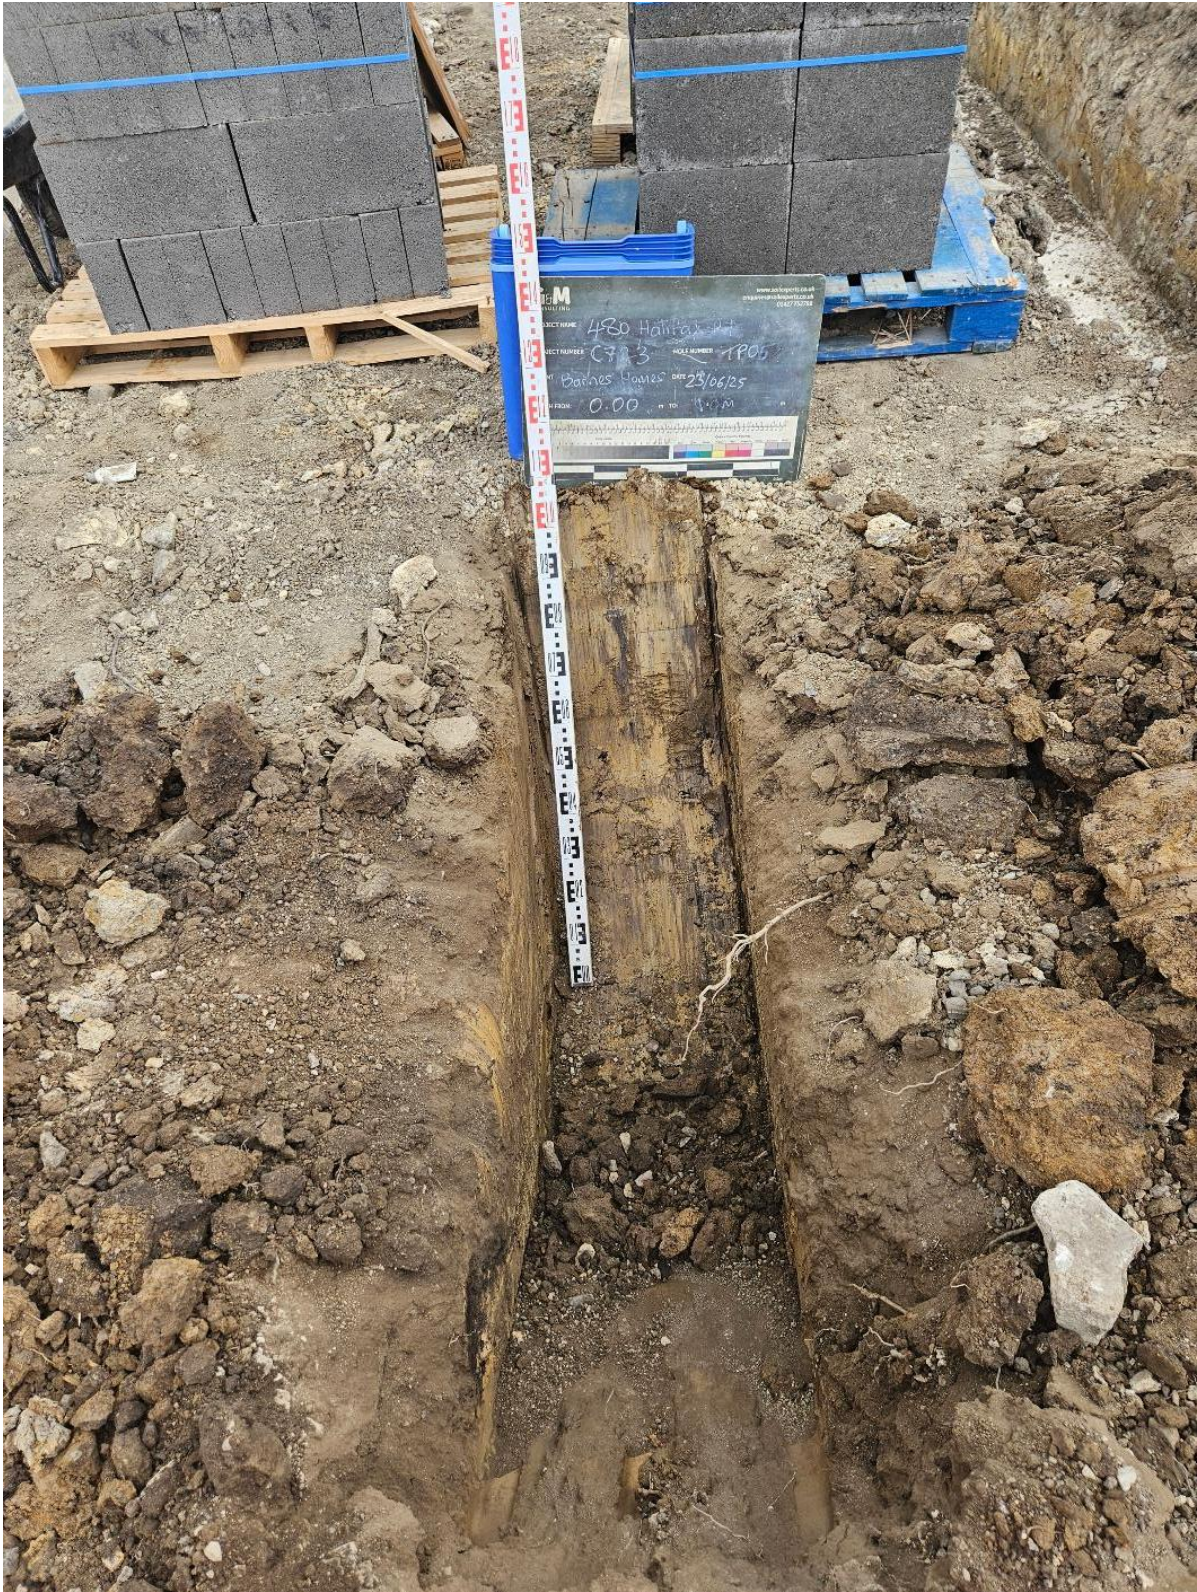
| Project Name<br>480 Halifax Road | Project No.<br>C723 | | Start Date<br>2025-06-23 | End Date<br>2025-06-23 |

| Remarks<br>Trial Pit Complete | Method, Plant, Stability, Dimensions<br>0.00 - 1.00m TP Doosan DX85R-7<br>Stable<br>Inclination: 90°<br>L = 1.60m<br>W = 5.00m | Logger<br>G Swinbourne |
