STAGE 2 GEO-ENVIRONMENTAL REPORT

LAND AT ST LUKES

OWENS DEVELOPMENTS LTD

CLIENT: OWENS DEVELOPMENTS LTD
JOB NUMBER: ODL/01
PROJECT: LAND AT ST LUKE'S, BIERLEY MARSH, EAST BIERLEY
REPORT TYPE: STAGE 2 GEO-ENVIRONMENTAL REPORT
REPORT REFERENCE: ODL/01r1

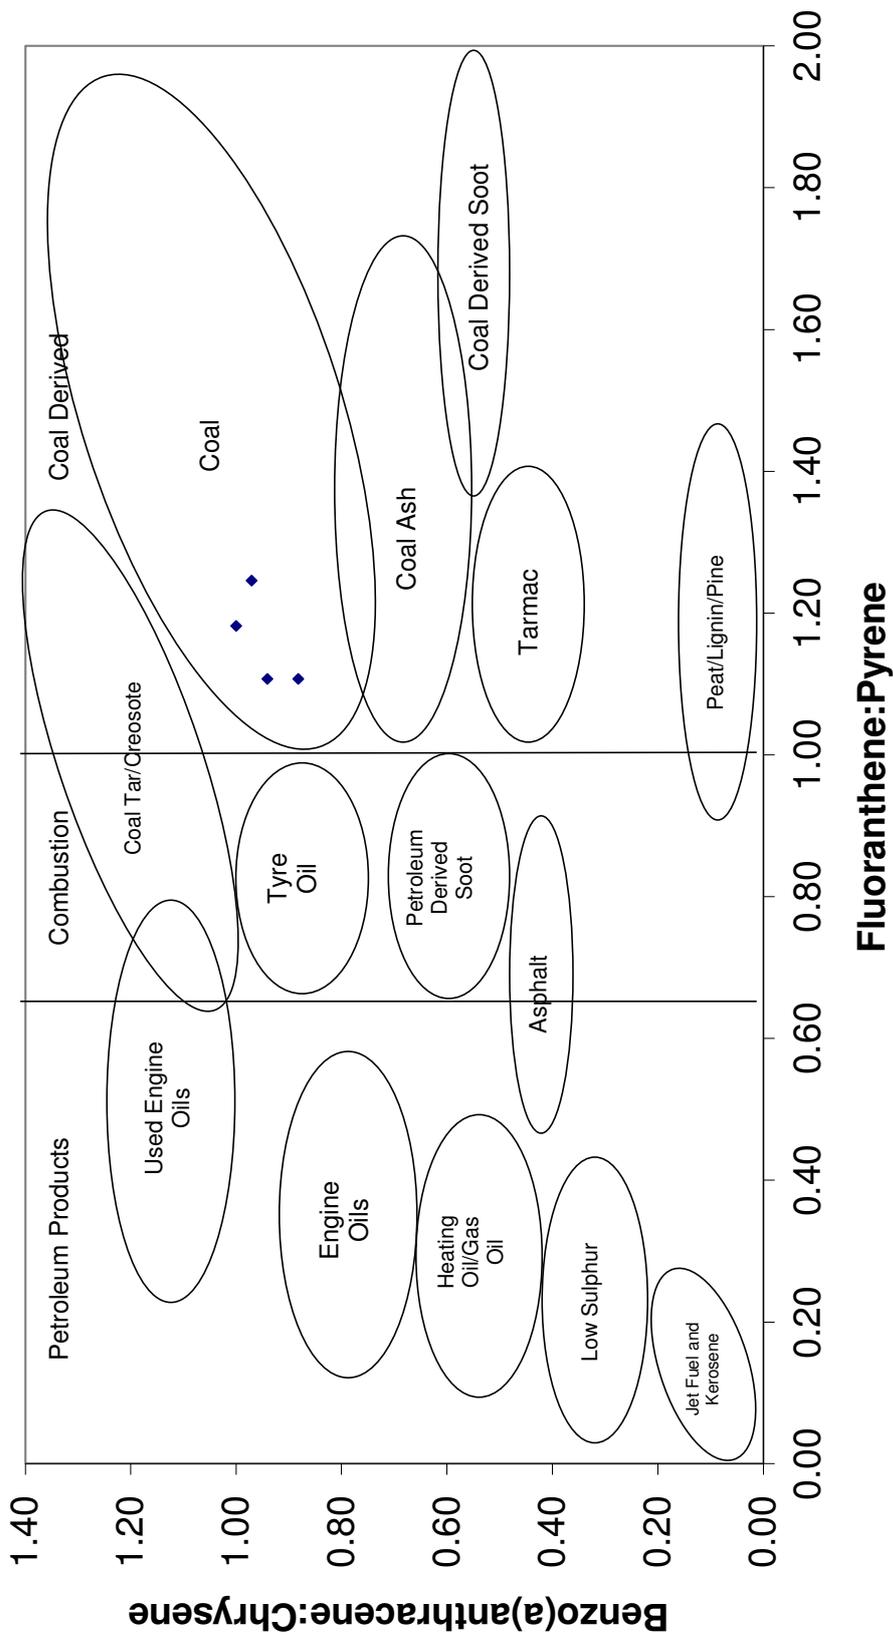
PAH Double Ratio Plot

Sample	Fluoranthene	Pyrene	Ratio Fl:Py	BAP Conc.	Benzo(a) anthracene	Chysene	Ratio B:Ch
WS1	3.10	2.80	1.11		1.50	1.70	0.88
WS2	6.20	5.60	1.11		3.20	3.40	0.94
WS3	7.10	5.70	1.25		3.30	3.40	0.97
WS4	2.60	2.20	1.18		1.00	1.00	1.00

concentrations are statistically applicable to all the topsoil sampled. The PAH ratio plots (presented in Appendix D) show the PAH to be from the presence of coal fragments. Arsenic and lead are elevated in WS3 only, both as outliers, meaning that these elevations are applicable only to WS3 (the rest of the samples having no exceedances for arsenic and lead).
