28th March 2022

Ref: C8781/AW/9824

RE: Supplementary Coal Mining Investigation for Land at Centre 27, off Bankwood Way, Birstall, Batley (Planning Application Ref: 2021/62/92528/E)

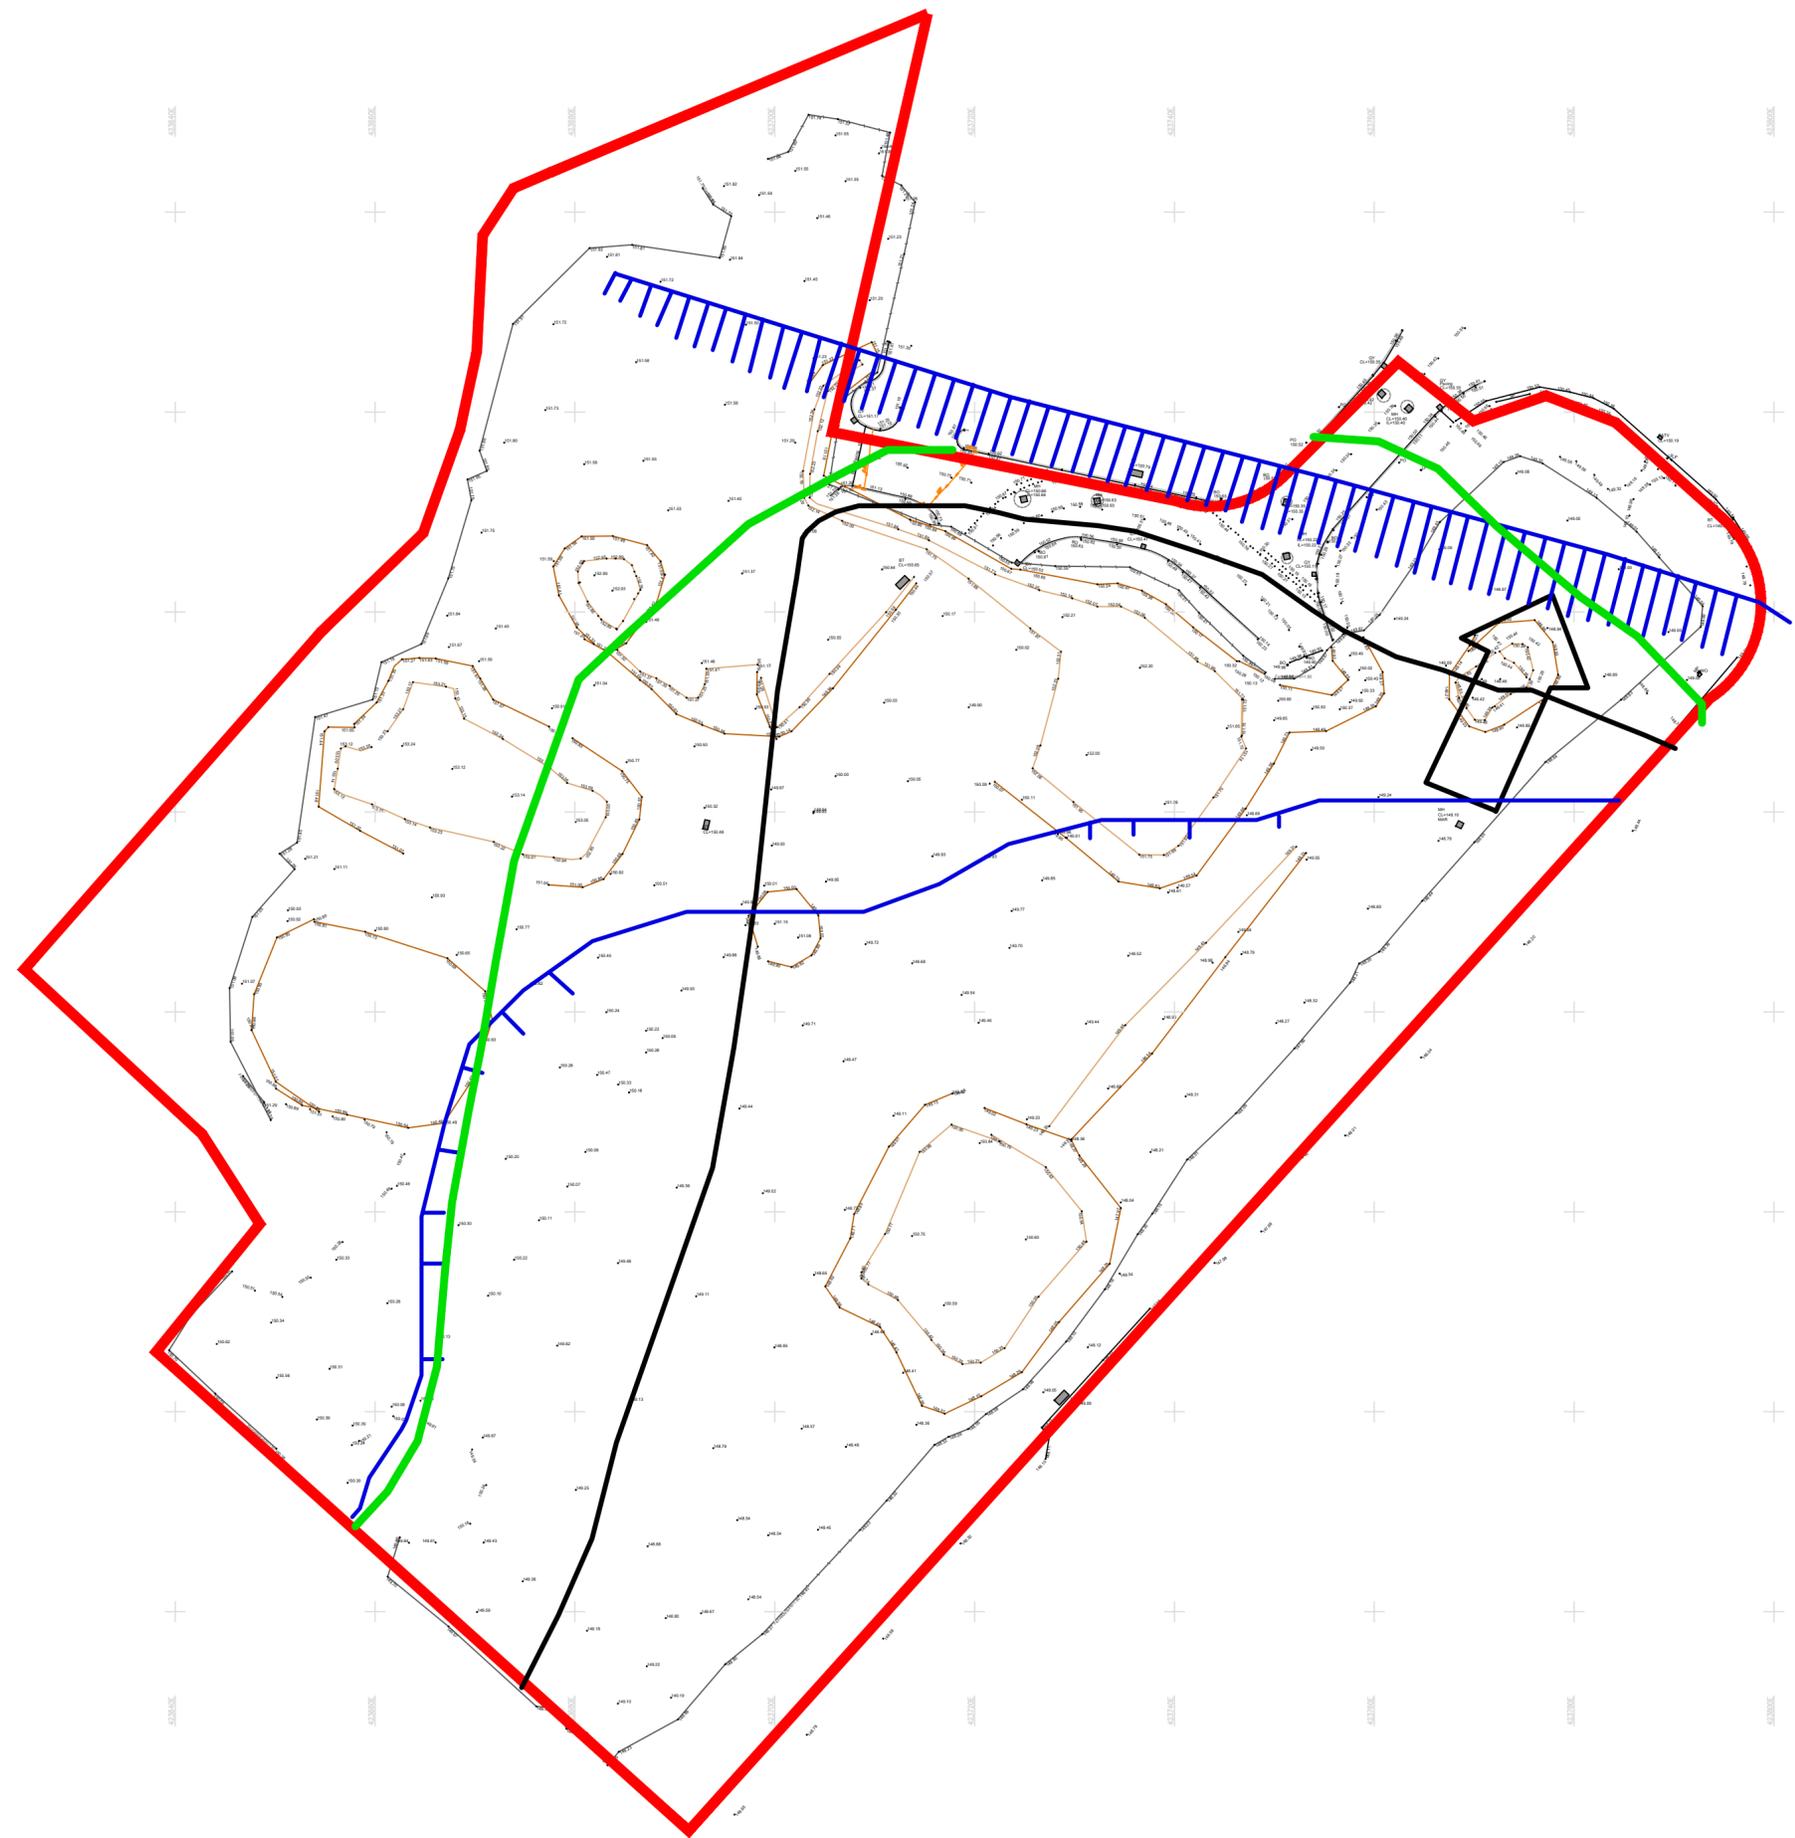
Drawing No. C8781/01 (included within Attachment A) summarises coal mining and pertinent historical features within the site, as taken from relevant British Geological Survey (BGS) records and historical OS maps.

- Site boundary
- Conjectured coal outcrop and adit (taken from Curtins Coal Authority mining report)
- ▤ Approximate extent of former earthworks, as taken from 1893 and 1974 historic OS maps.
- Approximate line of conjectured high wall of former opencast and landfill operations.
- Approximate location and orientation of adit ref. 423427-054 based on information provided by the Coal Authority.

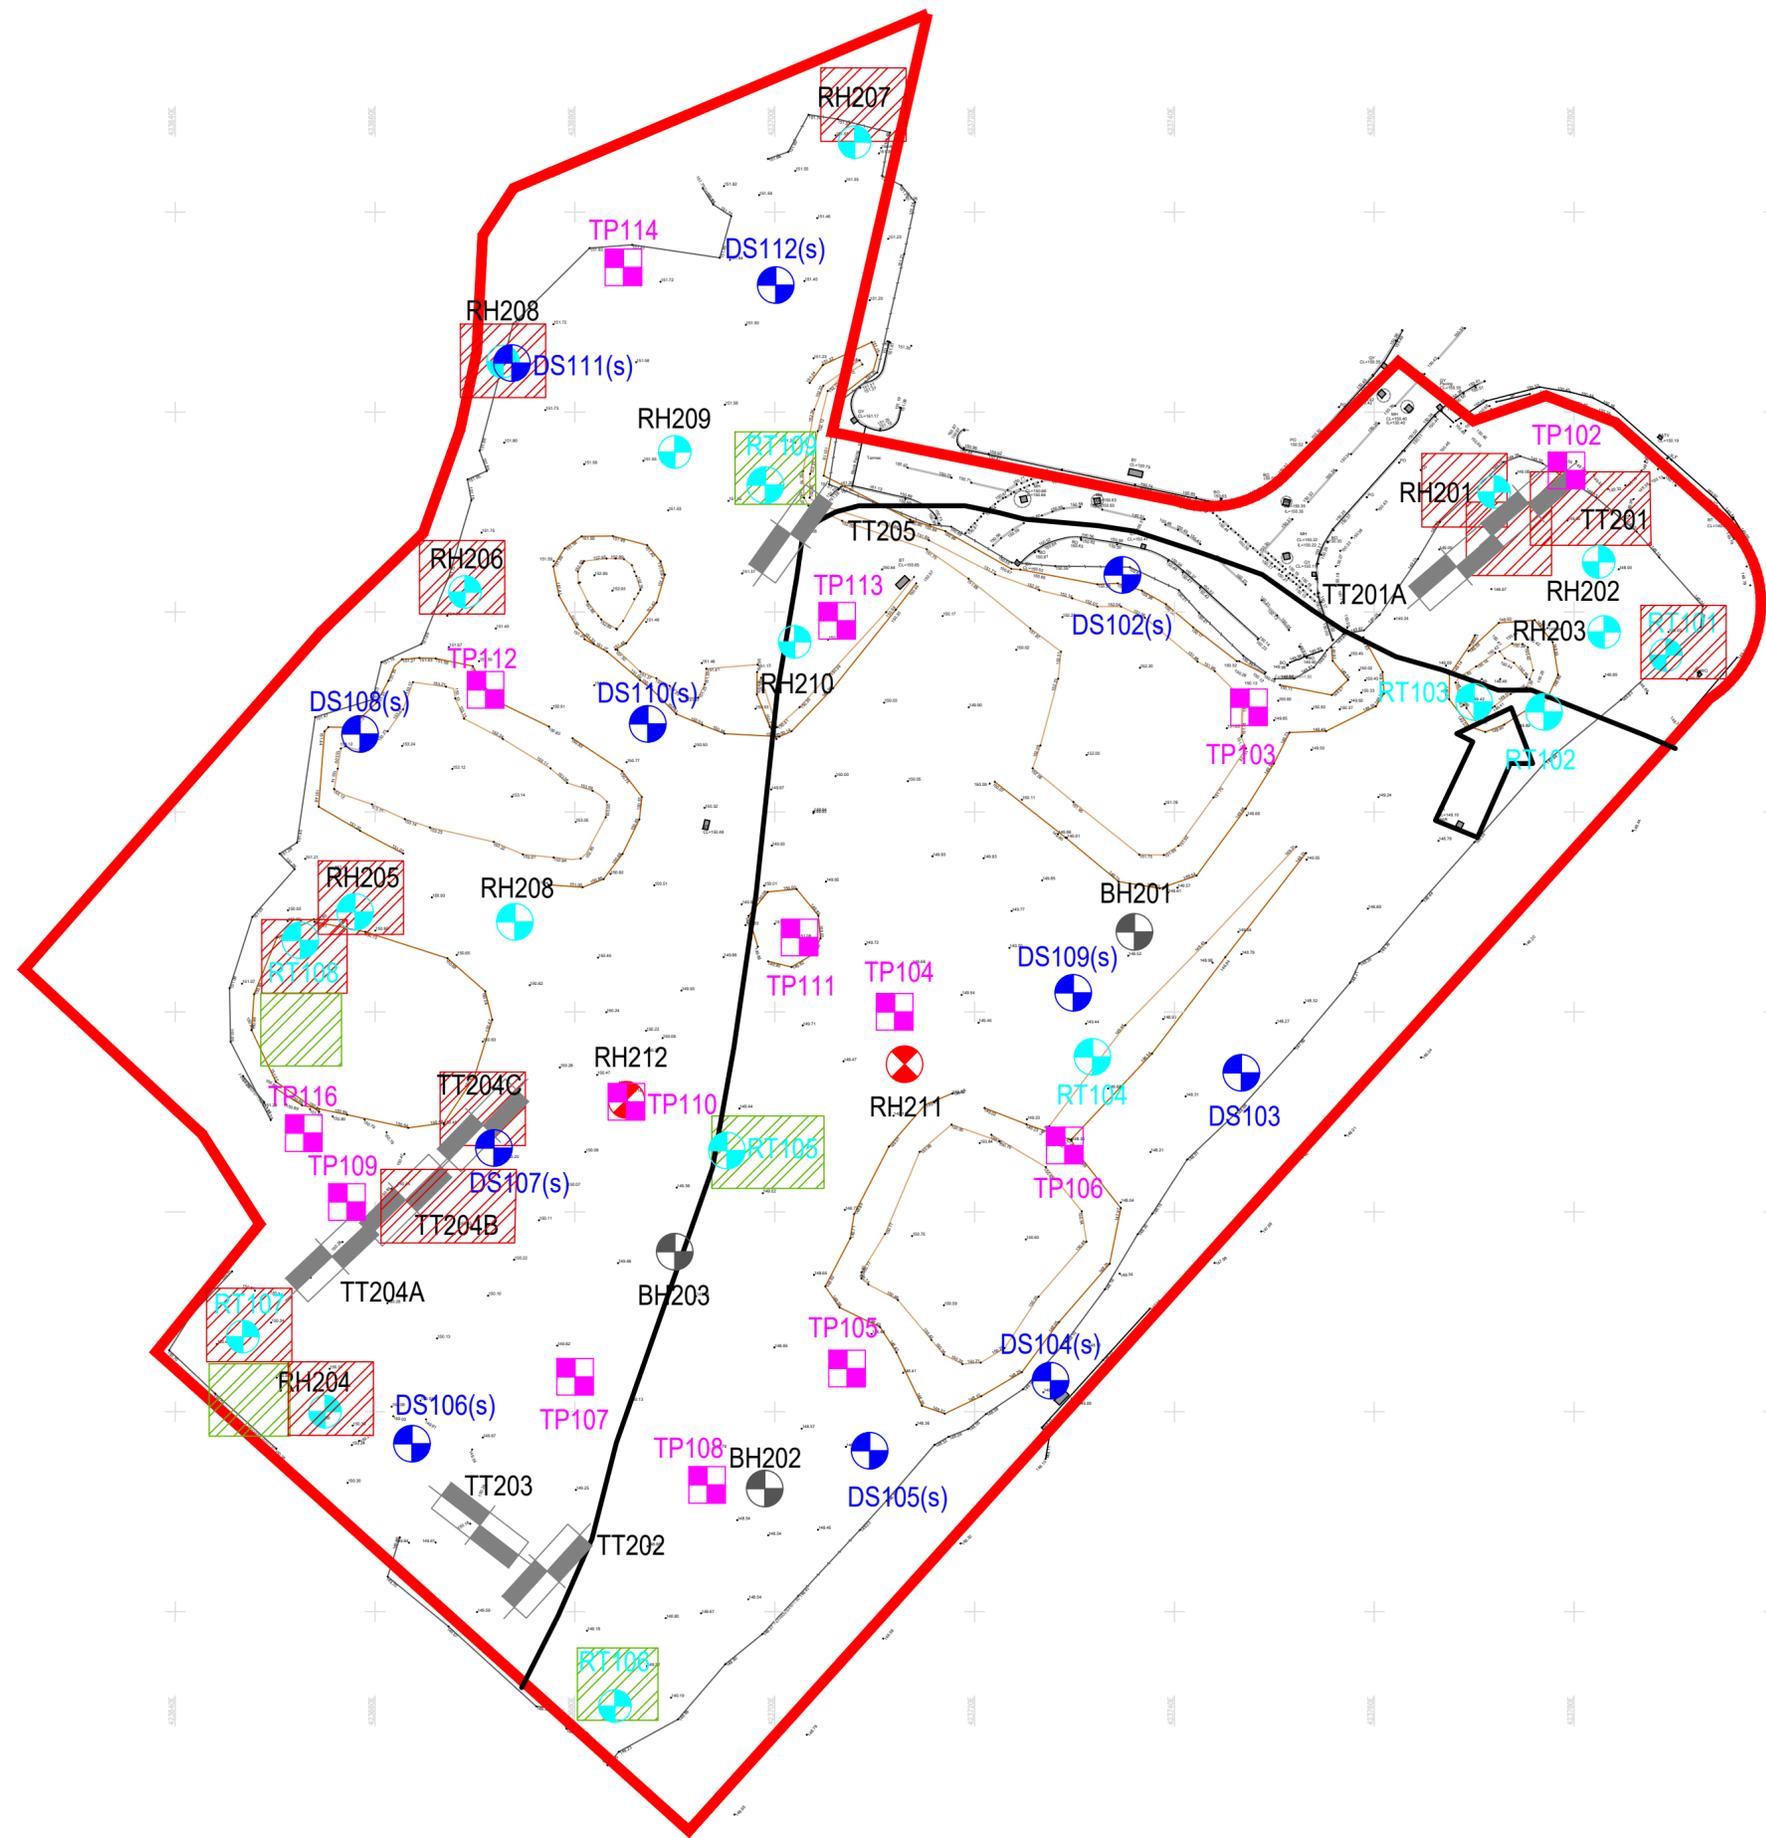
DRAWING NO. C8781/02	REVISION NO. 0
DRAWN BY MF	APPROVED BY GH
DATE March 2022	SCALE 1:500
	PAPER SIZE A2

Two phases of previous investigation have been undertaken at the site, initially by Delta Simons in 2018, subsequently followed by Curtins in 2020 with exploratory hole positions shown in Drawing No. C8781/02 included in Attachment A.

- Site Boundary
- Delta-Simons Site Investigation, 2018
 - Dynamic Sampler Borehole DS100
 - Rotary Borehole RT100
 - Trial Pit TP100
- Curtins Site Investigation, 2020
 - Rotary Probe Borehole RH200
 - Cable Percussive Borehole BH200
 - Rotary Probe Borehole with Cored Follow On RH210
 - Trial Trench TT200
- Evidence of Flockton Thin coal seam and / or evidence of mine workings.
- Evidence of Top Fenton / 1BM coal seam at depth (>30m bgl).
- Conjectured outcrop of Flockton Thin coal seam and adit (as taken from the Coal Authority mining report, included within the Curtins Ground Investigation Report).

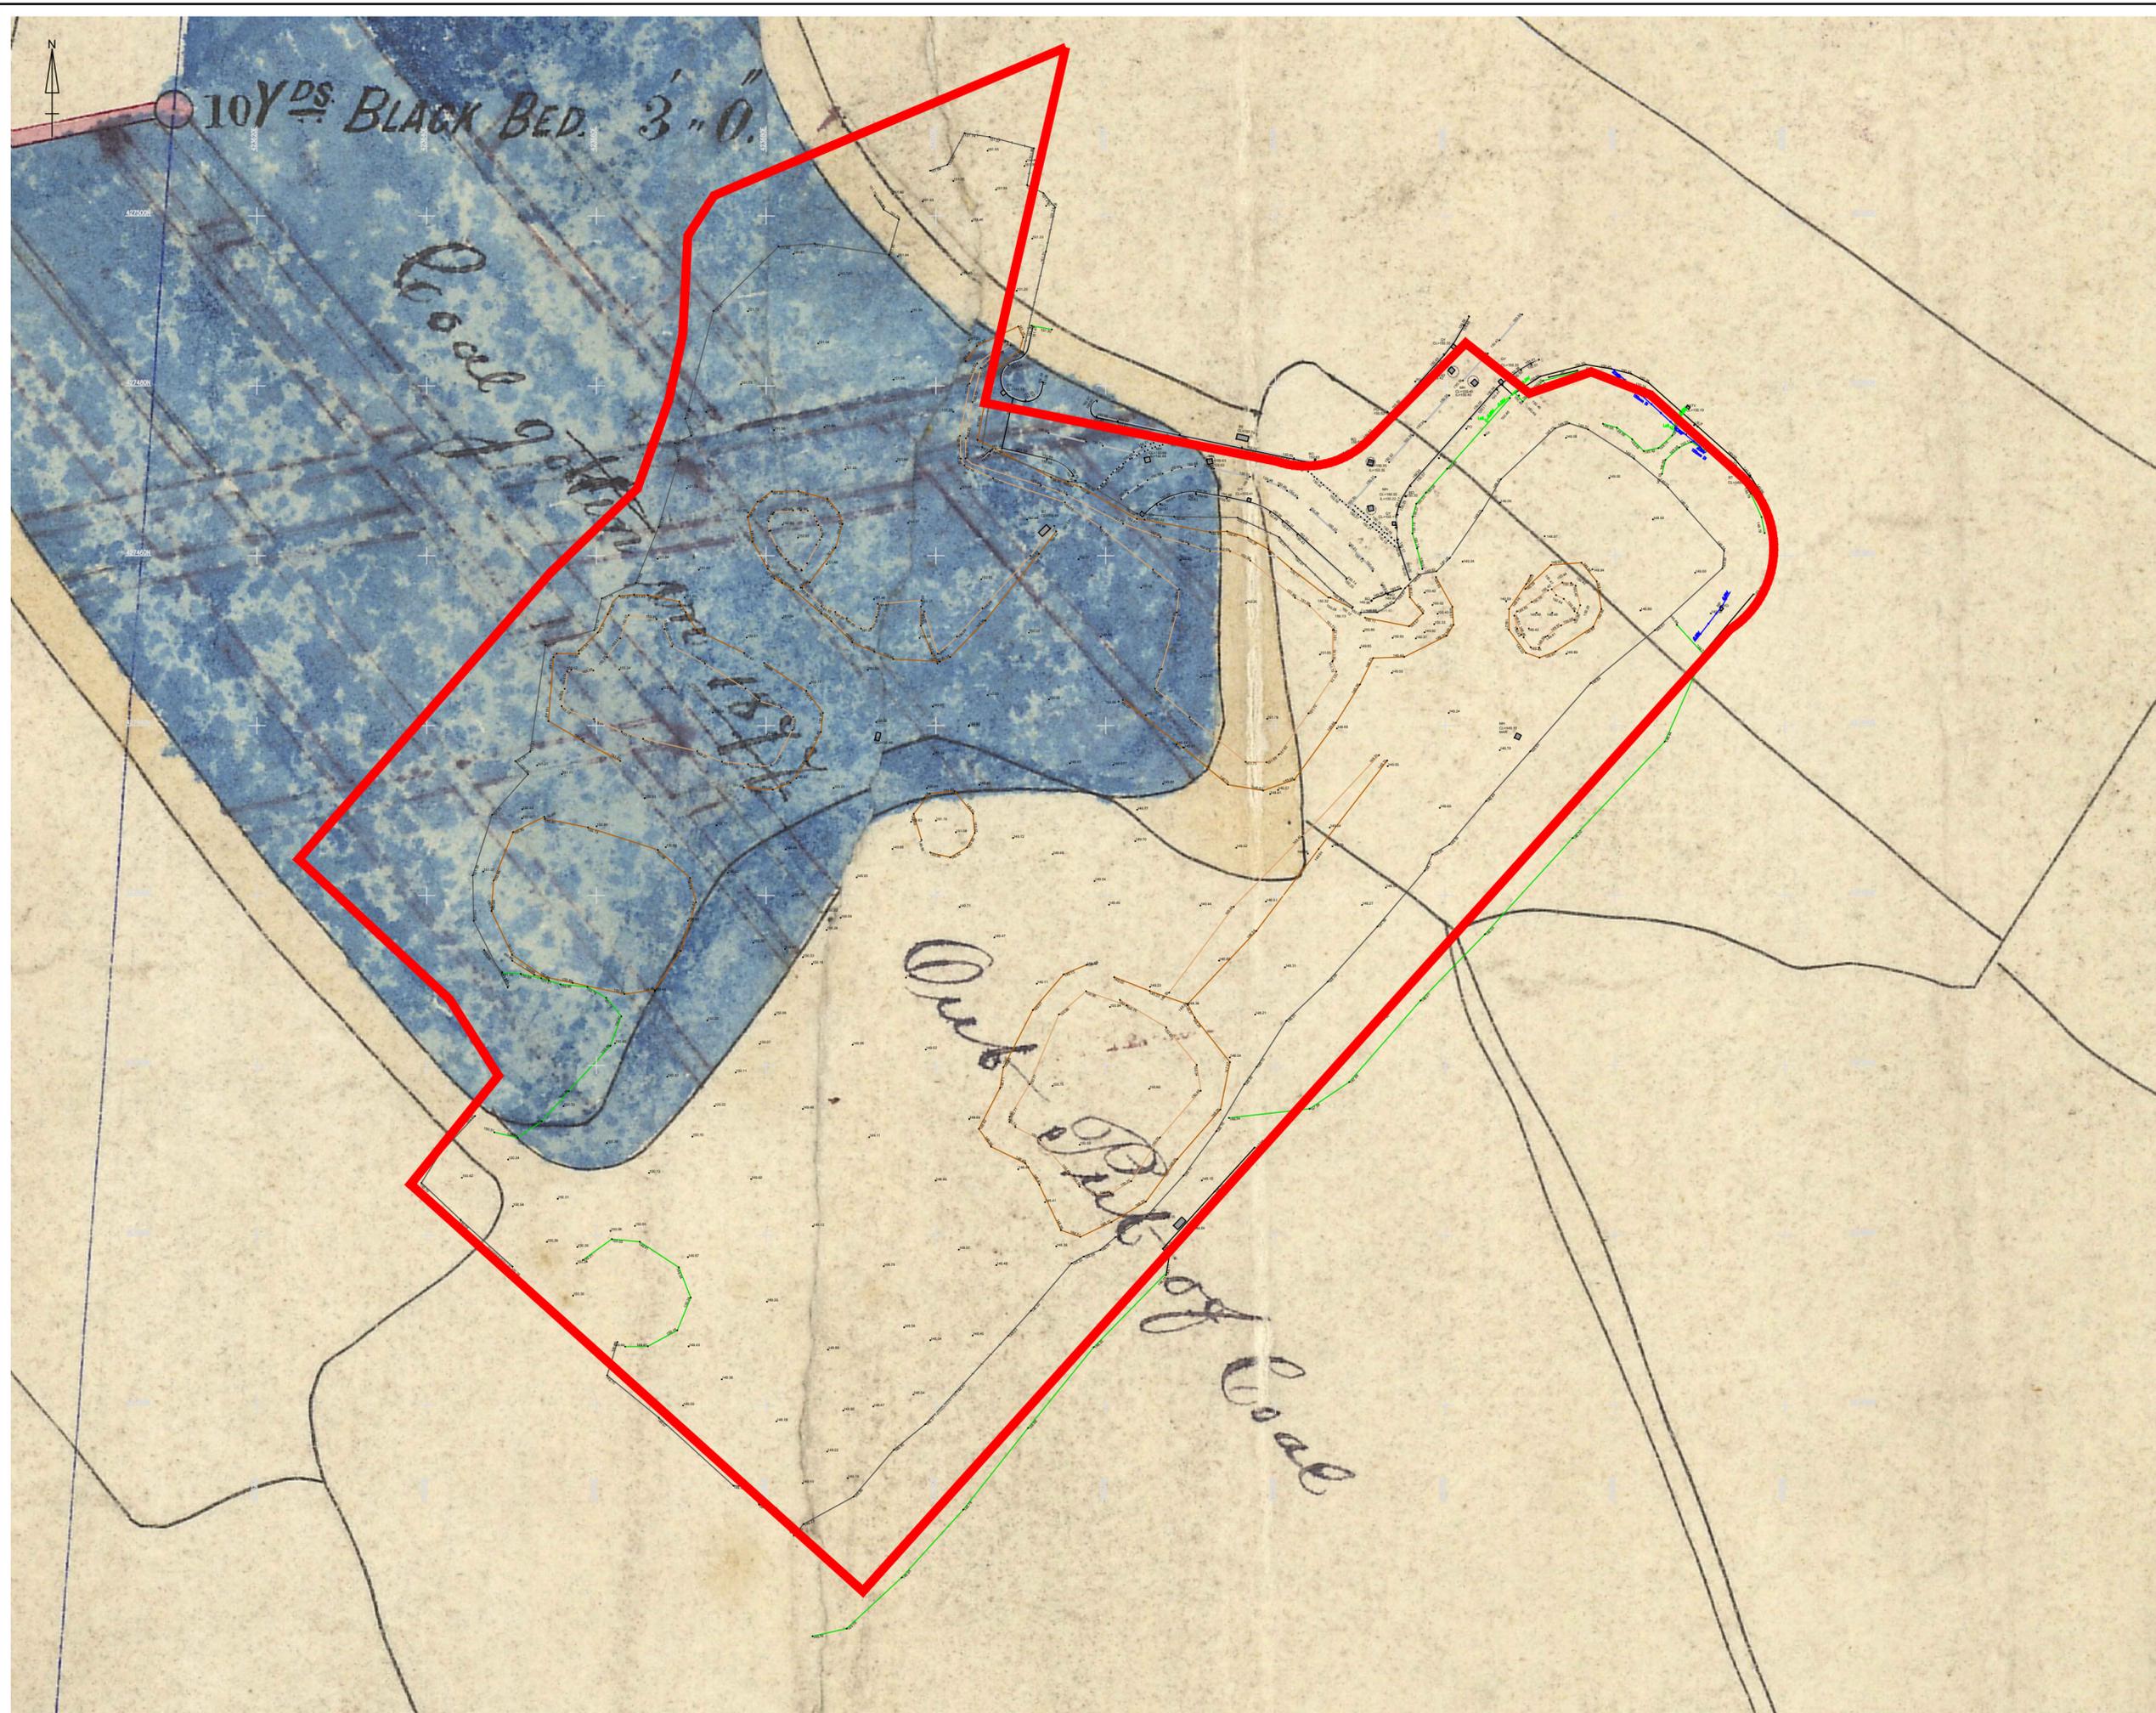
The Flockton Thin coal is shown to have been worked within the northwestern and western extents of the site, referenced on the plan as '10 yds Black Bed 3'-0"'. An adit is shown off site to the northwest. The area within the southeast of the site is referenced as 'output of coal', located to the east of the conjectured outcrop. A section of the coal indicates it to be typically 2' 8" [0.8m] thick, underlain by spavin (likely a seatearth) at a thickness of 1' 0" [0.3m].

Extract taken from Coal Authority Mine Abandonment Plan Ref. 913, Flockton Thin

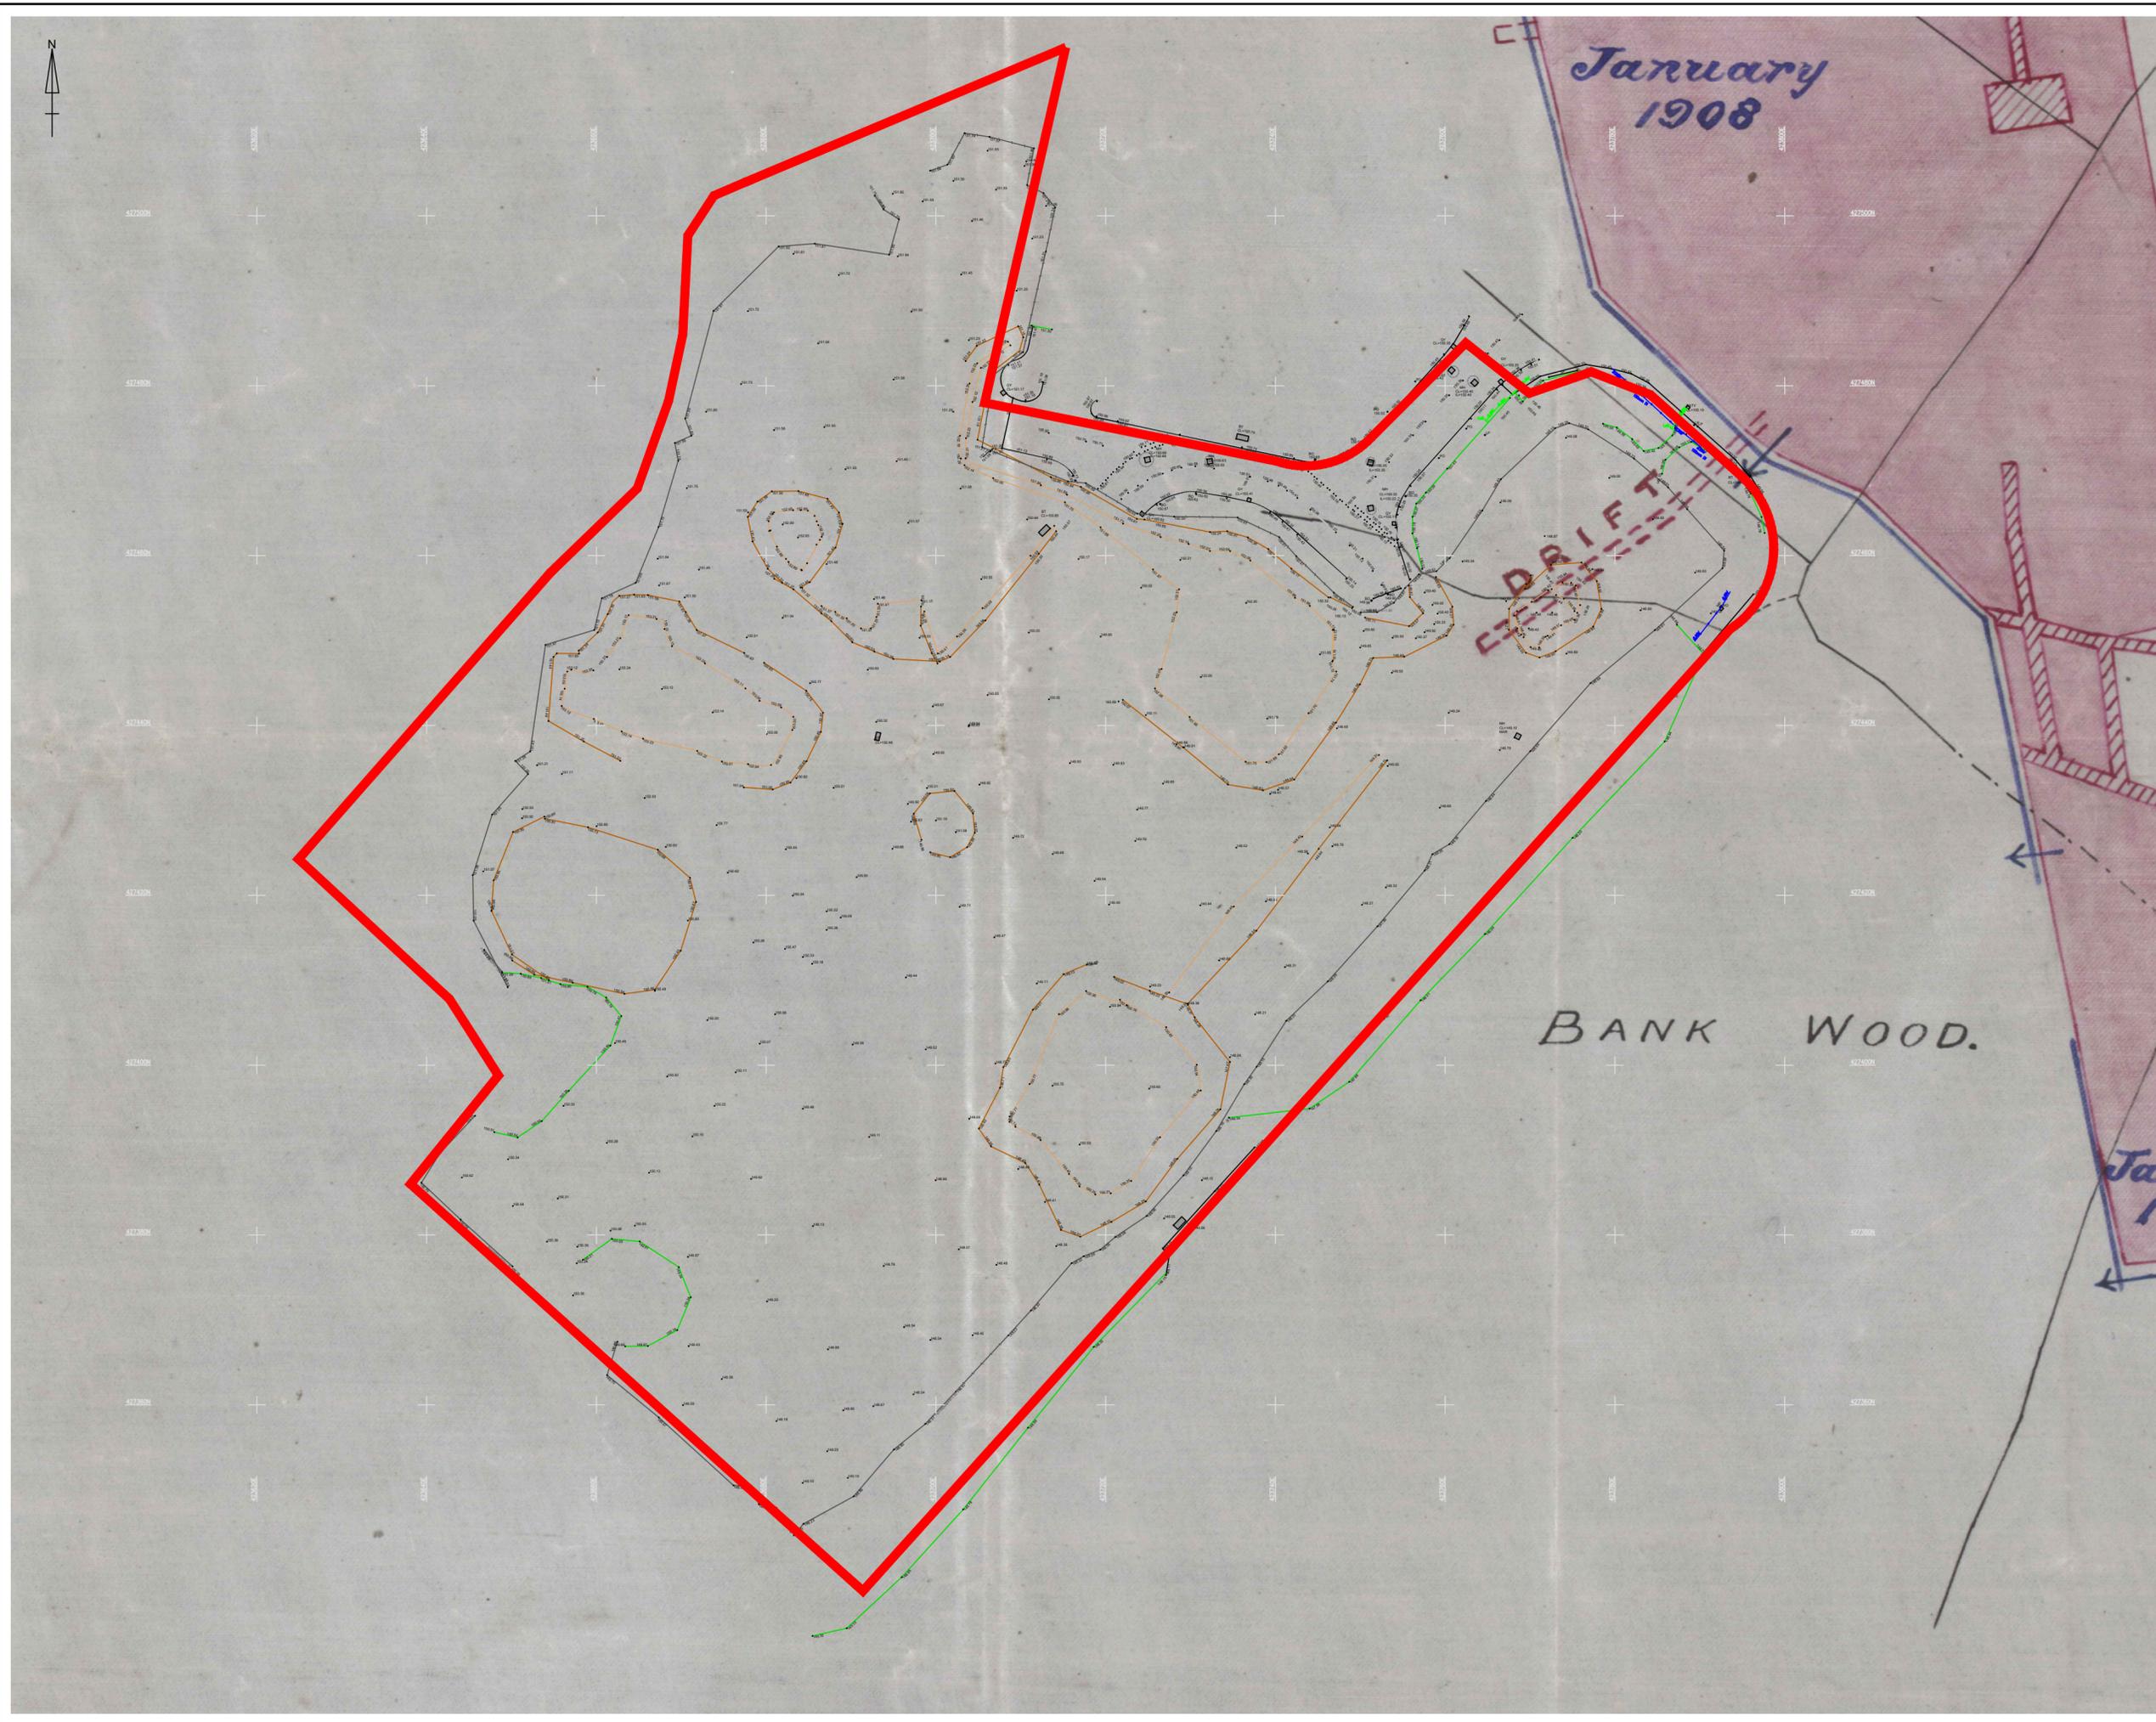
DRAWING NO. C8781/03B	REVISION NO. 0	
DRAWN BY MF	APPROVED BY GH	
DATE March 2022	SCALE 1:500	PAPER SIZE A2

The Top Fenton / First Brown Metal abandonment plan shows recorded workings within the First and Second Brown Metal Coal to the east and north of the site. The site is located to the south of an area with a reference to 'old workings'. A drift (assumed to be related to the recorded mine adit ref. 423427-054) is shown within the northeastern extent of the site, heading in a north easterly direction off-site.

An area of the plan to the north of the site indicates that the '*approximate depth from surface to Brown Metal Coal foot 40 yards*' [12m].

A section of the First and Second Brown Metal coal indicates bands of coal and dirt at up to 1 ft 11 inches [0.58m] and 3 ft 11 inches [1.2m] thick, respectively, separated by a 2 ft 1 inch [0.6m] thick band of 'dirt'.

Extract taken from Coal Authority Mine Abandonment Plan ref. 6019, Top Fenton or First Brown Metal

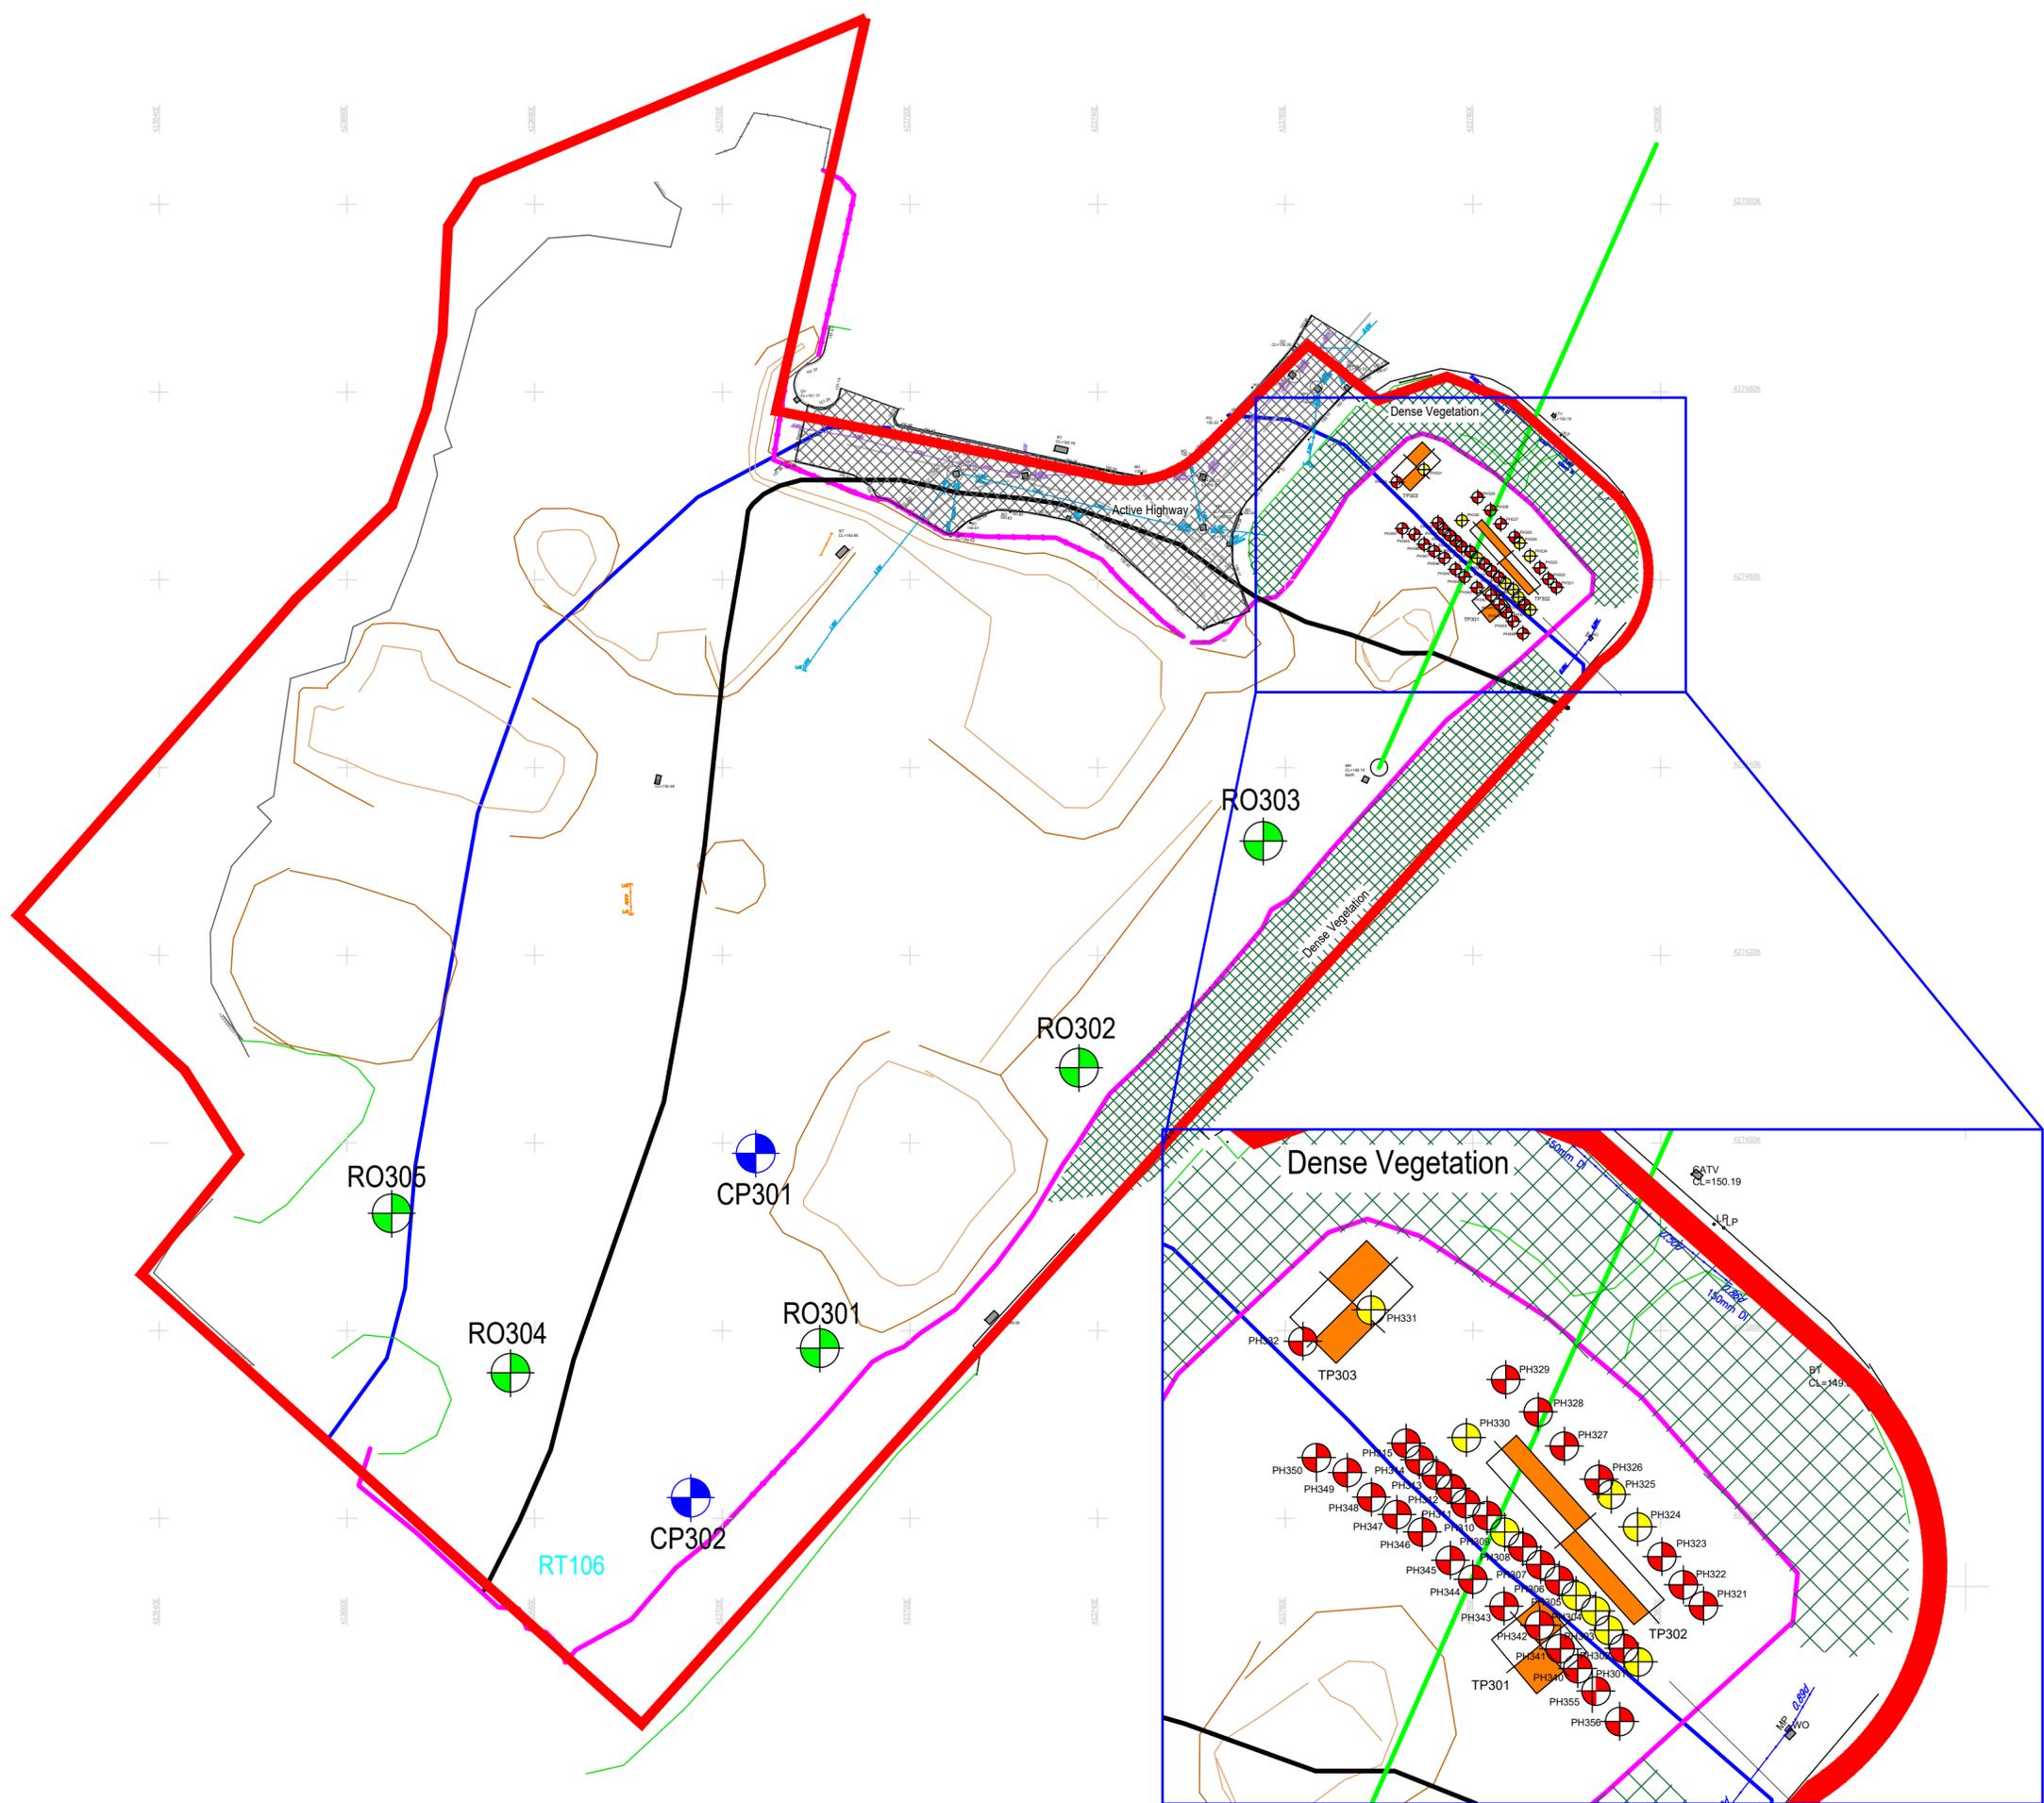
Adit work area - Scale 1.200

A CA recorded adit (CA ref. 423427-054) is located within the northeast of the site (as shown on Drawing No. C8781/04 included within Attachment A). The adit has a recorded angle of 24° and a departure of 8m from a recorded location of 423770 427440, with an assumed diameter of 2m. Evidence of a 'drift' (assumed to relate to the recorded adit) is indicated on the abandonment plans for the Top Fenton / First Brown Metal seam. Previous site investigations undertaken have not identified the adit, albeit its conjectured location was targeted. Further investigation of the feature was recommended to determine the presence/absence of the feature and its dimensions, depth and locality if encountered.

On completion of the exploratory holes all locations were surveyed to National Grid Co-ordinates and the ground level at each location determined to Ordnance Datum, using GPS survey equipment. The positions of the exploratory holes are shown on Drawing No. C8781/04 included within Attachment A.

- NOTES**
- Site Boundary
 - Site Hoarding
 - Indicative location of adit based on coordinates and orientation provided by CA
 - Indicative location of historic quarry highwall
 - Conjectured coal outcrop
- Sirius Borehole Locations 2022**
- Cable Percussive Borehole with Gas / Groundwater Monitoring Well
 - Rotary Borehole with Gas / Groundwater Monitoring Well
 - Rotary probehole whereby solid coal was encountered
 - Rotary probehole whereby soft ground / no coal was encountered
 - Indicative Trial / Trench Location

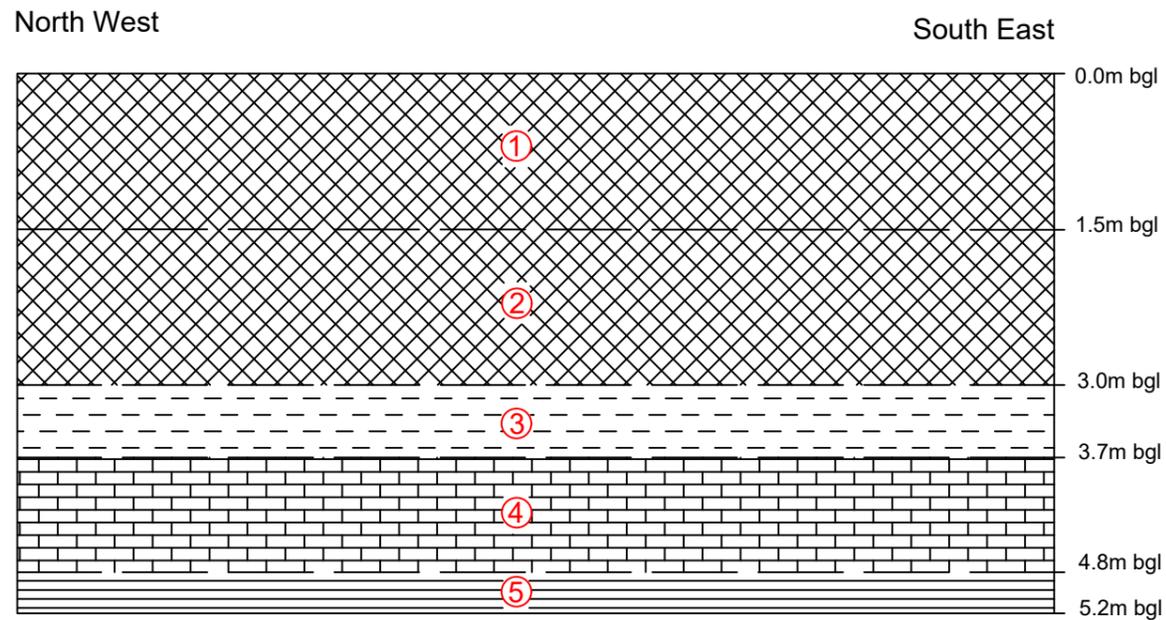
TP302 - Cross section

A 10m long trial trench (ref. TP302) was mechanically excavated parallel to the two most northern transects to expose the Flockton Thin coal seam, and to allow confirmation of the presence (or absence) of the conjectured adit or any associated mining features within the area of identified 'soft ground'. The excavation encountered made ground to a depth of 3.0m underlain by cohesive residual sandstone to 3.7m bgl. Intact coal inferred to represent the Flockton Thin seam was identified to a depth of 4.8m bgl along the full length of the trial trench. The coal was described as extremely weak, in turn underlain by similarly extremely weak mudstone. The presence of extremely weak (albeit intact) coal may be attributable to the occurrence of 'soft ground' or 'soft push' within rotary probe holes PH301 and PH303 to PH305, where limited / no return of flush occurred to corroborate the ground conditions.

A cross-section sketch of trial trench TP302 is presented within Drawing No. C8781/TP302 in Attachment B.

1. Made Ground - Grey sandy GRAVEL. Sand is fine to coarse. Gravel is angular to sub-rounded fine to coarse of sandstone, concrete, brick and rebar.
2. MADE GROUND - Firm dark grey sandy gravelly CLAY. Low plasticity (field description). Sand is fine to coarse. Gravel is sub-angular to sub-rounded fine to coarse of sandstone, mudstone and coal (Colliery Spoil).
3. Light brown / orangish brown sandy gravelly CLAY. Sand is fine to coarse. Gravel is angular fine to coarse of sandstone (Residual Sandstone).
4. Extremely weak black COAL. Recovered as sandy gravel of coal.
5. Extremely weak light grey MUDSTONE. Recovered as sandy gravel of mudstone.
