**Re: Hazardous Ground Gas Risk Assessment for Land at Centre 27, off Bankwood Way, Birstall, Batley (Planning Application Ref: 2021/62/92528/E)**

## 1.0 Introduction

Sirius Geotechnical Ltd (Sirius) was commissioned by Lidl GB Ltd (Lidl) to undertake a supplementary ground gas risk assessment for land at Centre 27, off Bankwood Way, Birstall, Batley ("the site"). This investigation is intended to supplement previous Phase 1 and 2 Ground Investigation reports for the site, undertaken by third parties, in order to better characterise and assess risks associated with hazardous ground gas.

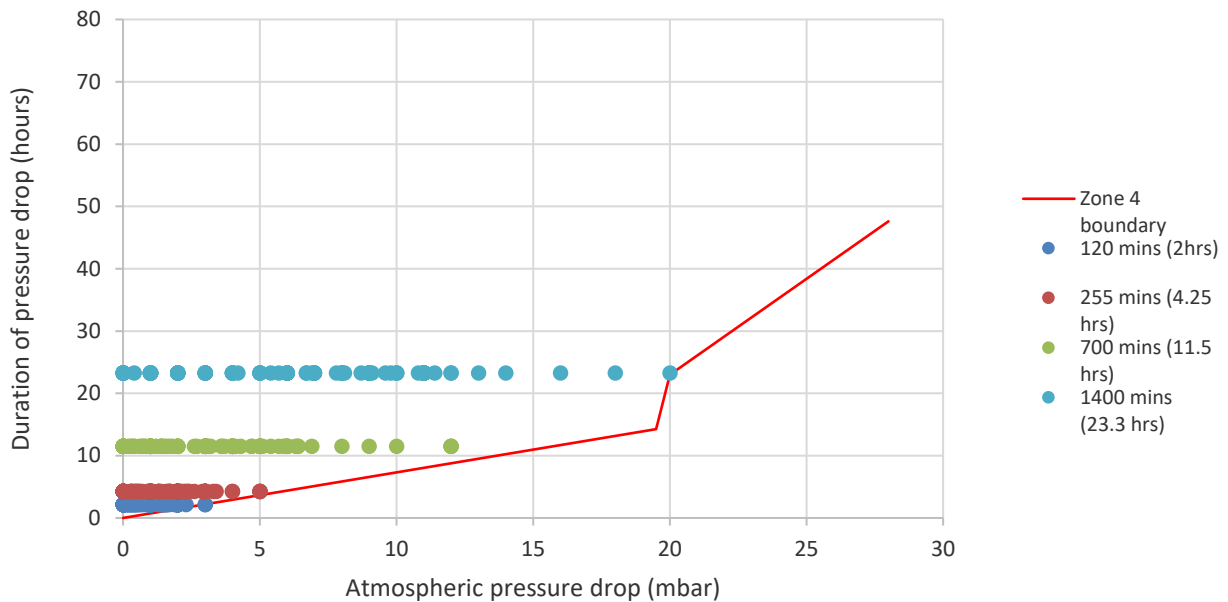
Figure A - Centre 27, Birstall - Summary of atmospheric pressure changes

It can be seen that a period of falling pressure over several timescales falls within the 'worst case' zone, with several other periods very near to the zone. On this basis it is concluded that the variation in conditions is sufficiently comprehensive to give a high level of confidence that likely worst case conditions have been considered as required by the guidance.

Atmospheric pressure during the period of monitoring ranged from 988mb to 1045mb, and showed a number of marked rises and falls. Based on guidance contained within CL:AIRE TB18 and TB17, care needs to be taken to ensure that monitoring encompasses suitable periods of 'worst case' atmospheric conditions where this could potentially be a significant driver of ground gas migration. Where continuous monitoring is carried out TB18 suggests that at least two such periods are included in order that characteristic patterns can be reliably identified. TB17 provides a basis for identifying where 'worst case' conditions are likely to have been monitored.

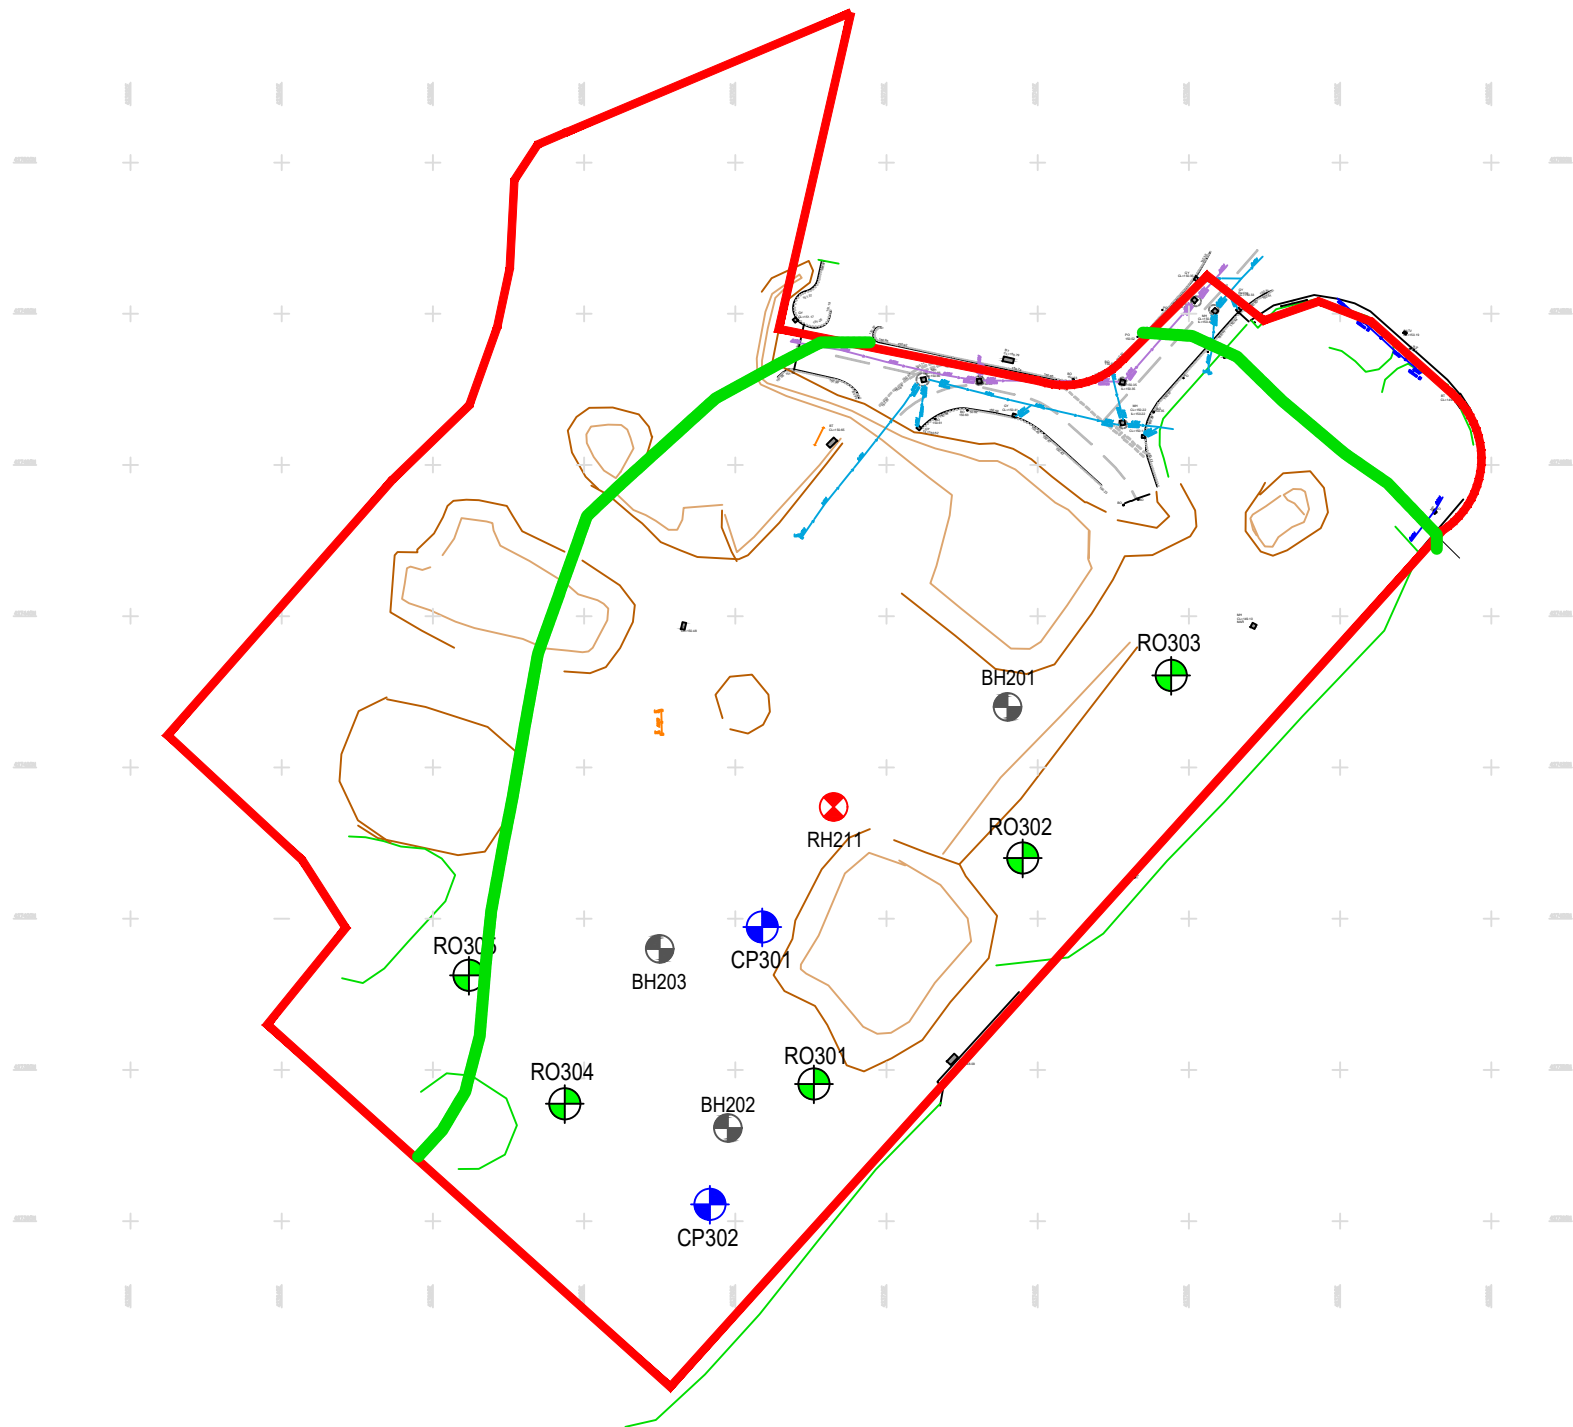
**Ground Gas Monitoring Well  
 Locations**

- Site Boundary
- Sirius Borehole Locations, 2022**
- Cable Percussive Borehole with Gas / Groundwater Monitoring Well (Sirius)
- Rotary Borehole with Gas / Groundwater Monitoring Well
- Curtins Borehole Locations, 2020**
- Cable Percussive Borehole with Gas / Groundwater Monitoring Well (Curtins)
- Rotary Borehole with Gas / Groundwater Monitoring Well
- Approximate line of conjectured high wall of former opencast and landfill operations.

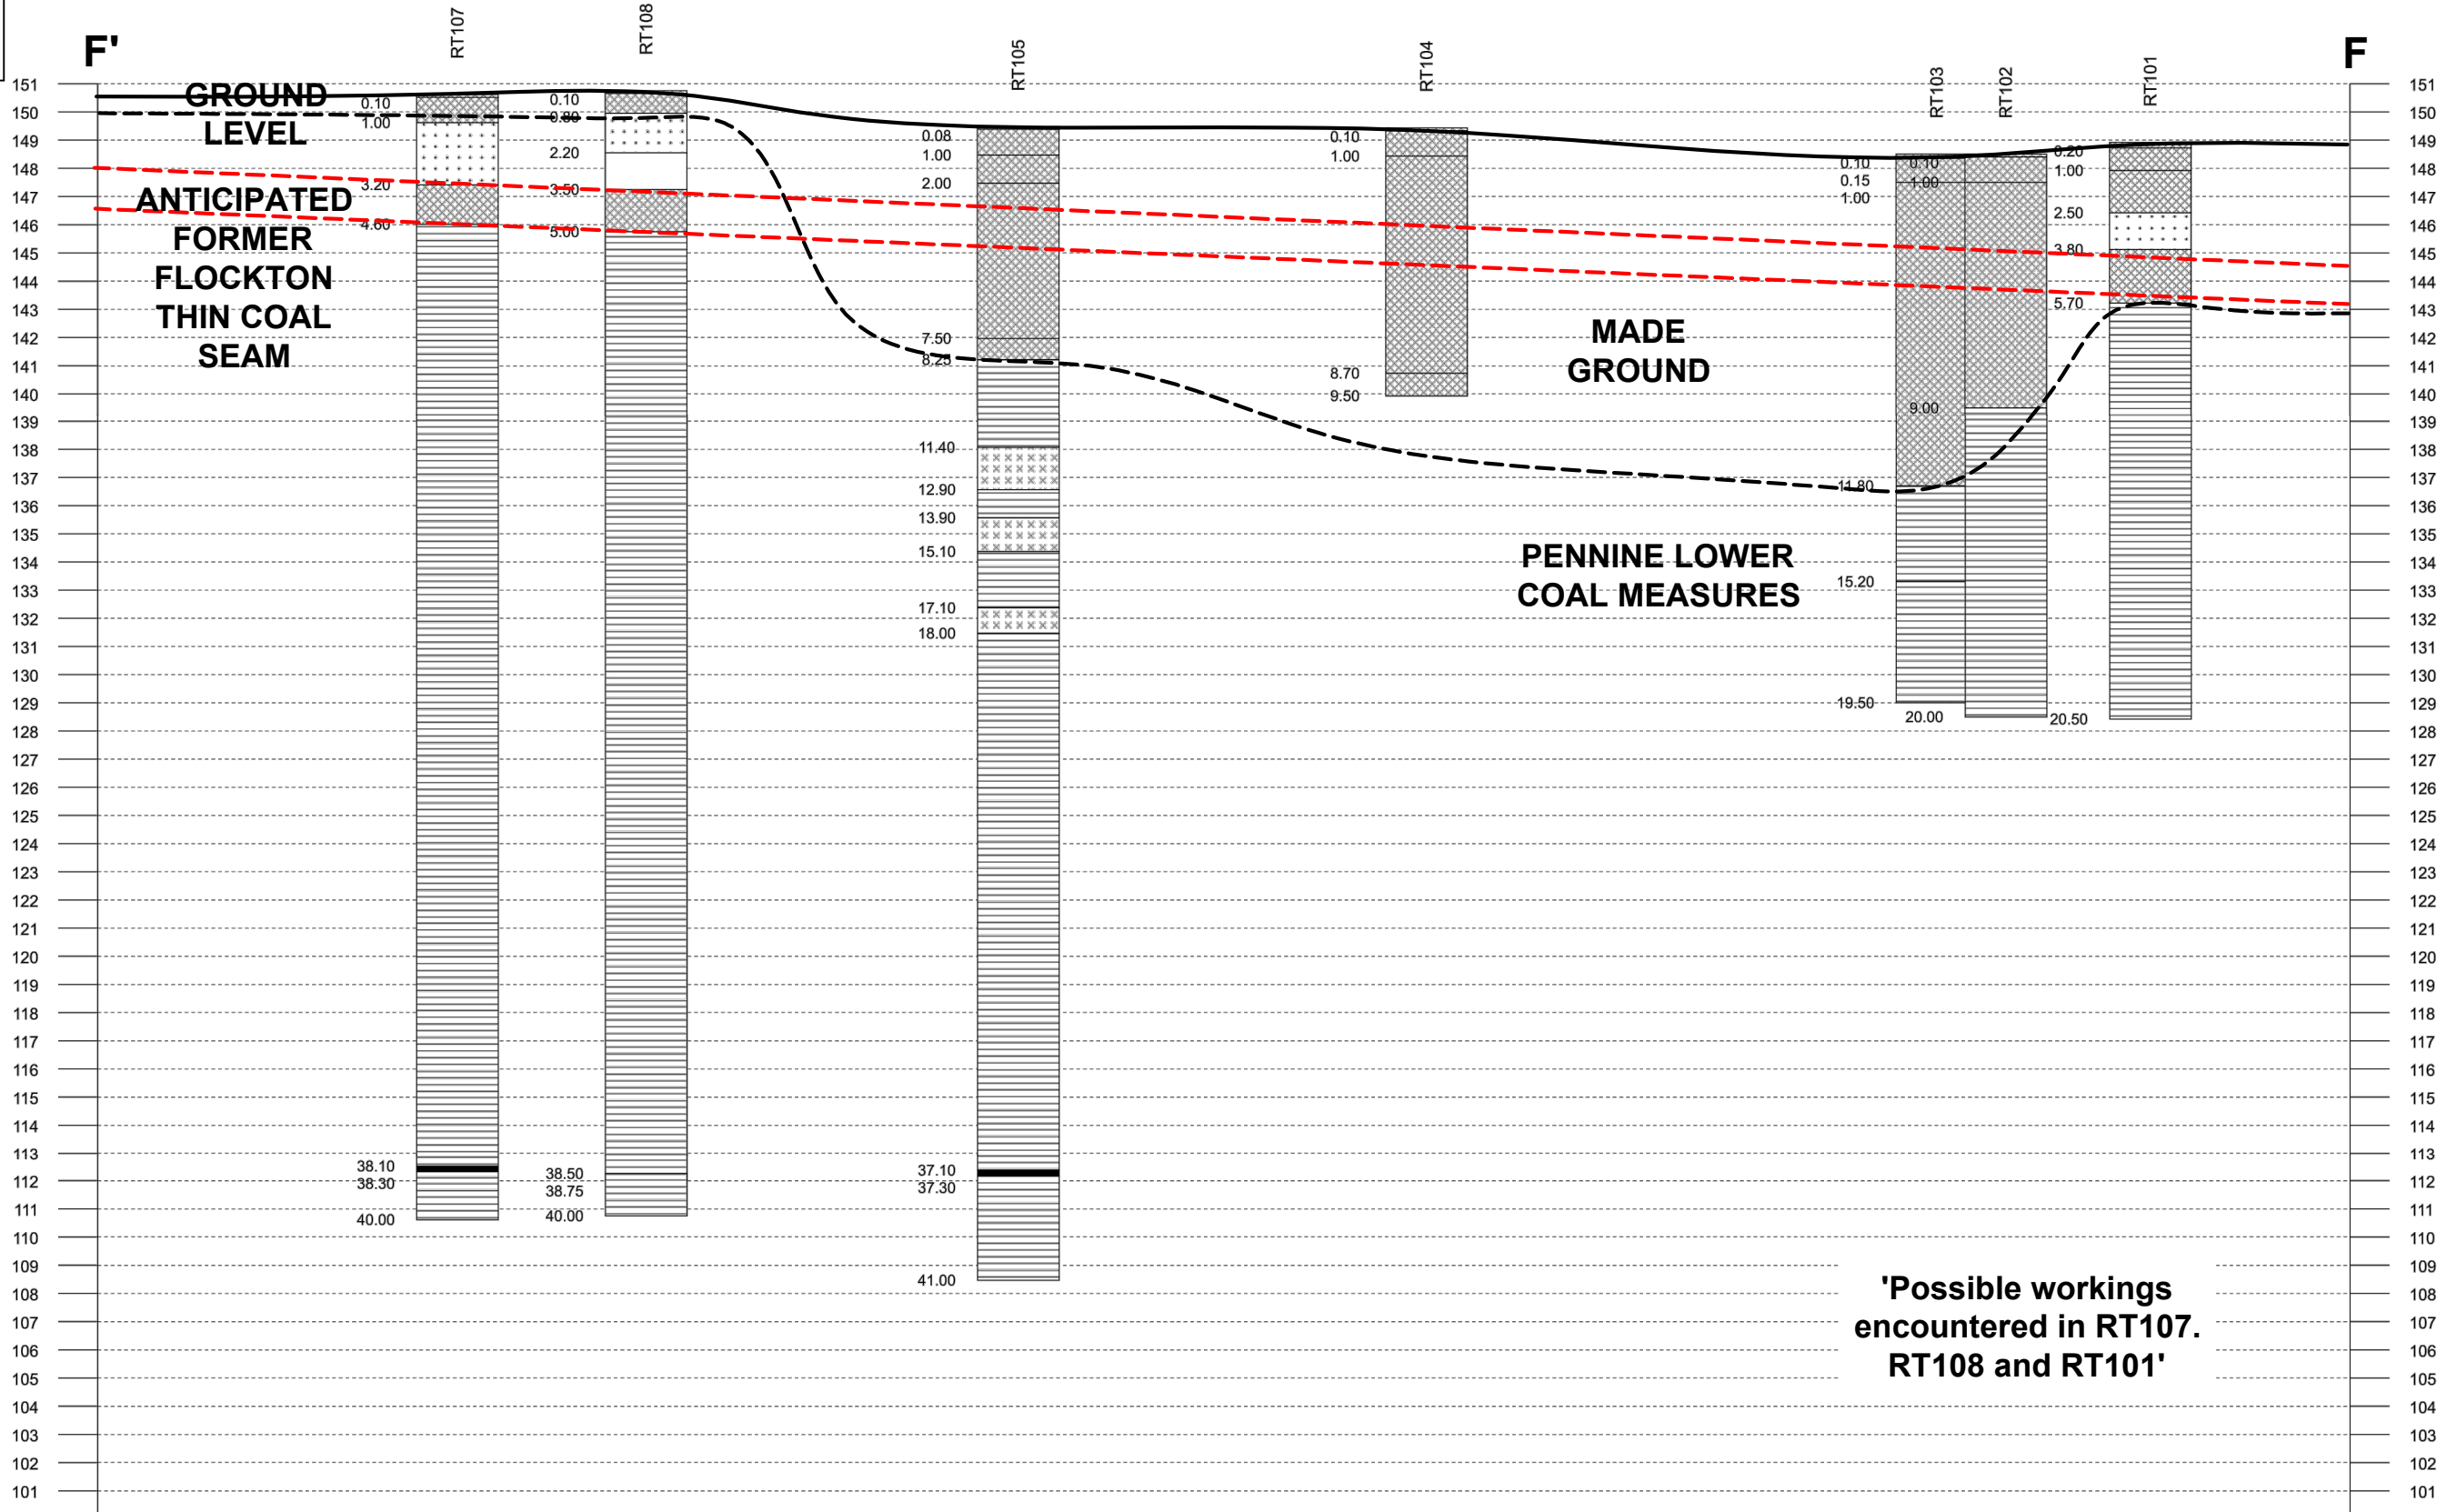
TITLE:  
Indicative Geological Cross-Section F - F'  
Centre 27  
Birstall

- Indicative Strata Boundary
- - - Anticipated former Flockton Thin Coal Seam

- MADE GROUND (Hatched pattern)
- SANDSTONE (Dotted pattern)
- TOPSOIL (Cross-hatched pattern)
- Void (White)
- MUDSTONE (Horizontal lines)
- SILTSTONE (Vertical lines)
- COAL (Solid black)

The variation in made ground is considered to be associated with earthworks identified on the historical mapping. Cross sections reproduced from the Delta Simons report (drawing Refs 14-60723.03 – 7c & 7f contained within Appendix B of this report), illustrate the general profile of the infilled excavation, along with the inferred former location of the Flockton Thin Coal seam, having since been removed by either opencast or underground mining. Similarly, the sections show

the steeply-sloping highwall in the northeast of the site, and the thicker landfill waste deposits in the southwest.
