Bat Survey to
56 Greenhill Bank Road
New Mill
HD9 1ER

26th August 2025

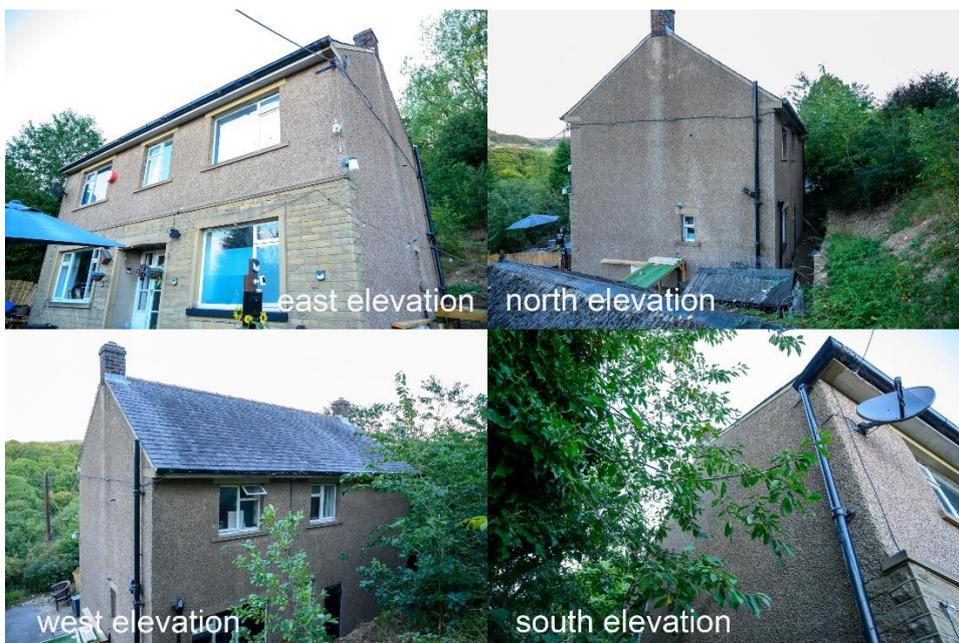
Photo 1: Showing general exterior view of the house

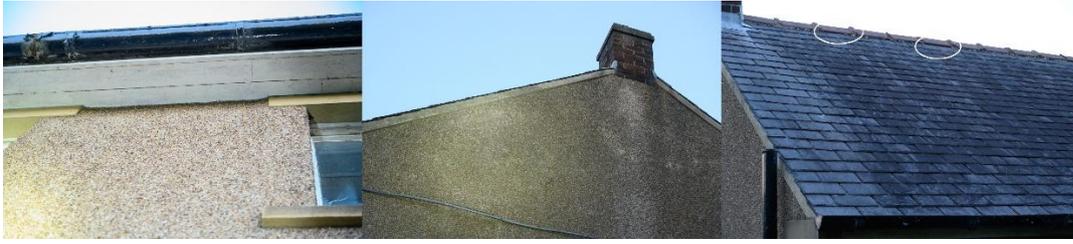
The house is a detached dwelling with a blue slate roof and rendered walls. The roof is sound and without any missing or slipped tiles though there are two small sections of missing ridge pointing on the west side of the ridge. The verges are very sound and are sealed by the render and there does not appear to be any potential access at the roof edges where the slates meet the verge. The walls are completely rendered forming a tight seal at the boxed eaves on the front and rear of the house and there are no external decorative wooden features.

Photo 2: General view of sealed eaves, dry verge and section of failed ridge mortar

The render is in excellent condition and forms such a tight seal at the eaves and dry verges that it effectively eliminates any potential for bats to roost. The only potential roosting features are the sections of missing ridge pointing on the west side of the roof. An internal inspection of the attic revealed that the ridge section and the internal gable apex are heavily covered in cobwebs. There was no light ingress and no scattered droppings or discarded prey remains, Bats have not used the internal roof sections. The limited number and diversity of potential roosting features classify the dwelling as very low value to bats and only a single activity survey is called for.

In order to compensate for any slight loss of potential roosting features, permanent roosting features should be included in the fabric of the new dwelling. An integral bat roosting feature should be included on both the south and west elevations and be in place prior to occupancy of the building. There are a wide range of bat roosting features available such as those from Schwegler e.g, Schwegler bat wall system 3FE. Style and location can be marked on the final plans.
