BIRKENSHAW

SUPPLEMENTARY INVESTIGATION

ORION HOMES

OCTOBER 2024

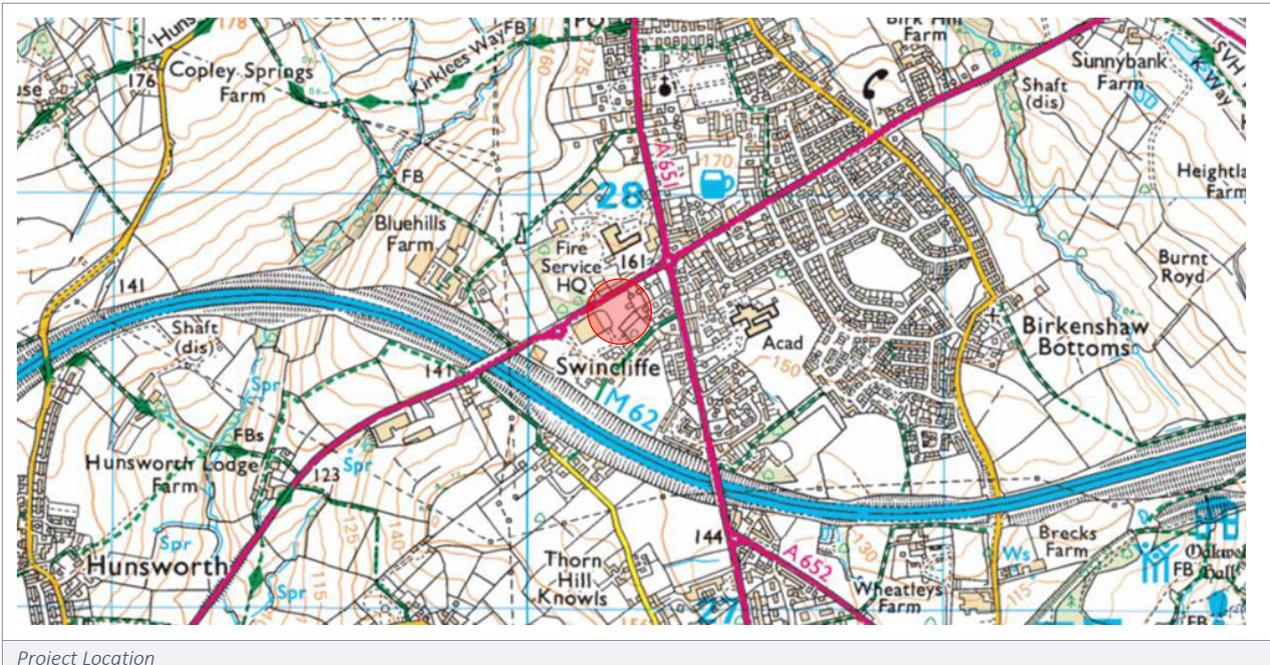
The site is located circa 4.7 miles south east of Bradford City Centre, as shown on the Project Location Plan GRO-23390-PO1 and is approximately centred on National Grid Reference 439118, 424304.

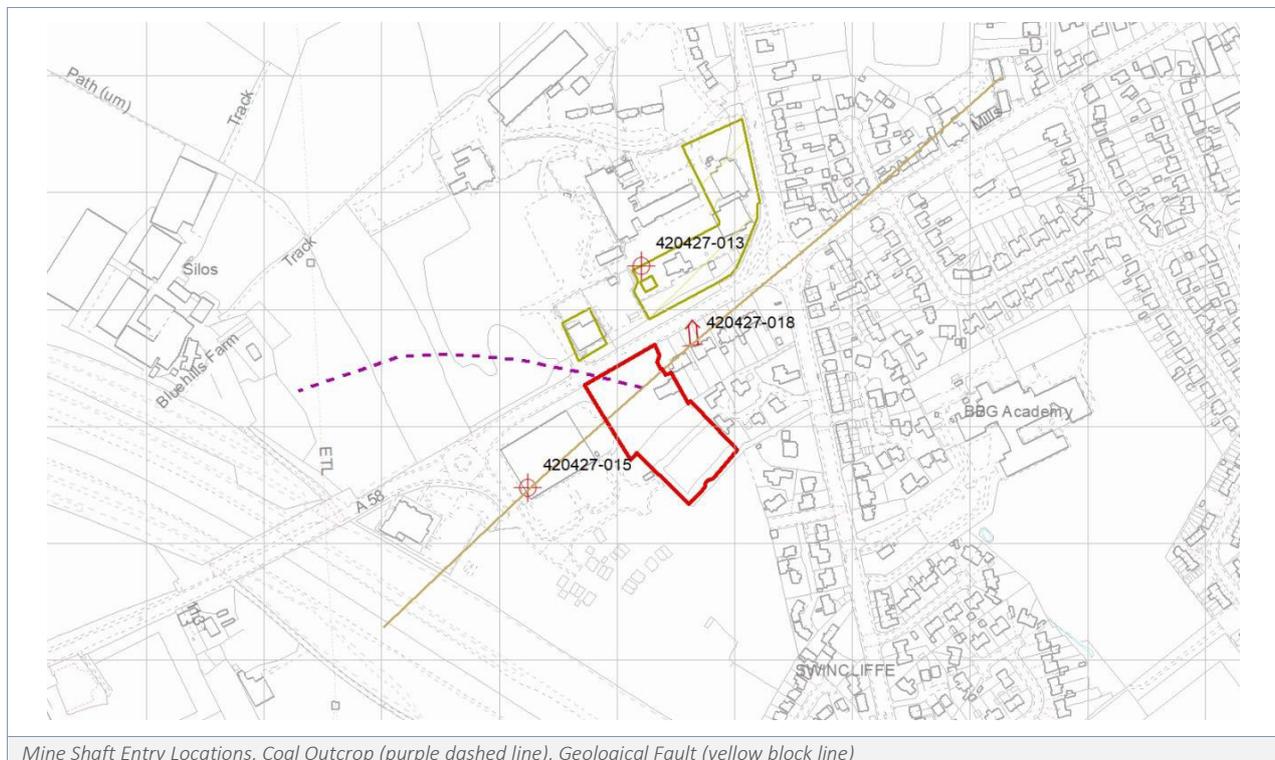
Mine Entry No.	Shaft / Adit	Grid Reference	Treatment Description
420427-013	Shaft	420221 427837	Not given
420427-015	Shaft	420125 427647	Not given
420427-018	Adit	420264 427771	Not given

The adit is indicated at an angle of 355° heading away from site. It is likely that the adit is targeting the First Brown Metal seam away from site.

The positions of the shafts are highlighted on the plan below:

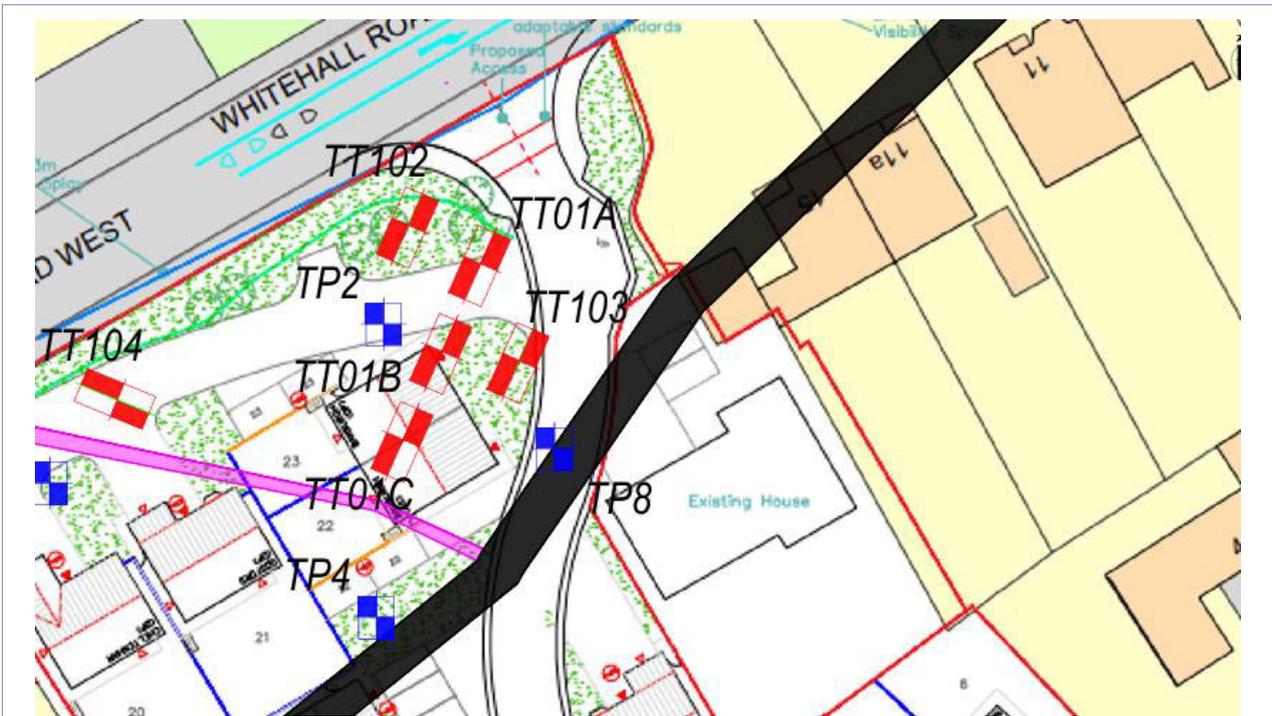
Exploratory Hole Locations

- 4 No. Trial Trenches (TT101 to TT104) were mechanically excavated to depths of between 2.3m and 5.75m begl using a 20 tonne tracked excavator

The exploratory hole locations are presented on Groundtech Plan GRO-24208-P03 and the exploratory hole logs are in Appendix 3.

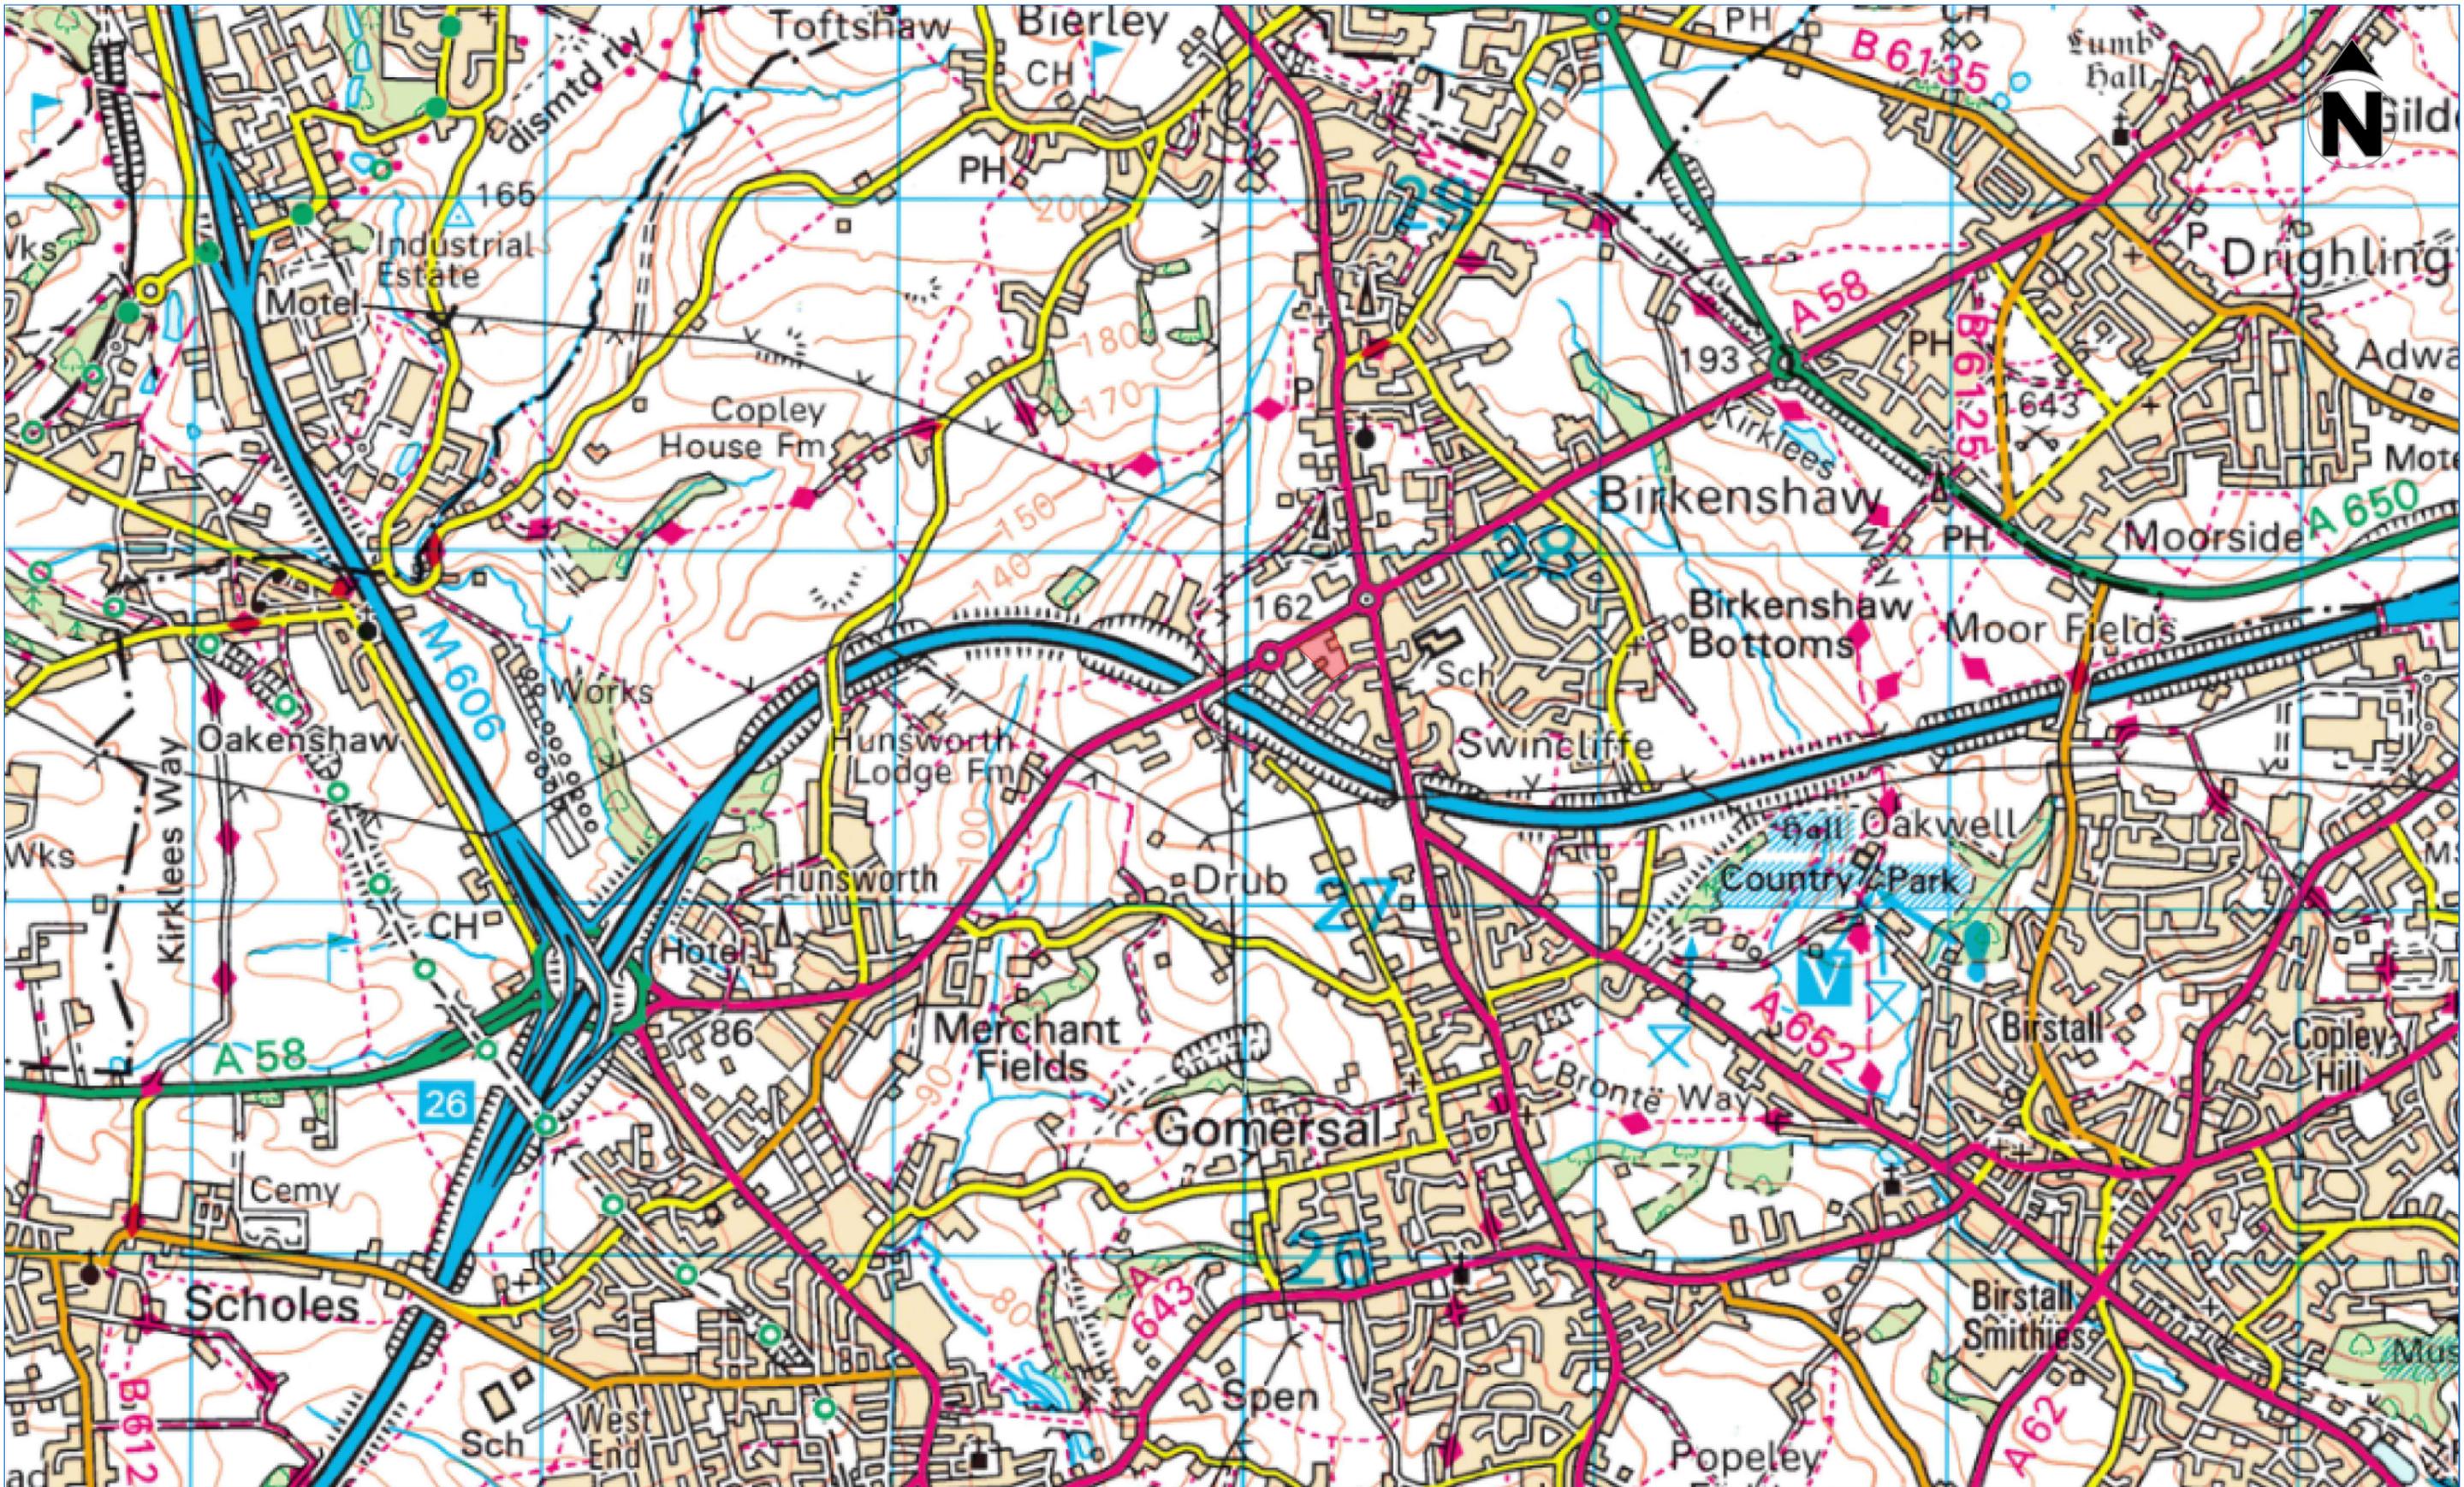
DATE	AUGUST 2024
SCALE	NTS
PLAN NUMBER	GRO-24208-P01

CLIENT	ORION HOMES
PROJECT TITLE	BIRKENSHAW
PLAN TITLE	PROJECT LOCATION PLAN

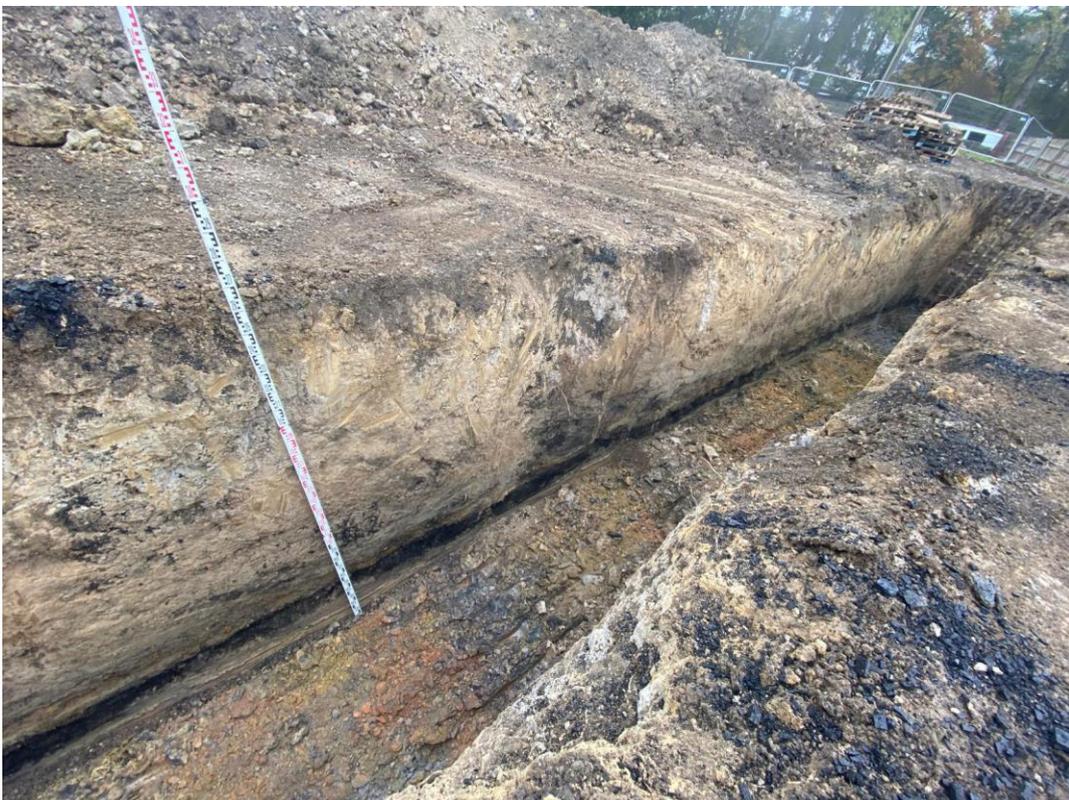
Photograph 2 – TT101A/B/C

Weak to medium strong light grey Siltstone slightly weathered recovered as angular fine to coarse Gravel and Cobbles was encountered within TT101A between the depths of 4.4m and 5.57m bgl.

Slow progress was noted while excavating TT101A between the depths of 4.0m and 5.75m begl due to the competent Siltstone bedrock encountered.

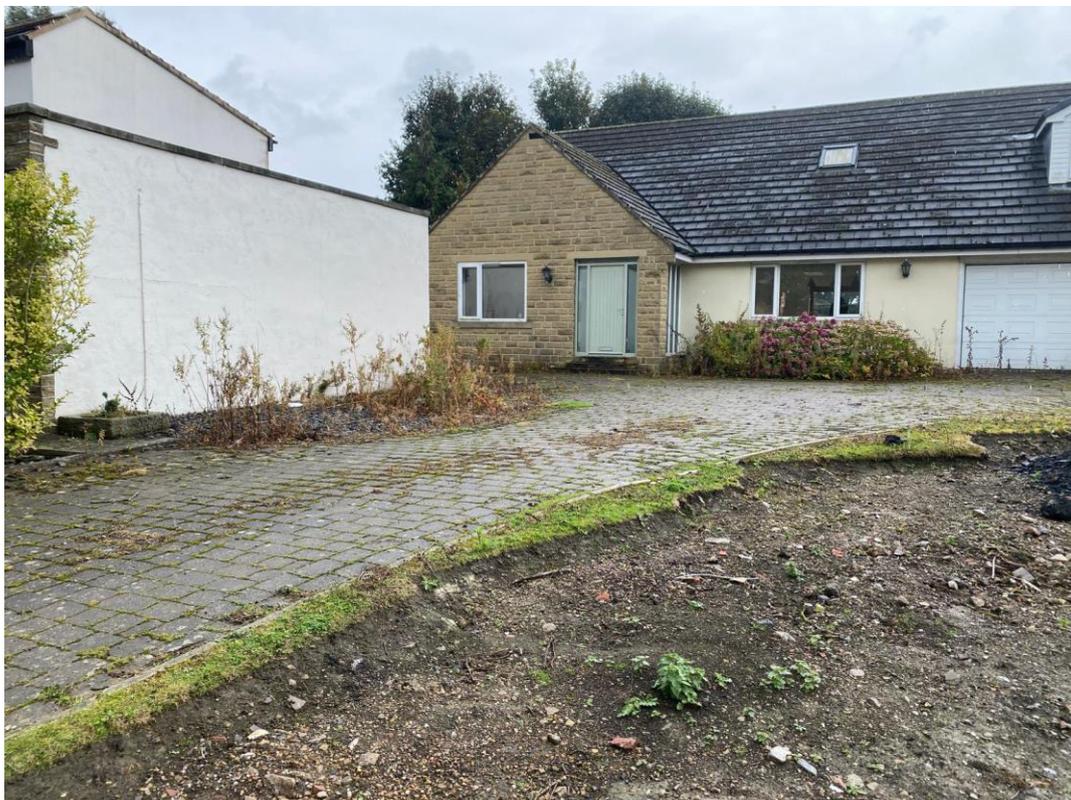
Photograph 8 – Existing residential dwelling with driveway
