**COMBINED STAGE 1/STAGE 2
GEO-ENVIRONMENTAL REPORT**

AT
WHITEHALL ROAD WEST
BIRKENSRAW
ON BEHALF OF
ORION HOMES LTD

CLIENT: ORION HOMES LTD
 JOB NUMBER: ORH/20
 PROJECT: WHITEHALL ROAD WEST, BIRKENSHAW
 REPORT TYPE: COMBINED STAGE 1/STAGE 2 GEO-ENVIRONMENTAL REPORT
 REPORT REFERENCE: ORH/20r1

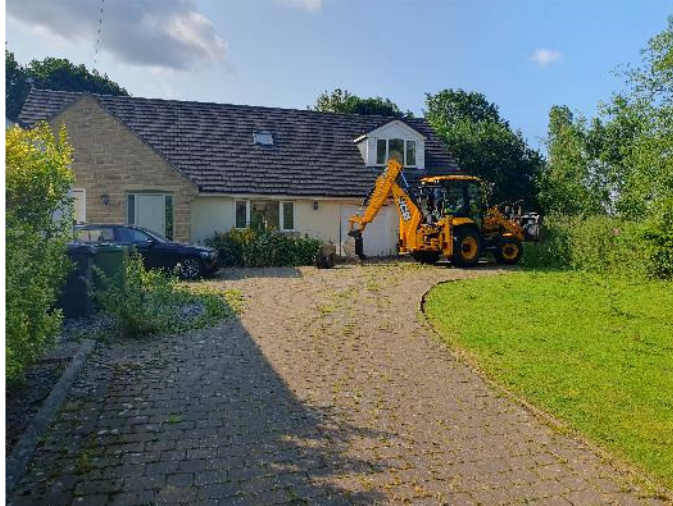
Looking south towards the detached house present on site.

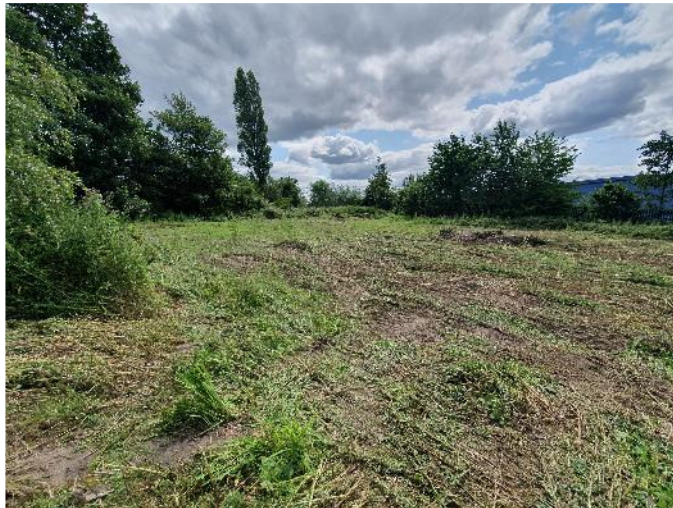
Looking west across the site towards the large warehouse off-site.

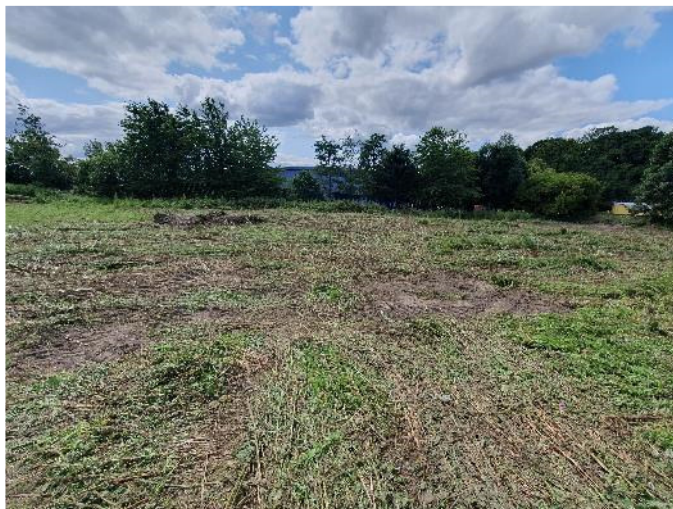
Looking north across the site towards Whitehall Road West.
