PHASE 1: DESK TOP STUDY AND COAL MINING RISK ASSESSMENT REPORT

PREPARED FOR CRL ARCHITECTS
PROPOSED RESIDENTIAL DEVELOPMENT
42 ROBIN ROYD LANE
MIRFIELD
WF14 0LG

Project No: 25-306

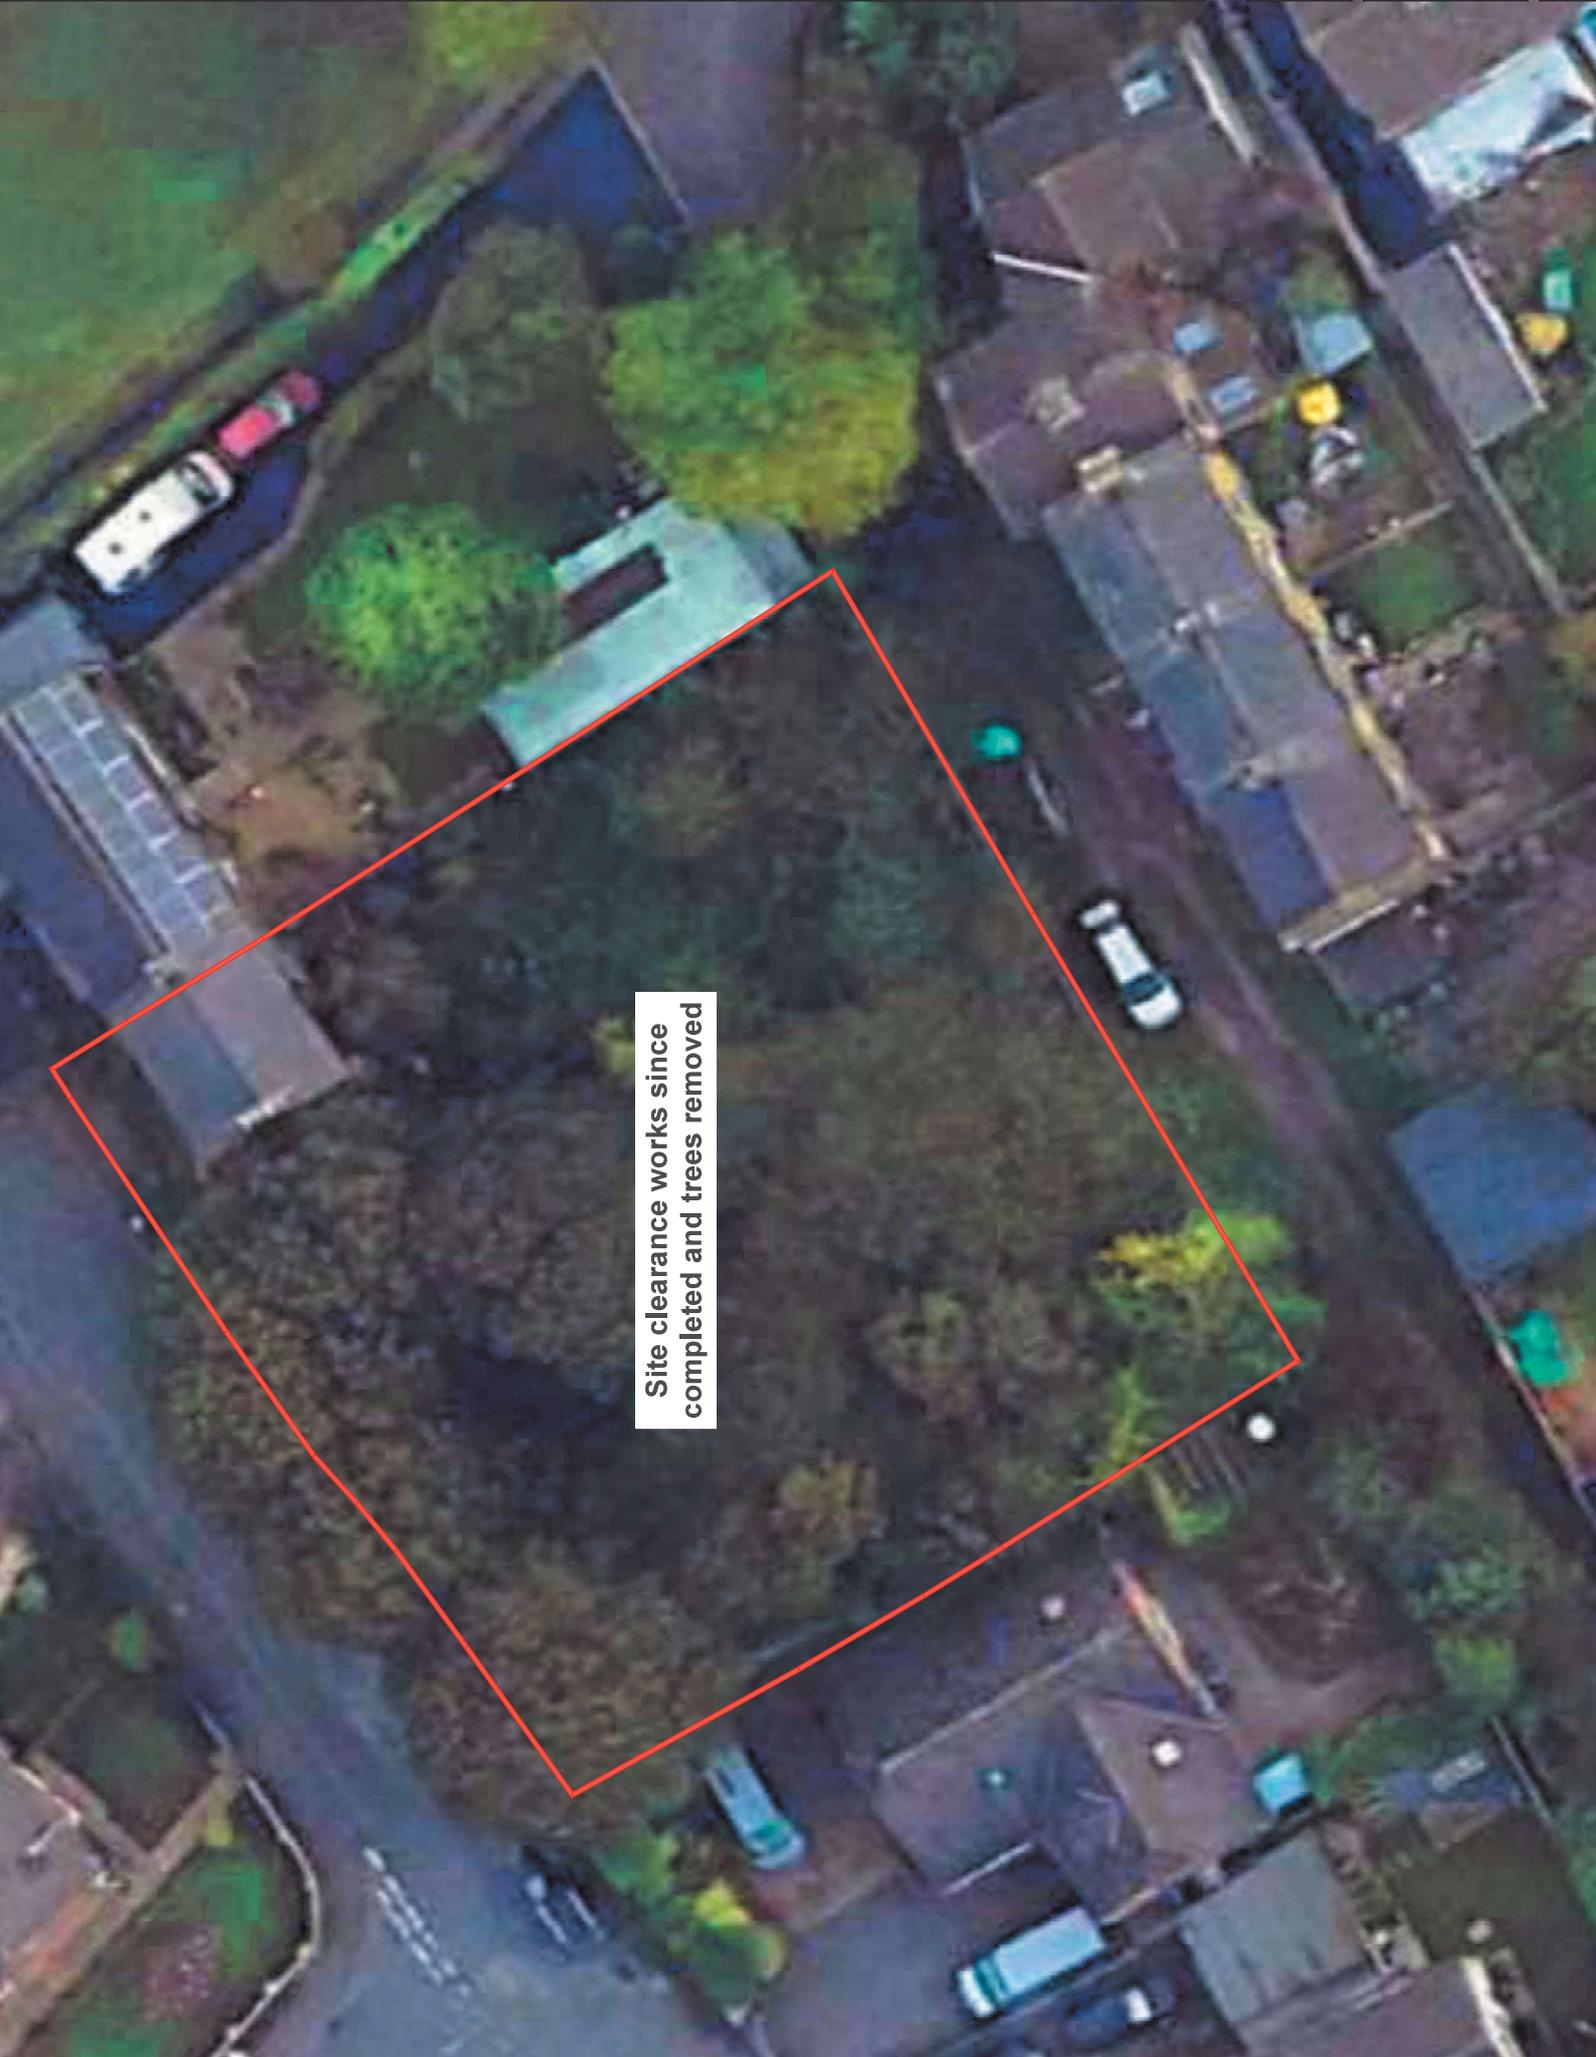
Site clearance works since
completed and trees removed
