# Preliminary Ecological Appraisal and Roost Assessment

Grandstand Autos, Mark Street, Paddock, Huddersfield, Kirklees, HD1 4ST

‘Change of use from Commercial to Residential to erect a two-storey terrace block’

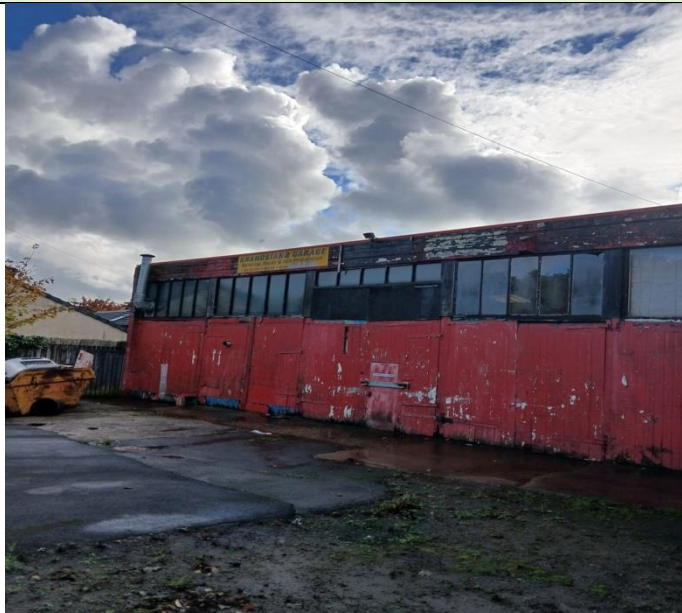
| <p><b><u>Summary</u></b></p> <p>B1 is a former red brick-built single storey garage. It is located to the rear of the site forming the southern and western boundaries of the site. The front of the building is of timber construction with large timber clad doors and panelling. Between the doors and panelling there is a row of panelled windows. The roof is made up of steel metal corrugated sheeting externally and is internally lined with timber clad. Internally there are some supporting structural steel beams. The external structures present suitable bat roosting and access features under timber boards, eaves and missing mortar in the brickwork. The building is to be demolished.</p> <p>No evidence of bats was observed within B1. Overall B1 is considered to offer ‘low’ habitat value.</p> | | | |

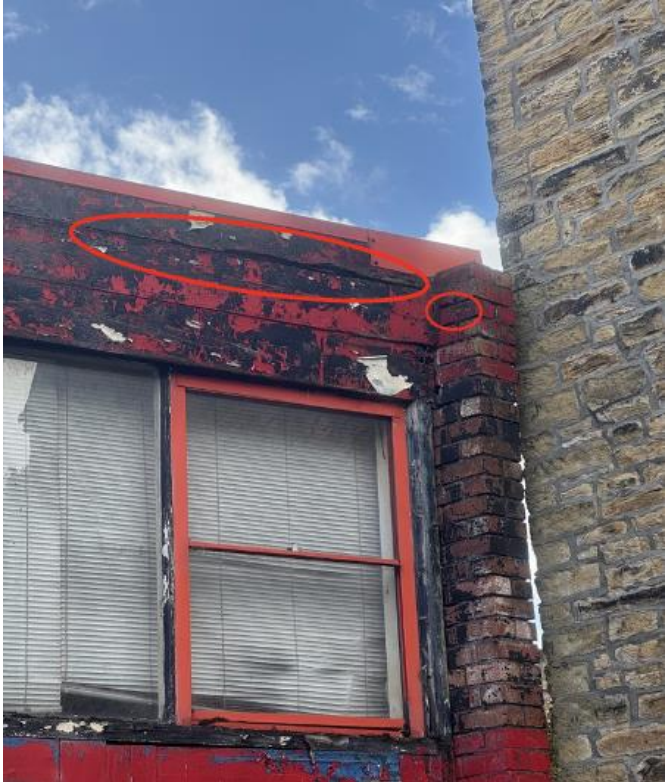
| Walls | Timber to the north, brick built on the east, south and western elevations | <p><b>Condition/description</b></p> <p>Section of lifted board above the panelled windows including a section of raised board on northwestern corner where the timber board meets the red brick.</p> <p>Missing mortar within the brickwork, most particularly on the northwestern corner where the timber board meets the red brick.</p> <p><b>Suitability/access/evidence of bats</b></p> <p>Raised external boards and missing mortar provide ideal roosting habitat for crevice dwelling bats. These features are not deemed likely to provide access to the whole roof structure and as such would only support a low number of bats. No evidence found but recent and current rain would wash this away externally.</p> | <p>Raised board to left, and missing mortar to right on the north/north-western elevation.</p> |

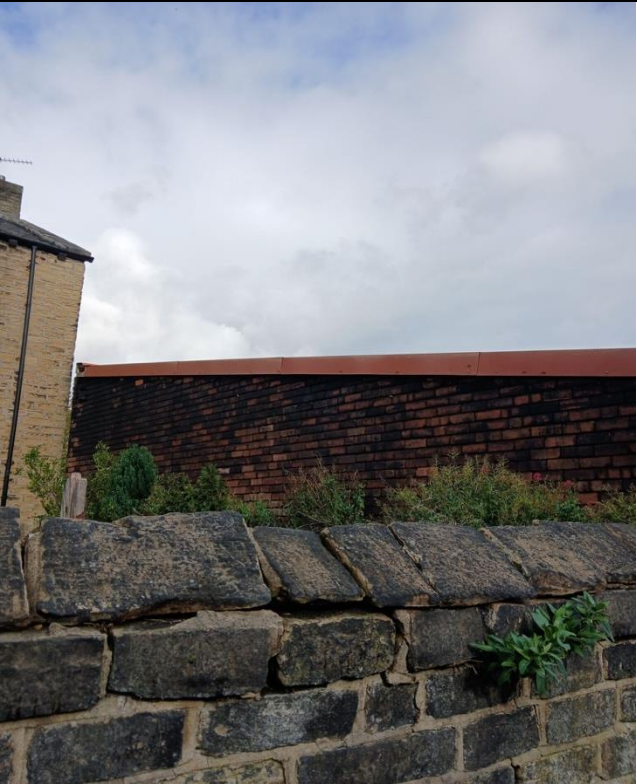
| Roof | Steel corrugated sheeting | <p><b>Condition/description</b><br/>Flat roof that cat slides to the southern elevation. The roof features skylights allowing natural light to spill into the building. Internally the roof is lined with timber.</p> <p><b>Suitability/access/evidence of bats</b><br/>The roof appears to be in good condition with no cracks externally. Metal sheeted roofs are unsuitable for roosting bats as they are unable to sustain a stable temperature.</p> | <p>Western elevation of B1.</p> |

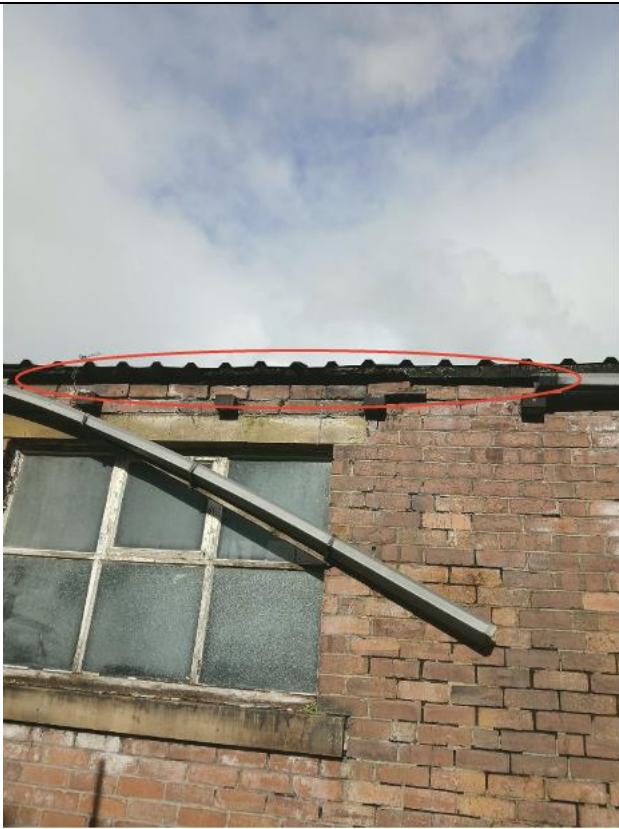
| Eaves | Overhanging | <p><b>Condition/description</b><br/>Overhanging eaves on the eastern and western elevations. Gaps present under eaves on the southern elevation.</p> <p><b>Suitability/access/evidence of bats</b><br/>Gaps under eaves could accommodate crevice dwelling bats. This feature may provide access to the wider structure of B1, however, is deemed unlikely to support a high number of bats due to the steel corrugated roof not providing a stable temperature. No evidence found but recent rain</p> | |

| | | would wash this away externally. Provides possible bat access into the brickwork where missing mortar/crevices are present. Could support roosts of low numbers of crevice dwelling bats. | <p>Gaps under eaves on the southern elevation.</p> |

| <i>Recommendations</i> | <p><b>Roosting habitat [Buildings]</b><br/>One bat emergence/re-entry survey is required on B1 during the active bat season (May – September) to confirm presence/likely-absence of bats roosting in or on the building. This survey visit should be completed during the optimal survey period mid-May to August inclusive.</p> <p>Sub-optimal: early May and September, would require greater justification of timing e.g., weather conditions, known local bat activity.</p> <p>Two surveyors are required to provide full coverage of the building's elevations to look for emerging/re-entering bats. All surveyors should be supported by night vision aids (NVA). One additional unmanned infrared camera should also be employed as part of the survey to cover the full extent of all access points into B1.</p> <p>Lighting mitigation may be required based on the outcome of the 'dusk' bat survey.</p> <p>If any bat roosts are confirmed from this survey schedule, a bat licence would be required to demolish the buildings as it would involve the destruction of roosts. This is applied for with the help of a class 2 licensed bat ecologist after planning permission is granted, but before commencement of works.</p> <p><b>Foraging and commuting habitat</b><br/>No further surveys are required.</p> <p><b>Artificial lighting</b><br/>A low impact lighting strategy will be adopted for the site during post-development which outlines the areas of the site that will be retained as dark corridors. Parameters can be found on the Bat Conservation Trust website:<br/><a href="https://www.bats.org.uk/our-work/buildings-planning-and-development/lighting">https://www.bats.org.uk/our-work/buildings-planning-and-development/lighting</a></p> <p><b>Suggested biodiversity enhancements</b><br/>Enhancements are dependent on the outcome of further surveys.</p> |

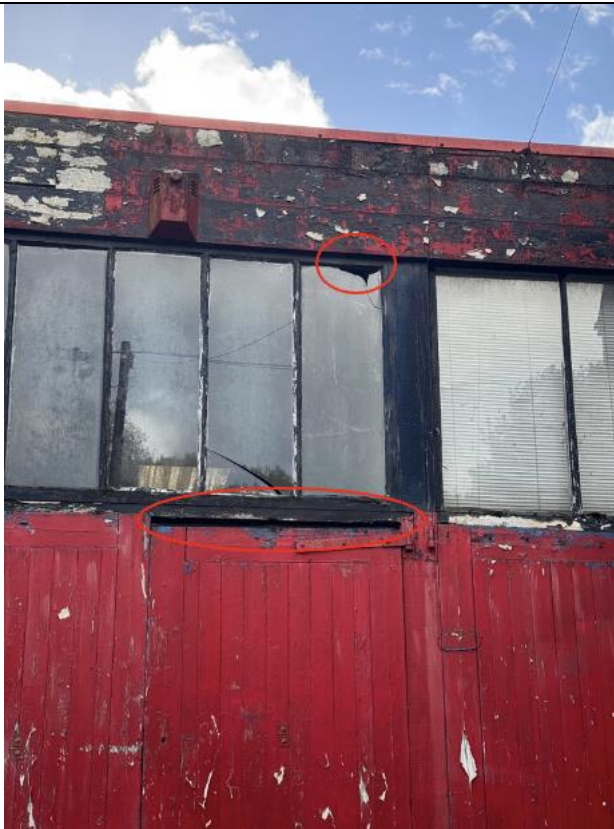
| Window/doors frames and lintels | Timber | <b>Condition/description</b><br>There are gaps present above/under the timber doors and a small gap in the centre. A small crack is present in one of the central panelled windows, all of which are found on the northern elevation. The remaining windows are tight fitting. | |

| | | <p><b>Suitability/access/evidence of bats</b></p> <p>The gaps and cracked window allow internal access to the building. Internally the building would be unsuitable for void and crevice dwelling bats due to the lack of stable dark spaces and lack of suitable roosting features within.</p> | <p>Gaps above door and crack within panelled windows on the northern elevation.</p> |

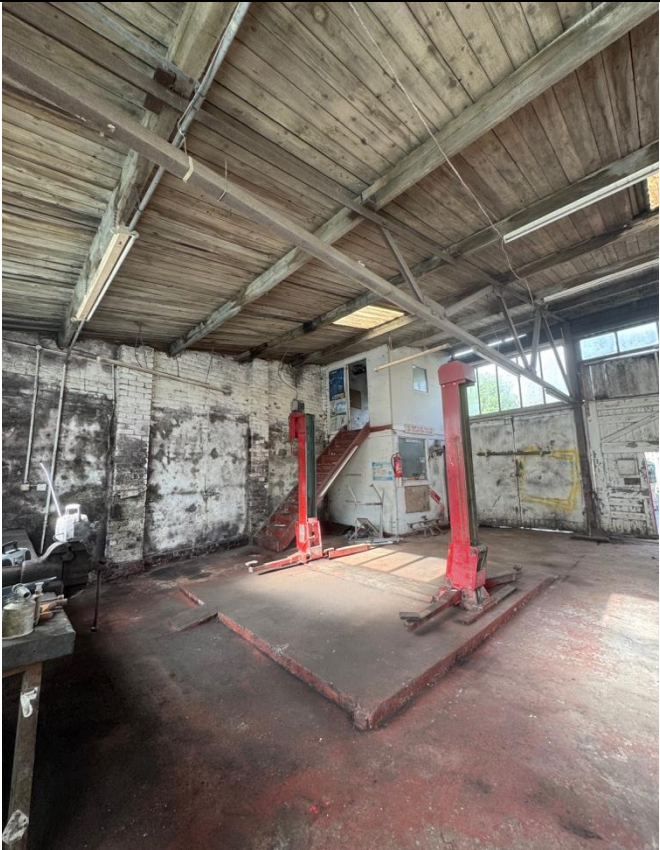
| Internal | Steel rafters and ridge beam. Open floor to ridge. | <p><b>Condition/description</b></p> <p>Internal space measures approx. 15m long, 9m wide, floor to ridge height approx. 8m.<br/> Humidity – 56.7%<br/> Temperature – 8.5°C</p> <p>Internal space is open from the floor to ridge. There is a small boarded room that once functioned as a 'spray' room when the garage was in operation. The roof is supported by steel rafters and ridge beams.</p> | |

| | <p>The roof is lined with timber clad. When in operation the building operated as a body works garage, experiencing regular disturbance from noise and lighting, the building is currently disused and as such is not currently subject to disturbance. However, if bats are used to the previous level of disturbance, it would not prevent them from roosting.</p> <p>A gap in the timber beams is evident to the south of B1, whereby the steel corrugated roof can be seen.</p> <p><b>Suitability/access/evidence of bats</b></p> <p>The steel rafters and beams are in good condition providing no suitable features for crevice or void dwelling bats. The gap within the timber lining could allow a large number of bats to access the internal structure via the gap noted under the eaves on the south elevation, however, the lack of stable dark spaces and suitable crevices within makes it unsuitable to support both void and crevice dwelling bats.</p> <p>Gaps noted under eaves, could provide access to the wider roof structure within the timber lining, which could offer value for maternity roosts, however, the roof comprises steel corrugated sheets providing a lack of stable temperatures. Further, the surrounding landscape comprises predominantly urban residential dwellings in all directions. This offers limited foraging and commuting opportunities for bats and therefore reduces the likelihood of the building supporting a maternity roost, as such roosts require close access to good quality foraging habitat to meet the energetic demands of raising young. Furthermore, the absence of nearby European Protected Species</p> | <p>Internal space of B1.</p> |

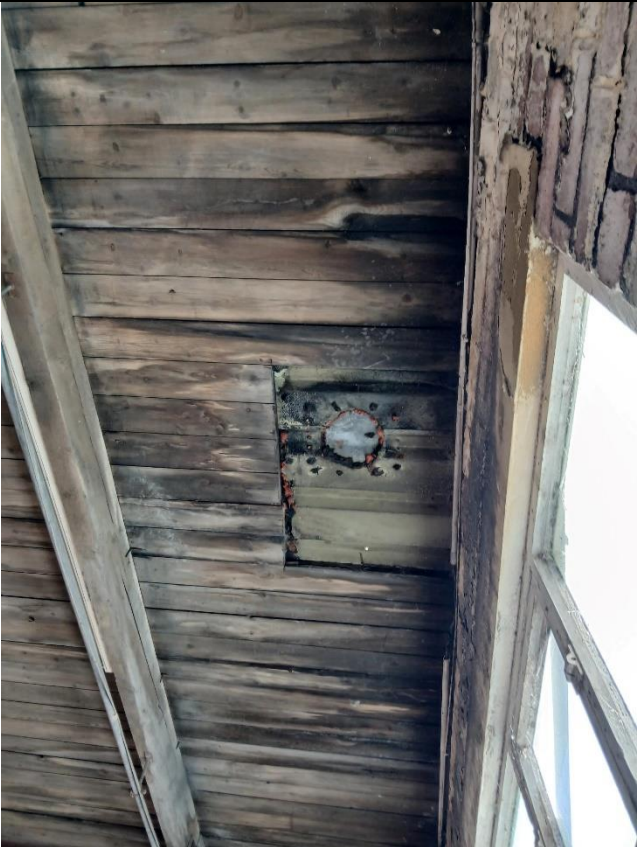
Gap in timber lining to the south of B1.

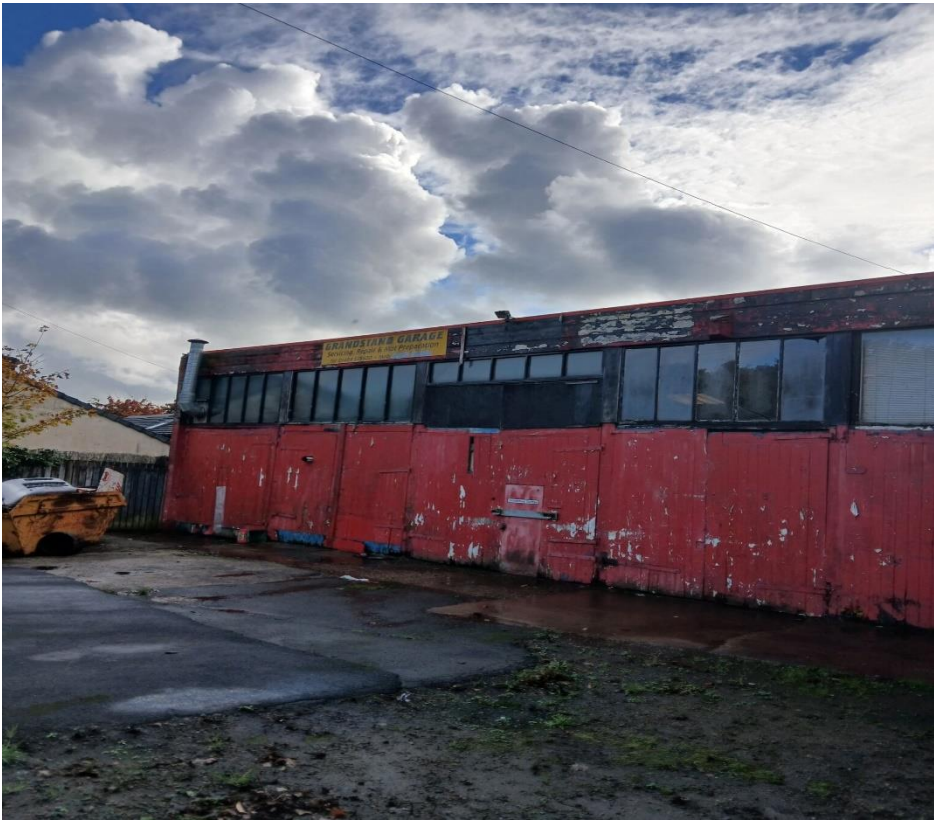
| Buildings | |
|---|---|
| | <p><b>Figure 1:</b> The disused garage (B1)</p> |

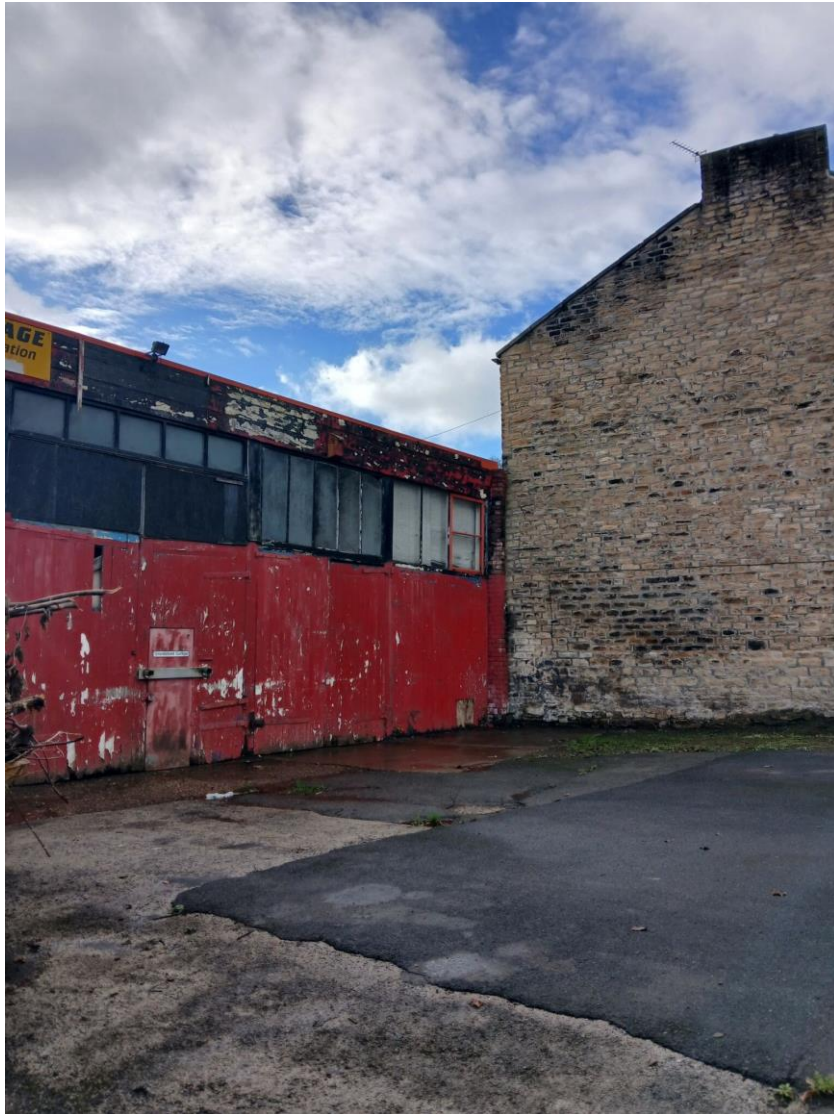
**Figure 2:** Former forecourt to the front of B1

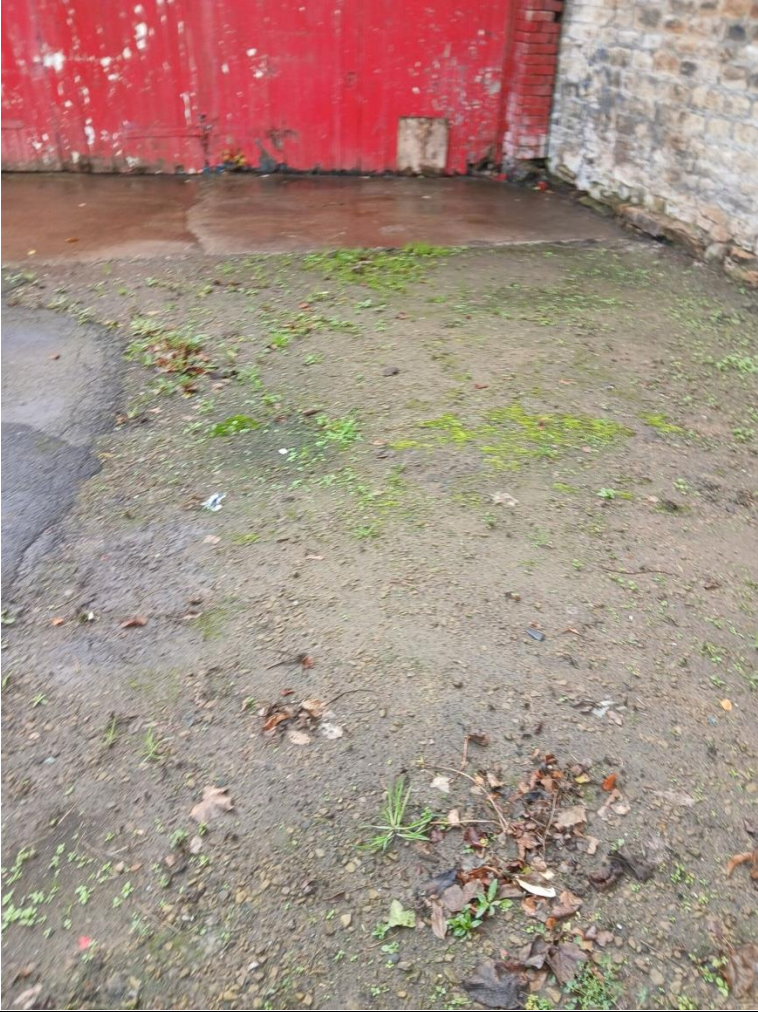
| Photograph | | Description |
|---|--|---|
| | | <p><b>Figure 3:</b> Area of unsealed surface with &lt;5% vegetation growth</p> |

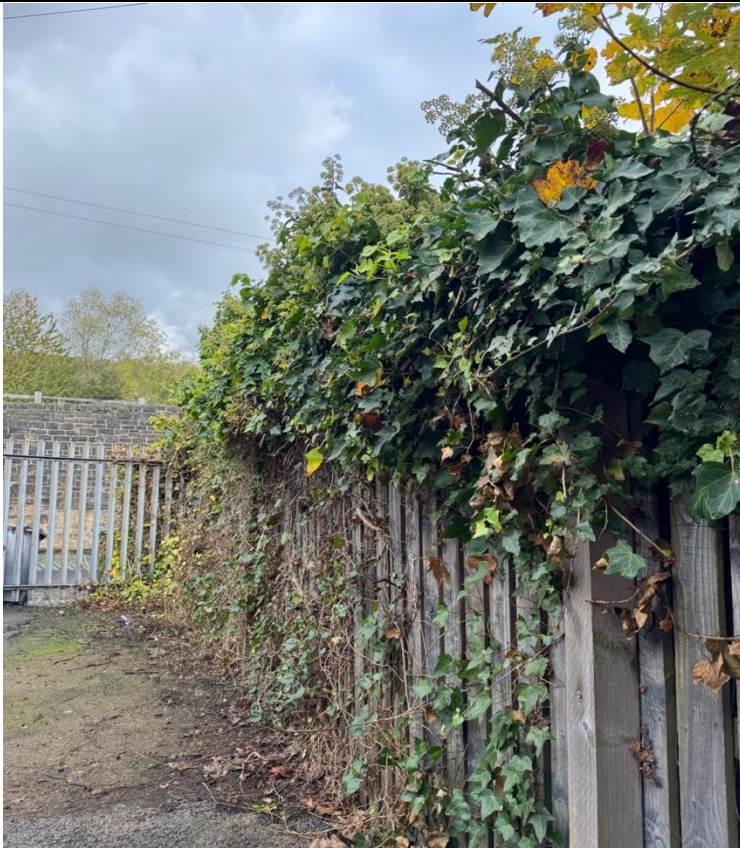
**Figure 5:** Wooden fencing along the eastern boundary
