METHOD STATEMENT

In support of an application to discharge conditions 3 and 5 of application ref. 2022/70/93907/W

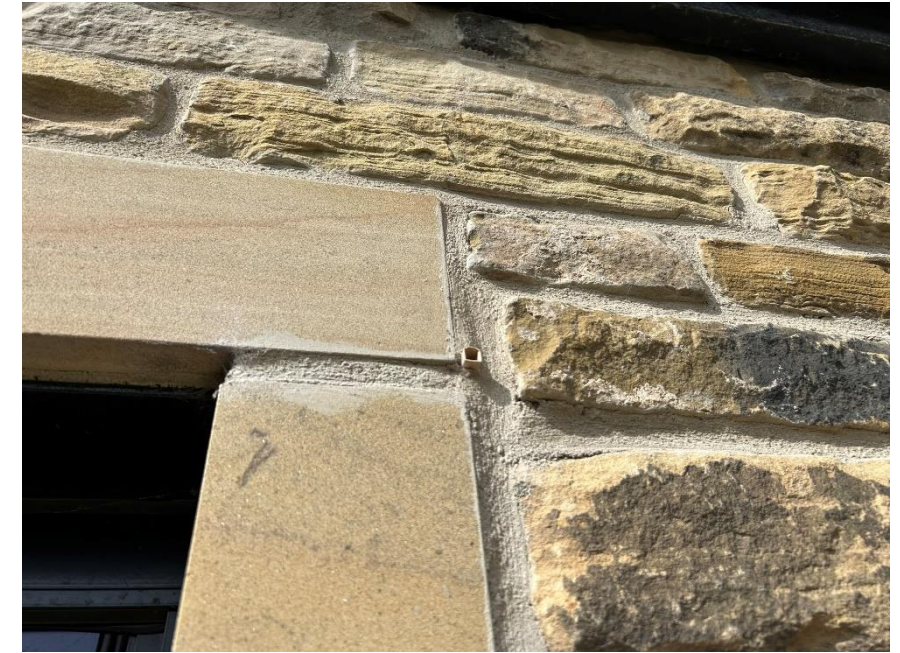
Photo H: Existing plastic gutter to Acre House adjacent to rear elevation to be replaced with new ogee profile aluminium gutter

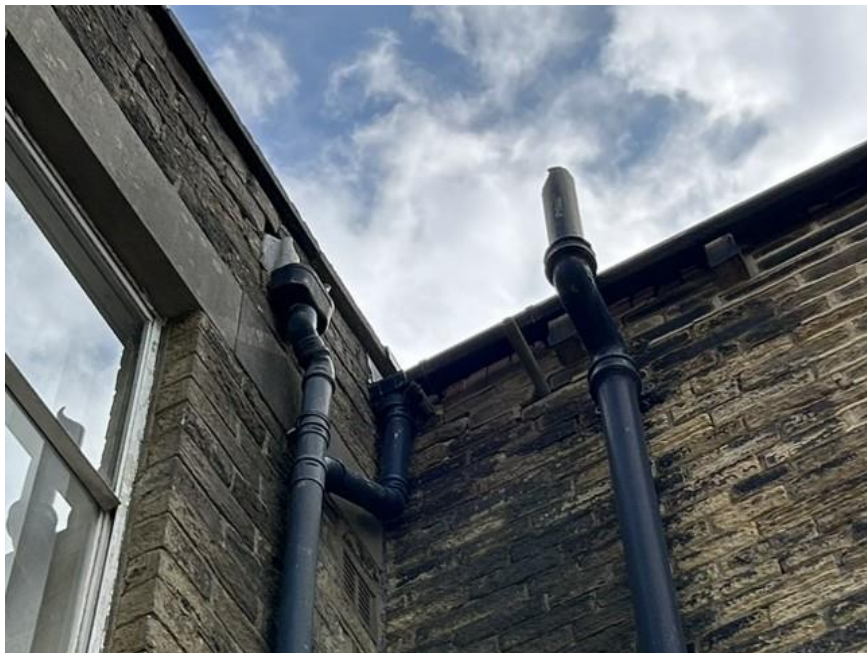
Photo J: Existing plastic gutter to outbuilding adjacent to rear elevation of Acre House to be replaced to match the above

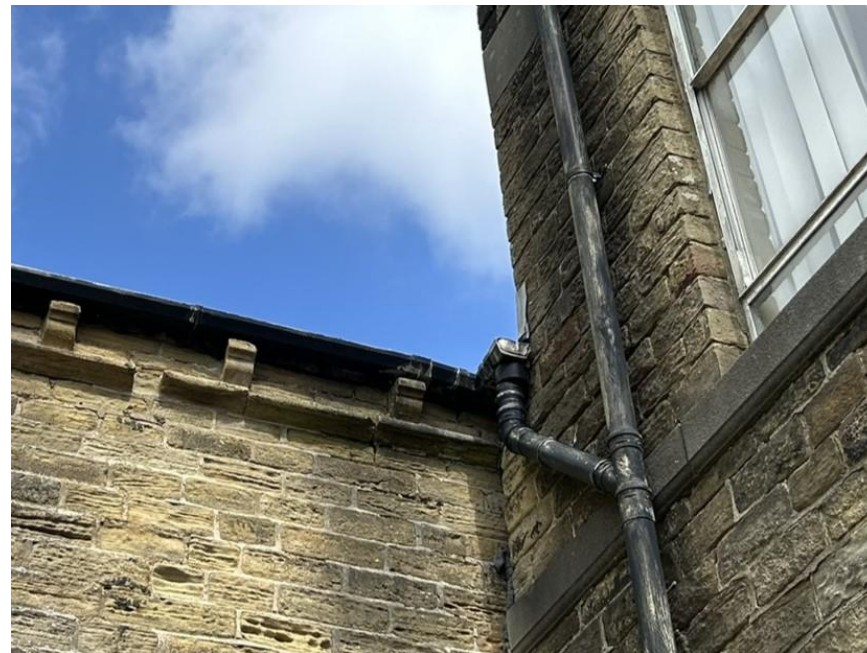
Main Front Staircase

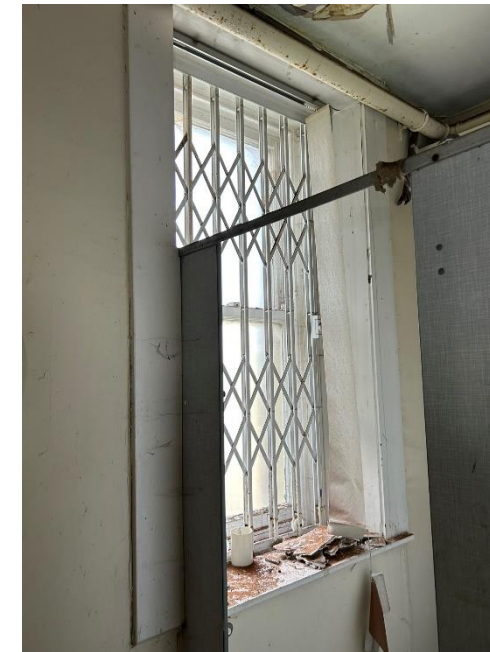
Photo 8.4: Modern plasterboard suspended ceiling, largely collapsed due to water damage

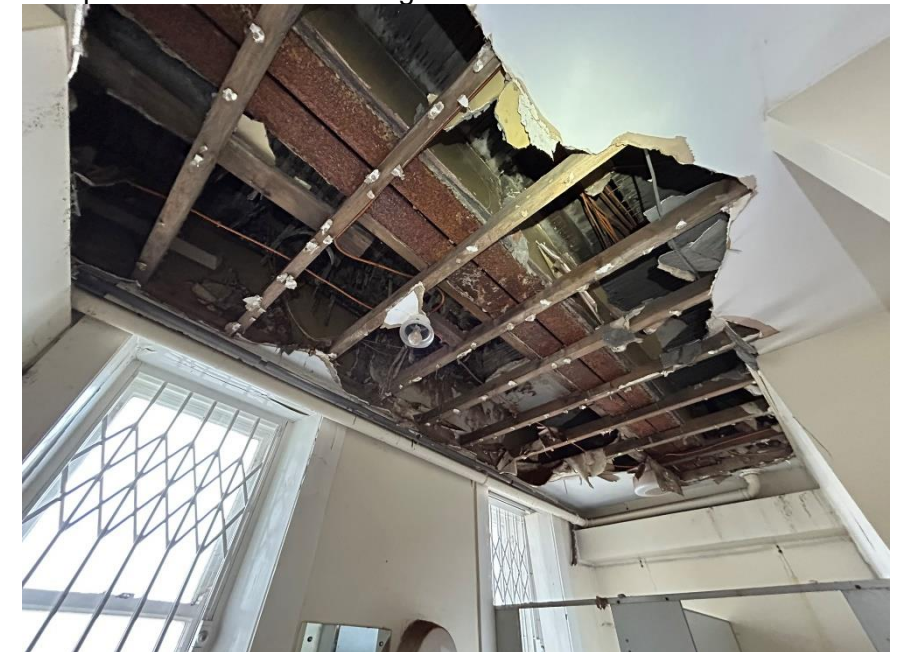
Room 9 – Sitting Room

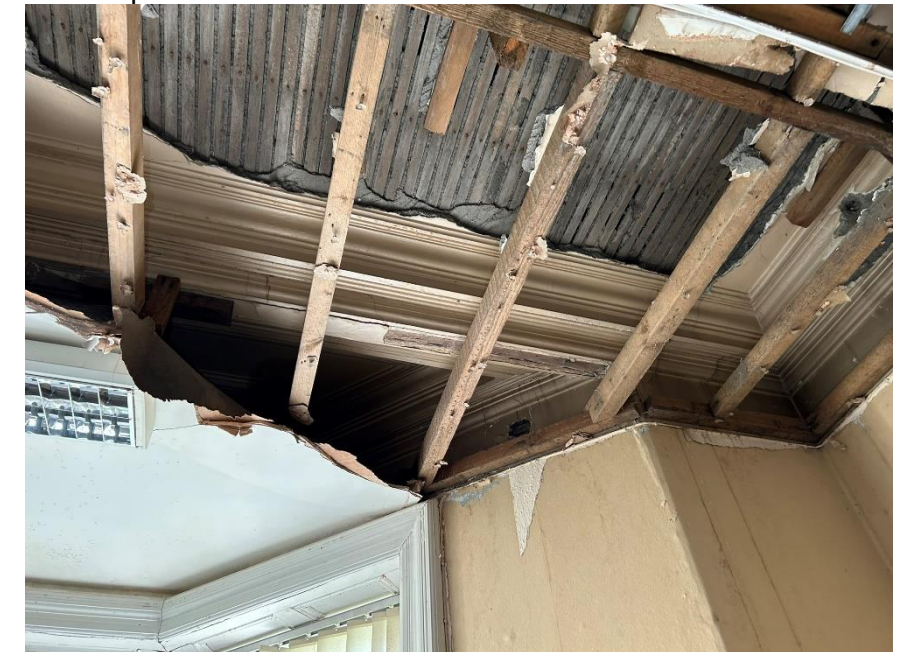
Photo 9.5: Damaged & missing section of cornice to be concealed with replacement suspended ceiling

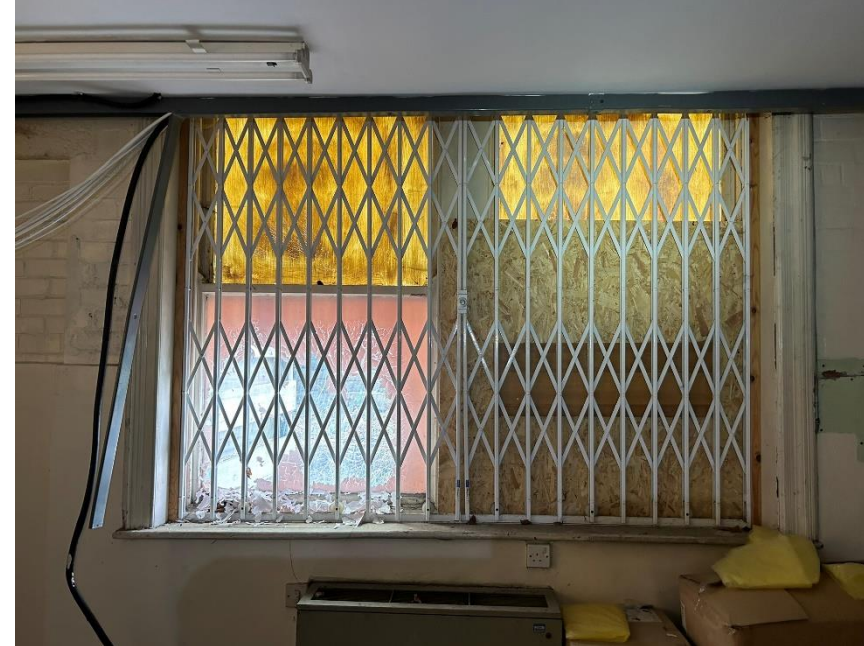
Photo 22.1: General view (wide angle) which is representative of modernised condition of room 22
