LV Rooms added (North Elevation)

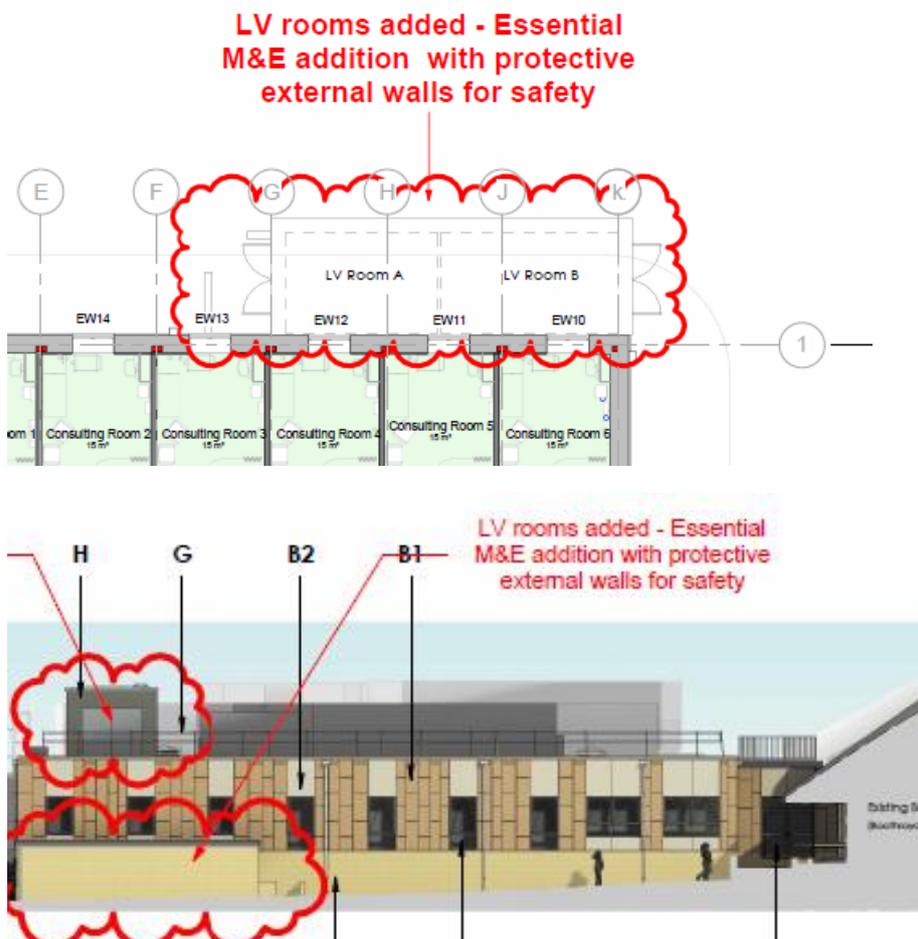
It was identified through detailed design development that the existing hospital electrical infrastructure could not adequately support the new building's power demands. As a result, additional electrical infrastructure was required, including the installation of two Low Voltage (LV) panels.

These panels needed to be positioned in close proximity to the building to maintain efficient cable runs and operational safety. For fire safety and maintenance accessibility, the LV panels were housed within an external outbuilding accessible only from outside the main building envelope, thereby reducing internal fire load and ensuring compliance with IET Wiring Regulations (BS 7671).

The north elevation was selected as the most appropriate location based on spatial availability, access for maintenance personnel, and separation from public areas. To mitigate safety risks during maintenance, a self-supporting wall was constructed adjacent to the LV room entrance to prevent door swings from impeding pedestrian routes. This wall also functions as a sacrificial barrier to absorb impacts in the unlikely event of vehicular collision, thus safeguarding the electrical equipment.

A protective crash rail was also installed along the north elevation to further enhance resilience and protect critical infrastructure.

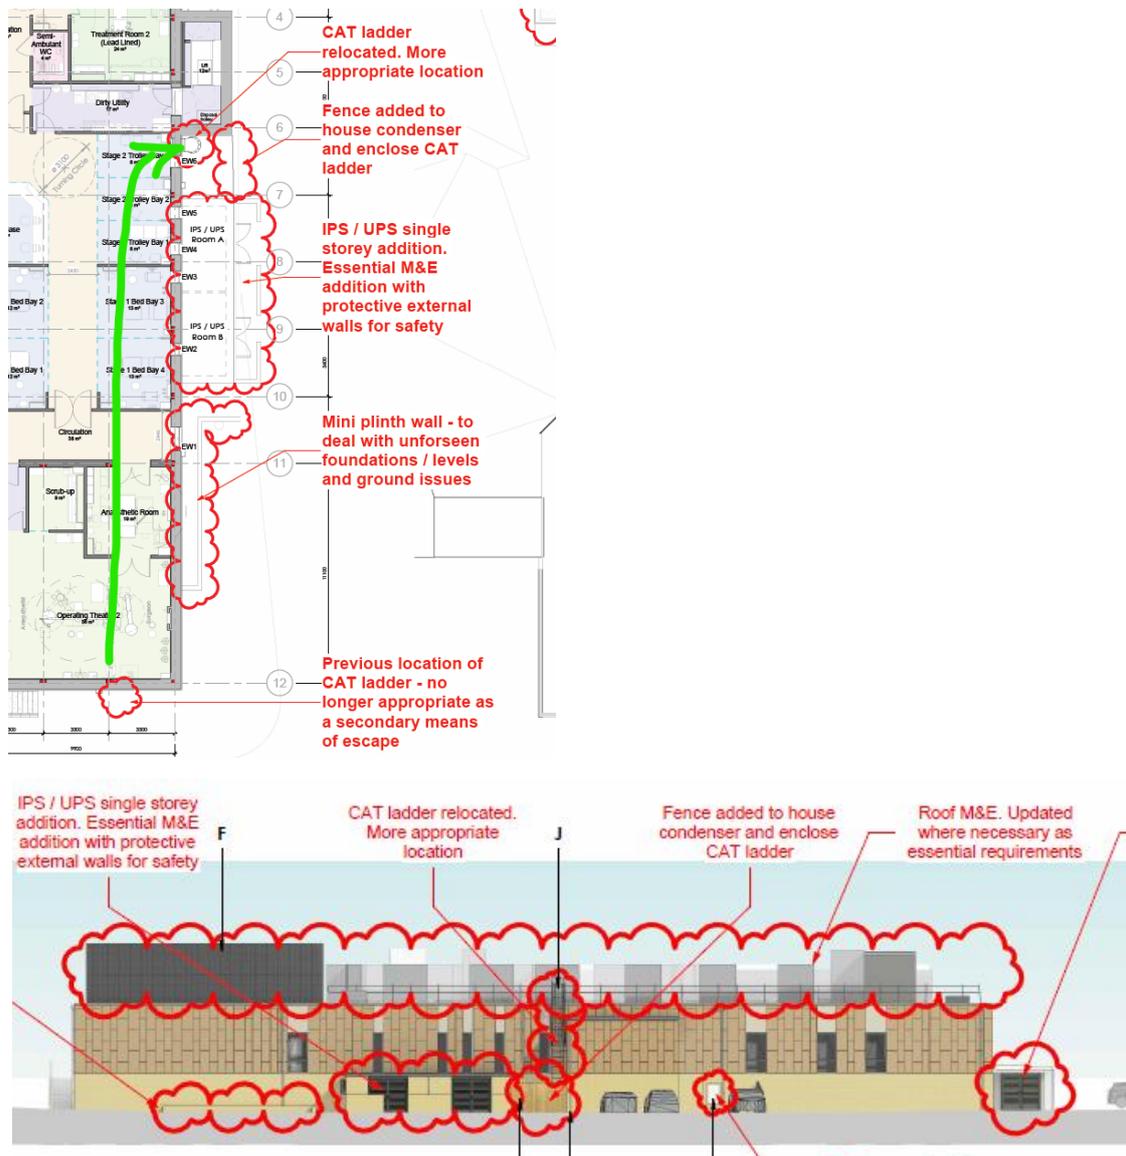
CAT Ladder relocated (East Elevation)

The original location of the CAT ladder on the south elevation was reviewed and deemed unsuitable following design changes to the roof layout.

As part of a reassessment of fire strategy and safe access provisions, escape distances for a secondary means of escape were recalculated in accordance with Approved Document B of the Building Regulations.

A new location was identified that met the required safety criteria while also allowing the ladder to be enclosed within a secure area, thereby preventing unauthorised access and enhancing site safety.

The revised placement offers improved functionality and reduces visual and physical obstruction, particularly as the original location was along a pedestrian route where it may have posed both a hazard and a point of concern in terms of appearance and usability.

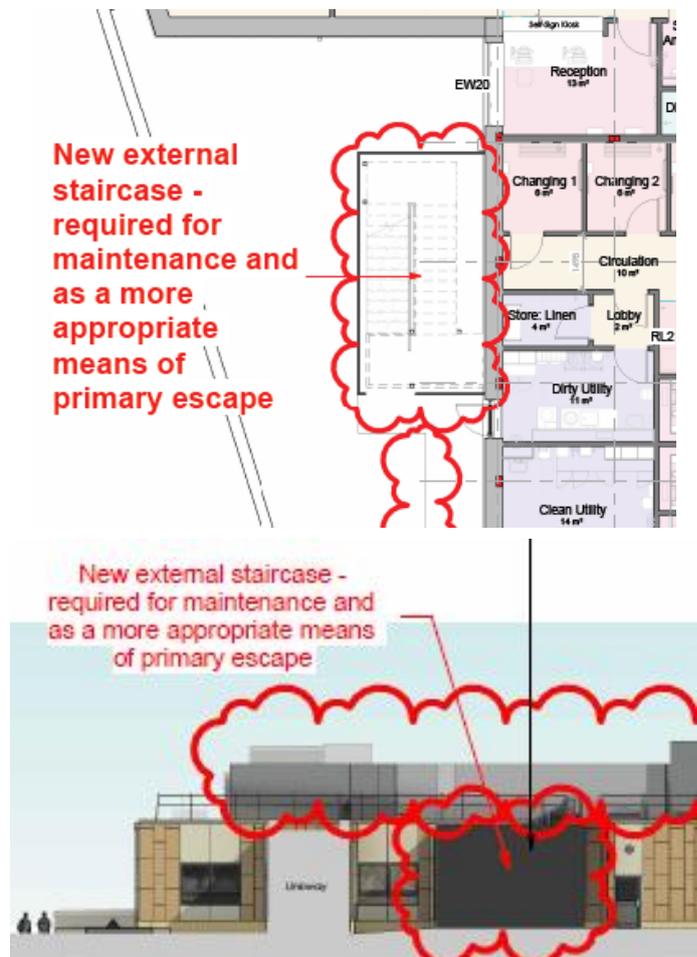
New enclosed staircase added (to replace a CAT ladder). (West Elevation)

The existing CAT ladder on the west elevation was replaced with an external staircase, following a design review which concluded that a staircase would offer a significantly safer and more practical primary means of access to the roof.

Unlike a CAT ladder, the staircase facilitates the movement of maintenance personnel and the transport of equipment in compliance with CDM Regulations 2015, which require safe access for maintenance activities. The revised access solution enhances both functionality and user safety.

The staircase structure was clad on three sides with metal panels finished in RAL7016 to ensure visual coherence with the building façade while maintaining weather protection.

The cladding was terminated at parapet height to reduce visual impact, as a fully enclosed roofed structure was considered disproportionate in scale and contextually inappropriate. This design approach ensured a modest and functional appearance that remains sympathetic to the surrounding architecture.

Access to the staircase is controlled via a lockable gate to restrict entry to authorised maintenance personnel only.

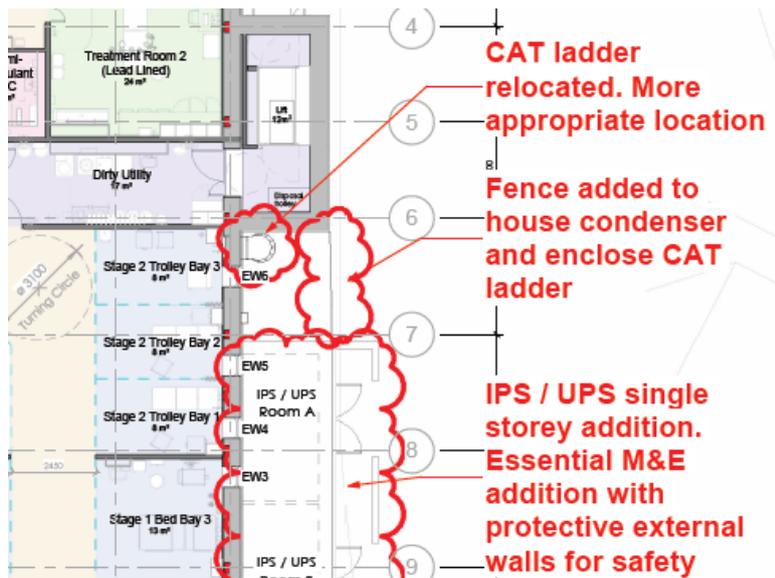
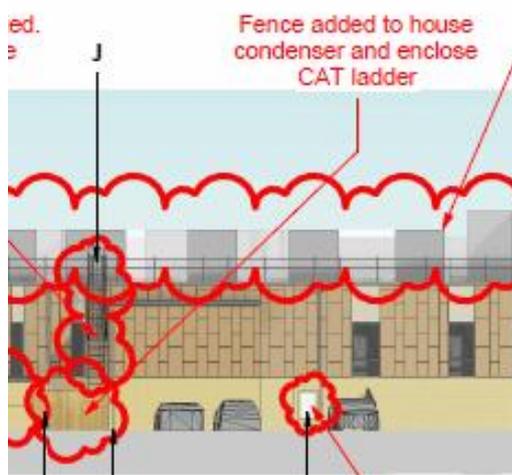
Fence added (East Elevation)

The proposed relocation of the CAT ladder to the area between the IPS/UPS rooms and the lift was reassessed due to significant health and safety and security concerns.

Its placement in this location could have enabled unauthorised access to the roof, presenting a risk to both personnel and infrastructure. In line with fire safety strategy and best practice, it was determined that the CAT ladder should serve exclusively as a secondary means of escape from the roof in emergency scenarios, rather than as a primary access route.

The newly installed external staircase provides the designated primary access, ensuring safe and controlled maintenance entry. To fully secure the CAT ladder, a vertical close-boarded timber fence was installed between the IPS/UPS rooms and the lift. This enclosure, fitted with a lockable gate, restricts access to authorised personnel only.

Additionally, the space within this secure area accommodates condenser pumps, offering a suitable and protected environment for essential air conditioning equipment, while maintaining compliance with mechanical services requirements.

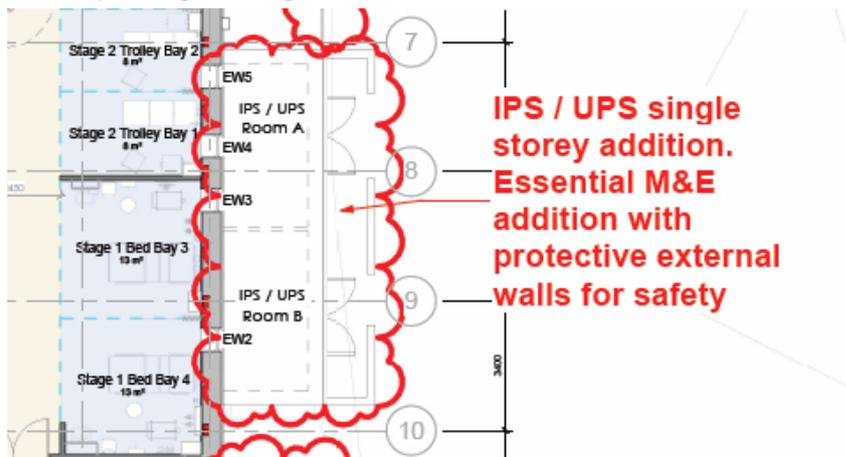
IPS / UPS rooms added (East Elevation)

Similar to the LV panel installation, the IPS (Instant Power Supply) and UPS (Uninterruptible Power Supply) rooms form a critical component of the building's electrical infrastructure.

Due to the technical specification of the equipment and the need to optimise internal space planning, it was determined that these rooms would be best accommodated within an external outbuilding, accessible from outside. This arrangement allows for improved environmental control and ventilation, ensuring the reliable operation of sensitive power equipment.

Locating the rooms externally also minimises the fire load and operational risk to the main building and its occupants.

To further enhance safety, a self-supporting wall was constructed adjacent to the IPS/UPS outbuilding. This wall prevents obstruction of pedestrian routes by allowing maintenance doors to open freely and safely, and it serves as a sacrificial barrier, designed to absorb impacts in the unlikely event of a collision or external incident, thereby safeguarding the critical infrastructure within.

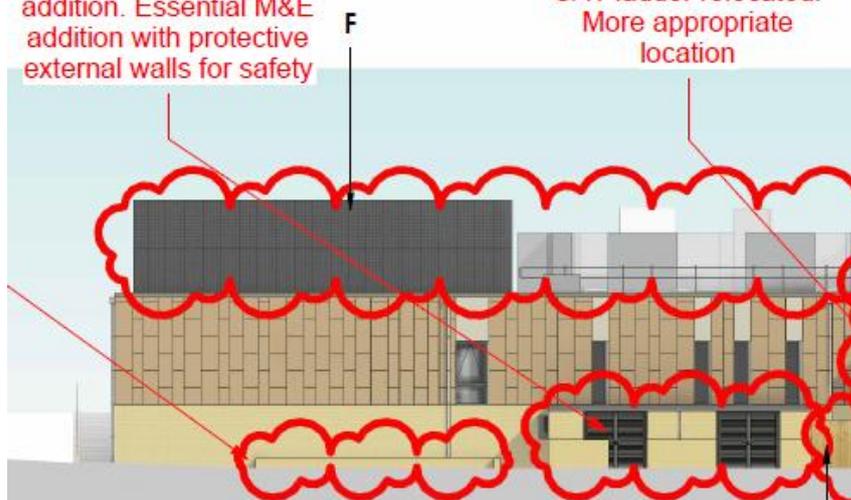
IPS / UPS single storey addition. Essential M&E addition with protective external walls for safety

CAT ladder relocated. More appropriate location

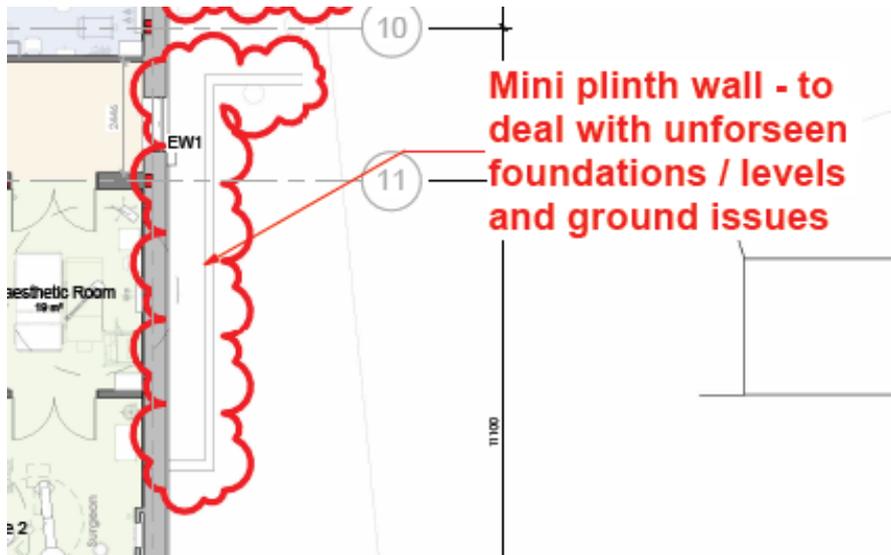
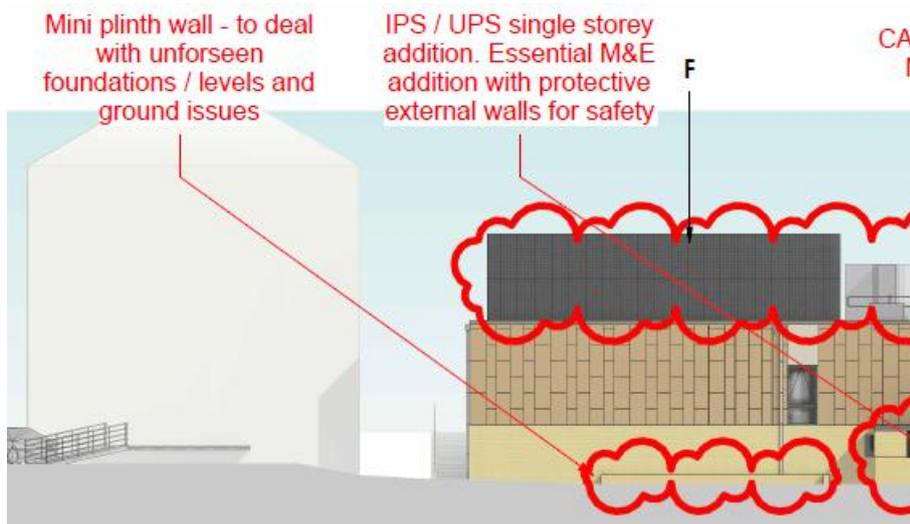
Mini plinth wall added (East Elevation)

The south-east corner of the building sits at the lowest point in the surrounding topography and is densely occupied by essential services and infrastructure, resulting in several spatial and level-related constraints.

During the implementation of the landscaping plan, sections of the structural foundations were found to be exposed. As these foundations are critical to the integrity of the building, any modification, such as cutting into them, was deemed unacceptable.

To address this, a practical and visually coherent solution was developed: a low plinth wall was introduced to conceal the exposed elements. This design not only preserved the structural integrity of the building but also allowed the landscaping and pedestrian pathway to function as intended. The wall worked effectively with the existing ground levels and enabled the formation of a DDA-compliant (Disability Discrimination Act) accessible route. This approach successfully resolved the competing requirements of structural protection, aesthetics, and accessibility.

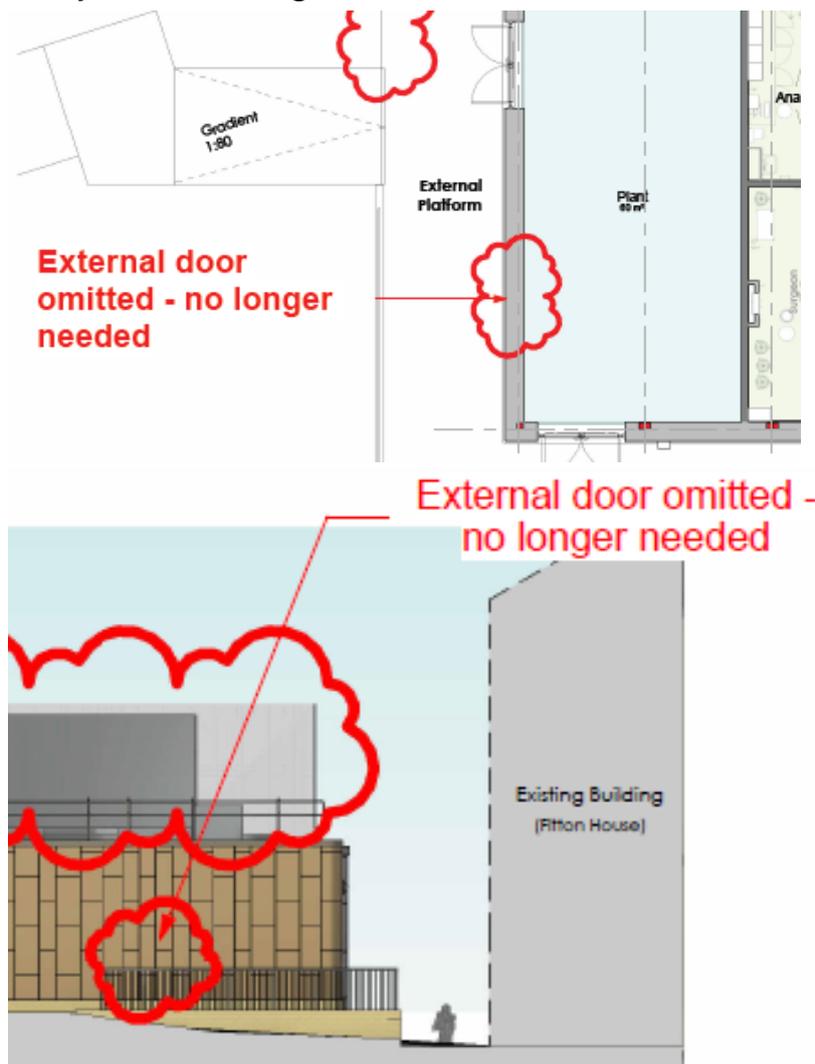
External door omitted (West Elevation)

The original design included a large plant room requiring two means of escape, along with a smaller adjacent plant room that only required a single point of access. However, during the refinement of the mechanical and electrical (M&E) layout, it was determined that a single, larger plant room would be more operationally efficient and spatially effective. As a result, the internal partition was removed to consolidate the two spaces.

The new combined plant room configuration featured three external doors, exceeding the necessary means of escape and access requirements. Given the revised M&E layout and the need to align key services along the perimeter wall, the door located at the far south end of the west elevation became redundant. The remaining two doors provided sufficient access and egress in accordance with Approved Document B of the Building Regulations.

The removal of the third door was therefore both functionally and visually appropriate, offering a cleaner elevation and having no adverse impact on the building's operation, safety, or surrounding context.

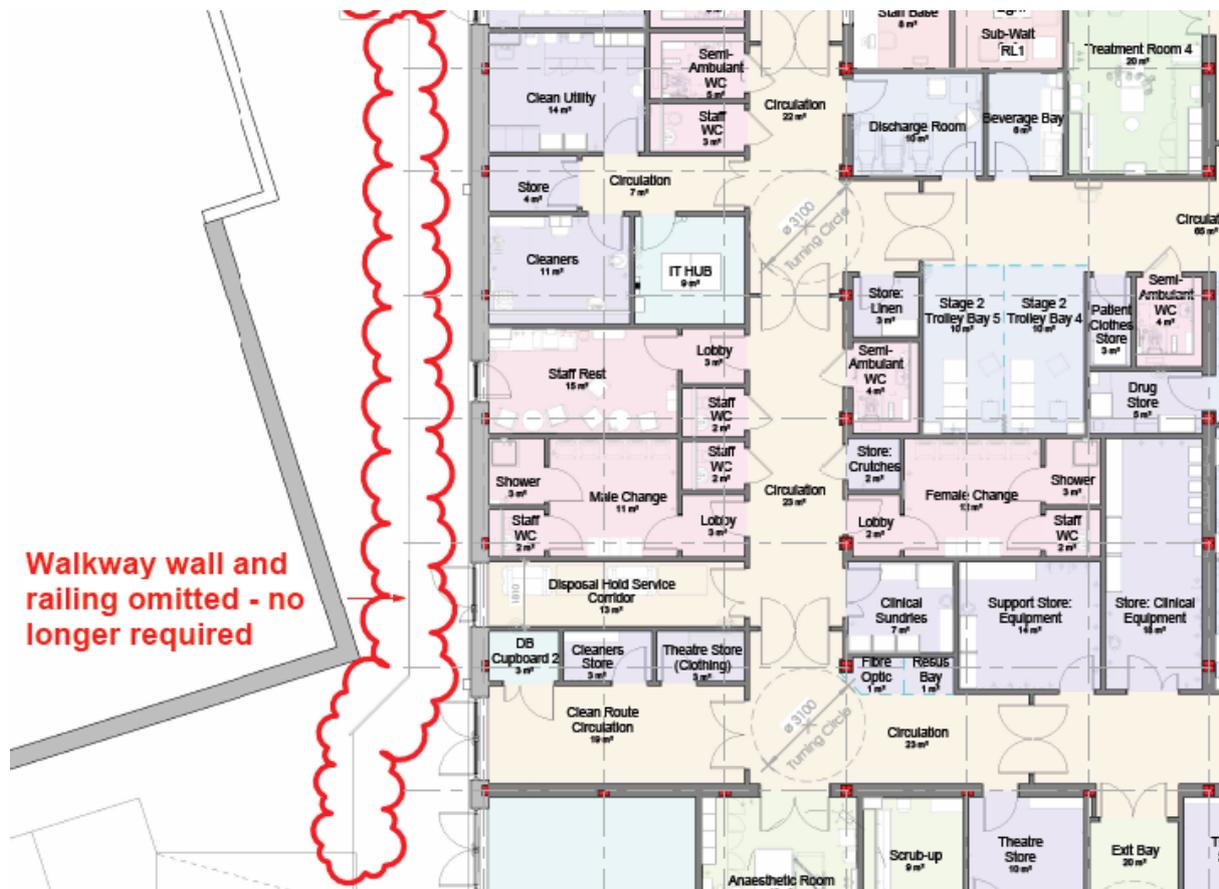
Walkway wall and railing omitted (West Elevation)

As the project progressed on site, the walkway and retaining wall design underwent refinement to address emerging technical and structural constraints. The initial proposal involved a retained walkway supported by deep foundations in close proximity to the existing Boothroyd building. This raised concerns over potential interference with the existing foundations, prompting a reassessment of the design. In parallel, the incorporation of a gas membrane, introduced as a precautionary measure to mitigate ground gas risks, rendered the original solution of a retaining wall with earth banked beneath the building unfeasible, as it would restrict necessary undercroft ventilation.

A revised detail was developed featuring a single deep foundation along the west elevation perimeter, supporting a reinforced retaining wall to stabilise the adjacent ground. This solution preserved structural integrity and ensured adequate airflow below the building in compliance with guidance in CIRIA C665.

The new approach eliminated the need for a separate perimeter wall and handrail at a level change, allowing for a more traditional pathway design using pin kerbs and regraded landscaping, resulting in a more elegant, buildable, and context-sensitive solution.

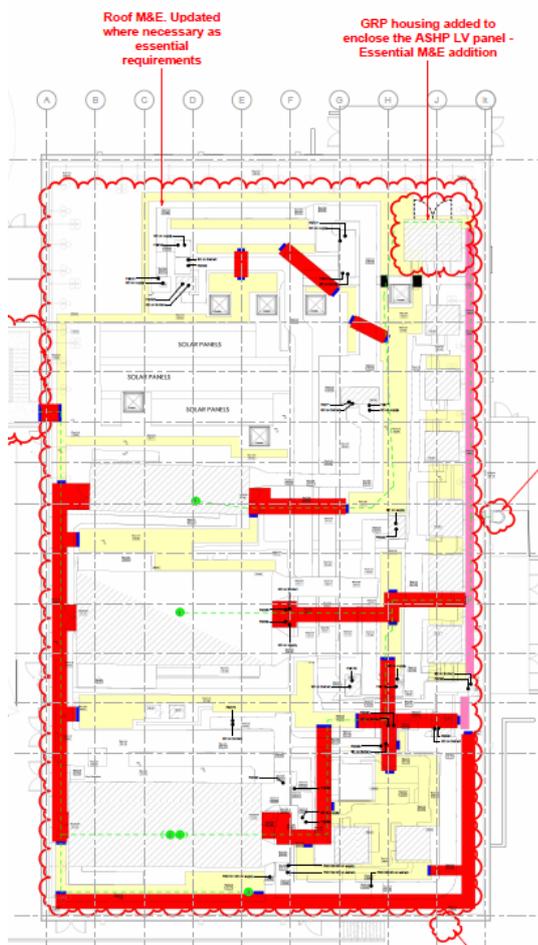
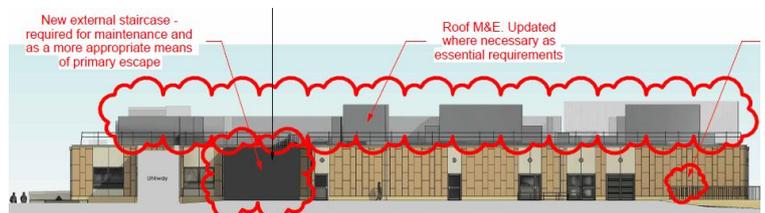
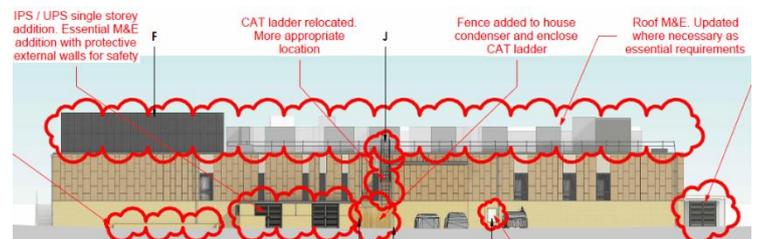
Roof M&E Updated (Roof Plan)

The initial M&E design developed at RIBA Stage 3 was found to be insufficient once the project progressed into RIBA Stage 4, where detailed specifications and operational requirements were fully defined. It became clear that the volume and scale of plant necessary to meet the building's performance standards were significantly greater than originally anticipated. This led to essential changes to the rooftop M&E strategy, which, although challenging within the constraints of the existing layout, were critical to the building's functionality.

Every effort was made to minimise the visual impact of the additional rooftop plant, including careful placement, screening, and maintaining the smallest feasible footprint.

These changes were instrumental in supporting the building's ambition to achieve a BREEAM Excellent rating, which necessitated enhanced sustainability systems and energy performance measures, many of which relied on rooftop services. There were no viable alternatives in terms of location or massing that met these technical and programme requirements. As such, the final design represents a considered and contextually appropriate response that balances functional necessity with architectural sensitivity.

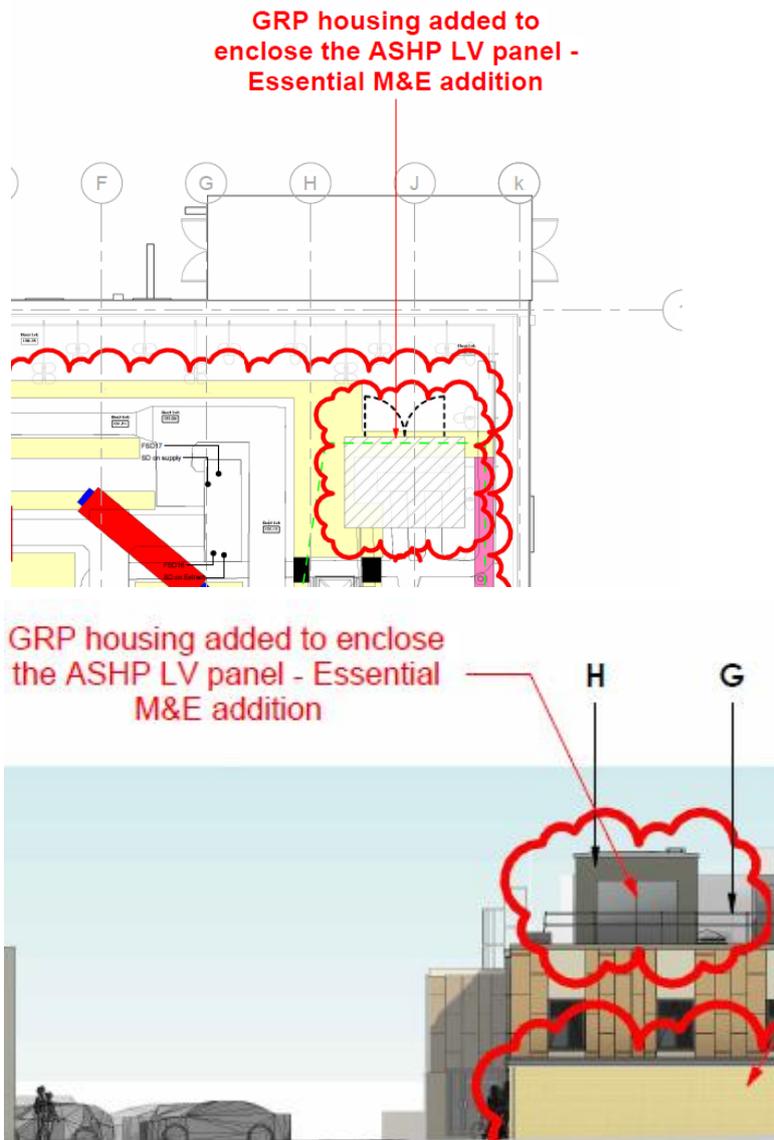
GRP housing added (Roof Plan)

Like the LV and IPS/UPS rooms, the GRP housing serves as a protective enclosure for a critical component of the building's power infrastructure, specifically the Air Source Heat Pump (ASHP) Low Voltage (LV) panel. As the ASHP units are located on the roof, the LV panel must be positioned in close proximity to ensure efficient operation and compliance with electrical safety standards (BS EN 61439).

The GRP enclosure is primarily functional, designed to meet regulatory size requirements while minimising its visual impact. To achieve this, the GRP was specified in a grey finish closely matching the existing plant equipment on the roof, allowing it to blend seamlessly with the rooftop plant area.

This design approach reduces the architectural prominence of the enclosure, ensuring it complements the overall building aesthetic and respects the visual character of the surrounding context.

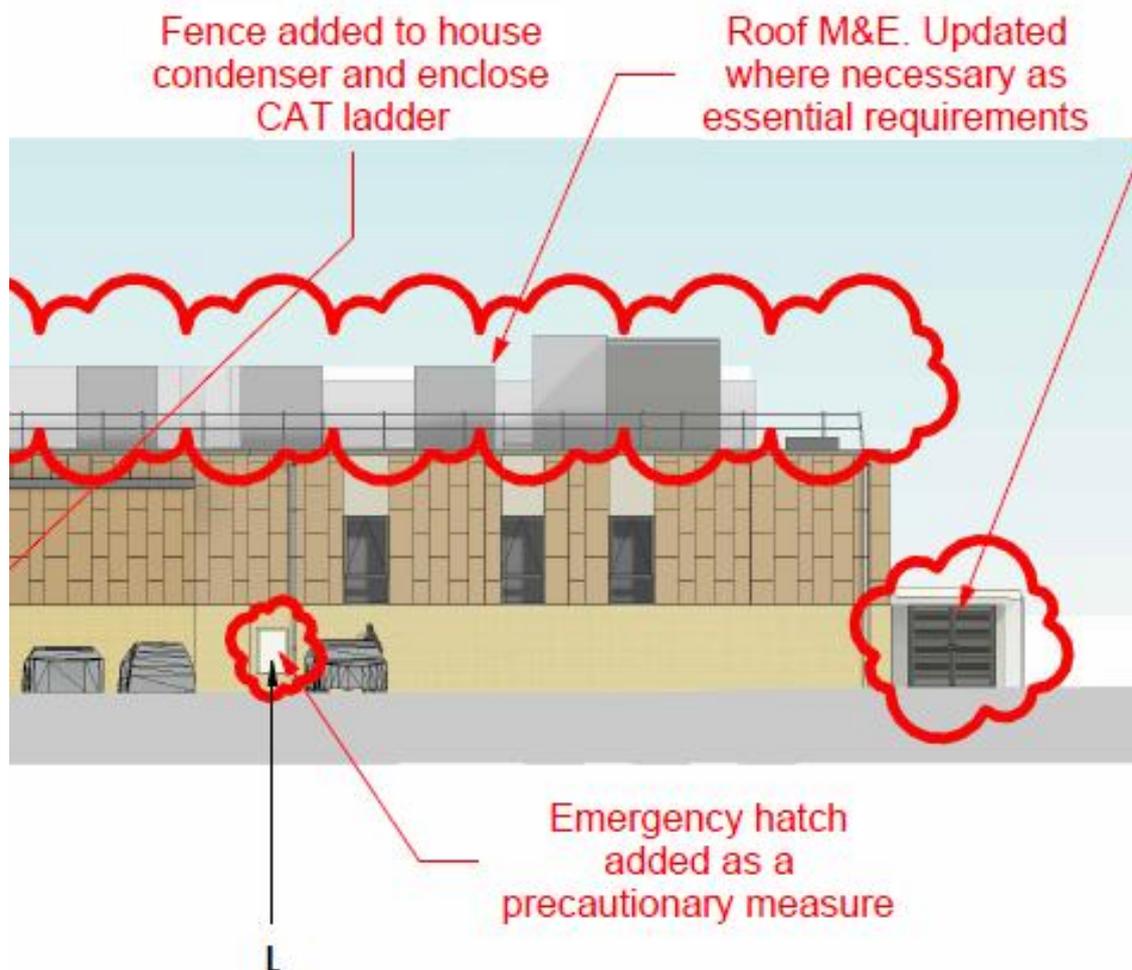
Emergency hatch added (East Elevation)

Following the specialist recommendation to install a gas membrane, the undercroft area of the building now constitutes a substantial enclosed volume requiring adequate cross ventilation to ensure safe environmental conditions. This was achieved through a considered ventilation design that complies with relevant building and health and safety regulations.

Given that electrical services are routed within the undercroft, an emergency access hatch was installed as a precautionary measure. Although routine access to this space is neither anticipated nor required, providing the hatch mitigates risks by allowing emergency entry if needed.

Omitting the hatch initially could have led to costly and time-consuming retrofitting, potentially impacting the building's operational timeline and, by extension, NHS service delivery. Therefore, the decision to include the hatch was deemed a prudent and necessary safeguard, balancing safety, functionality, and project continuity.
