**39A Beckett Rd, Dewsbury**

**PRELIMINARY BAT ROOST ASSESSMENT**

**December 2024**

**Report Ref:** M+P\_06\_01

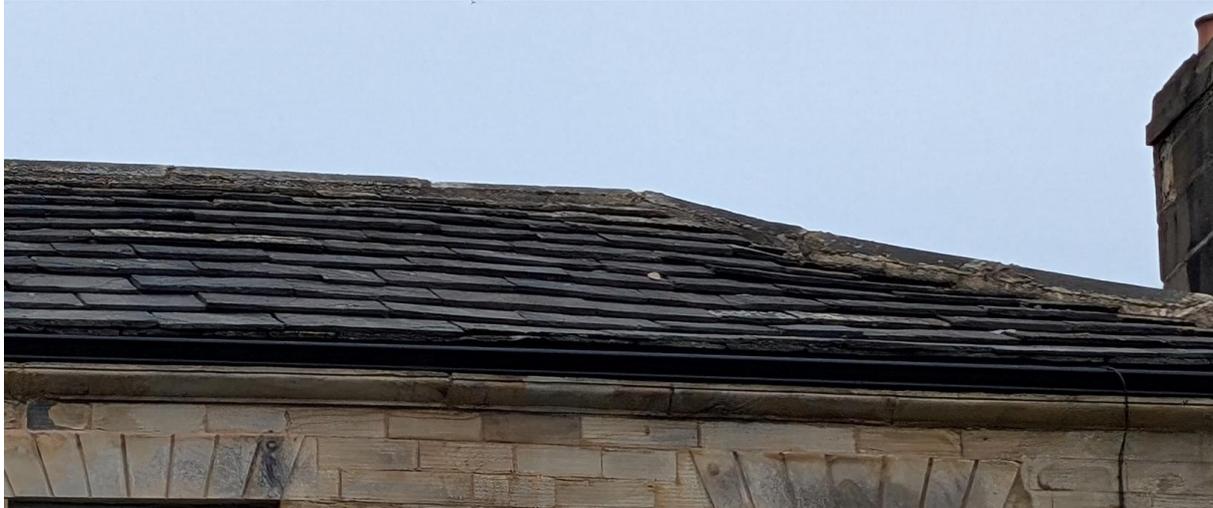
Potential bat roost features were restricted to crevices between the roof slates. Photo 3.1 provides a general example of these features. In relation to the findings of the preliminary bat roost assessment, the property was categorised as **low roost suitability**.

**Photo 3.1. Roof of the property with shallow crevices underneath the stone slates.**

- The roof slates are to be carefully removed by hand and the area underneath is to be fully checked for bats and evidence of bats.
- In the unexpected event that a bat is discovered during the works, the contractors will be advised to stop immediately and contact the licensed ecologist whom will travel to site to provide assessment and advice. Contractors will be specifically forbidden to handle bats. Contractors will be advised that if it is necessary to remove a bat to avoid it being harmed, gloves **MUST** be worn. It should be carefully placed in a cardboard box and kept in the dark in a quiet place until the licensed ecologist arrives on site.

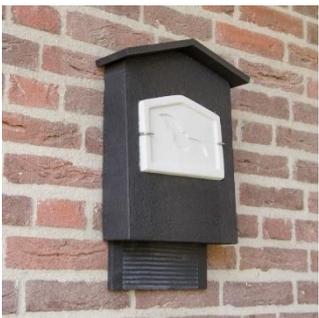
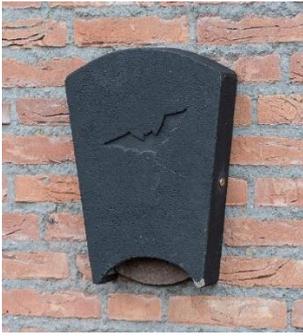
**Figure 5.1. Bat box recommendations**

BAT BOX			
<b>Locations and positioning</b>	The box can be fitted on the walls of the building at a height of at least 3m from the ground. It must be sited outside of any external lighting.		
<b>Bat box models and purchasing</b>	Bat box models along with the locations for purchasing are provided below. There can be a considerable waiting time for delivery for certain models, therefore, two options have been provided.		
	Vivara Pro Chillon Low Profile WoodStone Bat Box

Available from: <a href="https://www.nhbs.com/">https://www.nhbs.com/</a>
<b>Maintenance</b>	The models chosen do not require cleaning as bat droppings do not typically accumulate within these types of boxes to a level likely to cause problems for future habitation.

The proposed development presents a good opportunity to deliver enhancements for bats at the site. Details of the bat box recommended to be installed are provided in Table 5.1.

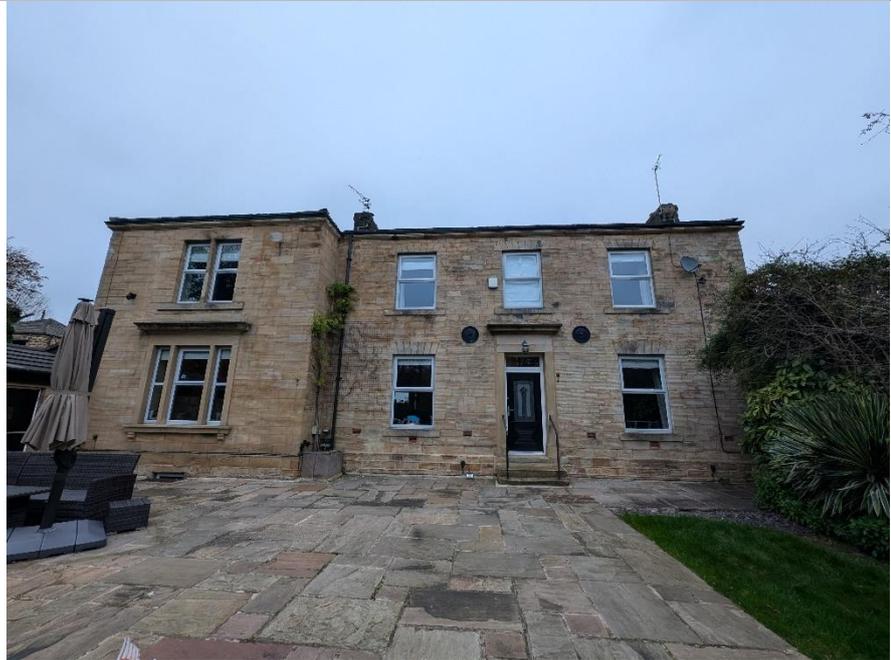
**Photo 1**  
Front (south)  
elevation.

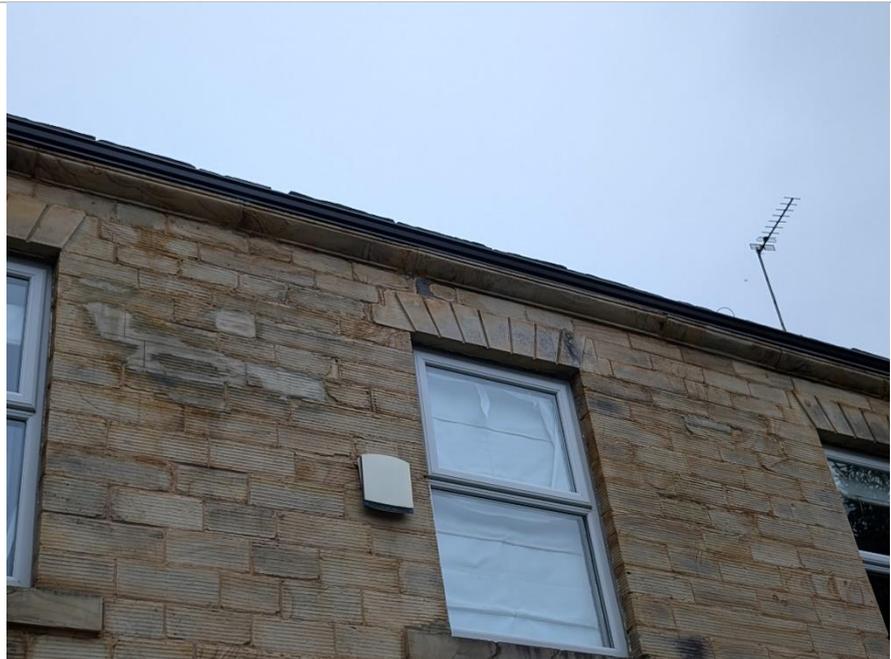
The frontage (south) featured cornice stones all along the roof verge. The guttering sat upon this stonework and there did not appear to be any roost access points all along the roof verge. The guttering on the rear (north) elevation was obscuring the roof verge and no potential roost features were identified. The main section of the house had a hipped roof which featured traditional stone slates. The pitch of the roof was notably shallow. The ridge tiles of the roof appeared well-bedded in and the pointing mortar appeared solid. As is typical of such roof types, there were numerous crevices within the roof due to slightly lifted and misshapen tiles. Such features can provide roosting opportunities for individual bats. Internally, the loft of the property had recently been boarded out and lights had been fitted along the entire ridge. Due to the shallow pitch, the loft height was shallow (approximately 1.2m). The roof had a traditional, bitumen based, underlining. No light gaps were observed throughout the loft.

**Photo 2**  
View of roof verge on  
front.

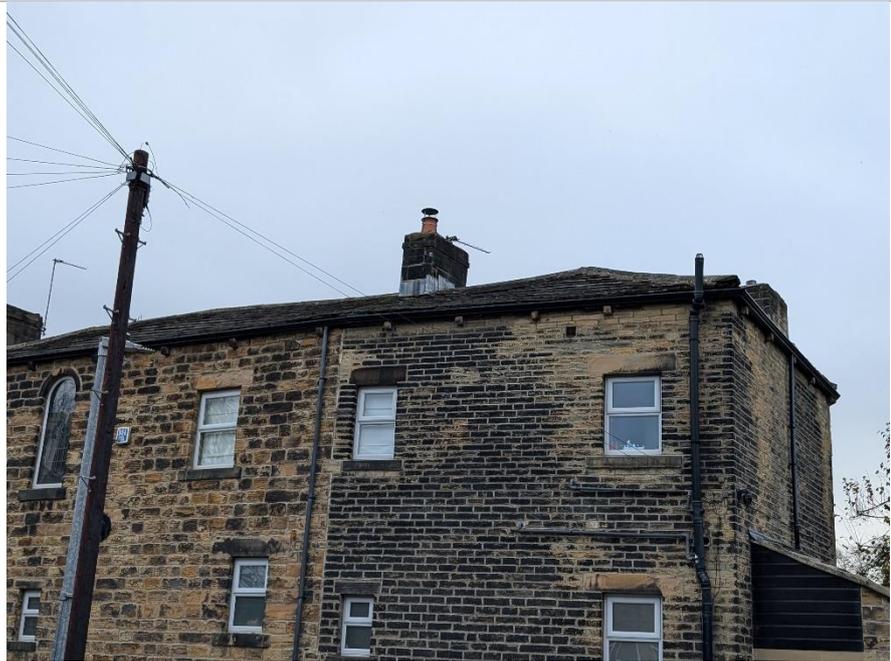
**Photo 3**  
Rear (north)  
elevation and west  
gable.

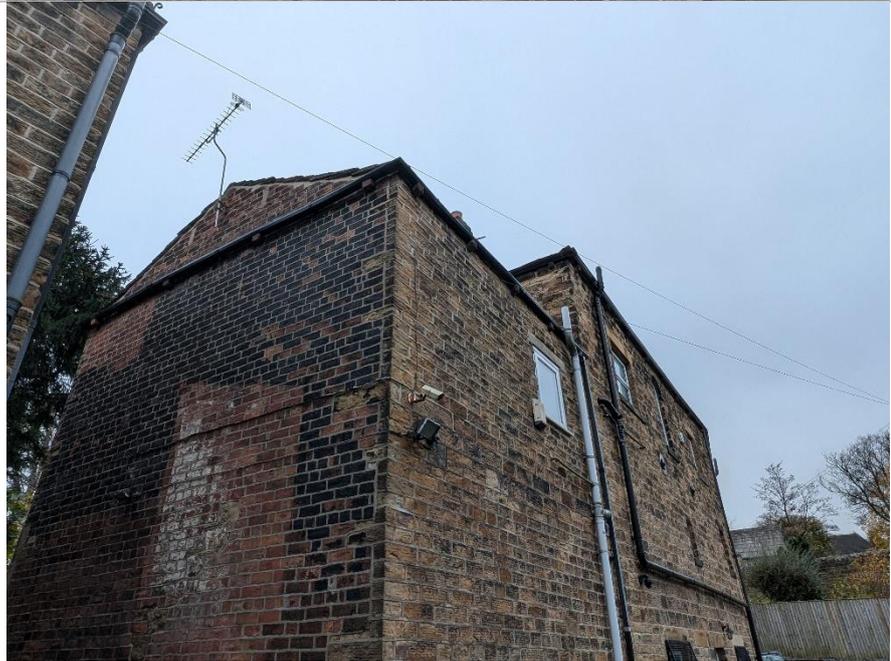
**Photos 4**  
Rear (north) elevation  
and east gable.

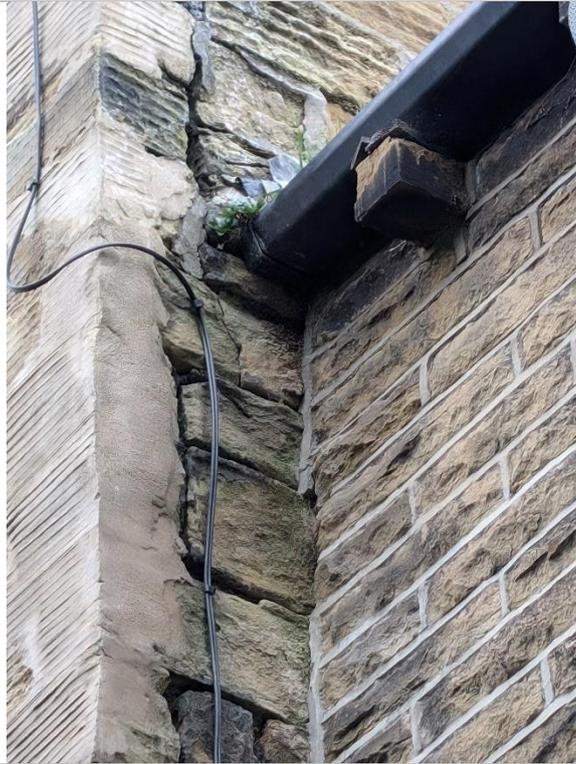
The property comprised a two-storey, stone-built dwelling. The stonework of the property had been repointed and repaired relatively recently. A very narrow section of the stonework on the south-east corner had not been pointed and there did appear to be crevices in the stonework. However, upon further inspection, these crevices appeared shallow and filled broken mortar and detritus.

**Photo 5.**  
Shallow crevices in  
south-east corner of  
stonework  
(suboptimal bat  
roost features).

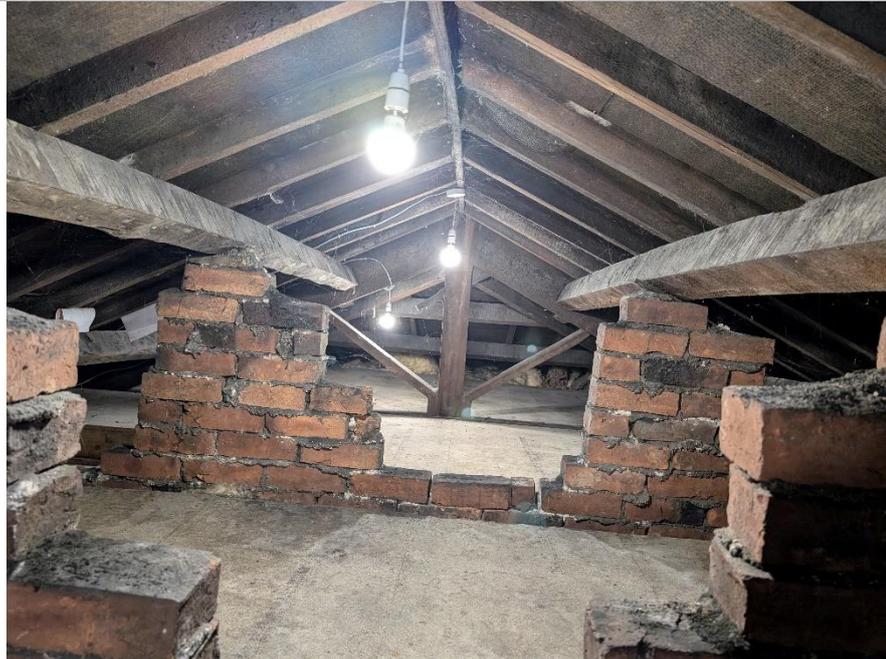
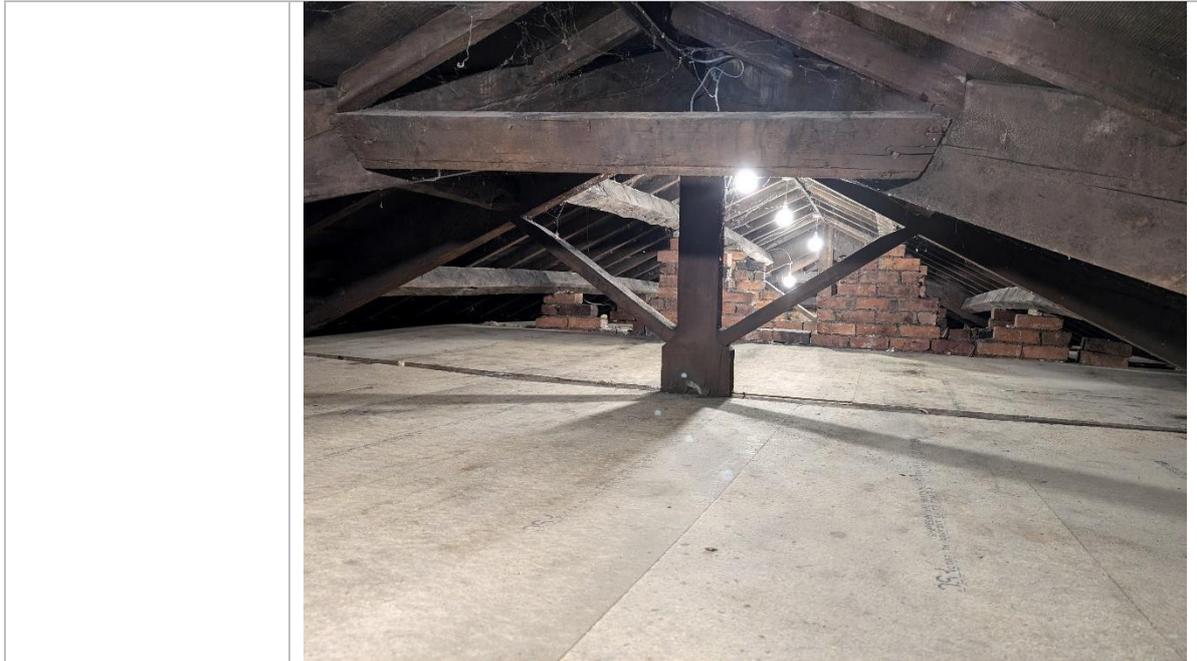
**Photos 6a – 6b.**  
Loft of property.
