**RED HOUSE, OXFORD ROAD, GOMERSAL.**

**PRELIMINARY ROOST ASSESSMENT.**

**Ref No: 250141.**

**Date: 30<sup>th</sup> January 2025.**

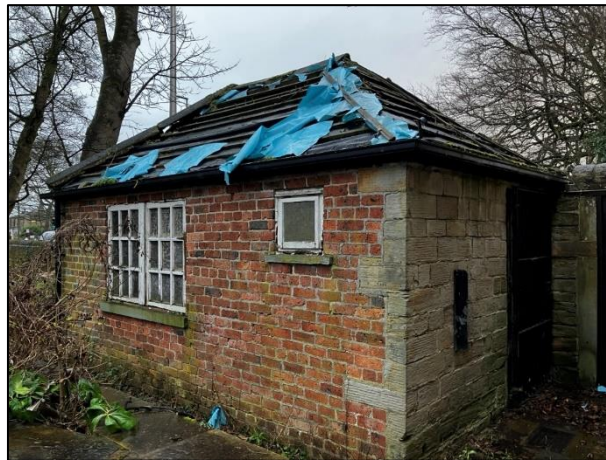
3.3.1.1. Building 1 comprised a single storey brick and stone toilet block. The brick and stone were in a good condition with no gaps or crevices and the windows and doors were tight fitting and all in situ. There was a metal grill over both doors leaving a sheltered area before the doorway into the building. The photograph below shows the southern and western elevations of the building.

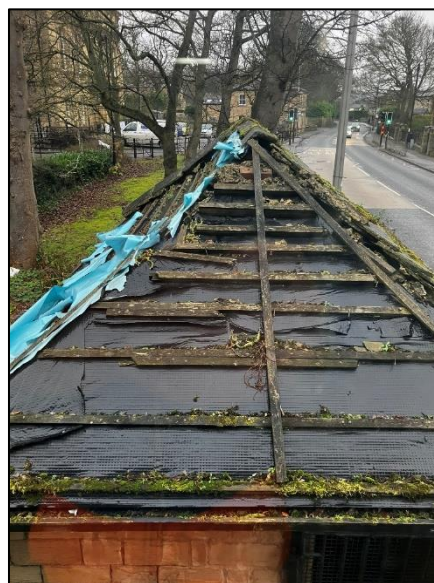
3.3.1.2. The roof of the building was hipped with a plastic roof lining. The plastic roof lining was in a good condition and there was wooden sarking underneath the plastic roof lining. All the stone roof tiles had been removed only leaving several of the stone ridge and hip tiles. The photograph below shows the southern elevation of the roof.

3.3.1.4. There was no access for bats inside the building. However, there could be potential for individual bats to roost between the plastic roof lining and the wooden sarking.

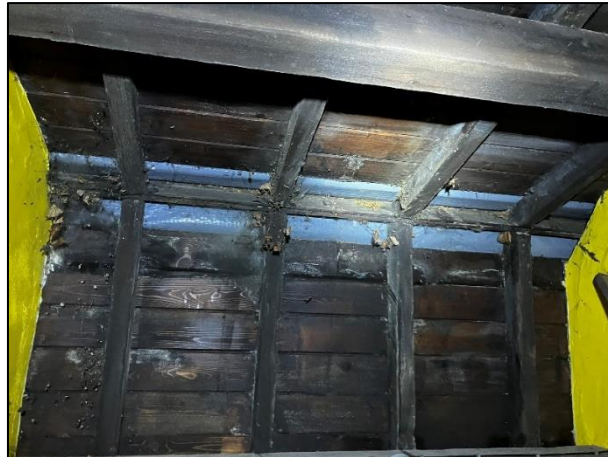
3.3.1.3. Internally the rooms were open to the rafters as shown in the photograph below.

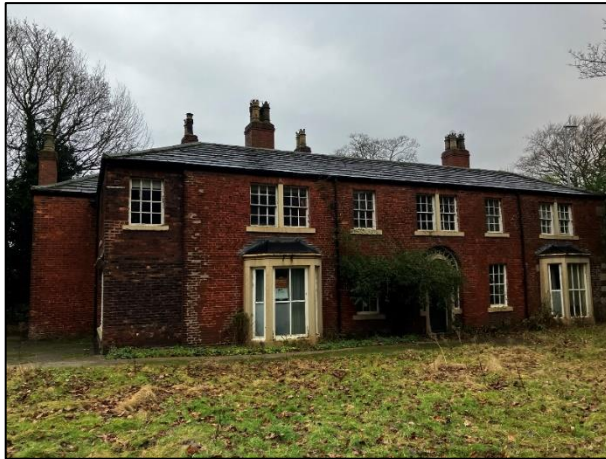
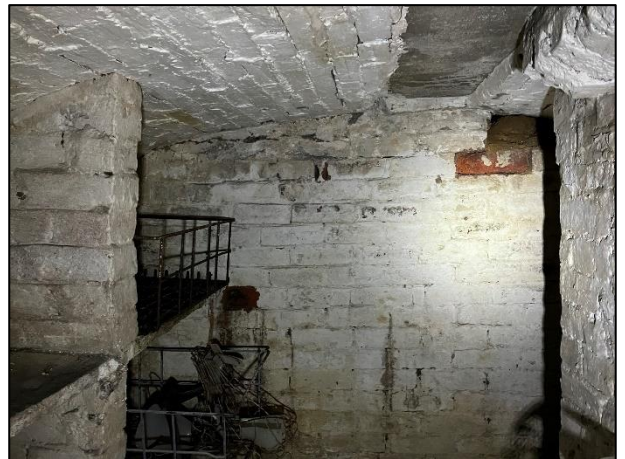
3.3.2.1. The surveyed building was a two-storey brick and stone building with a small cellar with access internally and no external access. The photograph below shows the southern elevation of building 2 on the left and the small cellar on the right.

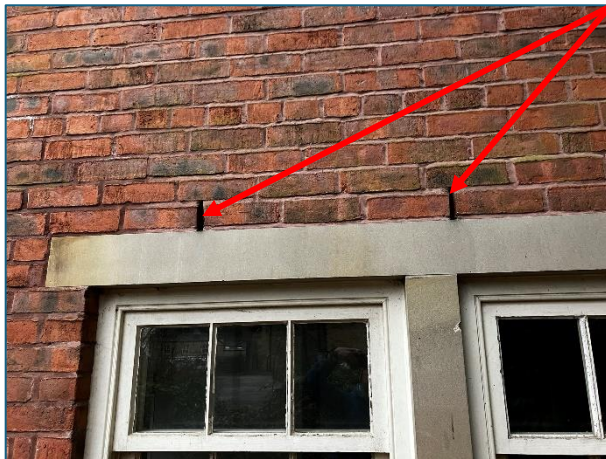
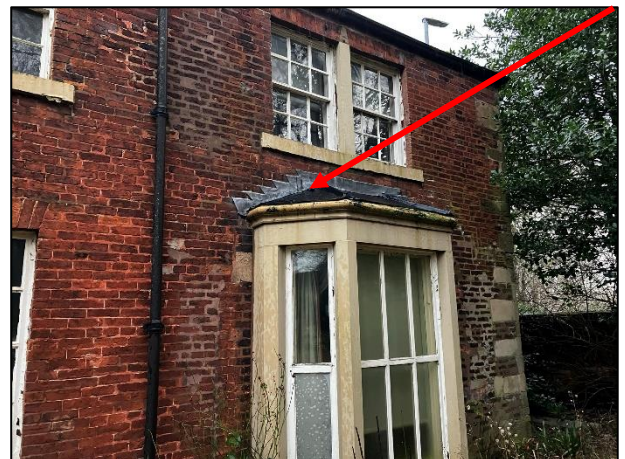
3.3.2.2. The brick and stonework were in a good condition with some small gaps and crevices. The photograph on the left below shows two weep holes above the ground floor window lintel and the photograph on the right shows the damaged flashing above one of the bay windows. This could allow access for solitary bats to roost during the summer months.

5.1. Building 1, 2 are assessed as having low potential and building 4 is assessed as having moderate potential for roosting bats according to the Bat Conservation Trust's 'Good Practice Guidelines'. Therefore, it is recommended that one dusk emergence survey is carried out on building 1 and 2 and two dusk emergence surveys carried out on building 4 during the bat activity season, which extends from May to August inclusive, to determine whether bats are using the building to roost. The surveys need to be carried out at least three weeks apart.

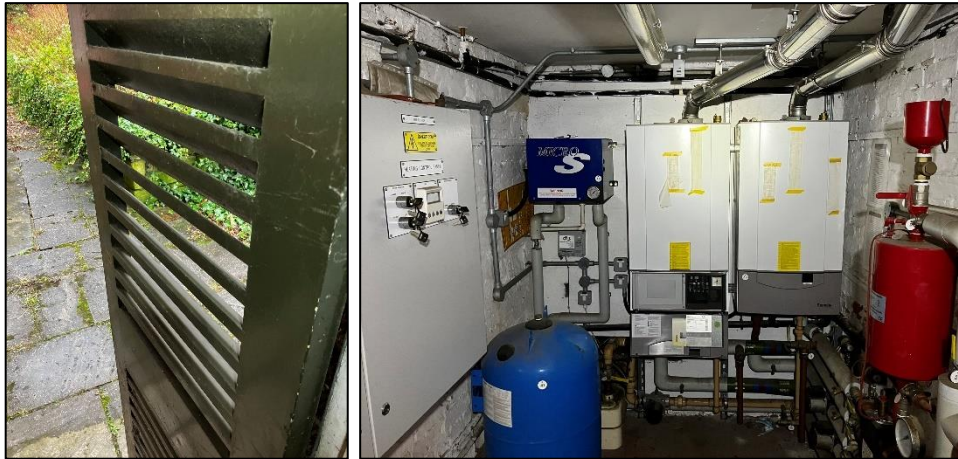
3.3.2.3. The windows and doors were tight fitting and all in situ. However, one of the doors to a storage room on the ground floor was louvred. This could allow access for bats to access the room. Although, this is a regularly used room where all the building services are located. The room doesn't maintain a warm temperature and will allow draughty conditions to cool the services.

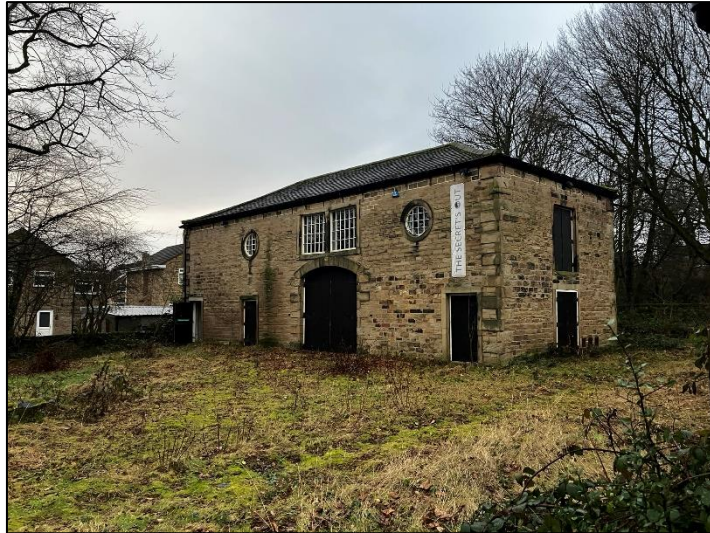
3.3.3.1. The surveyed building was a two-storey stone building. The photograph below shows the eastern and northern elevation of building 3.

3.3.3.2. The stonework was in a good condition with no gaps or crevices.

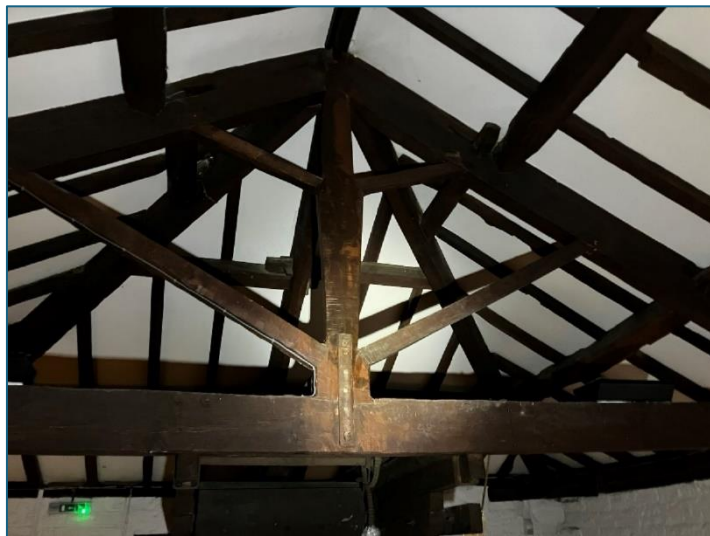
3.3.3.3. The roof of the building was hipped and covered with stone roof tiles, stone ridge and hip tiles. Internally the roof is open to the rafters and boarded between the rafters. It is not known if the roof is lined. However, it is likely due to the age of the roof. The photograph below shows the internal elevation of the roof.

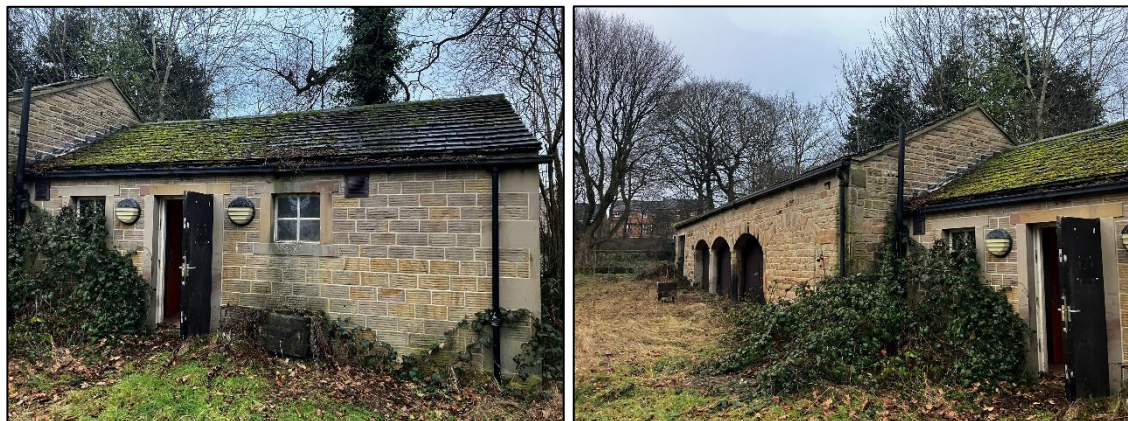
3.3.4.1. The surveyed building was a single-storey stone building. The photograph below shows the southern elevation of building 4.

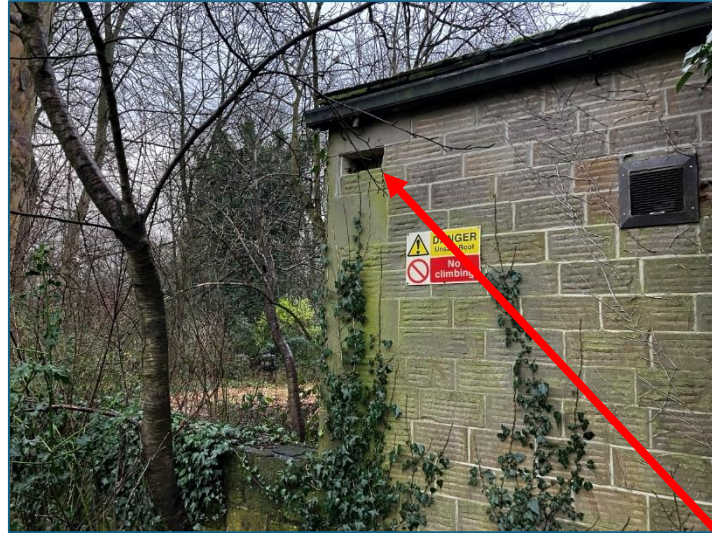
3.3.4.2. The stonework was generally in a good condition. However, there was a missing stone in the northern elevation of the building leading into the wall cavity. The photograph below shows the area of missing stone.

3.3.4.8. The results of this survey found several features under the remaining roof tiles and the missing brick in the north of the building that will provide potential roost features for bats. However, no access points leading inside the building were identified. Therefore, the building is assessed to provide **moderate potential for summer roosting bats**.

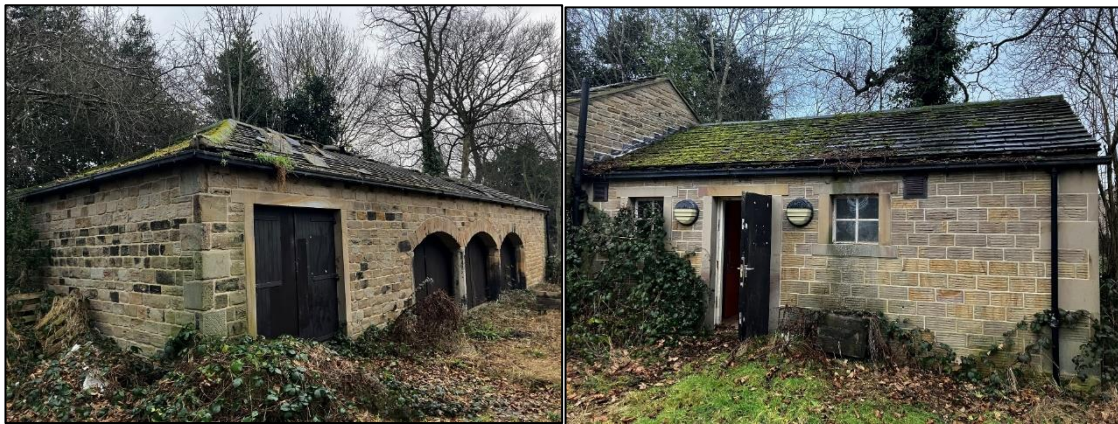
3.3.4.3. The roof of the building was a ridge with three gable ends. Internally the roof is open to the rafters and boarded between the rafters. It is not known if the roof is lined. However, it is likely due to the age of the roof. A large amount of the stone roof tiles had been removed only leaving approximately 30% of the stone roof tiles, stone ridge and hip tiles. The photographs below show the western elevation of the roof on the left and the eastern elevation of the roof on the left.

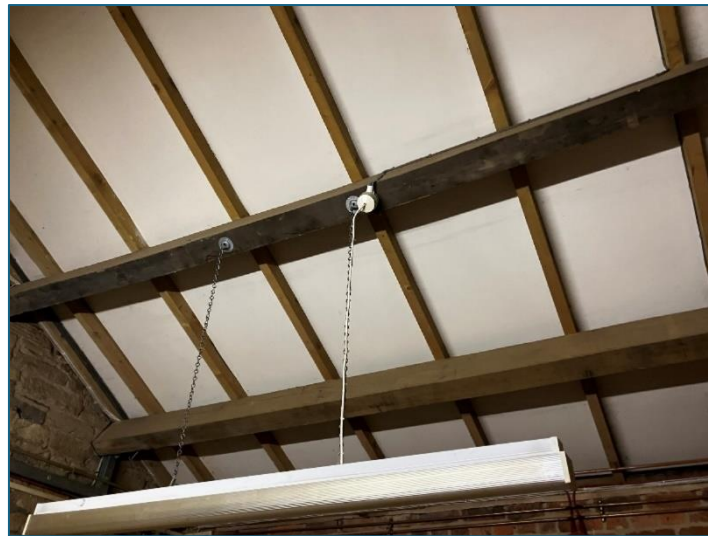
3.3.4.4. The photograph below shows the internal elevation of the roof.
