**Project Name: Huddersfield Open Market**

Paint & mortar analysis

October 2021

**Client: Watts (Suzannah Meade)**

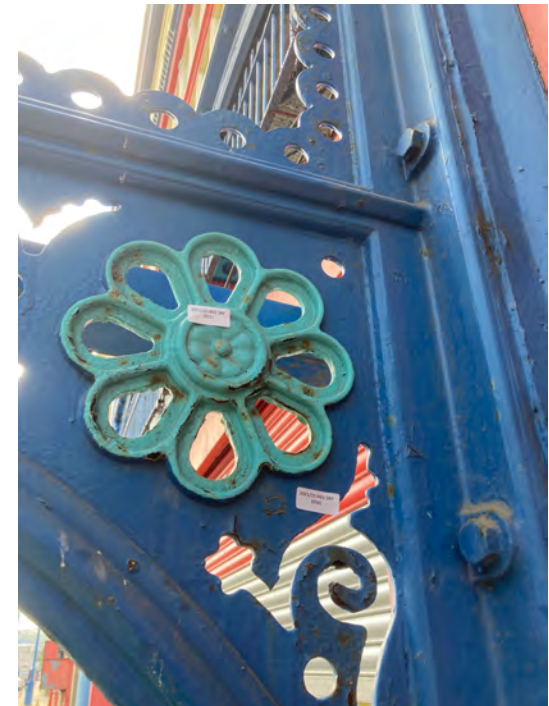
### Samples 1 – 5:

- column base and turquoise painted collars

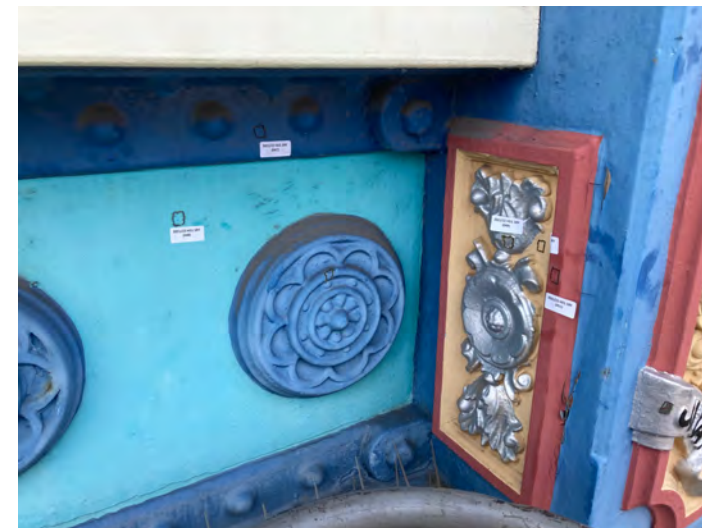
Samples 48 – 53:

Image of the armorial side panel and adjacent frieze with blue painted roundels.

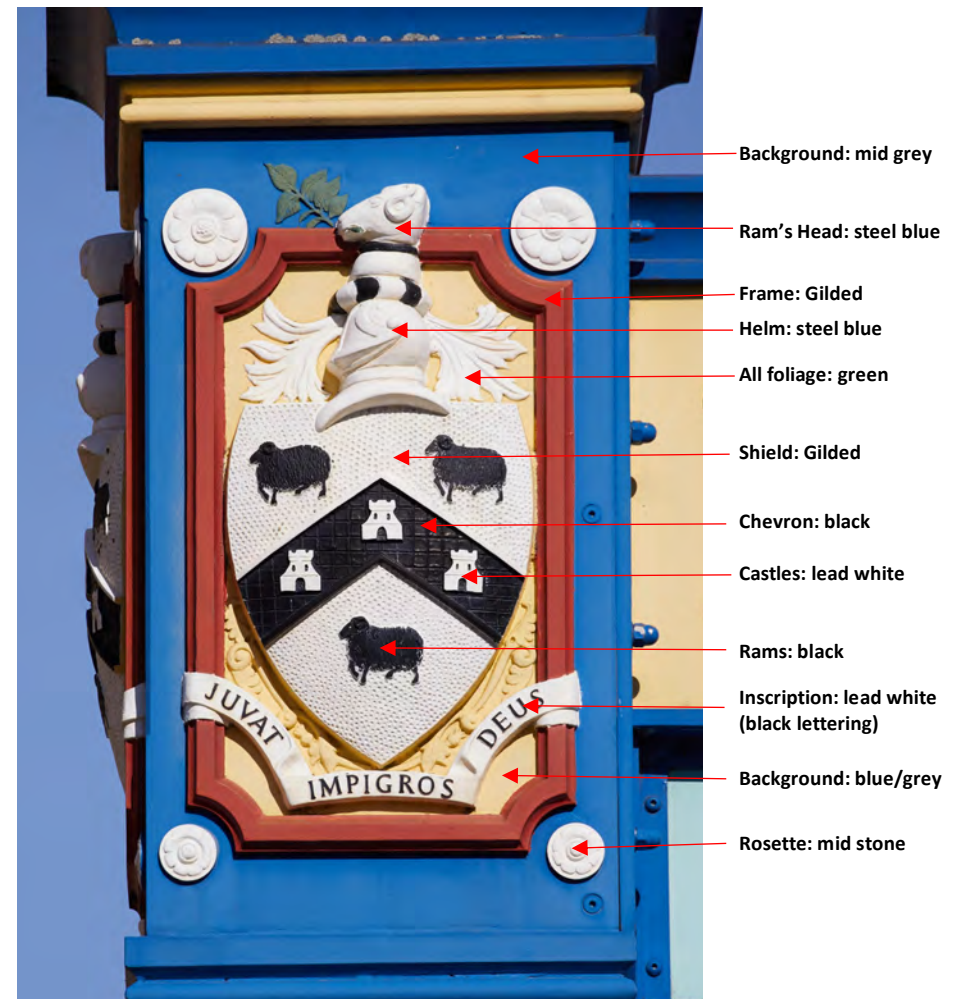
Figure 3: Suggested colour allocation for the armorial<sup>4</sup>

- vii) One of the key decorative features here is the Huddersfield Coat of Arms armorial capping each of the supporting columns. The remaining paint evidence on the example sampled was quite fragmentary and a little confused due to the cleaning and preparation of surfaces prior to repainting.
- viii) A suggested colour allocation for the armorial is provided in fig.3 that represents the original late 19<sup>th</sup> century appearance.

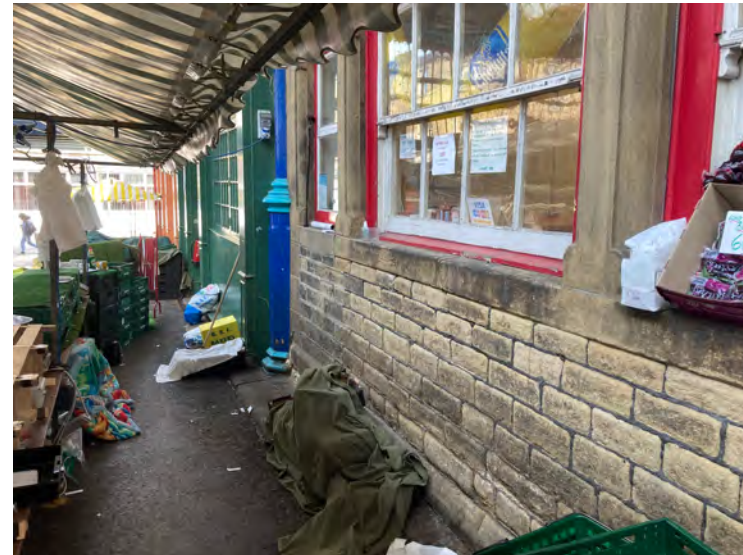
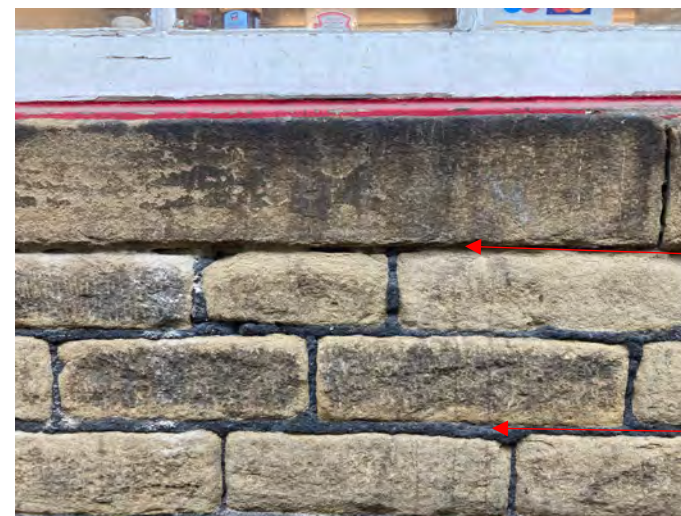
### 9.2.1: Samples 1 & 2

Sample 2:  
Underlying early mortar

Sample 1:  
Black re-pointing

A non-hydraulic repair mortar (NHL 2.0) of a neutral limestone colour using a 2:1 mix ratio with an average aggregate grain size is suggested for this location.

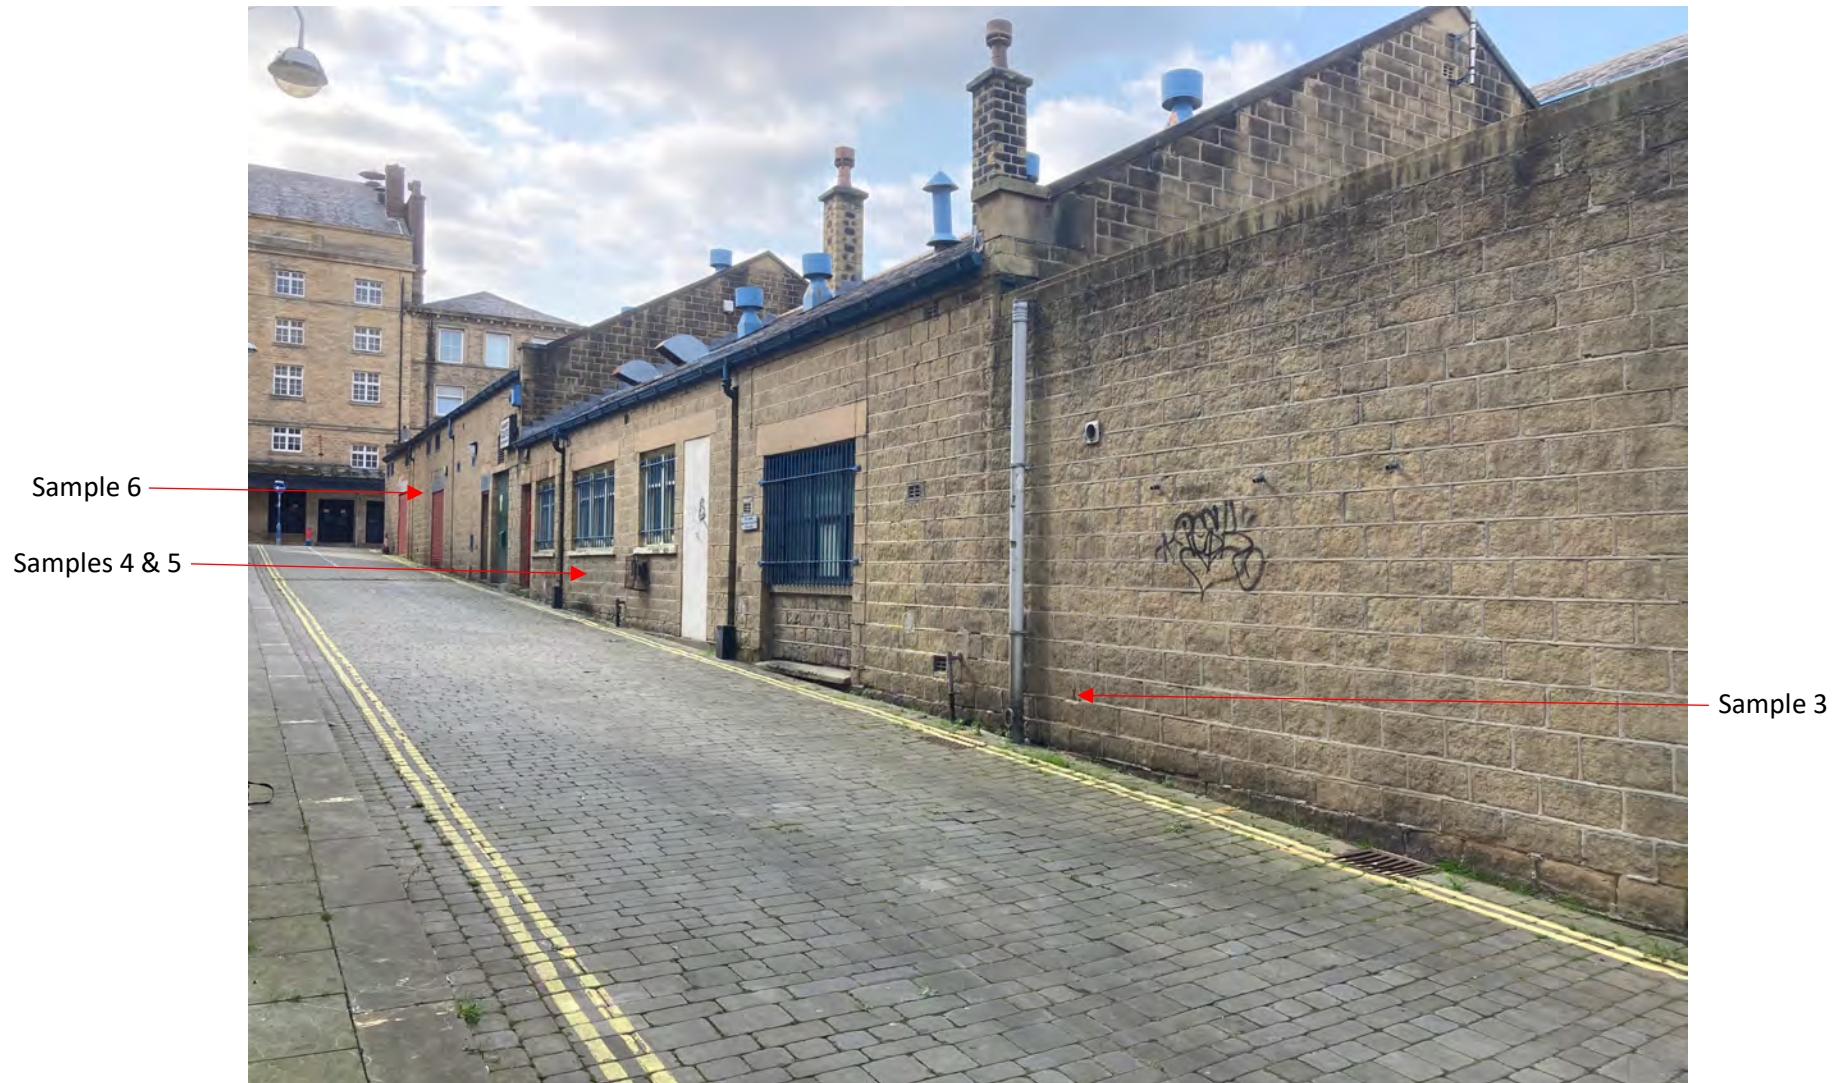
9.2.2: Samples 3 - 6

- ii) Samples 3 and 4 were removed from the hard 'ribbon' re-pointing applied relatively recently (possibly during the 1980 restoration or even later). This is a hard and inflexible Ordinary Portland Cement (OPC) overlying the original lime mortars defined here as samples 5 and 6.

- iii) Samples 5 & 6 are early mortars that lie beneath the later OPC ribbon pointing. Both are lime based, with sample 5 defined as a hydraulic lime and sample 6 as non-hydraulic. Presumably both samples were applied at different periods and may represent an example of earlier repair or repointing. In both cases a mix ratio of approx. 4 parts aggregate to one part binder was used with an average aggregate grain size of 0.5 – 1.0mm.
