# Report on a Geo-environmental Investigation

Location: Open Market, Huddersfield,  
HD1 1RY

For: Kirklees Council

Report No. J3644/16/E

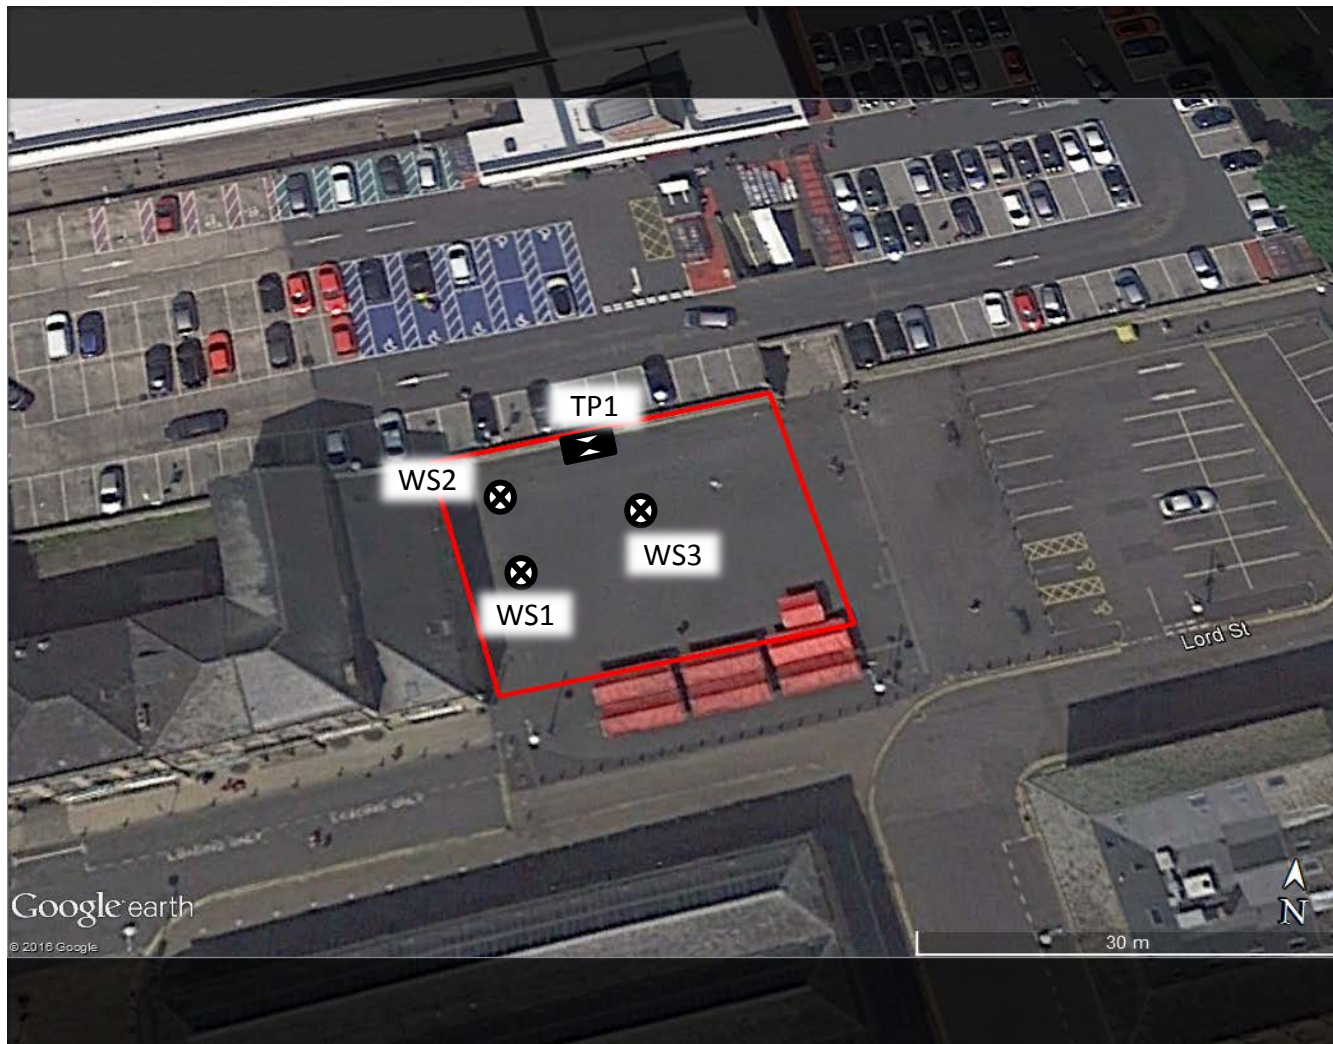
Title: **Investigation Location Plan**

Plan not to scale and investigation positions approximated from site operative's notes.

The investigatory locations are shown on the site plan which is presented in Appendix 1 to this report.
