Our Ref: AC00100/JaggerLaneEmley/LS/NP-02

Land Adjoining 23 Jagger Lane, Emley Moor, Huddersfield, HD8 9SY
Planning Ref: 2012/62/90390/E – Demolition of Existing Buildings and Erection of 2 No. Detached Dwellings
Progress Report on Remediation Validation – Conditions 8 & 9

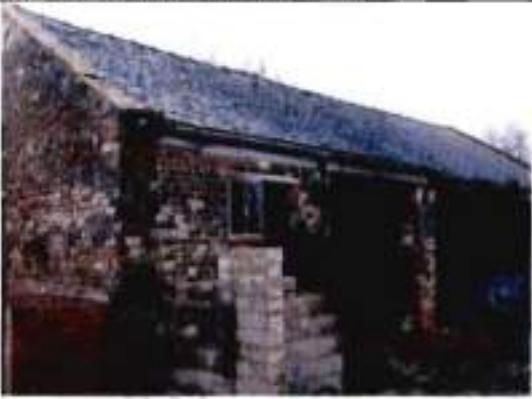
Sample No – No sample taken		DESCRIPTION: Item 02 – Barn 1 Overview	
Location	Barn 1

Floor	Ground		
Area	Overview		
Amount	N/A		
Access	N/A		
Component	N/A		
Exposure	N/A		
Friability	N/A		
MATERIAL ASSESSMENT (A)			
A1) Product type	N/A		0
A2) Extent of Damage or deterioration	N/A		0
A3) Surface Treatment	N/A		0
A4) Asbestos type	No asbestos suspected		0
TOTAL			0
PRIORITY ASSESSMENT (B)		Summary	
Likelihood of disturbance			
B1) Location	0	Material Assessment (A)	0
B2) Accessibility	0	+	
B3) Extent	0	Priority Assessment (B)	0
TOTAL	0	Total Risk Score	0
Recommendations		No further action necessary	
Comments		Brick built, slate roof, stone copings, wooden fascia, plastic gutters and downpipes. No undercloaking. No damp course.

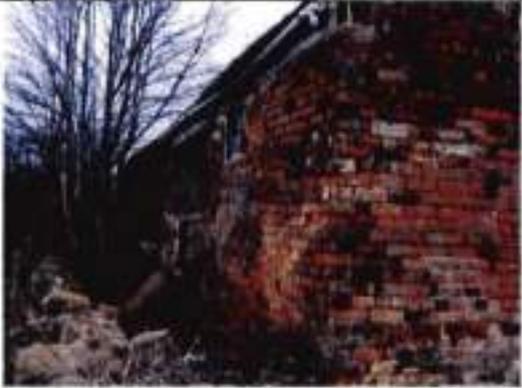
Sample No – No sample taken		DESCRIPTION: Item 03 – Barn 1 Rear	
Location	Barn 1

Floor	Ground		
Area	Rear		
Amount	N/A		
Access	N/A		
Component	N/A		
Exposure	N/A		
Friability	N/A		
MATERIAL ASSESSMENT (A)			
A1) Product type	N/A		0
A2) Extent of Damage or deterioration	N/A		0
A3) Surface Treatment	N/A		0
A4) Asbestos type	No asbestos suspected		0
TOTAL			0
PRIORITY ASSESSMENT (B)		Summary	
Likelihood of disturbance		Material Assessment (A)	0
B1) Location	0	+	
B2) Accessibility	0	Priority Assessment (B)	0
B3) Extent	0		
TOTAL	0	Total Risk Score	0
Recommendations		No further action necessary	
Comments		Brick built. Slate roof. Wooden fascias. Plastic gutters.

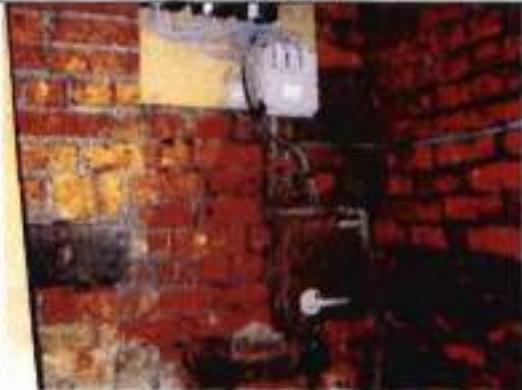
Sample No – No sample taken		DESCRIPTION: Item 05 – Barn 1 Electrics behind Stud Wall	
Location	Barn 1

Floor	Ground		
Area	Electrics behind stud wall		
Amount			
Access	Easy		
Component	Strongly presume asbestos textiles		
Exposure	Maintenance		
Friability	Medium		
MATERIAL ASSESSMENT (A)			
A1) Product type	Woven fabrics		2
A2) Extent of Damage or deterioration	Fair		1
A3) Surface Treatment	Sealed		1
A4) Asbestos type	Strongly presumed		2
TOTAL			6
PRIORITY ASSESSMENT (B)		Summary	
Likelihood of disturbance			
B1) Location	1	Material Assessment (A)	6
B2) Accessibility	0	+	
B3) Extent	0	Priority Assessment (B)	1
TOTAL	1	Total Risk Score	7
Recommendations		Remove prior to demolition	
Comments		Presume woven fabrics to electric box

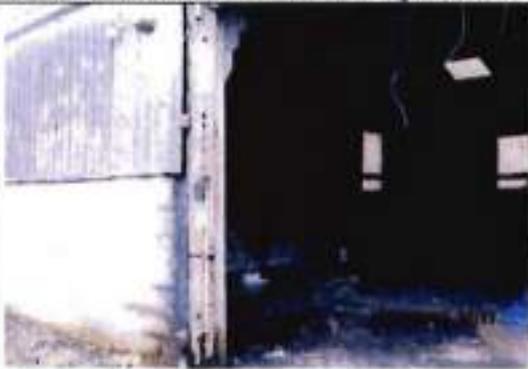
Sample No – No sample taken		DESCRIPTION: Item 06 – Barn 2 Cladding to all sides	
Location	Barn 2

Floor	Ground		
Area	Cladding to all sides		
Amount	140m ² approx to all sides		
Access	Easy		
Component	Strongly presume asbestos cement		
Exposure	General public		
Friability	Medium		
MATERIAL ASSESSMENT (A)			
A1) Product type	Asbestos cement		1
A2) Extent of Damage or deterioration	Fair		1
A3) Surface Treatment	Sealed		1
A4) Asbestos type	Strongly presumed		1
		TOTAL	4
PRIORITY ASSESSMENT (B)		Summary	
Likelihood of disturbance			
B1) Location	0	Material Assessment (A)	4
B2) Accessibility	1	+	
B3) Extent	3	Priority Assessment (B)	4
TOTAL	4	Total Risk Score	8
Recommendations		Remove prior to demolition	
Comments		Strongly presumed asbestos cement due to age of building.

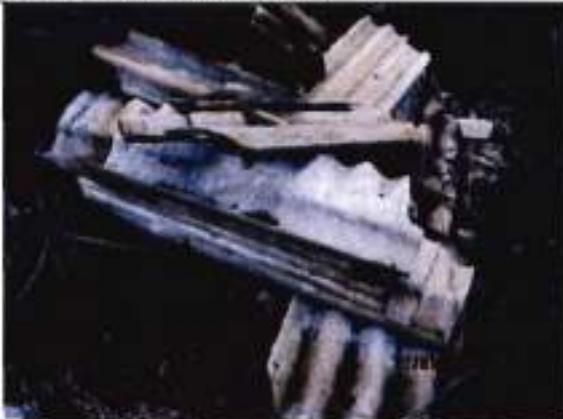
Sample No – No sample taken		DESCRIPTION: Item 08 – Exterior	
Location	Exterior

Floor	Ground		
Area	Outside		
Amount	20m ² approx		
Access	Easy		
Component	Strongly presume asbestos cement		
Exposure Friability	General public Medium		
MATERIAL ASSESSMENT (A)			
A1) Product type	Asbestos cement		1
A2) Extent of Damage or deterioration	Debris		2
A3) Surface Treatment	Sealed		1
A4) Asbestos type	Strongly presumed		1
		TOTAL	5
PRIORITY ASSESSMENT (B)		Summary	
Likelihood of disturbance			
B1) Location	0	Material Assessment (A)	5
B2) Accessibility	3	+	
B3) Extent	2	Priority Assessment (B)	5
TOTAL	5	Total Risk Score	10
Recommendations		Remove as soon as possible by licenced contractor	
Comments		Strongly presumed asbestos cement due to age of building

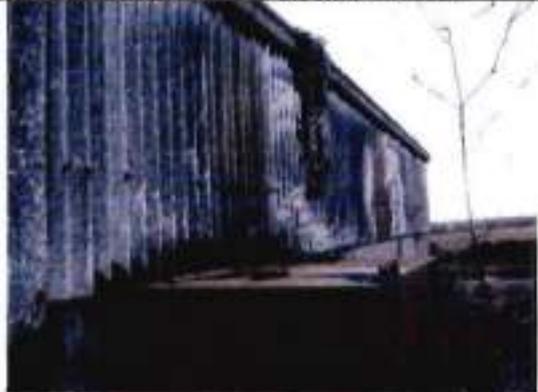
Sample No – No sample taken		DESCRIPTION: Item 09 – Barn cladding to side	
Location	Barn

Floor	Ground		
Area	Cladding to side		
Amount	140m ² approx to all sides		
Access	Easy		
Component	Strongly presume asbestos cement		
Exposure Friability	General public Medium		
MATERIAL ASSESSMENT (A)			
A1) Product type	Asbestos cement		1
A2) Extent of Damage or deterioration	Fair		1
A3) Surface Treatment	Sealed		1
A4) Asbestos type	Strongly presumed		1
		TOTAL	4
PRIORITY ASSESSMENT (B)		Summary	
Likelihood of disturbance			
B1) Location	0	Material Assessment (A)	4
B2) Accessibility	1	+	
B3) Extent	3	Priority Assessment (B)	4
TOTAL	4	Total Risk Score	8
Recommendations		Remove prior to demolition	
Comments		Strongly presumed asbestos cement due to age of building.

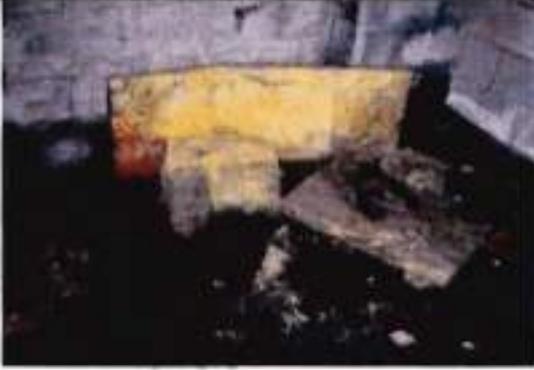
Sample No – No sample taken		DESCRIPTION: Item 11 – Barn 2 Fibreglass on Floor	
Location	Barn 2

Floor	Ground		
Area	Floor		
Amount	N/A		
Access	N/A		
Component	N/A		
Exposure	N/A		
Friability	N/A		
MATERIAL ASSESSMENT (A)			
A1) Product type	N/A	0	
A2) Extent of Damage or deterioration	N/A	0	
A3) Surface Treatment	N/A	0	
A4) Asbestos type	No asbestos suspected	0	
		TOTAL	0
PRIORITY ASSESSMENT (B)		Summary	
Likelihood of disturbance			
B1) Location	0	Material Assessment (A)	0
B2) Accessibility	0	+	
B3) Extent	0	Priority Assessment (B)	0
TOTAL	0	Total Risk Score	0
Recommendations		No further action necessary	
Comments		Fibreglass to floor

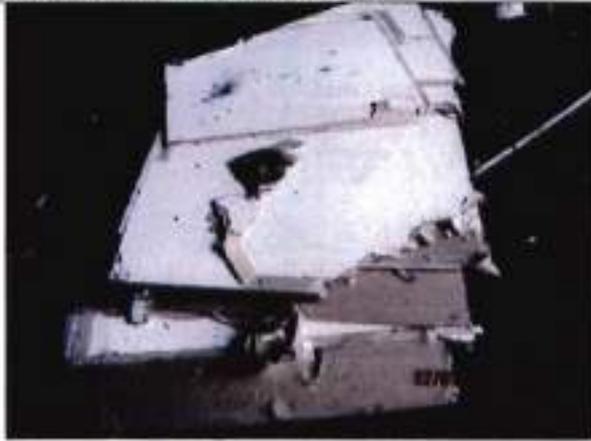
Sample No – No sample taken		DESCRIPTION: Item 12 – Barn 2 Floor	
Location	Barn 2

Floor	Ground		
Area	Floor		
Amount	N/A		
Access	N/A		
Component	N/A		
Exposure	N/A		
Friability	N/A		
MATERIAL ASSESSMENT (A)			
A1) Product type	N/A	0	
A2) Extent of Damage or deterioration	N/A	0	
A3) Surface Treatment	N/A	0	
A4) Asbestos type	No asbestos suspected	0	
		TOTAL	0
PRIORITY ASSESSMENT (B)		Summary	
Likelihood of disturbance	0	Material Assessment (A)	0
B1) Location	0	+	
B2) Accessibility	0	Priority Assessment (B)	0
B3) Extent	0	Total Risk Score	0
TOTAL	0		
Recommendations		No further action necessary	
Comments		Marked Gypsum plasterboard to floor

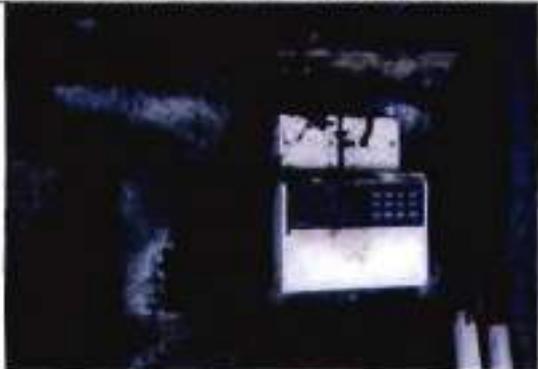
Sample No – No sample taken		DESCRIPTION: Item 14 – Barn 2 electrics on wall	
Location	Barn 2

Floor	Ground		
Area	Electrics on wall		
Amount	N/A		
Access	N/A		
Component	N/A		
Exposure	N/A		
Friability	N/A		
MATERIAL ASSESSMENT (A)			
A1) Product type	N/A		0
A2) Extent of Damage or deterioration	N/A		0
A3) Surface Treatment	N/A		0
A4) Asbestos type	No asbestos suspected		0
TOTAL			0
PRIORITY ASSESSMENT (B)		Summary	
Likelihood of disturbance		Material Assessment (A)	0
B1) Location	0	+	
B2) Accessibility	0	Priority Assessment (B)	0
B3) Extent	0	Total Risk Score	0
TOTAL	0		
Recommendations		No further action necessary	
Comments		Modern electrics

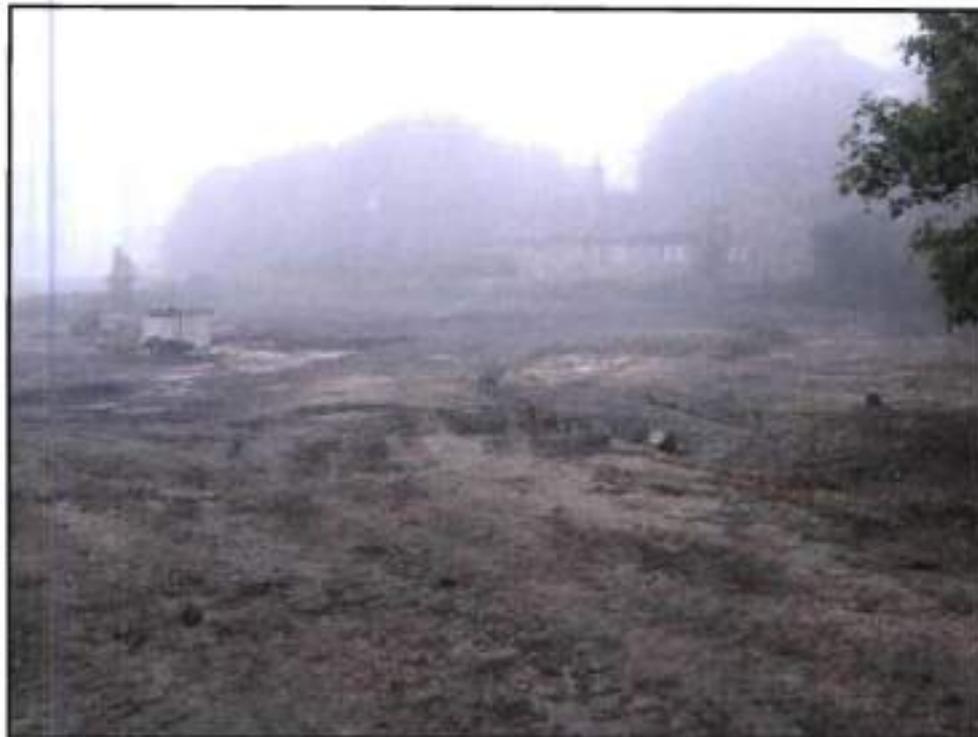
Photograph 1 View looking west from site entrance showing proposed driveway (slightly raised area) and areas where surface soils have been removed

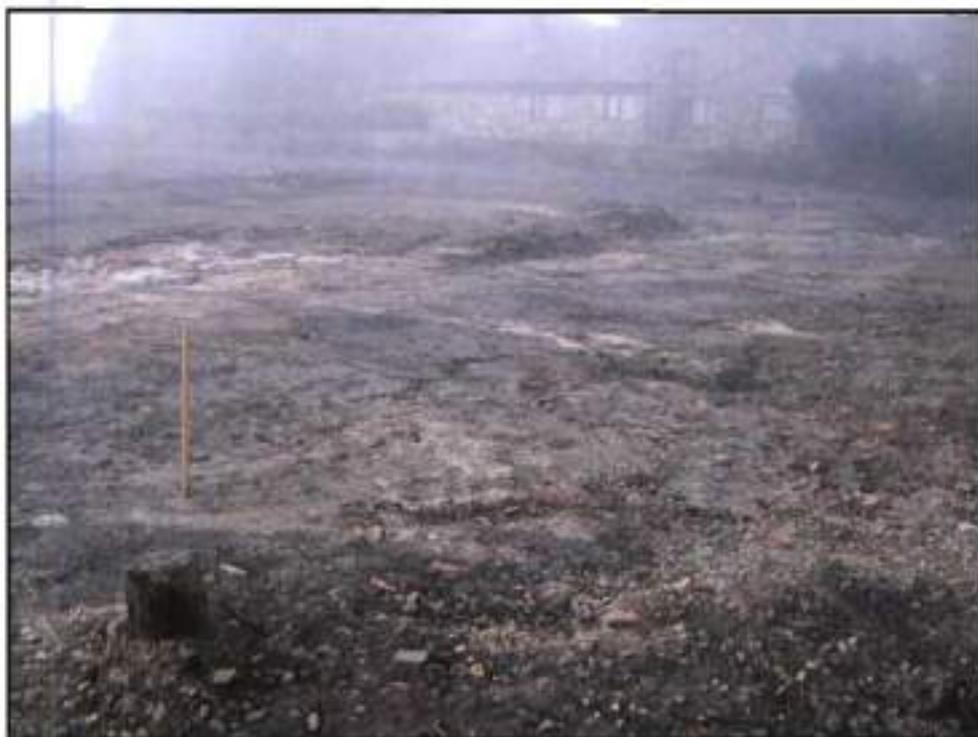
Photograph 2 View across the western end of the site showing validation sampling marker pegs and proposed driveway (slightly raised area centre)

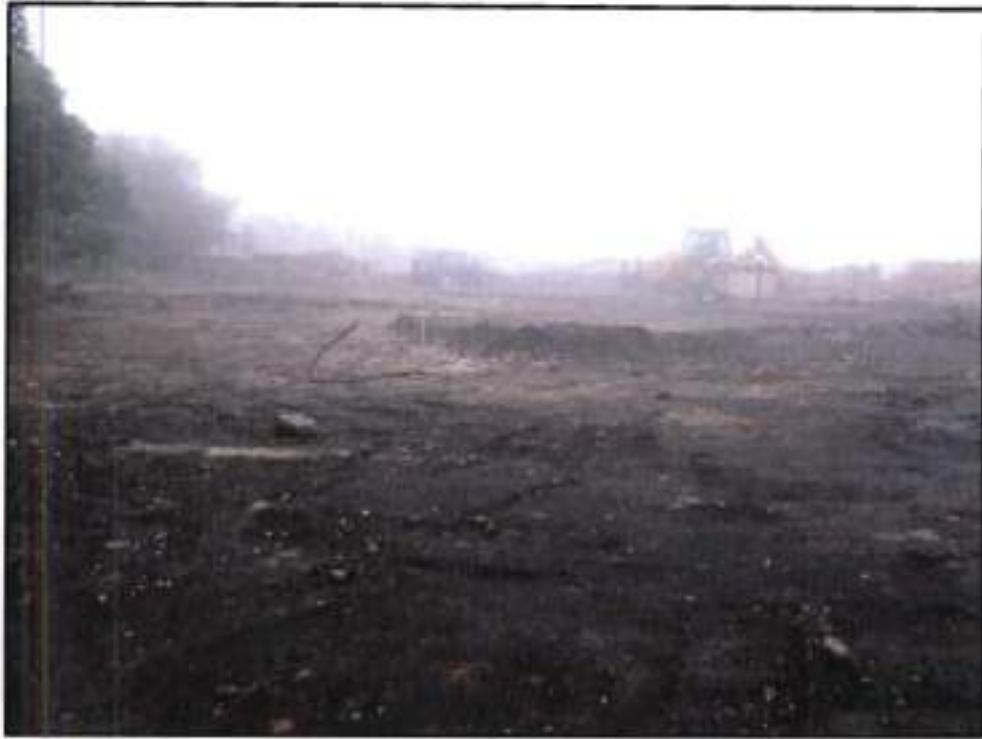
Photograph 3 View across the northern part of the site looking east showing termination of proposed driveway where surface soils have not been removed

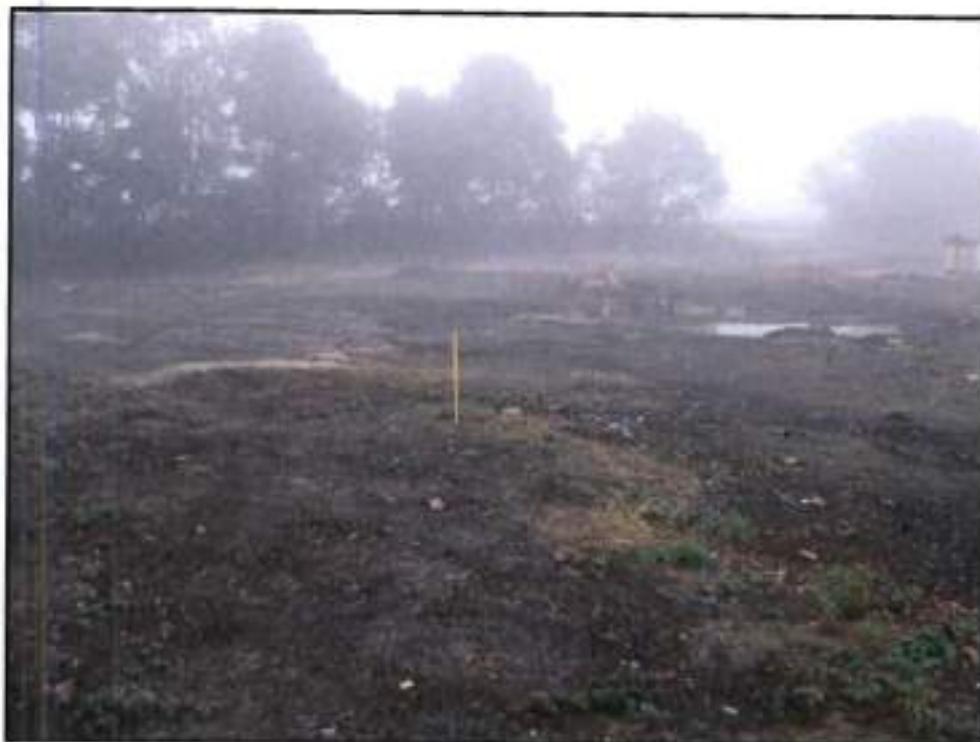
Photograph 5 View across the northern part of the site looking north. The surface water (centre right) relates to deeper excavations to remove localised TPHs

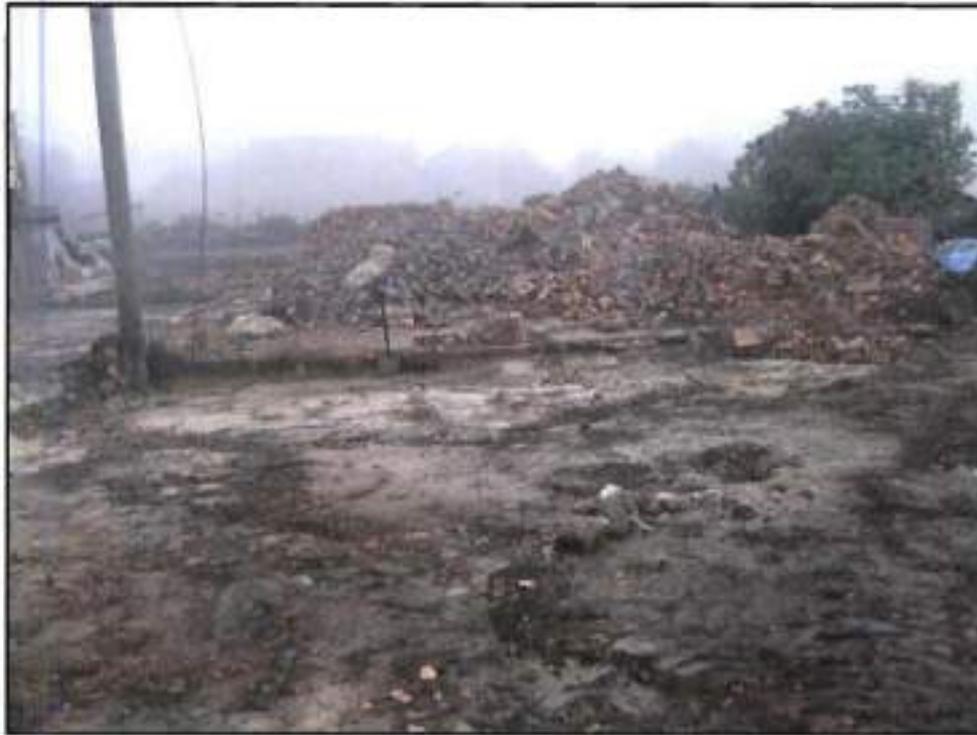
Photograph 7 Former location of TP1 near the western elevation of the demolished brick barn where surface soils have been removed to a depth of 0.6m

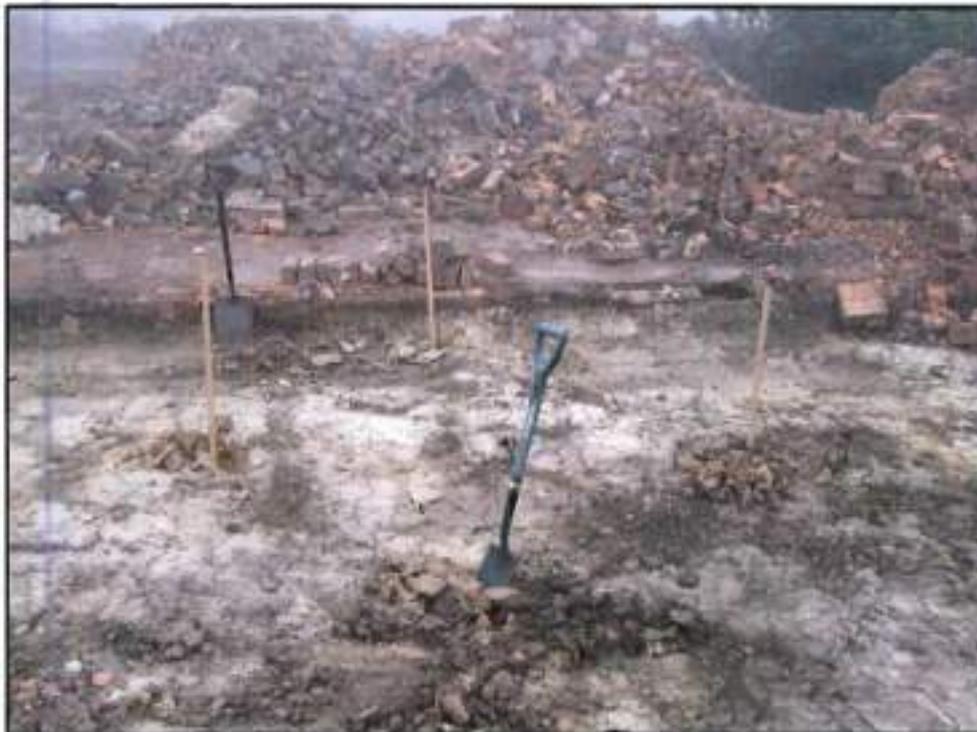
Photograph 8 TP1 validation sampling points (TP1-Vnorth (left), TP1-Vsouth (right), TP1-Vwest (spade foreground) and TP1-Veast (brick foundation))

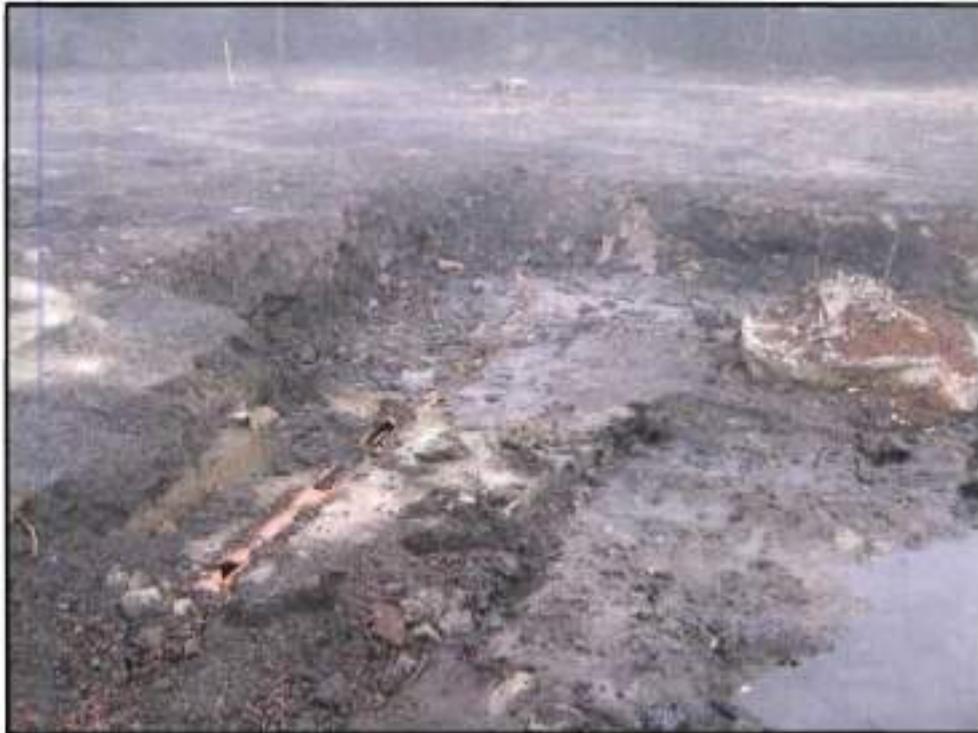
Photograph 9 Excavation at TP3 (top centre) to 0.75m which was extended to remove some visible petroleum hydrocarbon contamination (the concrete block denotes the north western corner of the former large shed)

During the over-digging at TP3 some slight visual and olfactory evidence of petroleum hydrocarbon contamination was noted and therefore the excavation area at this location was widened to enable the affected soils to be chased out both vertically and horizontally. The petroleum hydrocarbons may have been associated with the oil tank previously at this location (now removed to R & B Schofield yard) or from another unknown source associated with the former use of the site as a depot.

The excavation at TP3 covered an approximate area of 45m² and extended to depths of at least 0.75m and into the subsoil clay where groundwater accumulated. Approximately 33m³ of soils was removed for appropriate offsite disposal from this location. No visual or olfactory evidence of petroleum hydrocarbon contamination was noted within the water at the time of the inspection by AC Environment Solutions on 1st October. A close examination of the soils exposed around the edge and sidewalls of the excavation was also undertaken at several locations and no visual or olfactory evidence of petroleum hydrocarbon contamination was identified. On this basis and since this excavated area is located beneath the proposed footprint to one of the dwellings which are also to be provided with a radon barrier membrane (which will be specified and fitted in accordance with the appropriate standards), soil sampling for validation testing was not considered necessary.

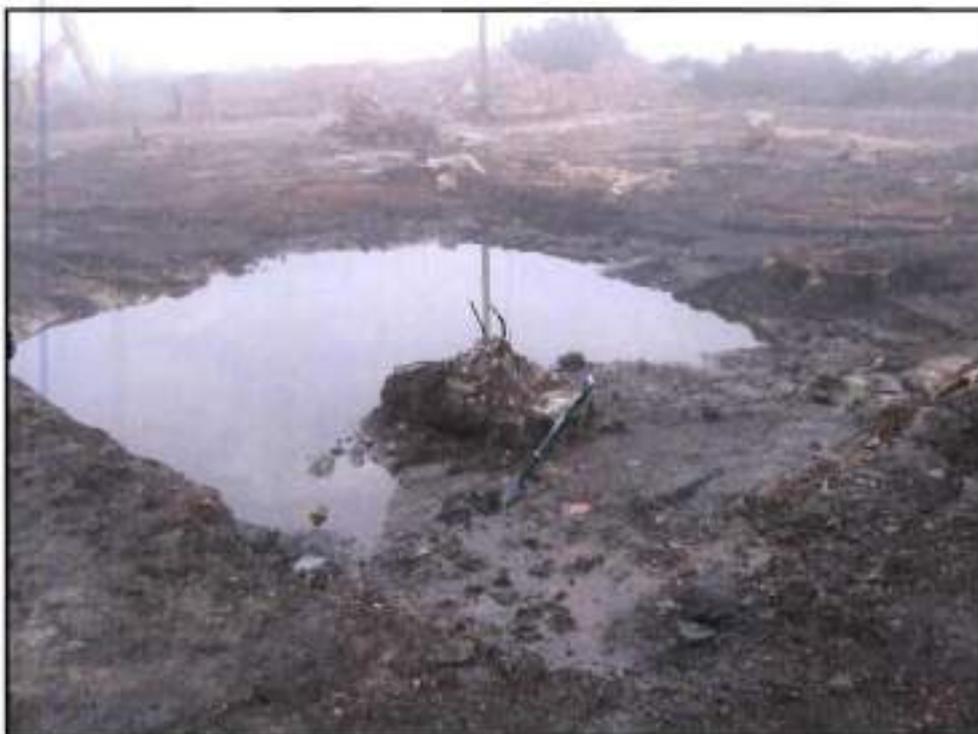
Photograph 10 Former location of TP3 (bottom centre) and extent of excavation to remove visible petroleum hydrocarbons that are no longer apparent

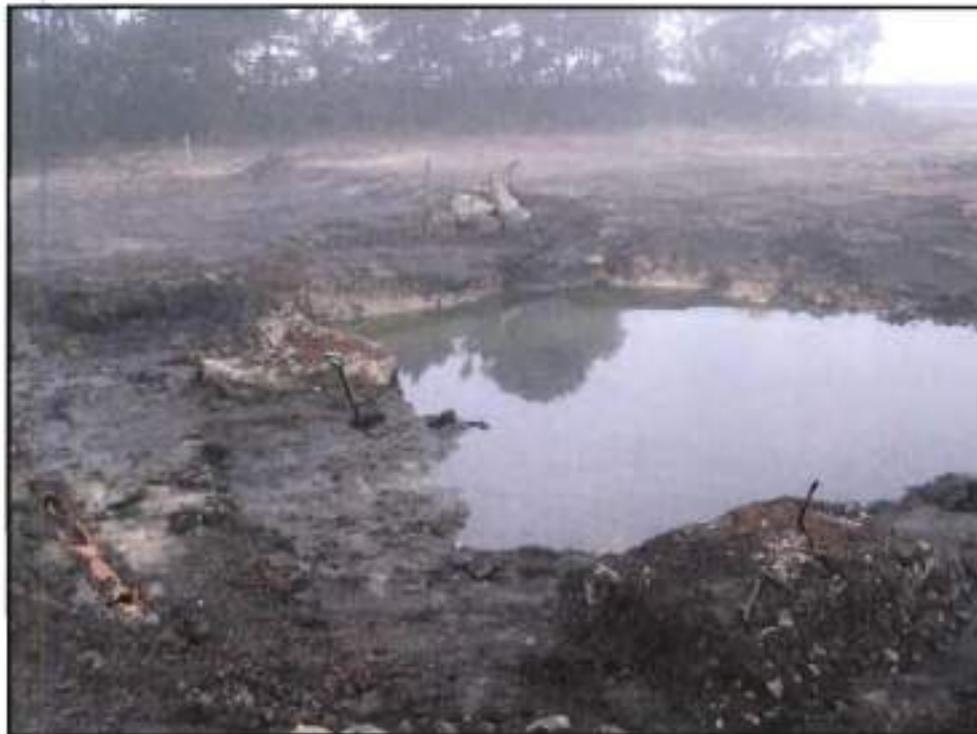
Photograph 11 Widened excavation from TP3 extending beneath location of proposed building footprint, looking north

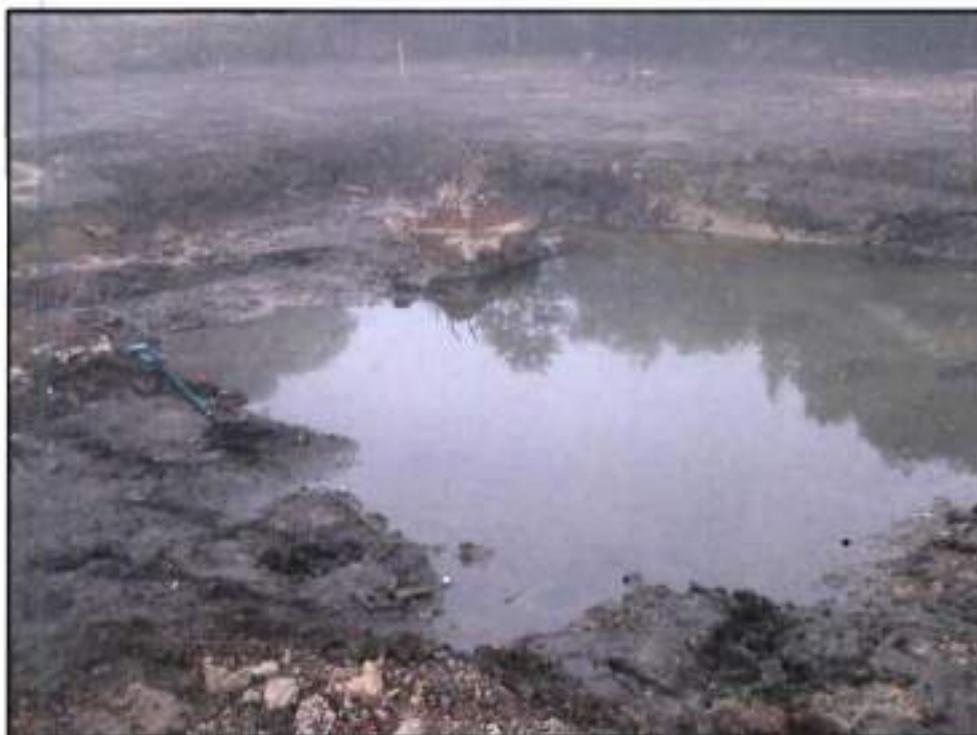
Photograph 12 Extent of excavation to remove visible petroleum hydrocarbons where a detailed inspection was conducted of exposed soils

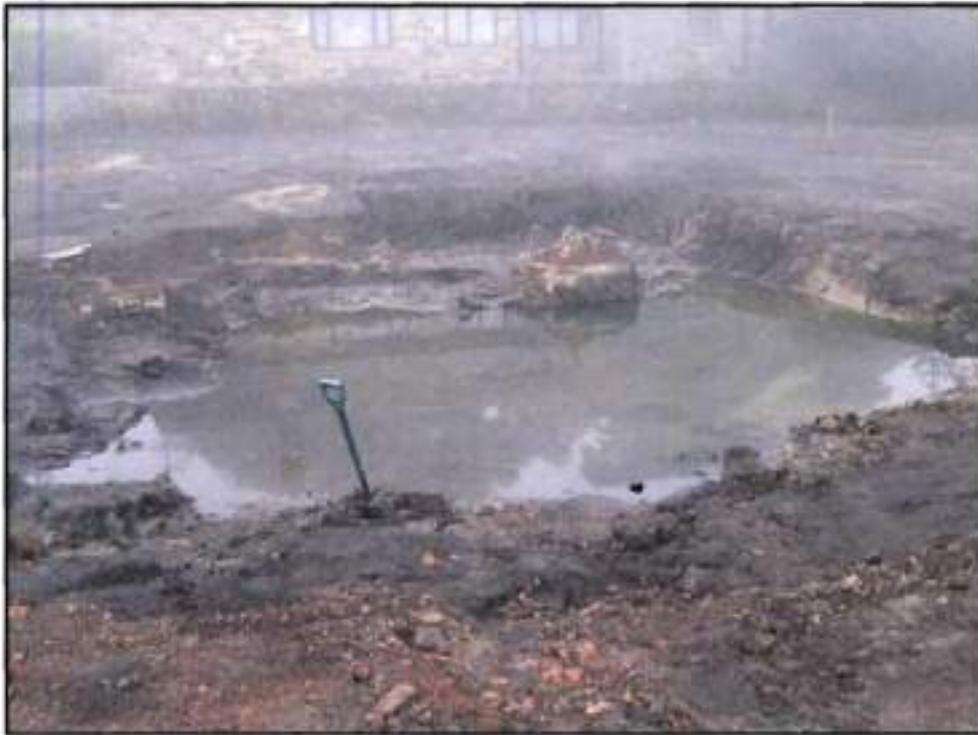
Photograph 13 Extent of excavation extending from TP3 to remove petroleum hydrocarbons that are no longer apparent

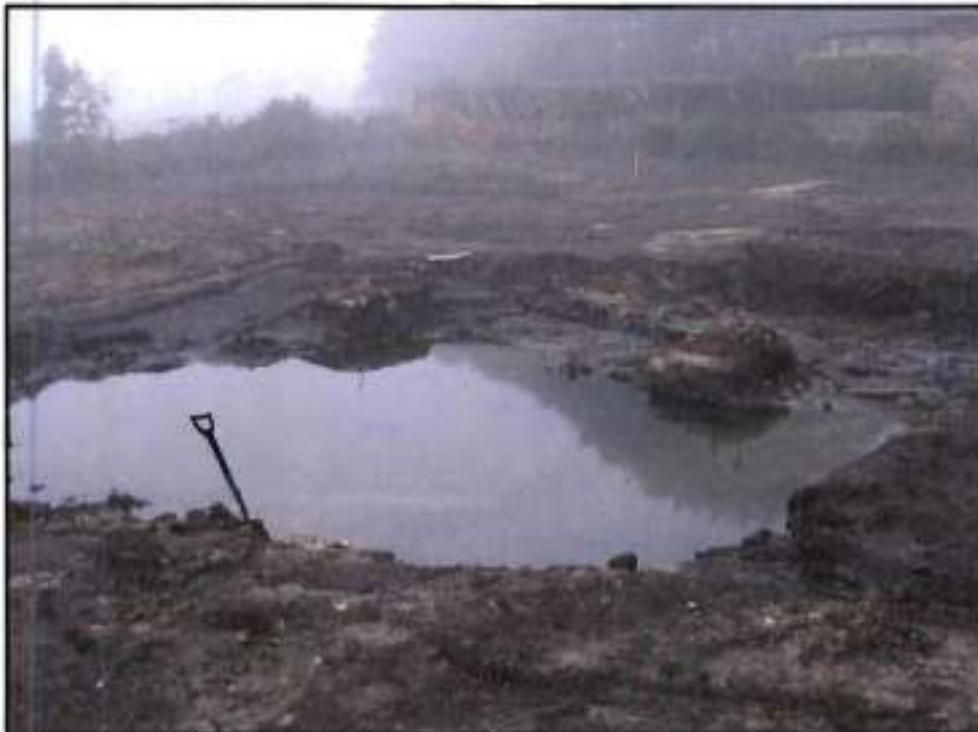
Photograph 14 Extent of excavation extending from TP3 to remove petroleum hydrocarbons that are no longer apparent

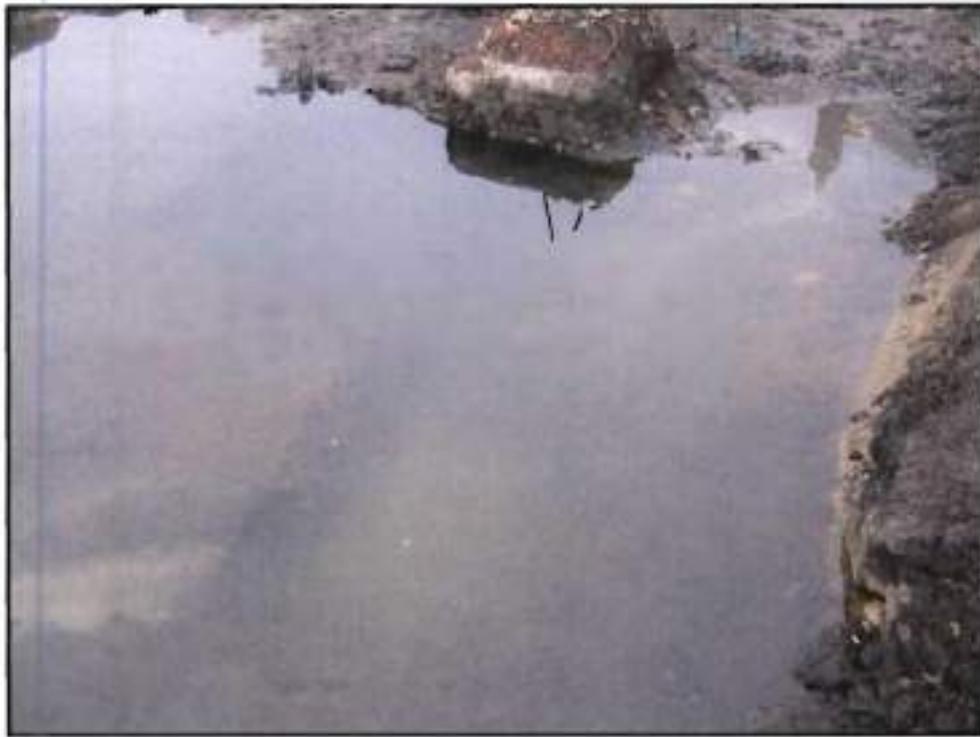
Photograph 15 Deepened section of the excavation into underlying clay (beneath water level) to remove visible petroleum hydrocarbons no longer apparent

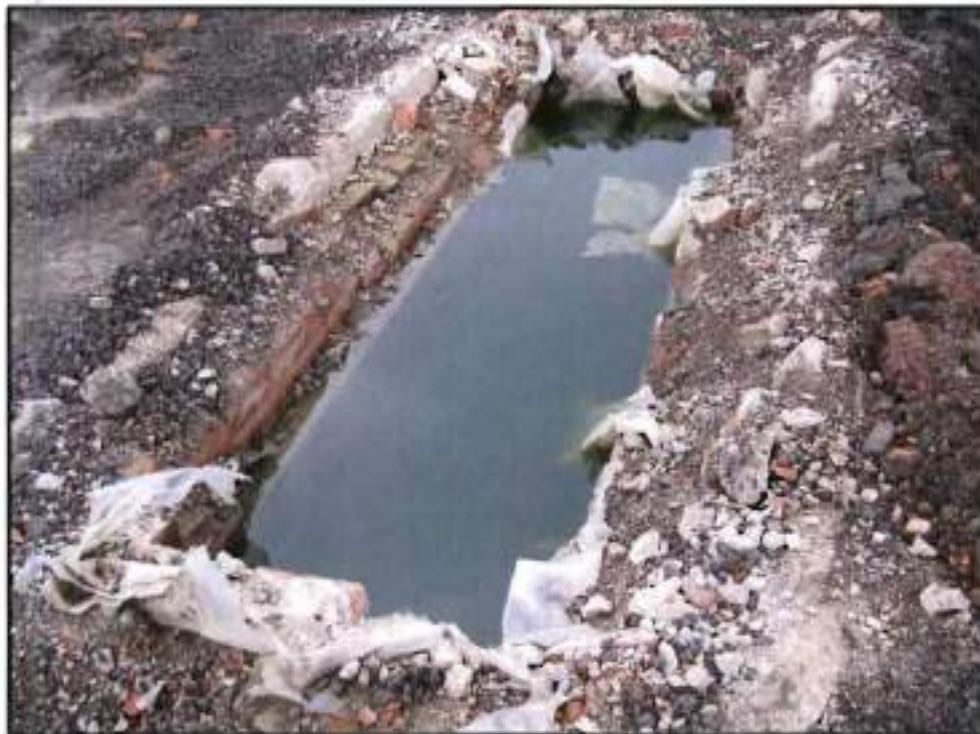
Photograph 16 Accumulation of rainwater within the vehicle inspection pit, in which there has been no visible petroleum hydrocarbons present

A further inspection undertaken on 1st October 2015 revealed rain had increased the depth of water within the pit which has continued to show no visual or olfactory evidence of hydrocarbon contamination (see photo 16 in Attachment 3). On this basis, prior to backfilling of the pit with suitable site won construction fill which will be compacted in layers and capped with concrete to prevent further water ingress, the pit water will be pumped to ground rather than being removed by gully sucking vehicle as originally proposed.

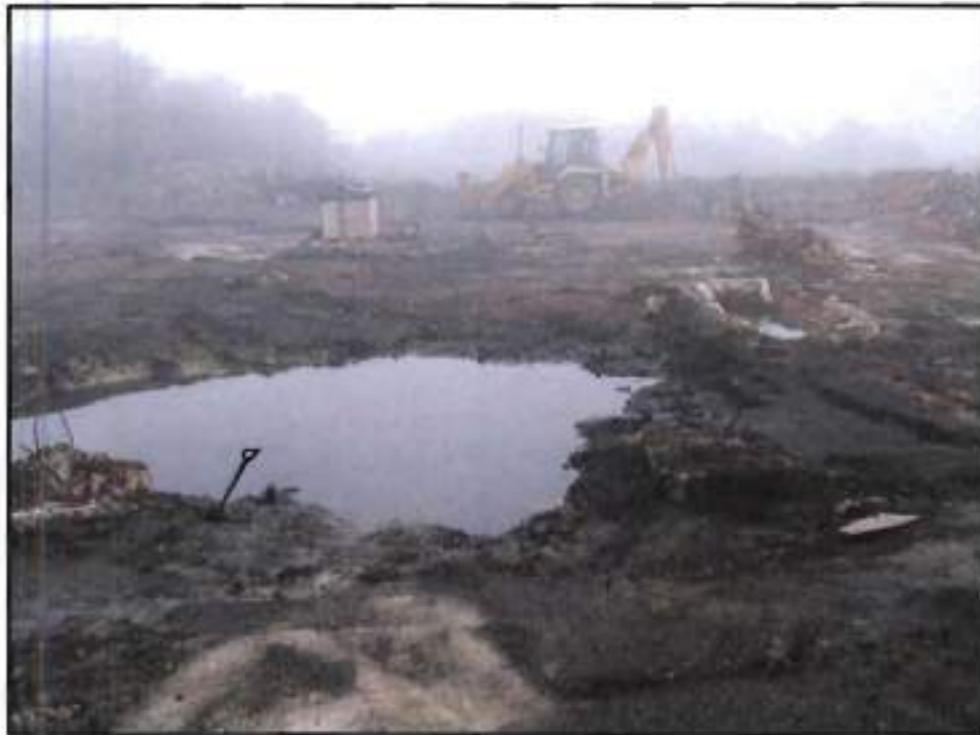
Photograph 17 Location of vehicle inspection pit (centre right) in relation to extended TP3 excavation

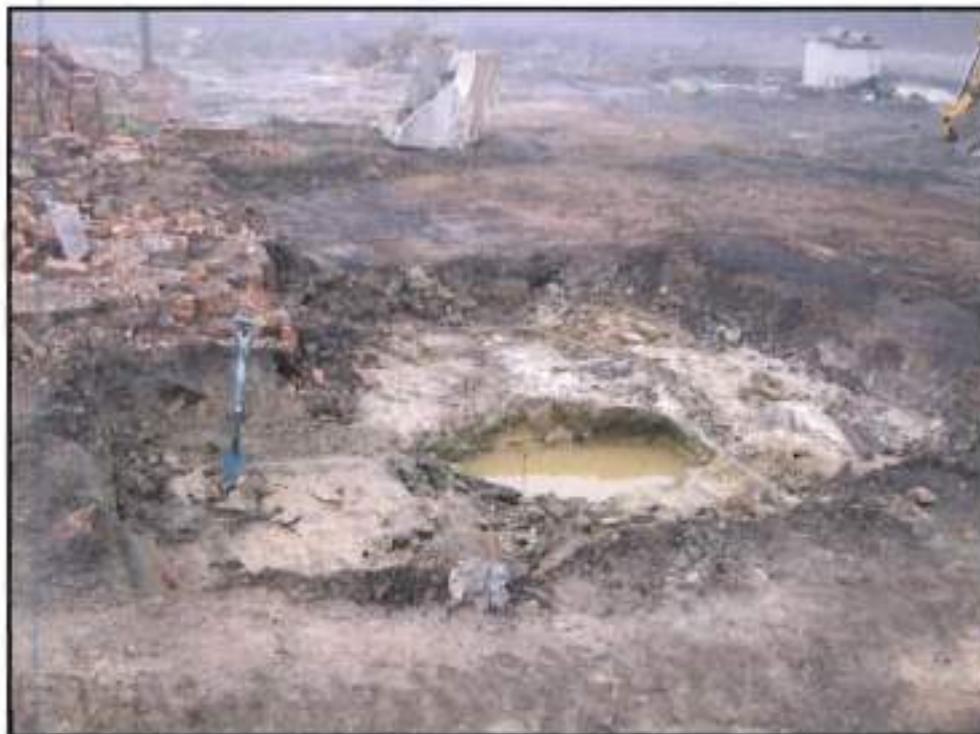
Photograph 18 Location of TP6 (centre) adjoining NE corner of demolished brick barn where full depth of trial pit (1.6m) was removed and surrounding soils to 0.6m

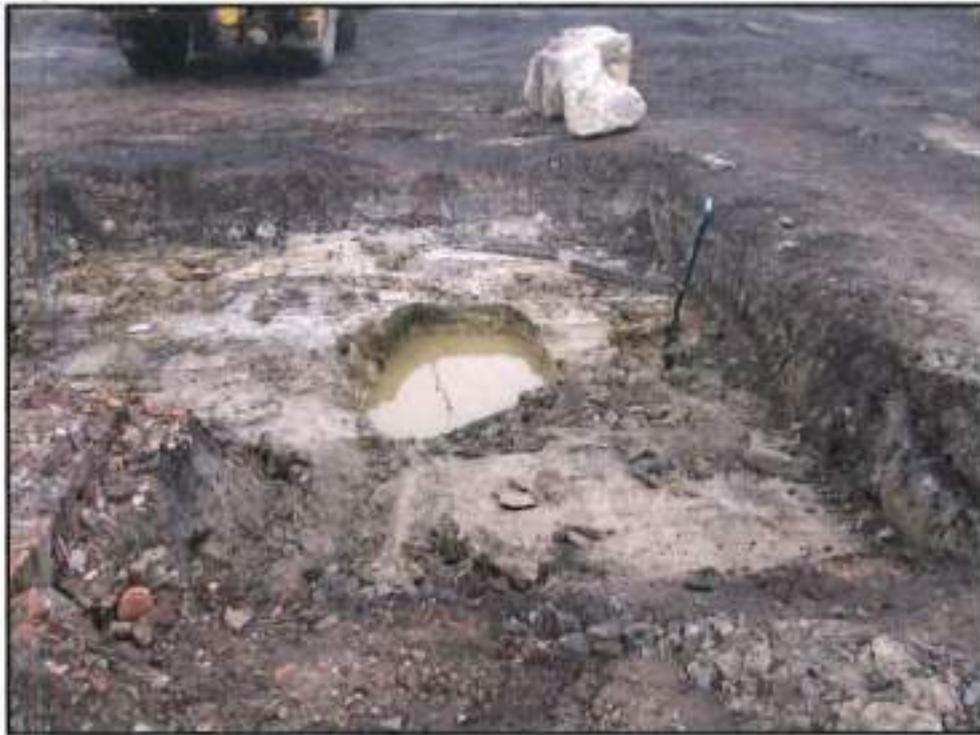
Photograph 19 Extent of excavations around TP6 looking north, where a detailed inspection of exposed soils was undertaken

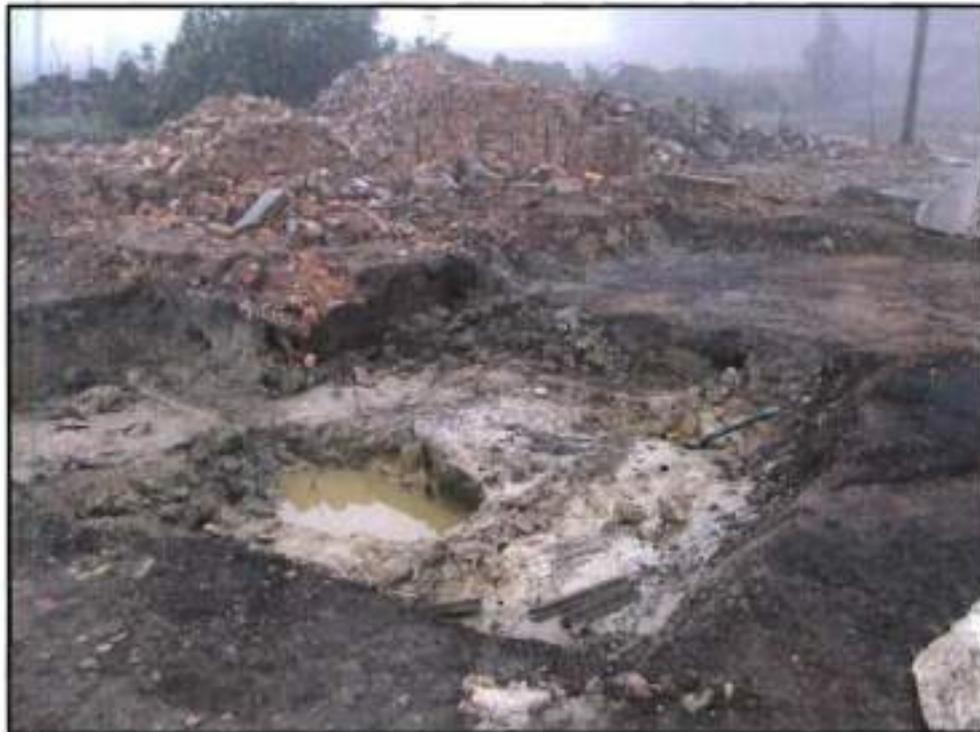
Photograph 20 Extent of excavations at TP6 looking south west. Slight hydrocarbon odours were found to remain at the far (western) end of the excavation beneath the suspected location of a former second tank

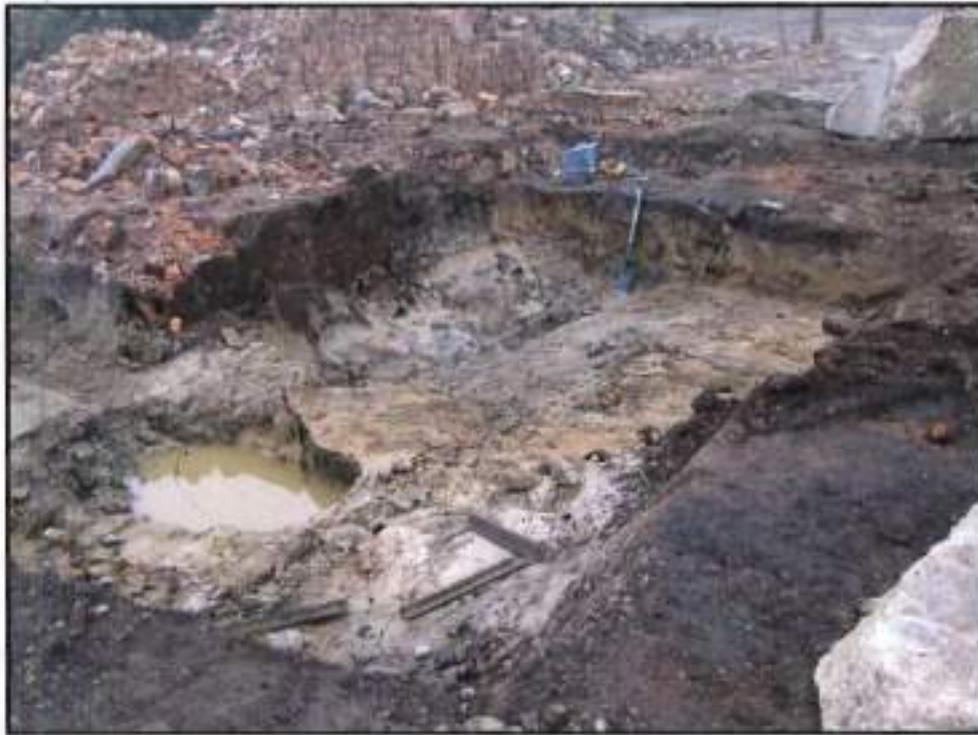
Photograph 21 Extended excavation at TP6 to remove residual petroleum hydrocarbons which appeared more odourous within soils above the line of a buried field drain (extending from spade)

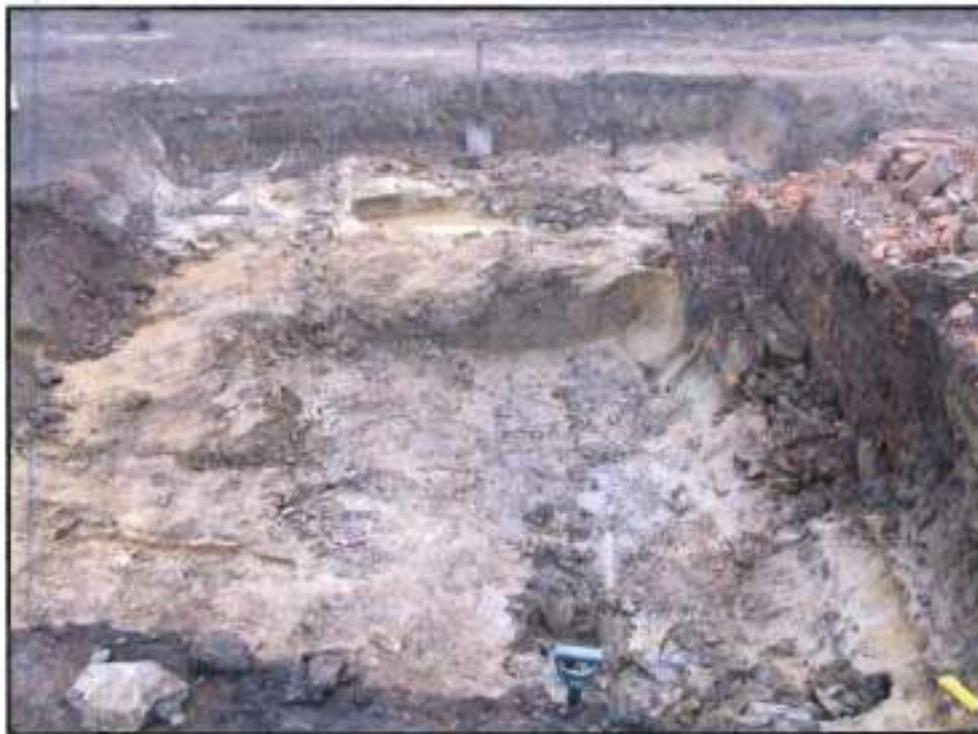
Photograph 22 Extended excavation at TP6 (beneath proposed building footprint) upon completion to a maximum depth of 1.15m below barn floor, looking east
