Our Ref: AC00100/JaggerLaneEmley/LS/NP-01

Date: 5 June 2015

Land Adjoining 23 Jagger Lane, Emley Moor, Huddersfield, HD8 9SY
Planning Refs: 2012/62/90390/E & 2015/44/90287/E
Supplemental Contamination Investigation for Development of 2 No. Detached Dwellings

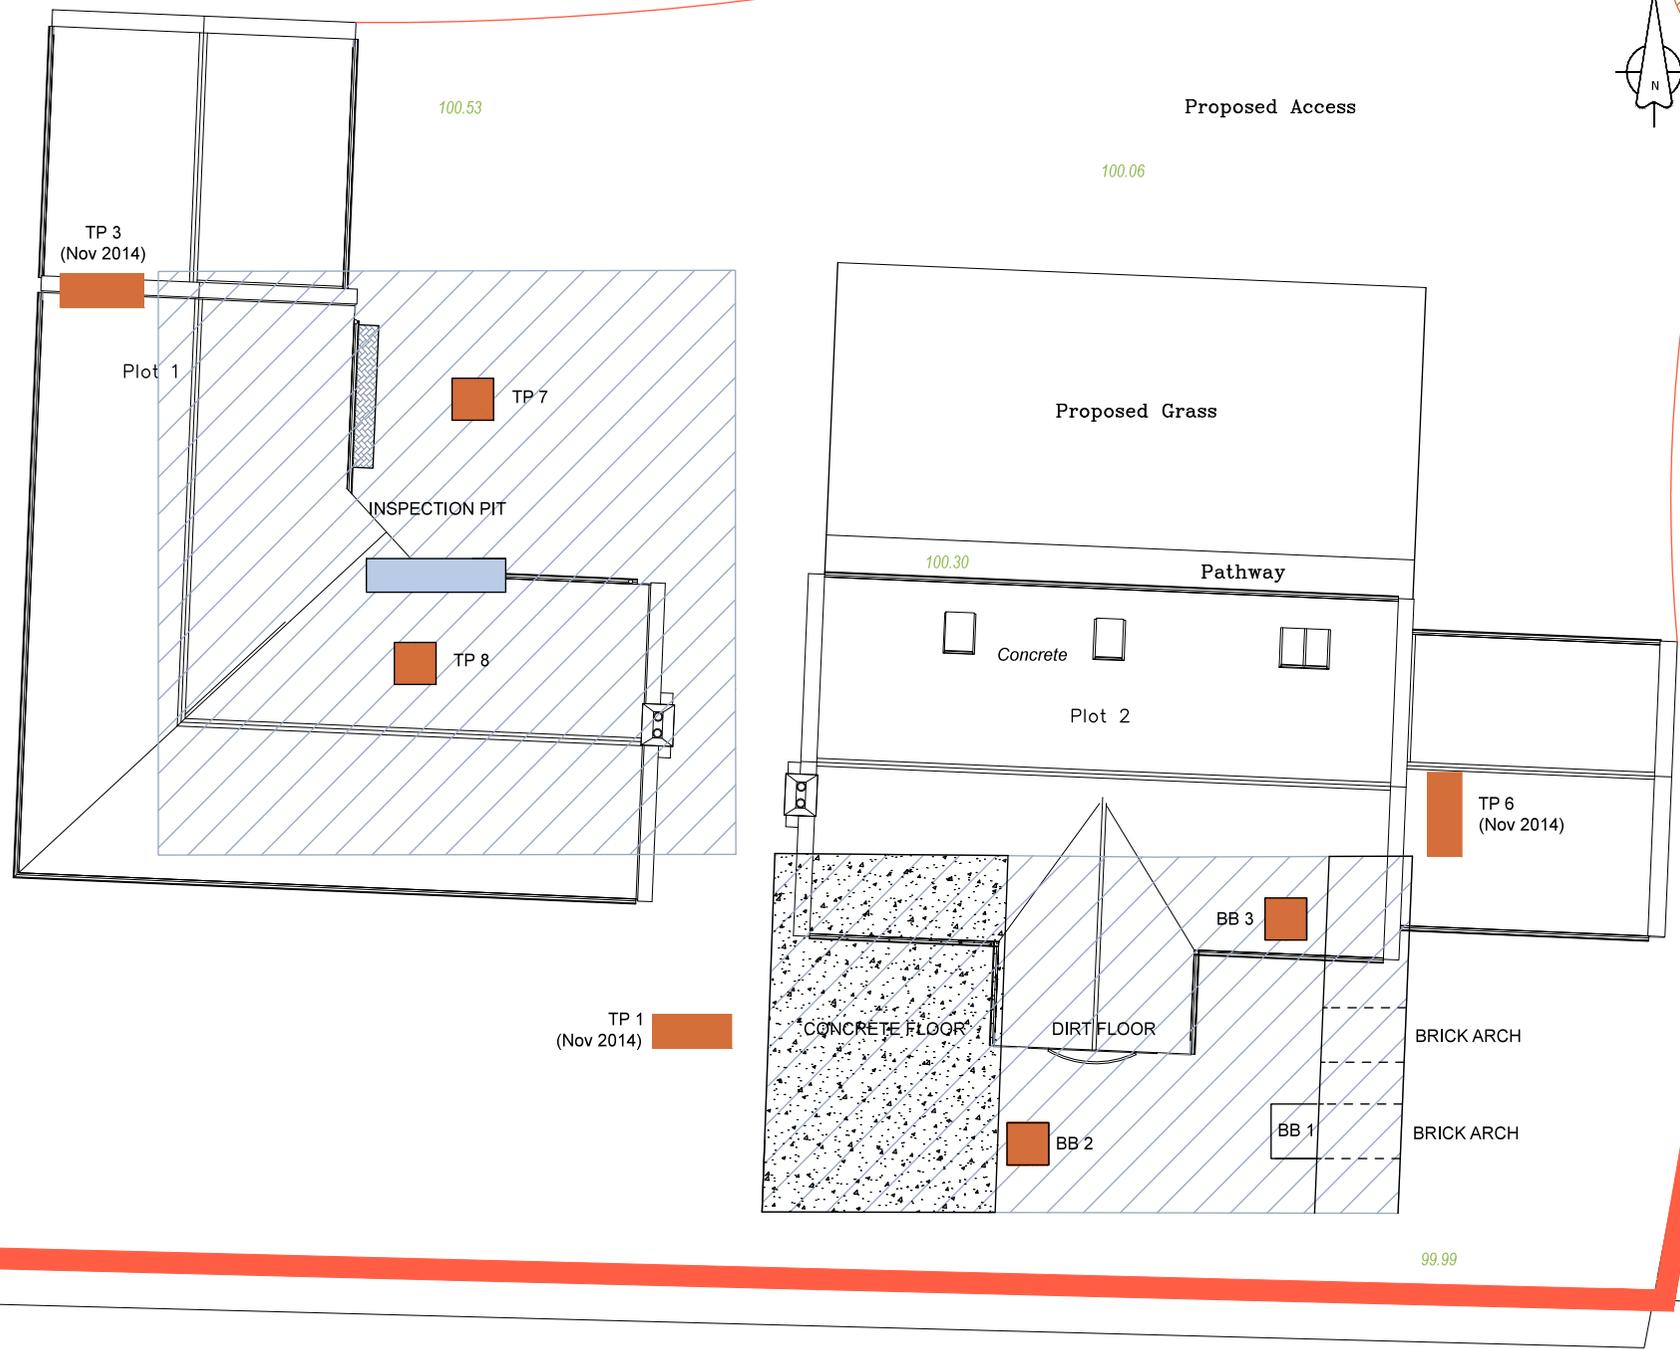
Attachment 1
Trial Pit Location Plan

- The excavation of 3 shallow trial pits by mini-digger across the dirt floor of the brick barn building to depths of between 0.50 and 0.95 metre at the locations (BB1-BB3) shown on the plan presented as Attachment 1;
- The collection of 1 soil sample from each pit (3 samples in total);
- Site supervision and recording by a Chartered Environmental Surveyor.

The trial pit locations are identified on the plan presented as Attachment 1 and a photographic record of the investigation is presented as Attachment 2.

Drawing Title:
 Trial Pit Locations

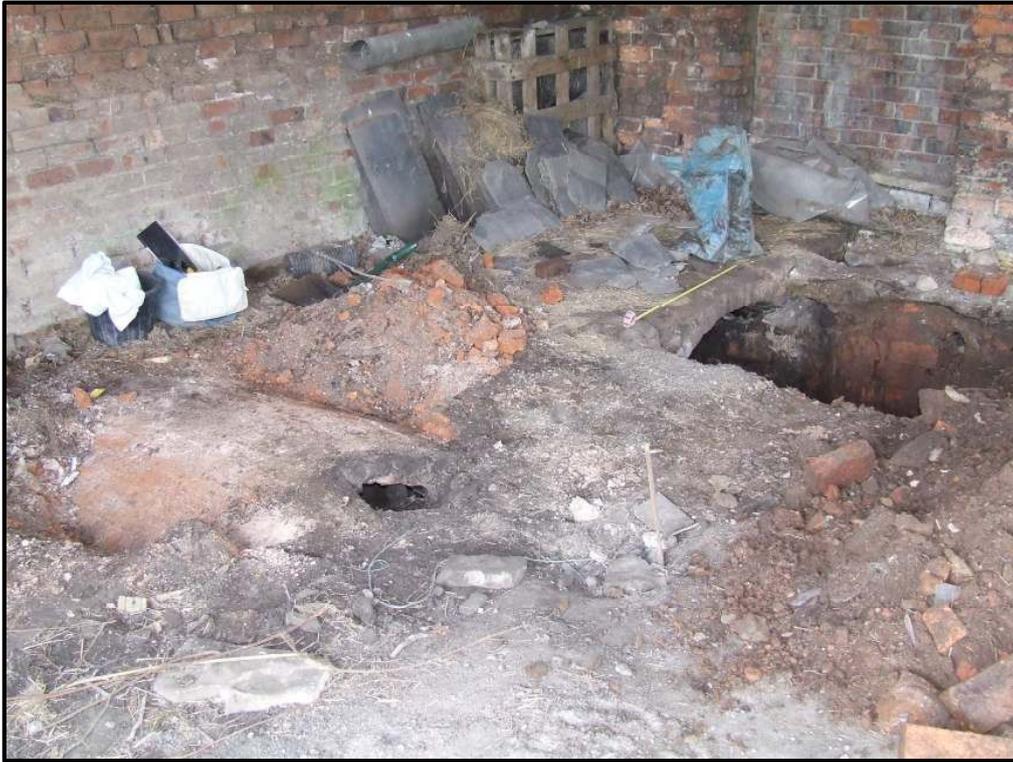
BB1 was excavated into the soils adjoining and extending into a brick arch structure that had been identified at ground level within the south eastern corner of the building during the previous investigation. The excavation exposed a brick lined pit measuring 1.7m² and 0.85 metre deep in front of the arch which was provided with a brick floor. A composite sample from the soils excavated from this location was taken for analysis.

Excavation of the surface soils by hand adjoining the exposed arch top identified a second similar arch structure and it is conceivable that at least one further arch also exists possibly making up a row of buried brick arch structures extending along the internal eastern elevation of the building.

It is possible that the arches formed part of the kilns associated with the former brickworks identified at this location in the 2012 Phase 1 Contamination Audit. Although whole orange coloured bricks and brick fragments were noted in the soils at BB1, no obvious evidence of burnt or scorched material was noted and no evidence of any former chimney to the brickworks has been identified. The size of the building and the period of occupancy of the brickworks within the second half of the 1800s (disused by 1893) suggests that this was a small works, possibly only established to supply the nearby Speedwell Colliery which had come into existence around the same time.

Photograph 1 Brick arches exposed beneath the floor at the eastern end of the brick barn (the tape extends to 1 metre for scale)

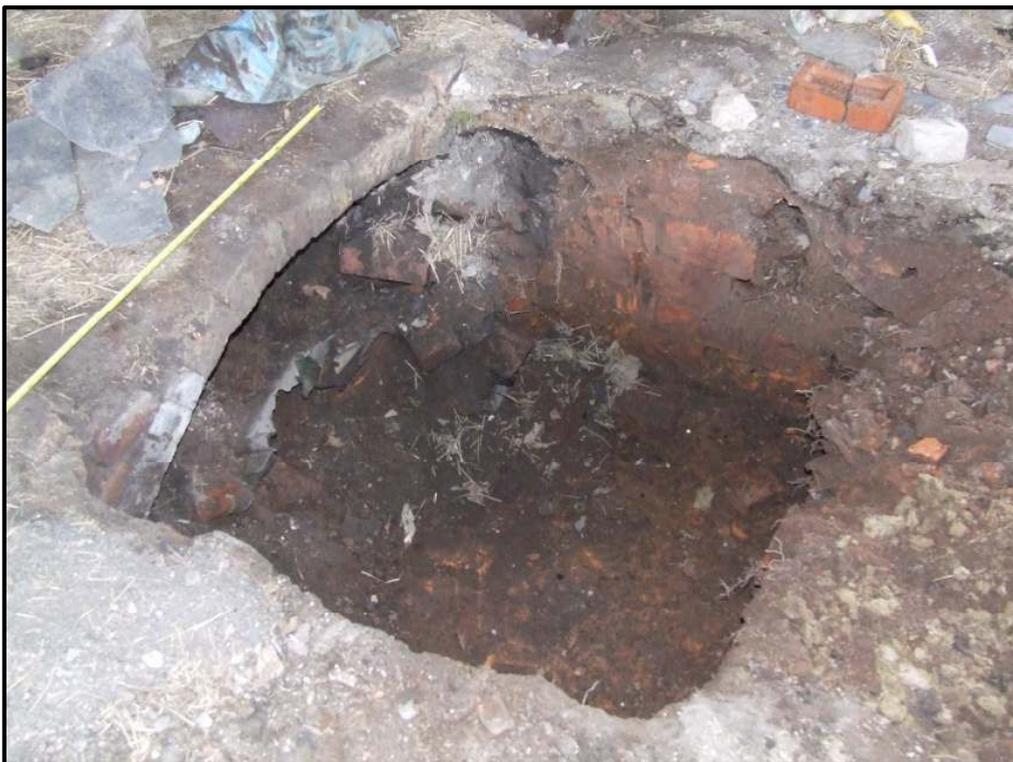
Photograph 2 Location of pit BB1 which exposed a small brick lined enclosure with brick floor extending from the soil filled brick arch

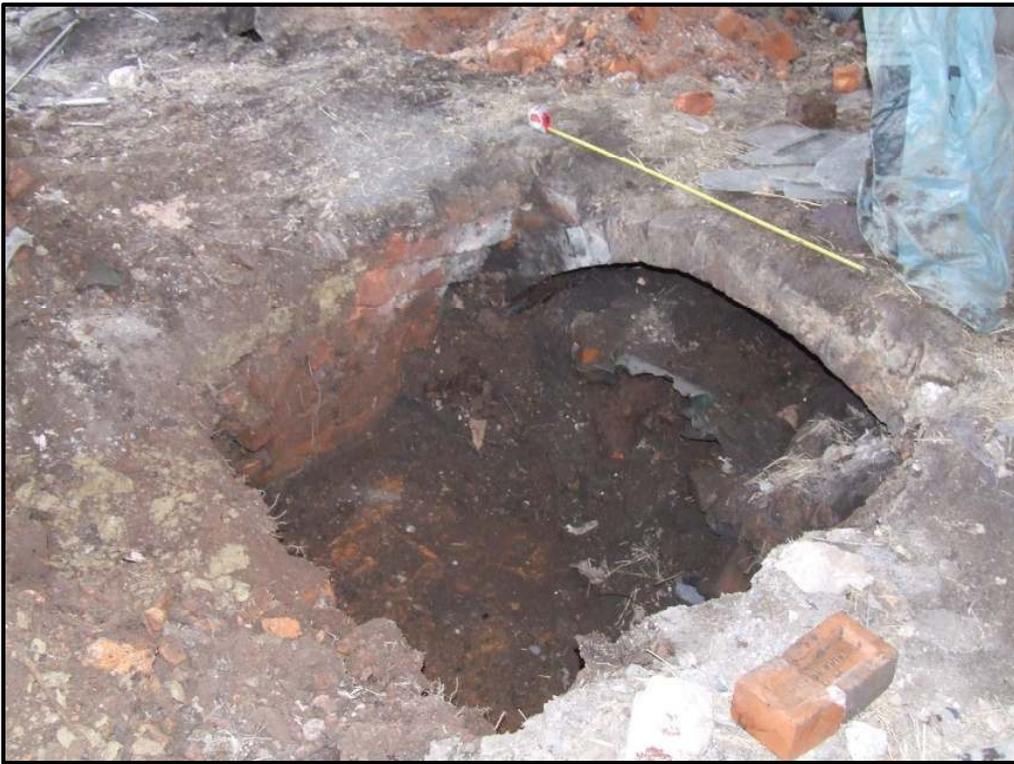
| Trial Pit | Depth (m) | Description | Sample Depth (m) |
|---|---|--|---|
| | 0.05 - 0.85 | Orange red brown sandy silty soil with occasional orange bricks and brick fragments, occasional fragments of roofing slate, linoleum, carpet underlay and blue polythene bag of concrete above brick floor (Made Ground) | |

Photograph 3 Location of BB1 (as described above). The soils incorporated some red brick, roofing slate, linoleum, carpet underlay and a blue polythene bag of concrete (top right)

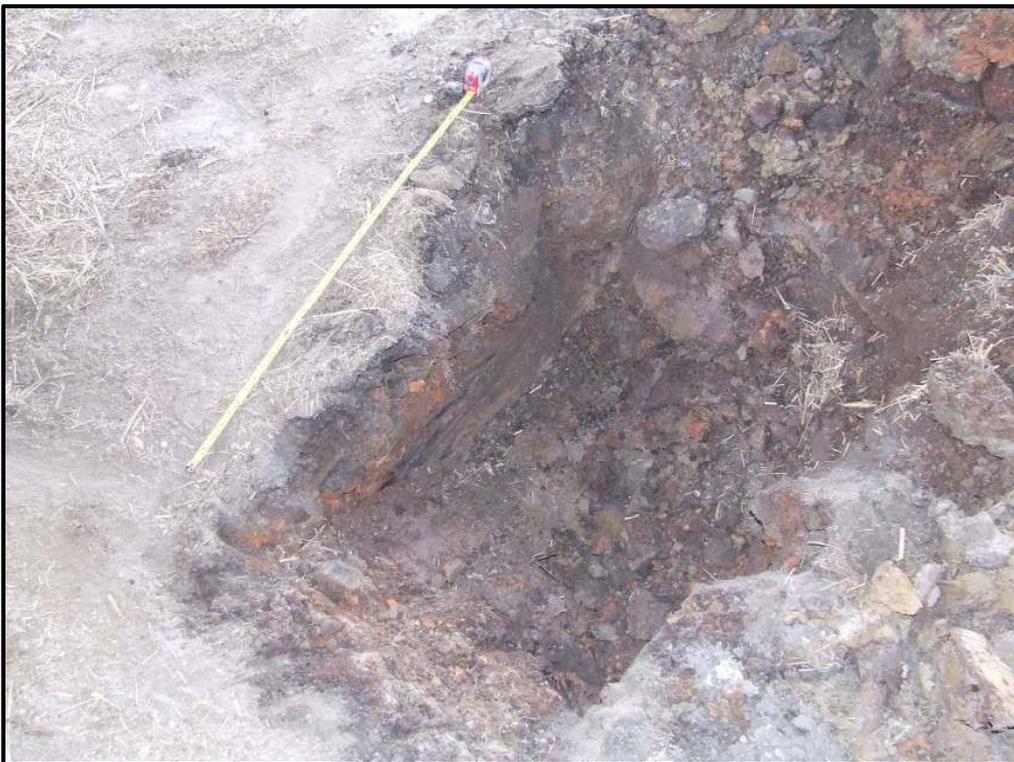
| Trial Pit | Depth (m) | Description | Sample Depth (m) |
|---|---|--|---|
| | 0.05 - 0.25 | Firm orange brown and grey clayey soils with occasional fine to coarse orange brick fragments (Made Ground). | |

Photograph 4 Trial hole BB2 excavated within the dirt floor of the brick barn (the tape extends to 1 metre for scale)

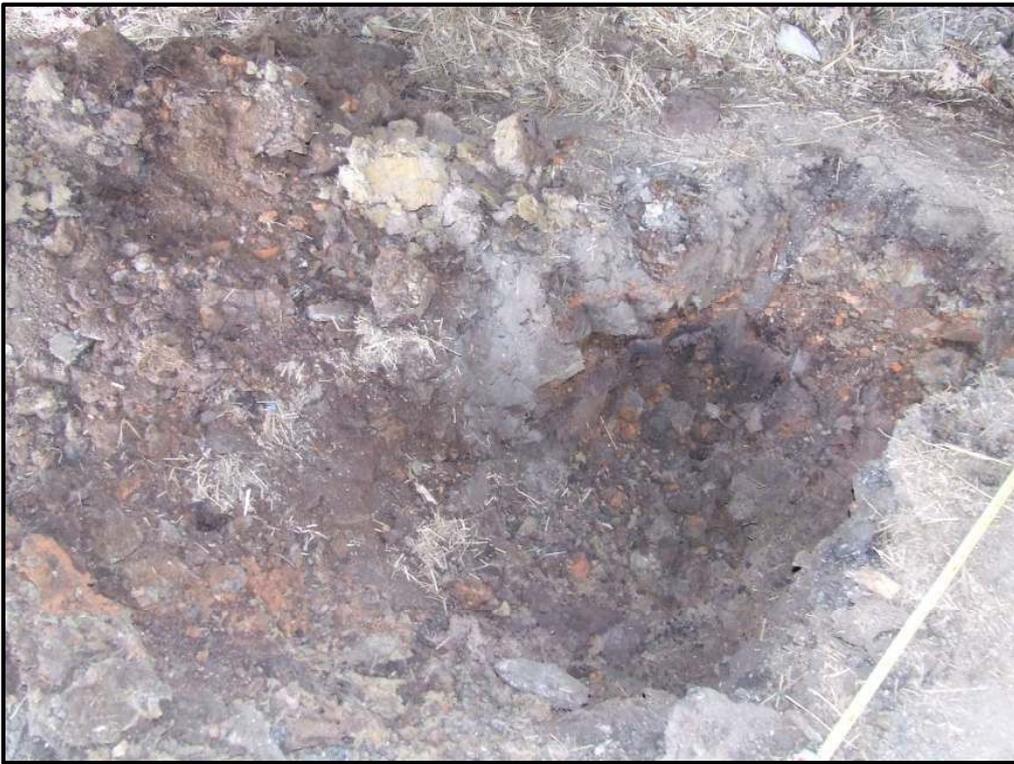
Photograph 5 BB2 and excavated soil arisings

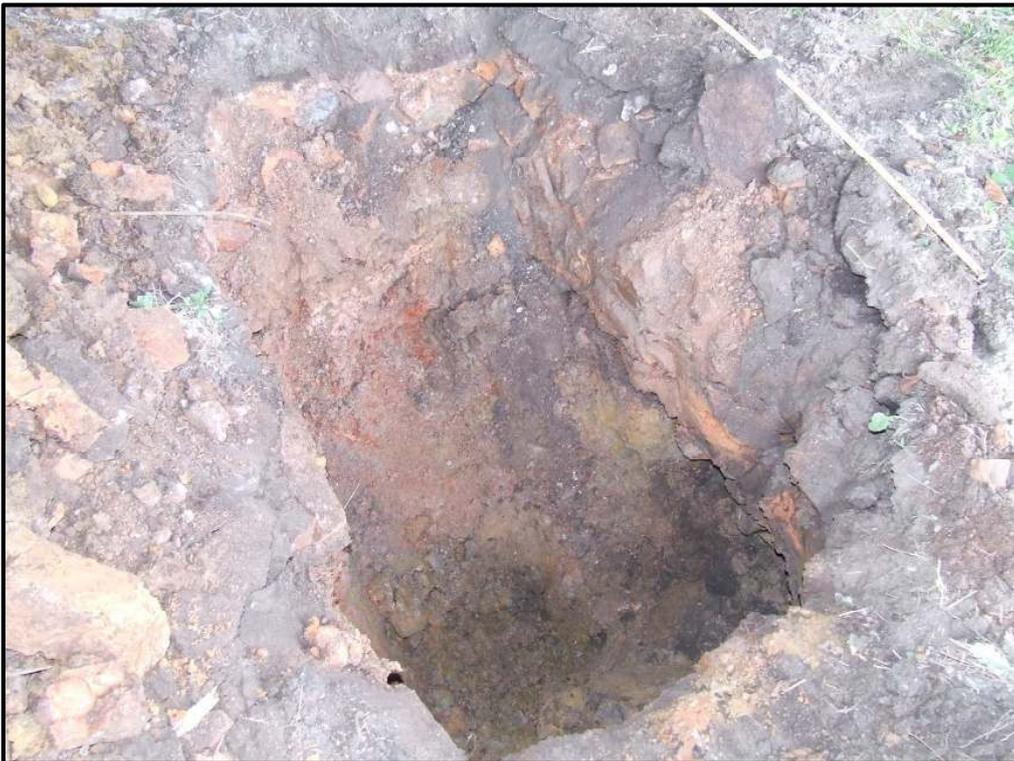
| Trial Pit | Depth (m) | Description | Sample Depth (m) |
|---|---|--|---|
| | 0.05 - 0.40 | Orange red brown sandy soil with orange brick rubble fill (Made Ground) | |

Photograph 6 BB3 excavated within the dirt floor of the brick barn

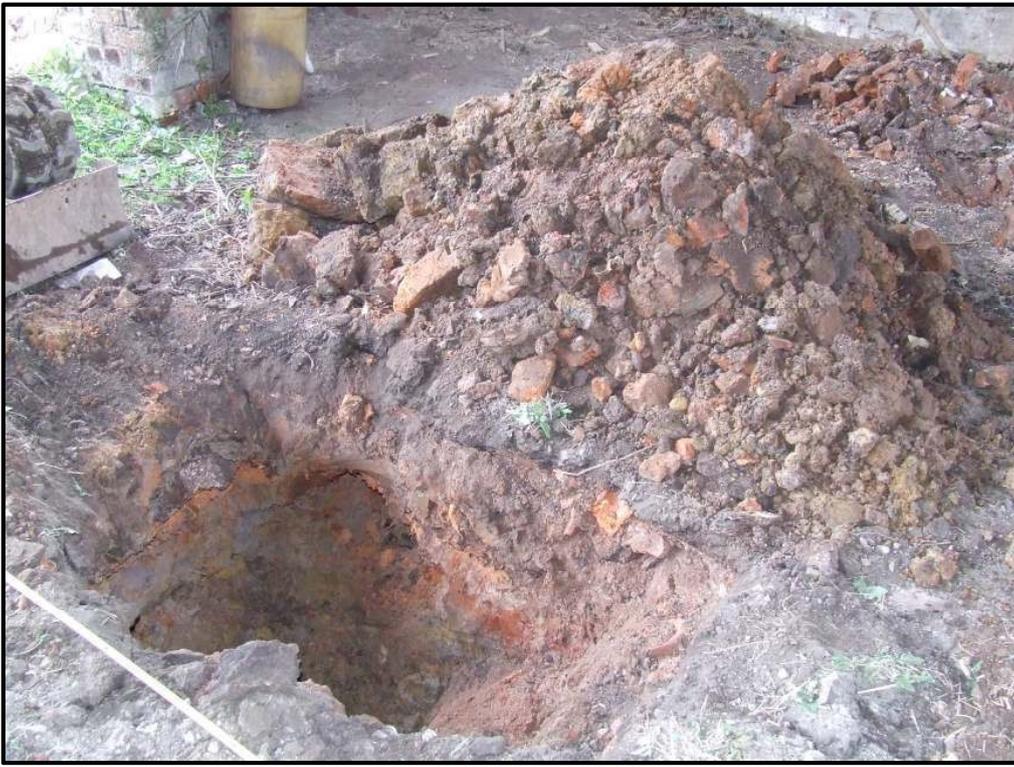
Photograph 7 BB3 and excavated soil arisings

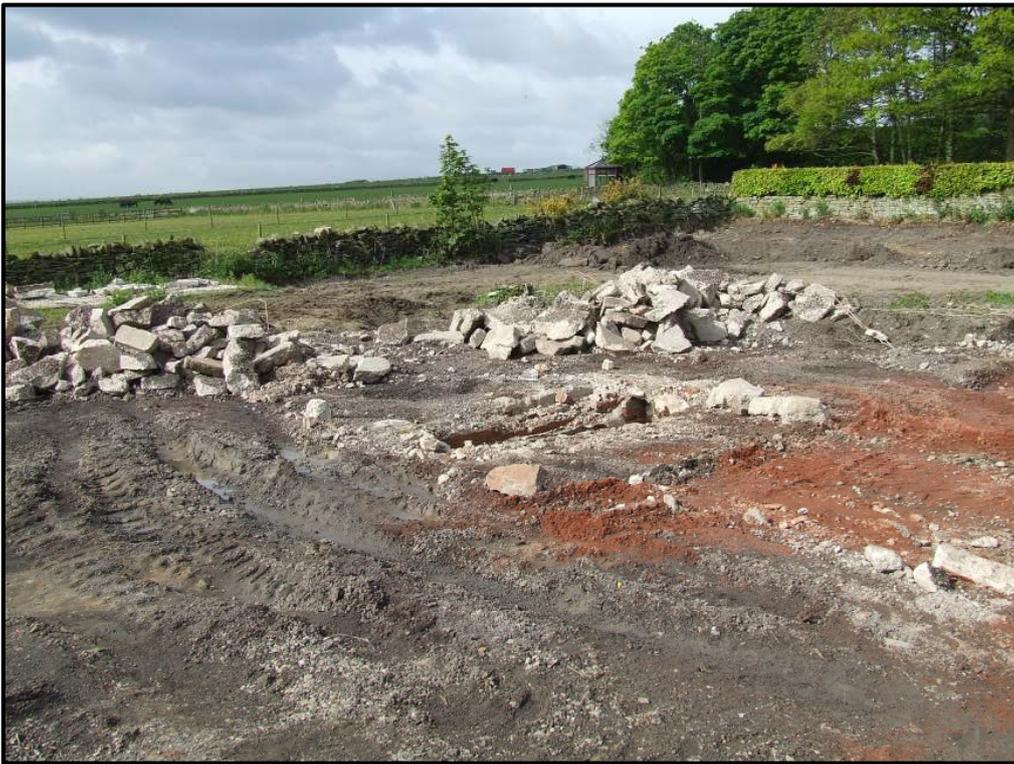
At the time of the investigation, the large concrete portal framed shed had been demolished and the concrete slab measuring 150-180mm thick had been removed to expose the underlying soils in which the vehicle inspection pit remained.

In accordance with item 3b. of the Remediation Statement an inspection of the ground surface beneath the floor slab was undertaken. Fill material was observed across the surface which included fragments of concrete and areas of a red sandy gravel and dark grey clinker gravel sub base, through which 2 shallow trial pits were excavated (TP7 and TP8). The thickness of fill was proven to depths of between 0.1 and 0.3 metre.

Photograph 8 Ground exposed beneath the floor slab of the demolished larger shed, looking south west and showing the location of the vehicle inspection pit (centre)

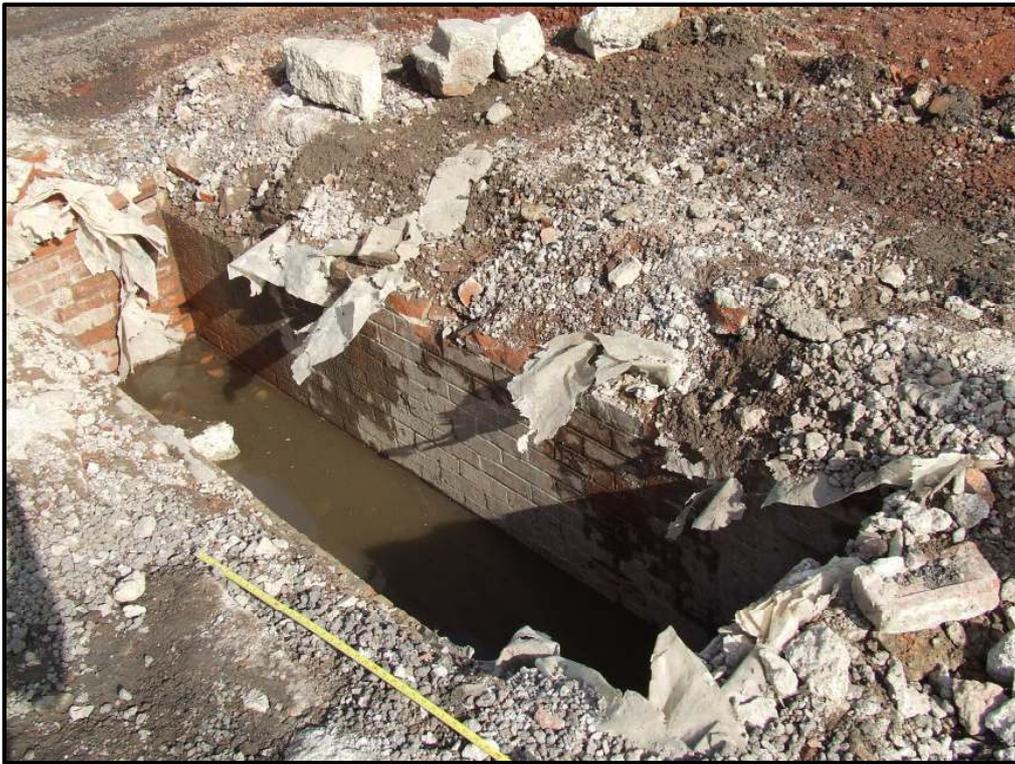
The vehicle inspection pit was observed to be of robust construction, with the sidewalls being lined with 3 leaves of brick with polythene between the first and second leaves and the external wall enclosed by reinforced concrete to a thickness of at least 150mm. Some water was observed within the pit in which no visual or olfactory evidence of hydrocarbon contamination was noted. Neither was any oil staining observed to the internal brickwork

Photograph 9 Vehicle inspection pit looking north west. The pit was lined with 3 leaves of brick with polythene between the first and second leaves and was encased with >150mm of reinforced concrete

The applicant is currently looking into a means of disposing of the inspection pit water (along with the contents of 2 old 205 litre metal drums) in accordance with item 3a. of the Remediation Statement. Following this, due to the robust construction of the inspection pit, its apparent clean condition and its location beneath the footprint of one of the proposed dwellings which is to be founded on a concrete floor slab, it is proposed to leave the inspection pit insitu and backfilled with a concrete slurry or suitable grade of engineering fill, such as site won crushed concrete or brick.

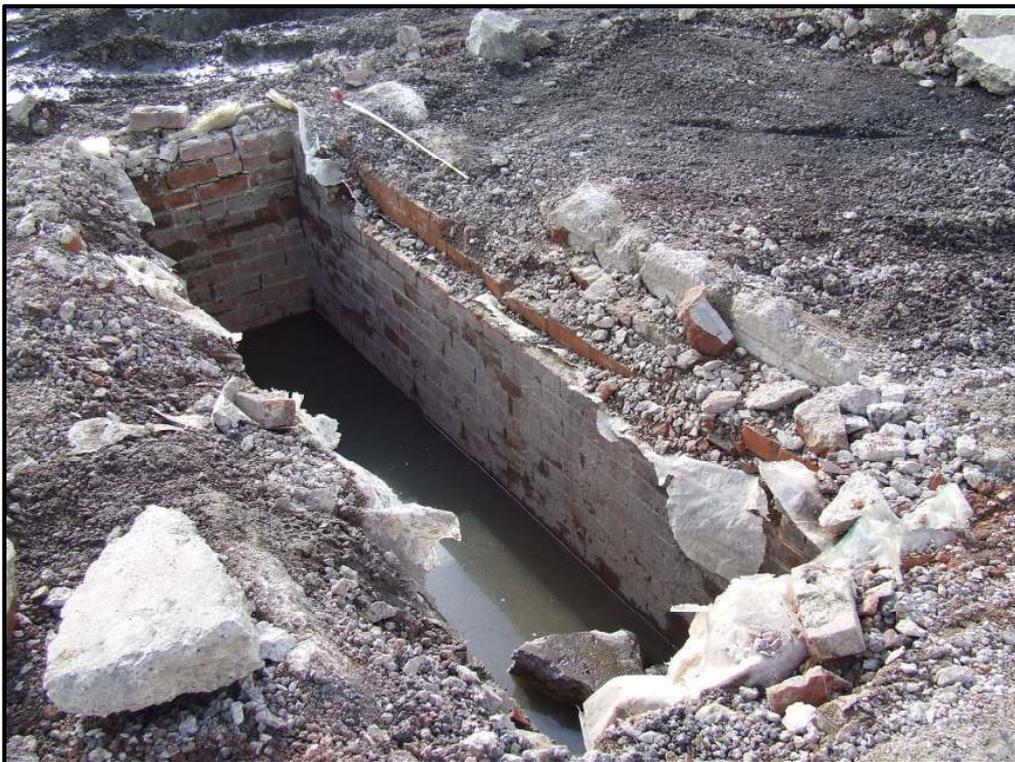
Photograph 10 Vehicle inspection pit looking south east (the tape extends to 1m for scale)

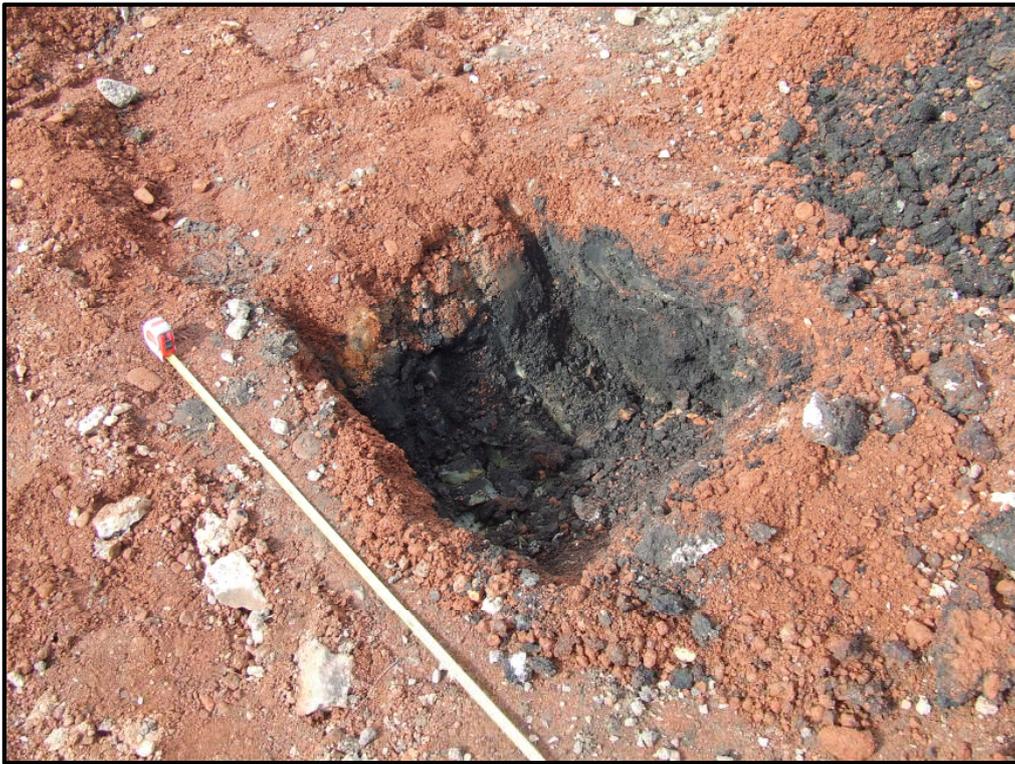
| Trial Pit | Depth (m) | Description | Sample Depth (m) |
|---|---|---|---|
| | 0.10 - 0.30 | Dark grey organic soil with dark grey fine sandy clinker gravel (Made Ground) | |

Photograph 11 TP7 excavated to the north of the inspection pit and at which 0.30m of Made Ground was encountered above a natural or reworked natural clay

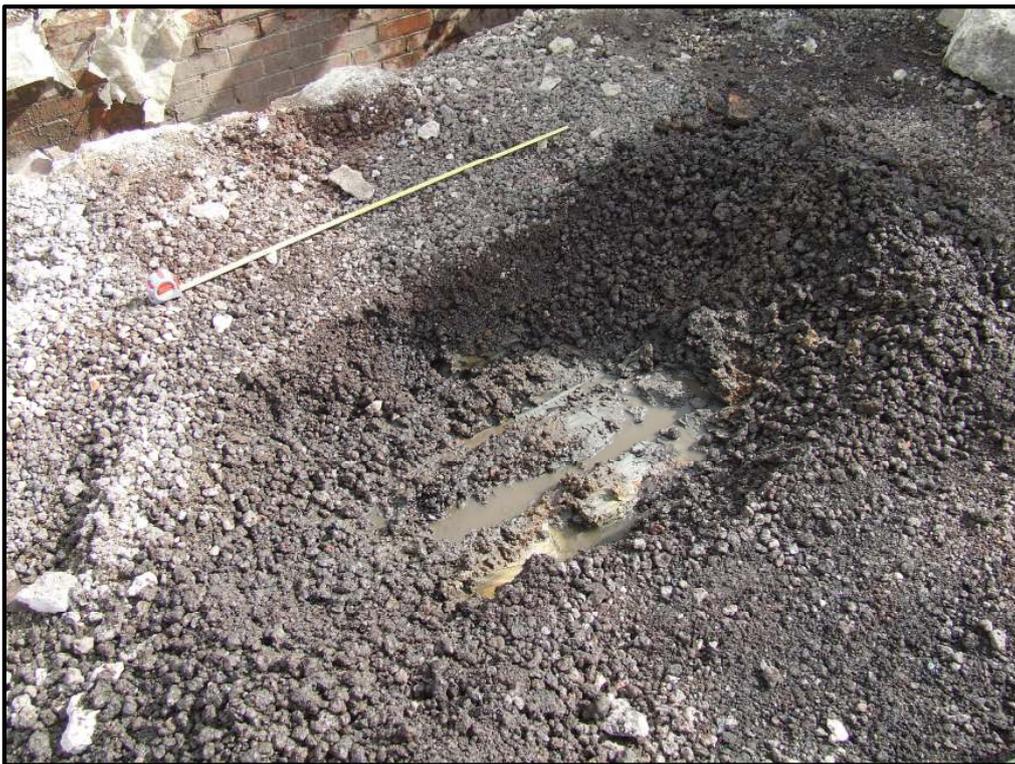
| Trial Pit | Depth (m) | Description | Sample Depth (m) |
|---|---|---|---|
| TP8 | 0.00 - 0.10 | Dark grey subrounded medium clinker gravel (Made Ground) | |

Photograph 12 TP8 excavated on the southern side of the inspection pit and at which 0.10m of clinker gravel was encountered above natural or reworked natural clay (the tape extends to 1m for scale)
