Bat Survey to  
26 East Street  
Lindley  
Huddersfield  
HD3 3NE

6<sup>th</sup> November 2025

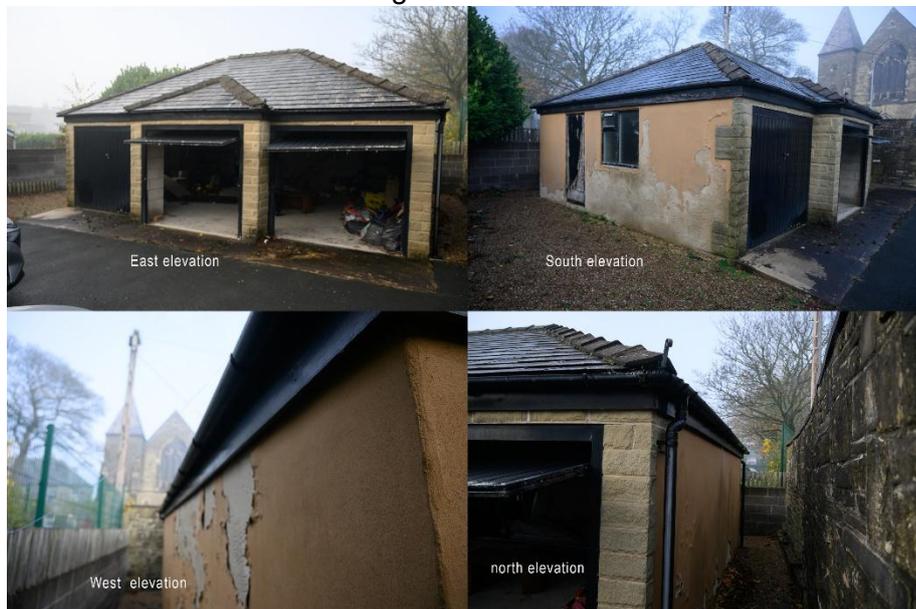
The building is a large, single storey triple garage located adjacent to the large period house at this site. The garage appears to be of recent construction (c,20+yrs) given the modern blockwork interior and breathable membrane to the roof. The outer walls are rendered blockwork with decorative stone to the front. There are no external cracks or cavities in the structure. The roof is blue slate and is hipped and the tiles are present and solid. The tiles along the hips have sections of failed mortar and there is a ridge tile also with failed mortar.

Photo 1: Showing general exterior view of the garage

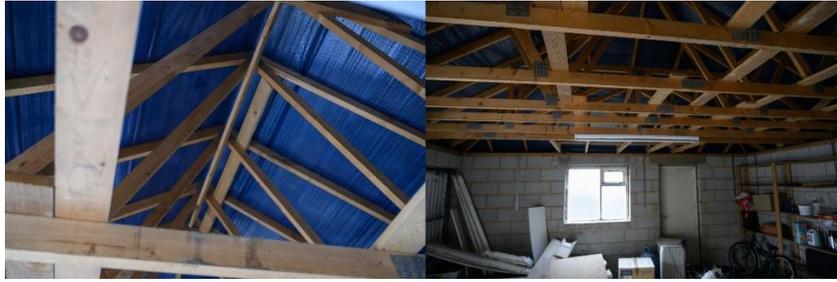
Internally, the roof is sound and there is no access from any ridge section to the interior and the lining is a breathable membrane which generally prevents access by bats. There is no central ridge beam that might allow ridge dwelling species to make use of the roof, and the interior is bright daylight entering from the window in the south wall.

Photo 2: Roof interior and general view showing light ingress

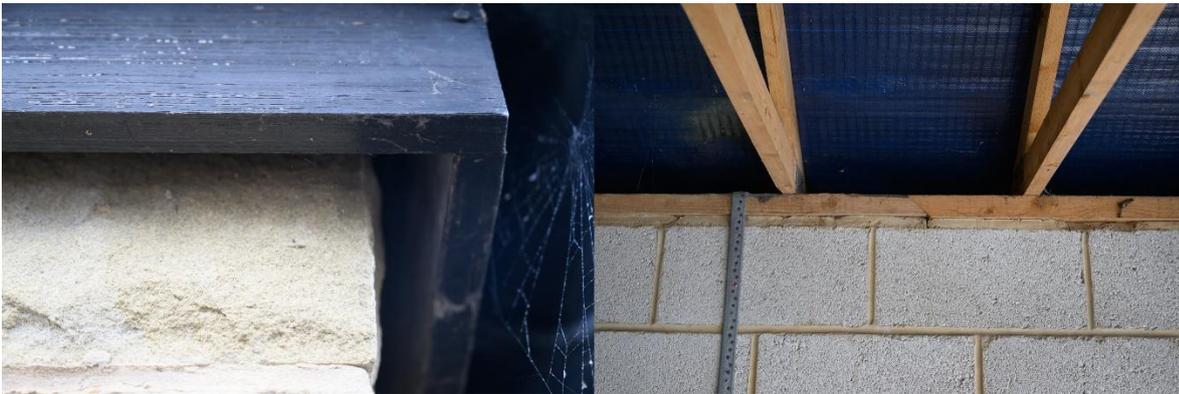
There is a wooden fascia that runs around the garage and has large gaps that might allow bats to roost behind the boards but is also accessible by birds and other predators. When shining a torch up behind the fascia, it appears the gap goes directly to the wall top and therefore, there is no tight crevice for bats and they would be susceptible to attacks from predators.

Photo 3: Showing large fascia gap and interior wall top.

Remove all fascia boards and ridge tiles by hand and in the case of the ridge tiles, by lifting carefully while checking underneath. In the unlikely event bats being encountered, works should immediately cease and advice sought from an experienced bat ecologist.
