PHASE 2

GEO-ENVIRONMENTAL REPORT

Report on a Phase 2 Geo-environmental Investigation

Location:	Land adj.18B Cowlersley Lane Huddersfield, West Yorkshire HD4 5TY	
For:	Luke Stead	
Report No.	C4351/24/E/6664	Report date: August 2024

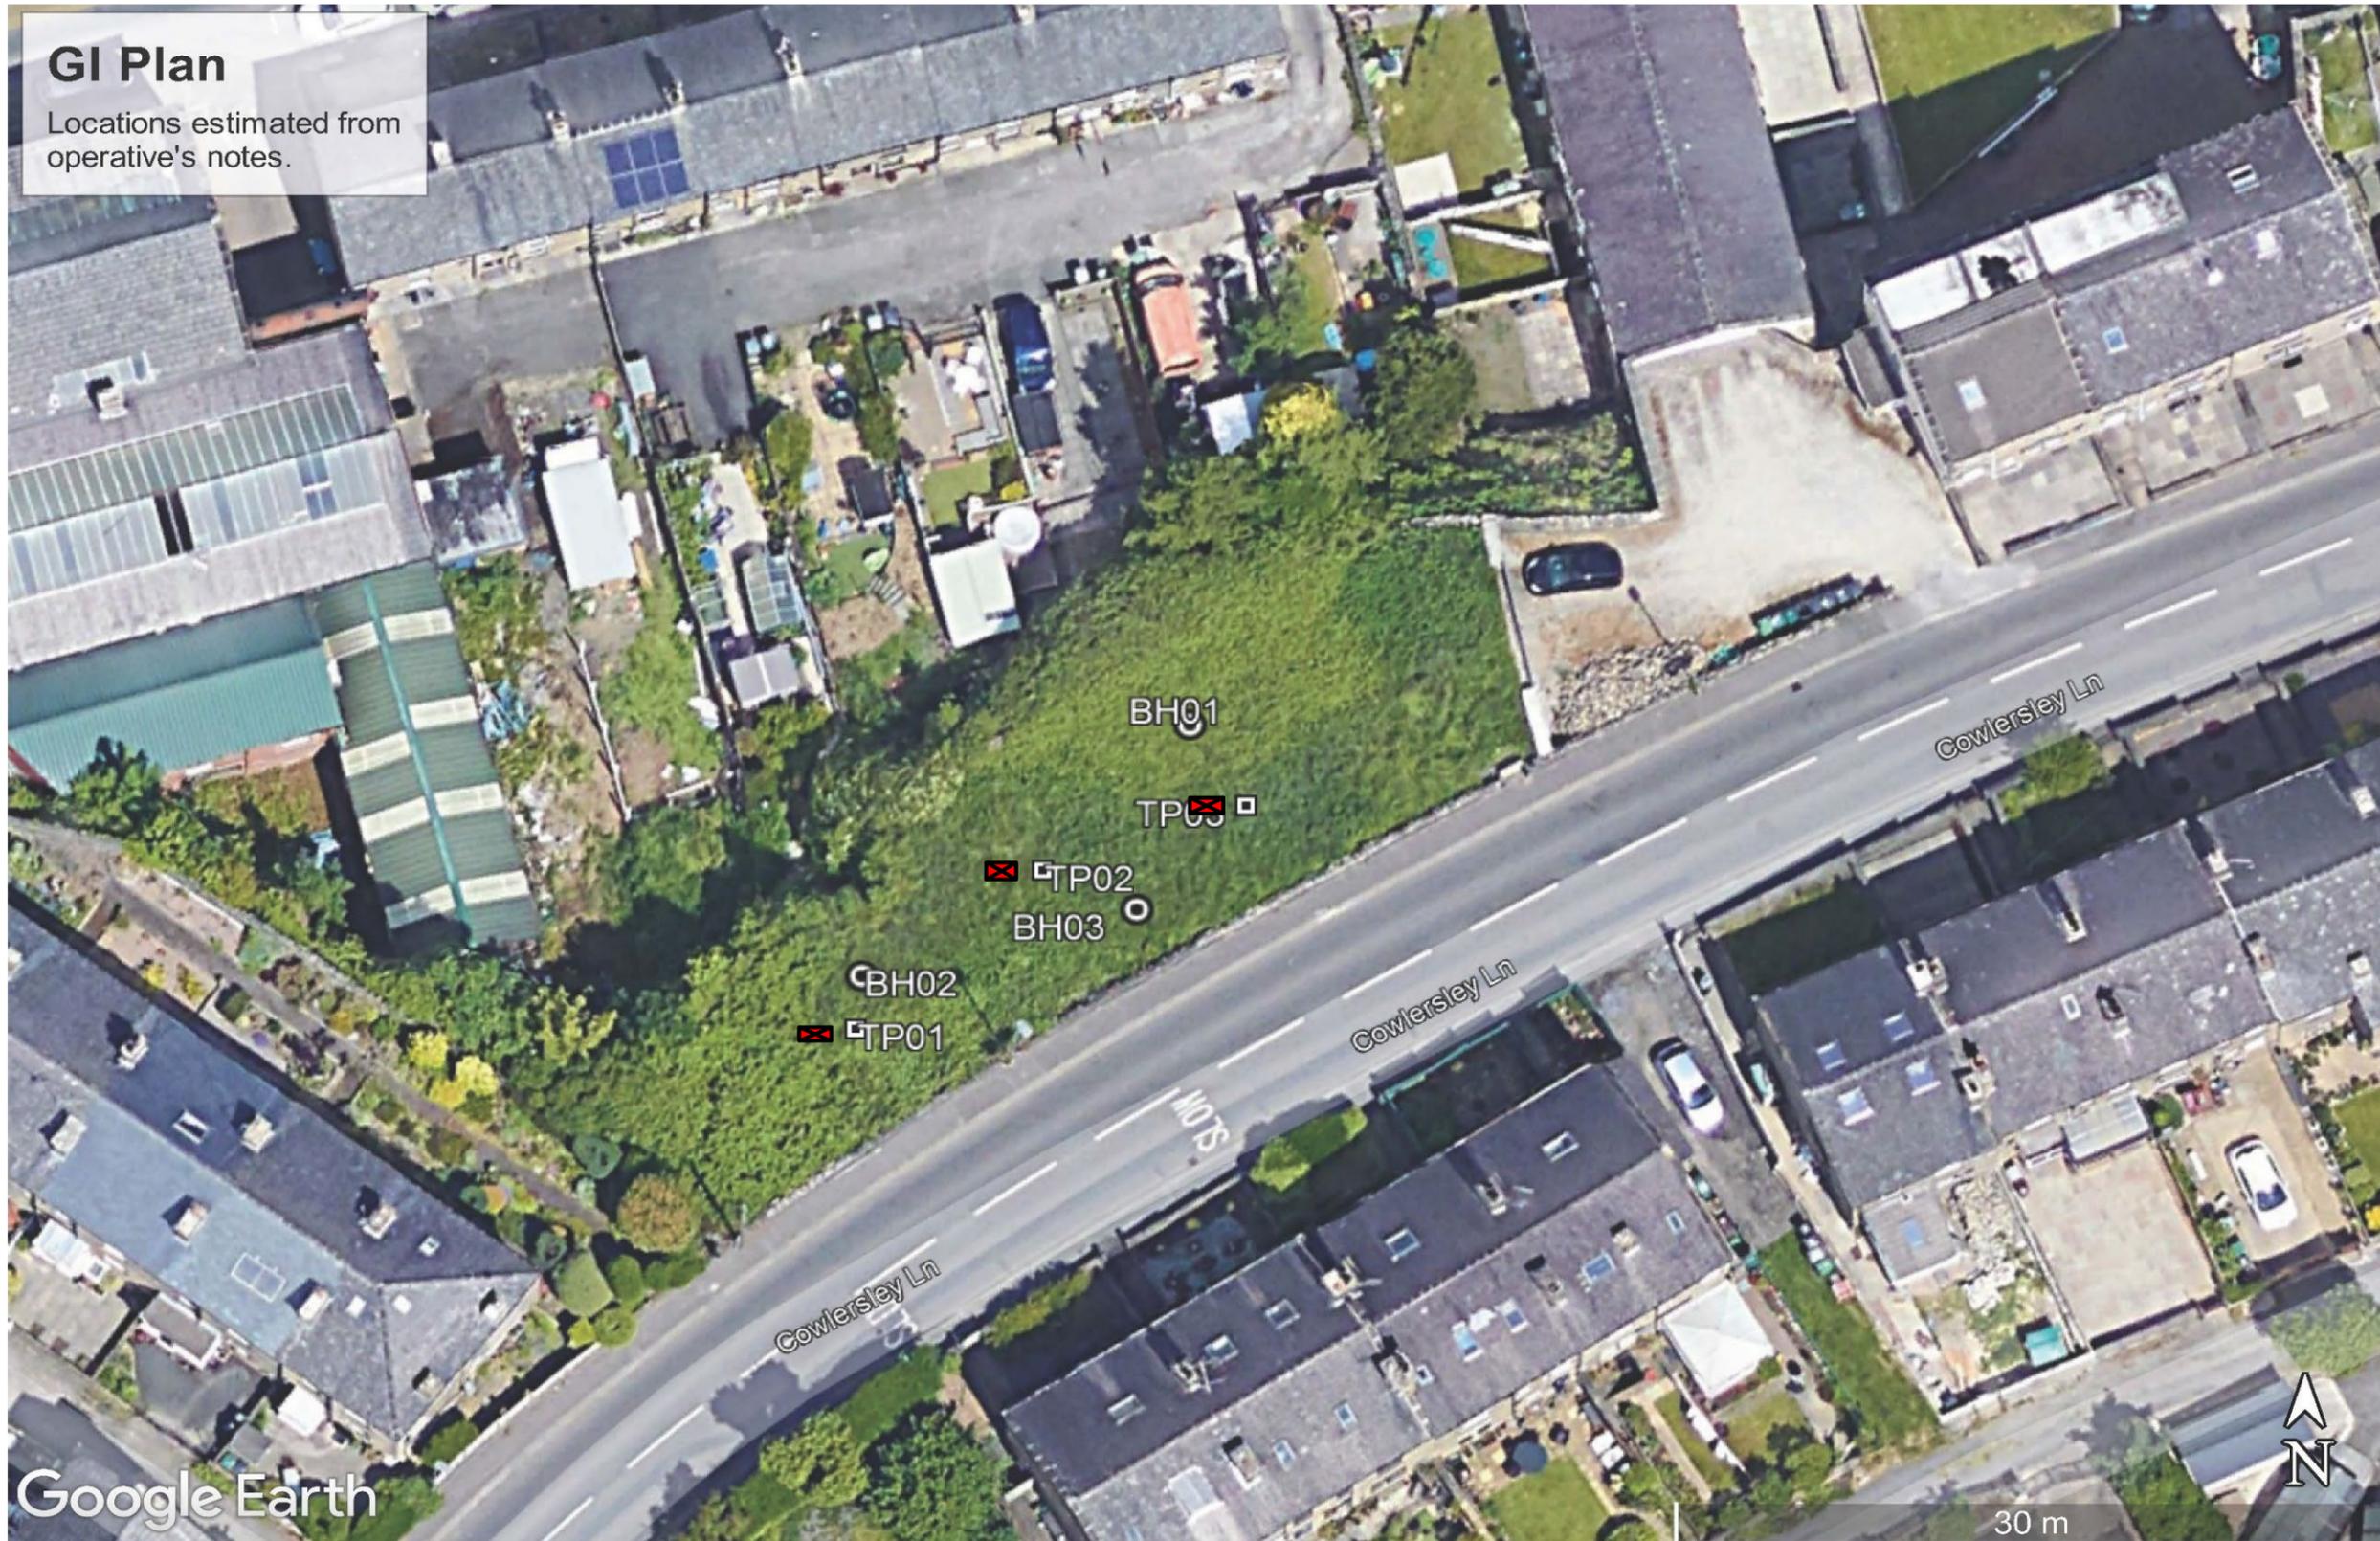
GI Plan

Locations estimated from operative's notes.

Notes:
Investigation positions approximated from site operative's notes.

The investigatory locations are shown on the site plan which is presented in Appendix 1 to this report.
