Land at Roslyn Avenue, Netherton For KCS Developments Ltd

Report no: 5080/1

Date: July 2024

SUMMARY OF GEOENVIRONMENTAL ISSUES

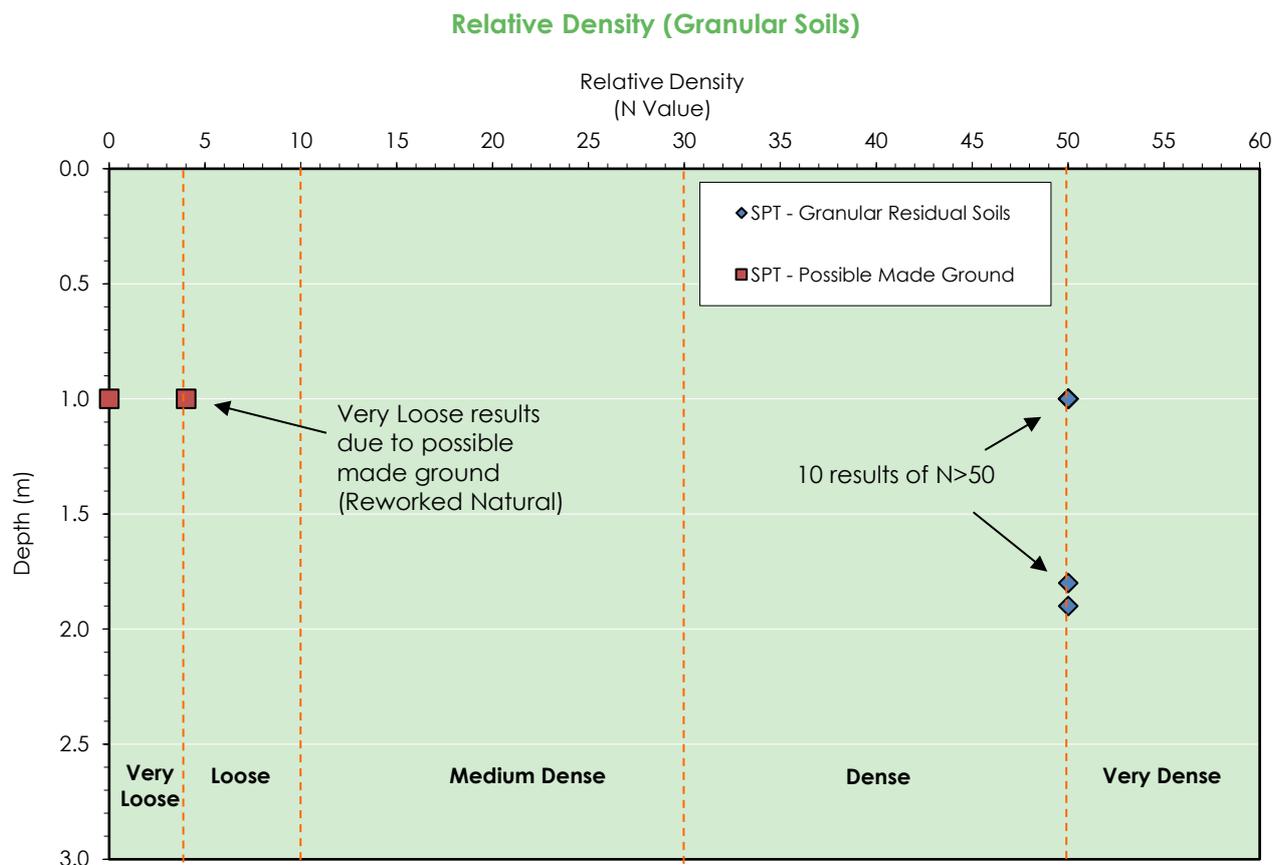
- 13.5.3 The plot below presents a summary of SPT 'N' values.

13.5.4 All of the SPTs (excluding the two within the possible made ground) within the Granular Residual Soils returned N values of N>50. These values are likely unrepresentative of the granular soils and are likely more representative of the underlying Sandstone bedrock.

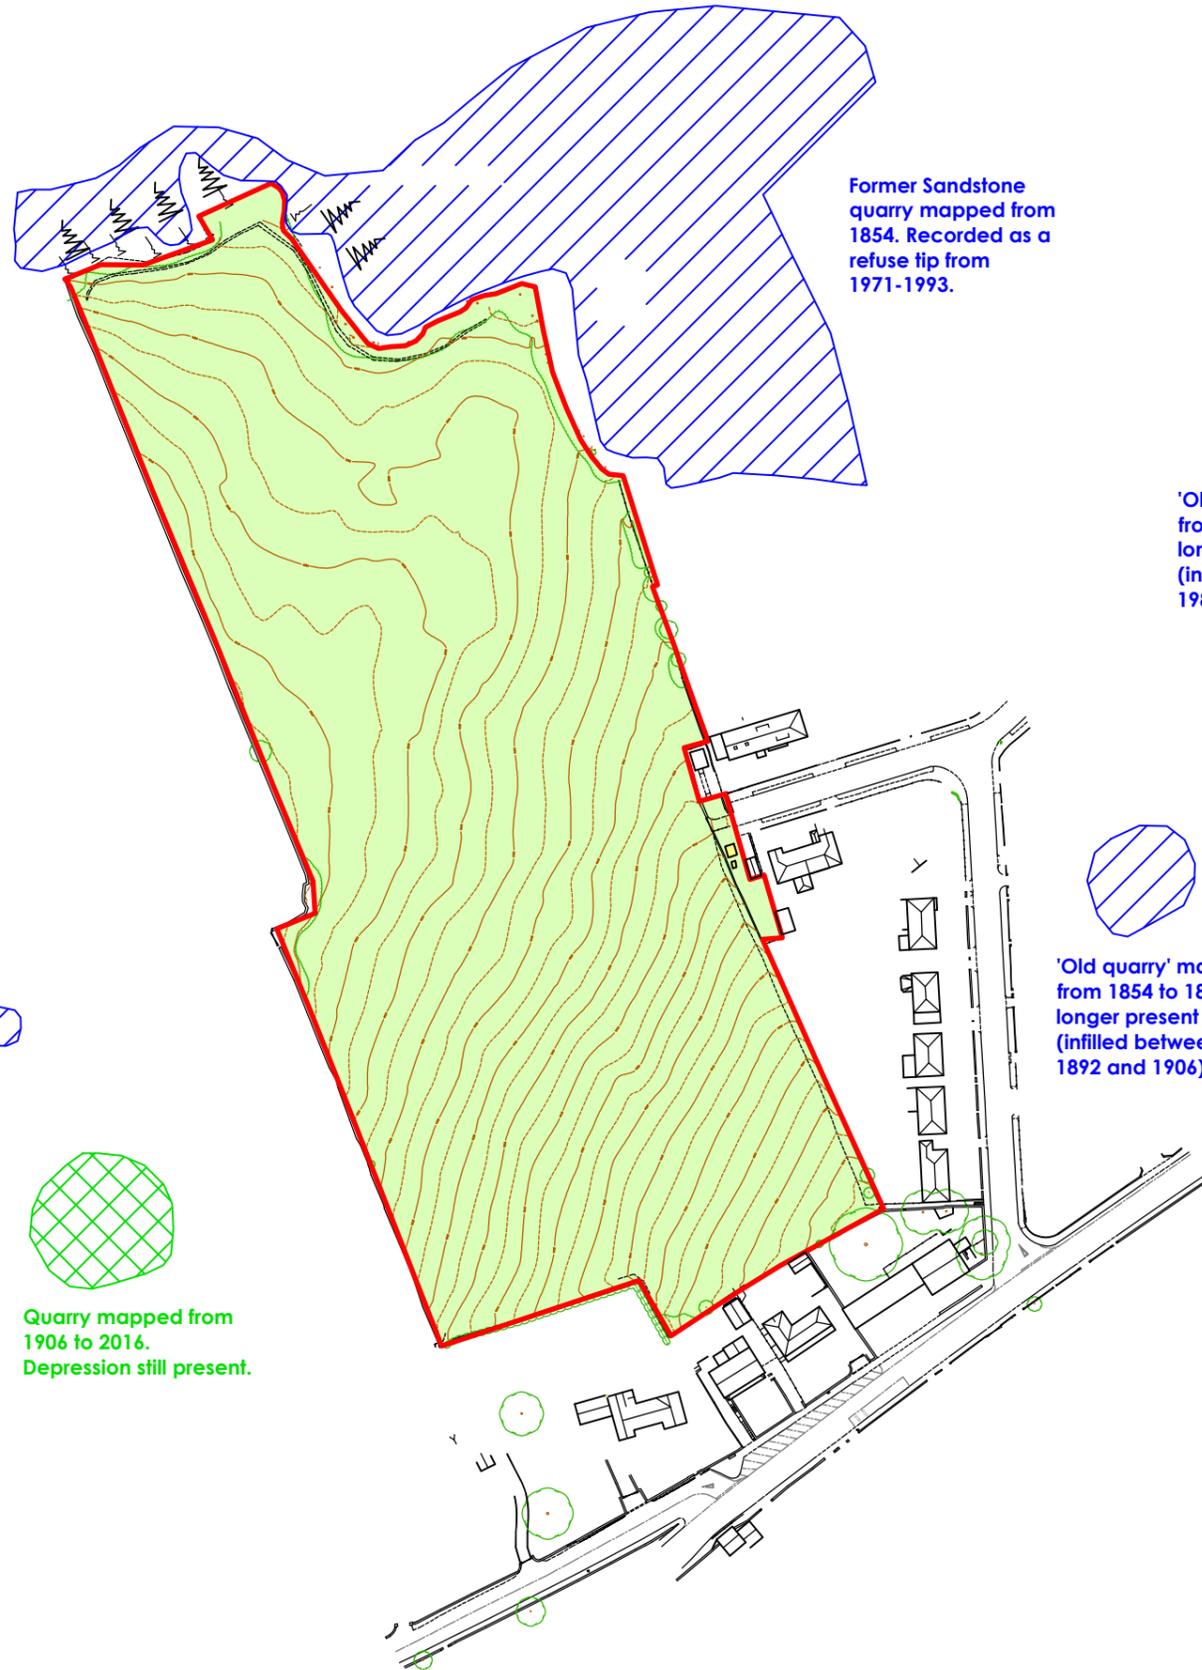
SCALE	SHEET	DRAWING NO.	REVISION
NOT TO SCALE	A3	5080/4

Former Sandstone quarry mapped from 1854. Recorded as a refuse tip from 1971-1993.

'Old quarry' mapped from 1892 to 1984. No longer present in 2000 (infilled between c. 1984 and 2000).

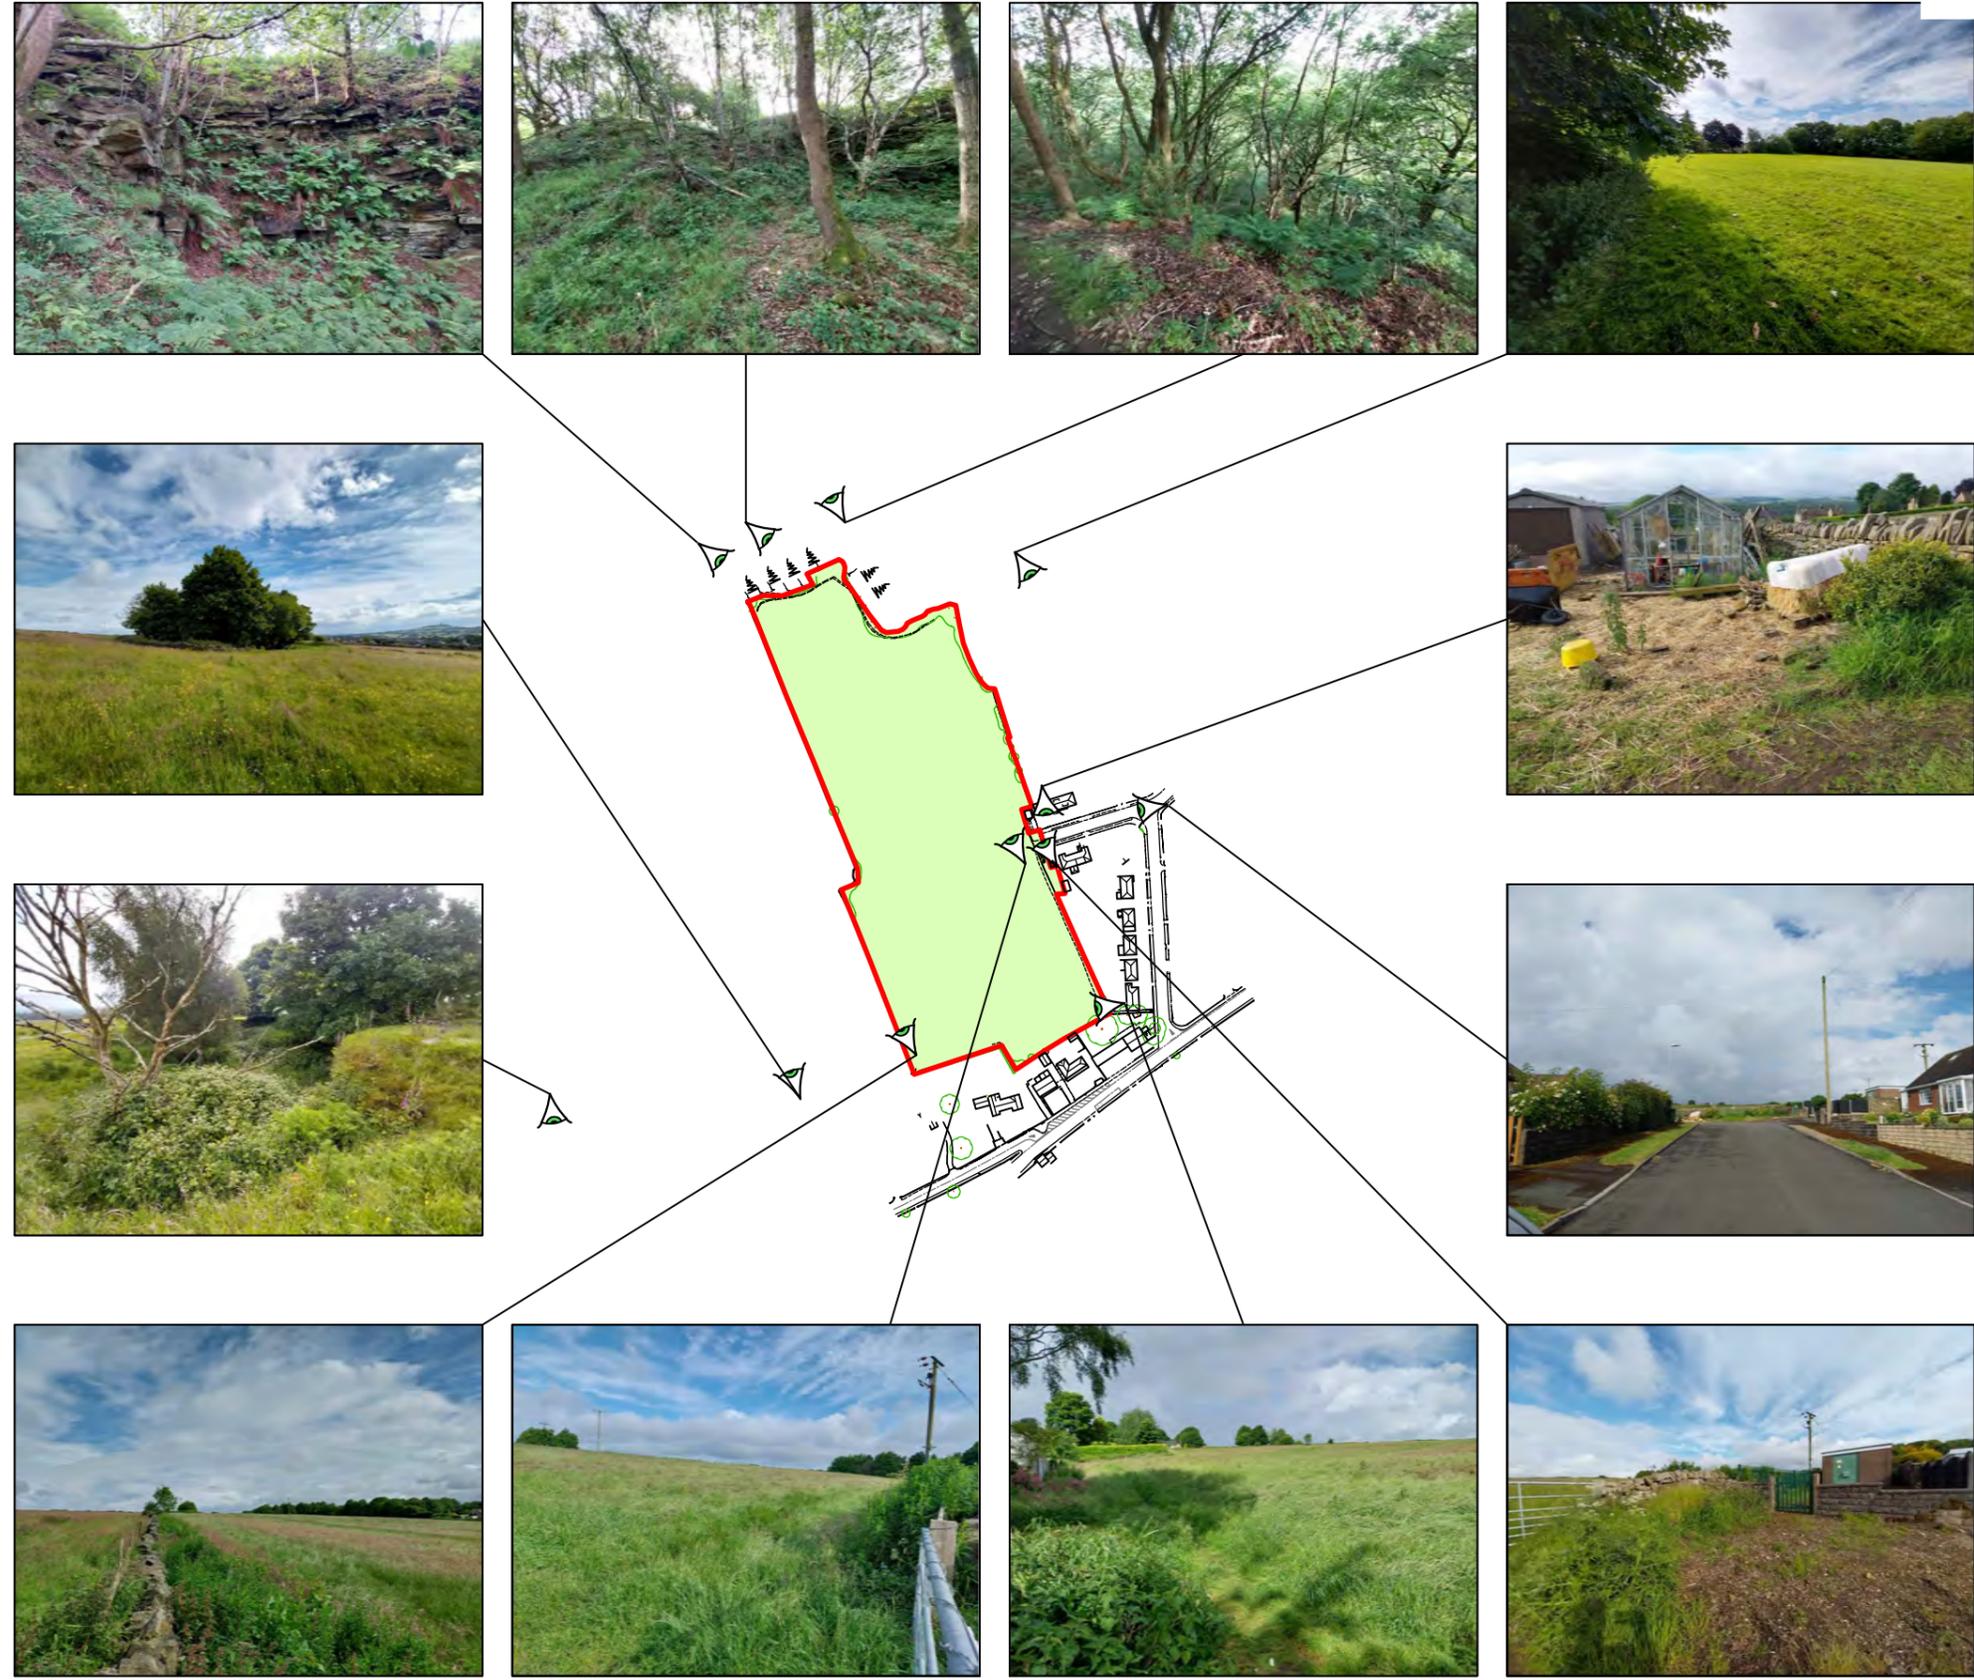
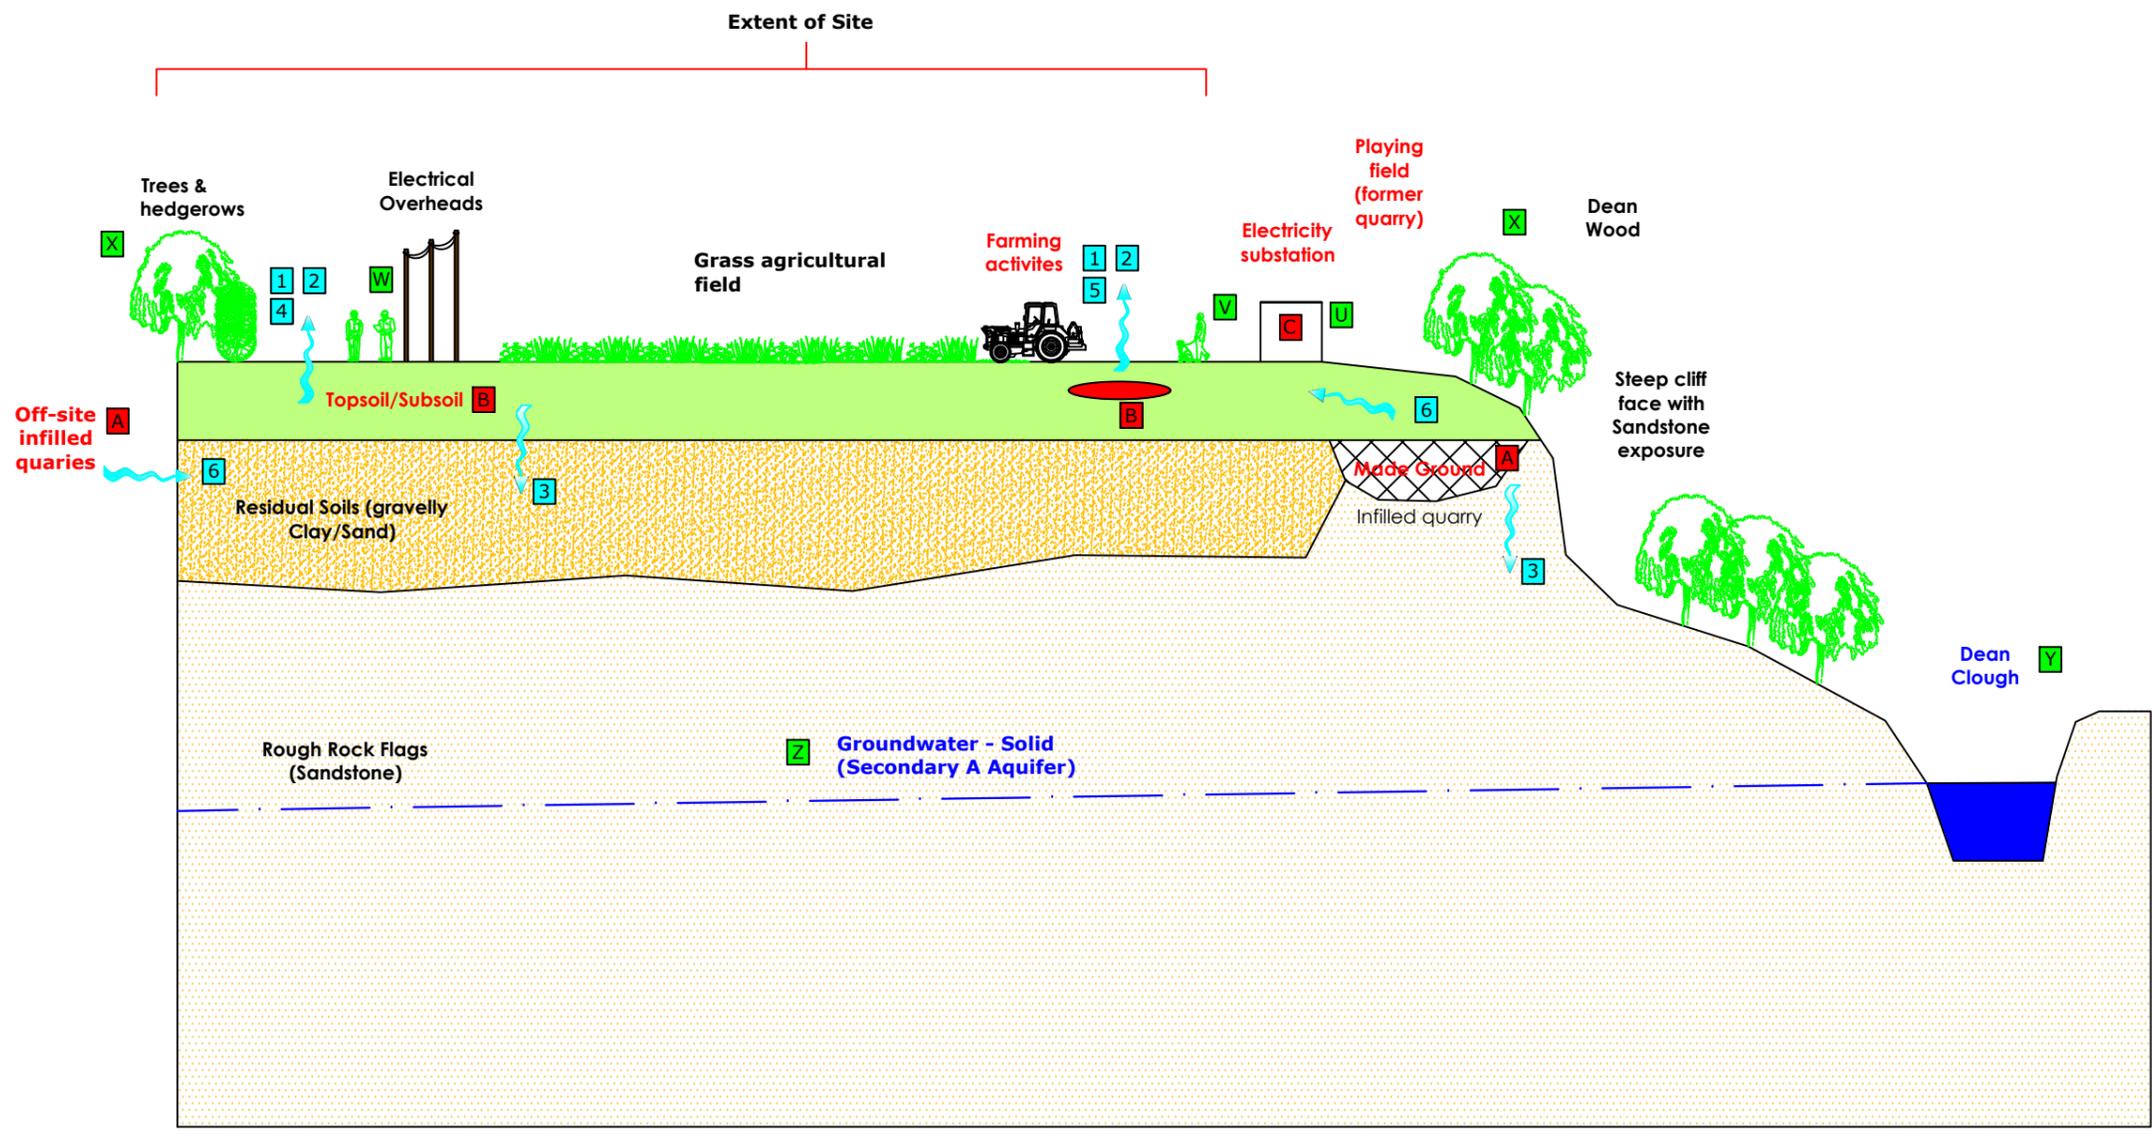
DRAWN	LB	DATE	18/06/2024	STATUS	FOR COMMENT <input type="checkbox"/>
CHECKED	AG	DATE	18/06/2024	FOR APPROVAL	<input type="checkbox"/>
				DRAFT	<input type="checkbox"/>
				FINAL	<input checked="" type="checkbox"/>
SCALE	Not to scale	SHEET	A3	DRAWING NO.	5080/5
				REVISION

SOURCES	
A	MADE GROUND - INFILLED QUARRIES (INORGANICS/ORGANICS/GAS)
B	TOPSOIL (FARMING ACTIVITIES - INORGANICS/ORGANICS)
C	ELECTRICITY SUBSTATION (PCBs)

PATHWAYS	
1	DERMAL CONTACT
2	INGESTION/INHALATION
3	LEACHING OF CONTAMINANTS
4	UPTAKE BY PLANTS
5	VOLATILISATION
6	MIGRATION OF GAS

- 6.1 A preliminary conceptual site model, presented as Drawing 5080/5 in Appendix B, has been prepared after consideration of all the data presented in Sections 2 to 4 inclusive of this report.
- 6.2 Potential contaminant linkages are shown on the preliminary conceptual site model.
- 6.3 Infilled quarries to the north, west, south-west and east are a potential source of contaminants and hazardous ground gas.
- 6.4 The conceptual model will likely be subject to modification in light of data arising from the proposed intrusive ground investigation; see Section 11.2.

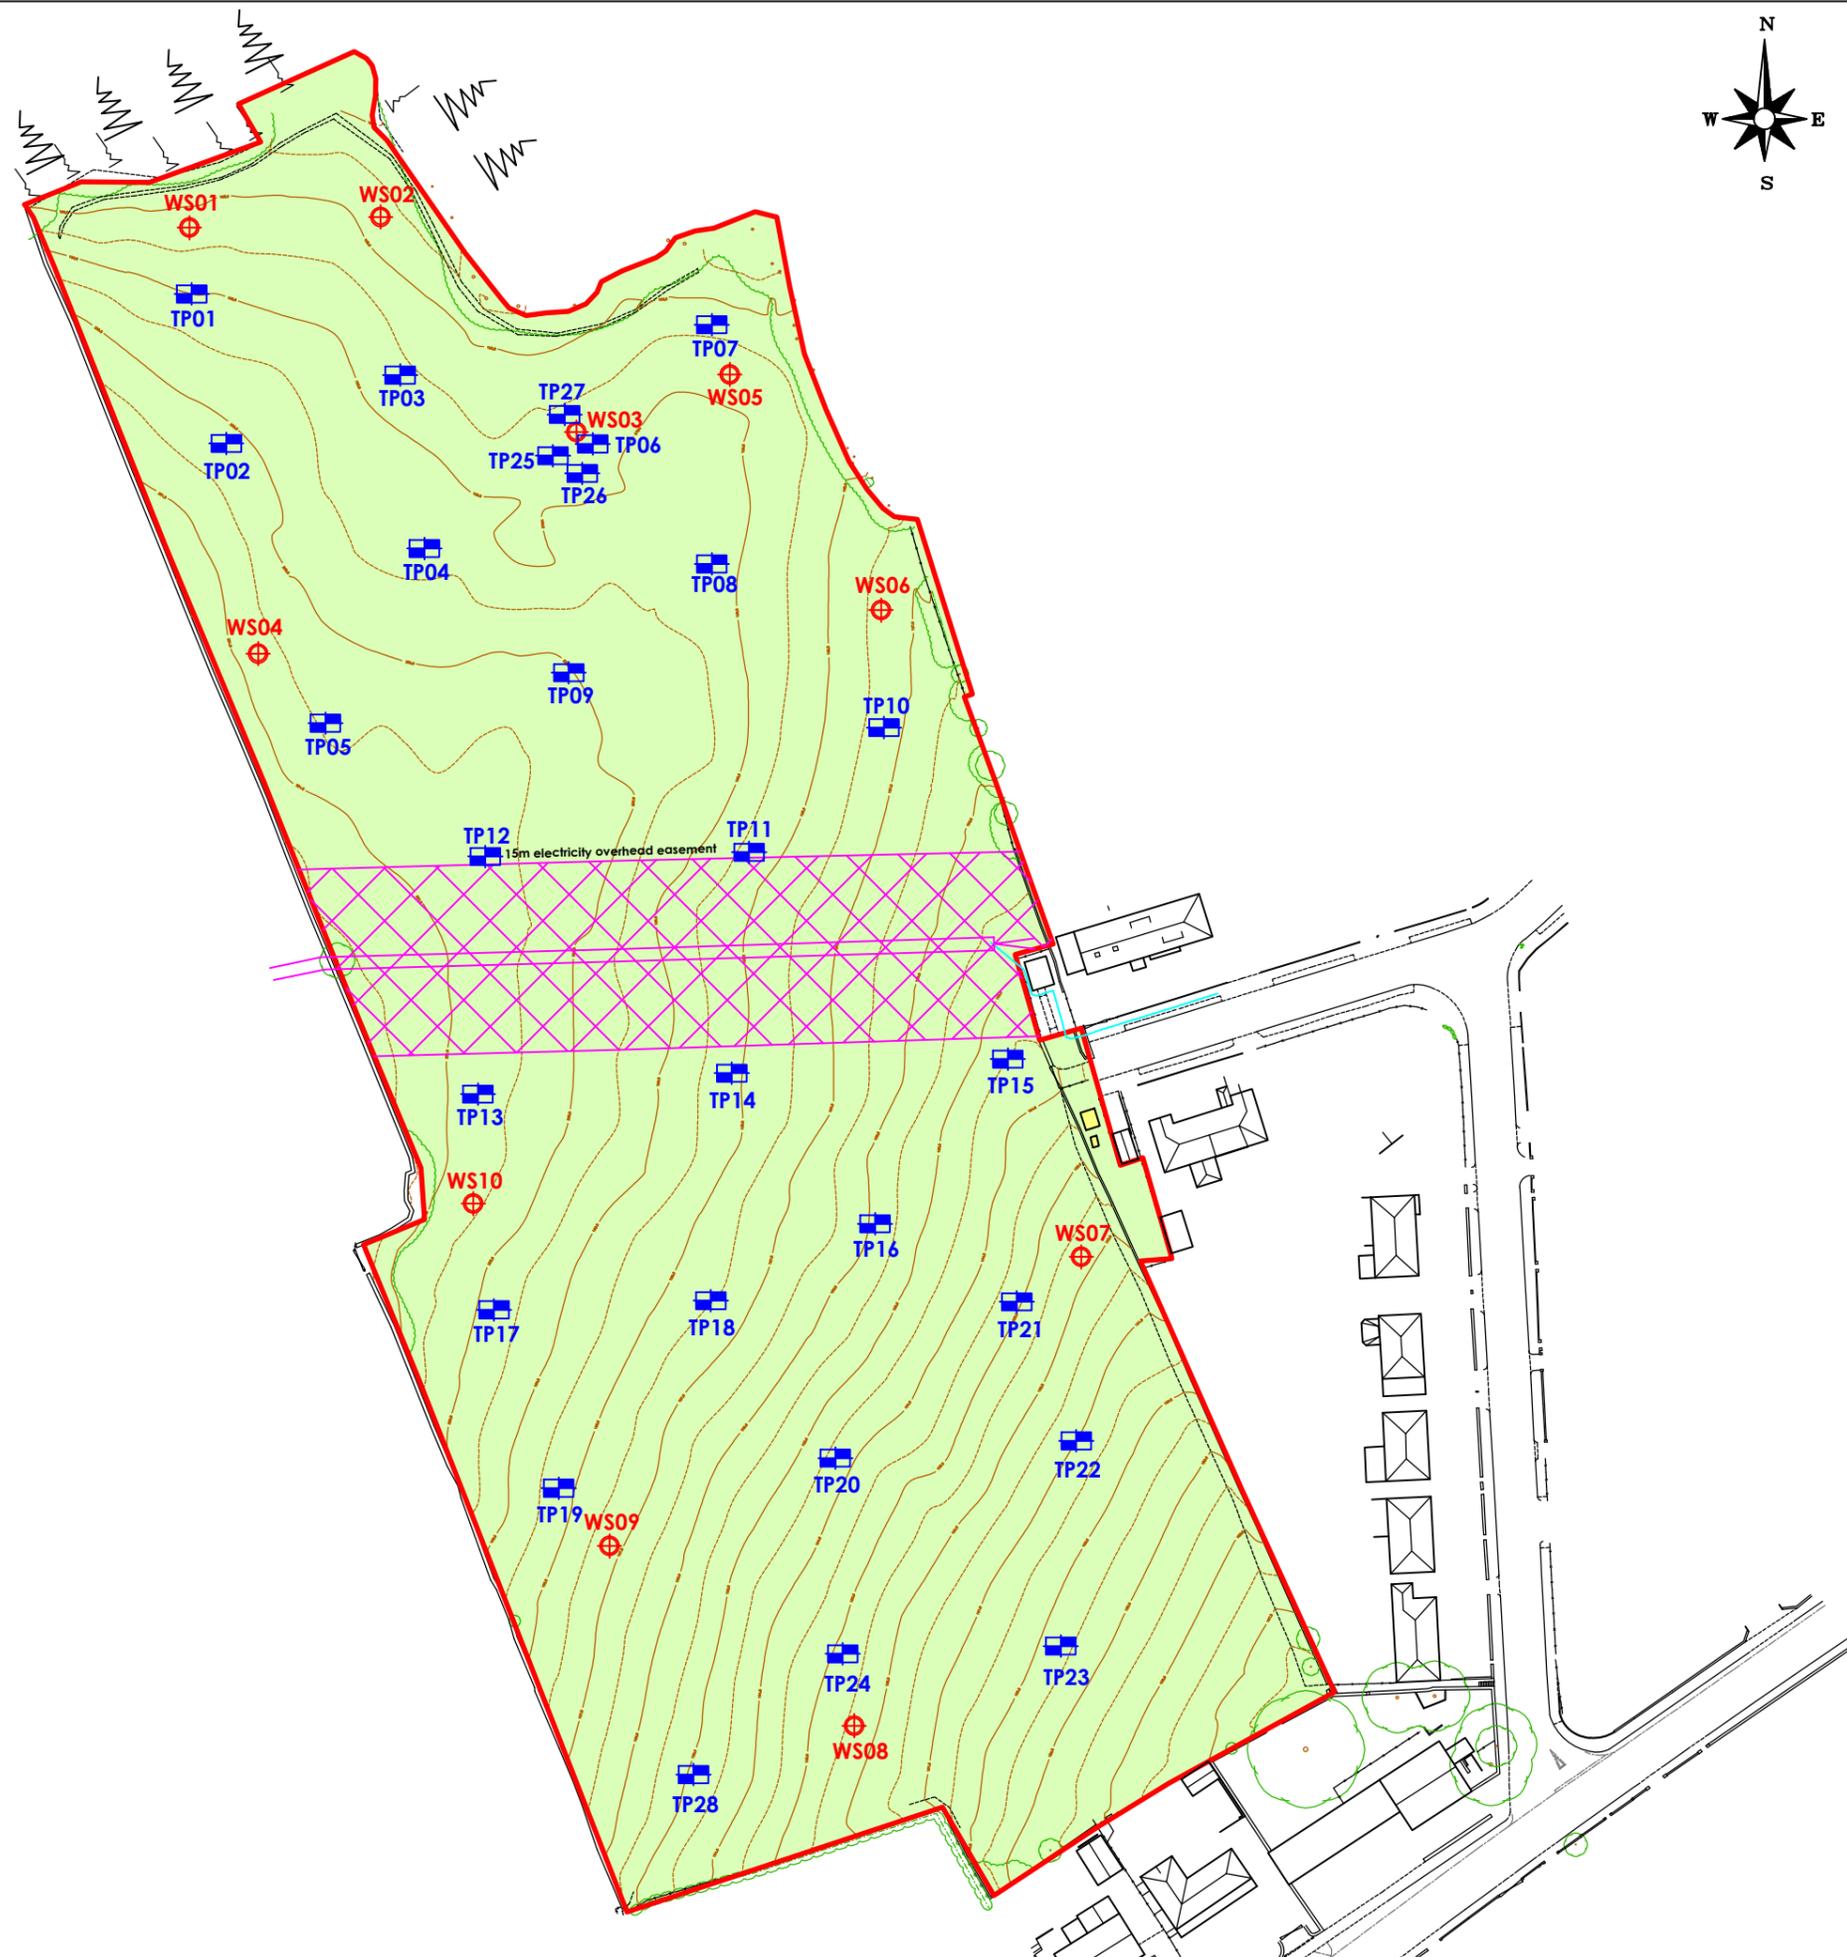
SCALE	1:1250	SHEET	A3	DRAWING NO.	5080/6	REVISION	
-------	--------	-------	----	-------------	--------	----------	--

- NOTES
- TRIAL PIT LOCATION
 - WINDOW SAMPLE LOCATION
 - APPROXIMATE SITE BOUNDARY
 - GRASS & OVERGROWN AREAS
 - BUILDING
 - LINE OF ELECTRICITY UTILITY (OVERHEAD)
 - LINE OF ELECTRICITY UTILITY (UNDERGROUND)
 - 15m EASEMENT AWAY FROM OVERHEADS

EXPLORATORY HOLE LOCATIONS BASED ON DATA FROM A HAND-HELD GPS (+/- 3M ACCURACY)

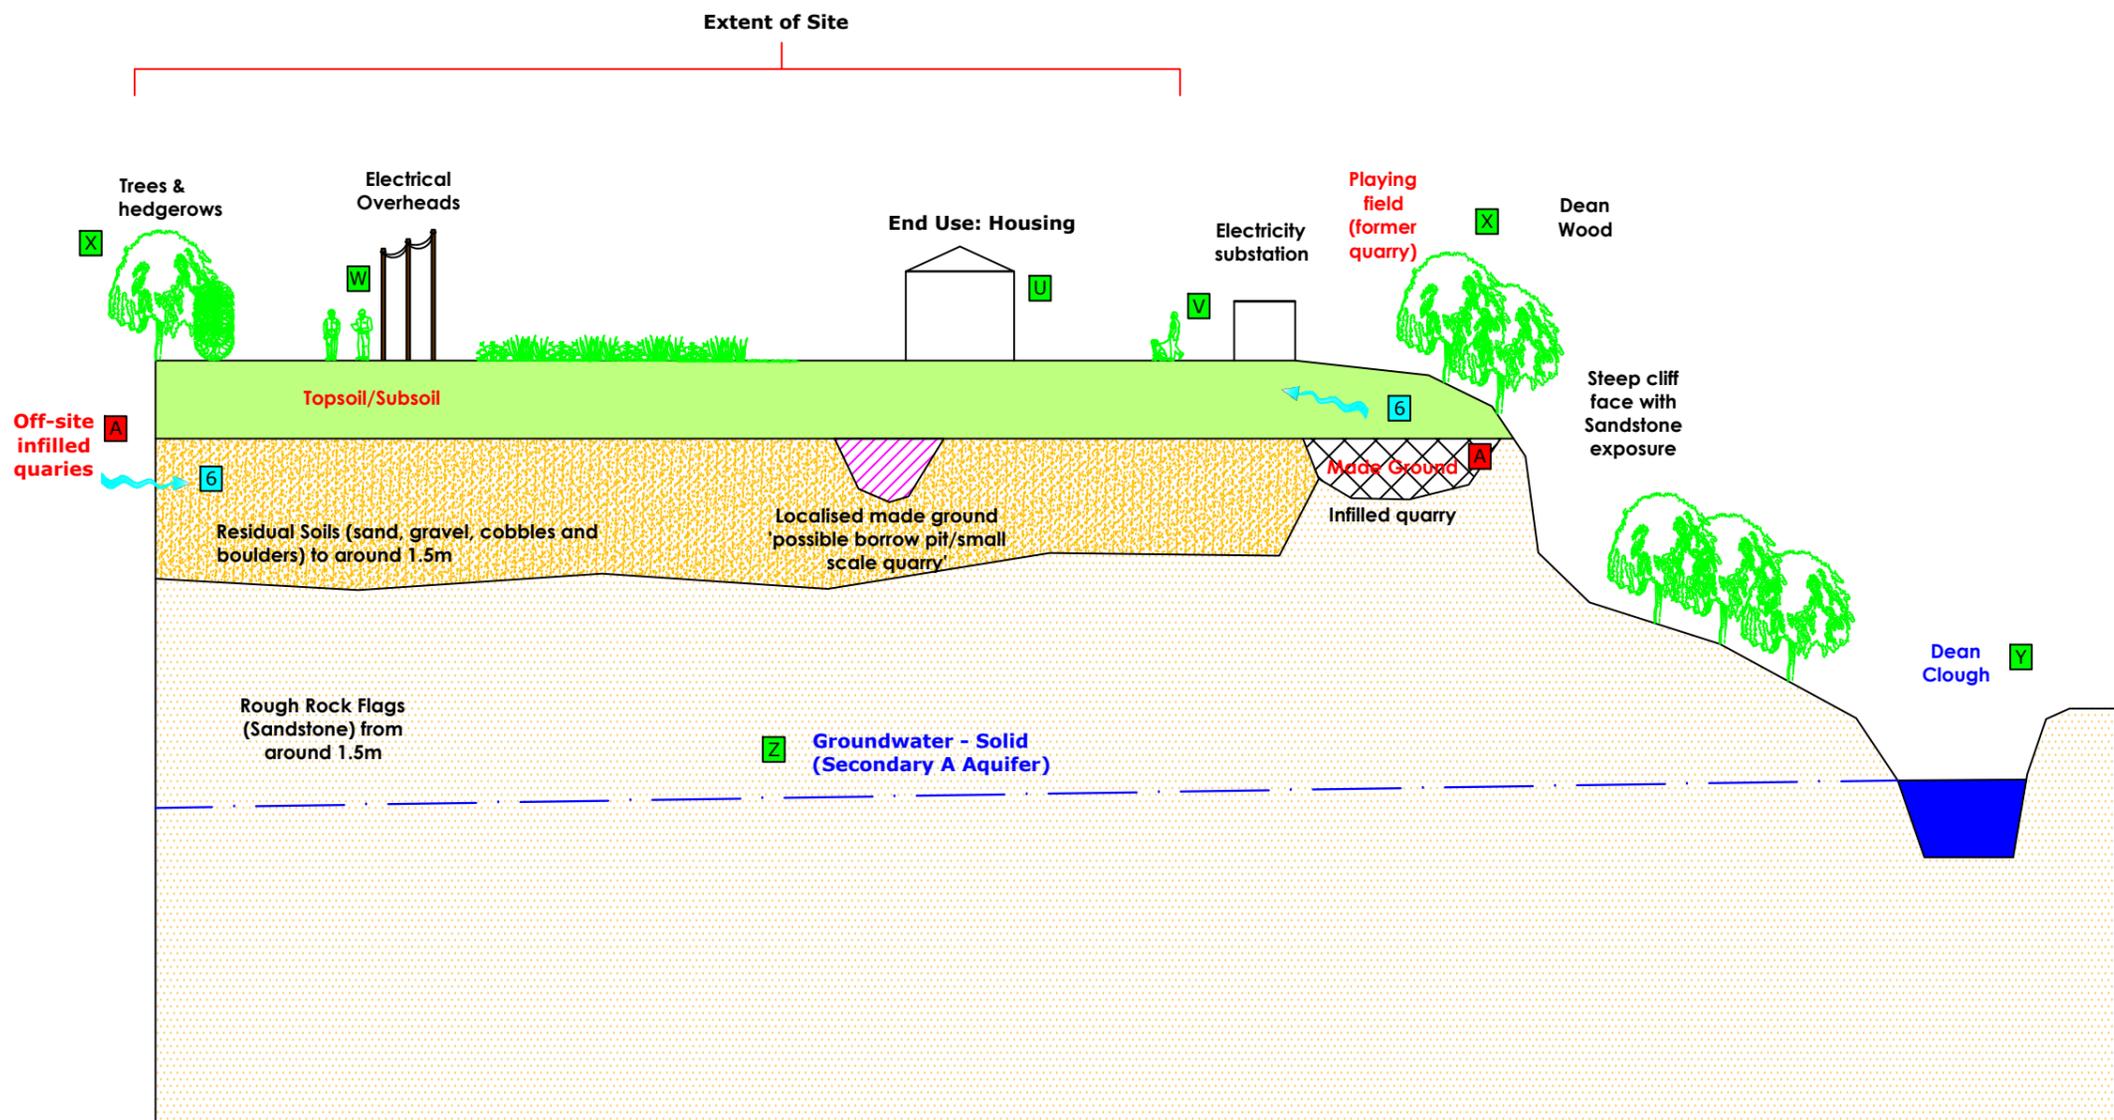
SOURCES	
A	INFILLED QUARRIES (GAS)

PATHWAYS	
6	MIGRATION OF GAS

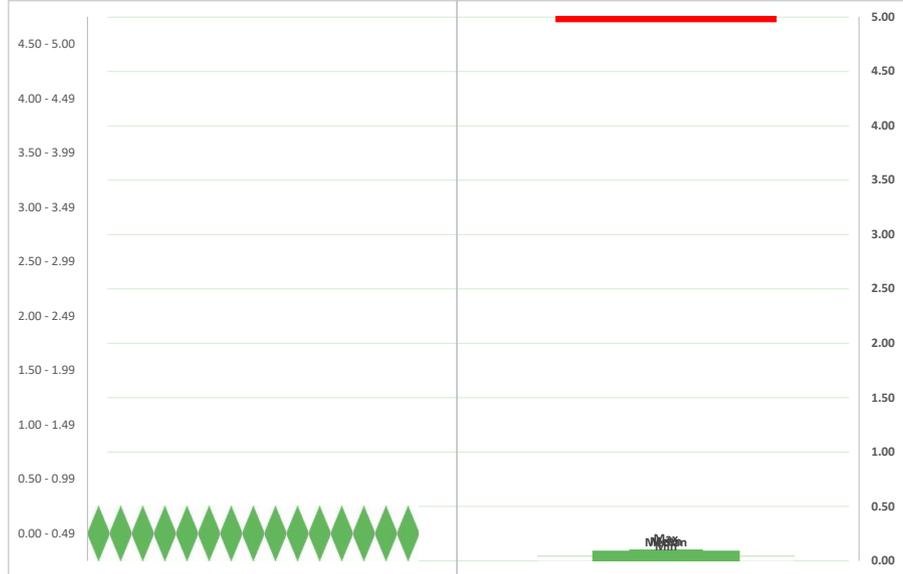
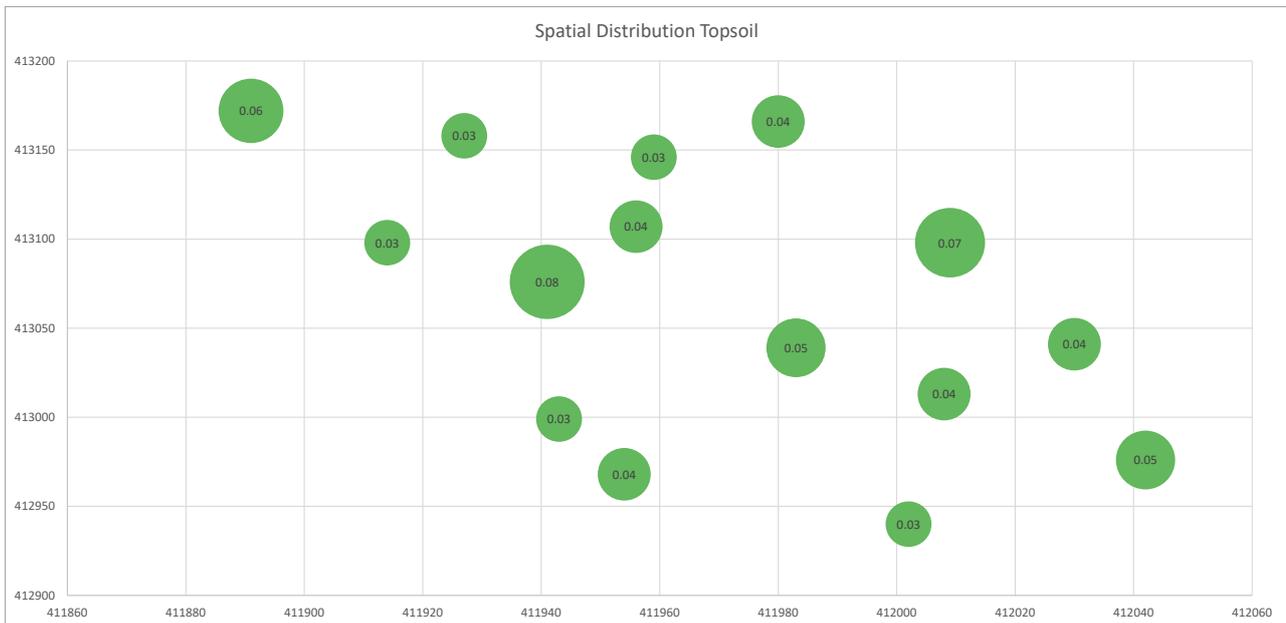
Determinant	B(a)P
Critical concentration	5.00
No. samples	15.00
Max	0.08
Mean	0.04
Min	0.03
Median	0.04
Standard Deviation	0.02
Standard Error	0.00
T value	2.14
Upper Confidence Level (95%)	0.05
Upper Confidence Level (80%)	0.05
Lower Confidence Level (5%)	0.04
Transform data	Normal
Upper Confidence Level for chart	95%

Spatial distribution can show sampling clusters based on ground type it **does not** identify areas of contamination

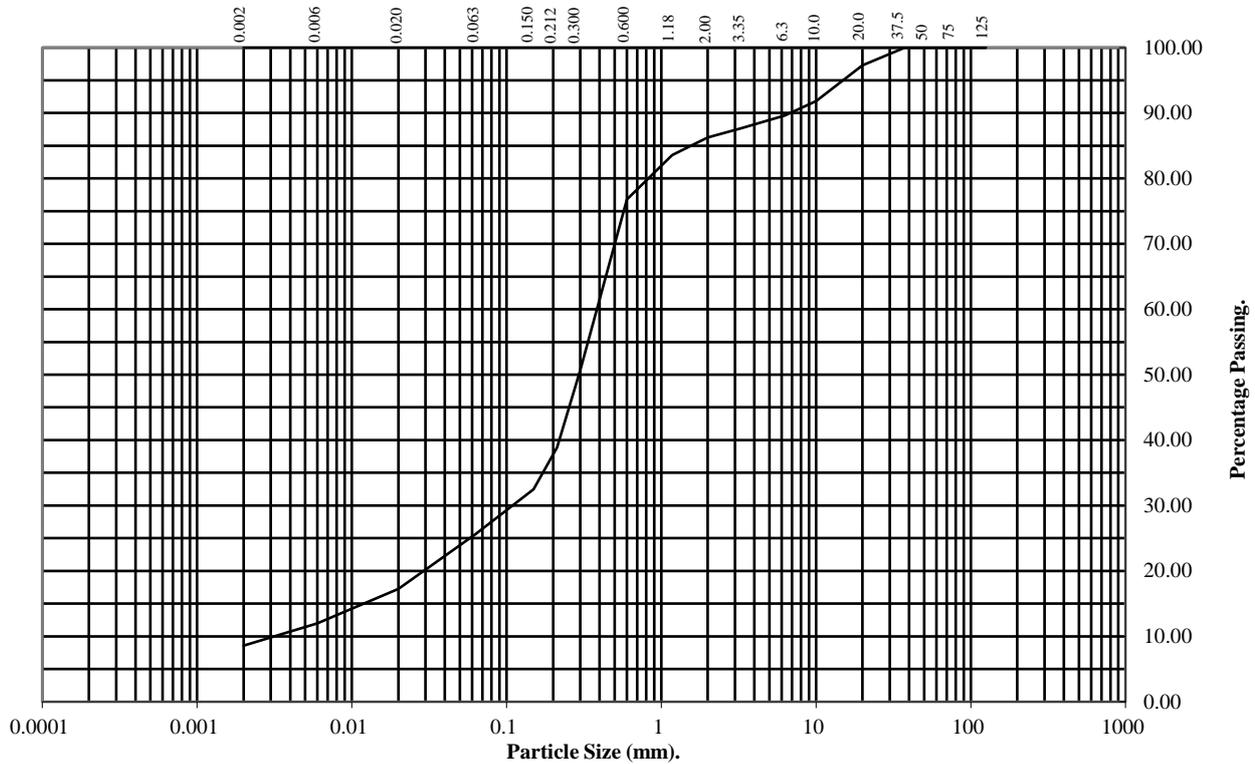
BS Test Sieve (mm)	Percentage Passing
125	100
75	100
50	100
37.5	100
20	97
10	92
6.3	90
3.35	88
2	86
1.18	84
0.6	77
0.3	51
0.212	39
0.15	32
0.063	26

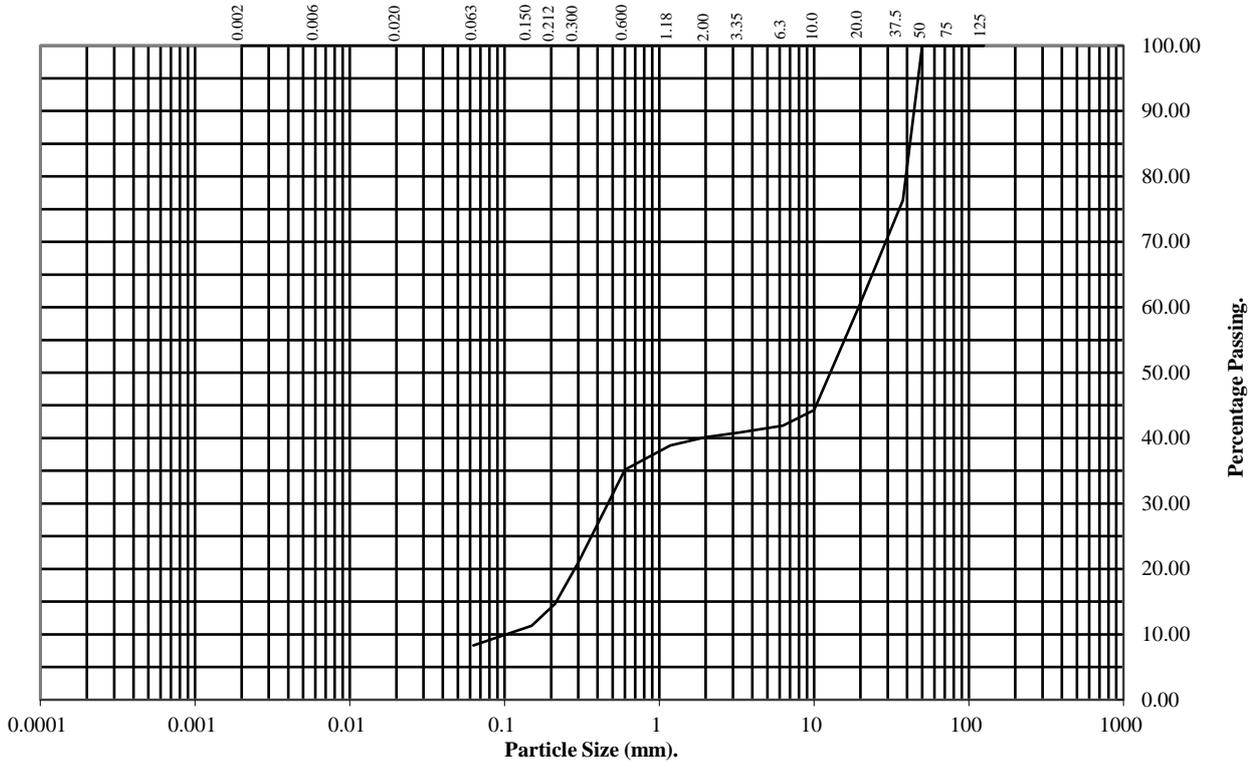
BS Test Sieve (mm)	Percentage Passing
125	100
75	100
50	100
37.5	76
20	61
10	44
6.3	42
3.35	41
2	40
1.18	39
0.6	35
0.3	21
0.212	15
0.15	11
0.063	8

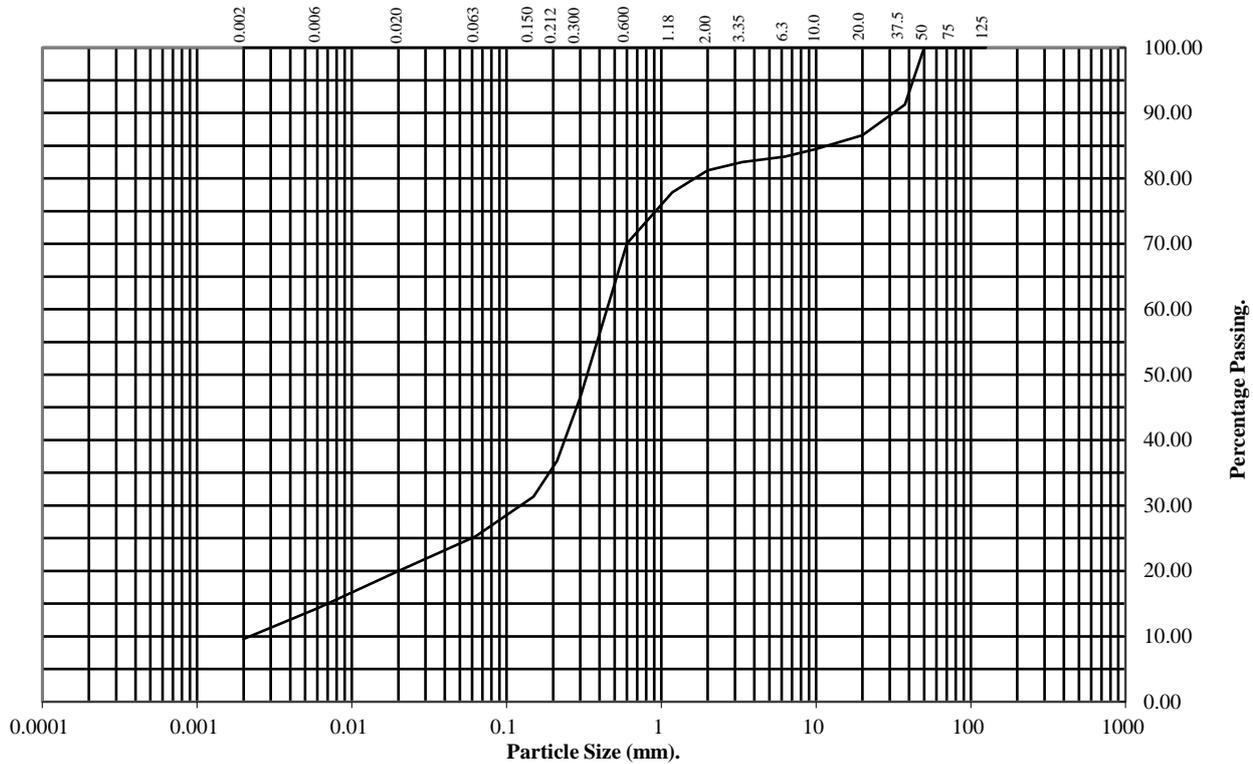
BS Test Sieve (mm)	Percentage Passing
125	100
75	100
50	100
37.5	91
20	87
10	85
6.3	83
3.35	82
2	81
1.18	78
0.6	70
0.3	47
0.212	37
0.15	31
0.063	25

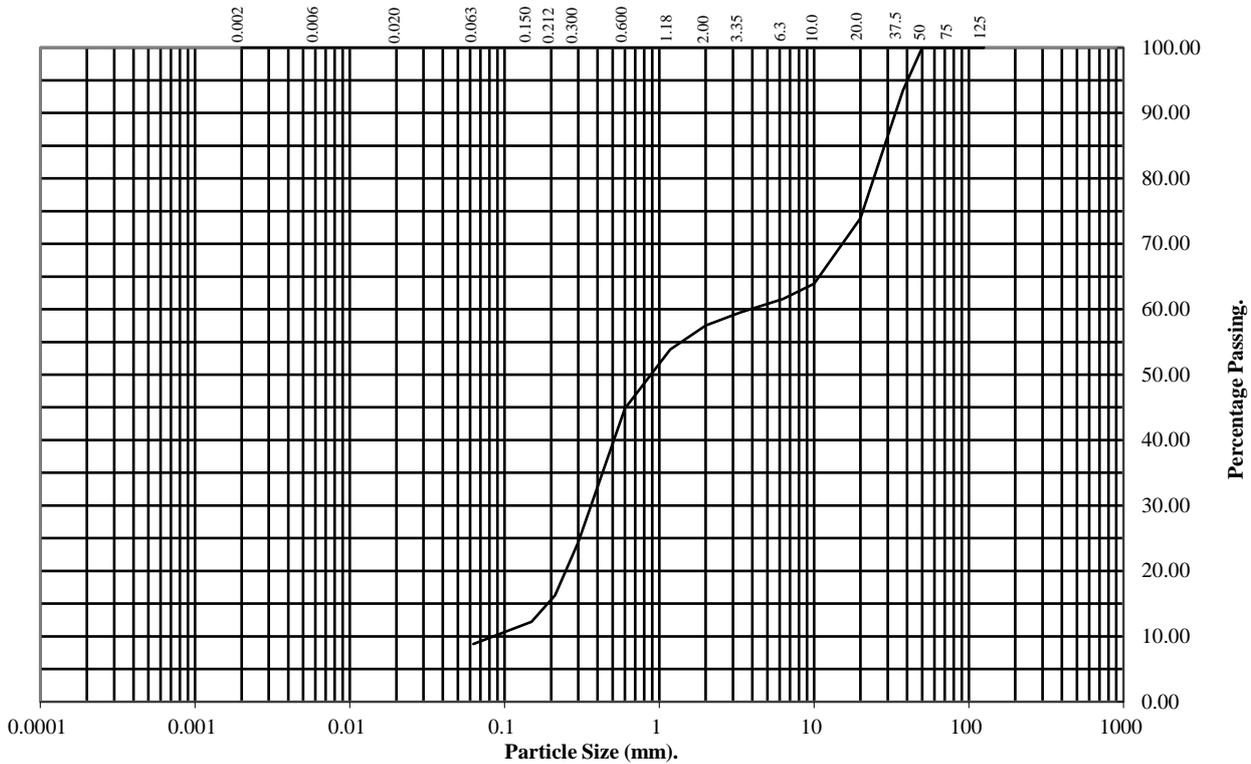
BS Test Sieve (mm)	Percentage Passing
125	100
75	100
50	100
37.5	93
20	74
10	64
6.3	62
3.35	60
2	58
1.18	54
0.6	45
0.3	24
0.212	16
0.15	12
0.063	9

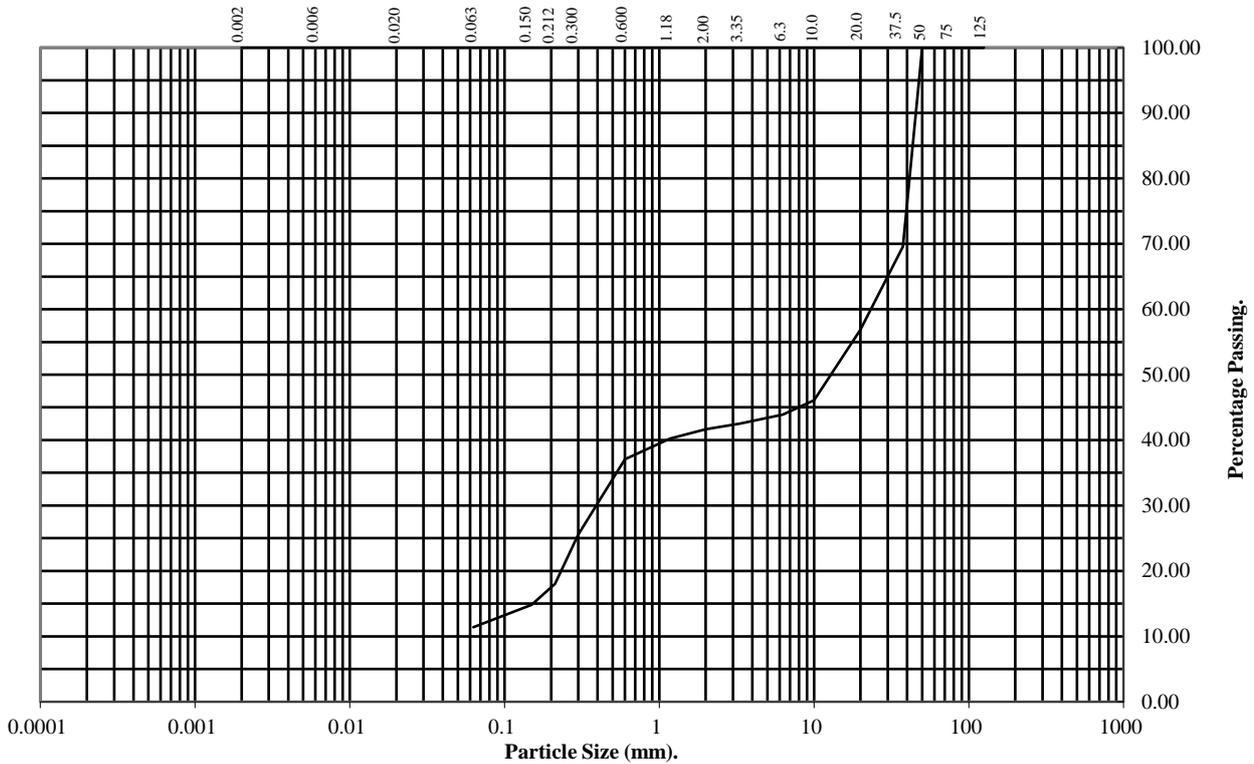
BS Test Sieve (mm)	Percentage Passing
125	100
75	100
50	100
37.5	70
20	57
10	46
6.3	44
3.35	43
2	42
1.18	40
0.6	37
0.3	26
0.212	18
0.15	15
0.063	11

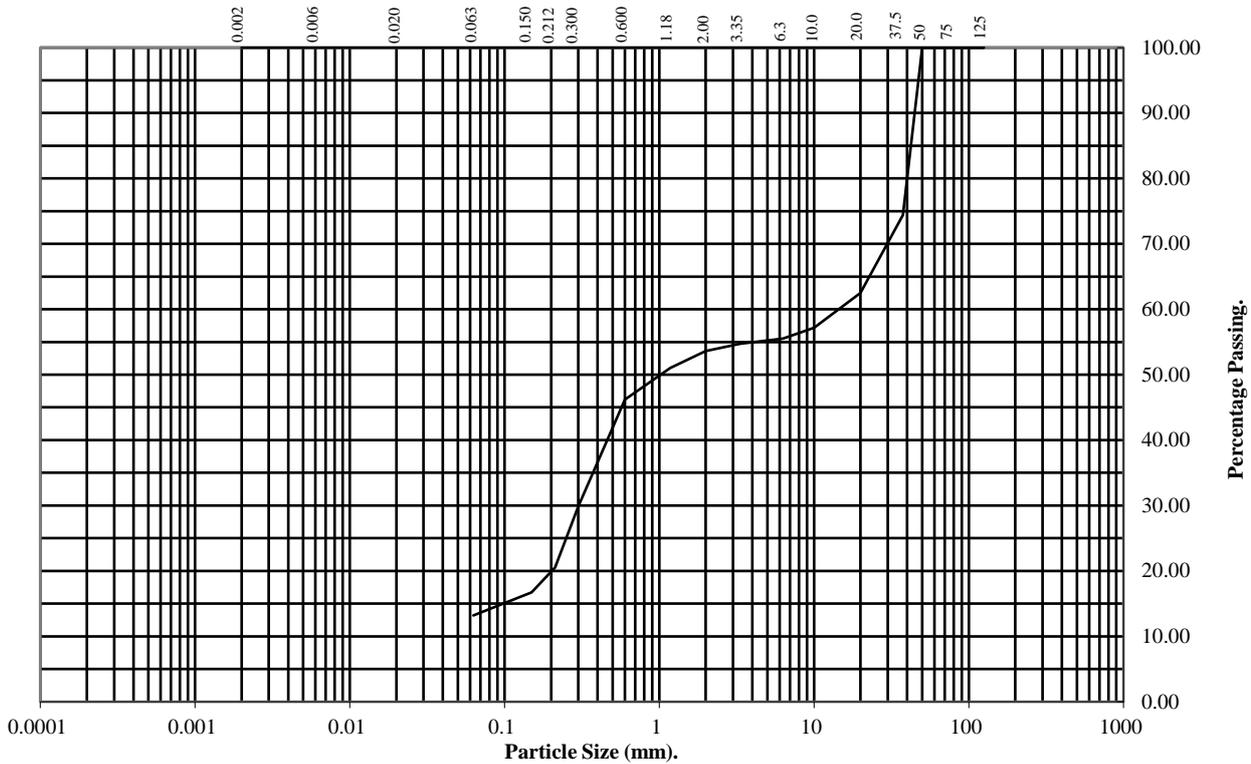
BS Test Sieve (mm)	Percentage Passing
125	100
75	100
50	100
37.5	74
20	62
10	57
6.3	55
3.35	55
2	54
1.18	51
0.6	46
0.3	30
0.212	21
0.15	17
0.063	13
