Land at Roslyn Avenue, Netherton For KCS Developments Ltd

Report no: 5080/1

Date: July 2024

SUMMARY OF GEOENVIRONMENTAL ISSUES

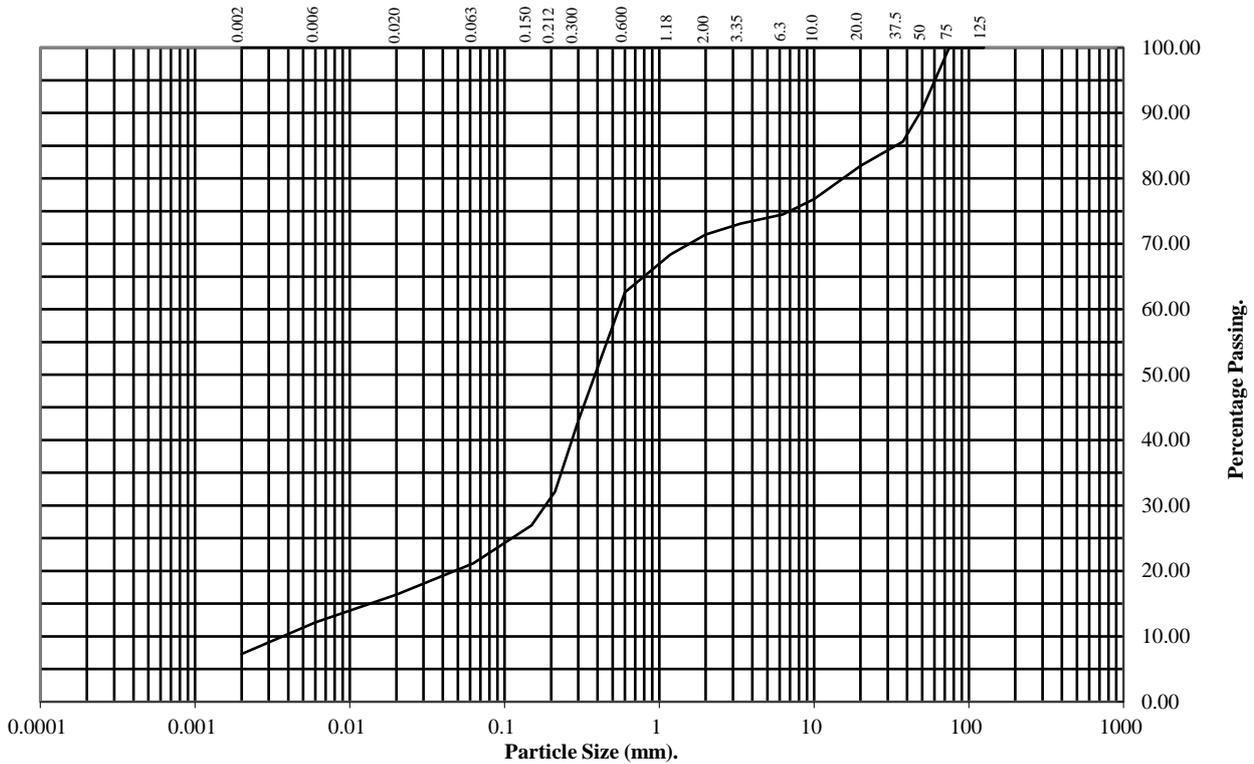
BS Test Sieve (mm)	Percentage Passing
125	100
75	100
50	91
37.5	86
20	82
10	77
6.3	74
3.35	73
2	71
1.18	68
0.6	63
0.3	43
0.212	32
0.15	27
0.063	21

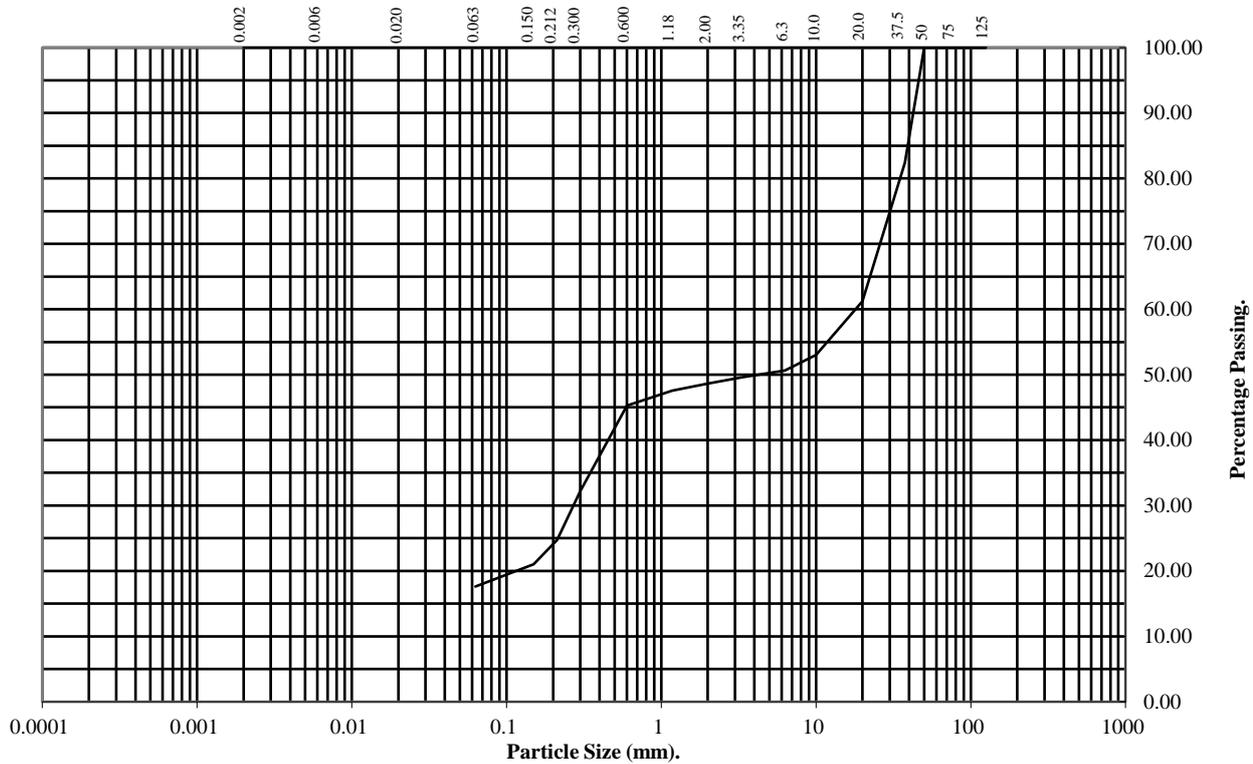
BS Test Sieve (mm)	Percentage Passing
125	100
75	100
50	100
37.5	82
20	61
10	53
6.3	51
3.35	50
2	49
1.18	48
0.6	45
0.3	32
0.212	25
0.15	21
0.063	18

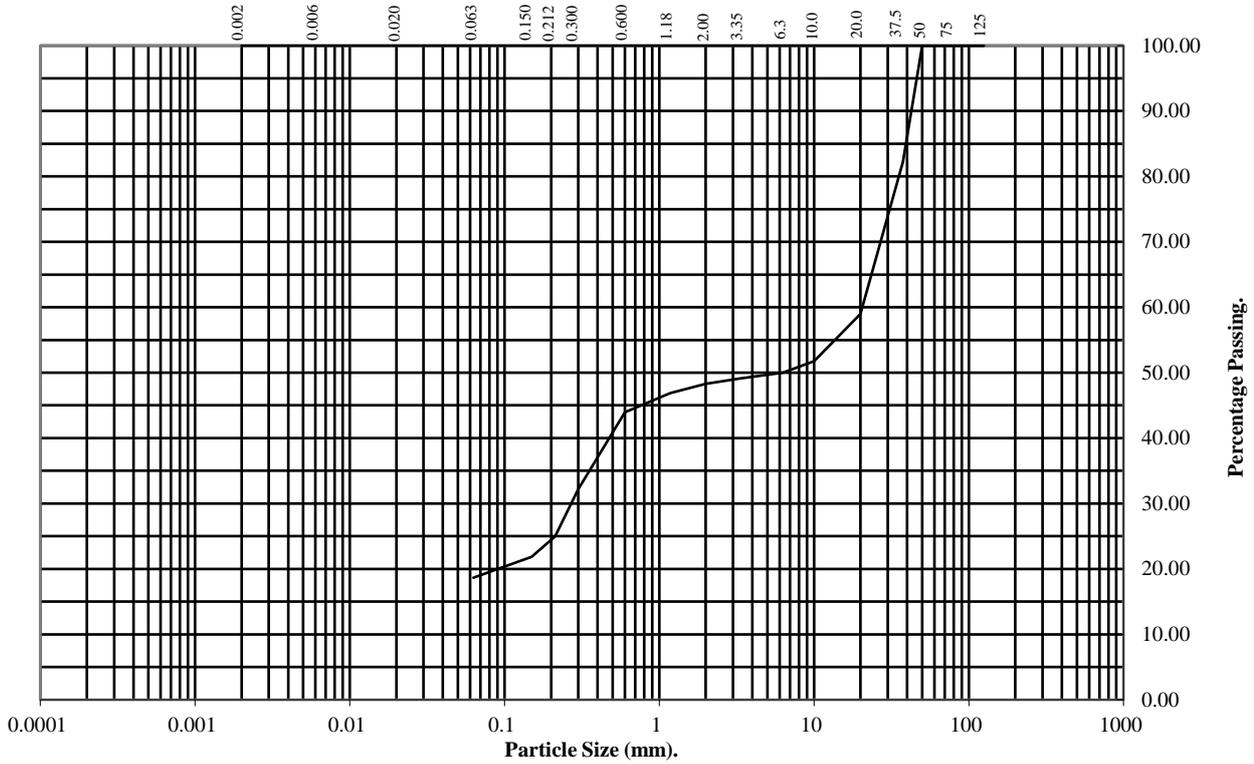
BS Test Sieve (mm)	Percentage Passing
125	100
75	100
50	100
37.5	82
20	59
10	52
6.3	50
3.35	49
2	48
1.18	47
0.6	44
0.3	32
0.212	25
0.15	22
0.063	19
