**Surface Water Management Plan**  
**Roslyn Avenue, Netherton**  
**Harron Homes (Yorkshire) Ltd**

| <b>Title</b> | Surface Water Management Plan | | |

SURFACE WATER MANAGEMENT PLAN

ROSLYN AVENUE, NETHERTON

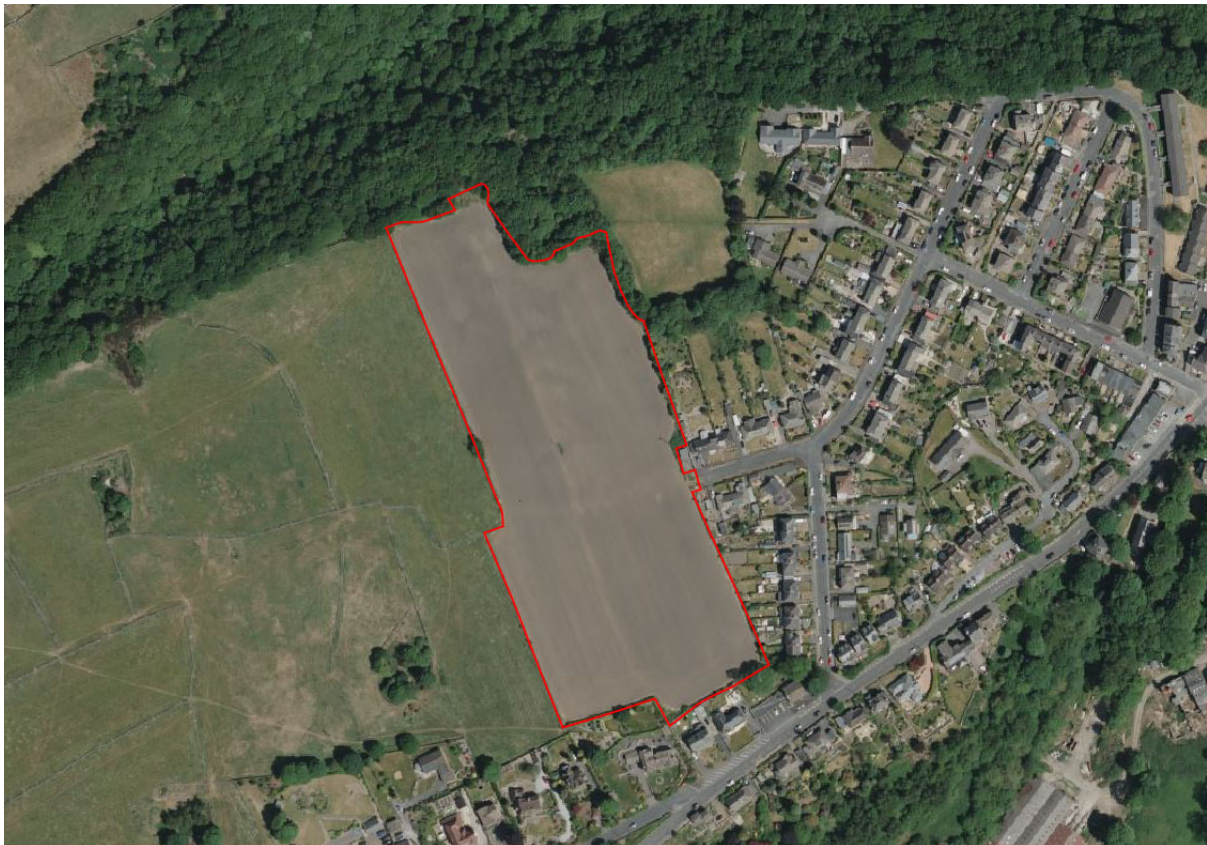
Figure 1 – Site Location Plan

The site is located off Roslyn Avenue, Netherton and is centred about Ordnance Survey Grid Reference 411974, 413060. The site is roughly rectangular in shape orientated in a North South direction. The site occupies an area of approximately 3.499ha. Figure 1, below, shows the site location and boundary.

The site is currently undeveloped grassland which is accessible via a gated entrance of Roslyn Avenue located to the East of the site. The site bound to the North by mature woodland. The Southern and Eastern boundaries are defined by established fence lines over which are existing residential properties. The Western boundary is defined by dry stone wall with access to the land to the West. The land to the West is undeveloped grassland / agricultural land.

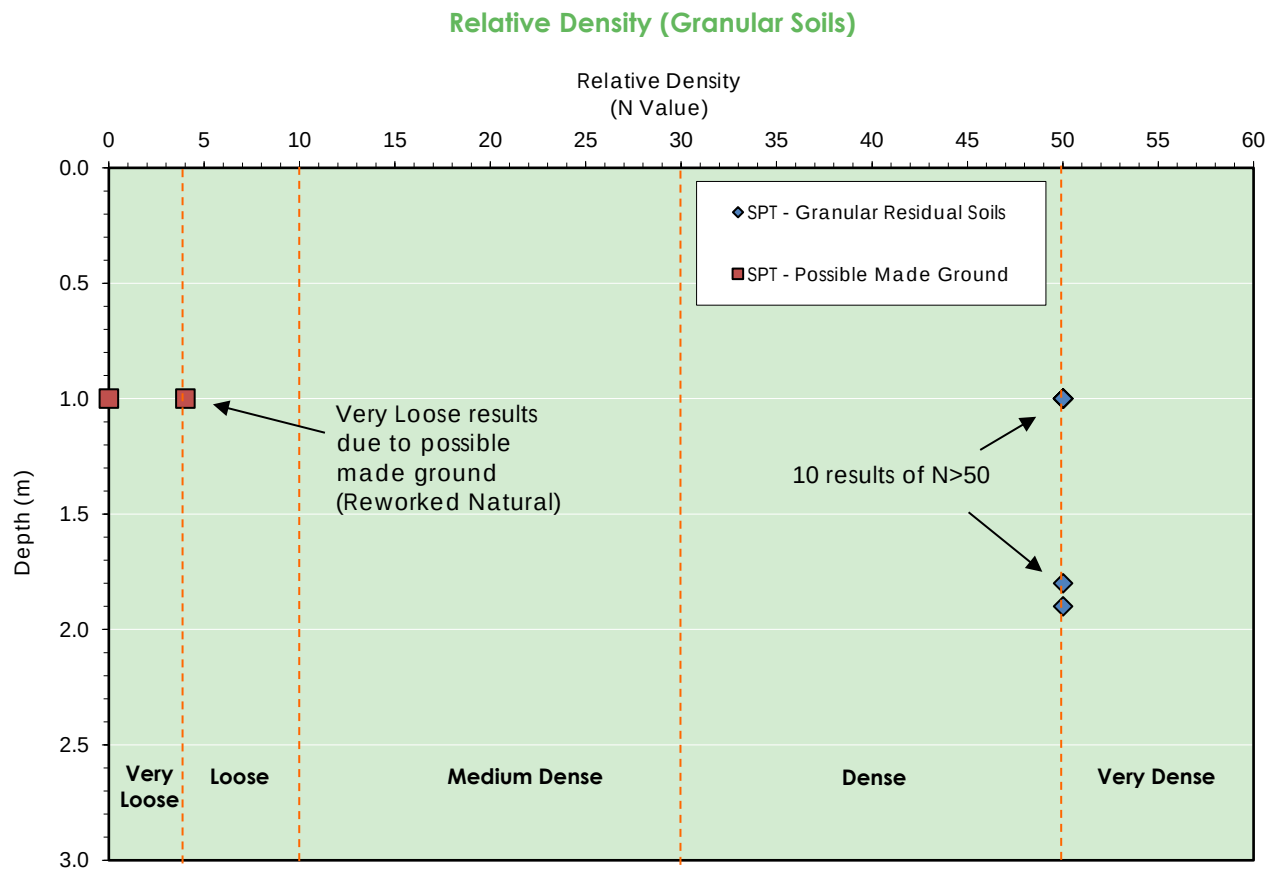
- 13.5.3 The plot below presents a summary of SPT 'N' values.

- 13.5.4 All of the SPTs (excluding the two within the possible made ground) within the Granular Residual Soils returned N values of N>50. These values are likely unrepresentative of the granular soils and are likely more representative of the underlying Sandstone bedrock.

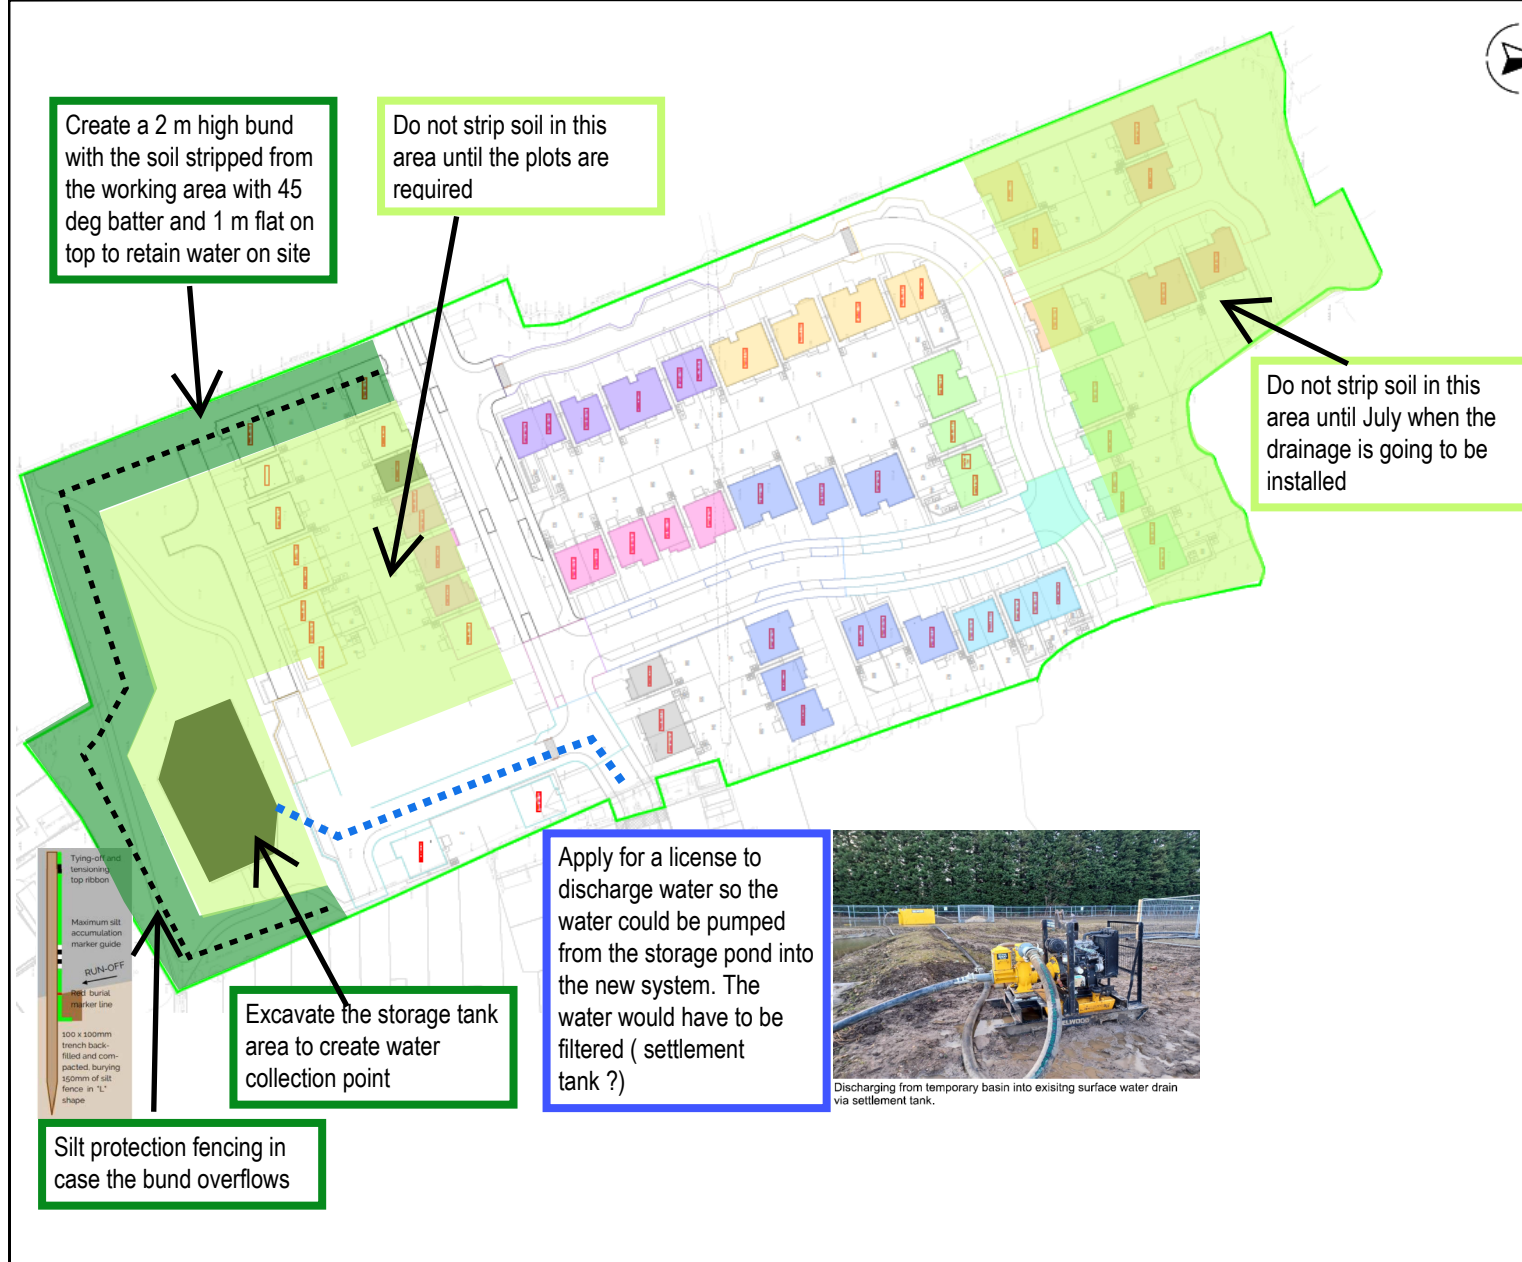
A plan produced by RJ Howard Engineering Ltd can be found in Appendix F showing the proposed measures to manage surface water runoff during construction.

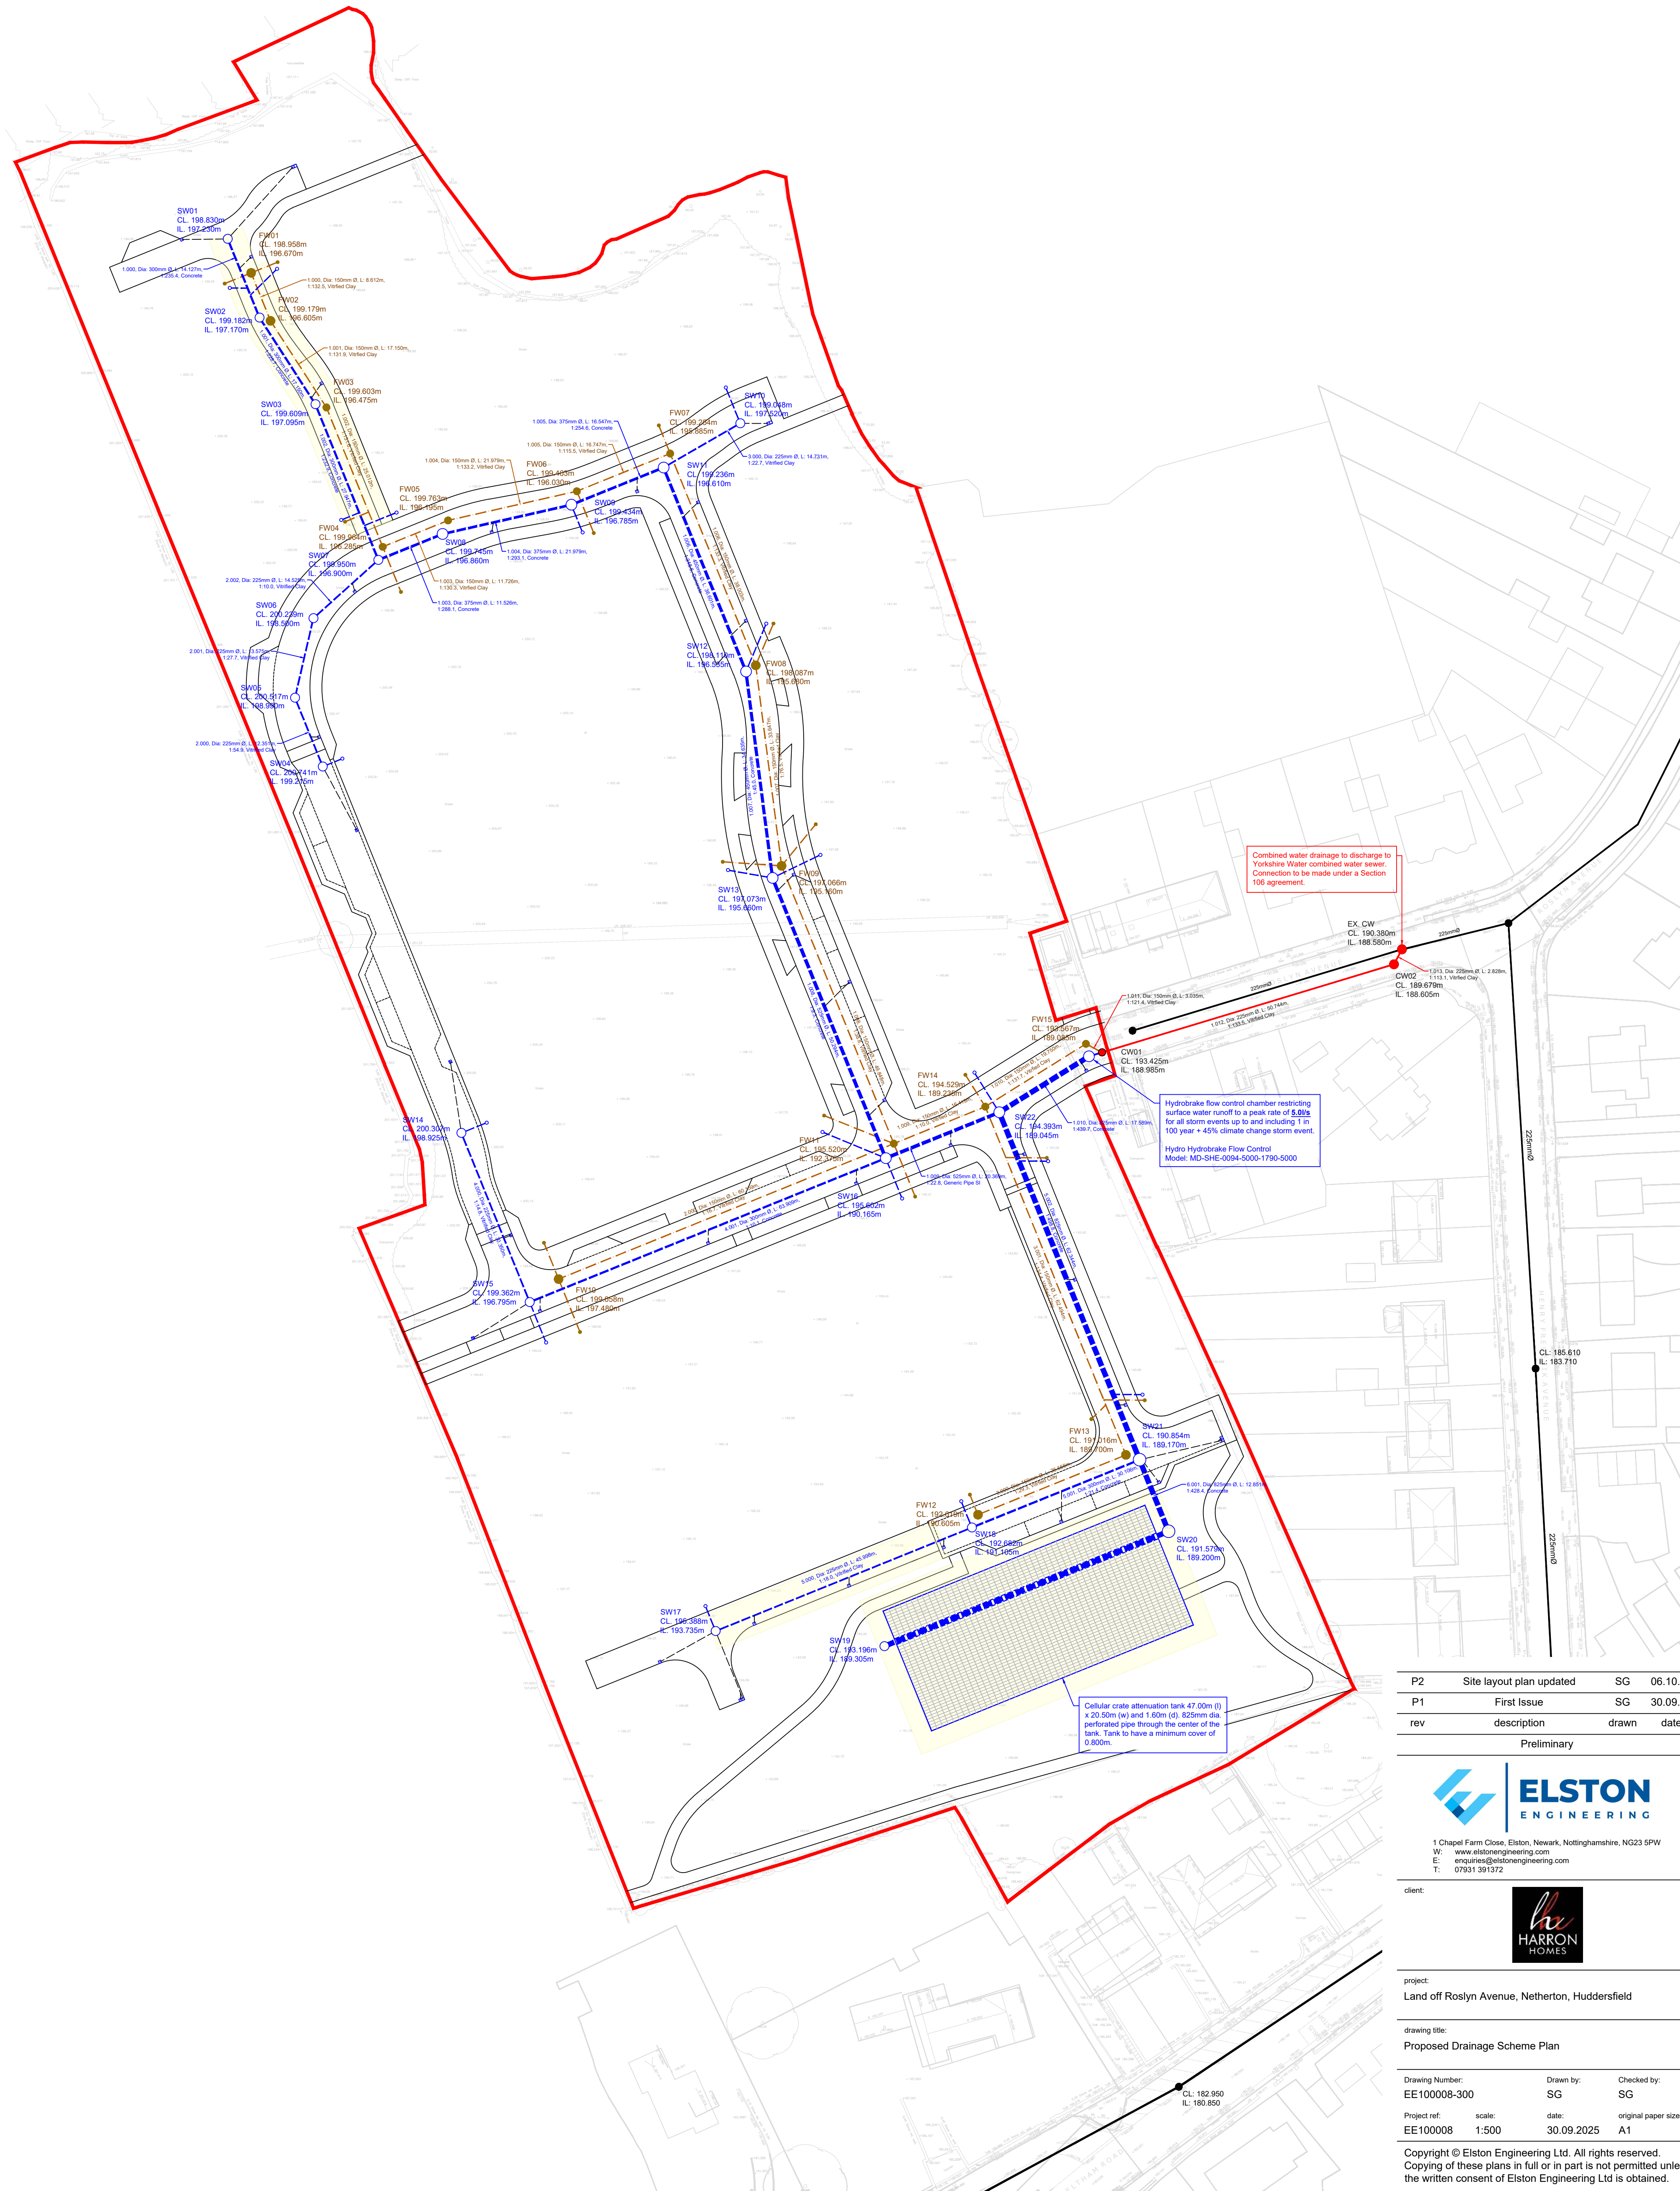
A copy of drawing EE100008-300 - Proposed Drainage Scheme Plan can be found in Appendix G showing the proposed foul and surface water drainage systems.

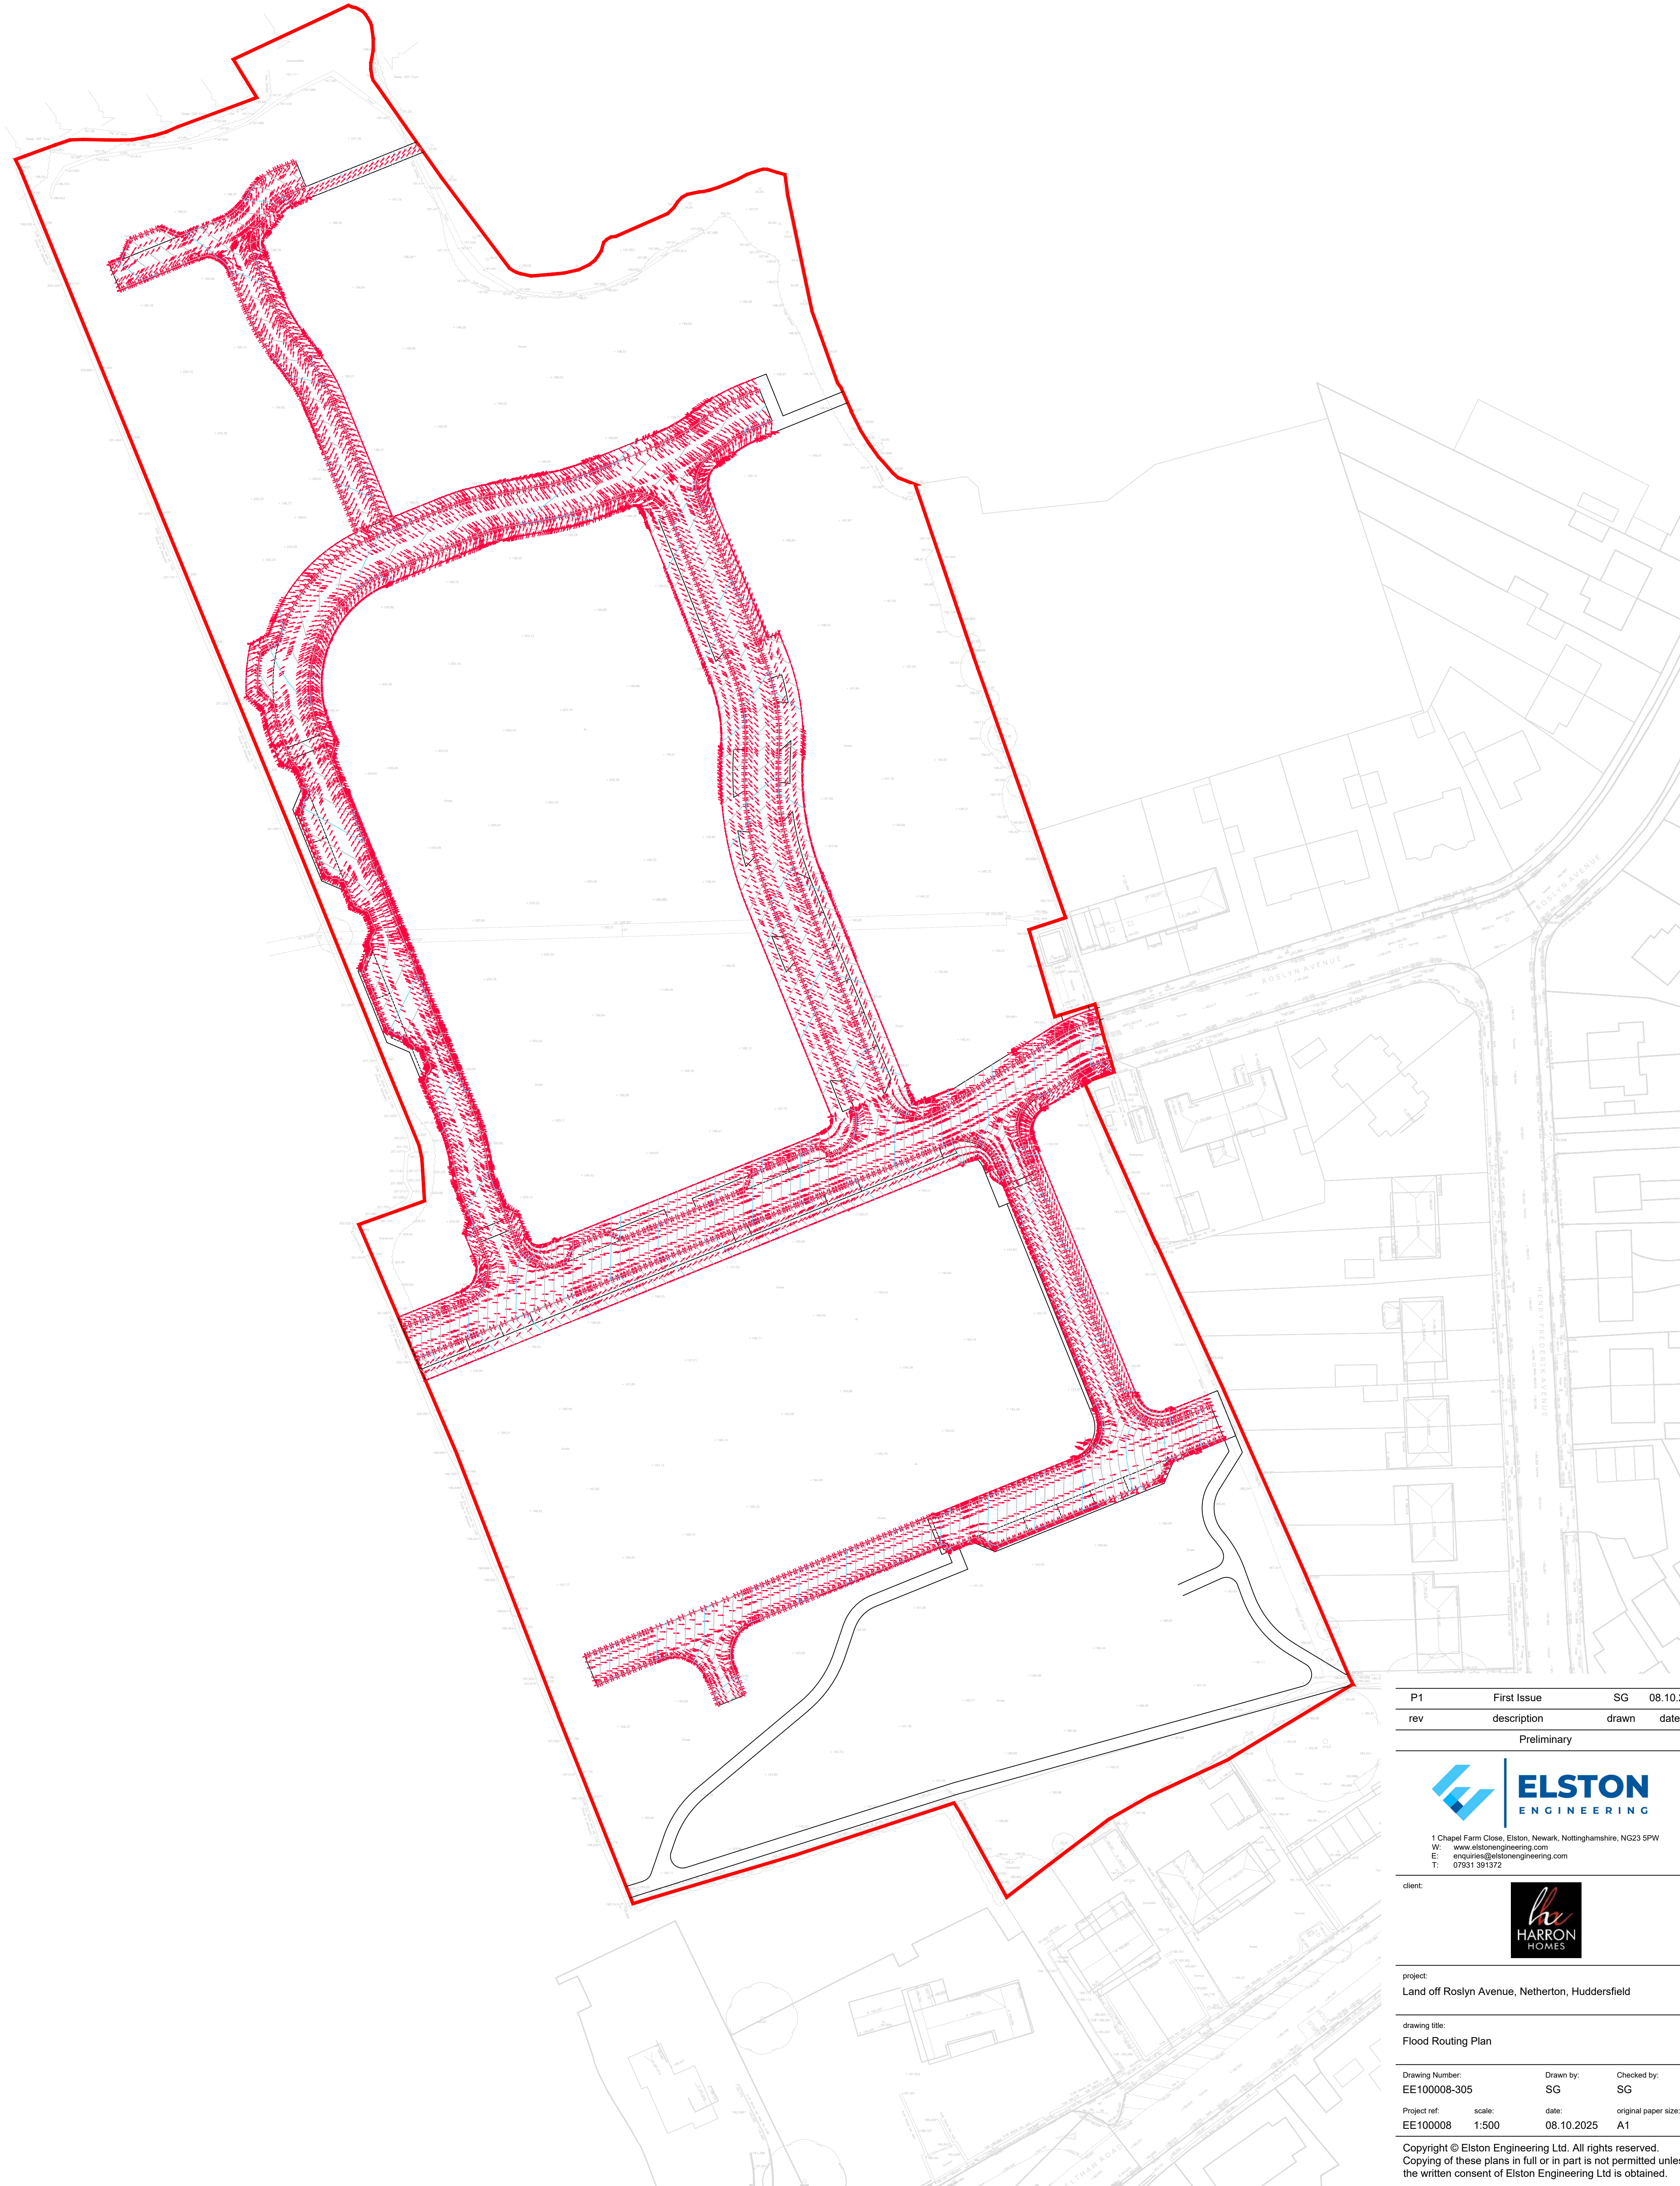
A copy of drawing EE100008-305 - Flood Routing Plan can be found in Appendix H which shows the direction of flows should there be an issue with the onsite surface water drainage system.

It is envisaged that the large public open space area to the South of the development would act as an interceptor for any flows and limit potential surface water runoff affecting the adjacent properties. If runoff is found to be high on site during the construction phase additional long-term measures can be incorporated along the site boundaries such as filter drains to intercept flows before they leave site.
