Phase I Coal Mining Risk Assessment

Premier Inn, Bradford South, Whitehall Rd, Dyehouse Dr, Cleckheaton BD19 6HG

CRM.1483.062.GE.R.001.A

Project:	Premier Inn, Bradford South, Whitehall Rd, Dyehouse Dr, Cleckheaton BD19 6HG
For:	Whitbread PLC
Ref:	CRM.1483.062.GE.R.001.A
Status:	Final
Date:	August 2024
Author:	Richard Hamilton Director of Geoenvironmental
Reviewer:	Steve Rhodes Director

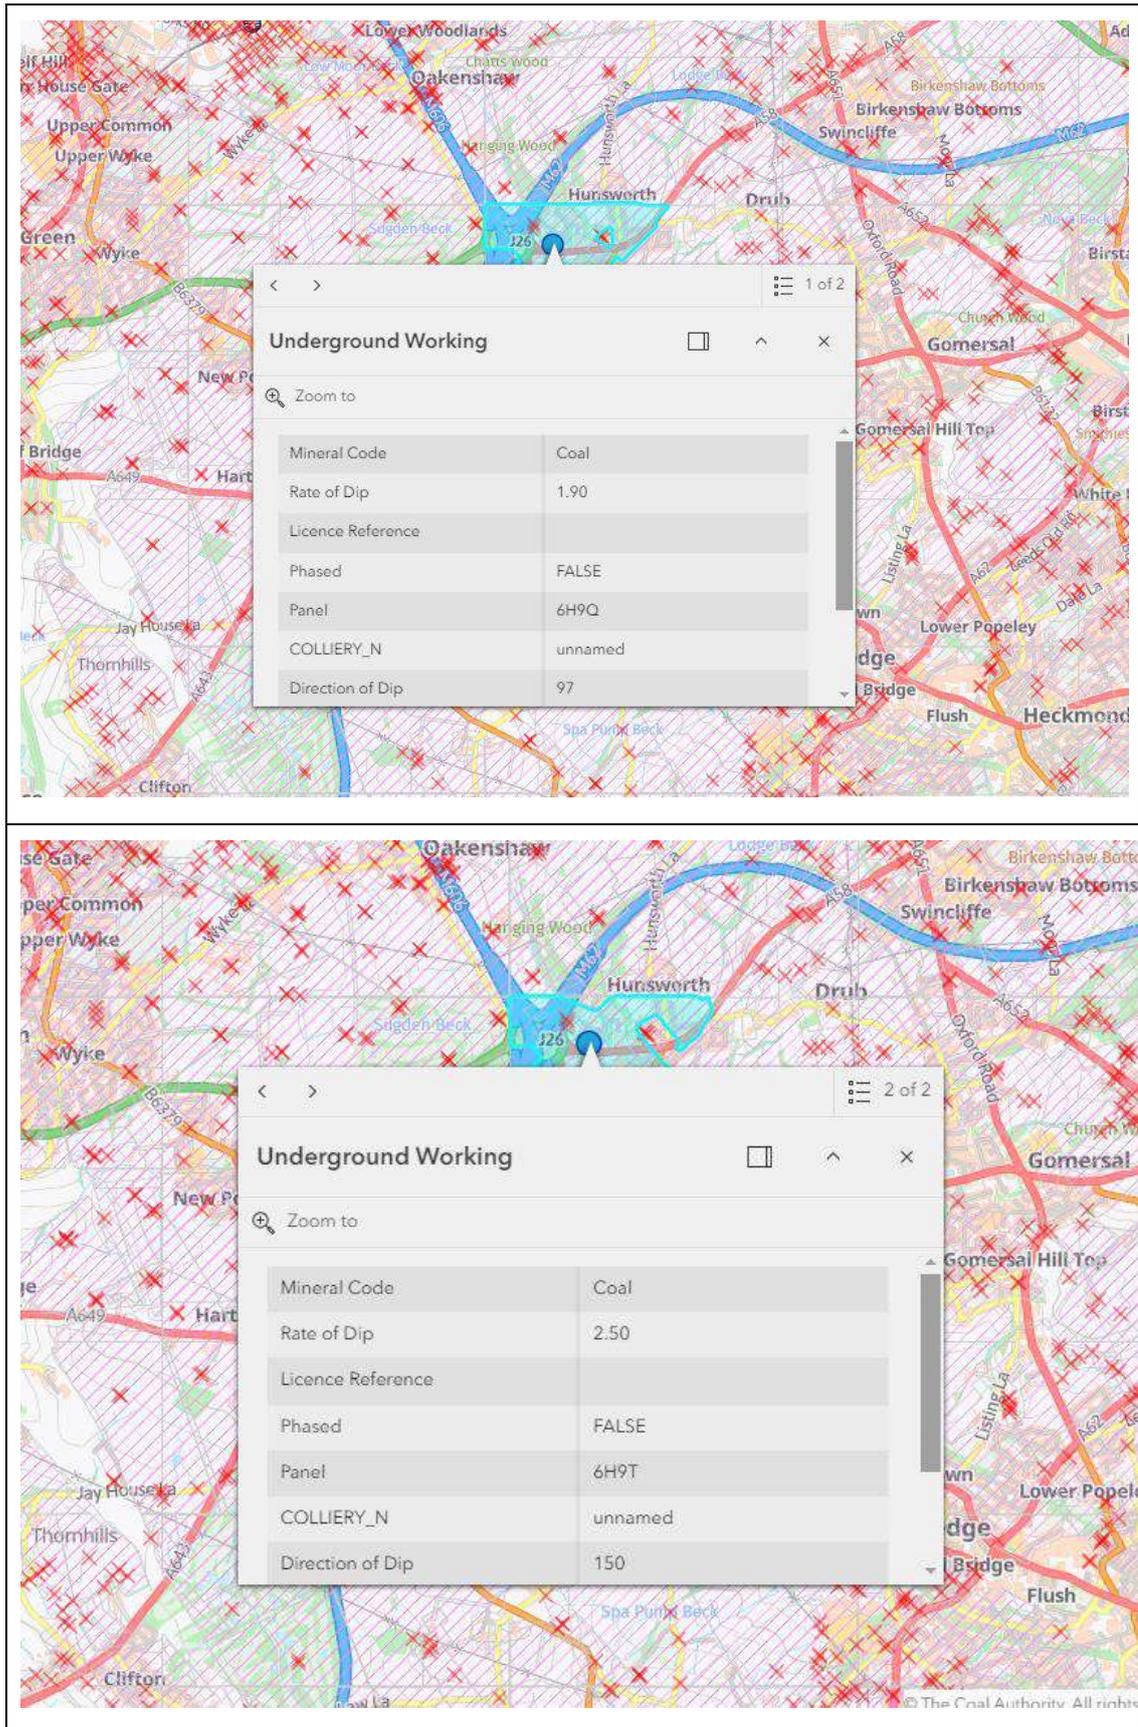
Table 5.3.6 Workings extent

5.3.7 The coal mining report has also recorded probable un-recorded shallow working which agrees with the Coal authority interactive website. The extent of the probable shallow workings is shown below and is likely to be related to the outcrop location 5m north west of the site.

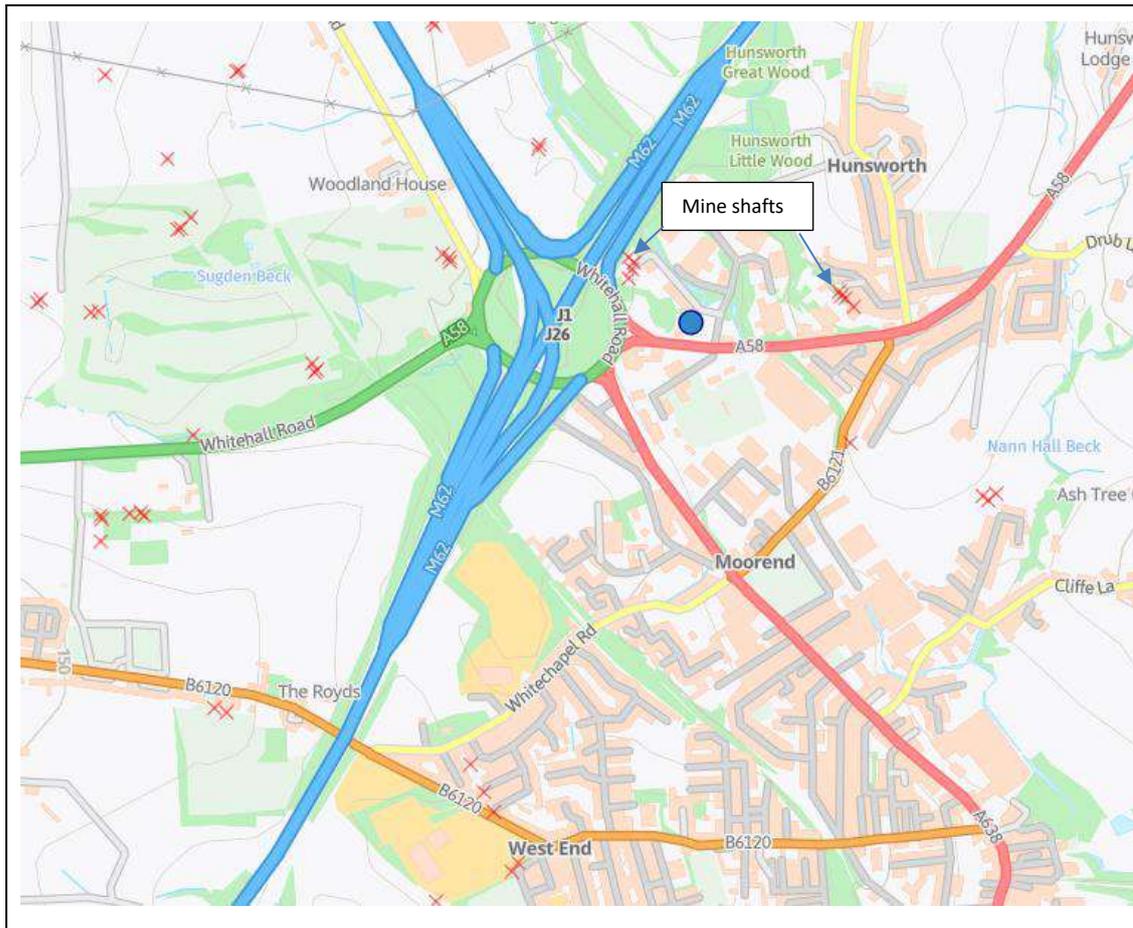
Table 5.3.8 Mine shaft location plan

5.3.8 There are no mine shafts within 100m of the site. The closest recorded mine shaft is shown 141m north west in the Coal Authority interactive website and the historical plans which is beyond the search criteria for the mining report. Given the distance to the site of the mine shaft recorded in the interactive website this is not considered a significant risk to the site.

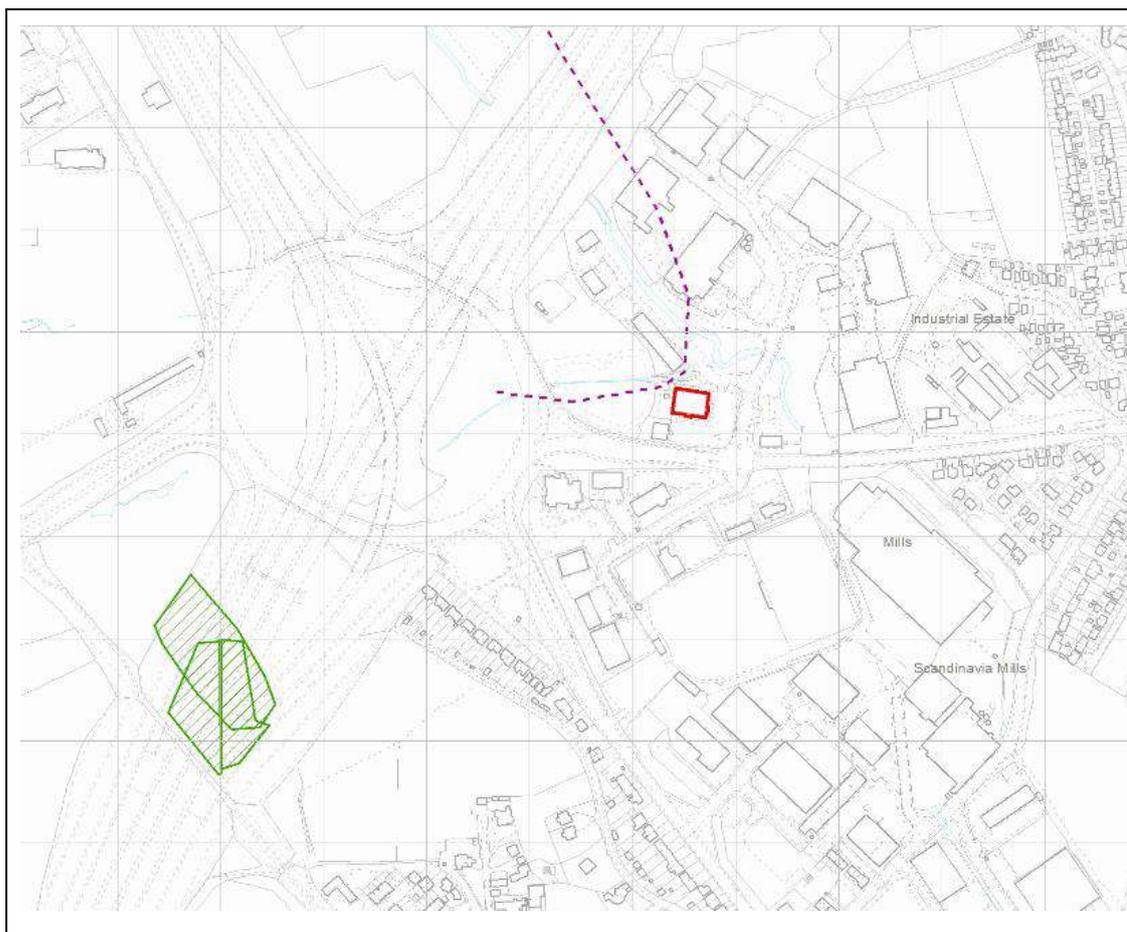
Table 5.3.11 Outcrop location and opencast sites

5.3.10 The coal authority confirms the name and distance of the outcrop to be the Little Coal and this is located 8.8m north west and has been worked which confirms the probable shallow workings confirmation and the coal authorities interactive website details.

5.3.11 No open cast coal mine sites with 500m of the site with the closest recorded in the coal mining report and the interactive coal authority website is 566m south west. Given the distance these are not considered a risk to the site.

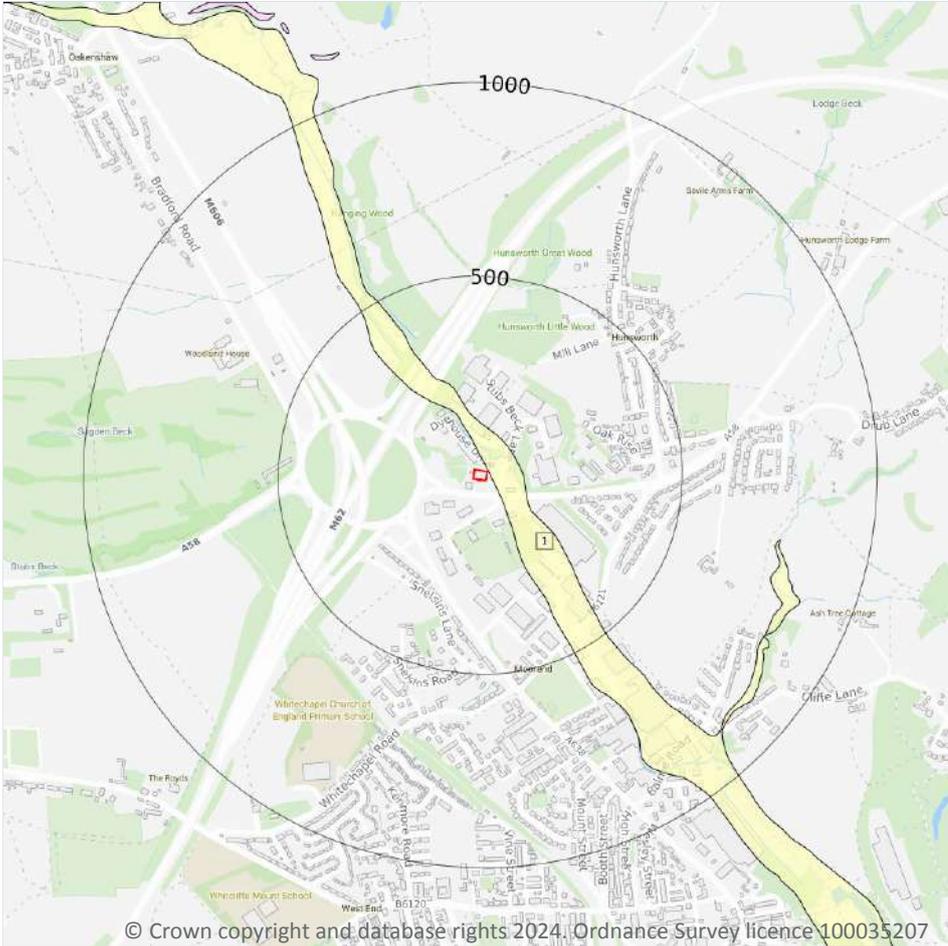
Geology 1:10,000 scale - Superficial

- Site Outline
- Search buffers in metres (m)
- Landslip (10k)
- Superficial geology (10k)
Please see table for more details.

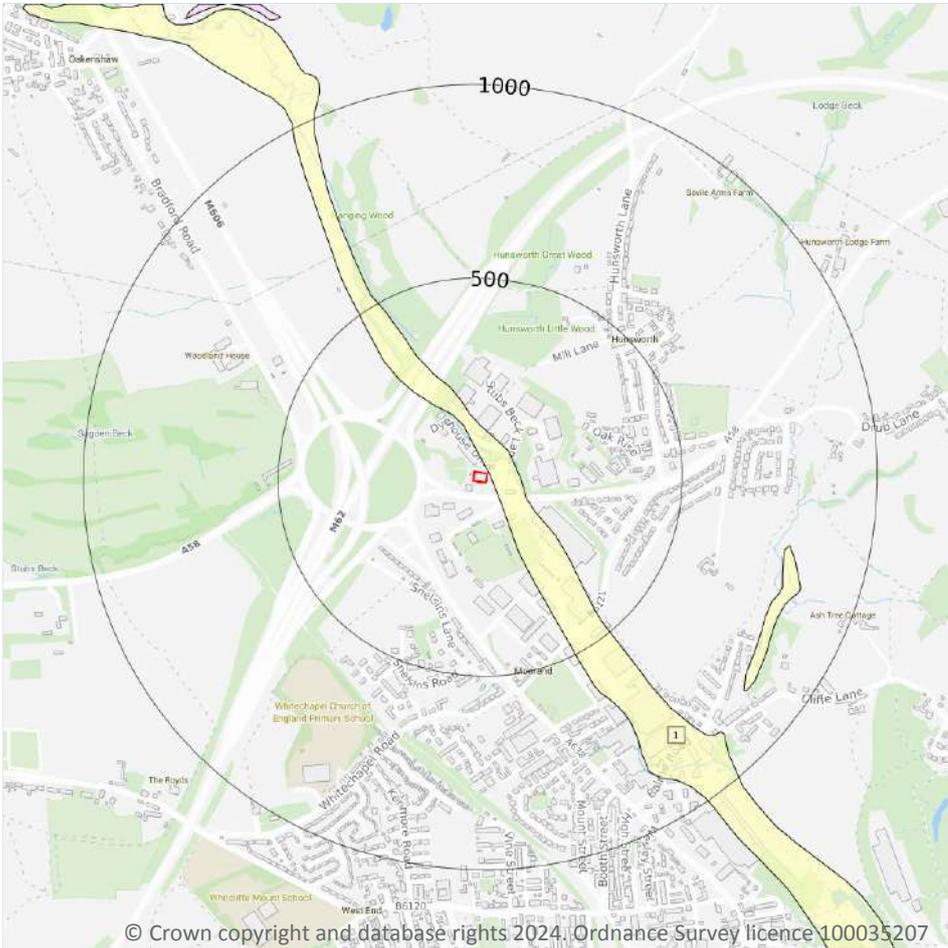
Geology 1:50,000 scale - Superficial

- Site Outline
- Search buffers in metres (m)
- Landslip (50k)
- Superficial geology (50k)
Please see table for more details.

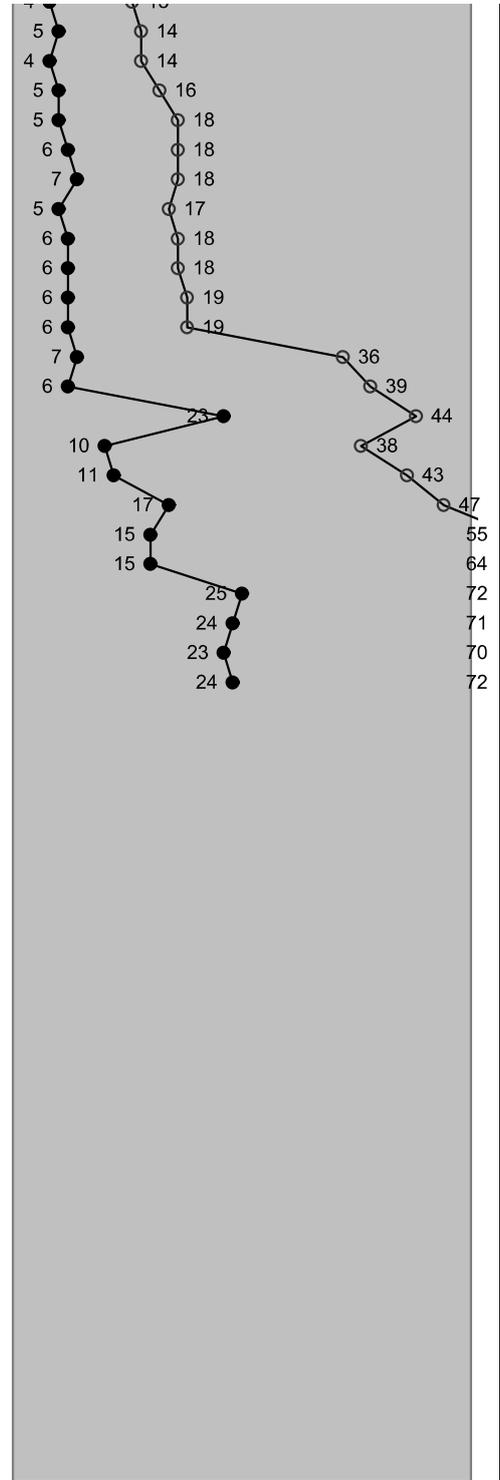
Super Heavy Dynamic Probe Test

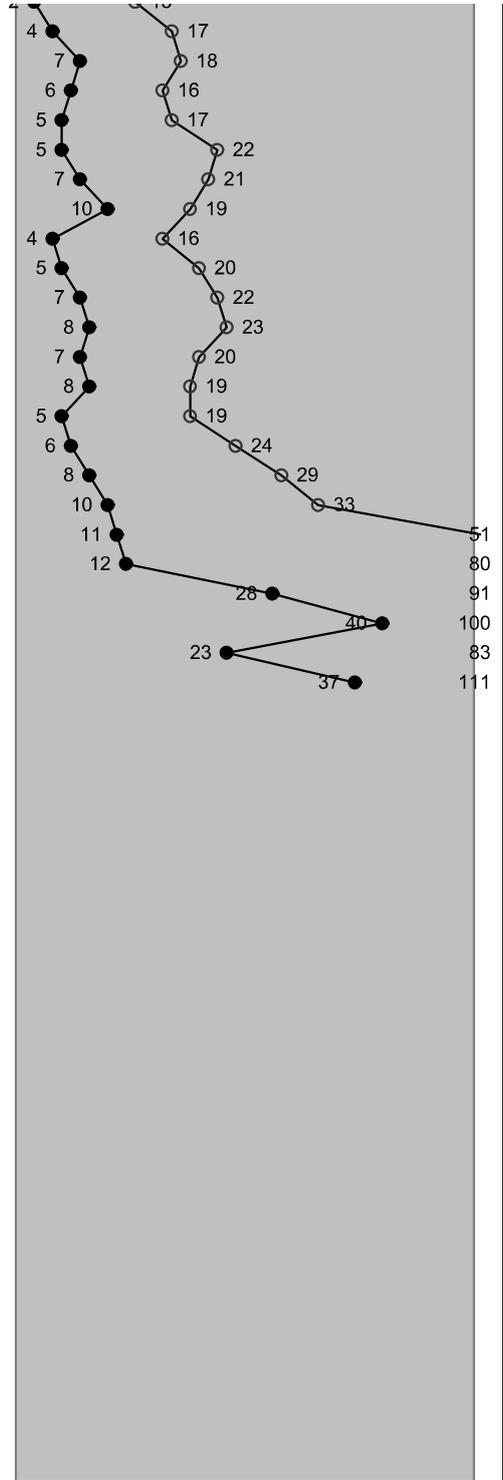
Super Heavy Dynamic Probe Test

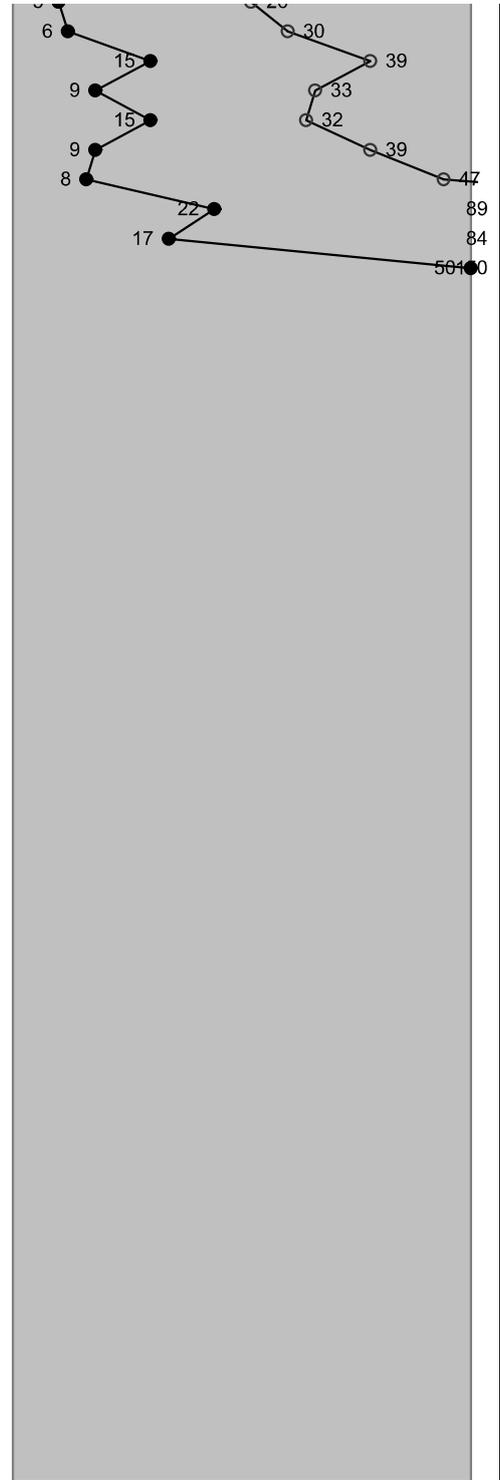
Super Heavy Dynamic Probe Test

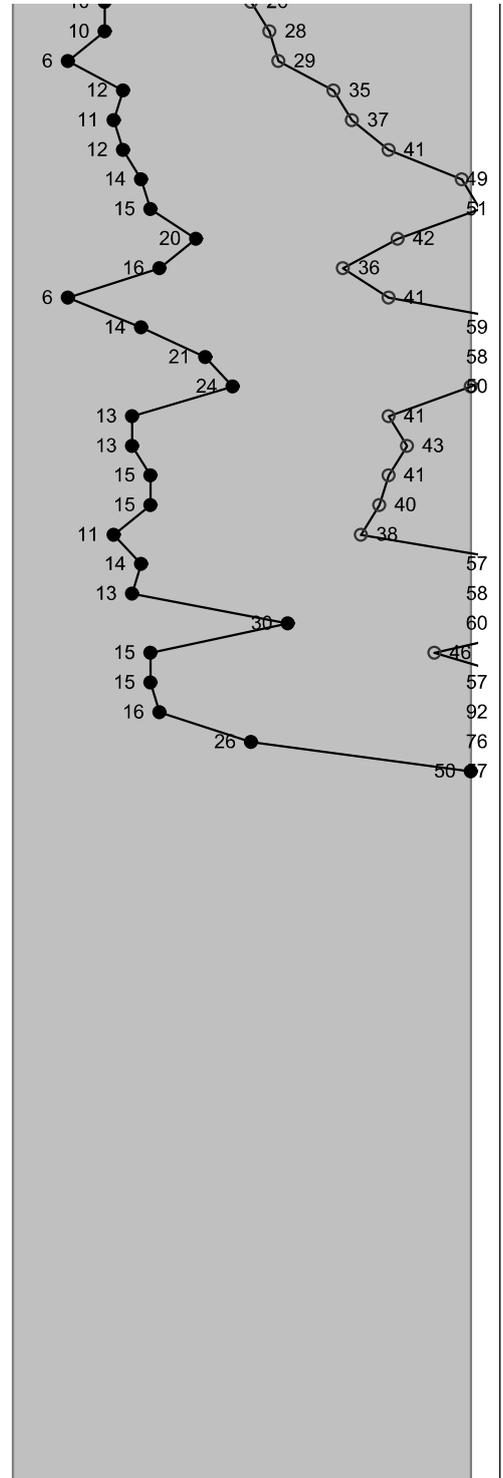
Super Heavy Dynamic Probe Test

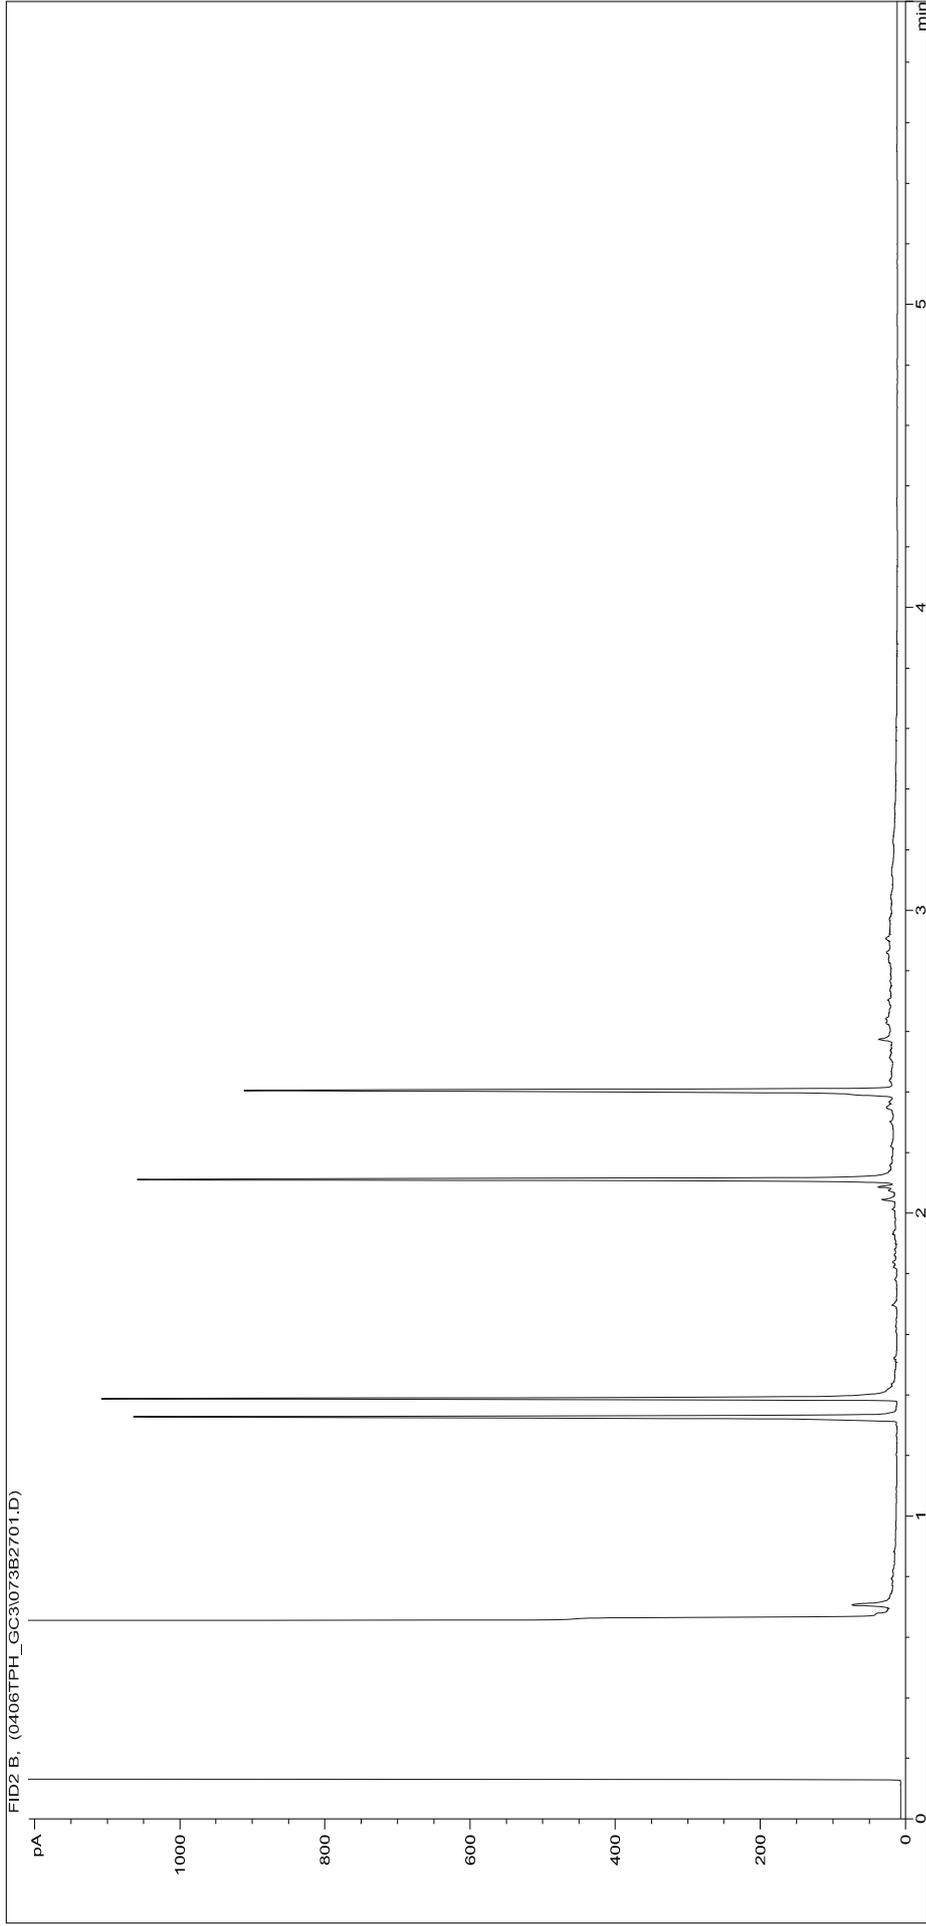
Petroleum Hydrocarbons (C8 to C40) by GC/FID

Sample ID: CL0907789	Job Number: S09_1829
Multiplier: 8	Client: Northern Foundations Ltd
Dilution: 1	Site: Cleckheaton
Acquisition Method: 5UL_RUNF.M	Client Sample Ref: WS1 0.6
Acquisition Date/Time: 06-Apr-09	
Datafile: D:\TESIDATA\Y2009\0406TPH_GC3\073B2701.D

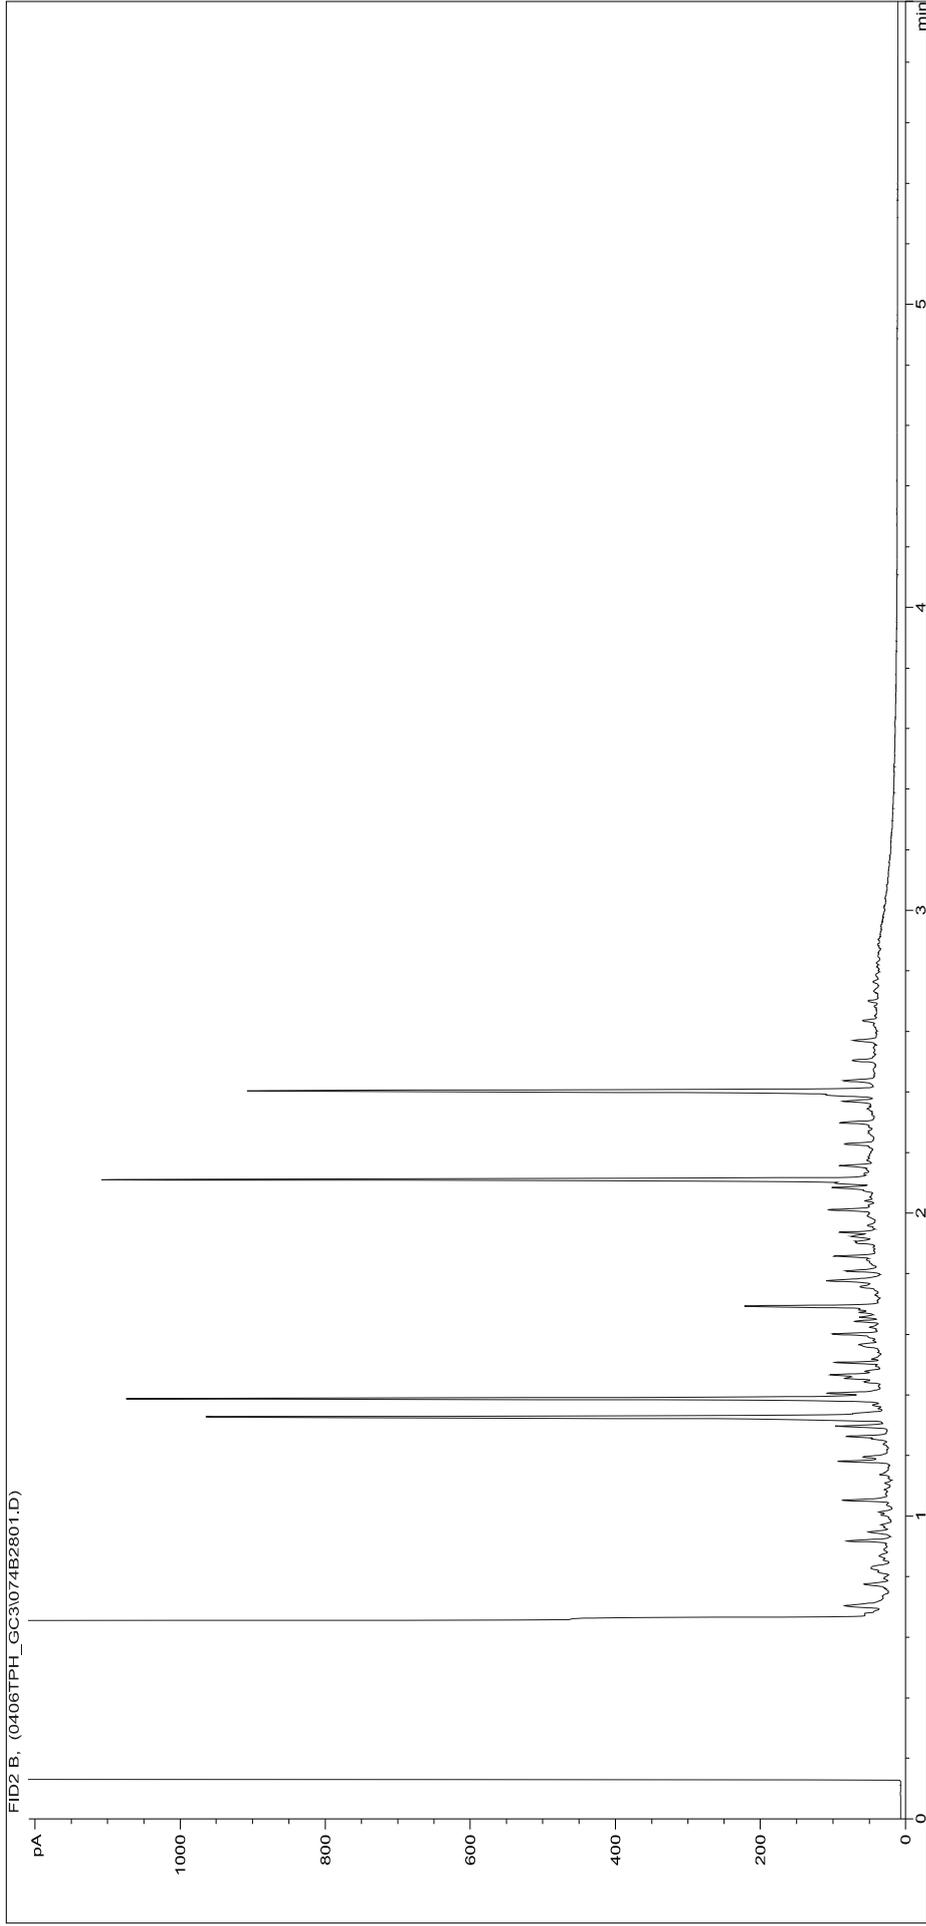
Petroleum Hydrocarbons (C8 to C40) by GC/FID

Sample ID:	CL0907792	Job Number:	S09_1829
Multiplier:	8	Client:	Northern Foundations Ltd
Dilution:	1	Site:	Cleckheaton
Acquisition Method:	5UL_RUNF.M	Client Sample Ref:	WS3 0.7
Acquisition Date/Time:	06-Apr-09		
Datafile:	D:\TESIDATA\Y2009\0406TPH_GC3\074B2801.D
