**274 Cumberworth Lane, Denby Dale**

**Ecological Impact Assessment**

**8<sup>th</sup> September 2025**

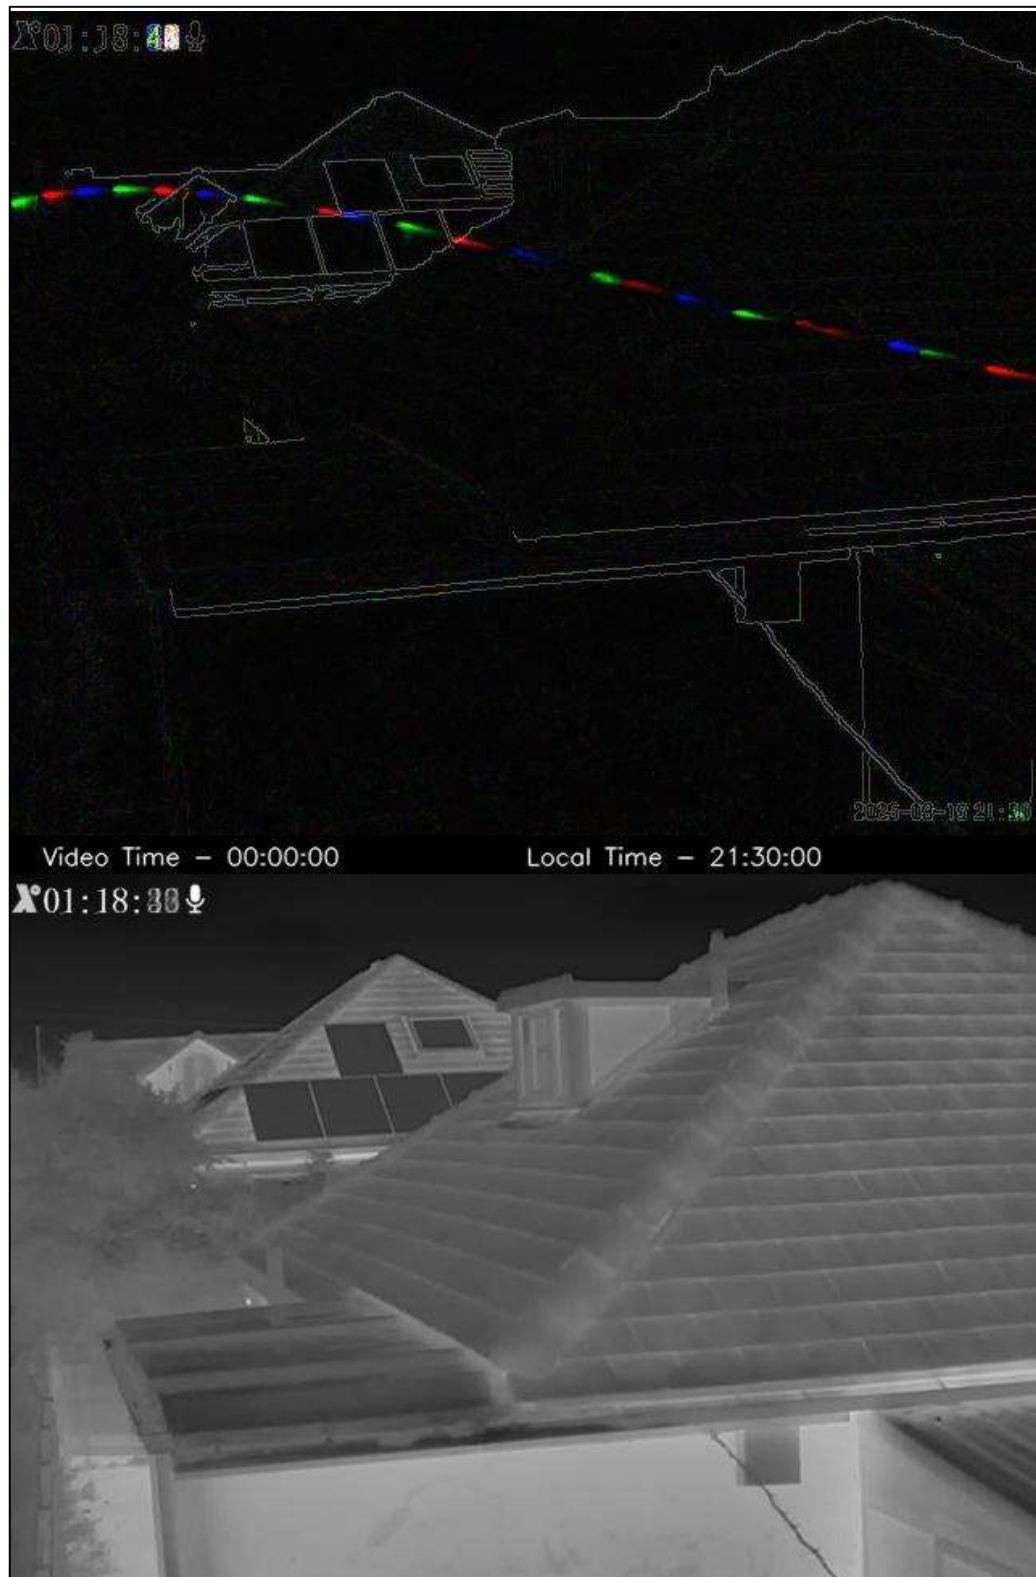
4.2.6 The camera footage from locations covered by surveyors was reviewed as required to check and confirm the observations made by the surveyors. The camera footage from unsupervised positions was initially analysed by Wildlife Imaging Systems. Their software identified all movement (frame by frame) within the videos and produced a set of images showing the movement traces for each 30 seconds of video. These images were then reviewed by Greg Slack and where the image identified a trace that could potentially have been a bat flight, the relevant section of the video was also reviewed. An example image produced by the software is shown in Plate 1.

Plate 1. An example image showing the flight path of a common pipistrelle as viewed from Surveyor Position 1

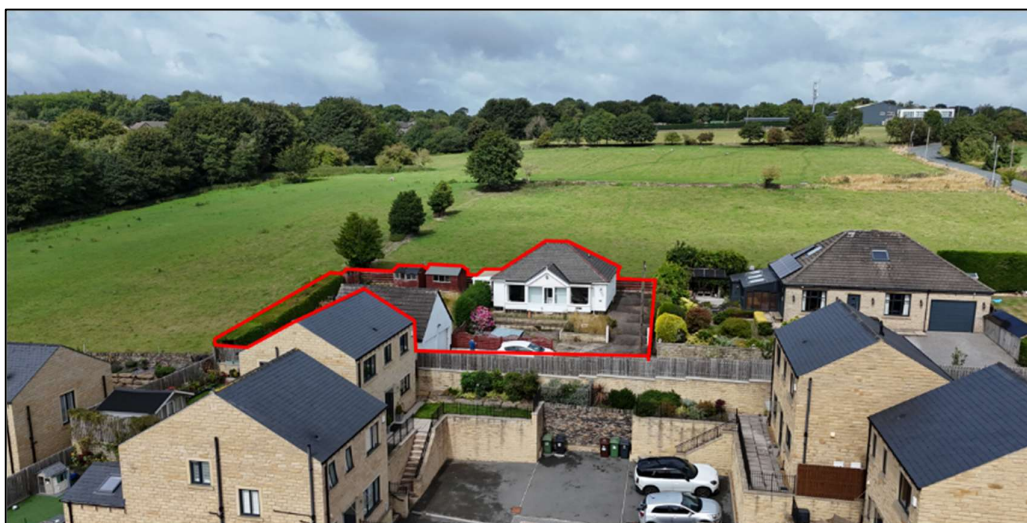
**Plate 2. The approximate survey area outlined in red, viewed from the southeast**

- 5.1.1 The site comprised a bungalow, garage, sheds and garden with two hedgerows (Plate 2).

- 5.1.2 The survey area was used by foraging but not roosting bats, common bird species (including for nesting) and was potentially suitable for use by hedgehogs, common amphibian species (but not likely to include great crested newts) and common invertebrate species.
- 5.1.3 The populations of bats and birds using the site were considered to potentially be of up to local importance. All other habitats and species present were considered to be of no greater than Site level importance.
- 5.1.4 A plan of the habitats recorded within the site is given as Appendix 3 with a list of plant species recorded during the survey given in Appendix 4.

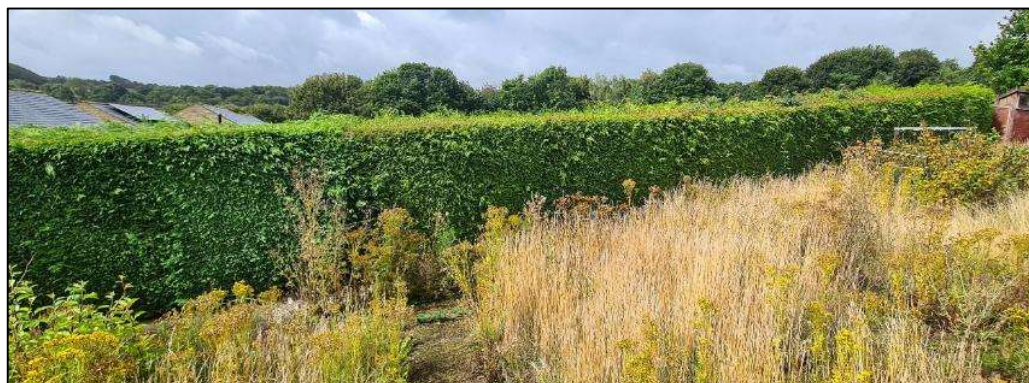
- 5.3.1 Two hedgerows were present within the site, both comprising non-native and ornamental hedgerows.
- 5.3.2 Hedgerow 1 comprised a Leyland cypress *Cupressus × leylandii* hedge located on the southwest boundary of the site. The hedge was c. 2 m high and 1 m wide (Plate 3).

**Plate 3. Hedgerow 1 viewed from the east**

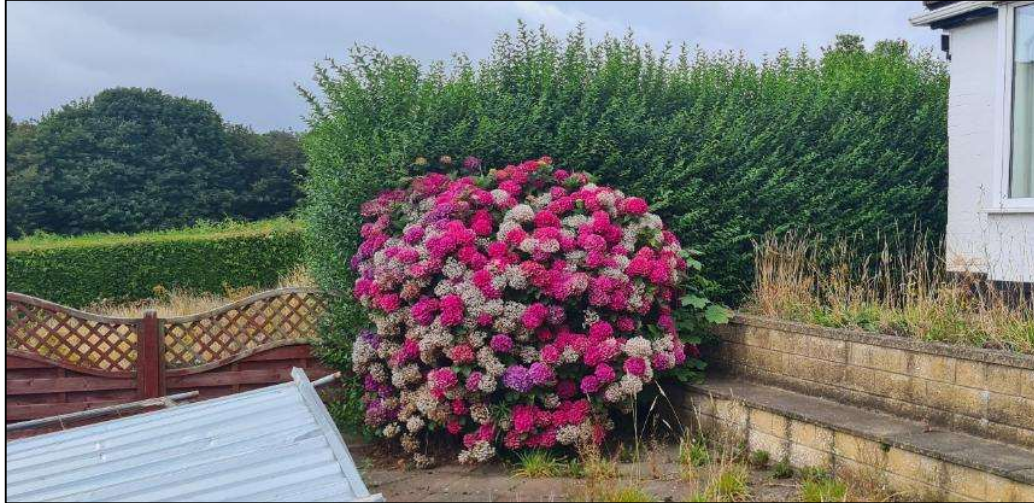
- 5.3.3 Hedgerow 2 was dominated by garden privet *Ligustrum ovalifolium* although also included rowan *Sorbus aucuparia* and a French hydrangea *Hydrangea macrophylla* (Plate 4). This hedgerow partially divided the plot running from the south corner of Building 1 approximately two thirds of the way to the north corner of Building 2. The

hedge was c. 3 m high and 1.5 m wide.

**Plate 4. Hedgerow 2 viewed from the east**

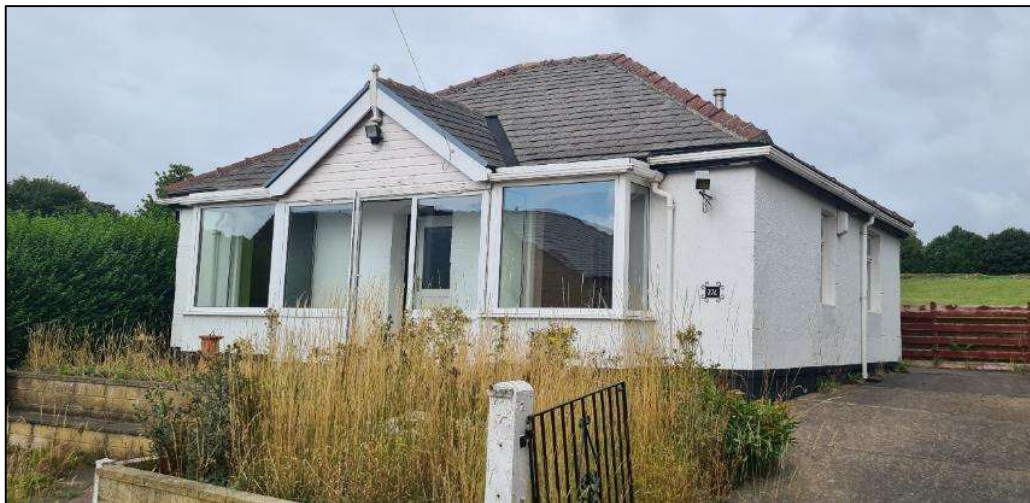
- 5.3.4 Two buildings were present within the site. The buildings comprised a dwelling (B1), and detached garage (B2). Three sheds (B3 – B5) were also present on site (Appendix 3).
- 5.3.5 The dwelling was a bungalow constructed from brick and render with a two -pitched, hipped roof with additional dormer above the front door, and a second at the rear of the building (Plate 5 and 6). The roof was covered with Welsh slate and angle cap ridge tiles. The rafters were exposed at the eaves. The dormer over the door had wooden cladding and a pitched roof. The rear dormer had a flat roof covered with sheet lead.
- 5.3.6 A flat roofed porch was present at the rear (north) with a conservatory on the southwest side of the building. The roof of the porch was also covered with sheet lead and the windows were framed with uPVC.

**Plate 5. The façade (southeast elevation) and side (northeast elevation) of B1**

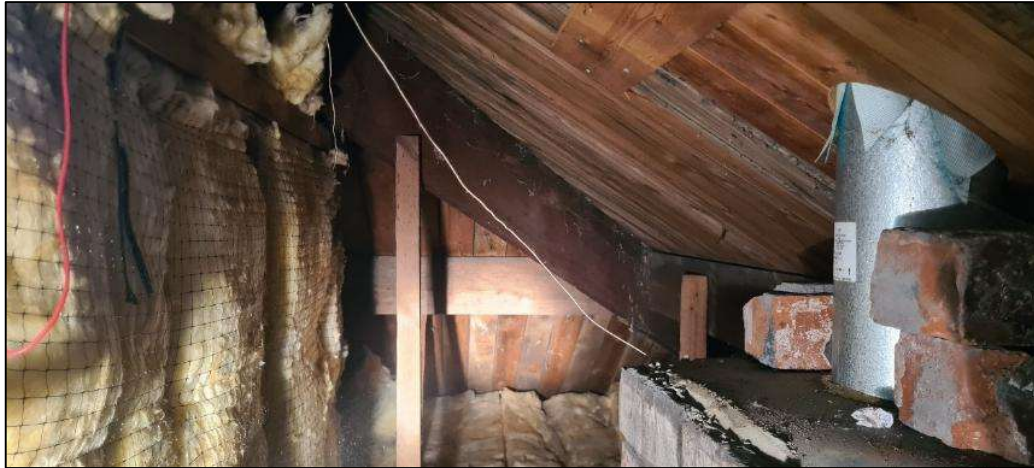
- 5.3.7 A bedroom was present in the attic with a vaulted ceiling and rear dormer window. A void used for storage had been retained within the eaves (Plate 7). The roof was supported by purlins and rafters. The slates were backed by a breathable membrane (Proctor Roofshield) with timber sarking below.

**Plate 7. The eaves storage space within B1**

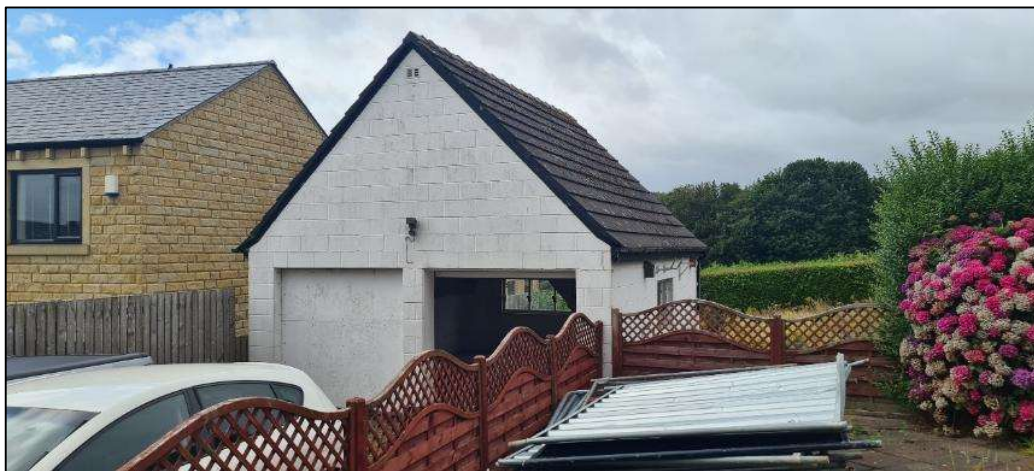
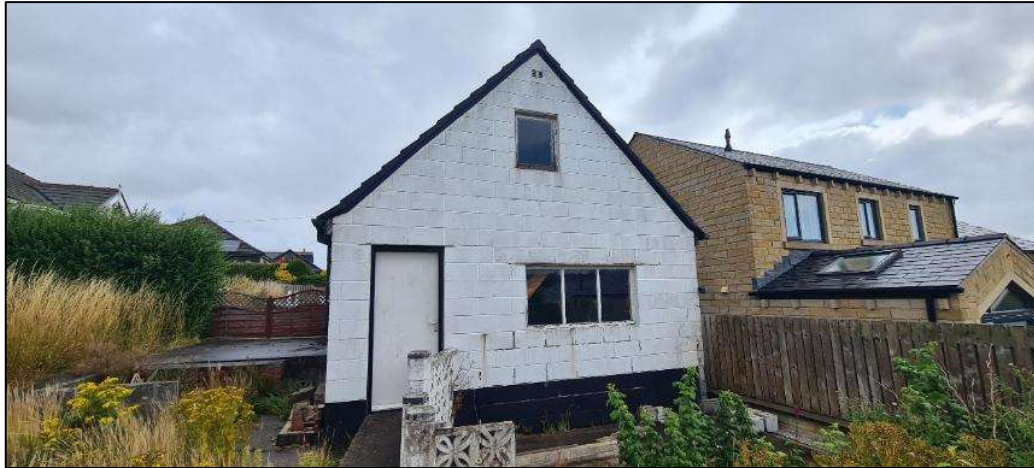
5.3.8 Building 2 was a detached double garage with a first floor storage area. The building was constructed from concrete blocks with a steep two-pitched roof. The roof was covered with interlocking concrete tiles and angle cap ridge tiles. A soffit box enclosed the eaves. The windows had wooden frames and one roller door was present on the northeast elevation (Plate 8 & 9).

**Plate 8. the northeast elevation of B2**

**Plate 9. The southwest elevation of Building 2**

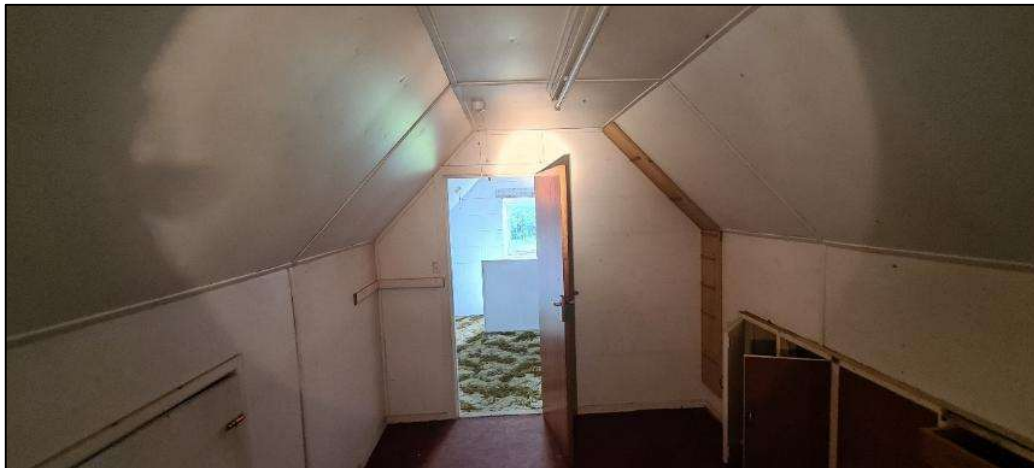
- 5.3.9 The building had a vaulted ceiling although a small void (less than 0.5 m in height) had been retained at the top of the pitched roof (Plate 10). Storage space had been retained at the eaves and the bitumen coated Type 1F felt was visible below the tiles (Plate 11).

**Plate 10. The interior of the first floor of Building 2.**

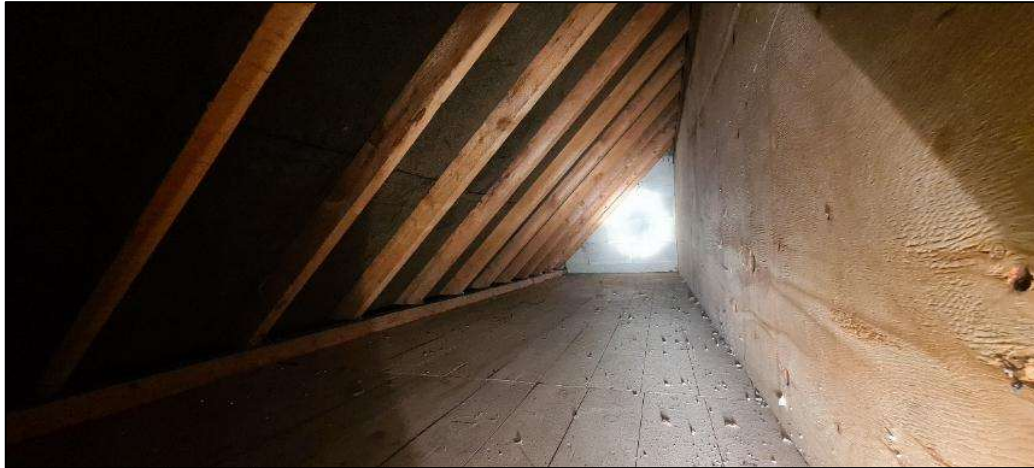
**Plate 11. The storage space at the eaves of Building 2**

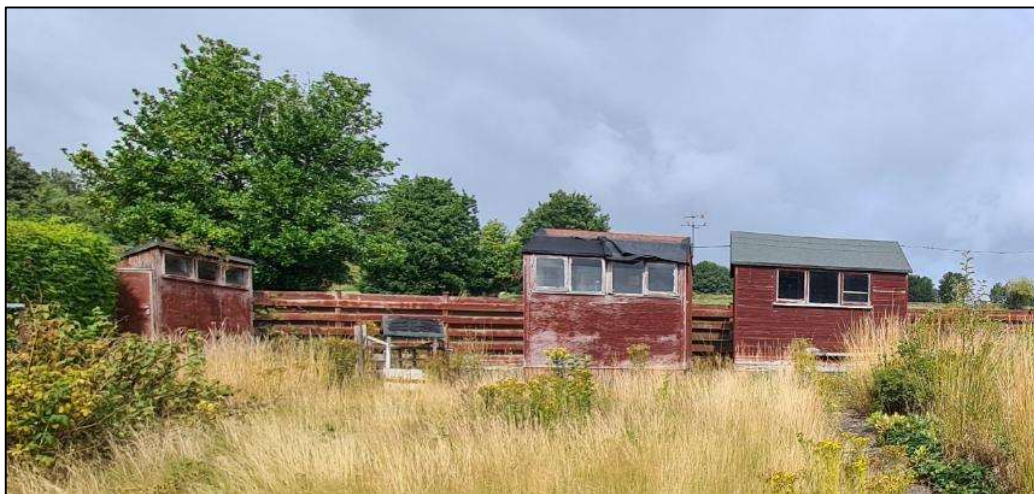
5.3.10 Building 3, 4, and 5 were a series of wooden sheds with pitched roofs. Building 3 had had the roof recently recovered with bitumen coated felt (Plate 12). The roof covering on Building 4 was becoming dislodged and the roof covering on Building 5 was in reasonable condition. All three had wooden framed windows with high interior light levels.

**Plate 12. From right to left: Buildings 3, 4, and 5 viewed from the south**

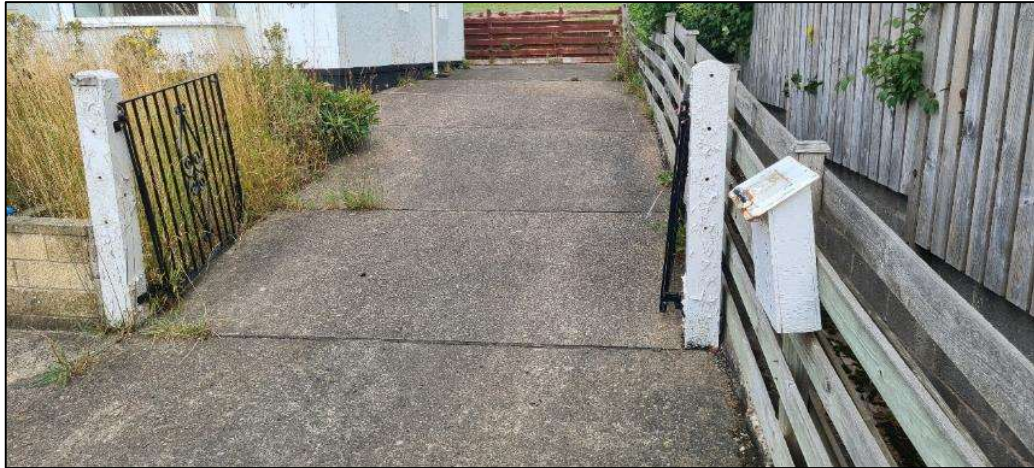
**Plate 13. Area of hard standing driveway to the east of the dwelling (Building 1)**

5.3.13 A series of hard standing paths, driveways, patios, and what appeared to be the bases of demolished buildings were present within the garden (Plate 13 & 14).

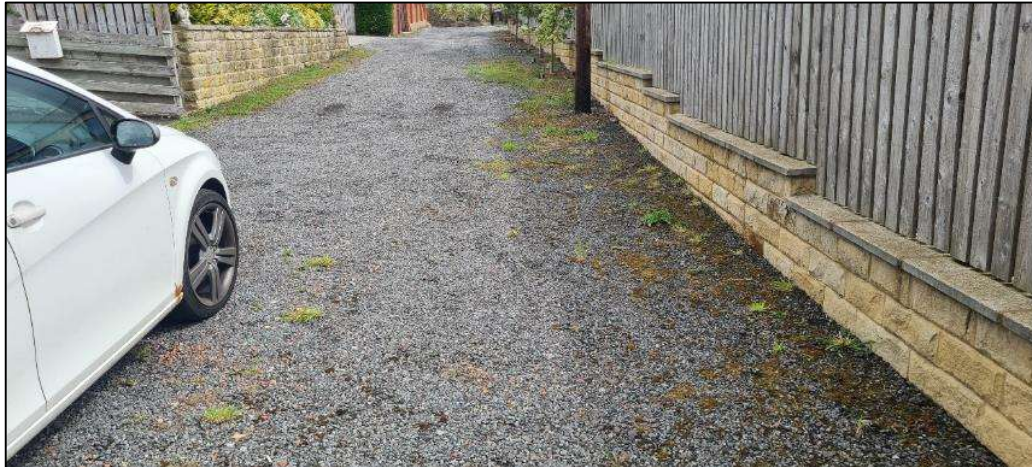
**Plate 15. The compacted gravel driveway at the eastern corner fo the site leading to Cumberworth Lane**

5.3.18 A gravel driveway was present at the southeastern corner of the site leading from the detached garage (Building2) to Cumberworth Lane (Plate 15).

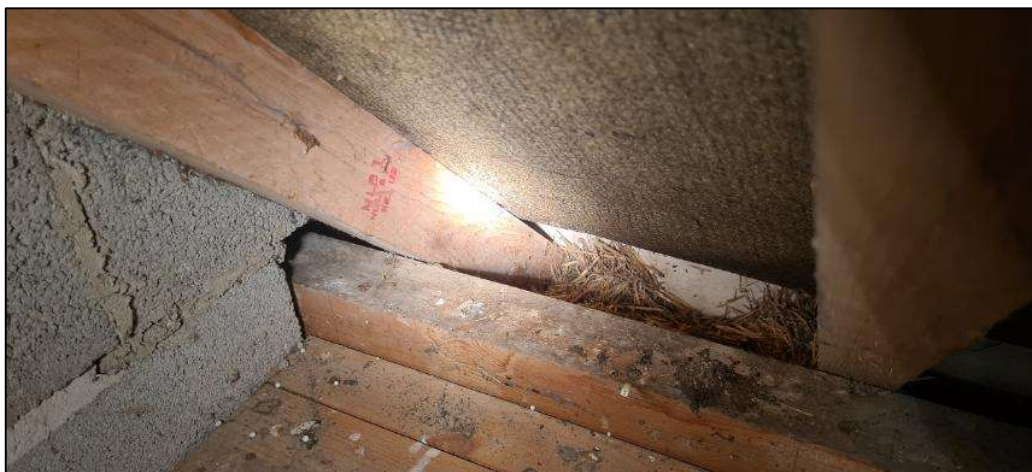
- 5.4.12 An old bird's nest was present within the soffit in the southeast corner of the garage (Plate 16). The presence of a dead juvenile starling *Sturnus vulgaris* in the ground floor of the garage suggested that the nest belonged to this species. Apart from the starling, bird species recorded on site and in the surrounding area comprised tawny owl *Strix aluco*, wood pigeon *Columba palumbus*, and jackdaw *Coloeus monedula*. Starling is a red listed bird species of conservation concern, wood pigeon and tawny owl are amber list species, and jackdaw are a green list species (Stanbury *et. al.*, 2021).

**Plate 16. Bird's nest in the soffit of the garage**

- 6.3.5 Nesting birds within the building and hedgerow were considered a possibility and it is recommended that the start of the demolition work, and vegetation removal either avoids the nesting bird season (March to September inclusive), or a check for active nests is undertaken prior to the start of demolition. If an active nest is present, it must be retained in-situ until the young have fledged. As stated in Appendix 2 active bird's nests are legally protected.

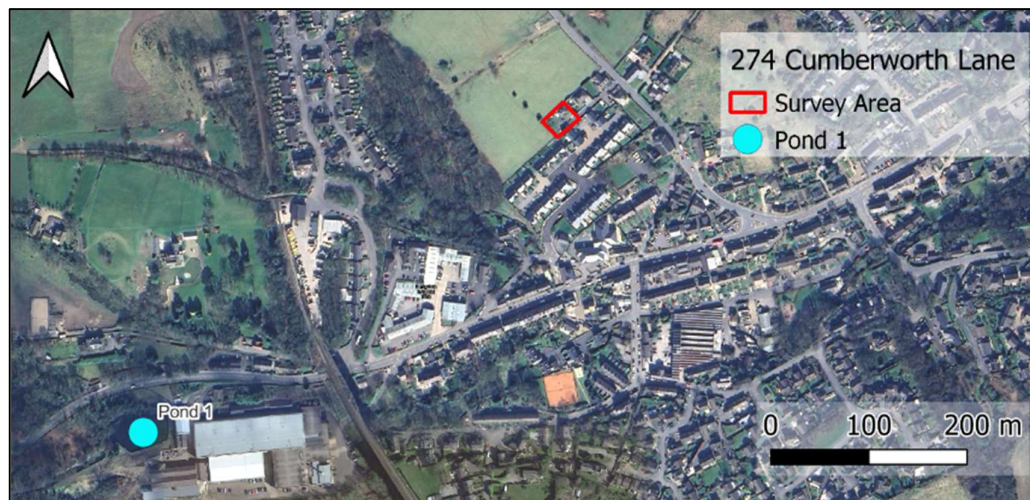
**Figure 3. Pond location**

- 5.4.20 Although one pond was located just within 500 m of the red line boundary (c. 485 m southwest of site), it was separated from the site by the A636 (Wakefield Road), the Barnsley to Huddersfield railway line, Denby Dale Industrial Park and other houses and gardens. Figure 3 shows the pond location relative to the site. Given the pond's distance from the site and the barriers to movement, it was considered highly unlikely that great crested newts would be present within the survey area, even if present in the identified pond.

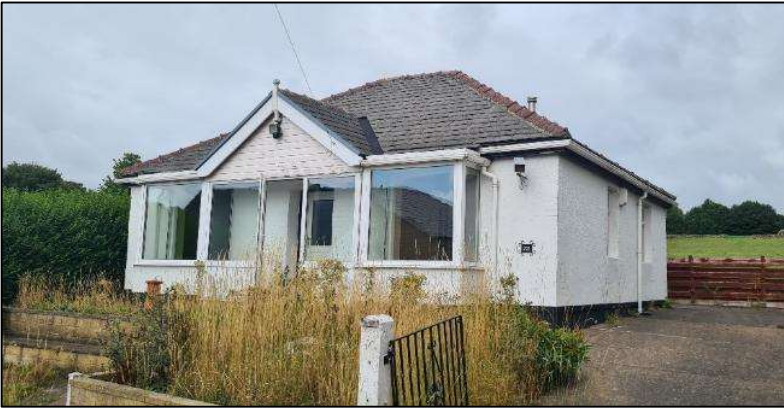
| <b>Building 1</b><br><br>Low bat roost suitability | | |
| | Description | Bungalow with a hipped pitched roof with dormers at the front and rear. The roof was covered with Welsh slate and angle-cap ridge tiles and was backed with a breathable roofing membrane with wooden sarking below. The brick walls had been rendered and the windows had uPVC frames. |
| | Features of bat potential | Gap on wall top (a), gap between slates (b). |
| | Bat evidence | None recorded. |

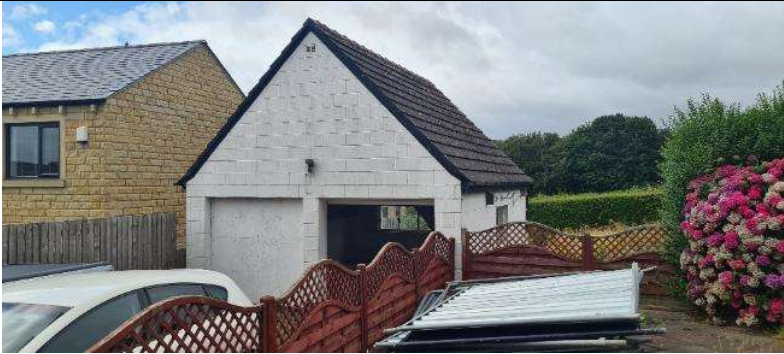
| <b>Building 2</b><br><br>Low Bat Roost Suitability | | |
| | Description | Garage constructed from concrete blocks with a two-pitched roof covered by interlocking concrete tiles. The tiles were backed by Type 1F bitumen-coated roofing felt. The building had a first floor with a partially vaulted ceiling. The windows had wooden frames. |
| | Features of bat potential | Bird box (c), air vent (d), and gap into the soffit (e). |
| | Bat evidence | None recorded. |

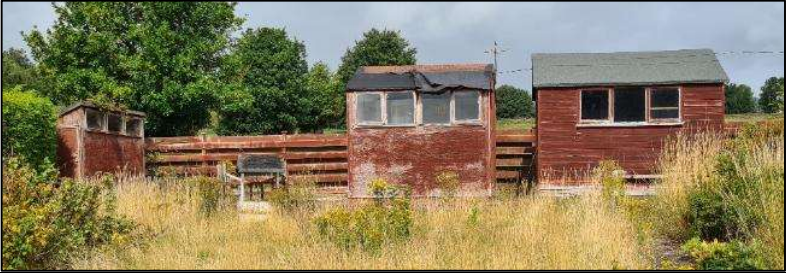
| <b>Building 3 -5</b><br><br>Negligible Bat Roost Suitability | | |
| | Description | Series of three wooden sheds with pitched roofs covered with roofing felt. The single pane windows had wooden frames. |
| | Features of bat potential | None recorded. |
| | Bat evidence | None recorded. |

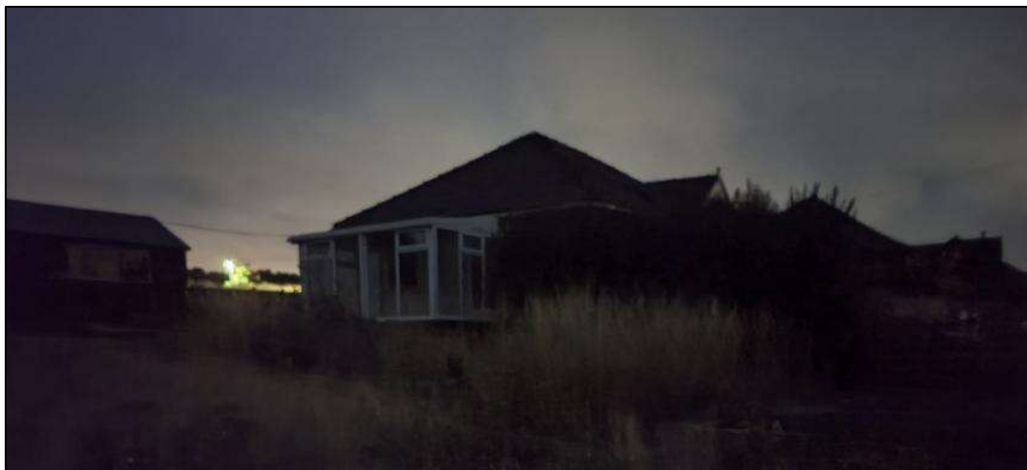
**Plate A6.1. Photo of the building taken from Surveyor Position 3 at 21:34 (68 minutes after sunset)**

The light levels within the site were low, with no external lighting present on the structures and relatively few light sources within the immediate surrounding area (Plate A6.1).

Bat activity was relatively low. The first bat recorded was a distant common pipistrelle at 20:46 (20 minutes after sunset), followed by a noctule at 20:49 (22 minutes after sunset). A *Myotis* bat species was recorded later in the survey at 21:30 (64 minutes after sunset). No bats emerged from the building. The activity recorded comprised occasional commuting and brief foraging passes by common pipistrelle, with isolated passes by noctule and *Myotis* species.

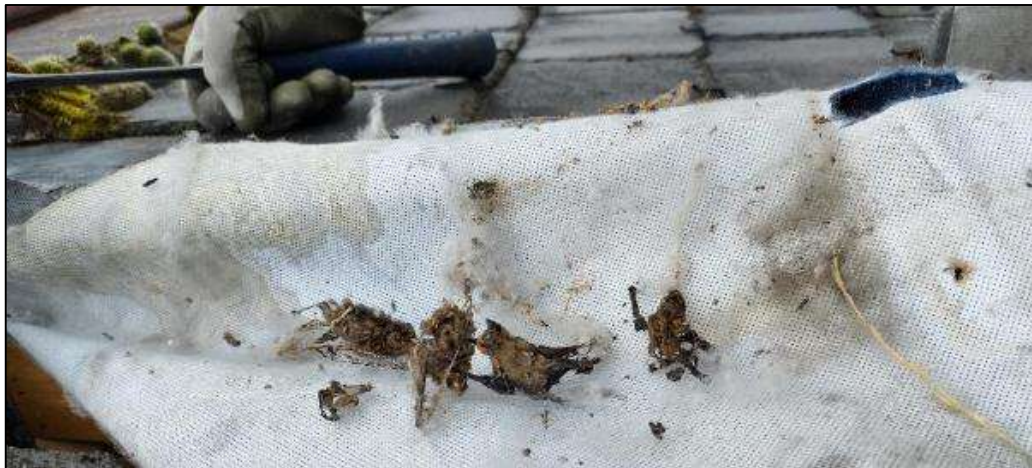
One example we have encountered comprised a pipistrelle roost which formed in a building extension constructed in 2009. Over the course of just 13 years the roofing felt degraded to the extent that it trapped and killed more than 10 bats. Fortunately, the problem in this roost was identified and remedial work was undertaken to replace the roofing membrane in 2022.

### **Plate A7.1. Four dead pipistrelles tangled in breathable roofing membrane**

Standard roof membranes can cause the death of significant numbers of bats. Traditional bitumen coated roofing felt is recommended where roosting bats are expected to be present.

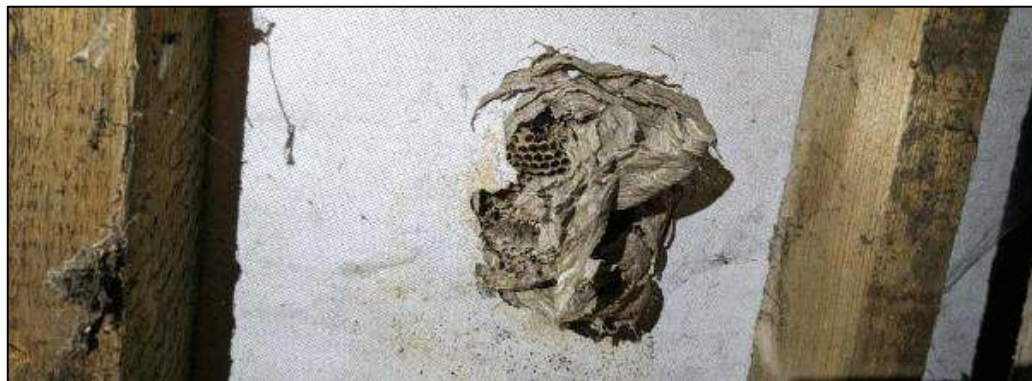
In recent years a fairly substantial proportion of the lofts we have surveyed which had existing breathable felt, were found to have been damaged by wasps (Plate A7.2). The wasps appear to have chewed holes in the felt and formed nests. This doesn't appear to be a problem associated with traditional bitumen coated roofing felt. Any holes within roofing felt are likely to significantly reduce its functionality as a secondary weather barrier. Where bats or birds come into contact with breathable roofing membranes, they can also damage it causing it to leak, they can also significantly reduce the breathability of the felt in that location.

#### **Plate A7.2. Damage to a breathable roofing membrane adjacent to a wasp nest**

Traditional bituminous Type 1F roofing felt is a non-breathable product and therefore ventilation is required. Sufficient ventilation can be usually be achieved, even in buildings with vaulted ceilings, however, some consideration during the design stage is required. Products to increase the ventilation within roofs where bituminous Type 1F felt has already been installed are also available.
