P4541  
27 June 2025

**Re: Inspection of Highway Wall at 170 Penistone Road, Shelley**

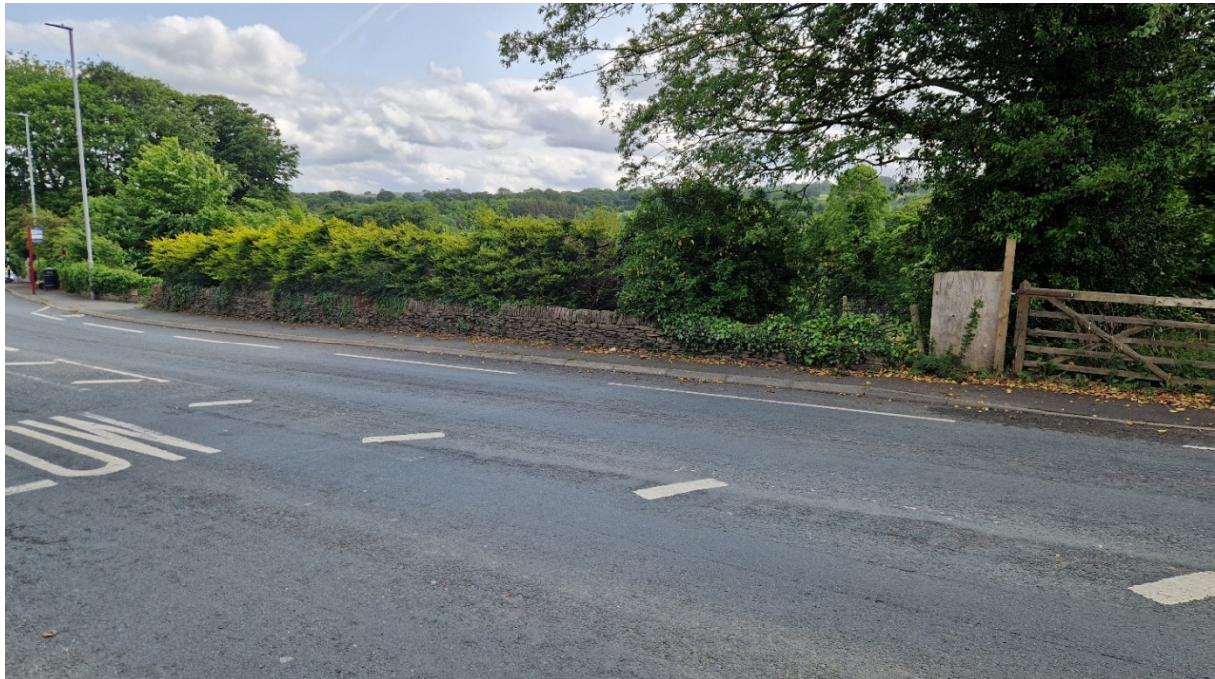
Figure 1. View of the wall

The wall forms the back edge of the footpath along the south side of the A629 Penistone Road and is constructed using coursed local dry stone with a vertical stone copings (Figure 1) and is approximately 450 mm thick.

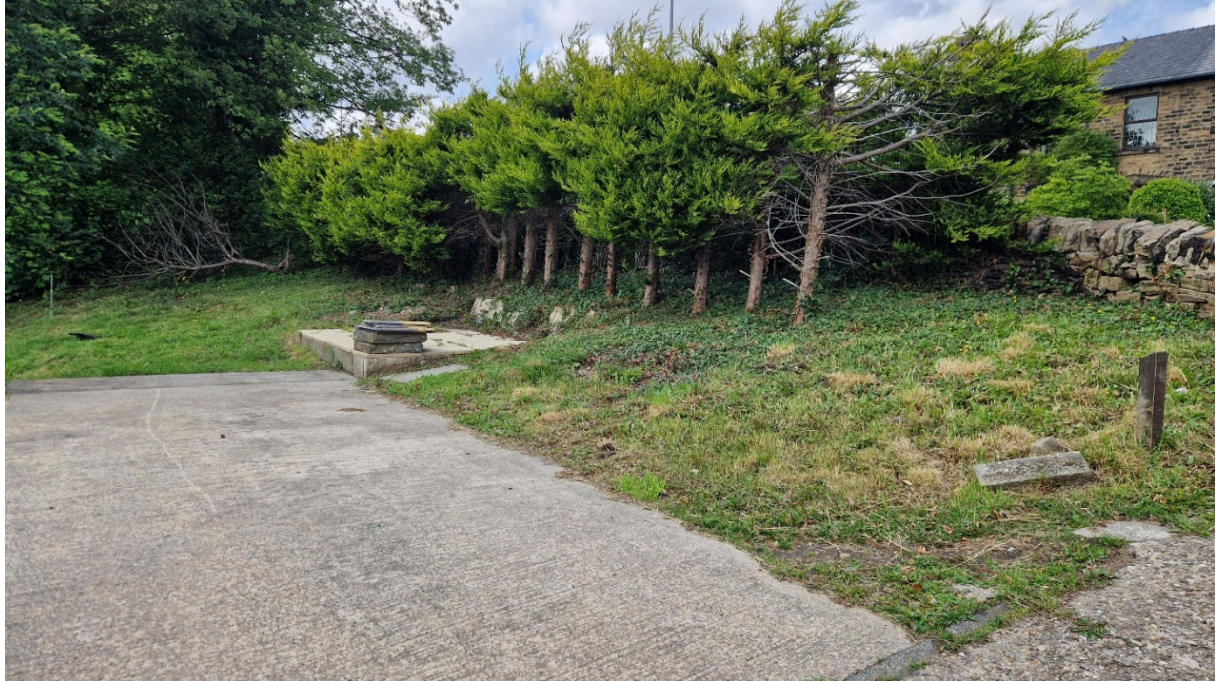
Figure 2. View of the rear of the wall

The site currently slopes down to the south, away from the highway and there is a row of mature leylandii trees 1.5 m to 2.0 m from the wall (Figure 2). The wall height measured between 450 mm and 800 mm high above the footpath and between 700 mm and 1100 mm above the ground on the site side (Figure 3). The maximum retained height is 400 mm.

We understand that it is proposed to raise the site levels as part of the construction of the new house and that these will not be higher than the footpath. This will add stability to the slope behind the existing wall and will enhance the stability.

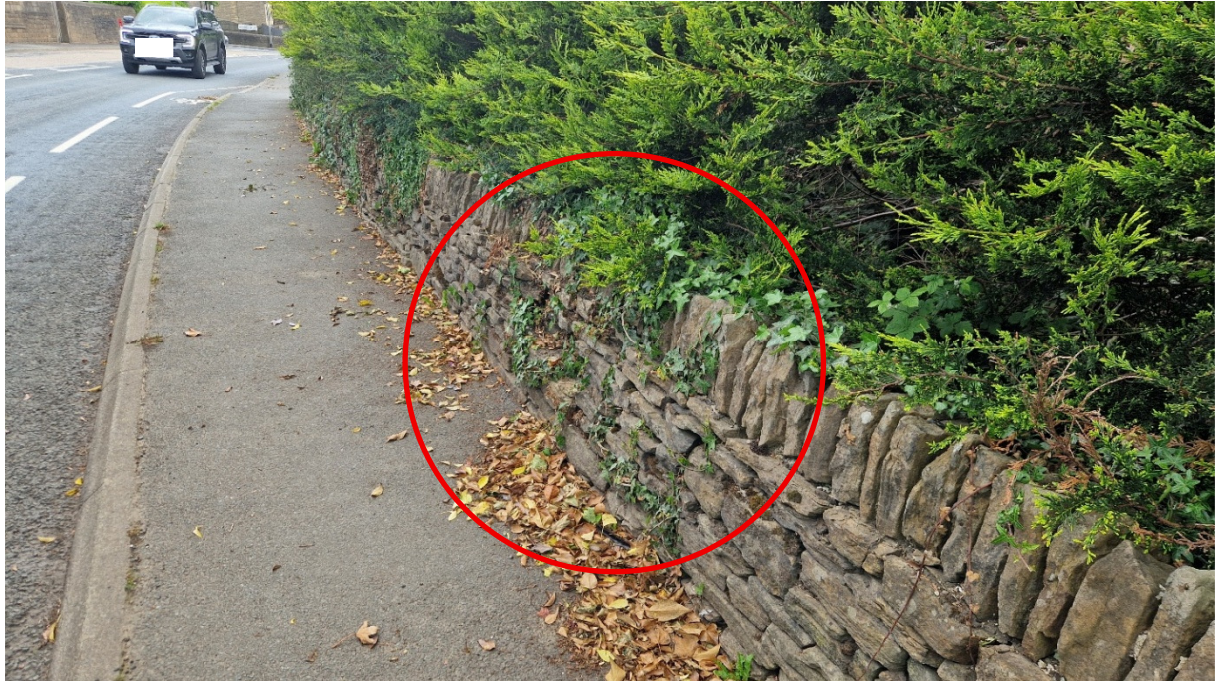
Figure 4. Minor impact damage

The wall is generally in good condition and appears stable. There is one small area of impact damage which has slightly displaced the stones (Figure 3 and Figure 4) but the wall is still stable.

The minor impact damage is of no detriment to the wall.
