GEOTECHNICAL RISK ASSESSMENT

170 PENISTONE ROAD
SHELLEY
HD8 8HZ

MR & MRS I SOWERBY

REPORT REF: IS 3619

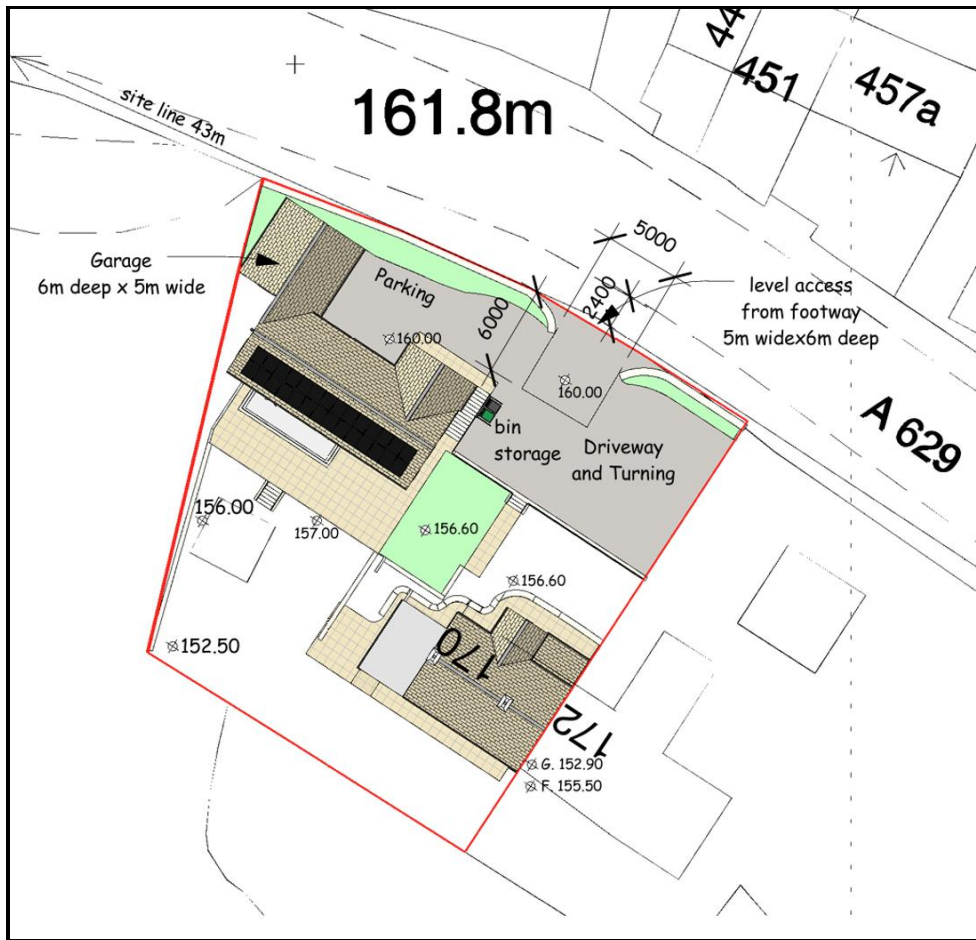
The site lies to the immediate south of the A629 Penistone Road. The site level at the centre of the road north of the site is 161.8m aOD. The north part of the site lies at 160.0m aOD reducing to 152.00m aOD at the southern end of the site.

The ground falls from 160m aOD to 158m aOD beneath the proposed house and falls further to 152m aOD in the rear garden. The slope measures as 15 to 20 degrees to the horizontal from the road to the rear of the site.

The site lies as a grassed lawn forming the garden to 170 Penistone Road. The site is bounded to the north by a stone wall and the A629 Penistone Road with residential housing beyond. The site is bounded to the east by the house and garden of 170 Penistone Road and to the

west by woodland. The site is bounded to the south by sloping ground down to Shepley Dyke and a mill pond at a lower ground level.
