GROUNDTECH
CONSULTING

DENBY LANE, GRANGE MOOR

DRILL AND GROUT VALIDATION REPORT

ORION HOMES

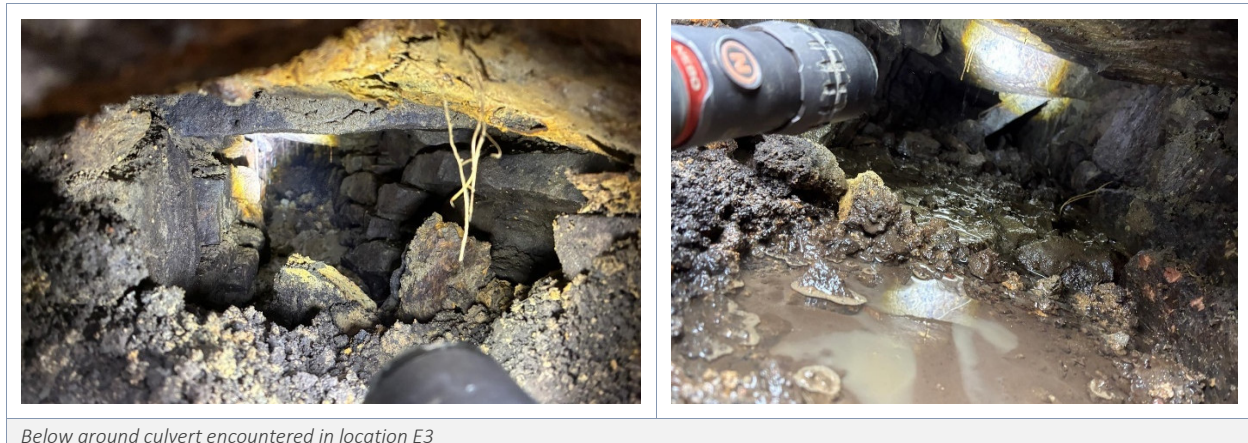
Broken Ground was recorded in location E3 between the depths of 1.2m and 2.9m begl in the bedrock deposits which were deemed to be anomalous and with respect the remainder of the locations undertaken

and CA recorded. Subsequent excavations determined this to be associated with a culvert and images are presented in the extract below:

Below ground culvert encountered in location E3

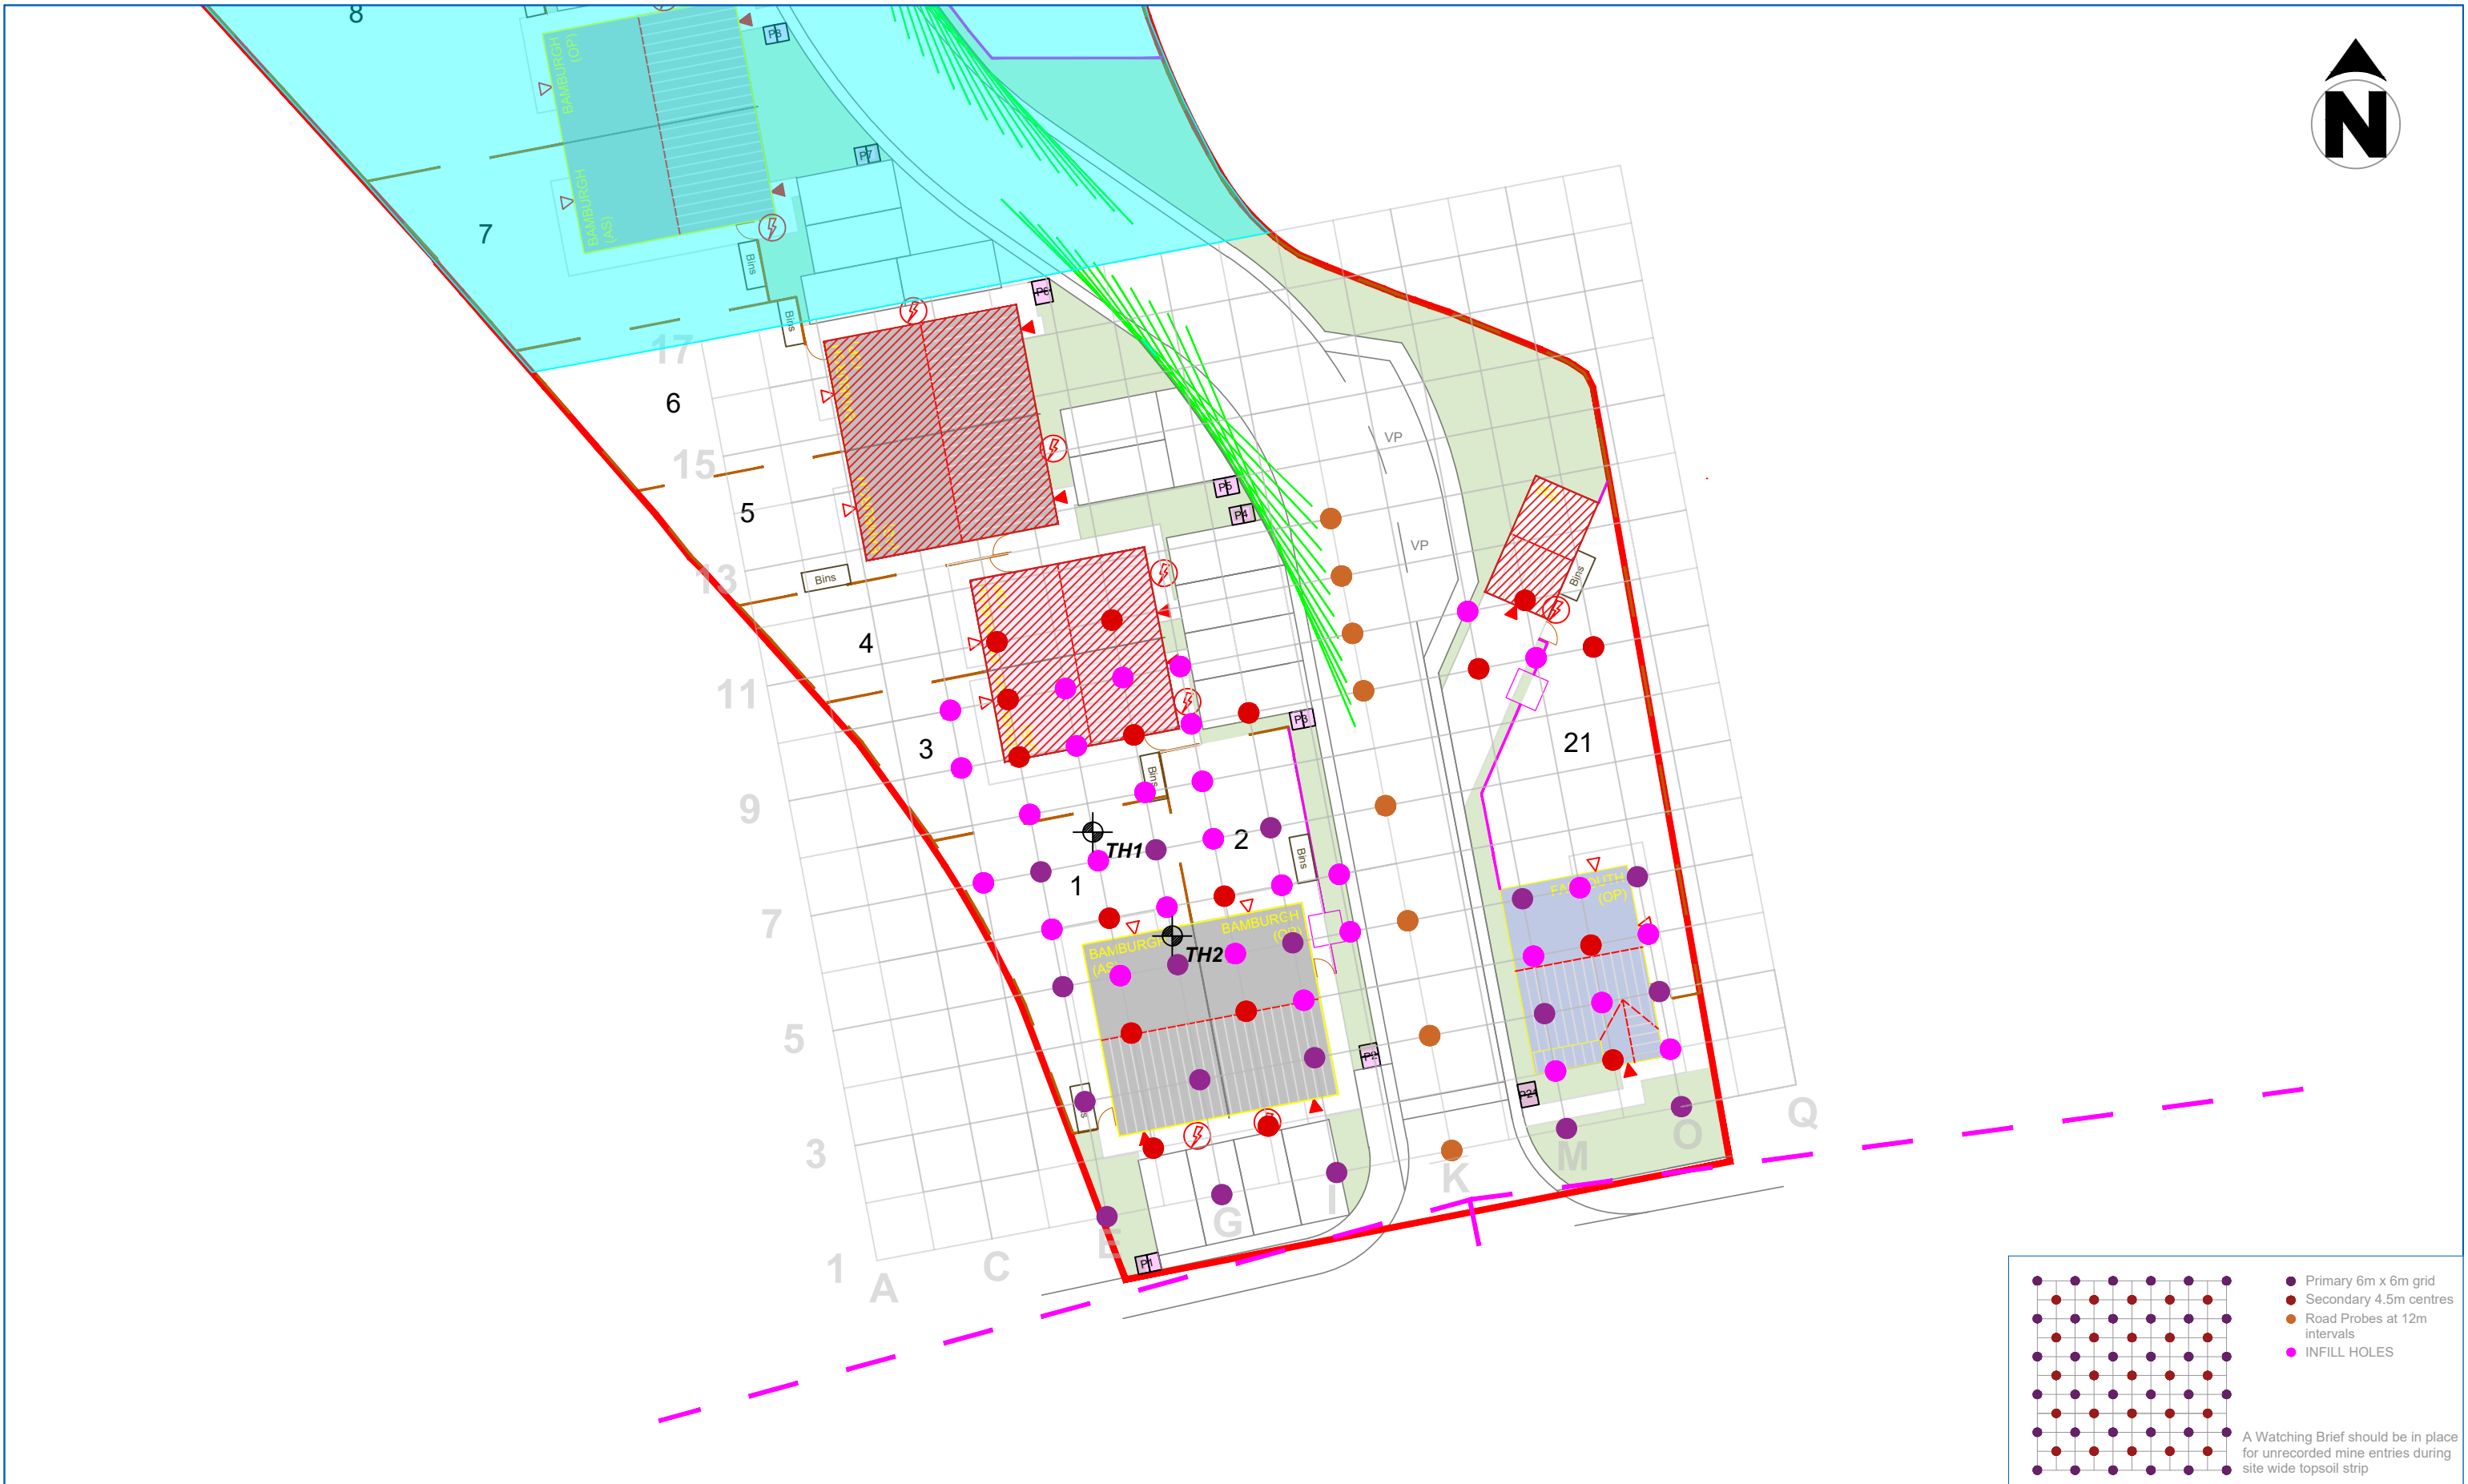
<ul style="list-style-type: none"> ● Primary 6m x 6m grid ● Secondary 4.5m centres ● Road Probes at 12m intervals ● INFILL HOLES
A Watching Brief should be in place for unrecorded mine entries during site wide topsoil strip

AREA NOT REQUIRING DRILL AND GROUTING
	PLOTS POTENTIALLY REQUIRING DRILL AND GROUT DEPENDING ON GROUT TAKES OF PLOTS 1/2 AND 21

LOCATIONS OF DRILL HOLES RE APPROXIMATE AND SHOULD BE POSITIONED ONSITE AT THE REQUIRED SPACING IN ACCORDANCE WITH THE SPECIFICATION

The proposed drilling and grouting work is presented on Groundtech Plan *GRO-24078-P08_1.1* in *Appendix 1*. This was confined to the southern area of the site and includes Plots 1, 2 and 21. If high grout intakes were recorded in these plots, additional grouting may be required in Plots 3 to 6.

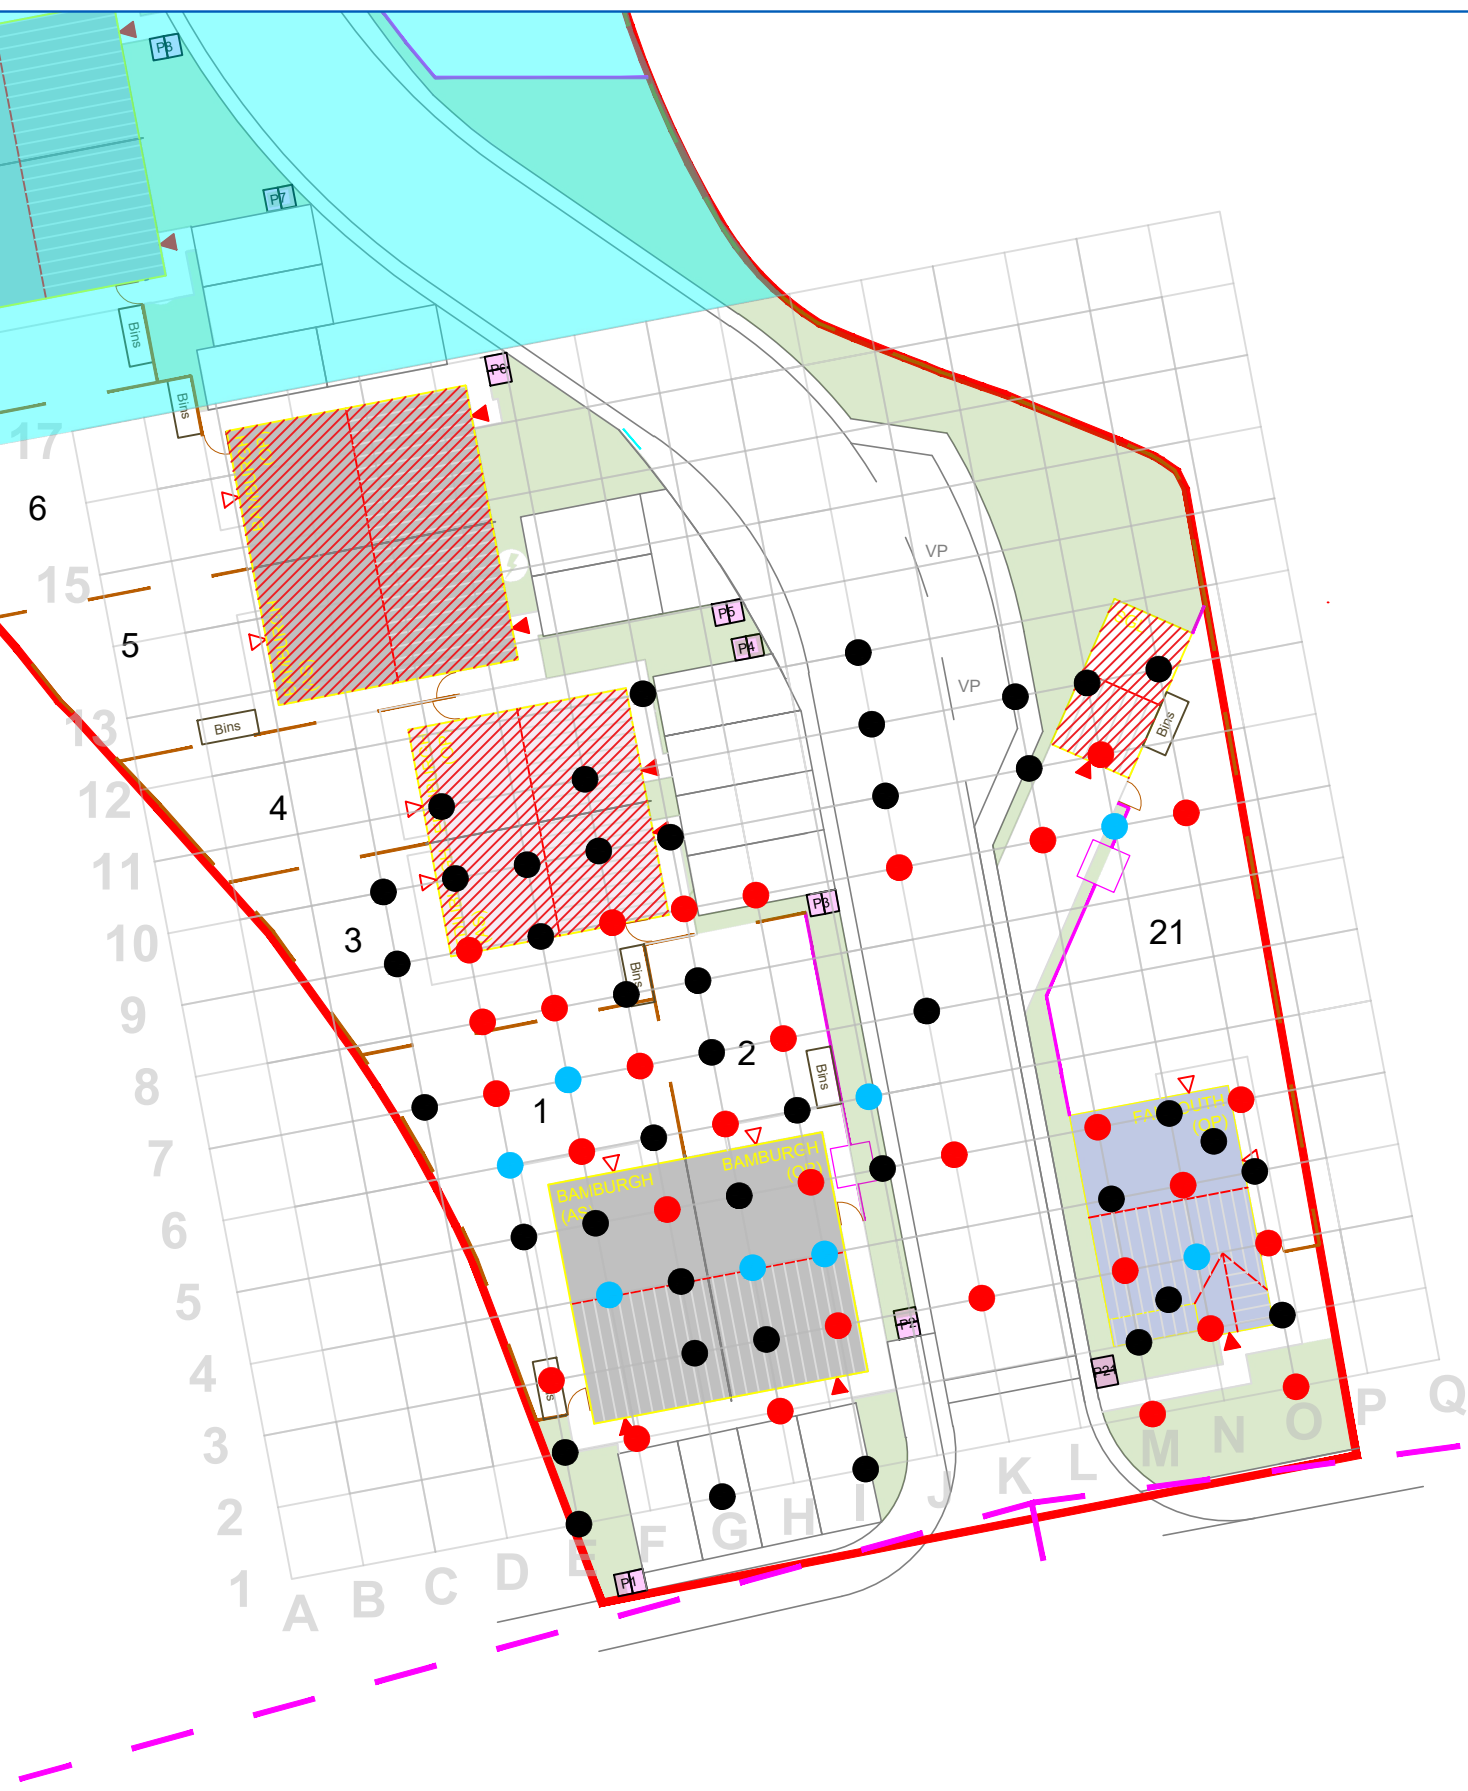
CLIENT ORION HOMES	DATE AUGUST 2025
PROJECT TITLE DENBY LANE, GRANGE MOOR	SCALE NTS
PLAN TITLE FINAL DRILL PLAN	PLAN NUMBER GRO-24078-P10

Notes	
●	ROTARY HOLES WHERE INTACT COAL ENCOUNTERED
●	ROTARY HOLES WHERE EVIDENCE OF SHALLOW WORKINGS ENCOUNTERED
●	ROTARY HOLES WHERE EVIDENCE OF GROUT ENCOUNTERED

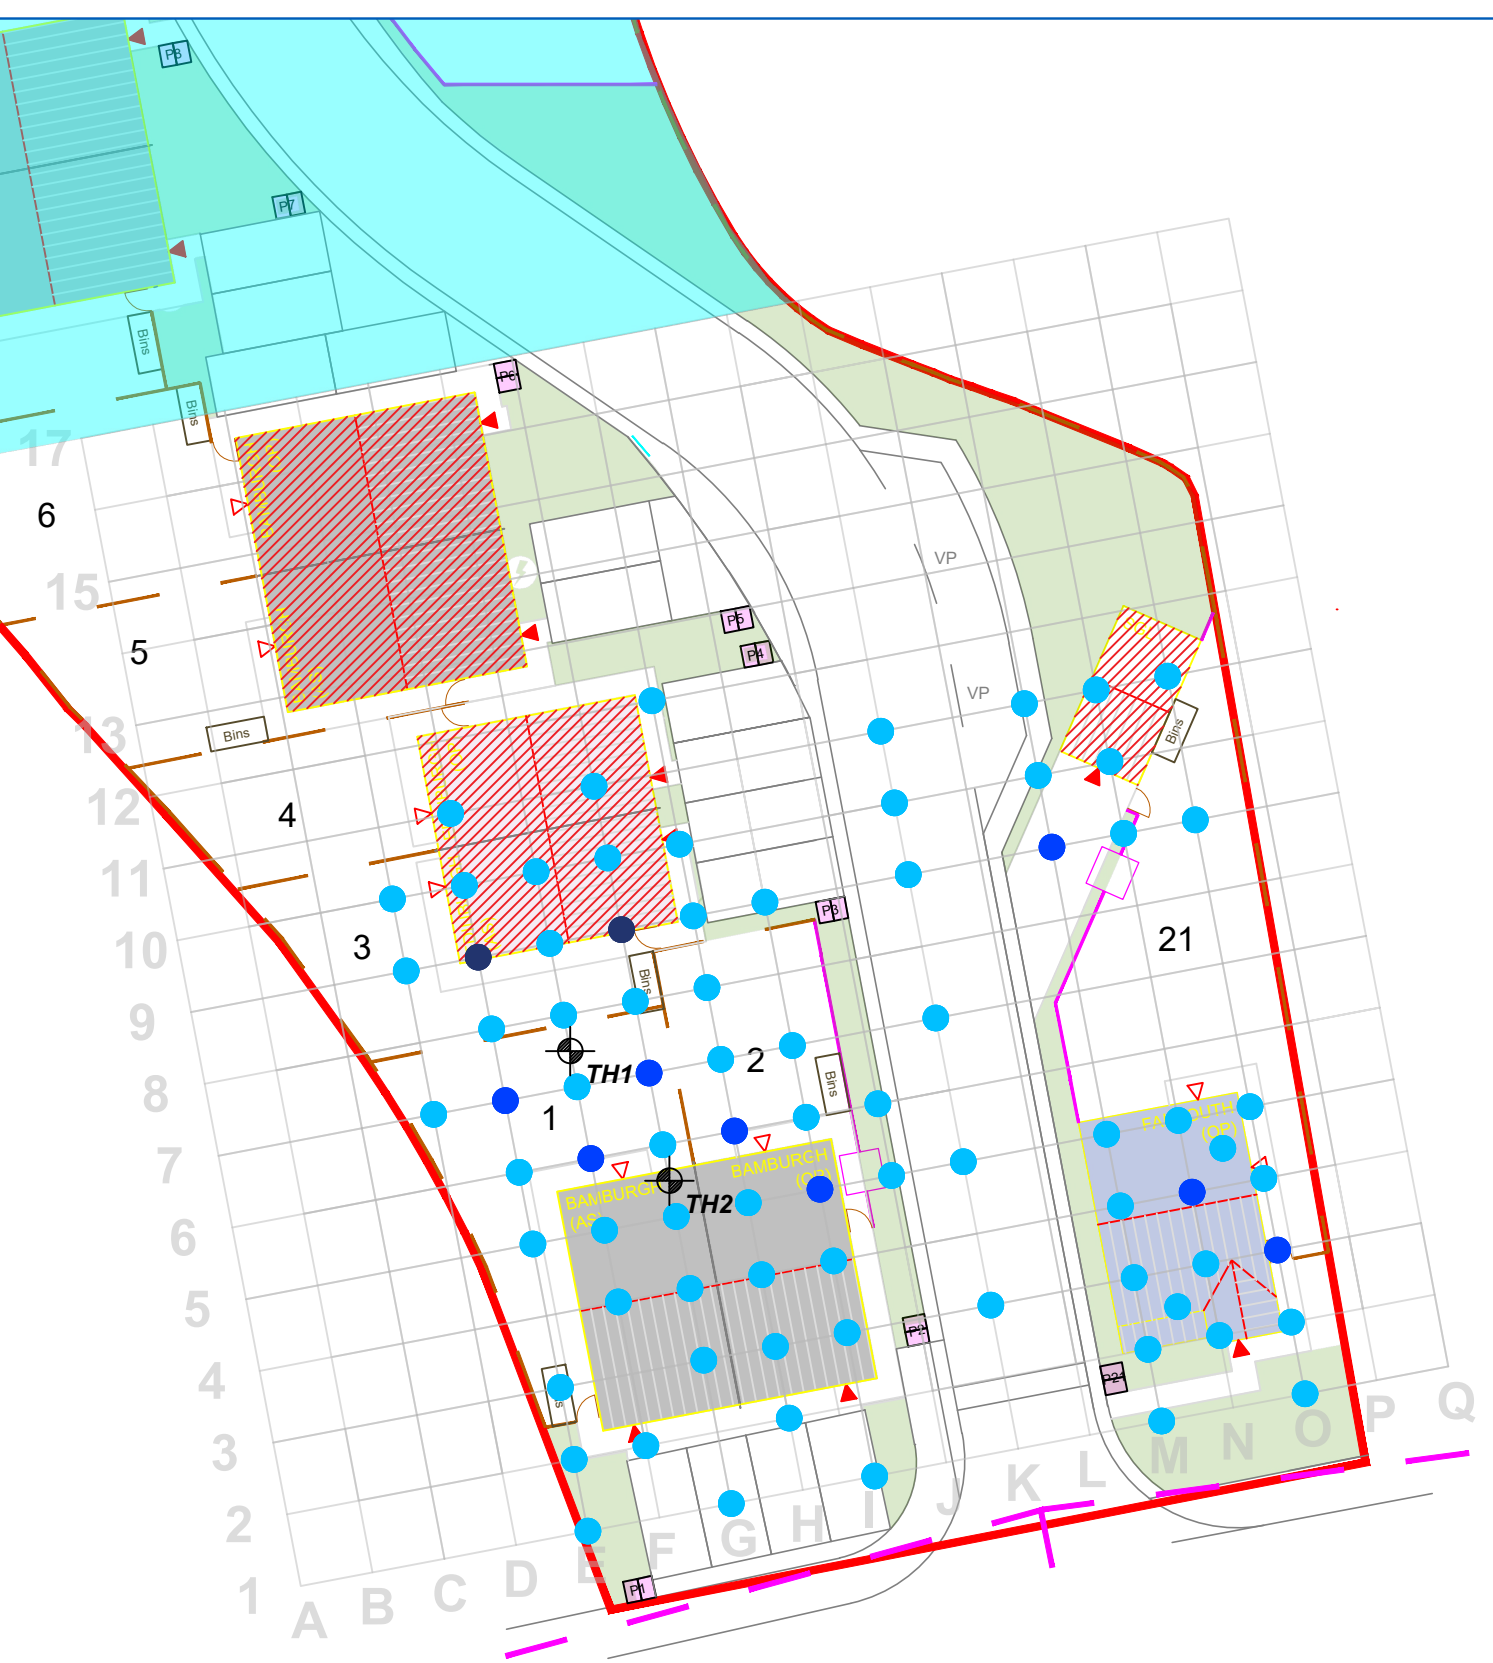
<ul style="list-style-type: none"> ● Primary 6m x 6m grid ● Secondary 4.5m centres ● Road Probes at 12m intervals
	<p>A Watching Brief should be in place for unrecorded mine entries during site wide topsoil strip</p>

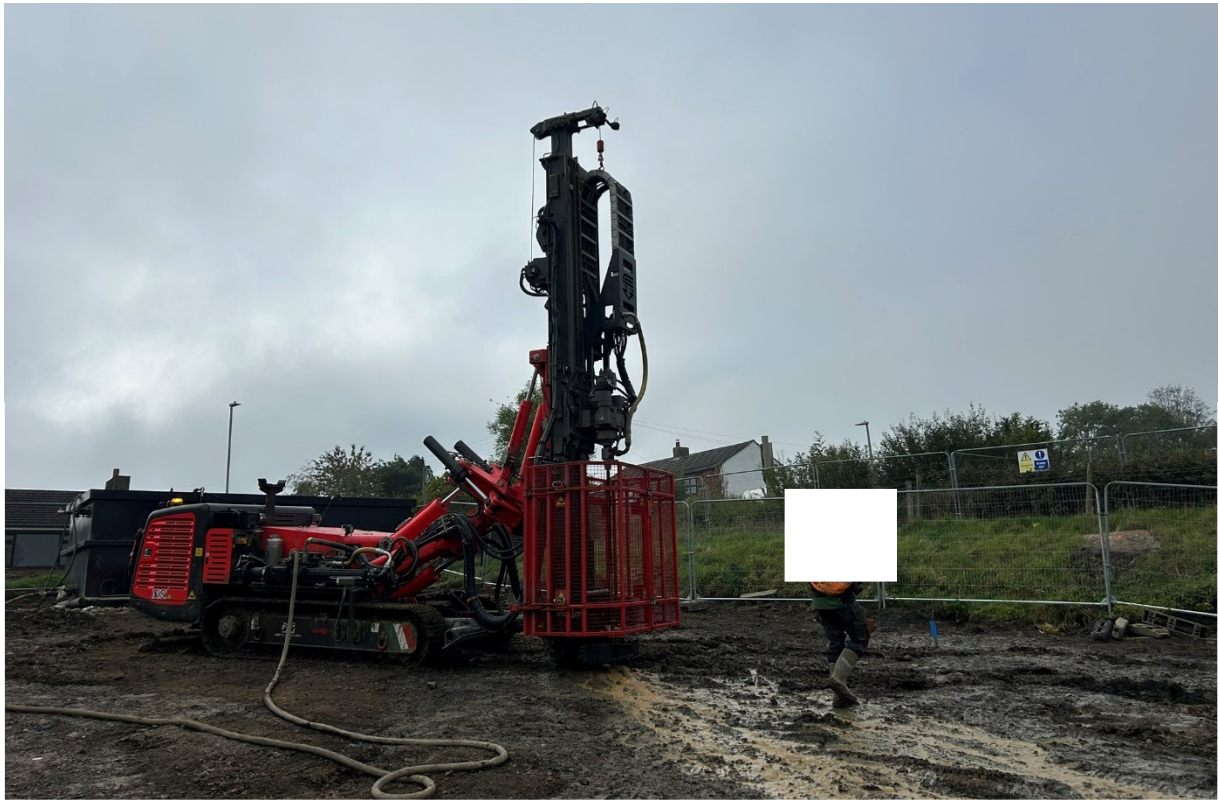
Photograph 1 – Drill and Grout works

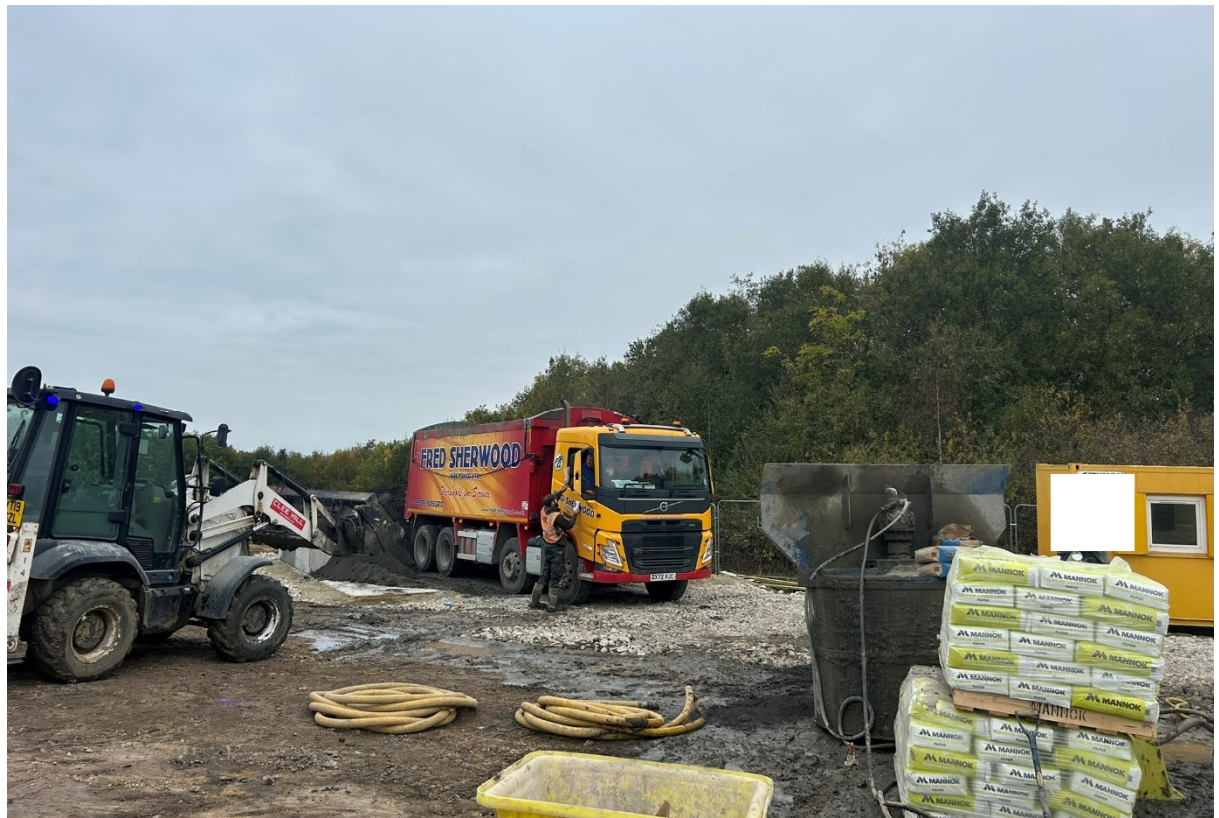
Photograph 2 – Photograph during the delivery of PFA.

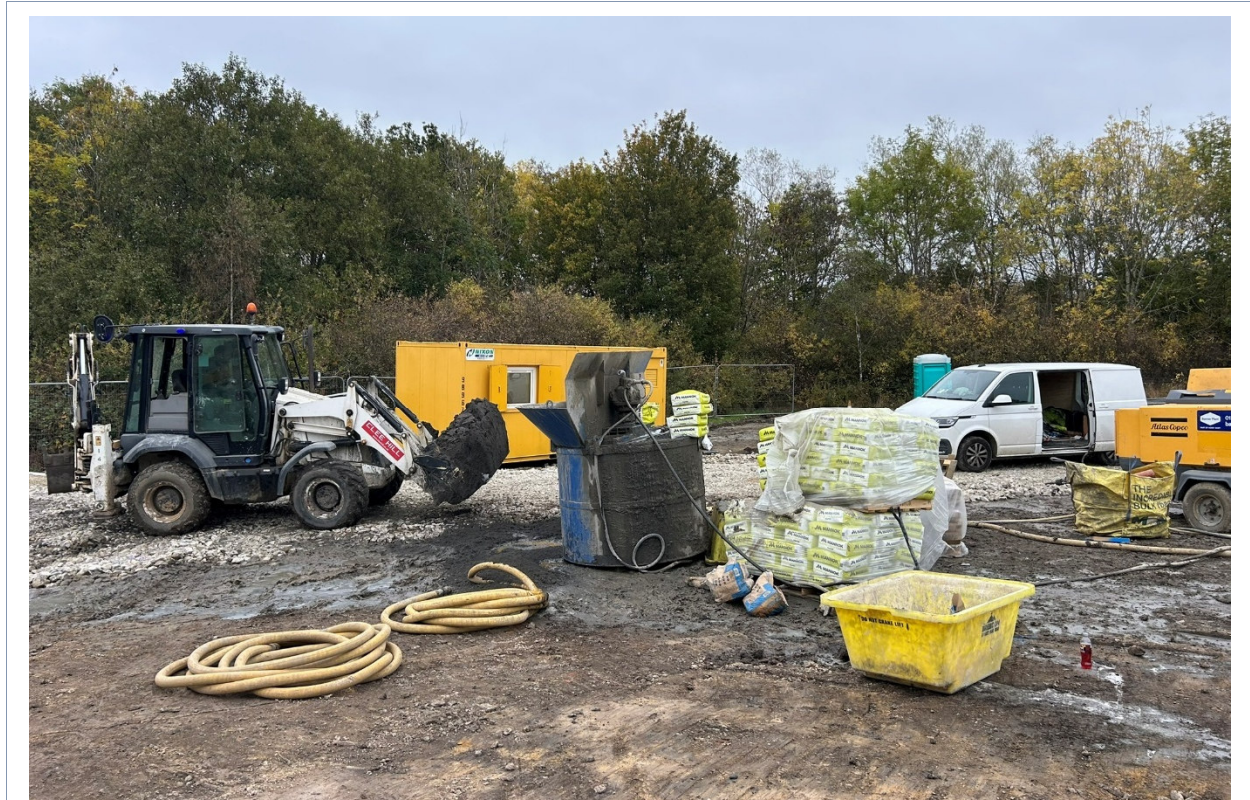
Photograph 3 – Photograph of grout mixing equipment.

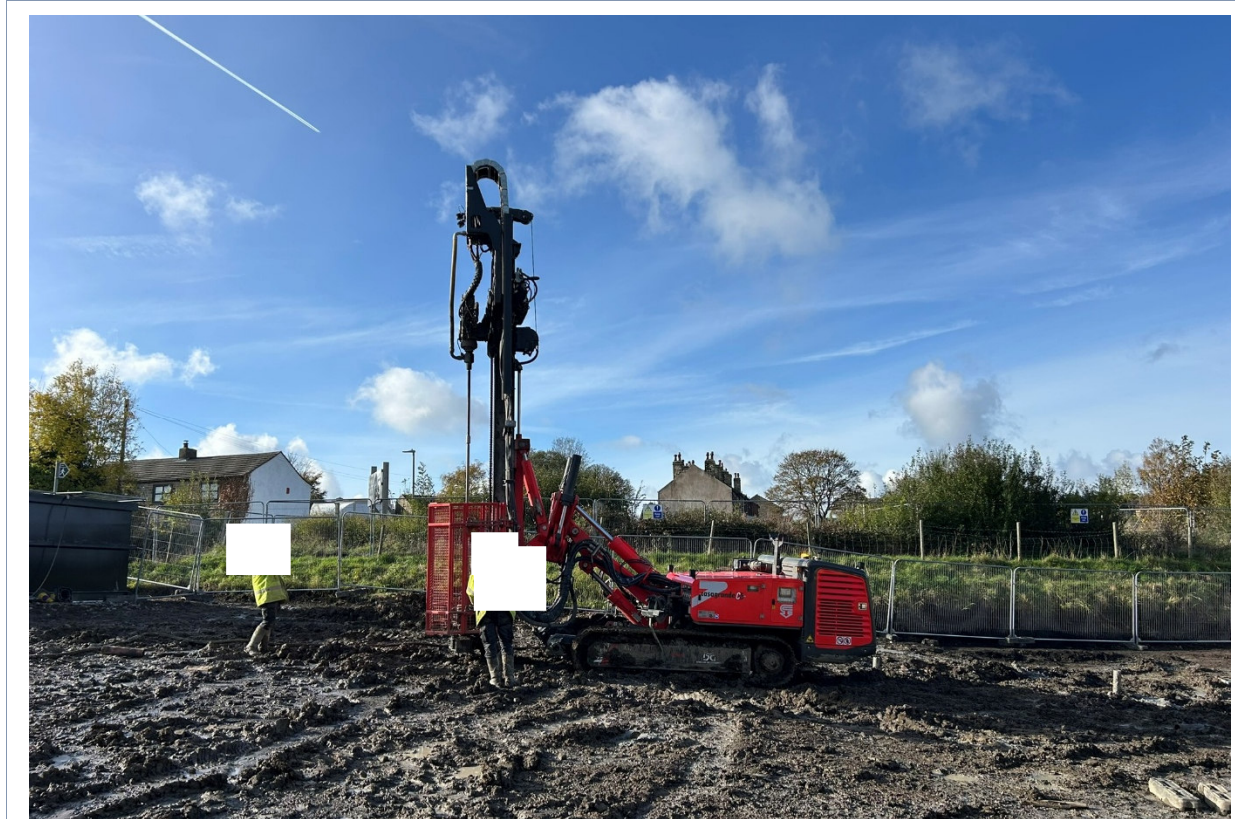
Photograph 4 – Drill and Grout works

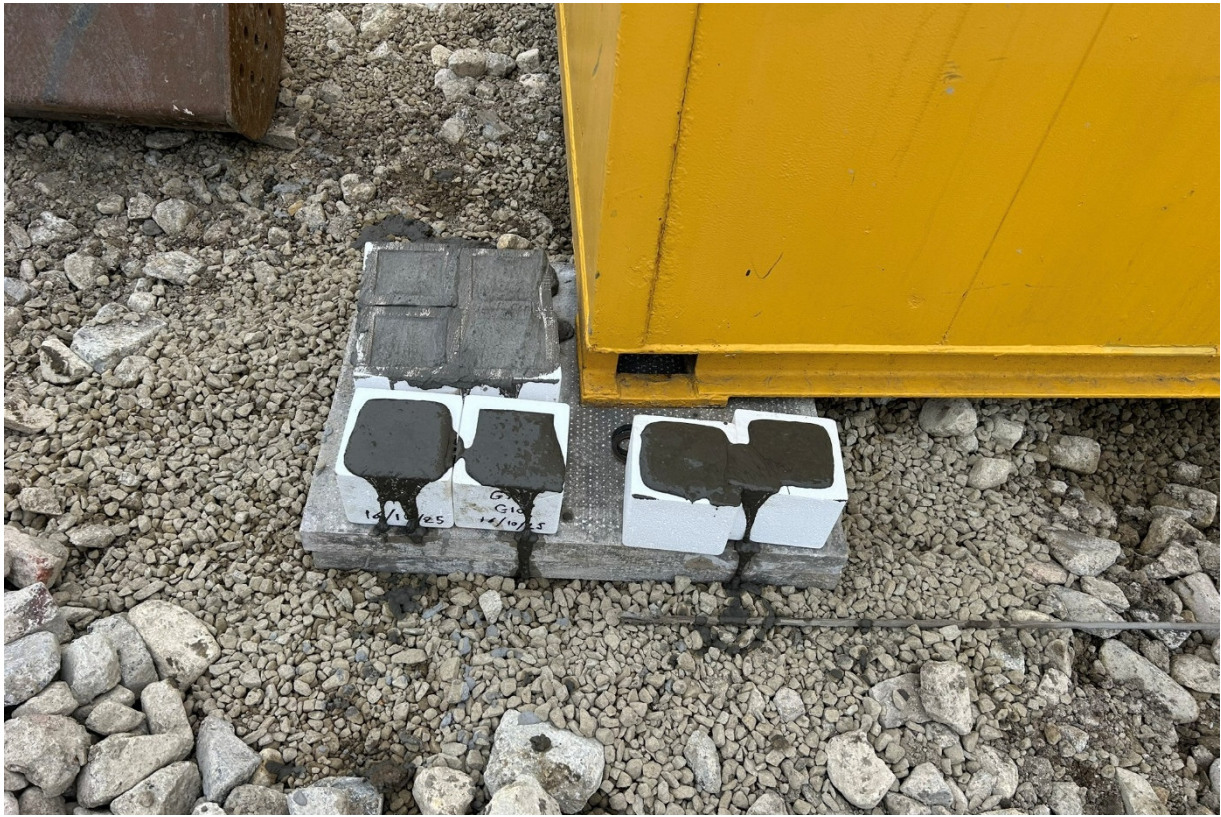
Photograph 5 – Photograph of grout cubes gathered during the works

As the site is being developed residentially, the grout mix generally consisted of PFA: cement grout which should be mixed in the proportions of 10:1 where water is present. Two representative cubes were taken of the grout mixes per week in order to test its strength. The strength of the grout should be no less than 1.0MN/m² at 28 days. All tests recorded strengths of between 1.0 MN/m² and 2.5 MN/m² at 28 days confirming that the grout was acceptable for use. The strength testing results can be found in *Appendix 5*.

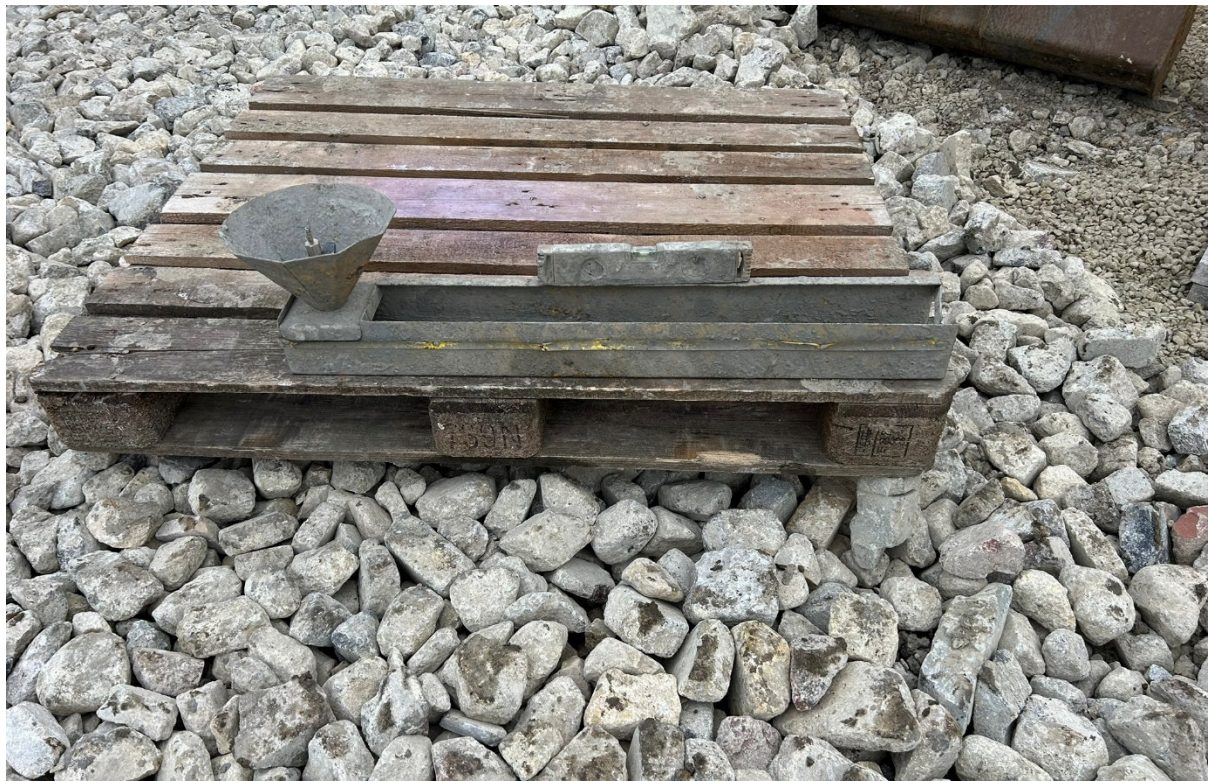
Photograph 6 – Photograph of grout flow testing equipment.

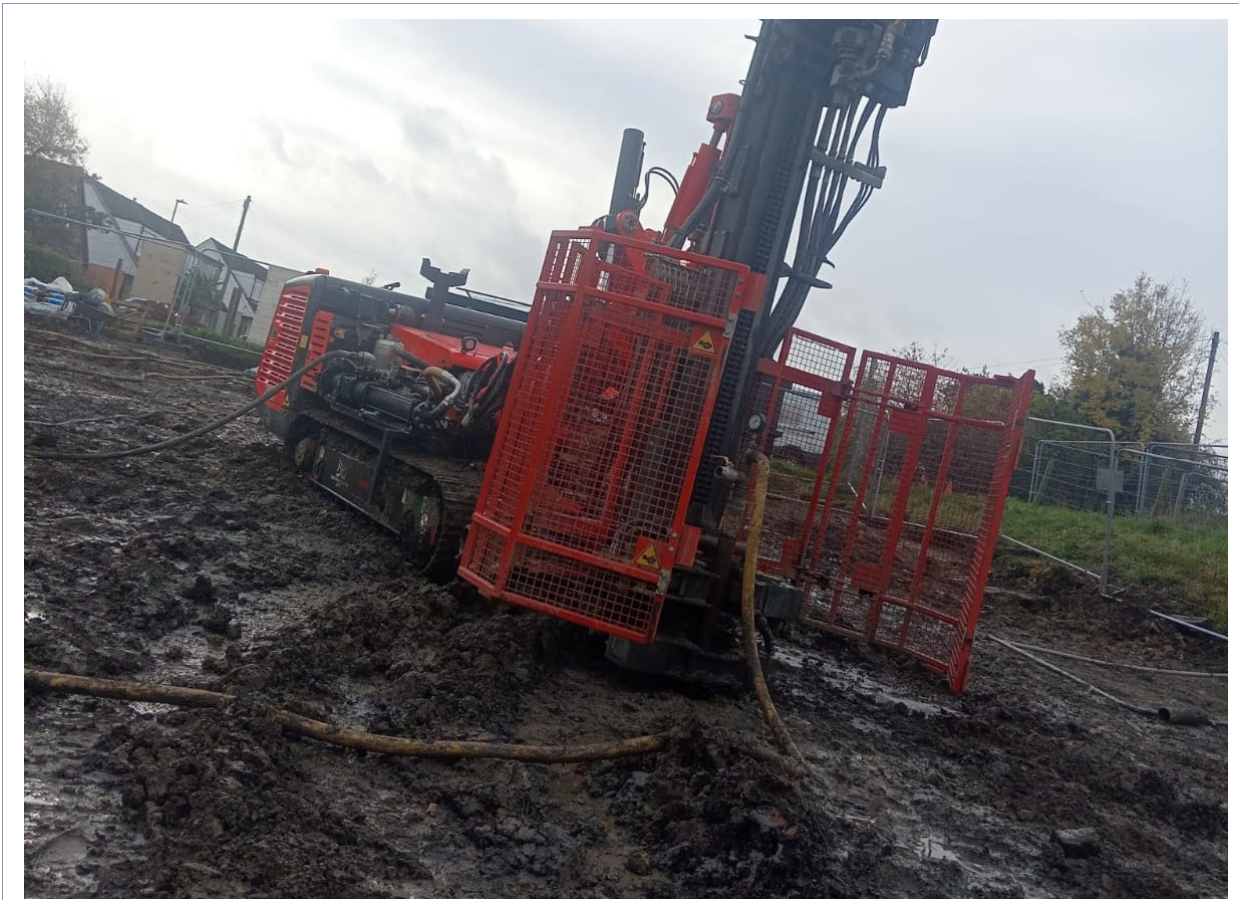
Photograph 7 – Photograph during TH2

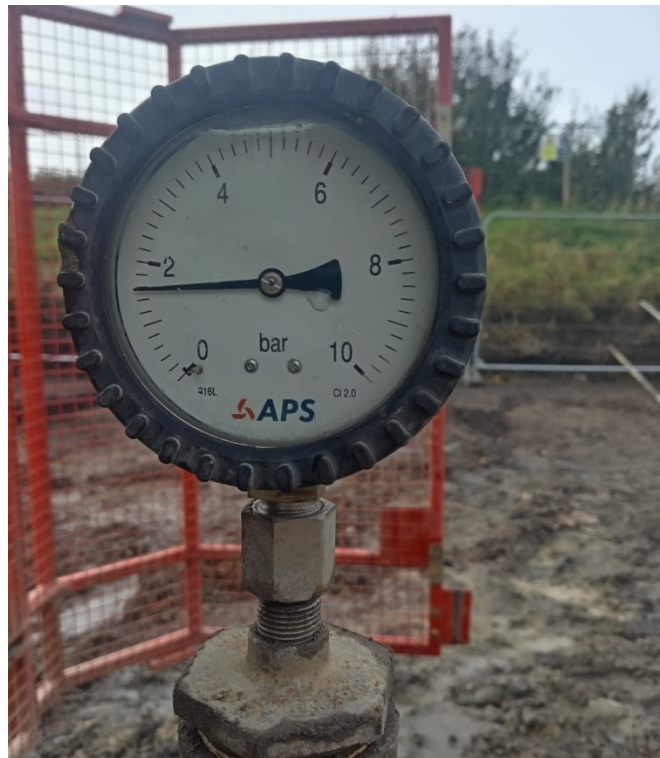
Photograph 8 – Pressure gauges during grouting of TH2.
