Torsion Projects Ltd
Rev: C (07th Jan 2026)

Planning Application Ref: **2023/62/91408/W**

ERECTION OF CARE HOME (CLASS C2) WITH SUB-STATION, ASSOCIATED CAR PARKING, ACCESS, SERVICING, LANDSCAPING AND OTHER ASSOCIATED WORKS
At: LAND ADJ, 21, THOMAS STREET, LINDLEY, HUDDERSFIELD, HD3 3JJ

Planning Condition 4:

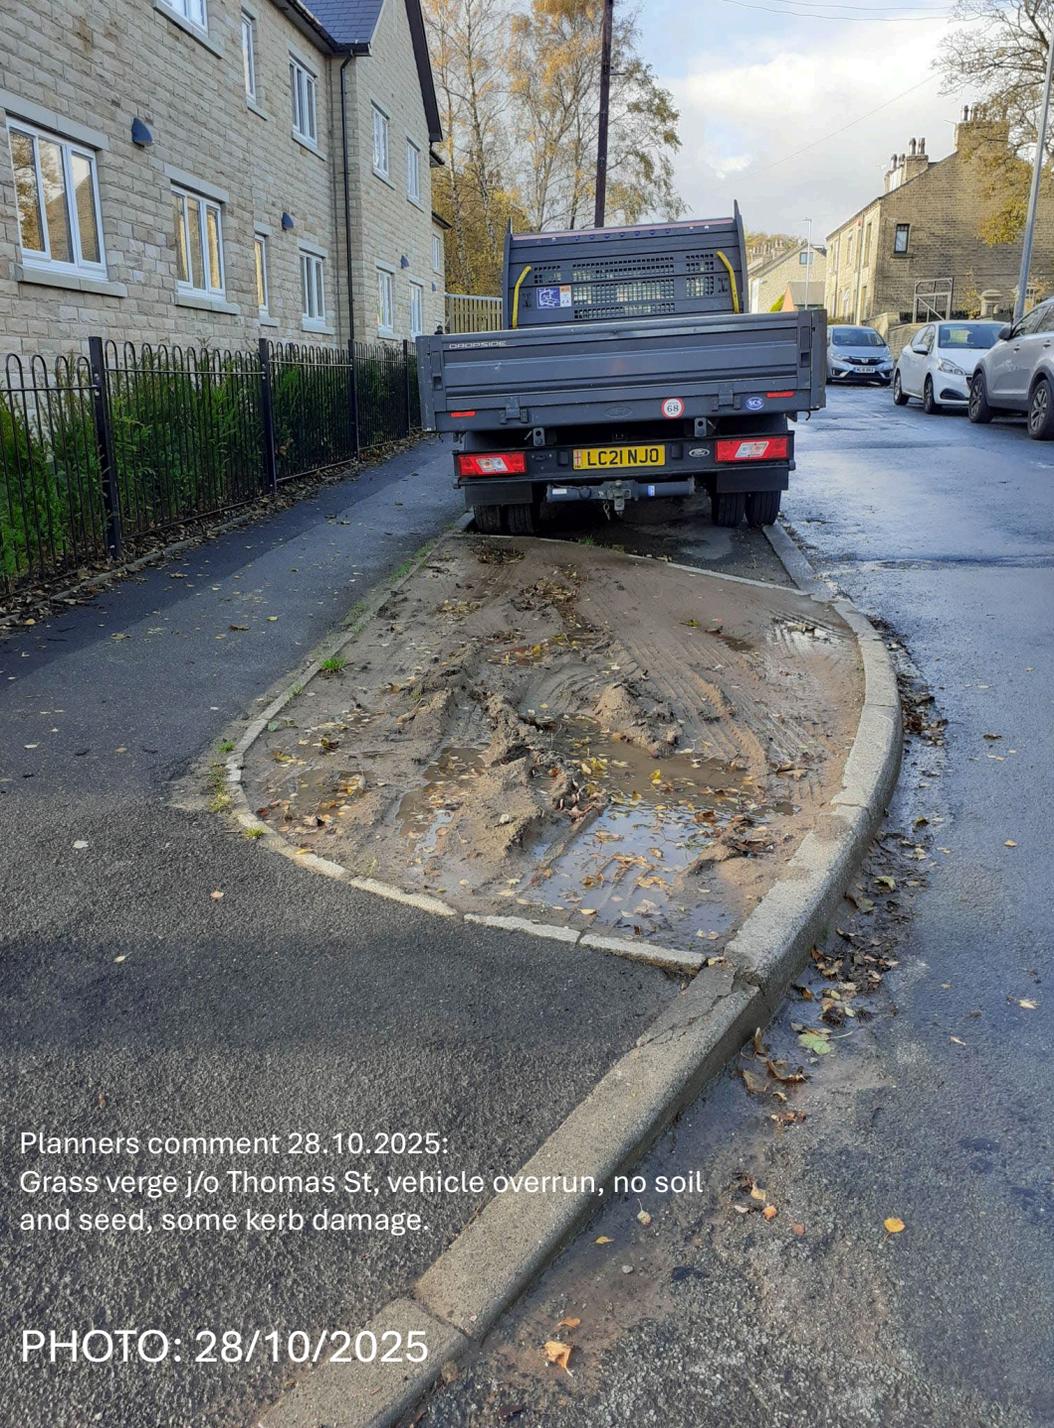
PHOTO: 28/10/2025

Planners comment 28.10.2025:
Grass verge j/o Thomas St, vehicle overrun, no soil
and seed, some kerb damage.

TPL response
30.10.2025:
Damaged kerbs in the
photos are existing
and have remained so,
during construction of
the care home.
Grass verge vehicle
overrun is also an
existing condition.

**Summary: No further
action required.**

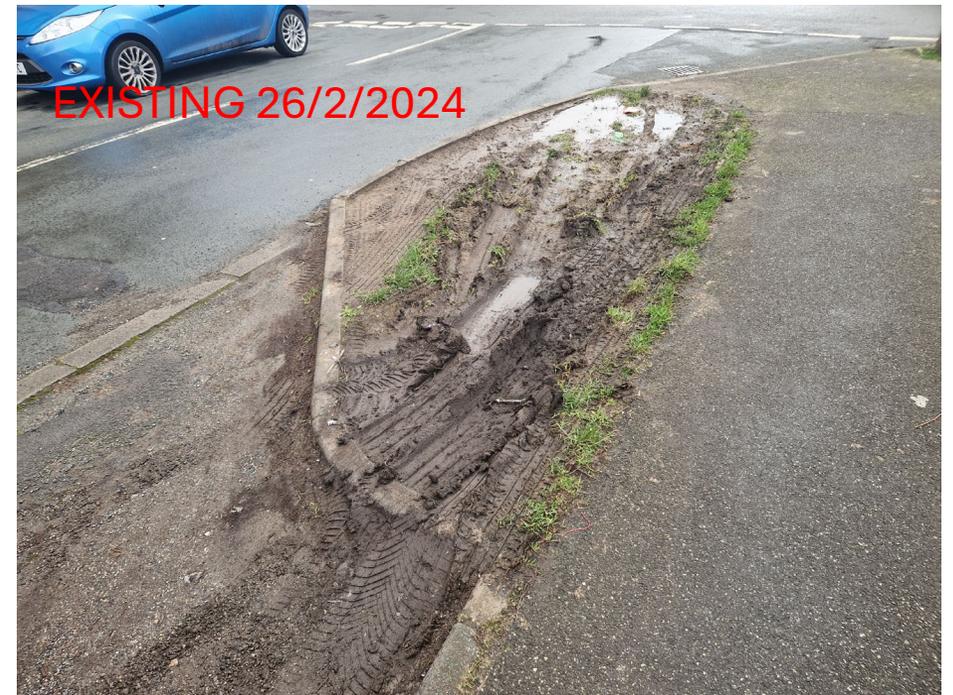
PHOTO: 28/10/2025

Planners comment 28.10.2025:

Grass verge j/o Thomas St, vehicle overrun, no soil and seed, some kerb damage.

TPL response 30.10.2025:

Damaged kerbs in the photos are existing and have remained so, during construction of the care home.

Grass verge vehicle overrun is also an existing condition.

Summary: No further action required.

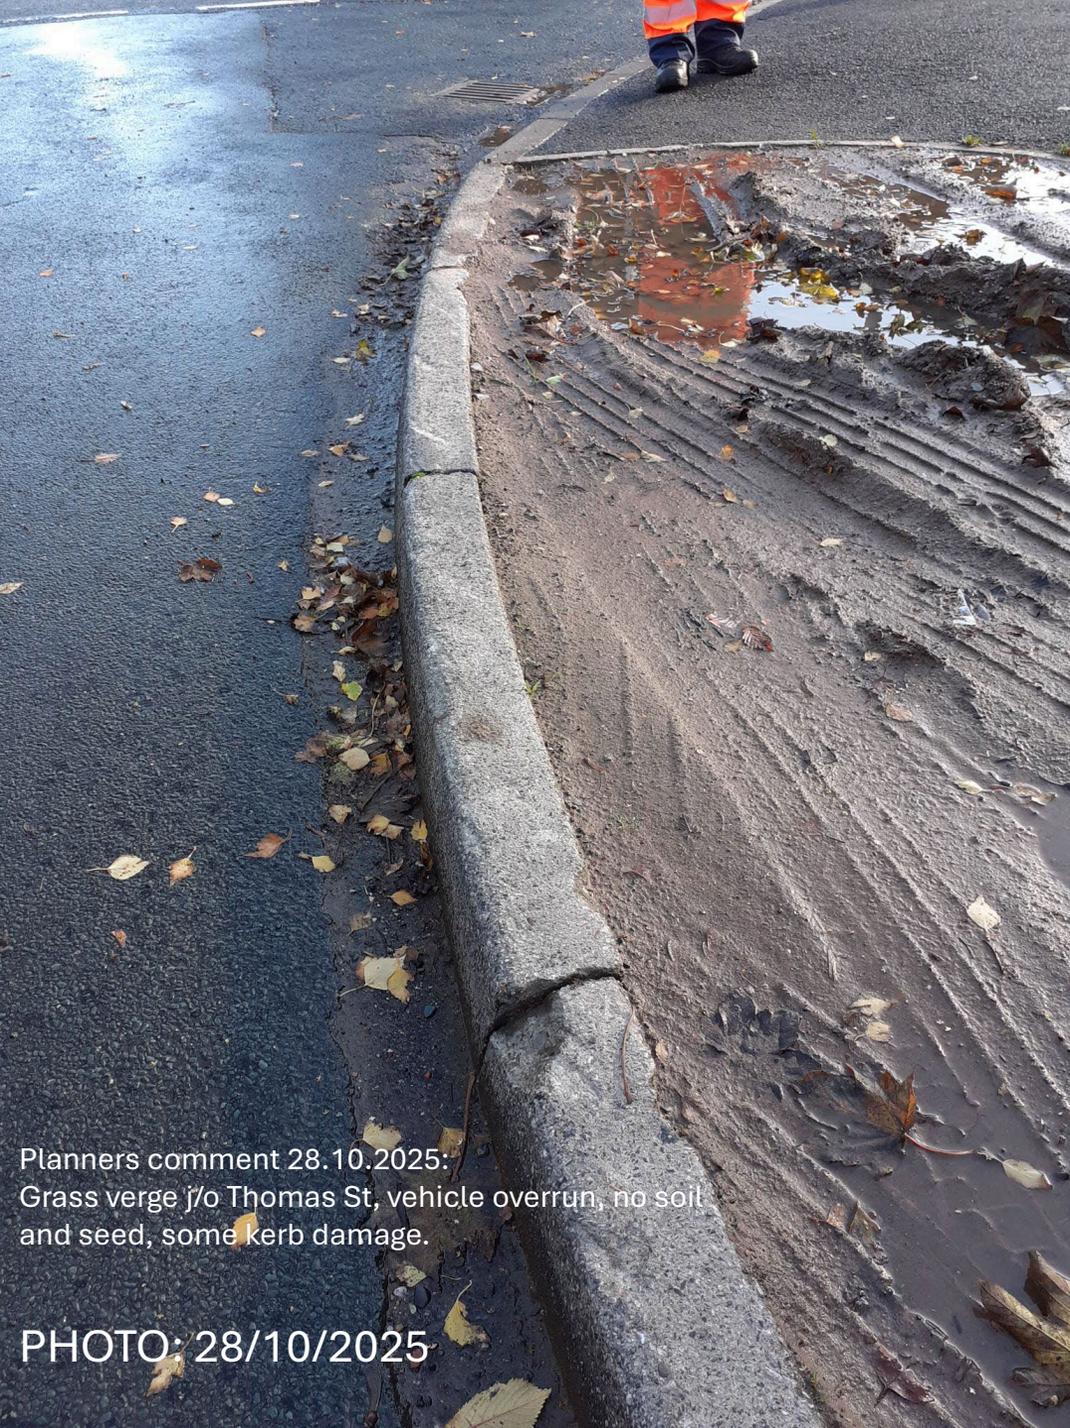
PHOTO: 28/10/2025

Planners comment 28.10.2025:
Grass verge j/o Thomas St, vehicle overrun, no soil
and seed, some kerb damage.

Damaged kerbs in the photos are existing and have remained
so, during construction of the care home.

Grass verge vehicle overrun is also an existing condition.

Summary: No further action required.

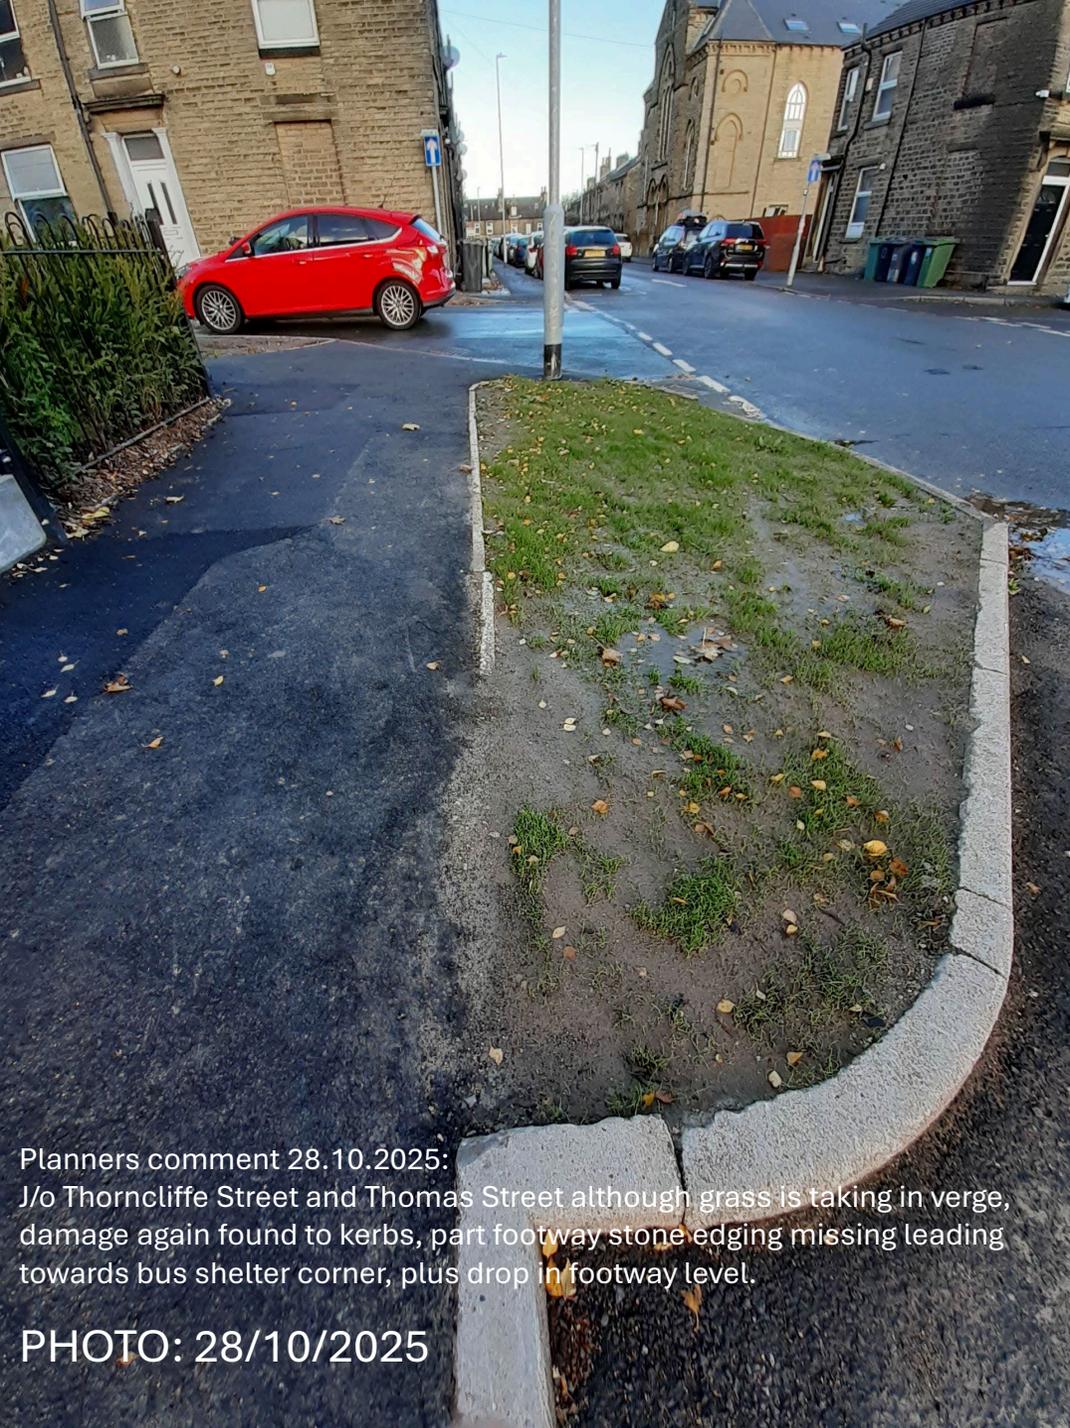
TPL response
30.10.2025:
Kerbs in the photos are existing and have remained so, during construction of the care home.
Stone edging missing was an existing condition.

Summary: No further action required.

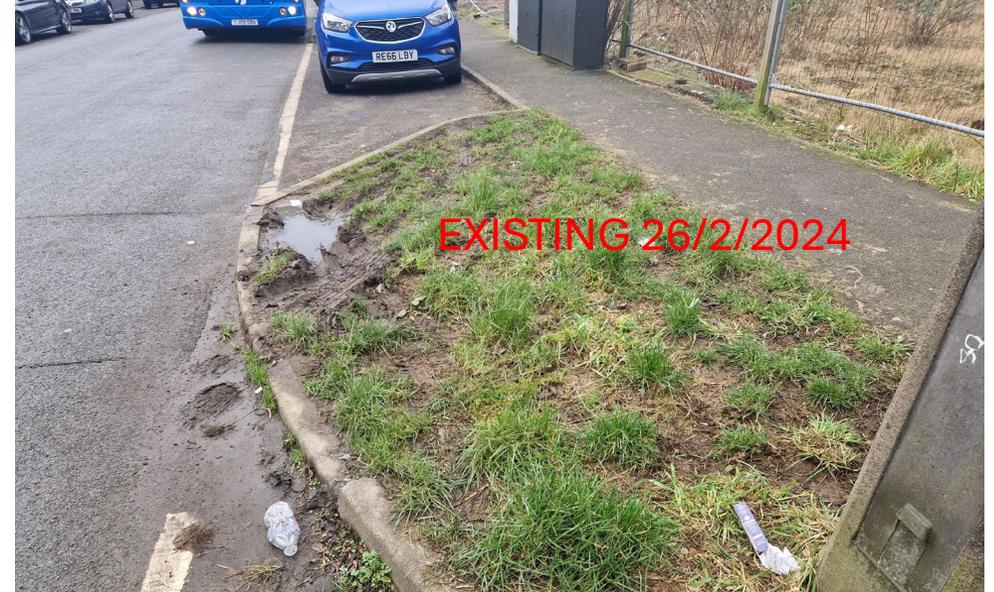
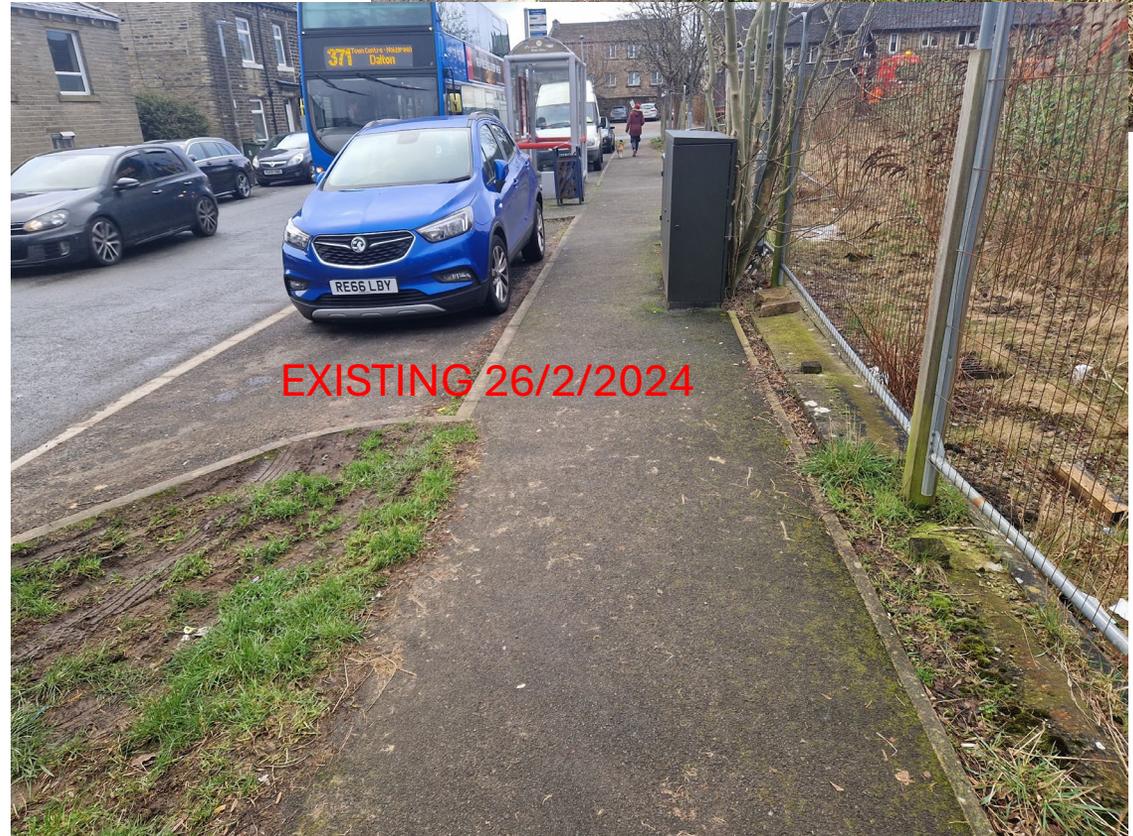
PHOTO: 28/10/2025

Planners comment 28.10.2025:
J/o Thorncliffe Street and Thomas Street although grass is taking in verge, damage again found to kerbs, part footway stone edging missing leading towards bus shelter corner, plus drop in footway level.

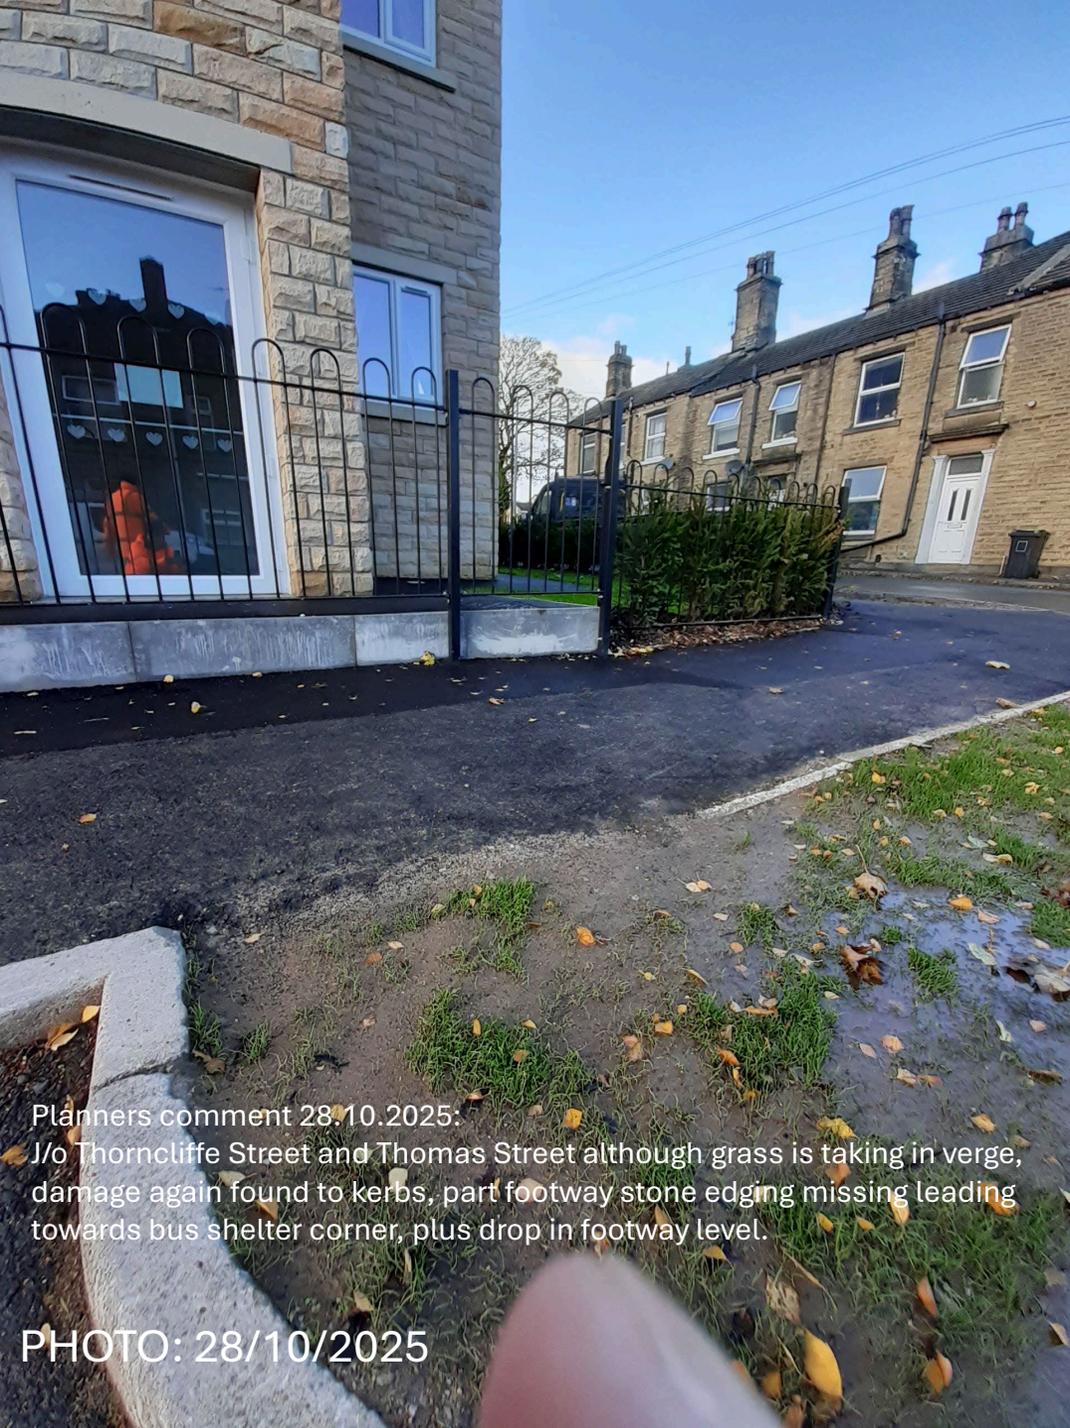
PHOTO: 28/10/2025

Planners comment 28.10.2025:

J/o Thorncliffe Street and Thomas Street although grass is taking in verge, damage again found to kerbs, part footway stone edging missing leading towards bus shelter corner, plus drop in footway level.

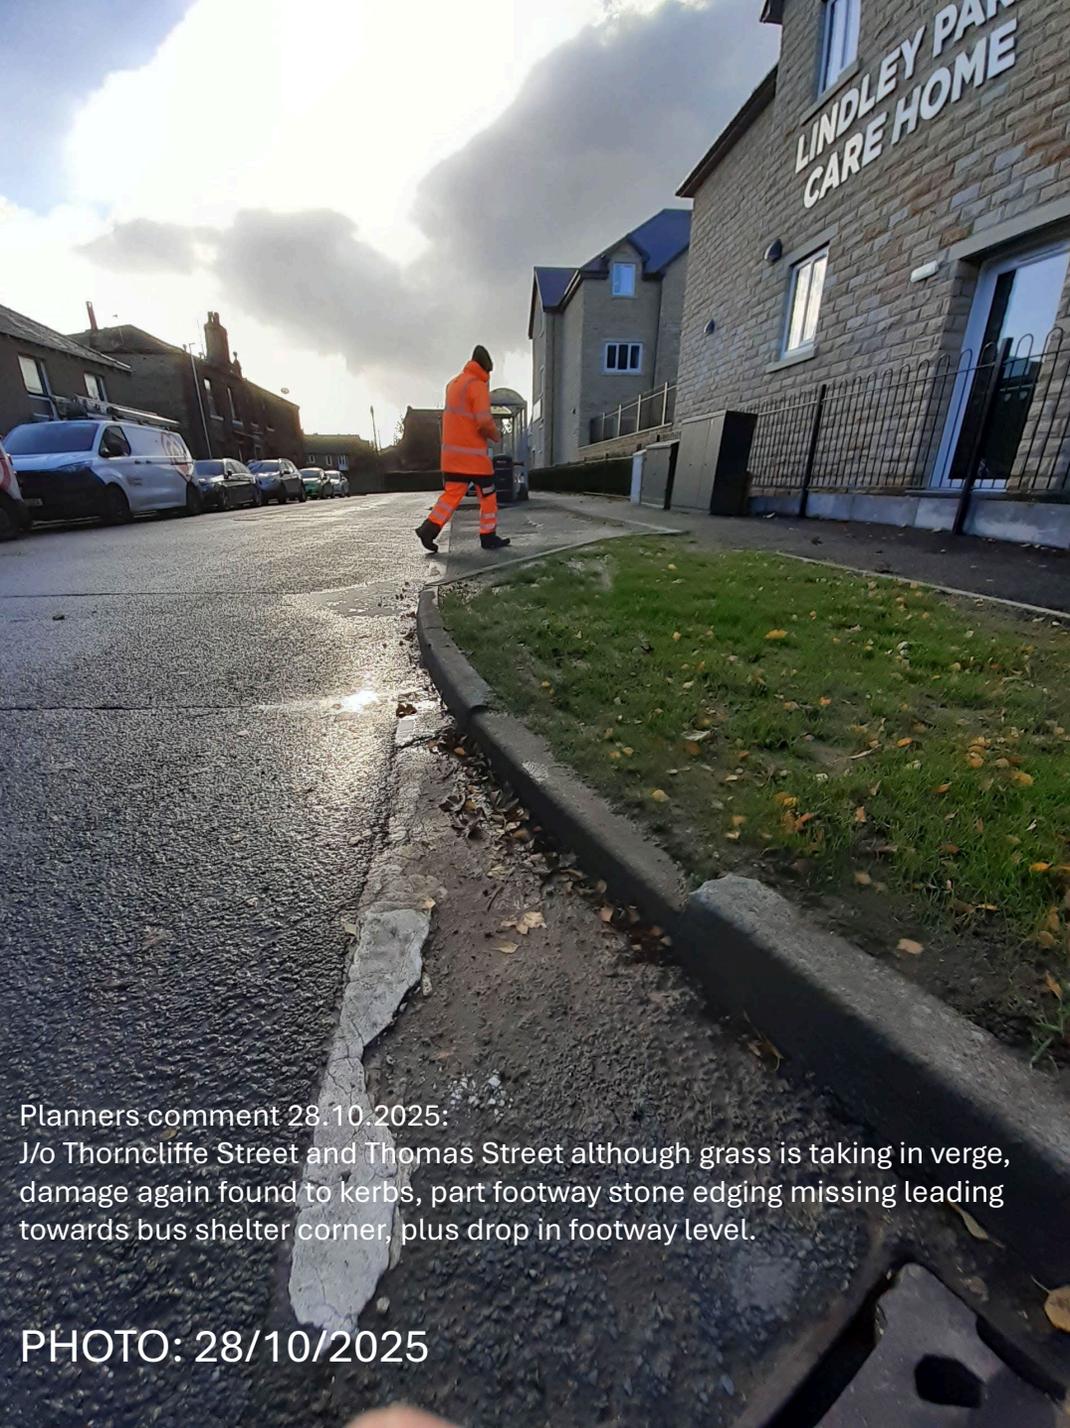
PHOTO: 28/10/2025

Planners comment 28.10.2025:
J/o Thorncliffe Street and Thomas Street although grass is taking in verge, damage again found to kerbs, part footway stone edging missing leading towards bus shelter corner, plus drop in footway level.

TPL response 30.10.2025:
Damaged kerbs in the photos are existing and have remained so, during construction of the care home.

Summary: No further action required.

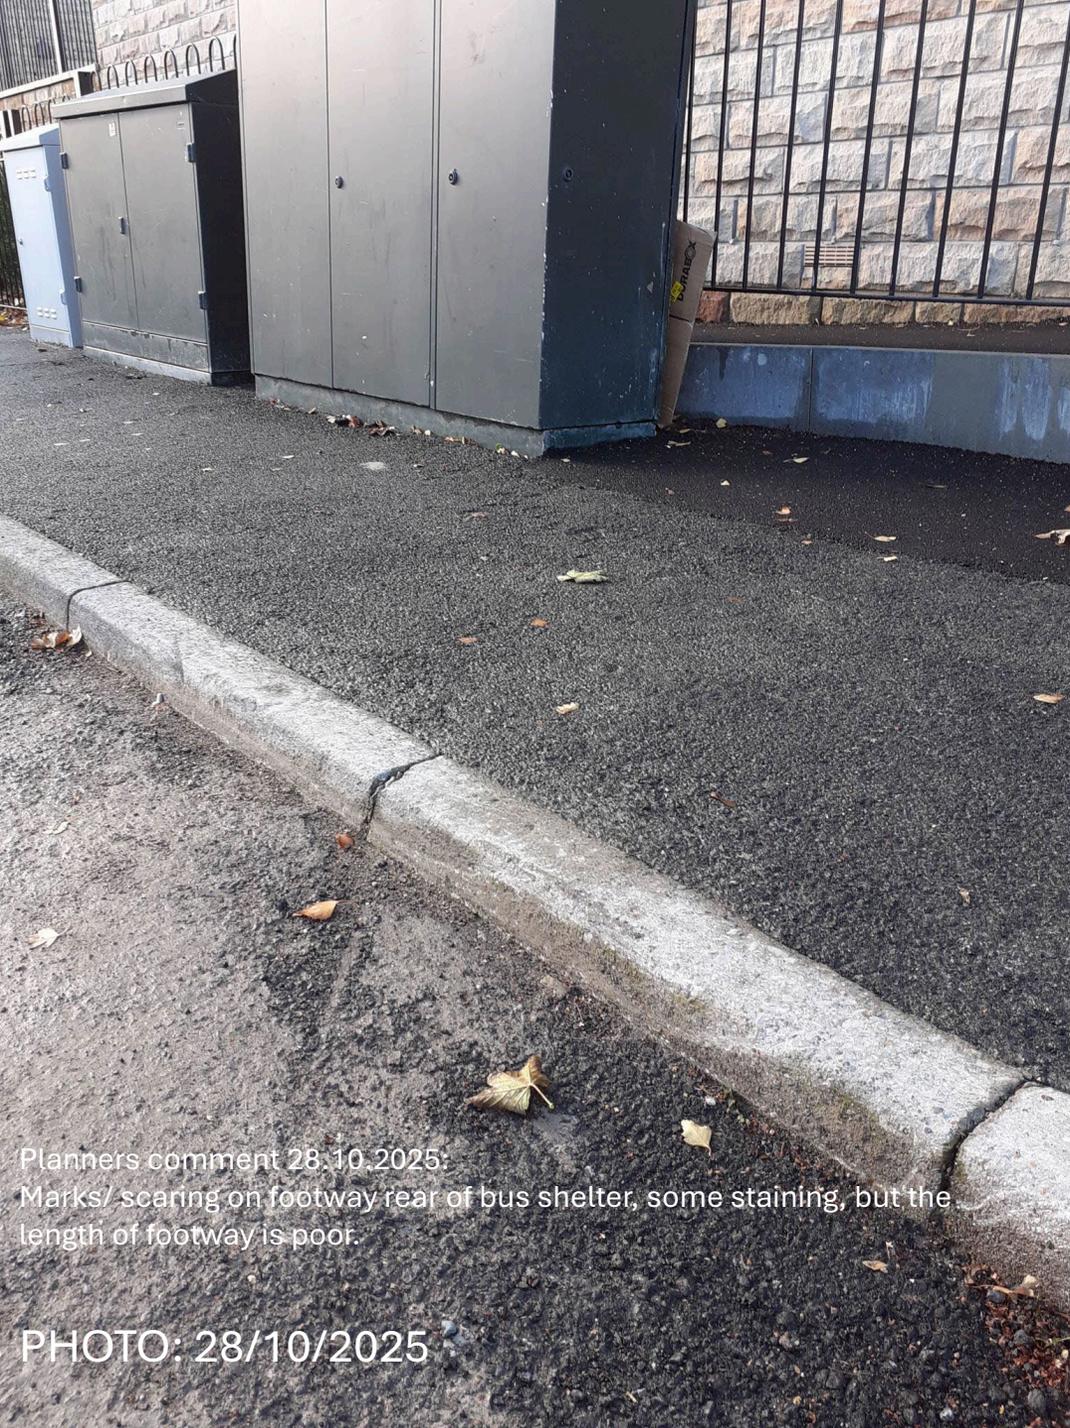
TPL response 30.10.2025:
Marks & scaring on kerbs in the photos
are existing and have remained so, during
construction of the care home.

Planners comment 28.10.2025:
Marks/ scaring on footway rear of bus shelter, some staining, but the
length of footway is poor.

Summary: No further action required.

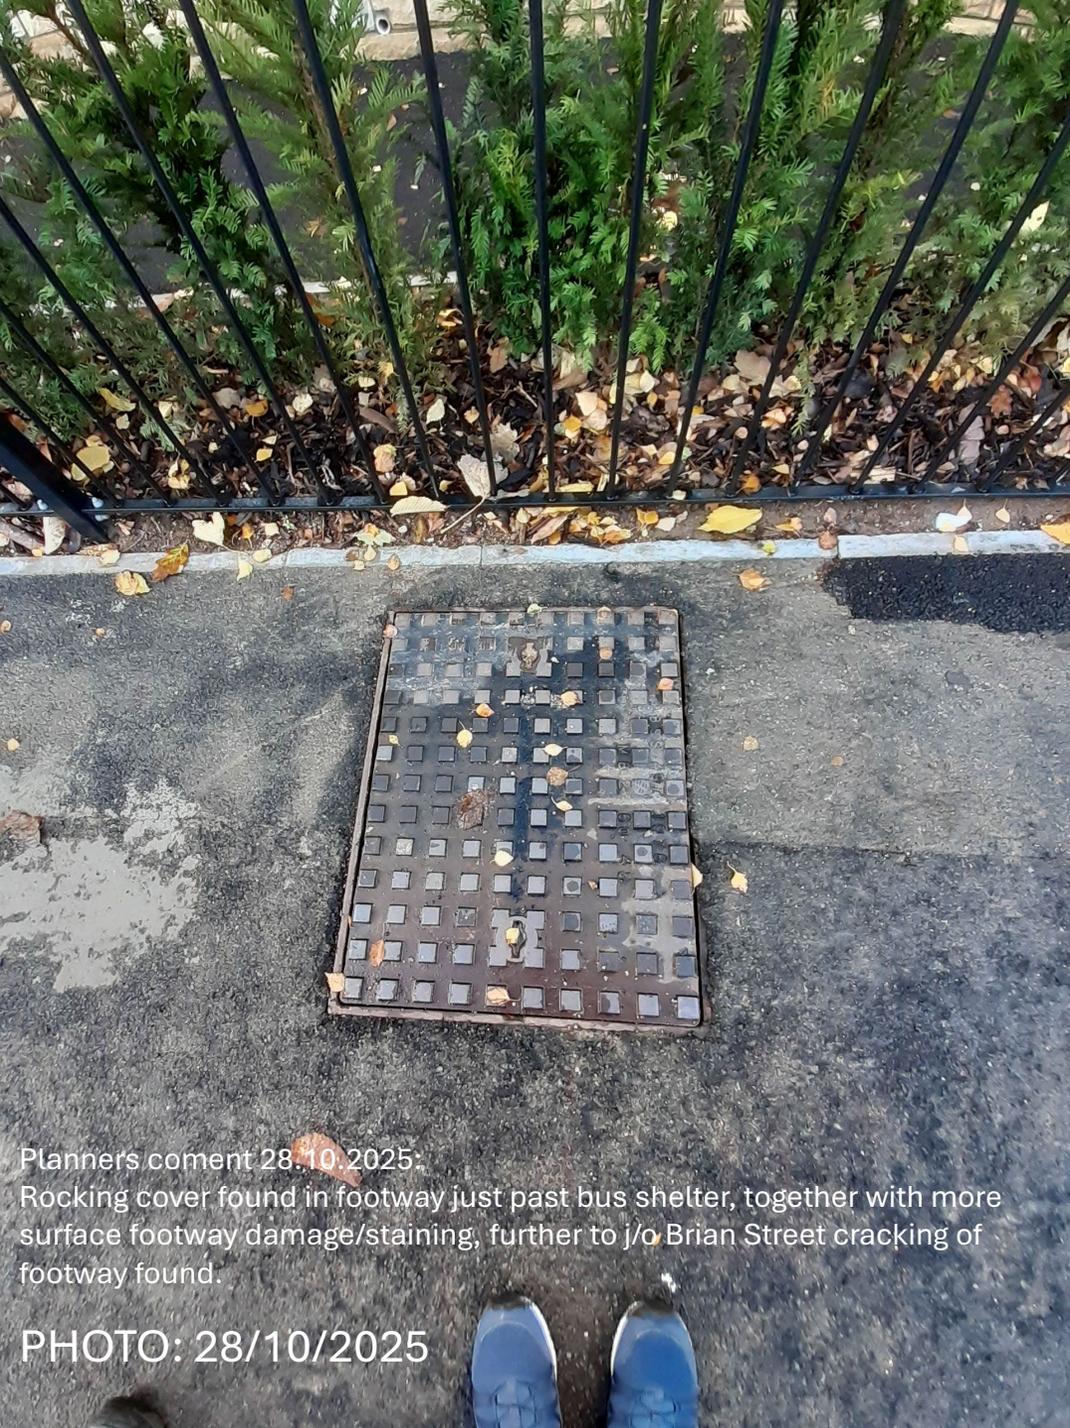
PHOTO: 28/10/2025

Planners coment 28.10.2025:
Rocking cover found in footway just past bus shelter, together with more surface footway damage/staining, further to j/o Brian Street cracking of footway found.

Will be patched by Torsion Projects

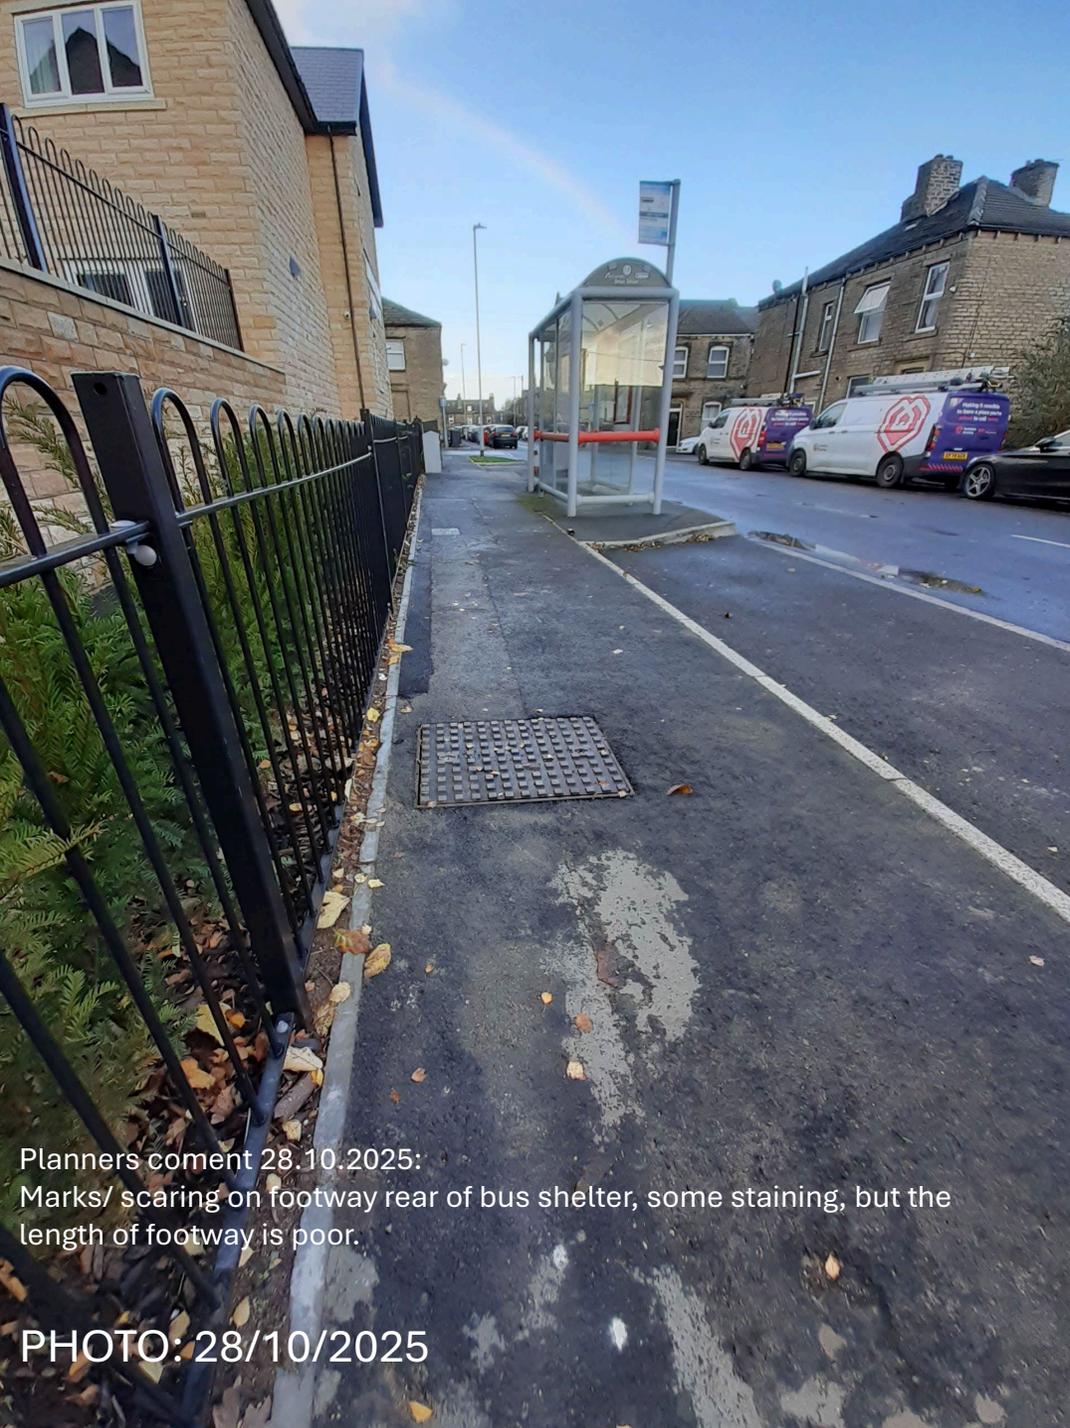
PHOTO: 28/10/2025

Planners coment 28.10.2025:
Marks/ scaring on footway rear of bus shelter, some staining, but the
length of footway is poor.

TPL response 30.10.2025:
Marks & scaring on kerbs in the photos are existing and
have remained so, during construction of the care home.

Summary: No further action required.

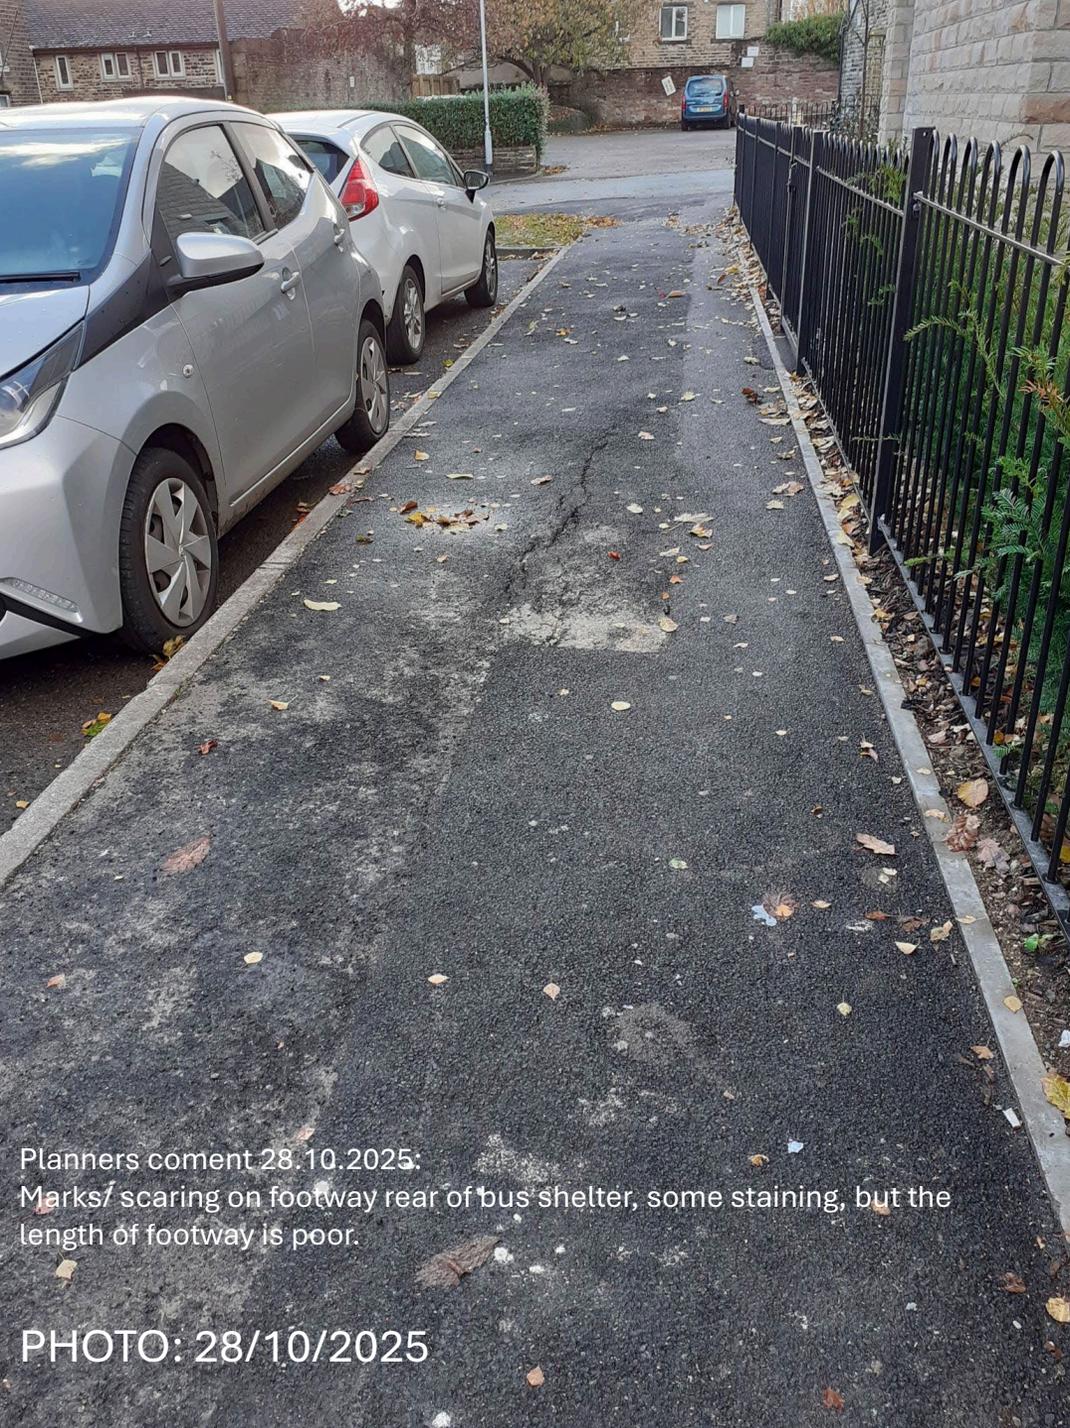
PHOTO: 28/10/2025

Planners coment 28.10.2025:
Marks/ scaring on footway rear of bus shelter, some staining, but the
length of footway is poor.

Will be patched by Torsion Projects

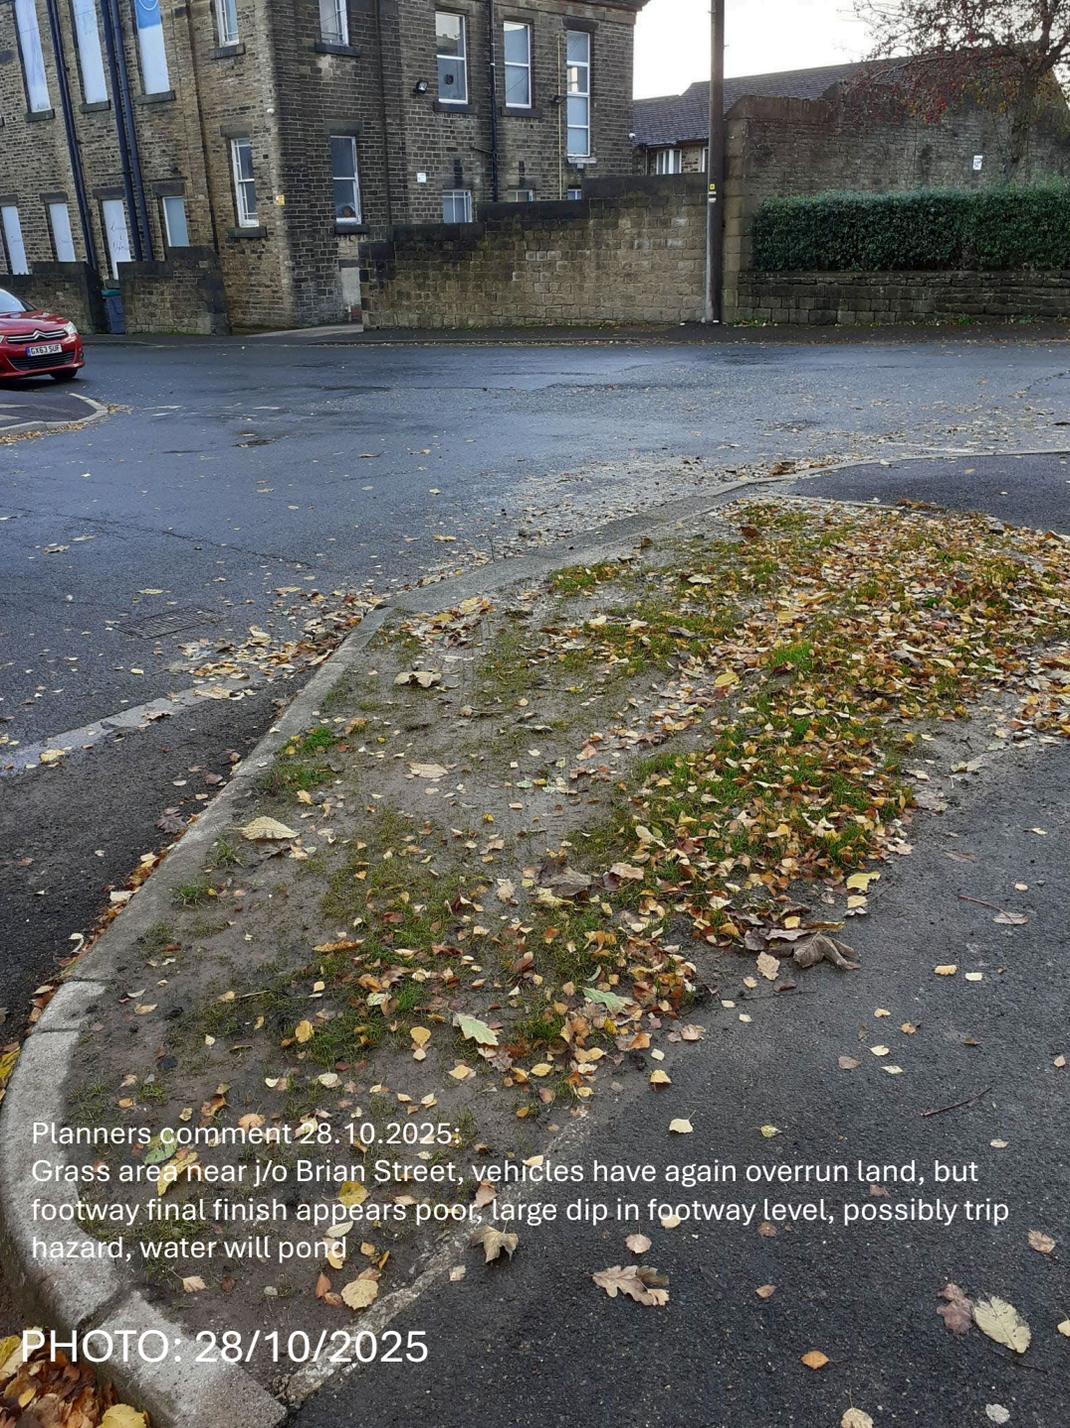
PHOTO: 28/10/2025

Planners comment 28.10.2025:
Grass area near j/o Brian Street, vehicles have again overrun land, but footway final finish appears poor, large dip in footway level, possibly trip hazard, water will pond

TPL response 30.10.2025:
Grass verge vehicle overrun is also an existing condition.

Summary: Footway and dip will be rectified by Torsion Projects

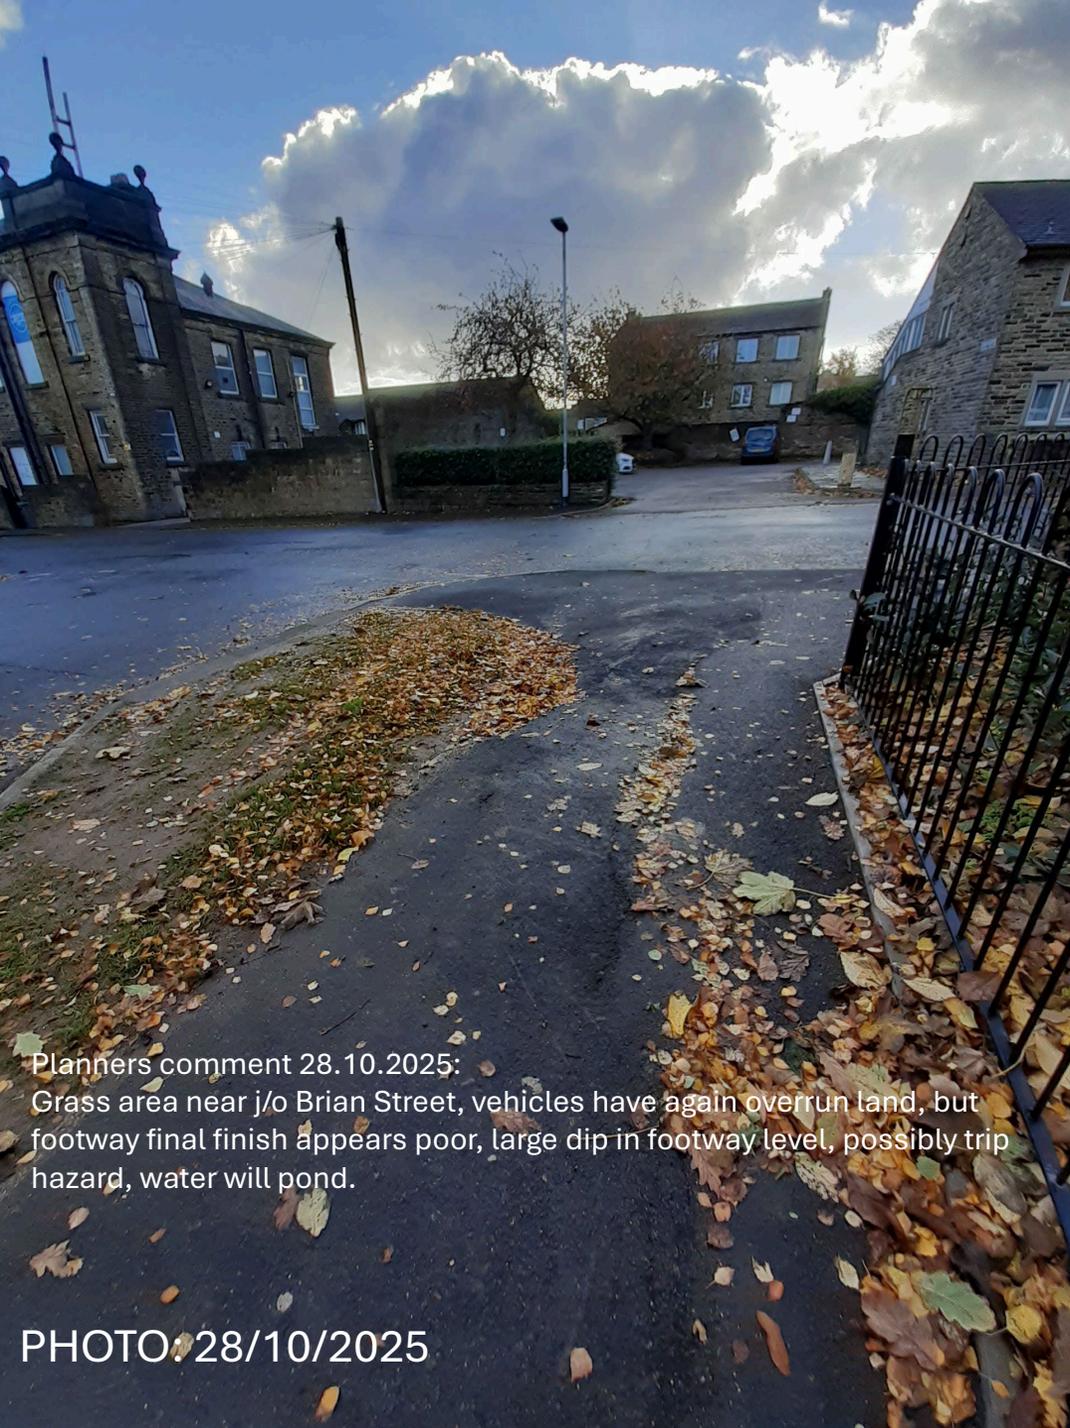
PHOTO: 28/10/2025

Planners comment 28.10.2025:
Grass area near j/o Brian Street, vehicles have again overrun land, but footway final finish appears poor, large dip in footway level, possibly trip hazard, water will pond.

TPL response 30.10.2025:
Grass verge vehicle overrun is also an existing condition.

Summary: Footway and dip will be rectified by Torsion Projects
